GEOTECHNICAL INSPECTIONS

Mary River Mine, Nunavut

October 31, 2017

702751

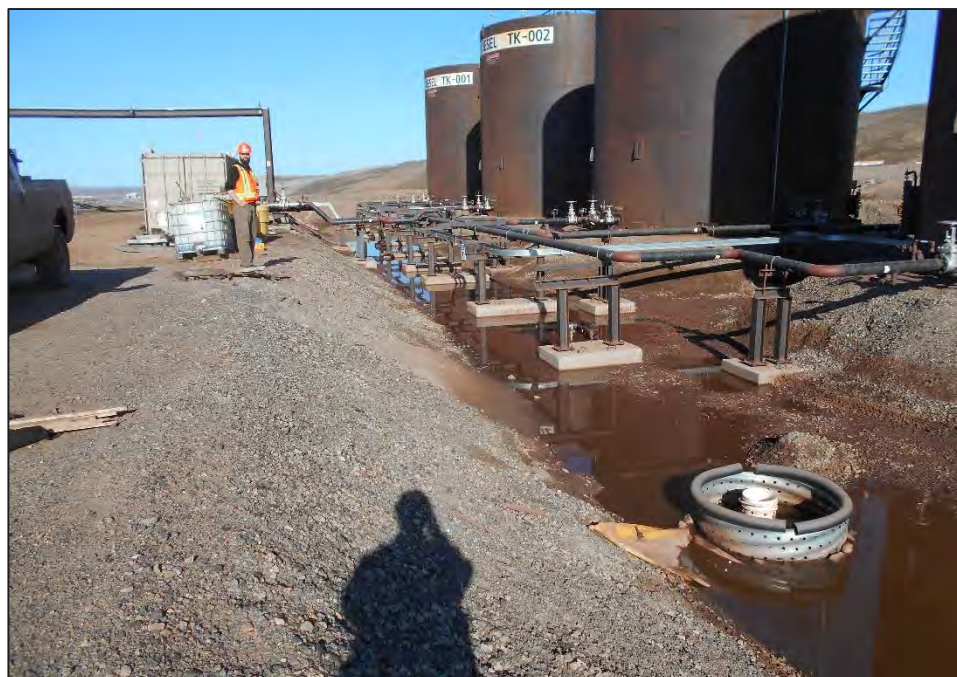
Photo: 2

Bulk Fuel Diesel ASTs – looking west along north berm. Note slope protection and an area where repairs made to berm.
