RE: Submission of 2018 Geotechnical Inspection Report No. 1 (Jul/Aug. 2018)

BAFFINLAND IRON MINES CORPORATION

ANNUAL GEOTECHNICAL INSPECTIONS

MARY RIVER PROJECT

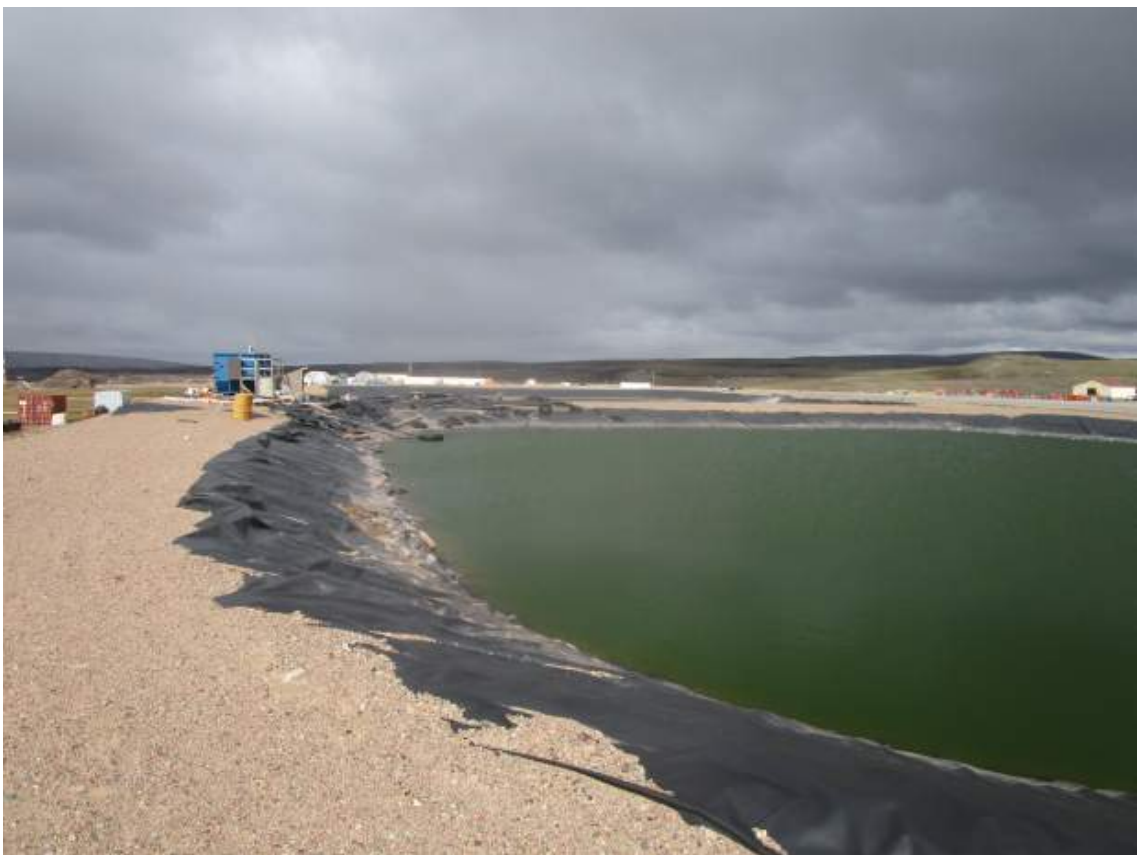
4. PWSP #2

Our review of this area around the pond at the base of the slopes showed no sign of seepage and hence we conclude that the liner has been effective in containing sewage and there are no tears or ruptures in the membrane, excepting some minor tears from past activity at the top of the dyke well above the allowable effluent level in the structure in the horizontal portion of the membrane.

A review of the top of the dyke showed no indication of cracking or settlement which would indicate stresses within the structure.

Many of the tears that had occurred in the liner on the top of the dyke have been patched during the period between reviews in 2008 and 2009 and are holding well. As well, there are no signs of weather related deterioration of the liner where it is exposed.
