RE: Submission of 2018 Geotechnical Inspection Report No. 2 (Oct. 2018)

SECOND INSPECTION OF TWO

October 2018

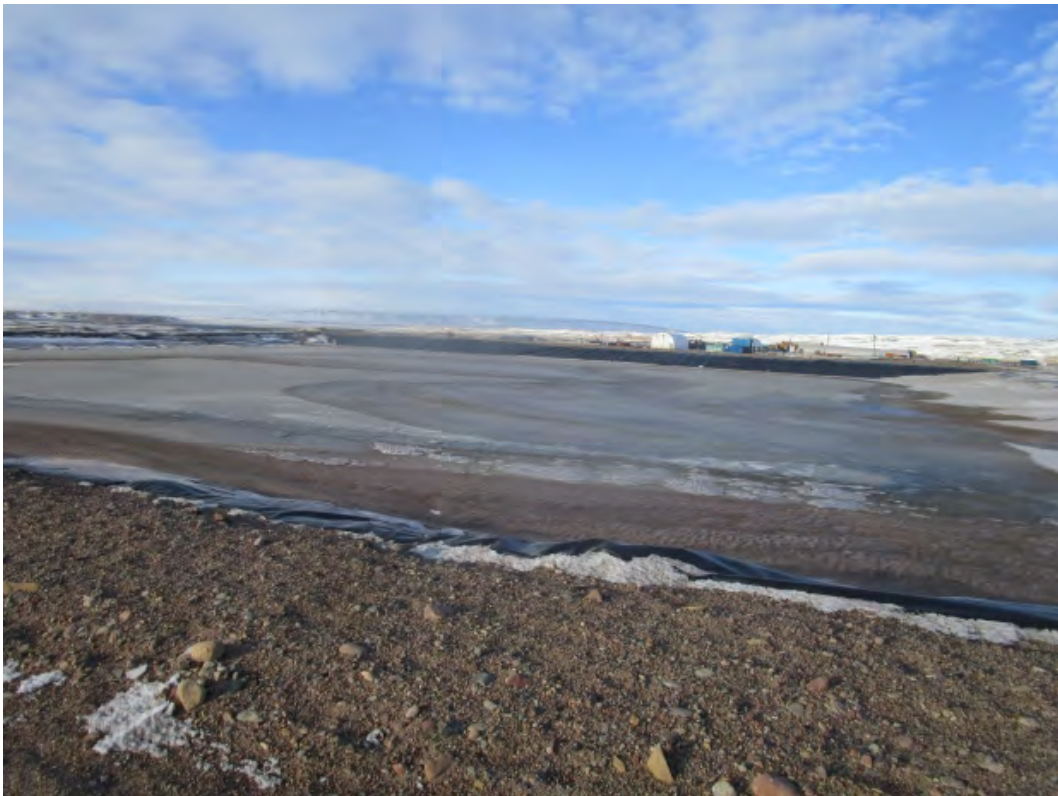
D. PWSP #3

Our review of the area around the pond at the base of the slopes showed no sign of seepage and hence we conclude that the liner has been effective in containing the sewage and there are no tears or ruptures in the membrane.

Monitoring points have been set up on the top of the dyke and have been monitored since 2009. Settlements have occurred since that time. These settlements have not led to any stress cracks in the structure. Monitoring was discontinued three years ago. There is no sign that these very minor settlements are affecting the function of this containment structure.

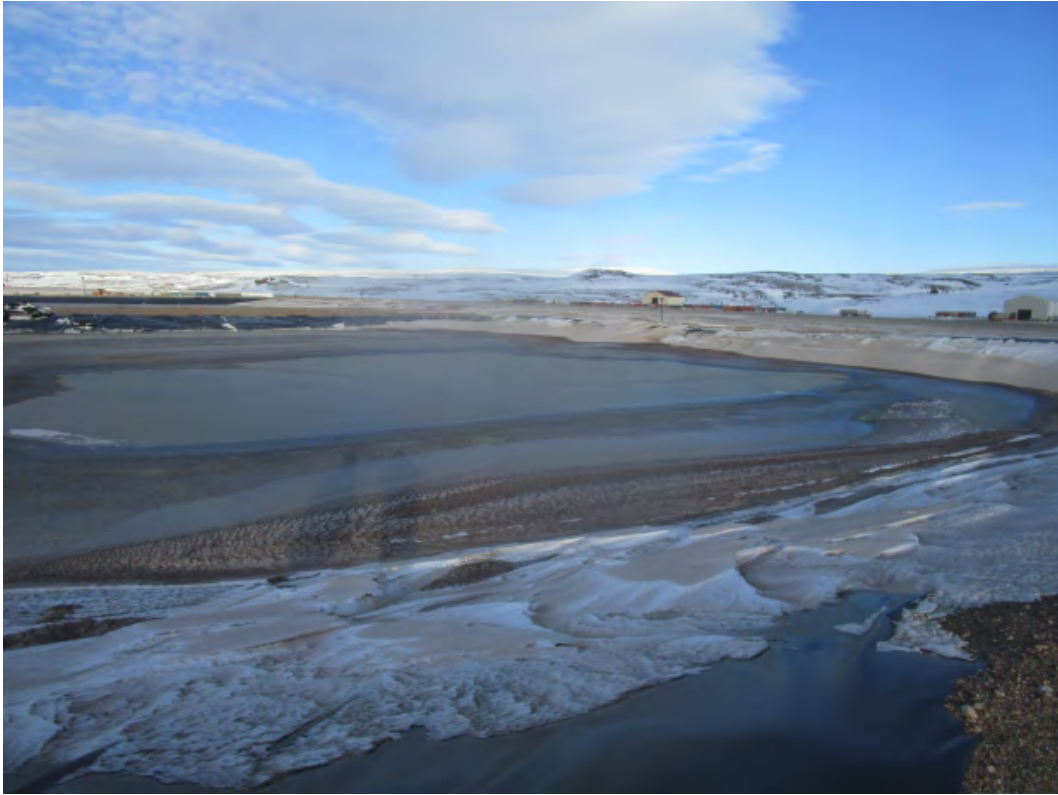
E. PWSP #2

Our review of this area around the pond at the base of the slopes showed no sign of seepage; hence, we conclude that the liner has been effective in containing sewage. There are no tears or ruptures in the membrane, excepting some minor tears from past activity at the top of the dyke well above the allowable effluent level in the structure in the horizontal portion of the membrane. Travel with small machinery in the past has caused many punctures and small tears in the top of the dyke.

Many of the tears that had occurred in the liner on the top of the dyke have been patched during the period between reviews in 2008 and 2009 and are holding well. As well, there are no signs of weather related deterioration of the liner where it is exposed.

The damage to the liner at the top of the dyke at the area where trucks dump into the cell should be repaired.

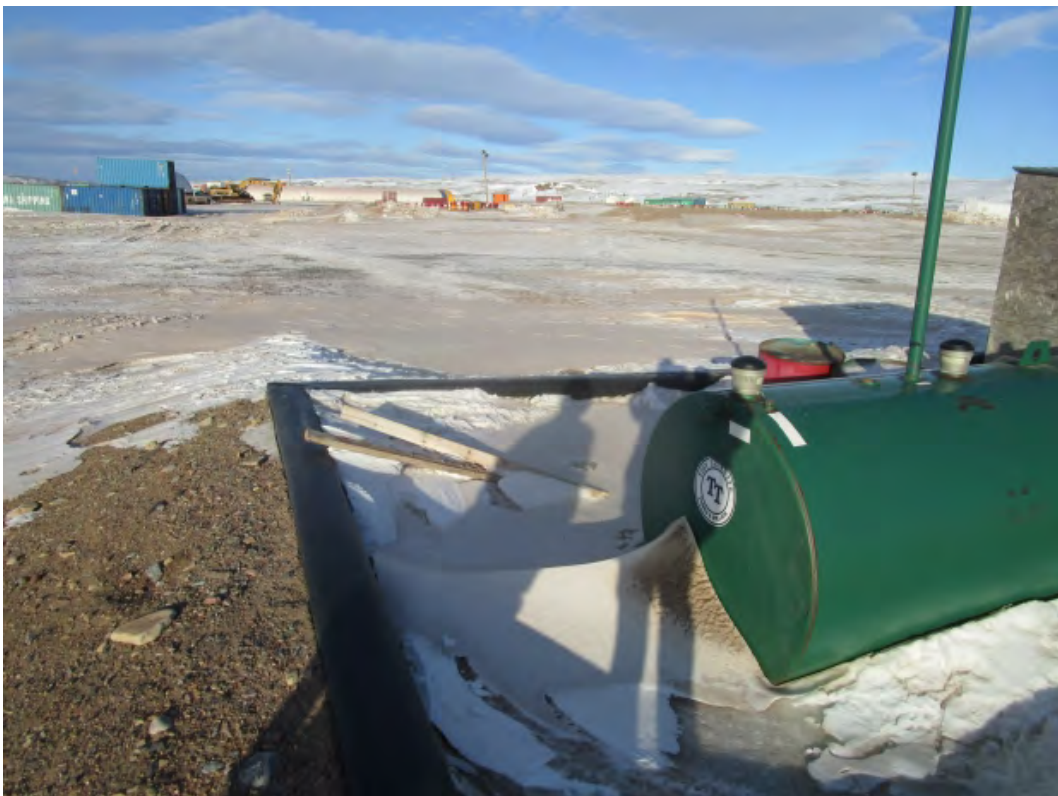
F. Helicopter Fuel Cell Containment

In the past, a liner clad wood curb had been added to the top of the berm to prevent the erosion of gravel off the berm, caused by pulling the fuel hose from within the dyke out to the helicopters to provide them with fuel.

A review of the exterior and the top of the berms showed no sign of cracking or settlement which would indicate stress within the structure.

The structure is considered to be stable in its present condition and contains water and ice that attests to its integrity.
