RE: Submission of 2019 Geotechnical Inspection Report No. 1 (July 2019)

Project #: TC190307

Annual Geotechnical Inspections – 2019 Report 1. Mary River Iron Mine Complex – Nunavut

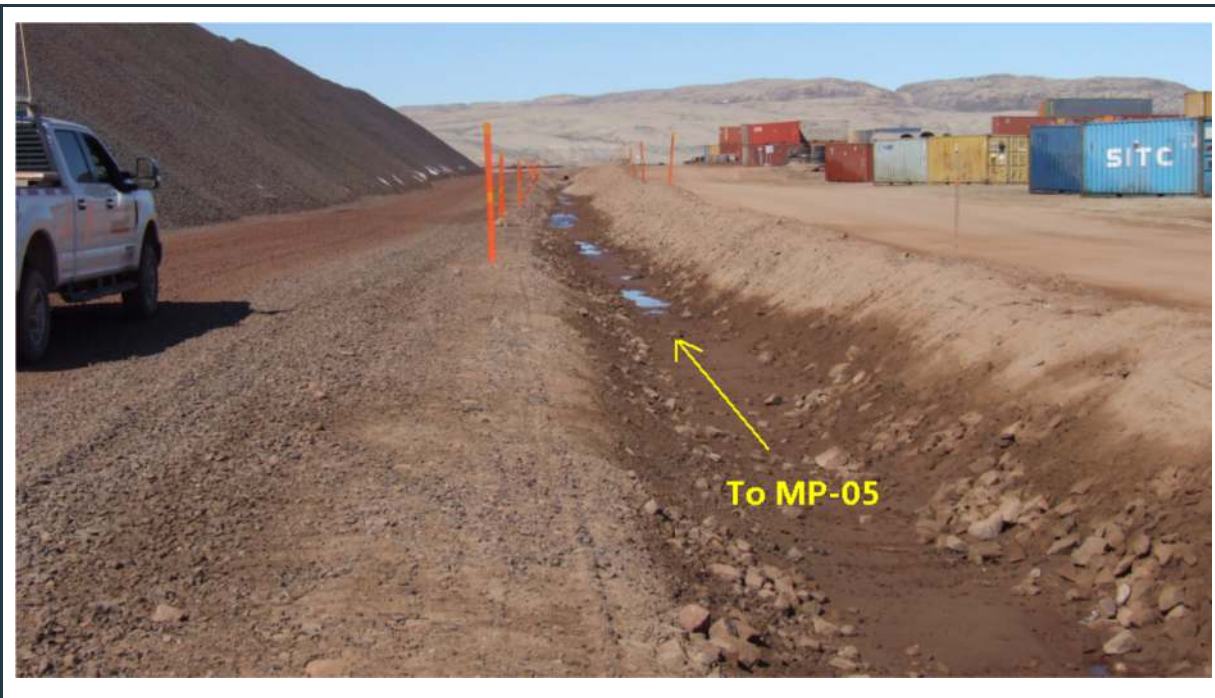
Figure 56: View of the MP-05 pond
