**RE: 2019 Inspection of the Milne Inlet Tote Road & Associated Borrow Sources  
Mary River Project, Type A Water Licence 2AM-MRY1325**

**2019 Inspection of the Milne Inlet Tote Road and Associated Borrow Sources**

DECEMBER 19, 2019  
ISSUED FOR USE  
FILE: ENG.EARC03171-01

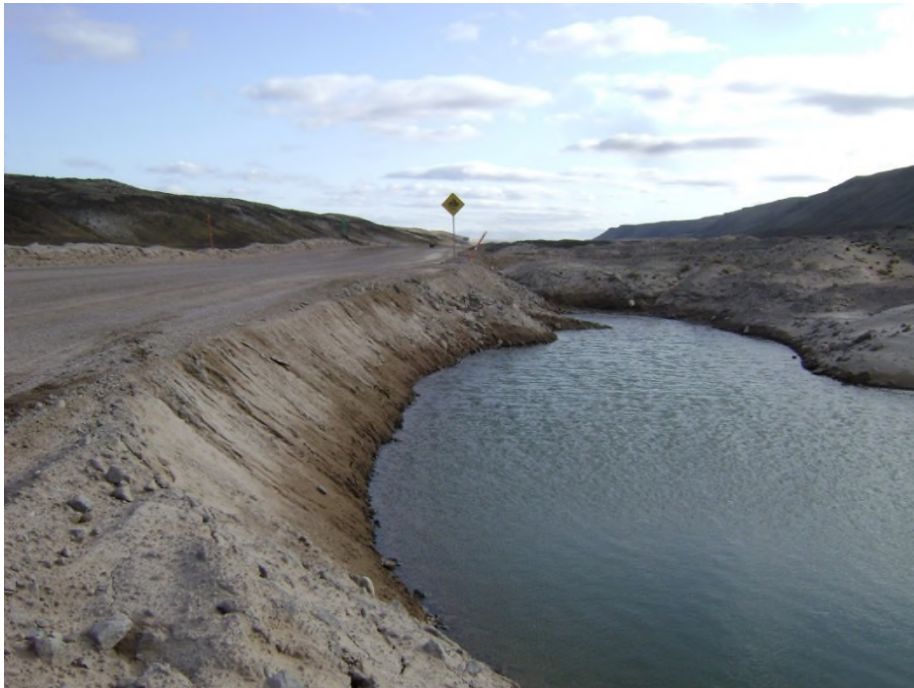
**Photo 26 (2597):**

10. KM 89.8 (pit 14) – See Photos 26 and 27. This is a very deep pond resulting from thaw of a massive ice body initiated because the protective active layer material was removed. Thaw is continuing and appears to be occurring under the side slopes of the road which are very steep and unstable. This pit should have the water removed and then it should be backfilled at least up to the elevation of the original ground. If sufficient material is not available to do this, 5 m wide berms should immediately be constructed along the toe of the slope to an elevation 1 m below the top of the embankment. This will hopefully start to arrest the thaw and provide additional stability to the road embankment.

Pit at KM 89.8 (Figure 12), photo shows borrow pit on the right side with very deep ponding due to thaw (centre of photo). Larger pond on the right is a natural thermokarst pond that existed before the road was constructed and is typical of the ponds that form due to thaw of massive ice bodies. This was likely also the case at the borrow pit location where the removal of the active layer initiated thaw of massive ice.

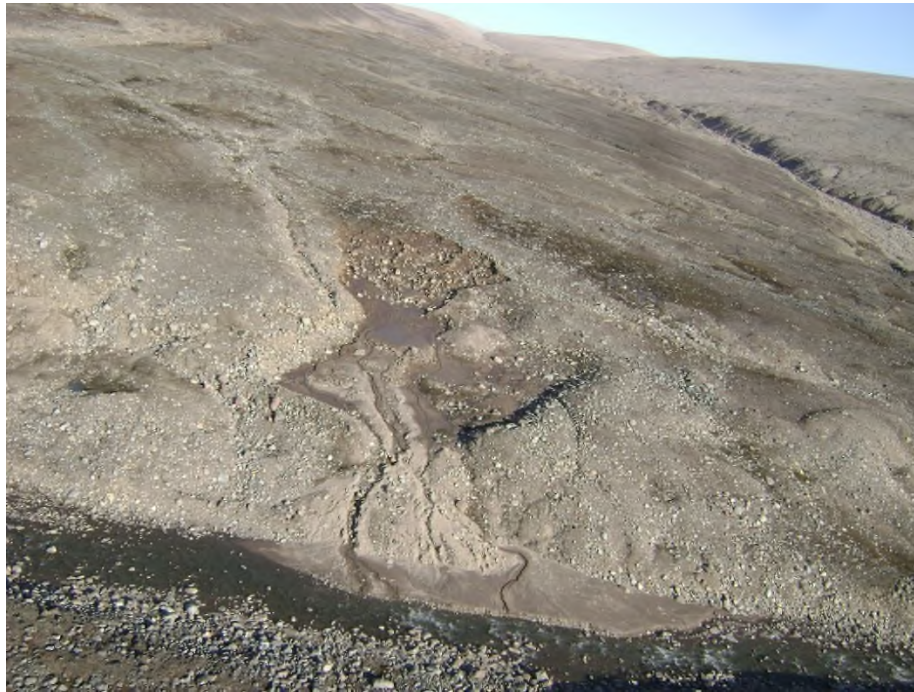
**Photo 43 (2721):**

Natural instability feature (active layer detachment side) on the headwaters of the Mary River 16 km east-northeast of the mine.

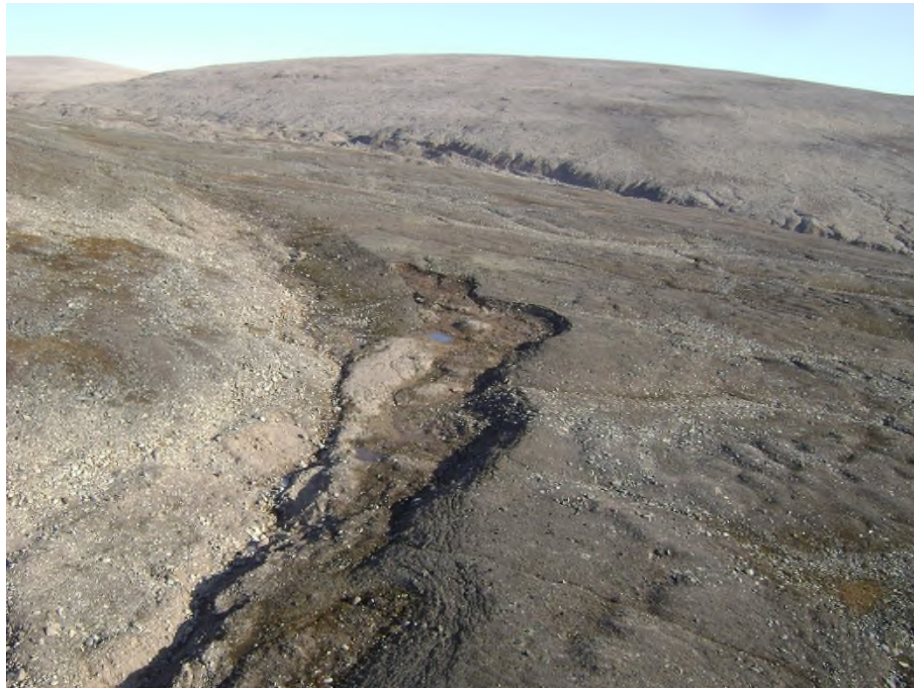
**Photo 44 (2722):**

Another natural instability feature (active layer detachment side) on the headwaters of the Mary River 16 km east-northeast of the mine. Note sedimentation into the river that lead to turbidity being observed in the river near the mine
