Baffinland Iron Mines Corporation

Annual Geotechnical Inspections – 2020 Report 1. Mary River Iron Mine Complex – Nunavut

Re: Annual Site Inspections and Reporting - Mary River Iron Mine Complex, Nunavut

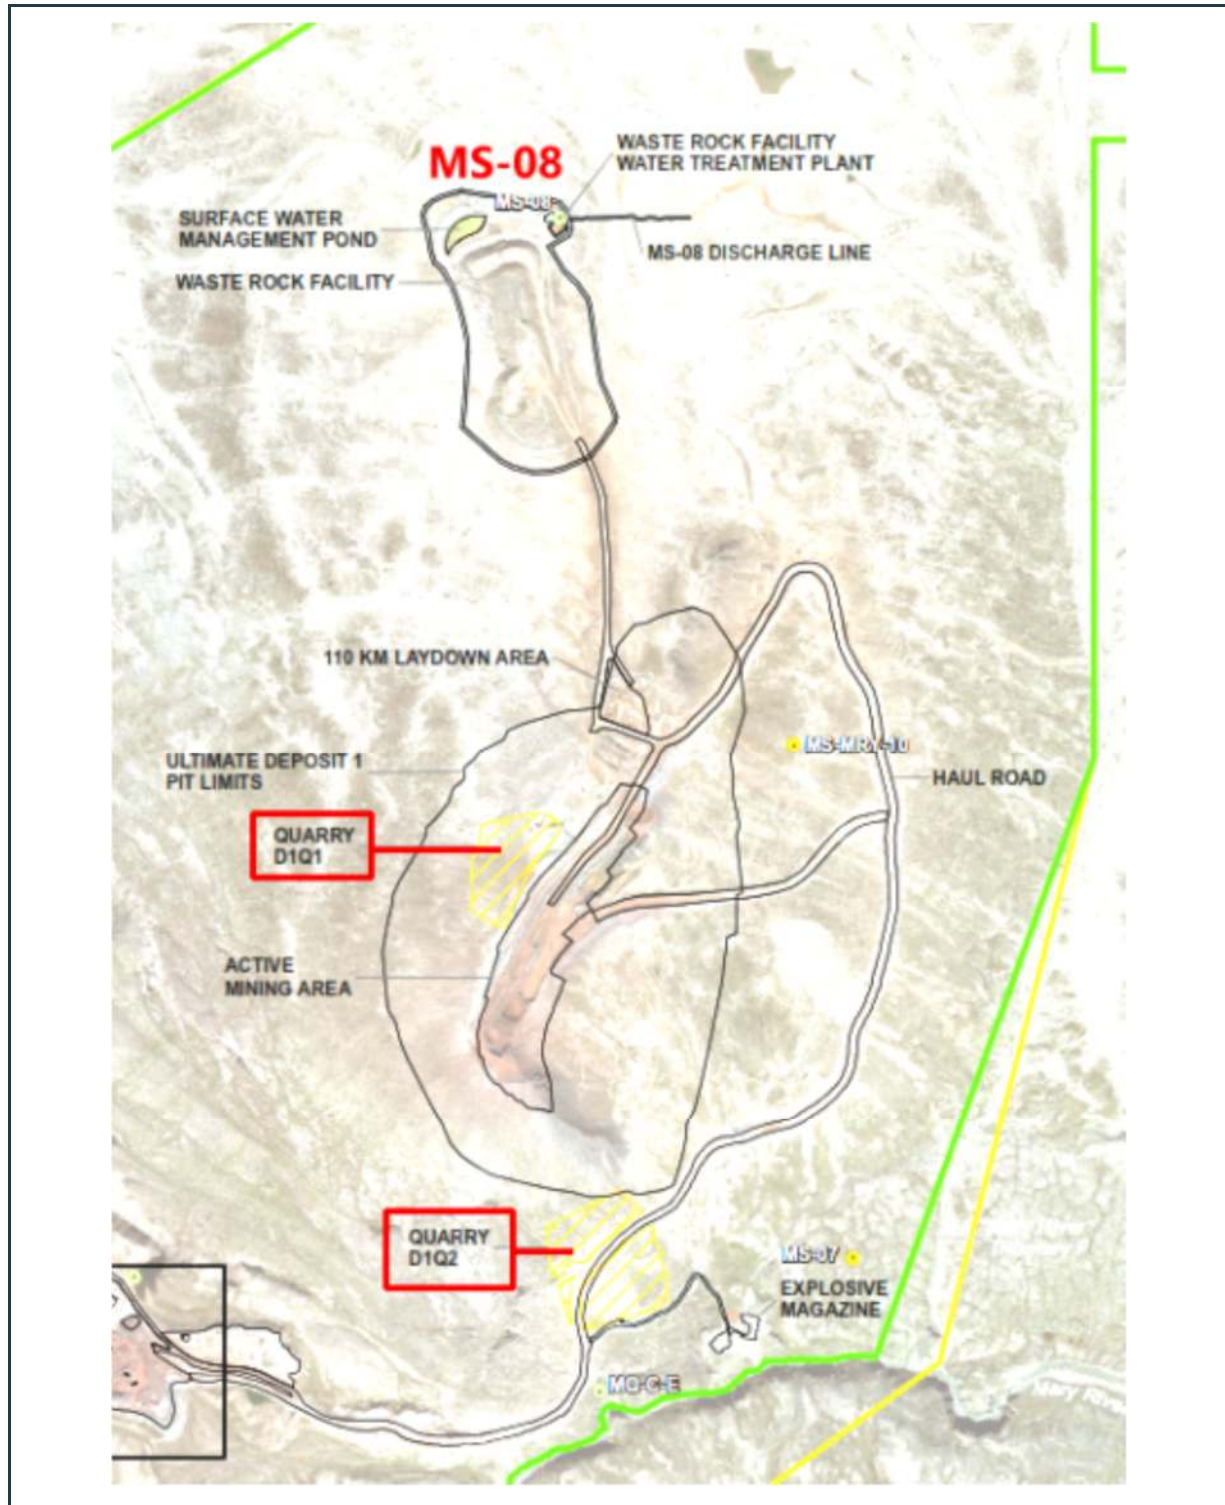
Figure 4: Site layout – Mary River Mine Site – Pit 1, D1Q1 and D1Q2 quarries and MS-08 pond

Similar to the D1Q1, the D1Q2 quarry will be developed as a future source of crushed aggregate. As shown in Figure 4, the selected area of this quarry is located south of the “Deposit-1” open pit, along both sides of the haul road. Maintenance work on the access road to the southern part of the future quarry was carried out during our inspection in July 2020. As shown in Figures 50 to 52, improvement to the surface water control process must still be completed in the area. Currently, all rainwater and melted snow flow without control (proper ditching) along the access road and the culverts, shown in Figure 51, require relocation. In order to improve the surface drainage in the area, ditches with proper sloping reporting to culverts at the lowermost point should be excavated along the road, as proposed in Figure 52.
