Baffinland Iron Mines Corporation

October 31, 2023
Project #: OMGM2212-23

Annual Geotechnical Inspections – 2023 Report 2.

APPENDIX "C" – Tote/Haul Road - Photographs

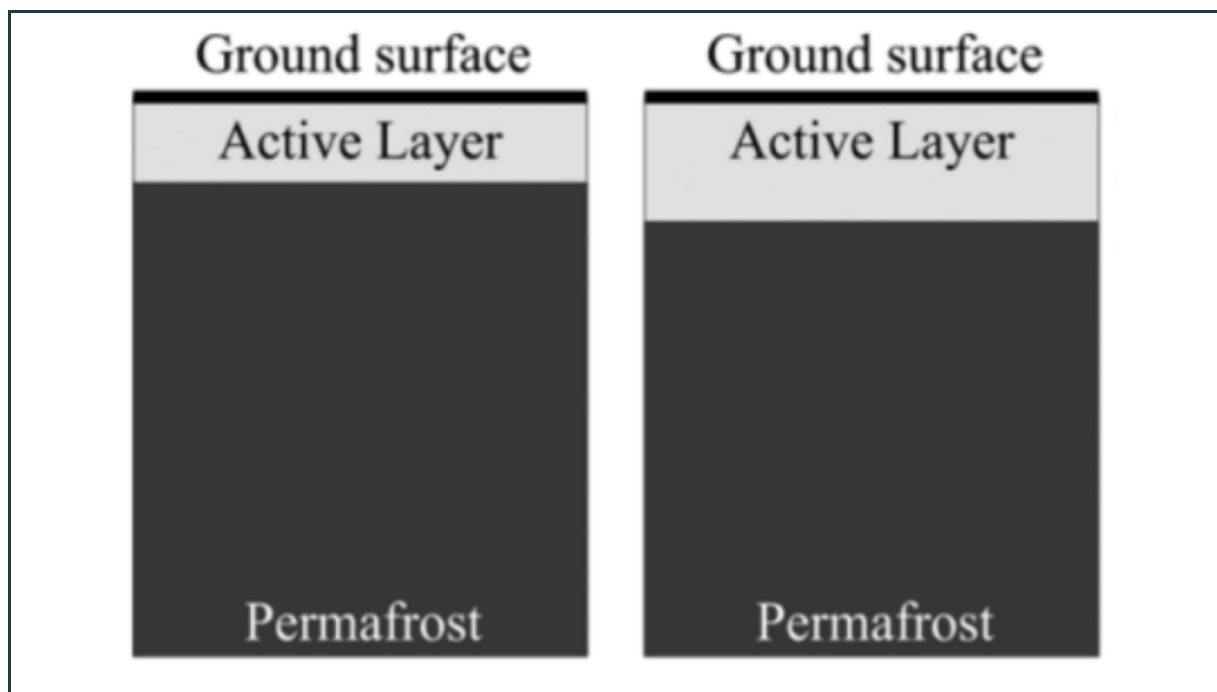
Figure 107: View of the two main zones in the ground in permafrost areas. The thickness of the two zones varies considerably depending on the location of the site (See Figure 108). At the Mary River site the thickness of the active layer is generally less than 1.5 m. - Source: Cannon et al.

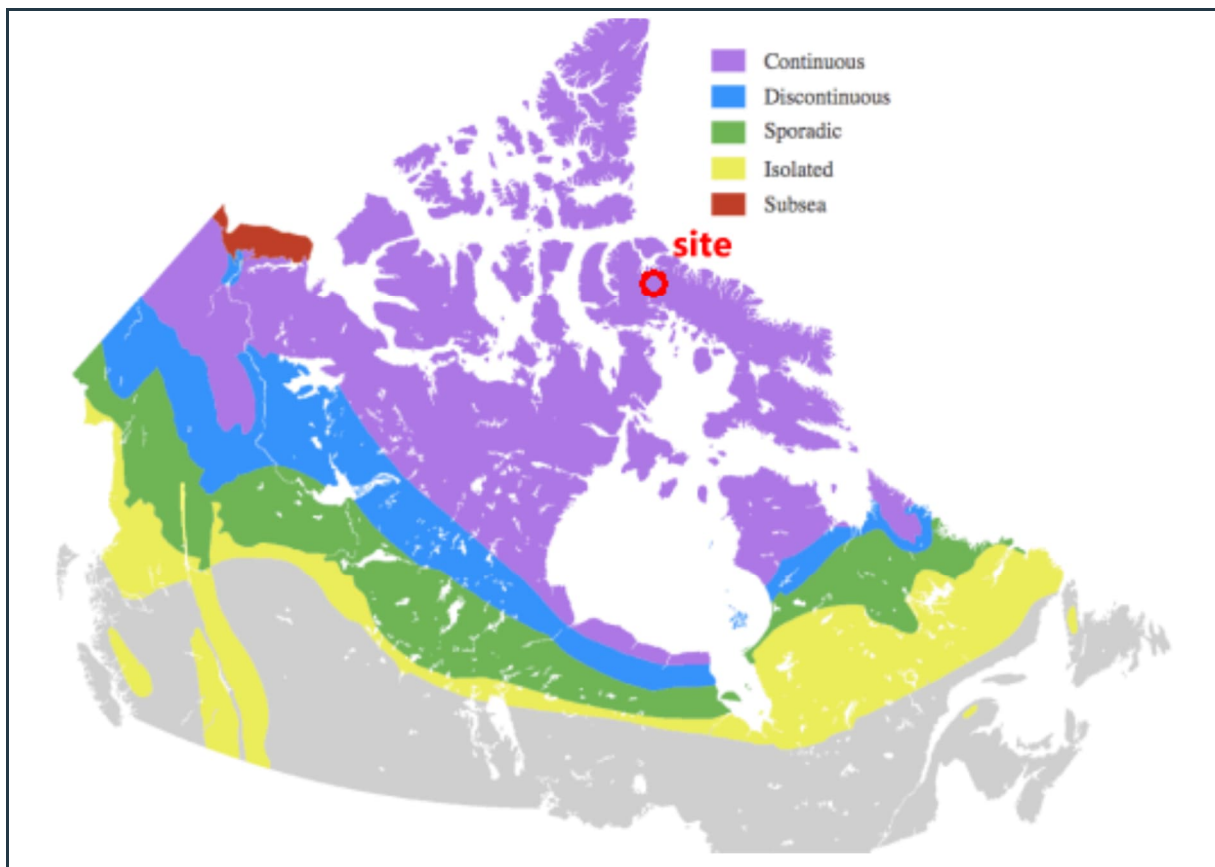
Figure 108: View of the various permafrost zones in Canada, with Mary River located within the continuous permafrost zone in the Baffin Region. - Source: Natural Resources Canada

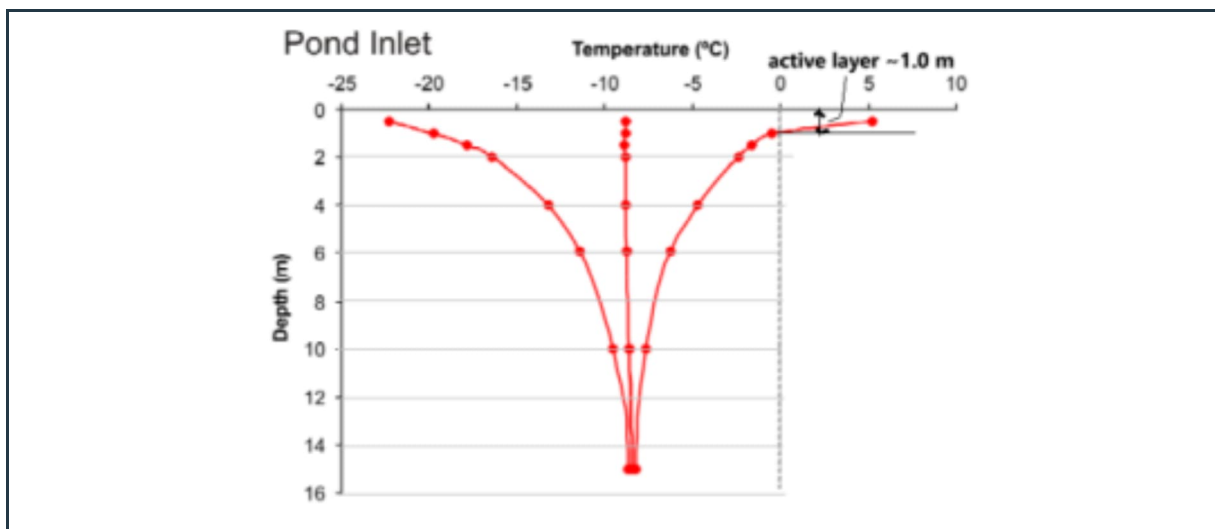
Figure 109: Annual mean, maximum and minimum ground temperatures to 15 m below grade in Pond Inlet (data collected from 2008-2009). Note the thin active layer of approximately 1.0 m. – Source: Geological Survey and Natural Resources Canada.
