**Submission of Annual Geotechnical Inspection – 2024, Mary River Project – Nunavut, Project # CA0039374.4332**

#### Mary River Project – Nunavut

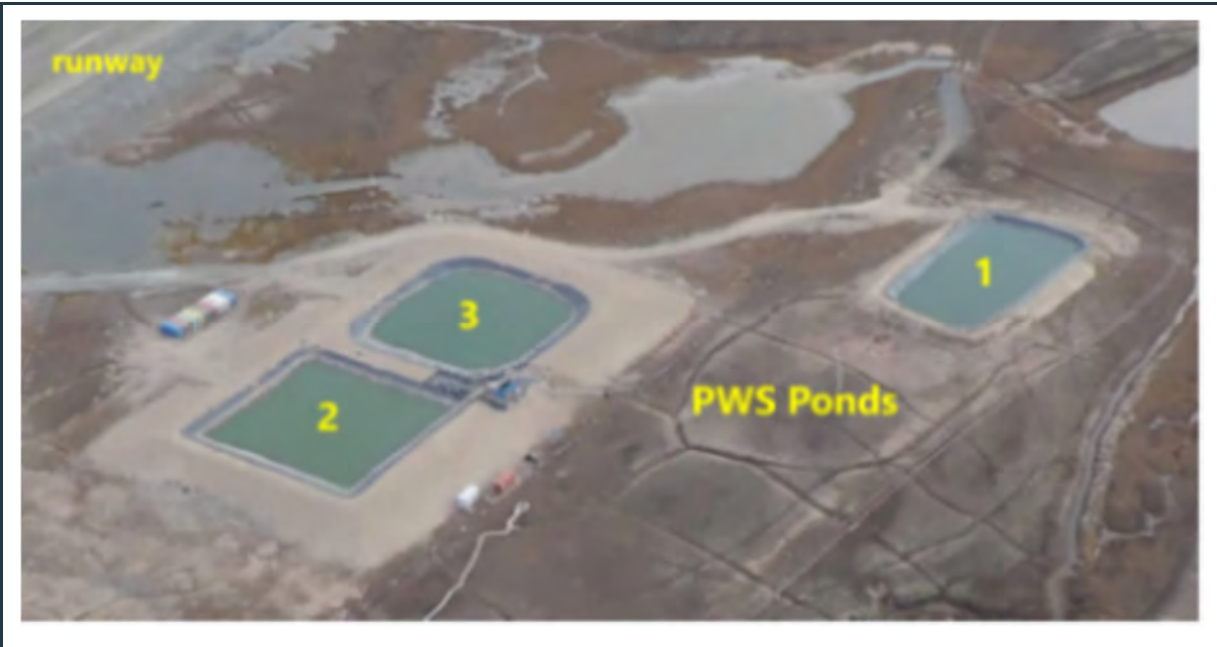
There are three (3) polishing waste stabilization (PWS) ponds, located adjacent to the airstrip, as shown in Figure 7. Pond #1 is a single structure, while Ponds #2 and #3 were constructed as twin-cells, as shown in Figure 13. The photograph in Figure 13 is a historic aerial image (taken by the author of this report in 2020) showing the robust and stable berms around the three stabilization ponds. As mentioned in previous inspection reports, these ponds were associated with the exploration phase of the mine, and currently serve as emergency holding ponds in case problems would arise, which would prevent the discharge of treated effluent directly to the receiving environment. The robust, stable berms around the ponds generally comprise granular materials (rock fill, sand, and gravel), with high density polyethylene (HDPE) geomembrane liners. No damage is visible on the membranes in the cells or on the upstream face of the slopes (see Figures 14 to 16).

Figure 13: Historical aerial image of the layout of the three PSW ponds with robust, stable berms.

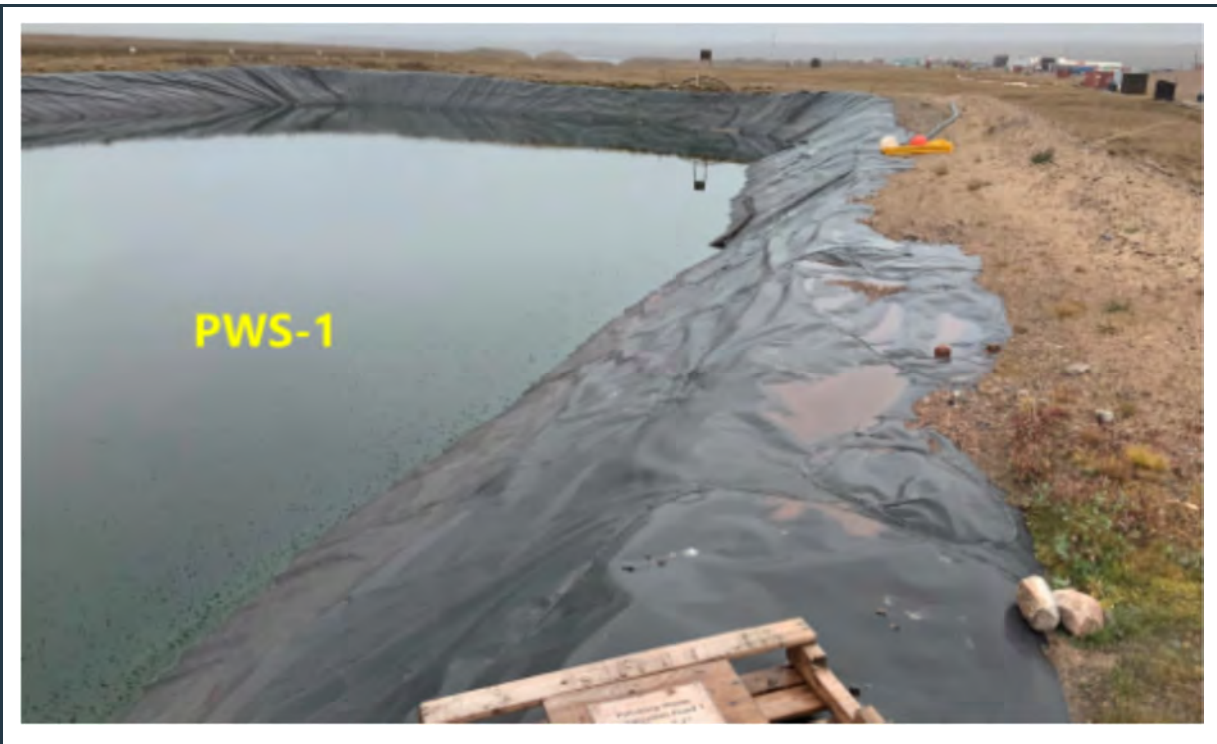
Figure 14: PWS pond #1. Well-maintained, stable perimeter berm and intact liner at the pond.

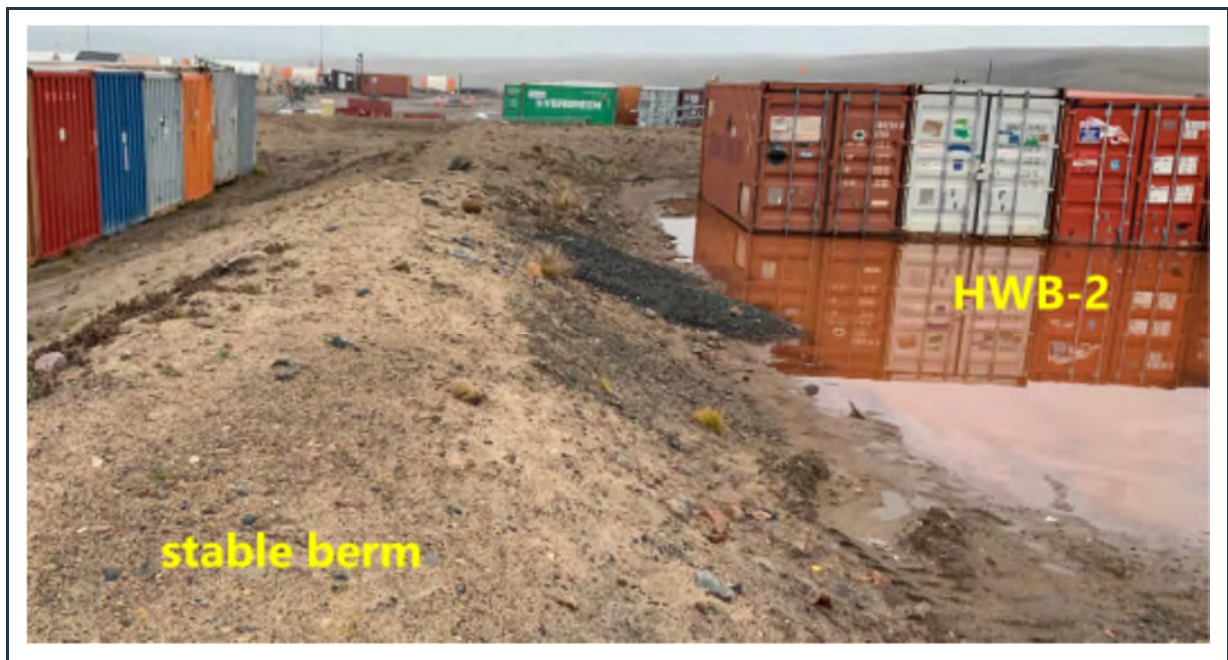
### b) HWB-2

As shown in Figure 18, only a few (5) shipping containers are currently stored in this cell. The robust perimeter berm around the cell appears to be stable and the presence of ponding water within the cell indicates good liner performance.

Figure 18: View of the robust, stable berm around HWB-2. The presence of water in the cell indicates good liner performance.

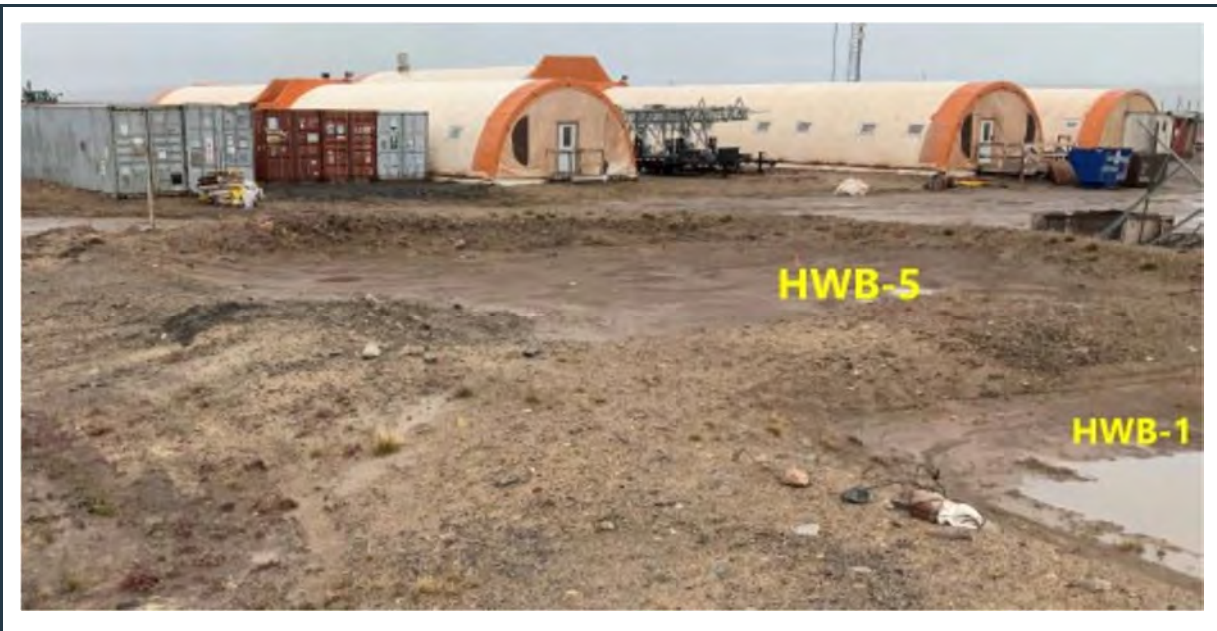
d) HWB-5

As shown in Figure 21, this cell is currently empty and has not been in use for years. The shallow berms around the cell appear to be stable, although the result of some surface erosion on the slopes is visible. No ponding water is visible in this cell indicating potential liner damage. As mentioned earlier for HWB-1, these two cells (1 and 5) could be reconstructed as one large new cell with new berms and liner, should additional storage requirements become necessary at the site.

Figure 21: View of the empty HWB-5 cell, which has not been in use for years (like HWB-1).

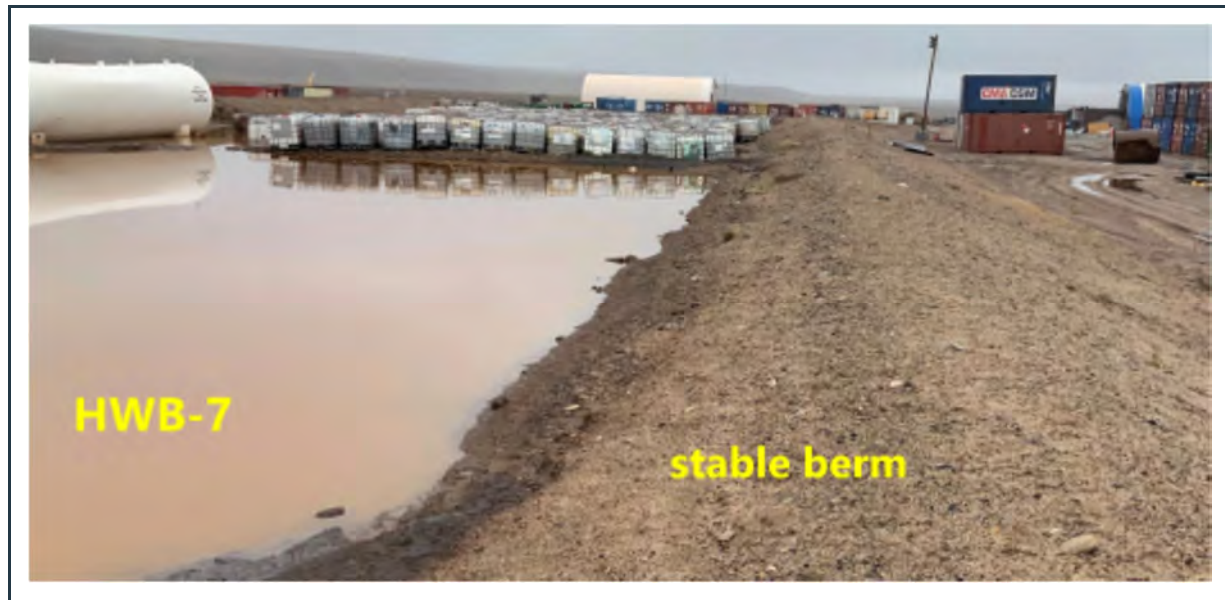
f) HWB-7

One (1) large white fuel tank is stored in this cell together with hydrocarbon products stored within containment totes as shown in Figure 23. The perimeter berm around the cell appears to be stable and the ponding water within the cell is indicative of adequate liner performance. The level of ponding water in this cell should be monitored closely, and some of the water should be removed if required, to prevent the potential for uncontrolled release of the water.

Figure 23: View of the stable berm around the HWB-7 cell, with an old fuel tank and oil filled plastic containers stored in the cell. The ponding water indicates good liner performance.

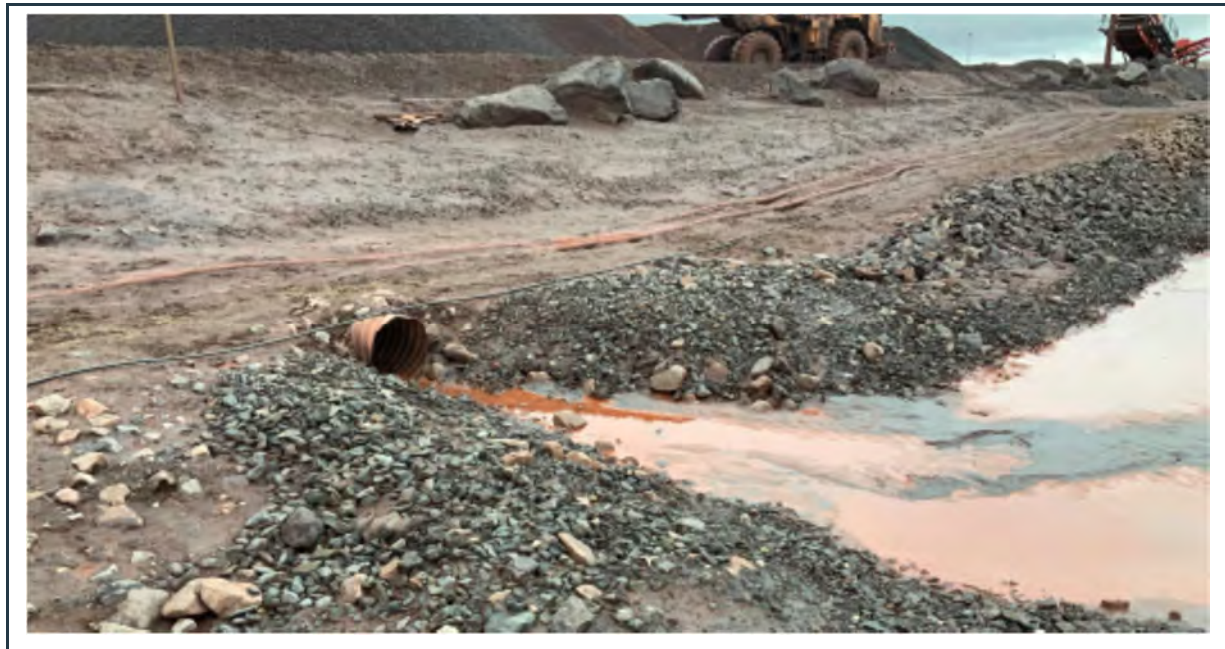
Figure 24: View of the discharge end of the recently cleaned culvert, draining the collected surface water from the crusher pad area to the MS-06 pond.

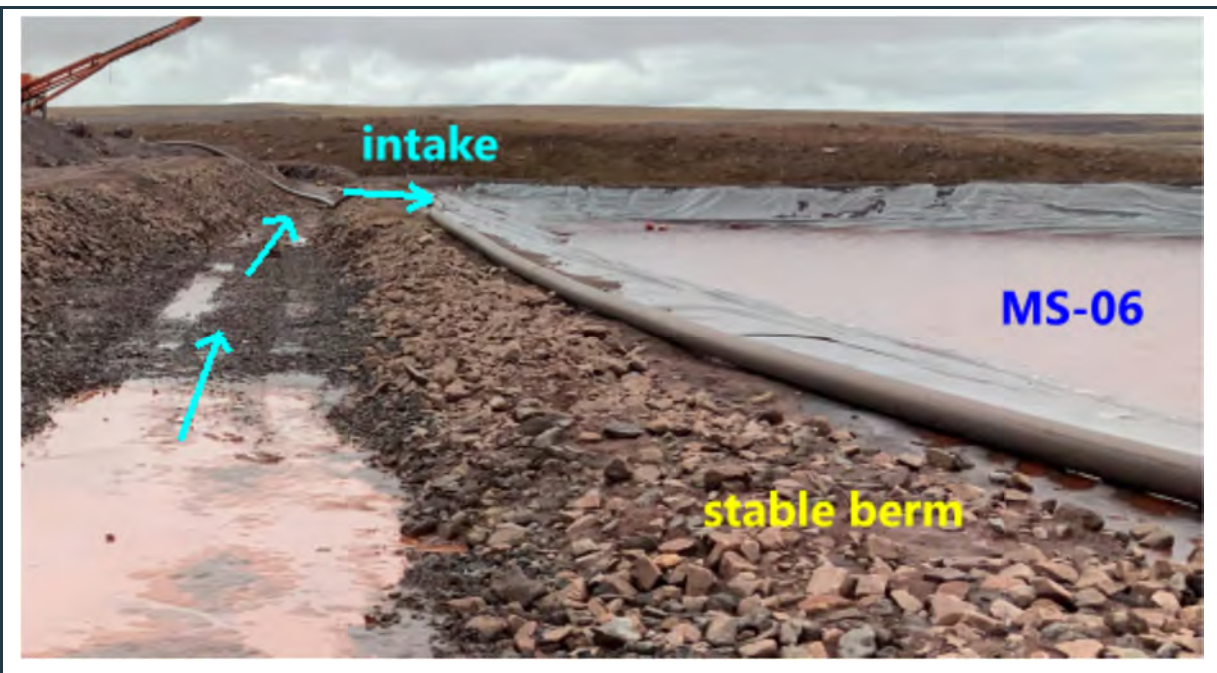
The MS-06 surface water management pond collects surface water from the area of the crusher pad. The surface water is collected in side-ditches around the crusher pad and conveyed into the MS-06 pond. One of the culverts, located under the adjacent road at the crusher pad entrance, is connecting one of the side ditches with the north corner of the MS-06 surface water management pond. The culvert appears to be well maintained and there is uninterrupted flow of water through the culvert, as shown in Figure 24. The liner within the pond and on the upstream slopes of the stable perimeter berm appears to be intact, as shown in Figure 25.

Figure 25: View of the robust, stable berm around the MS-06 pond, with intact liner.

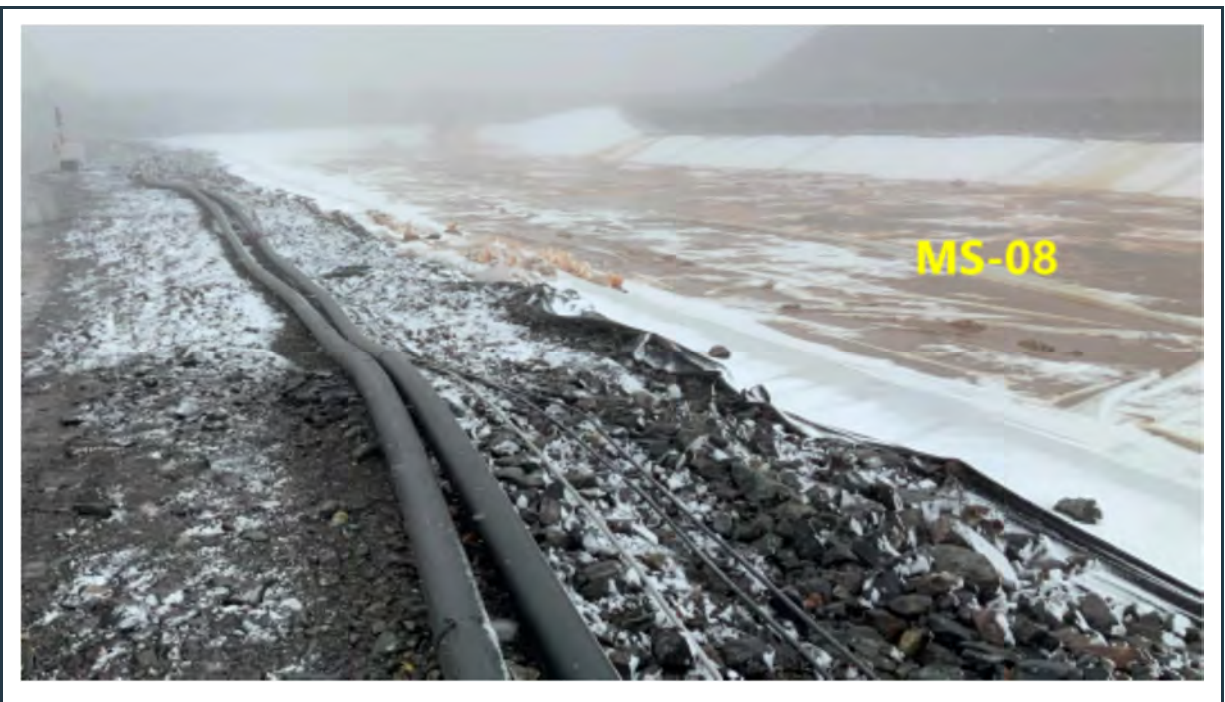
Figure 28: View of the stable, robust berm and intact liner at the MS-08 pond, which was almost empty at the time of the August 2024 visit. Note the snow already on the ground in August.

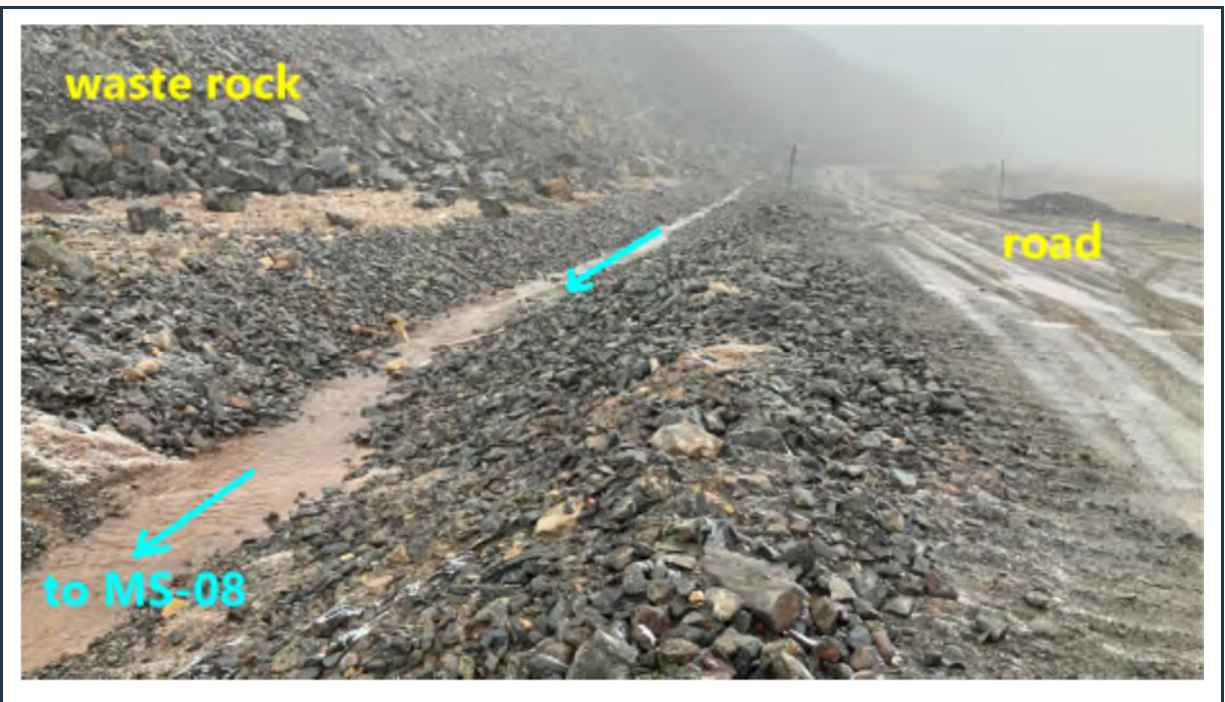
Figure 29: View of the well-maintained drainage ditch around the west side of the waste rock disposal facility, leading to the MS-08 pond.

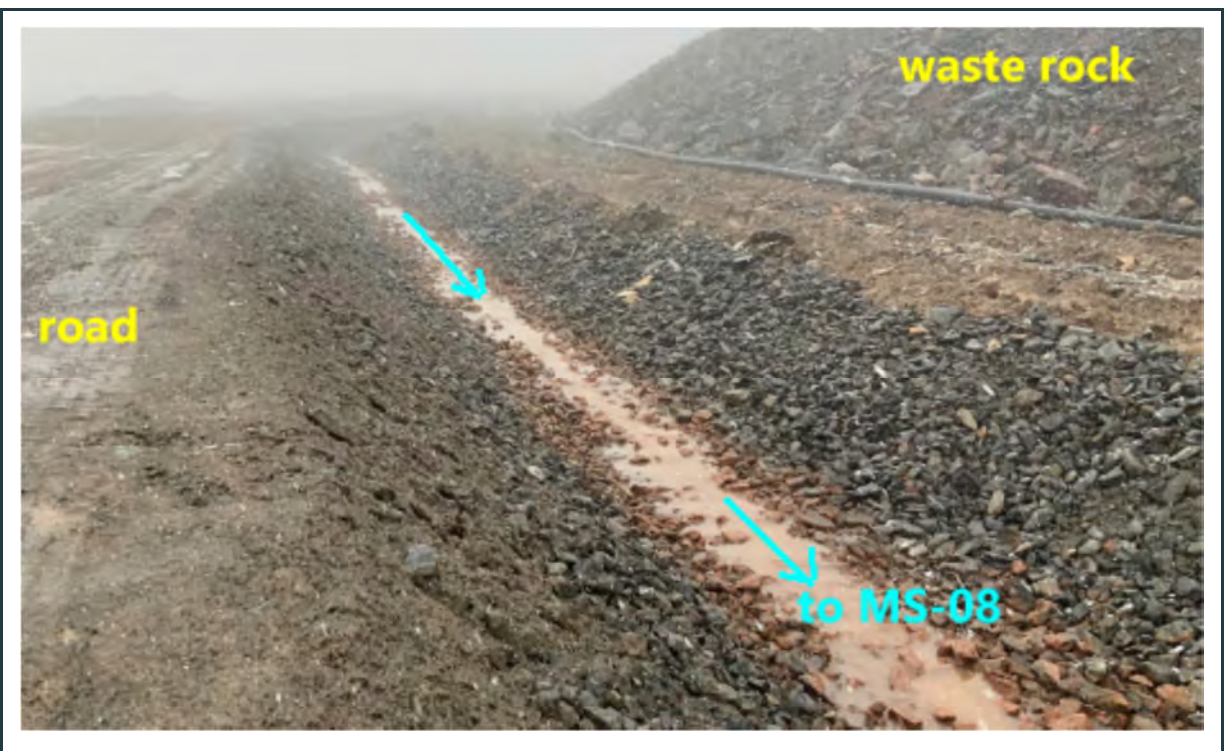
Figure 30: View of the well-maintained drainage ditch around the east side of the waste rock facility, leading to the MS-08 pond.

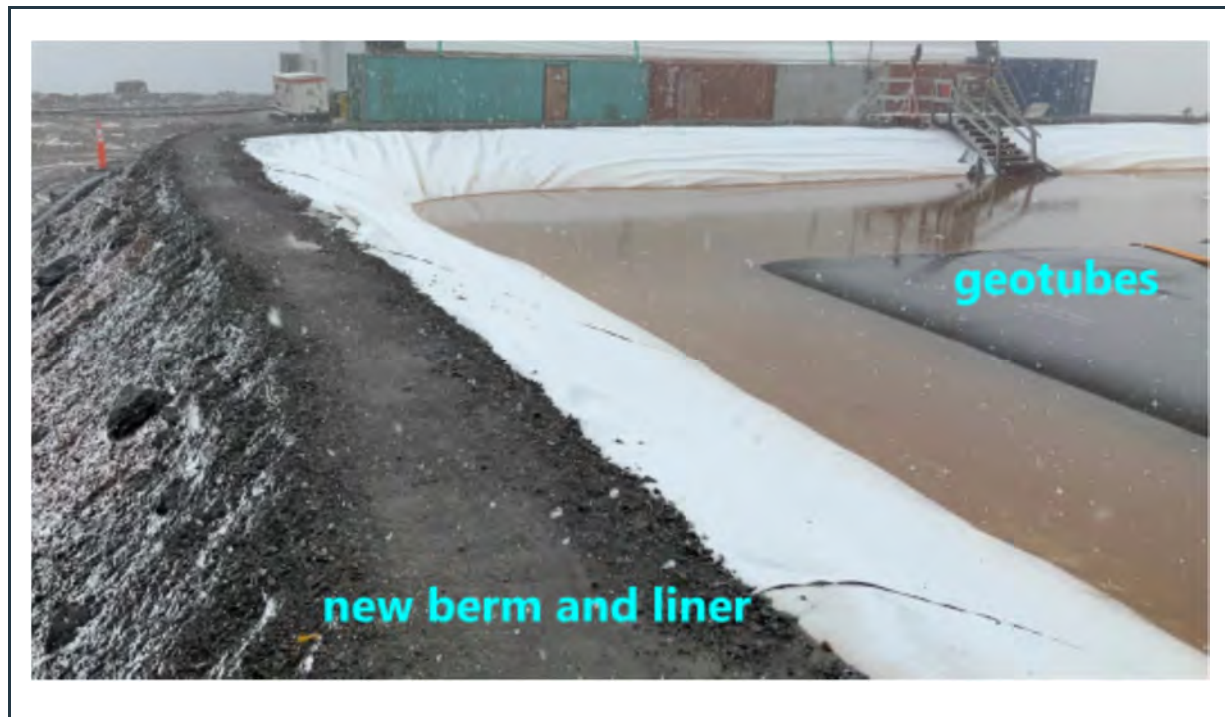
Water from the MS-08 pond can be pumped to the nearby designated facility for treatment, if required. There is a lined treatment cell (geotube pond) located immediately next to the WRSF water treatment plant. As shown in Figure 31, the berm around the pond has recently been reconstructed and new geomembrane liner was installed within the pond, all in excellent condition.

Figure 31: View of the completely refurbished perimeter berm and new liner at the geotube pond, located adjacent to the treatment plant.

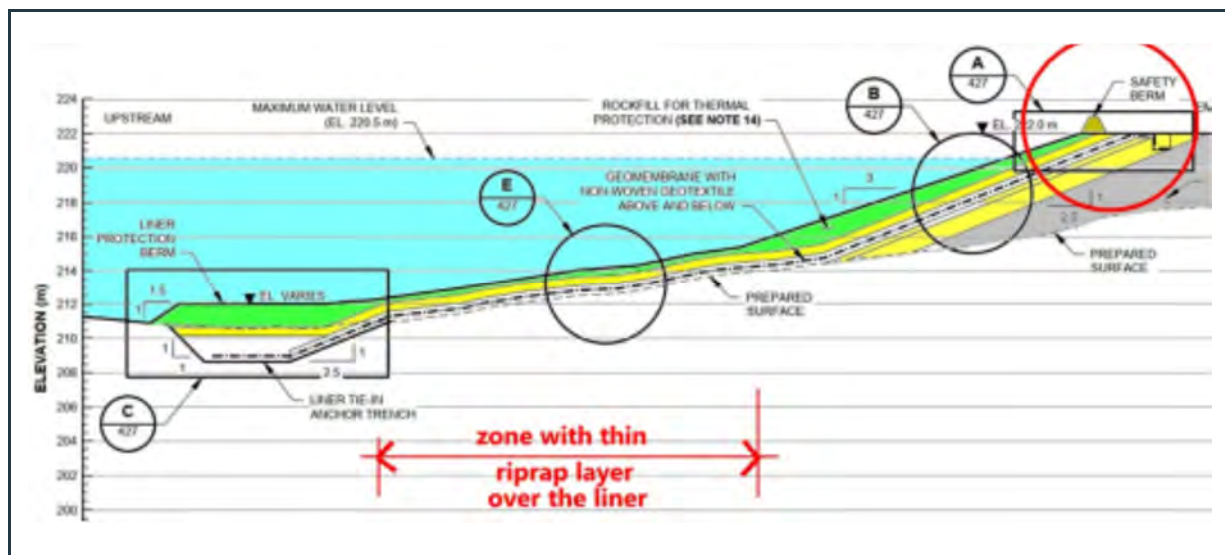
Two things could be noted in the Figure 34 image:

- The other is that one of the safety berms, constructed on the top of the riprap layer, immediately adjacent to the anchor trench at the crest of the embankment (see the red circle in the image). Based on information recently obtained at the mine it appears that during the filling of the ponds with runoff water, around June 11 and 12, 2022, sliding/sloughing of the cover layers and the displacement of the safety berm was noted along the crest of the embankment at the south pond. Figure 35, which was taken on June 22, 2022, shows the slipping (and cracking) of the cover layers (sand and riprap) and the downslope displacement (sliding) of the safety berm just a few weeks after the completion of the construction and during the early stage of filling the pond with water.

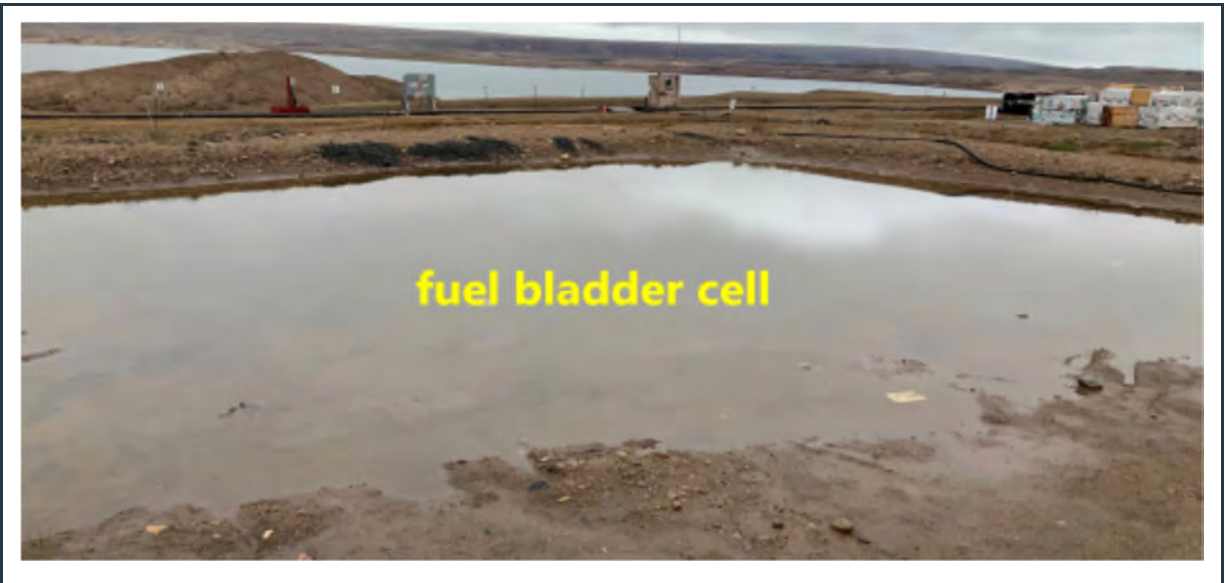
Figure 37: View of the stable perimeter berm around the empty “fuel bladder” cell. The ponding water in the cell indicates good liner performance.

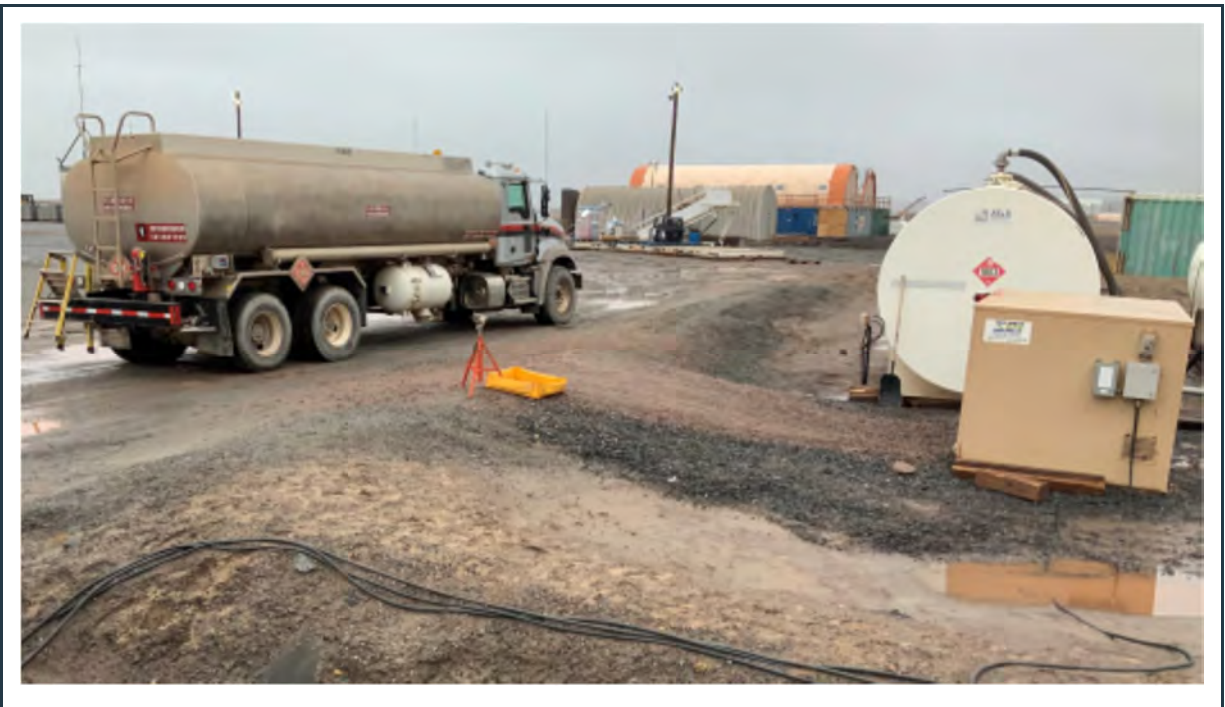
Figure 38: View of the well-maintained sand and gravel berm and access ramp at the lined jet-fuel storage facility. Ponding water in the cell indicates good liner performance.

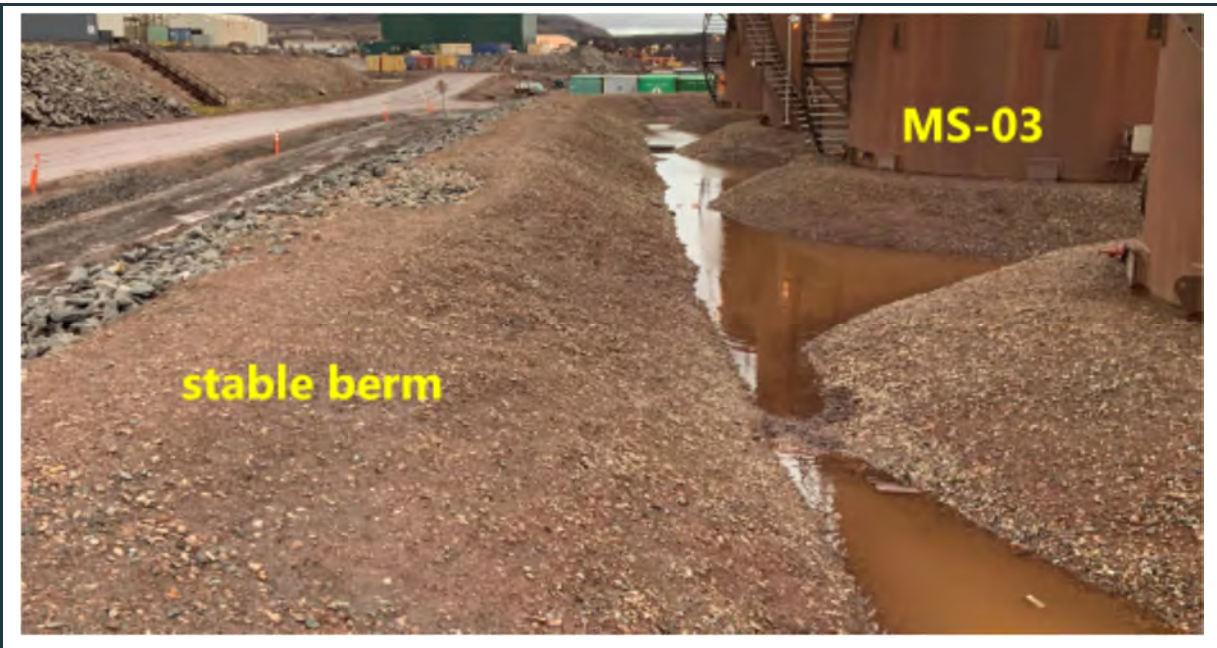
Figure 39: Well-maintained, stable berm around the MS-03 diesel fuel farm, with some ponding water, which is indication of good liner performance. Note the rock fill on the downstream slope of the berm for additional protection against erosion.

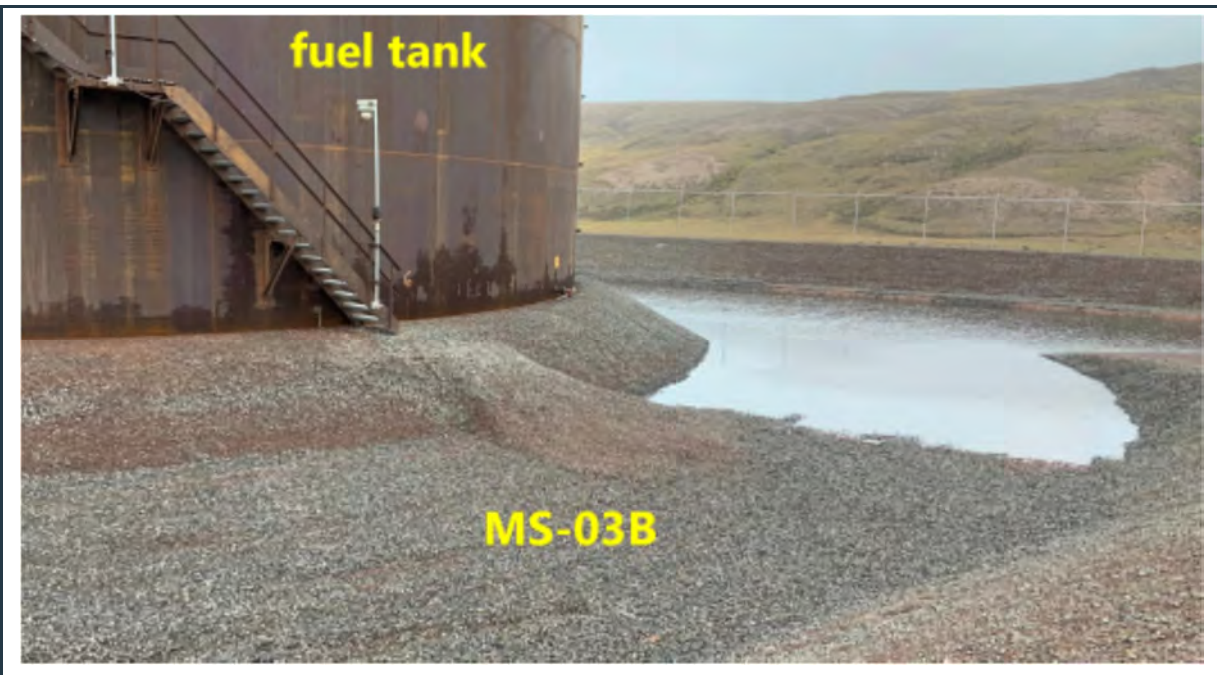
Figure 40: View of the well-maintained stable berm and interior granular fill over the liner at the new fuel tank farm. Note the ponding water in the cell, indicating good liner performance.

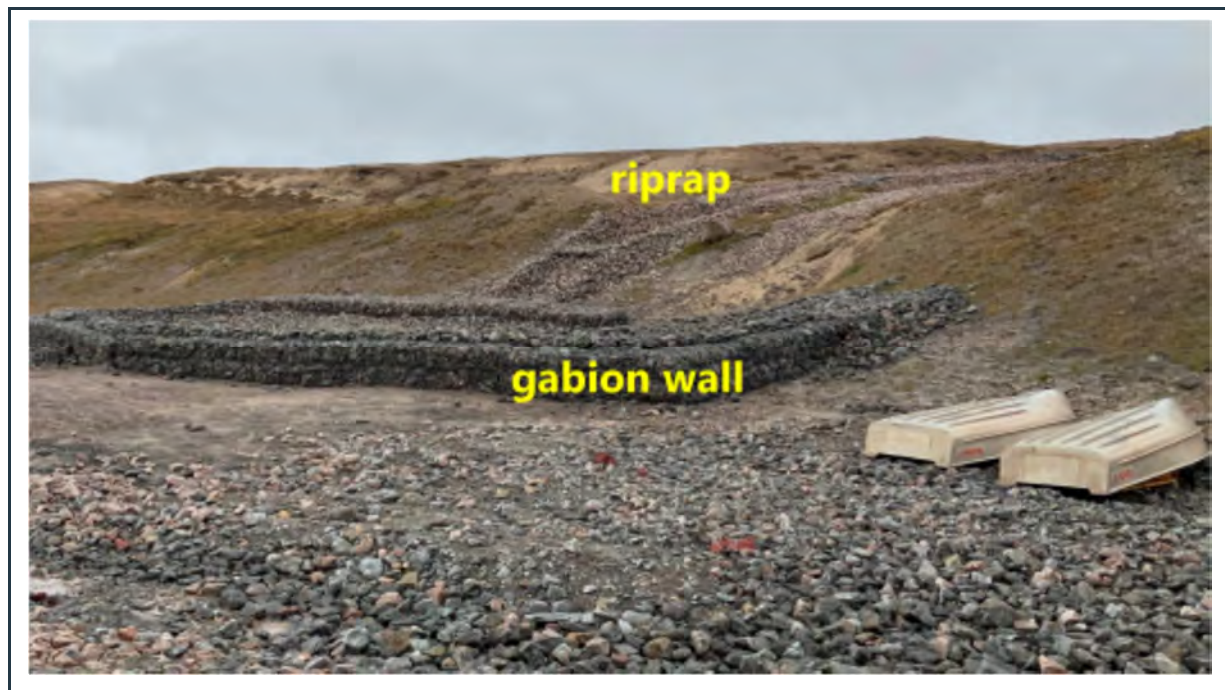
Figure 46: View of the new gabion wall and riprap adjacent to Camp Lake to capture suspended solids potentially eroding from the airfield area and to prevent siltation in the lake.

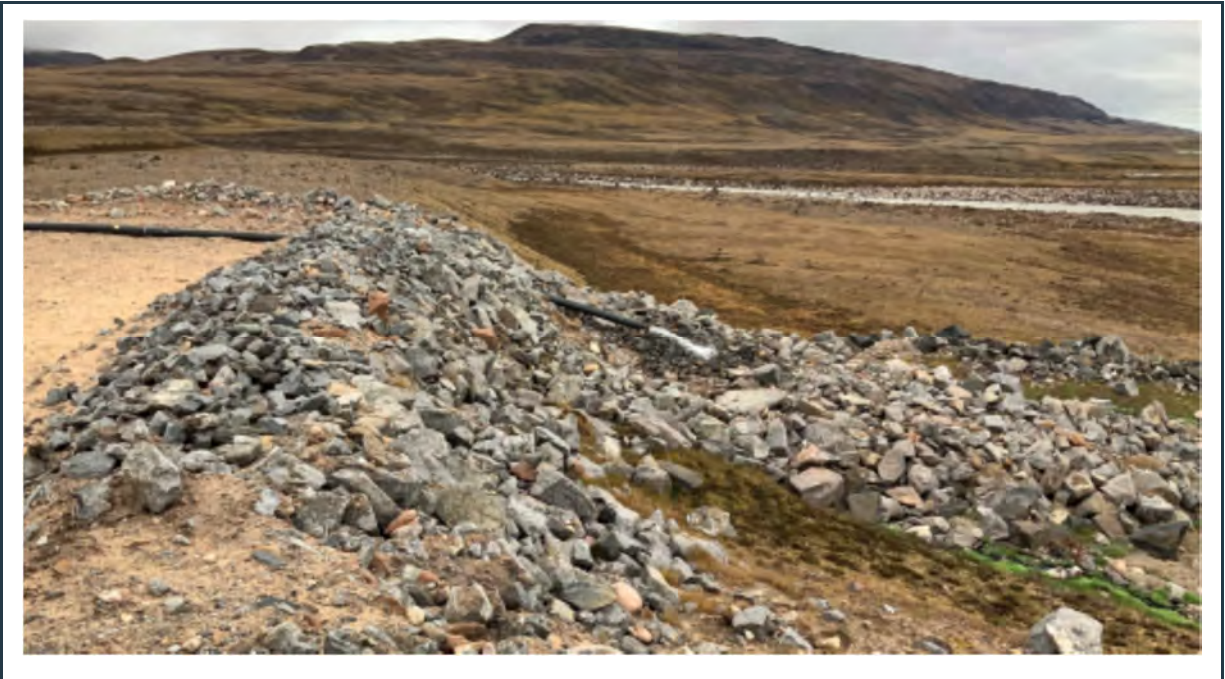
Figure 47: View of the stable slope with rockfill erosion protection at the water discharge area.

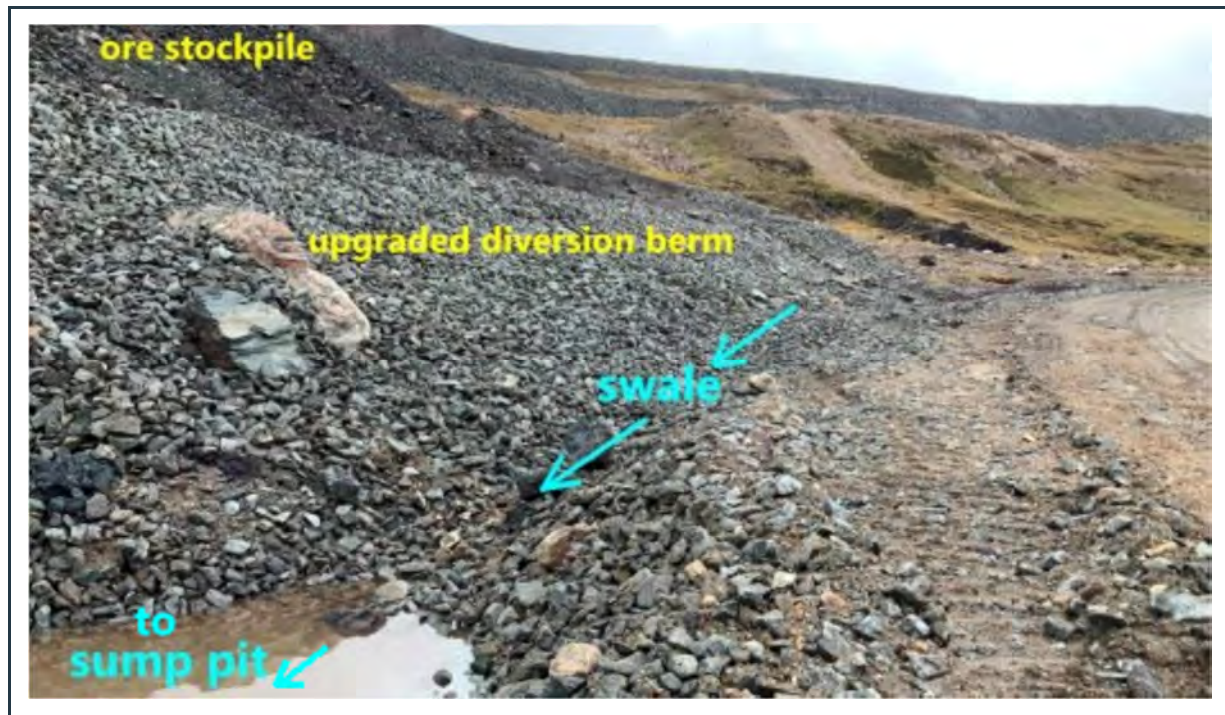
Figure 51: View of the new, recently upgraded diversion berm and drainage ditch/swale south of the ore stockpile area.

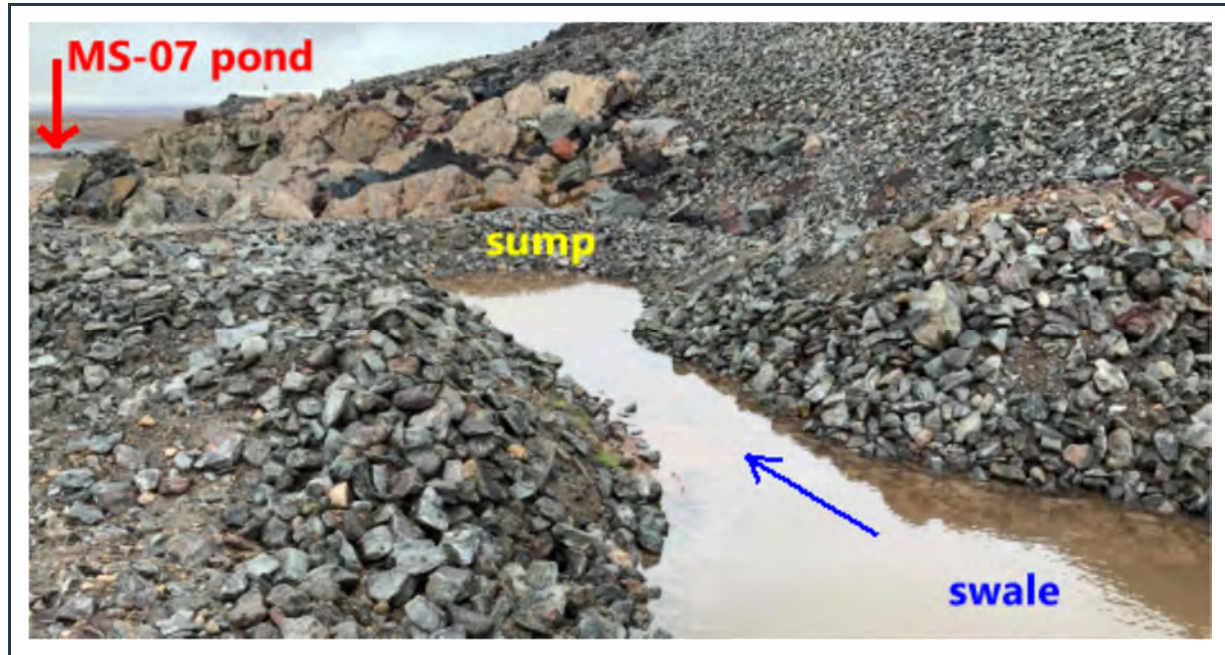
Figure 52: View of the new drainage ditch/swale and sump pit south of the KM-106 ore stockpile area, collecting local run-off. Note the recently completed riprap erosion protection along the sides of the swale and sump. Water from the sump is pumped into the nearby MS-07 pond.

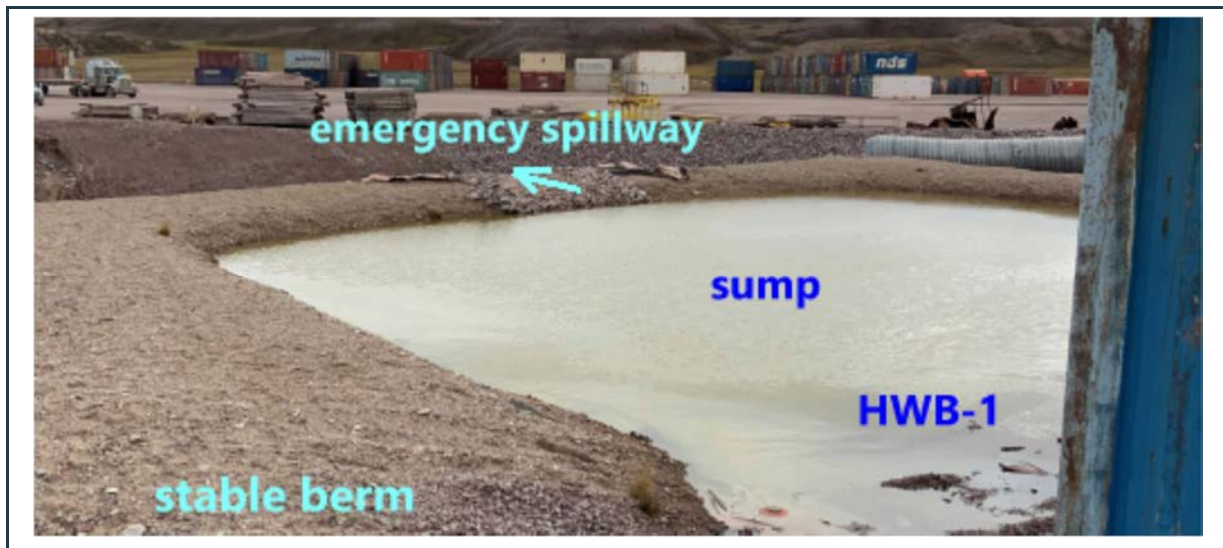
Figure 54: View of the sump and emergency spillway at the back of the HWB-1 cell with stable berm.

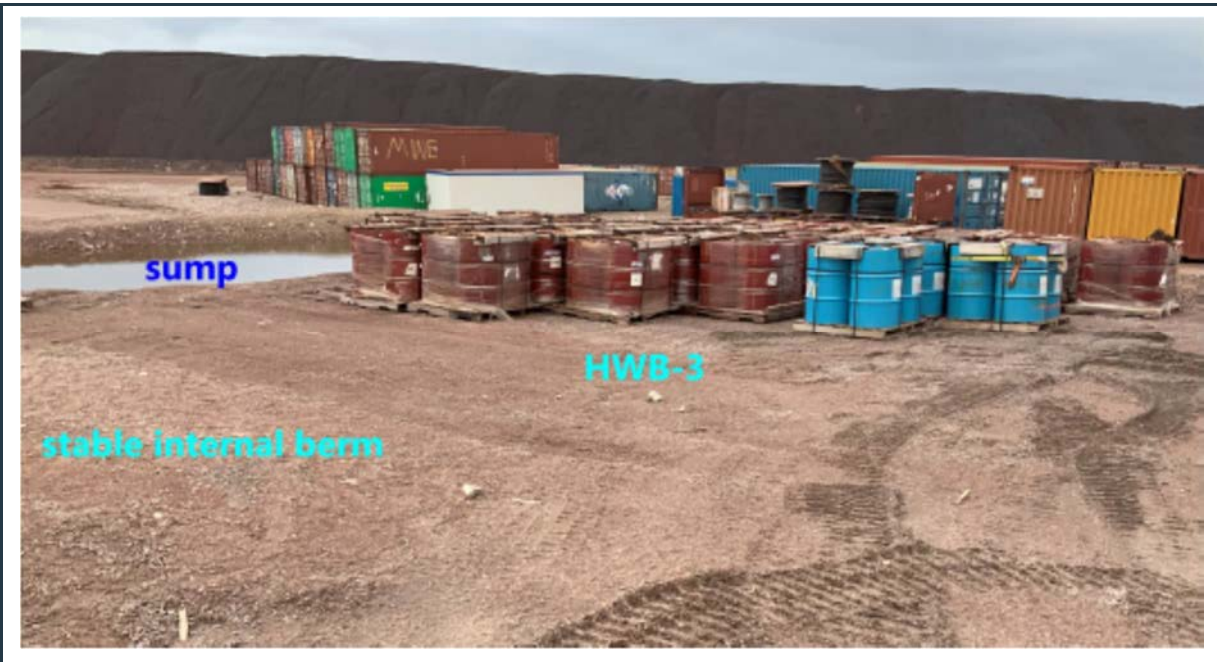
Figure 55: View of the well-maintained HWB-3 cell with stable berm, containing fuel barrels. The interior subgrade in the two cells had been regraded recently using clean sand and gravel fill.

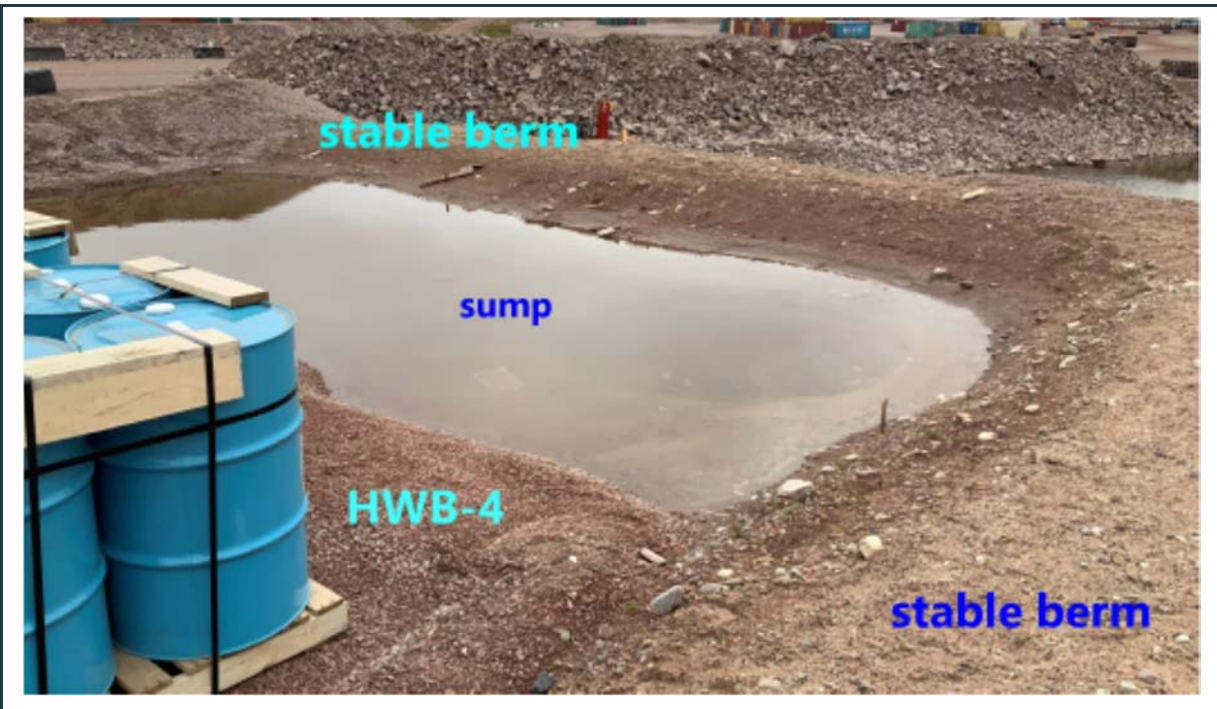
Figure 56: View of stable berm and the sump in the HWB-4 cell, storing jet fuel and shipping containers. Note the improved granular base within the cell, protecting the geomembrane liner.

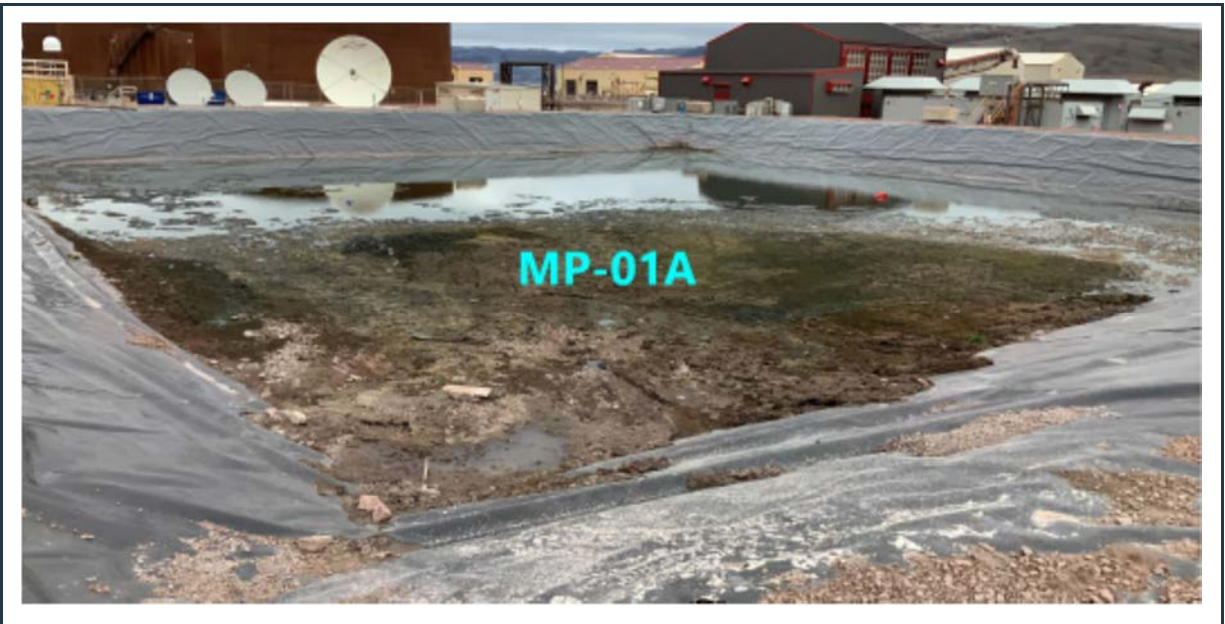
Figure 57: View of the robust, stable berm and intact liner at the practically empty MP-01A pond.

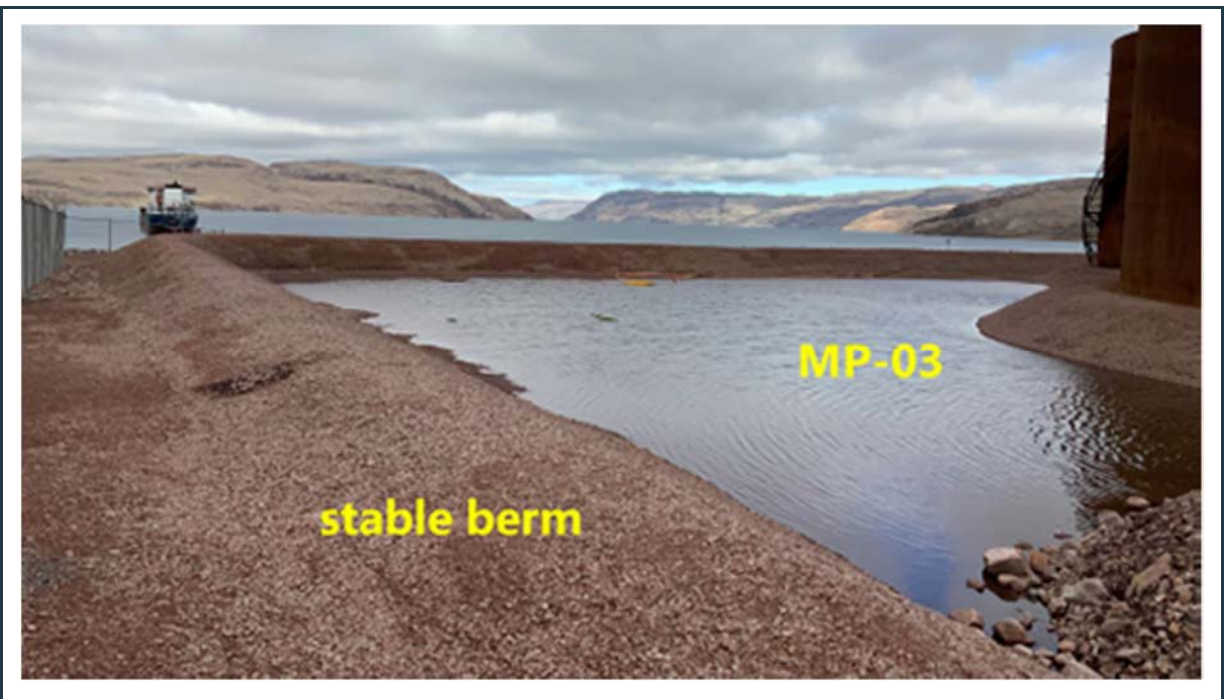
Figure 58: View of the well-maintained stable perimeter berm around the lined MP-03 fuel tank farm. The ponding water indicates good liner performance.
