**Submission of Annual Geotechnical Inspection – 2024, Mary River Project – Nunavut, Project # CA0039374.4332**

#### Mary River Project – Nunavut

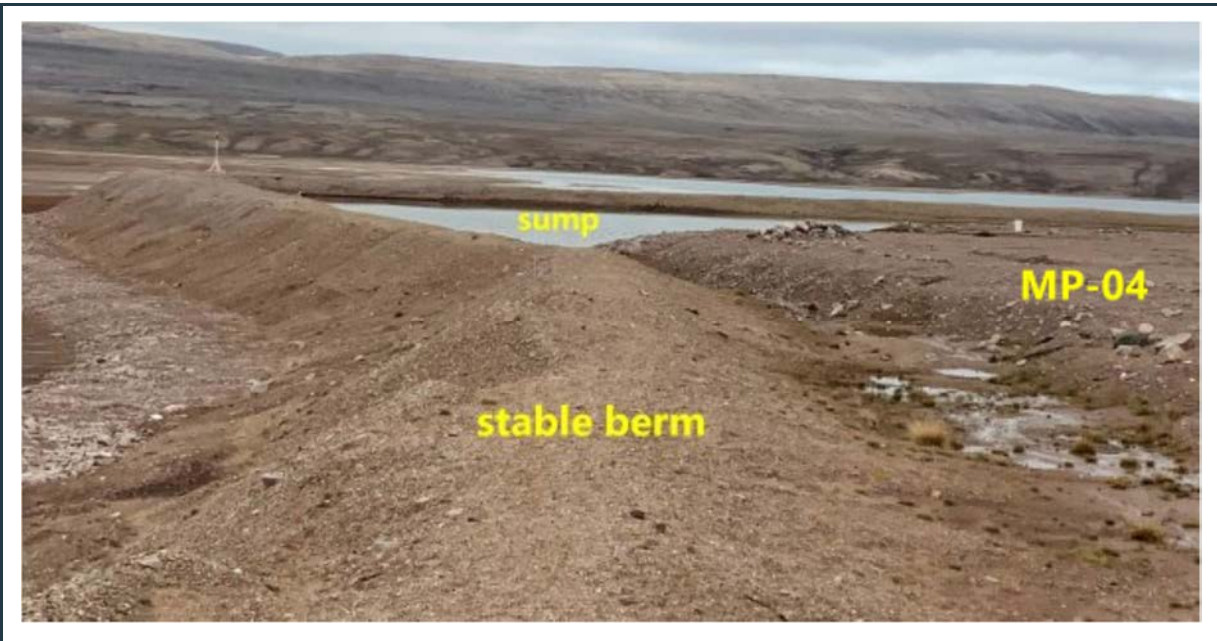
The MP-04 landfarm is in the southern zone of the Port at higher elevation (on the top of a hill), adjacent to the Q01 rock quarry. It is a large cell that stores potentially contaminated soils, as shown in Figure 59.

Figure 59: View of stable perimeter berm around the MP-04 landfarm, with ponding water in one corner of the cell (sump). Note the standard soil cover over the buried solid waste.

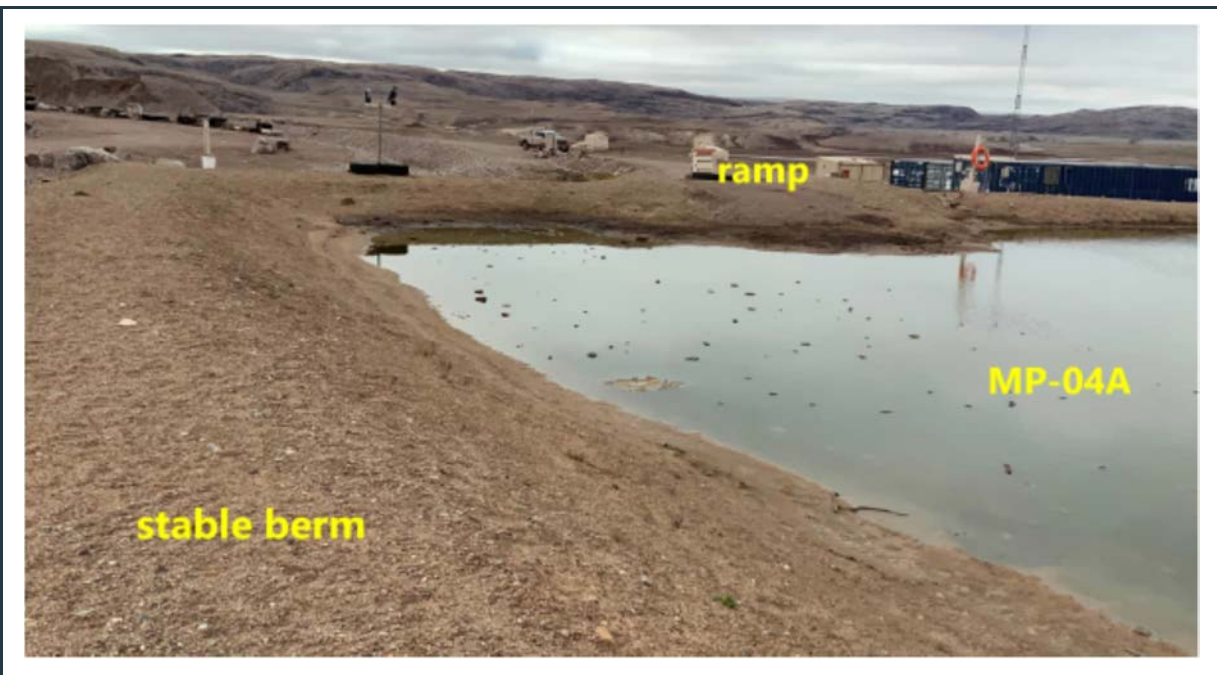
Figure 60: View of the lined MP-04A contaminated snow disposal cell with robust, stable perimeter berm. The ponding water (melted snow) indicates good liner performance. Additional protective layer of sand and gravel fill was placed recently over the access ramp.

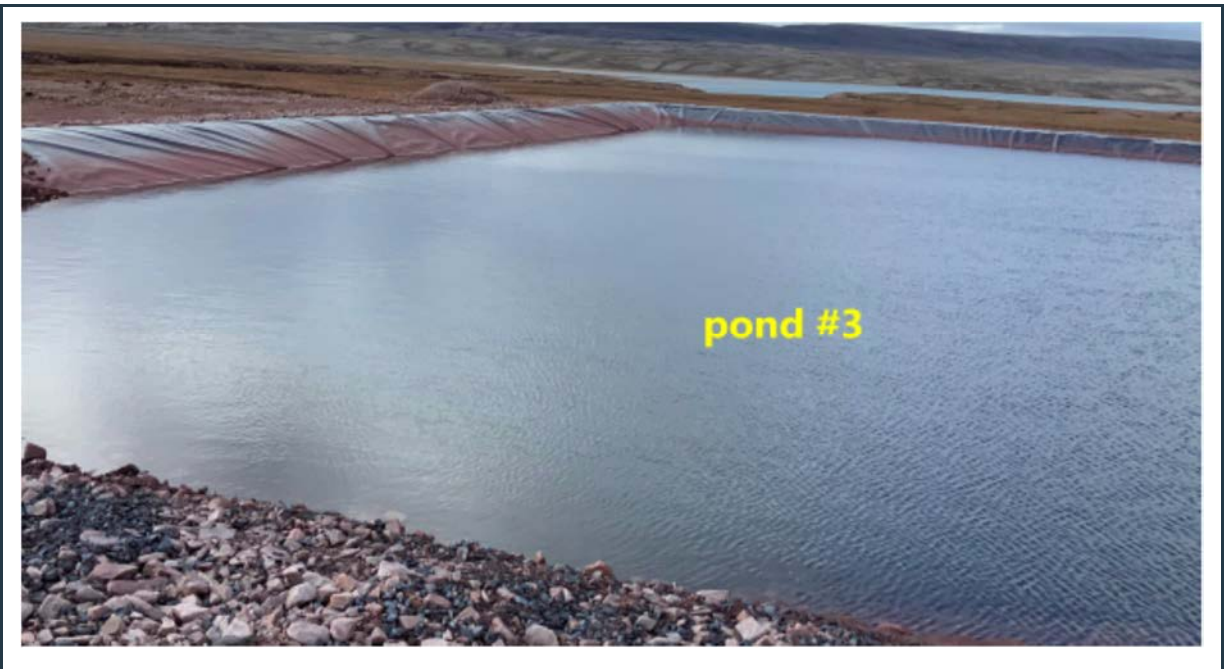
Figure 61: View of surface water management pond #3, with lined, stable berms.

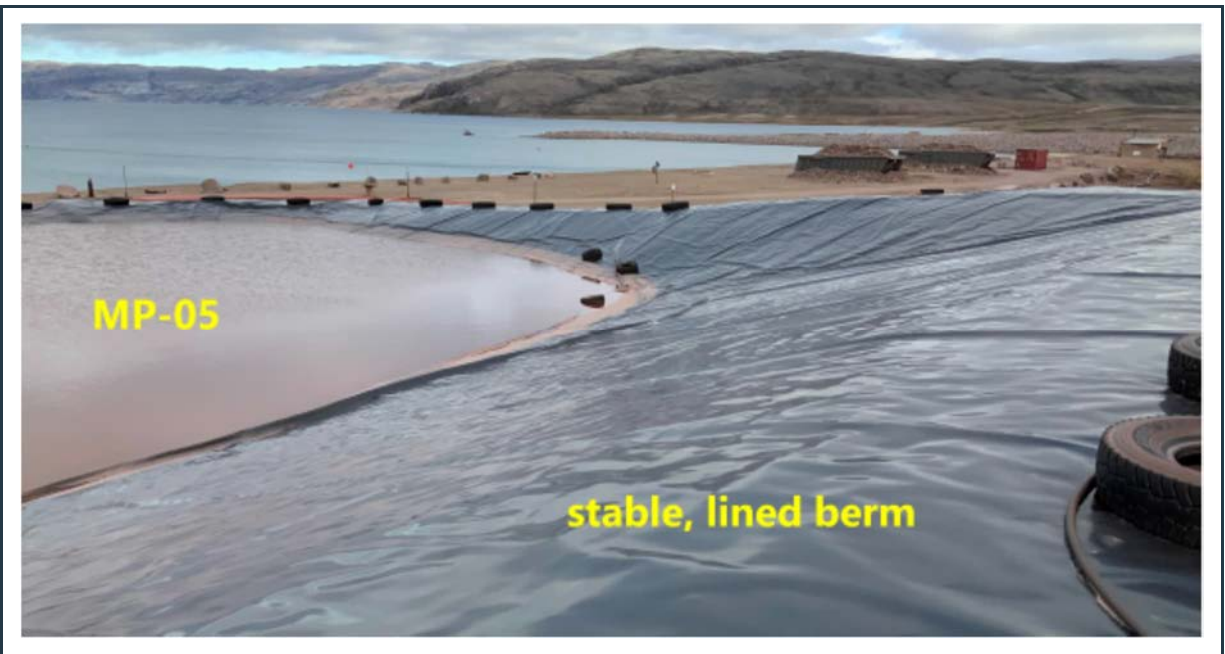
Figure 62: View of the robust, stable perimeter berm and intact liner at the MP-05 pond.

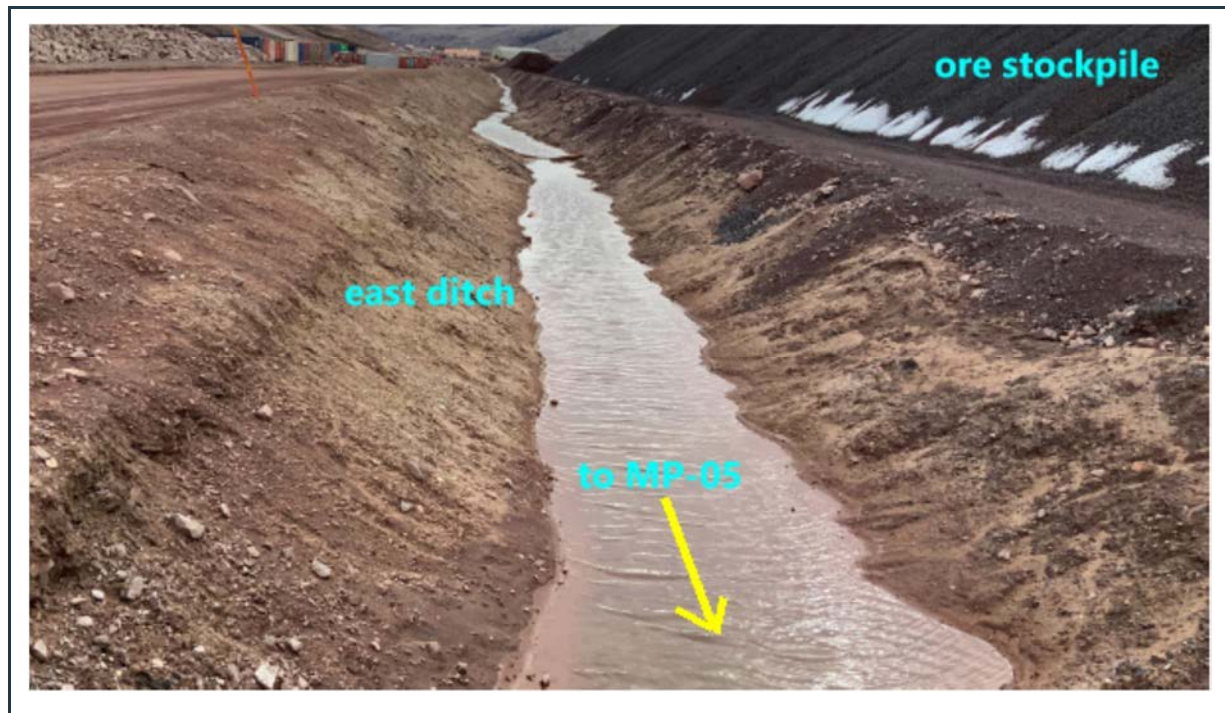
Figure 63: View of the "east" surface water collection ditch adjacent to the ore storage area, draining to the MP-05 pond.

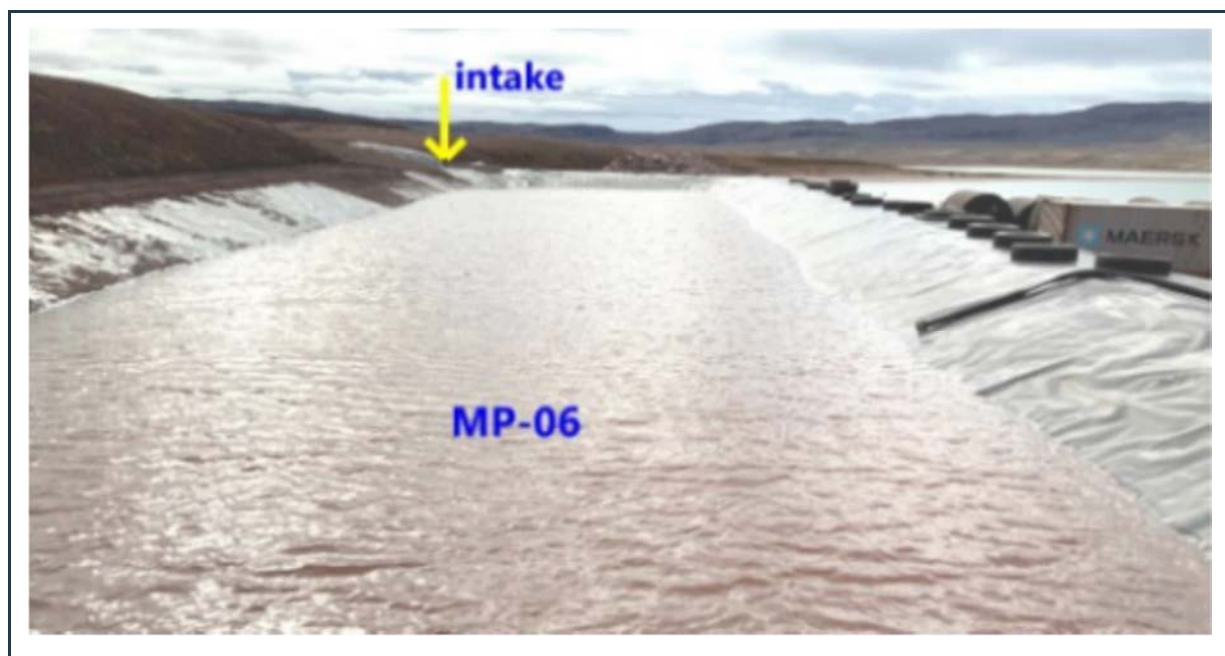
Figure 64: View of the lined MP-06 pond with robust, stable berms. Note the lined intake channel at the far-left end of the pond.

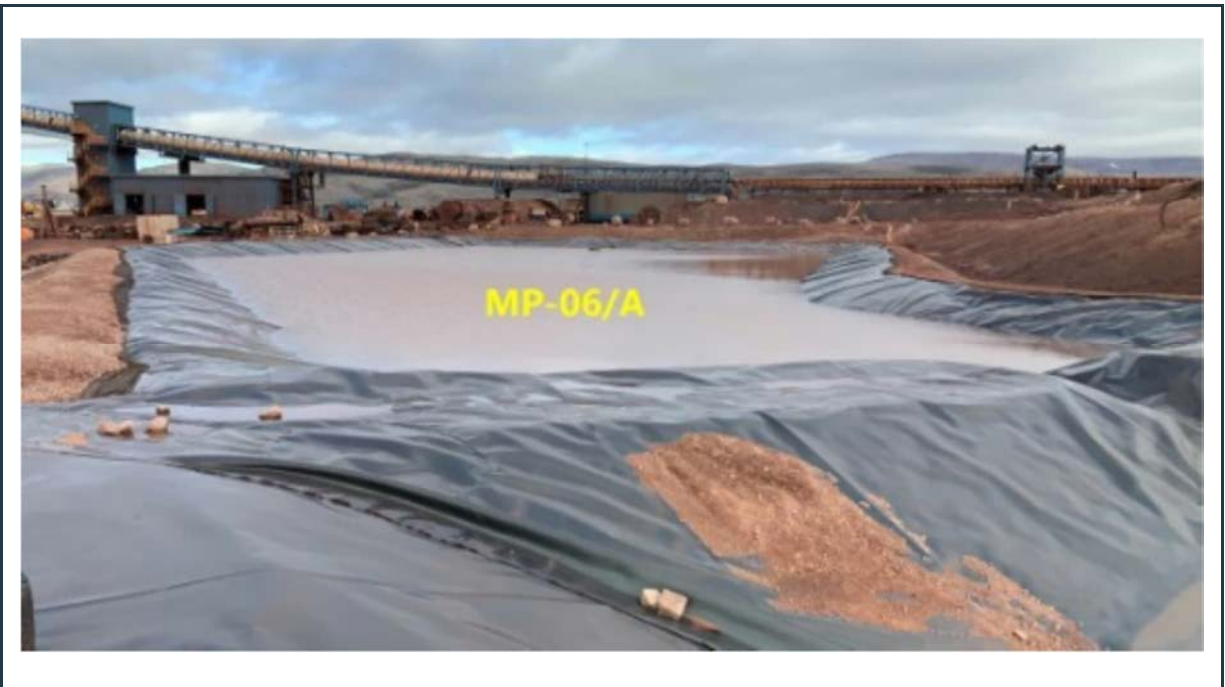
Figure 65: View of the lined MP-06A overflow pond with robust stable berms.

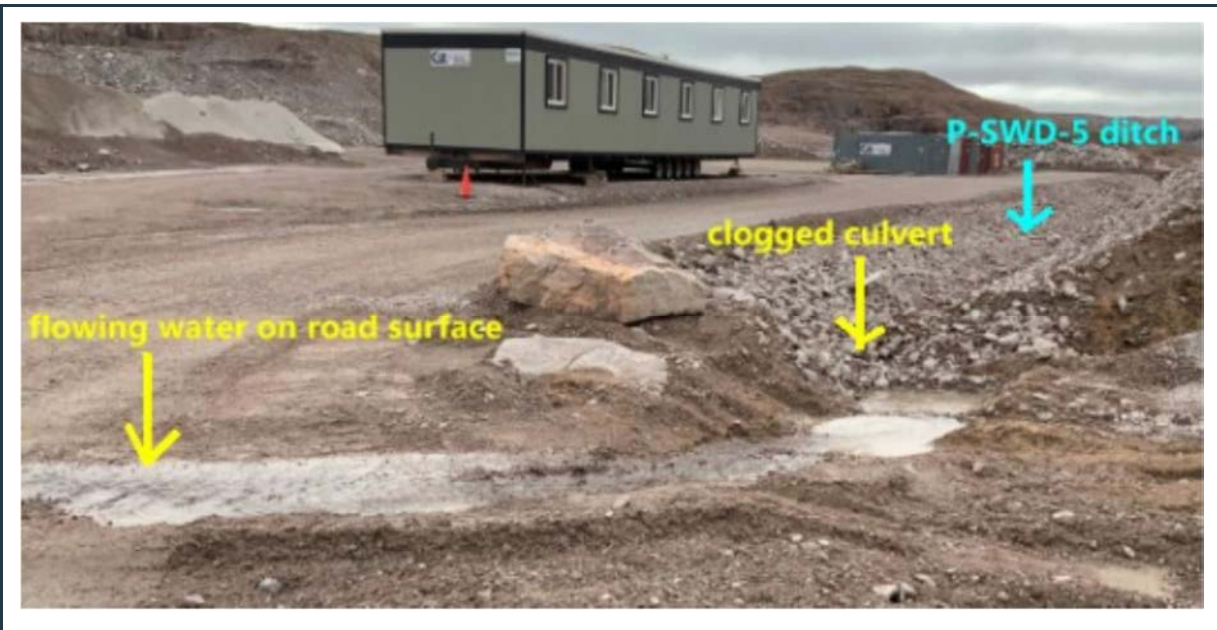
Figure 69: Poor surface water control in many areas of the lower (main) level of the Q01 rock quarry.

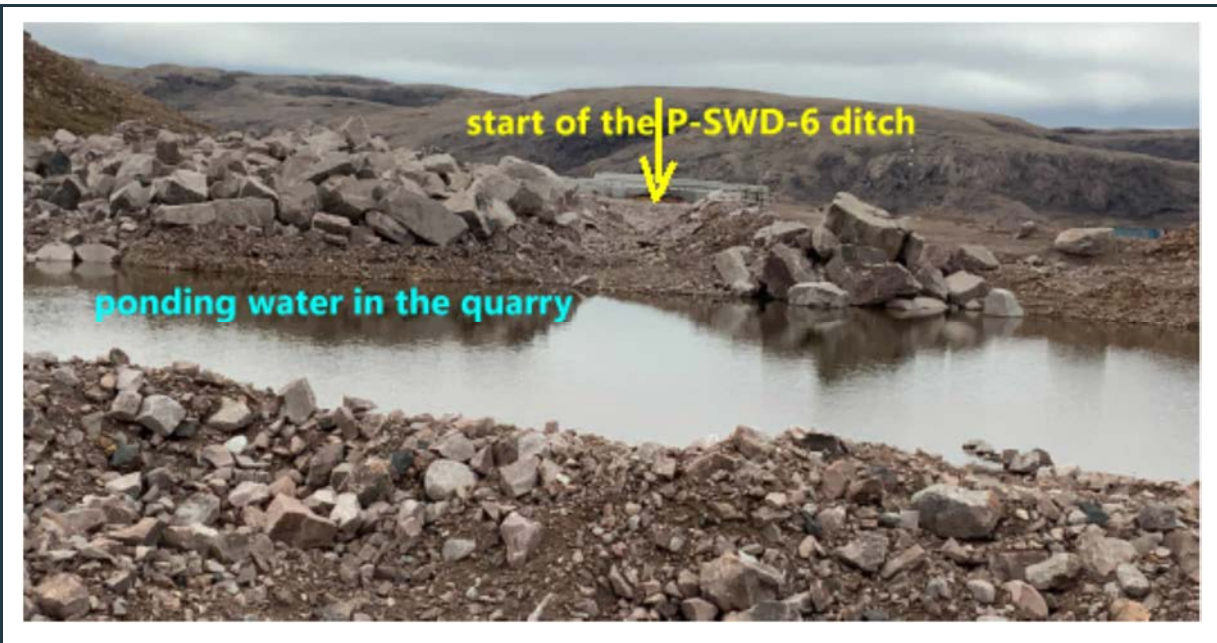
Figure 75: View of the over-excavated southern area of the Q01 quarry with ponding water (see Figure 11 for location). Note the start of the P-SWD-6 ditch in the image, with its invert level well above the new ground level in the area (bottom of the pond).

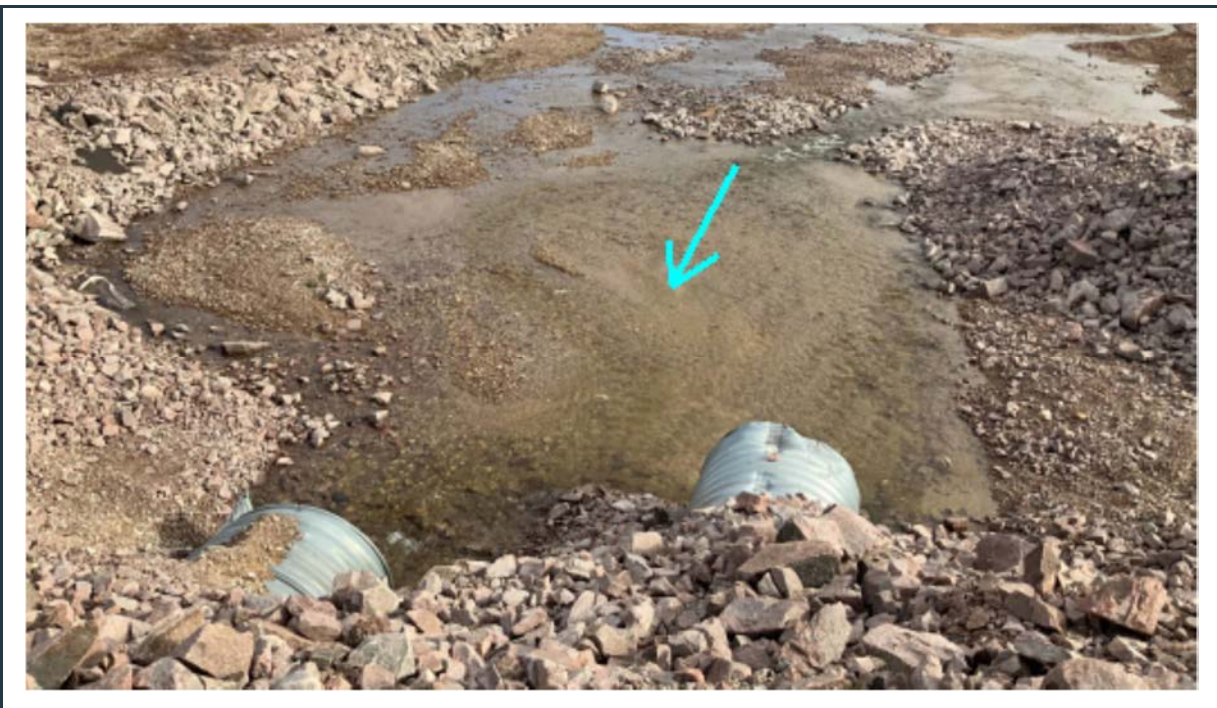
Figure 76: View of the P-SWD-7 surface water collection ditch and culverts (inlet).

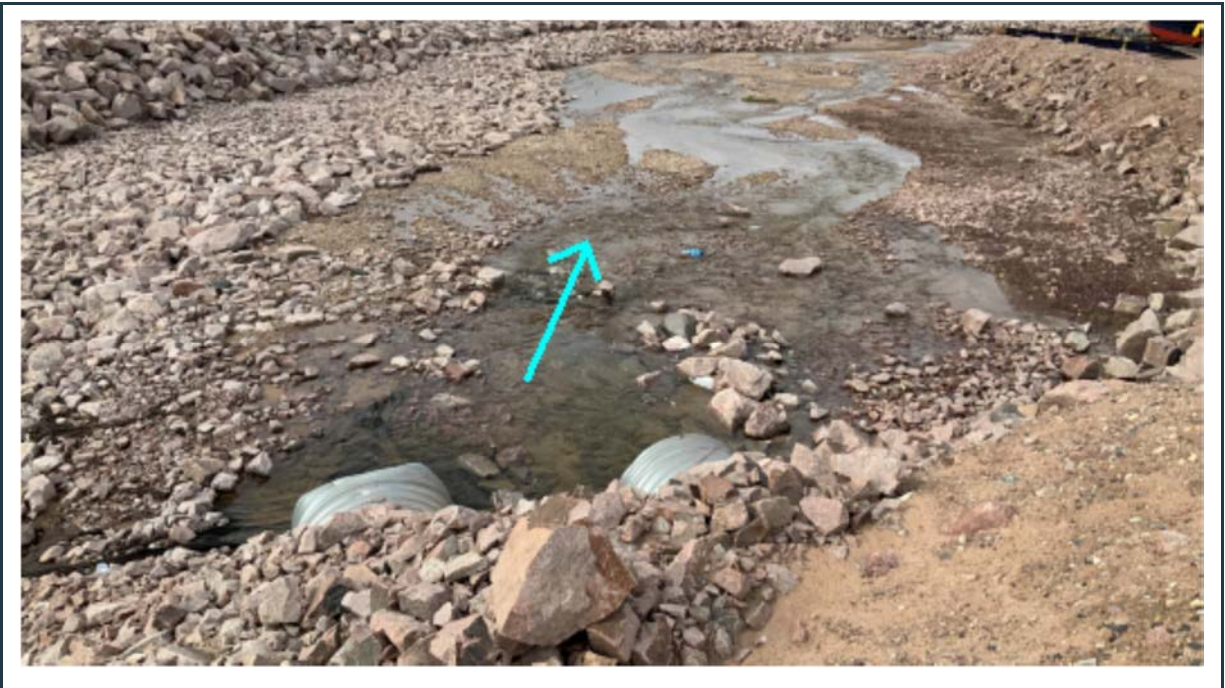
Figure 77: View of the well-maintained P-SWD-7 surface water collection ditch and culverts (outlet).

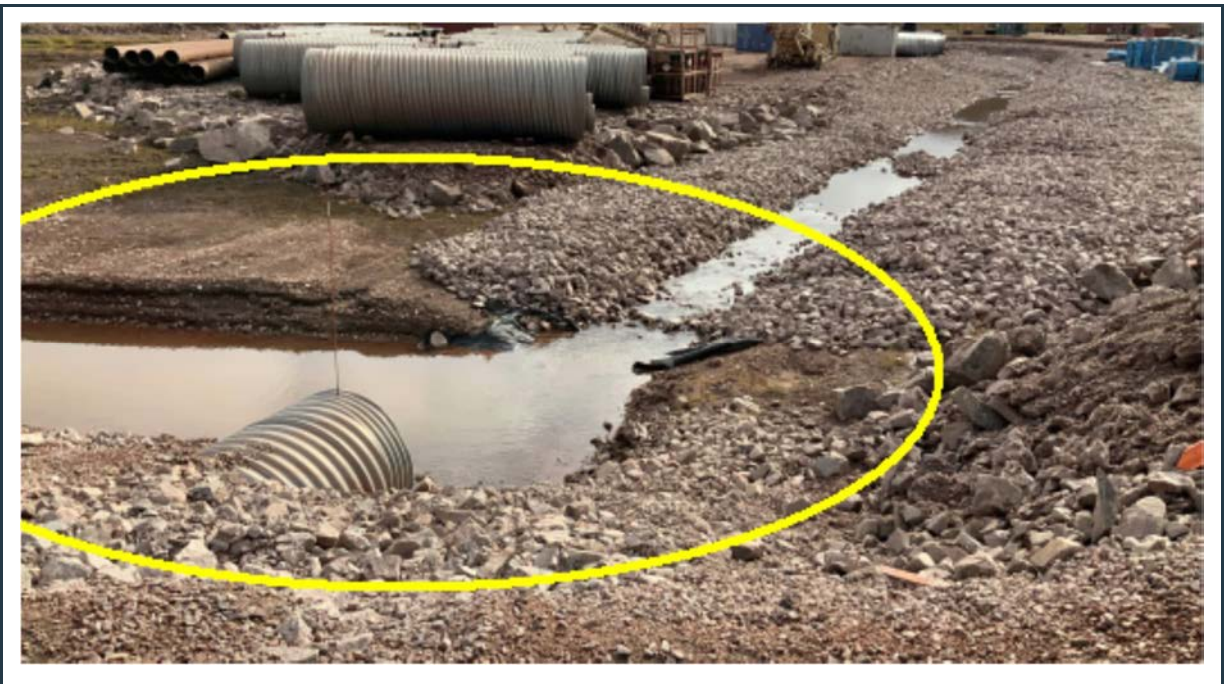
Figure 78: View of the partly completed W3/W14 surface water collection ditch with crushed rock riprap slope protection. The area around the culvert's inlet and the side-ditch from the left still require the placement of geotextile and riprap for erosion protection.

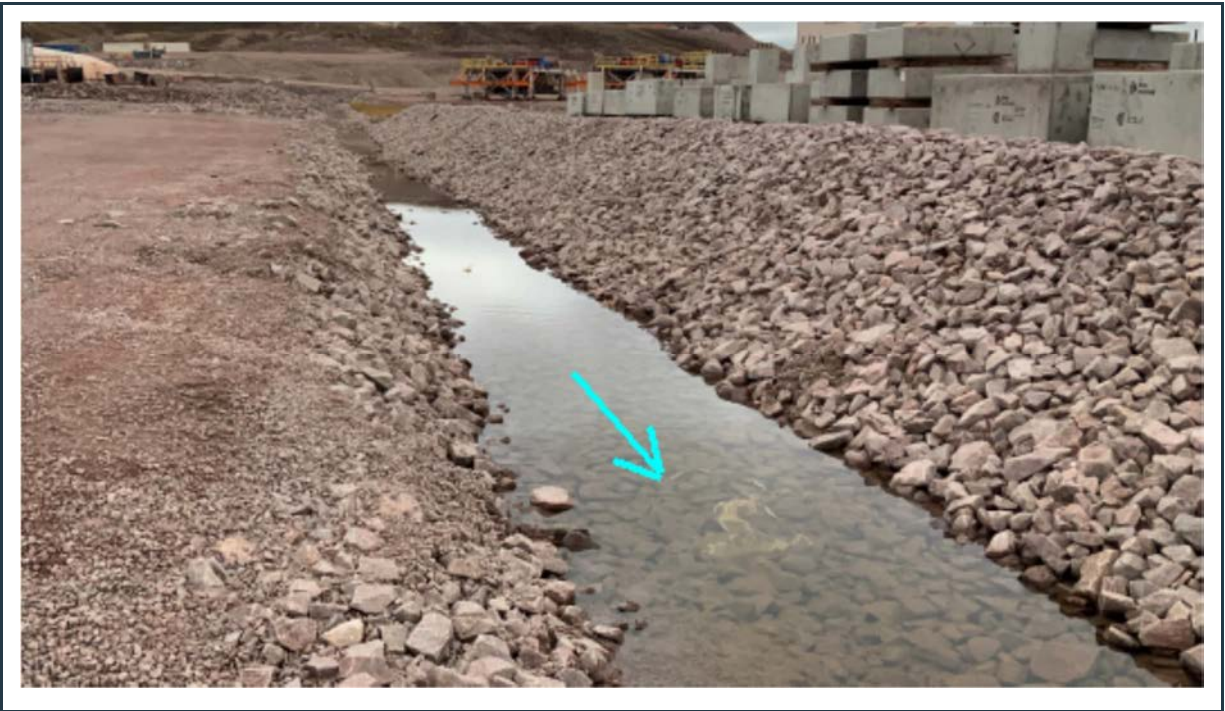
Figure 79: View of the well-maintained south section of the 380-Person Camp surface water collection ditch.

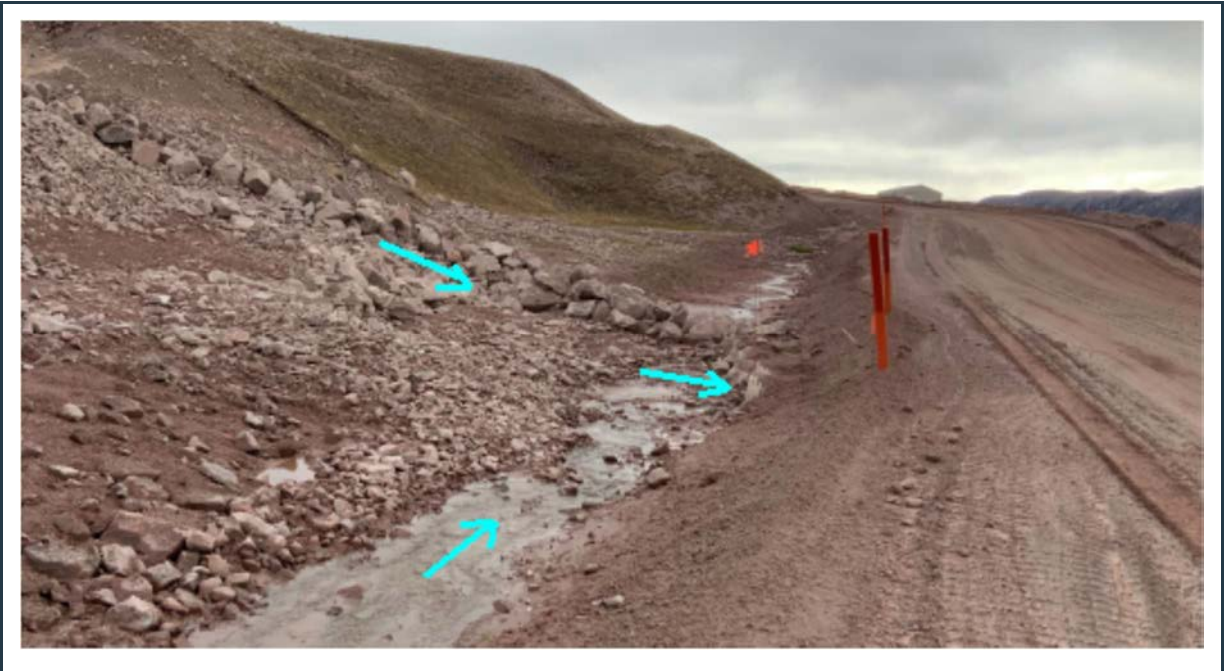
Figure 83: View the inlet of twin culverts draining surface water from the P-SWD-6 ditch and from the road's side-ditch, under the tote road.

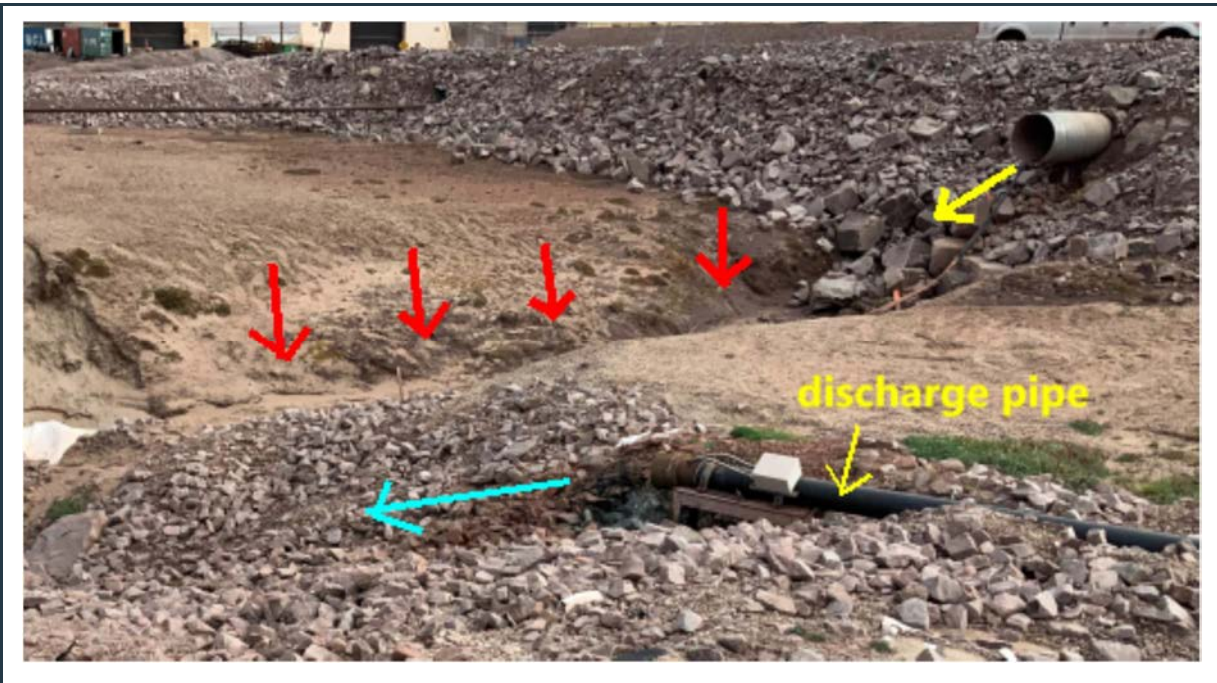
Figure 85: View of the end of the water discharge pipe (blue arrow) and a nearby culvert (yellow arrow) draining water to the same valley. More ripraps should be placed into the upper section of the valley, marked by red arrows, to prevent erosion of the valley floor and side-slopes.

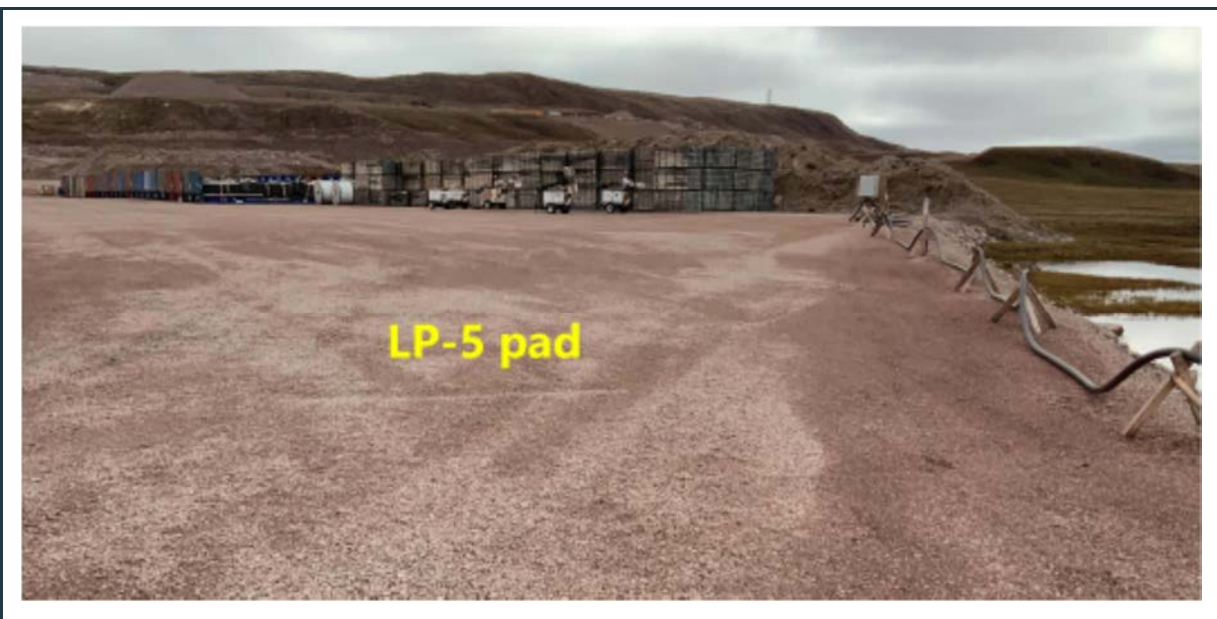
Figure 86: View of the recently regraded LP-5 storage area.

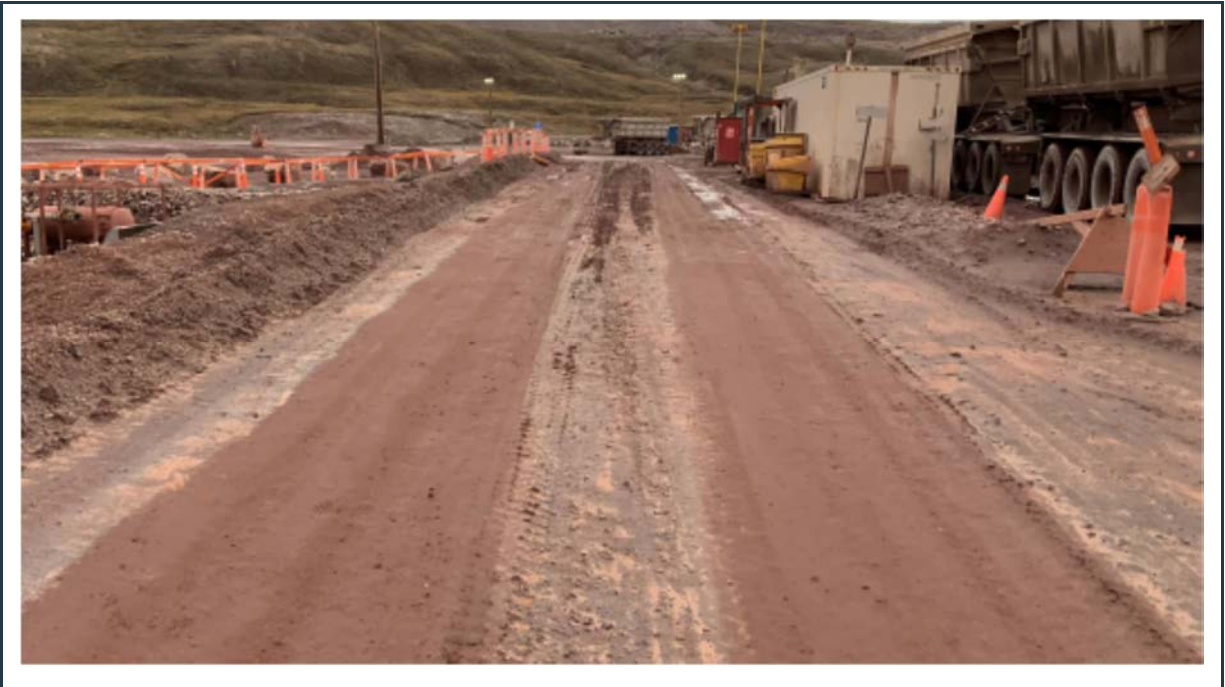
The Western Globe Fuel Module (WGFM), shown in Figure 87, is located north of the 380 Camp. As opposed to design specifications, no humps are visible at the entry and exit points of the refueling station. The top image of Figure 88 presents part of a historic design drawing (drawing number C01), showing a section of a 900 mm wide (at its crest) and 450 mm high drainage control hump with 10H:1V slopes, specified by B.H. Martin Consulting Engineer and Architect in June 2016. The purpose of the humps at the entry and exit points of the refueling station was to prevent oily surface water escaping the refueling area. As shown in the top image of Figure 88 the entire area of the refueling station has a liner beneath the road fill, which liner should also have a 10H:1V slope up to the internal edge of the 900 mm wide humps. Under the heavy truck traffic at the station; however, those humps were flattened/spread in the past but shall be reinstated. It is suggested that the edges of the liner beneath the road fill be exposed using hydrovac, and the humps reconstructed as designed. In addition, installation of timber beams is suggested within the humps, to prevent the flattening of the granular fill by the heavy trucks in the future, as shown in the lower image of Figure 88.

Figure 87: View of the Western Globe Fuel Module (WGFM) north of the 380 Camp. No humps are visible at the entrance and exit points of the refueling station.

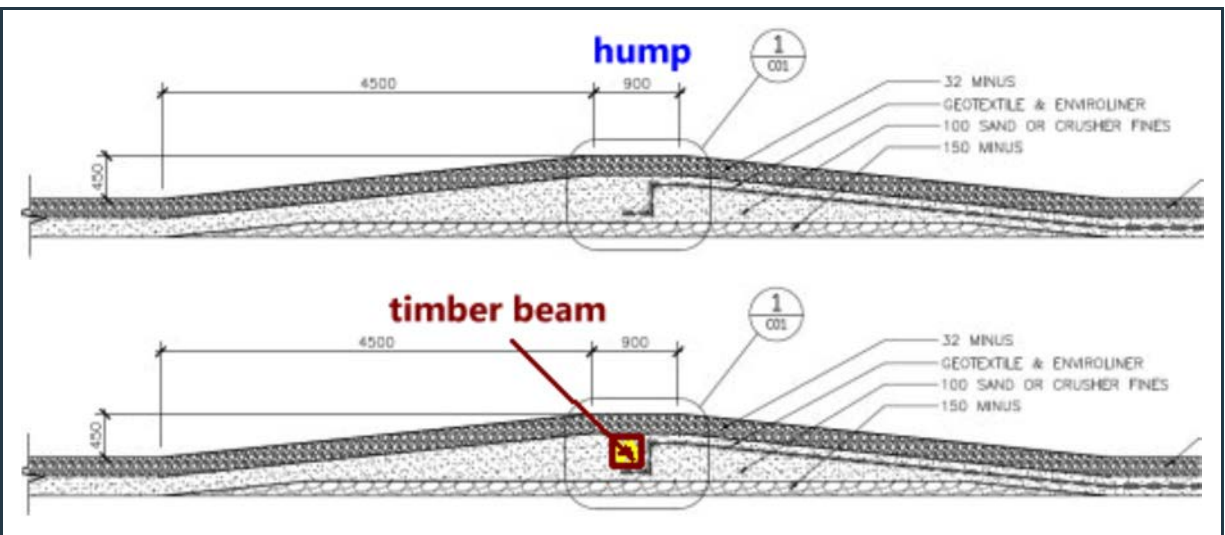
Figure 88: Top image: Section of 900 mm wide (at its crest) drainage control hump with 10H:1V slopes for the Western Globe Fuel Module (WGFM), specified by B.H. Martin Consulting Engineer and Architect, in June 2016. Lower image: A 10" by 10" timber beam should be installed within the humps to prevent the flattening of the granular fill by the heavy trucks. The humps should prevent potential oily surface water escaping the refueling area toward the ends of the WGFM.

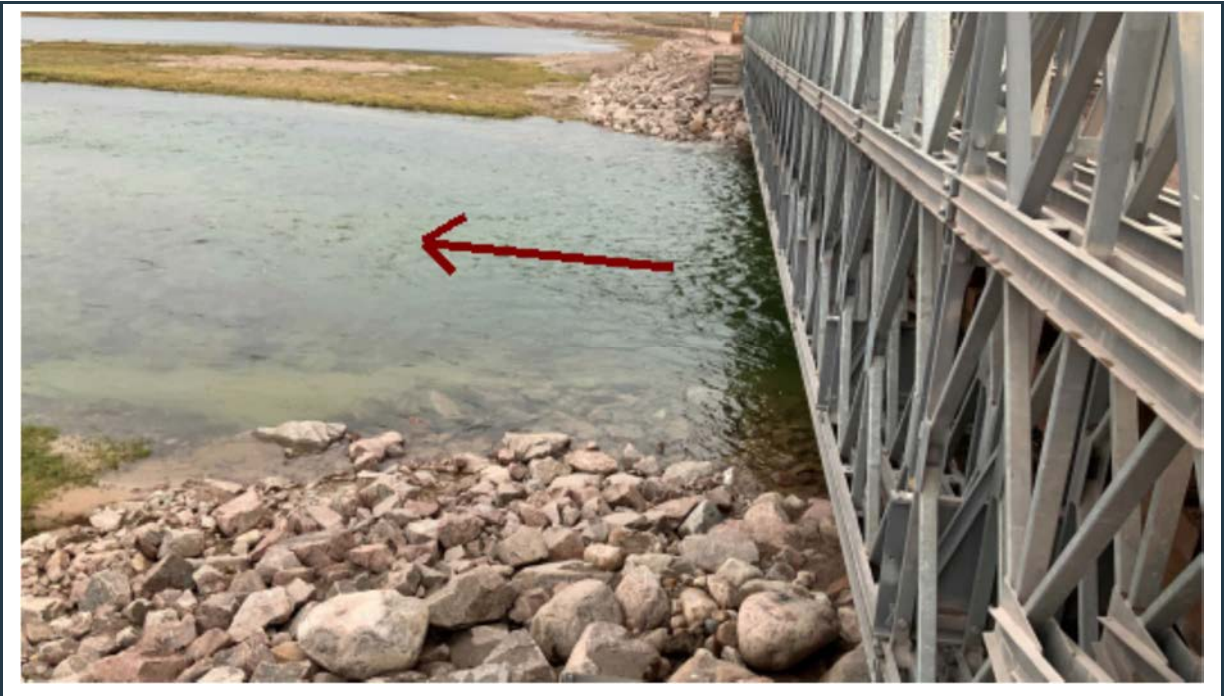
As shown in Figure 89 and Figure 90, the abutments and approach embankments at this bridge appear to be stable, and no scour was noted in the riverbed around the abutments during the August 2024 site visit. The abutments show no visible differential settlement or any structural discrepancy like deterioration of the steel bolt-a-bin abutments or sloughing of the riprap rock fill.

Figure 89: View of the stable abutments with riprap erosion protection at the north side of bridge KM17.

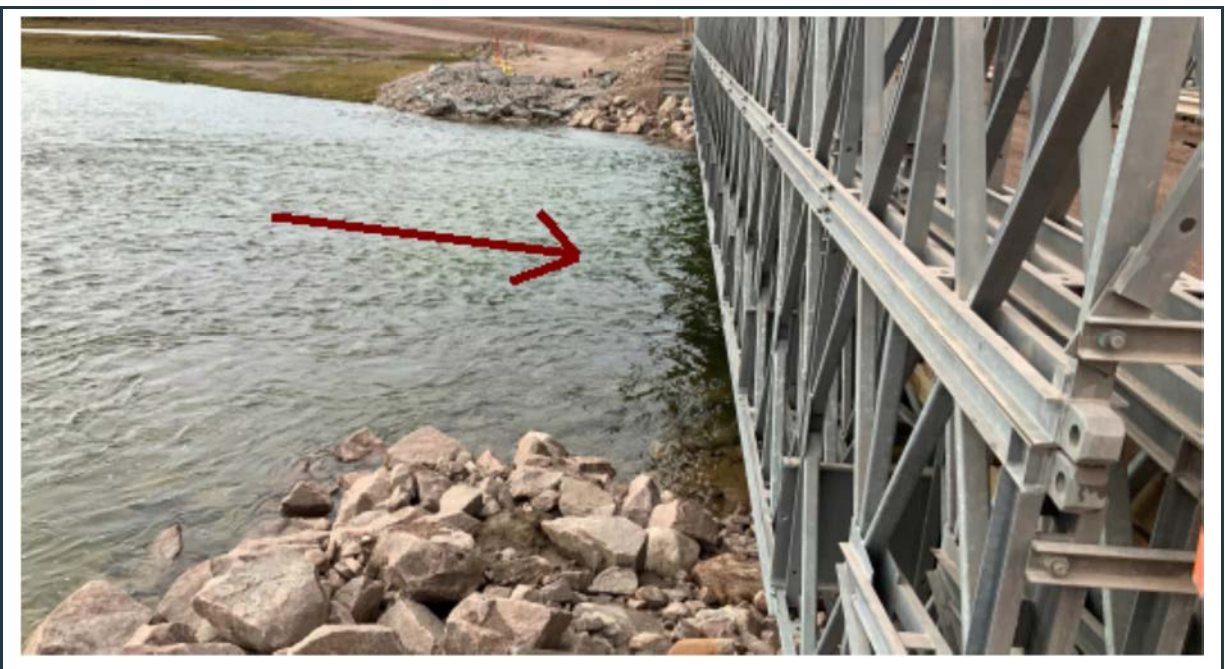
Figure 90: View of the stable abutments with riprap scour protection at the south side of bridge KM-17.

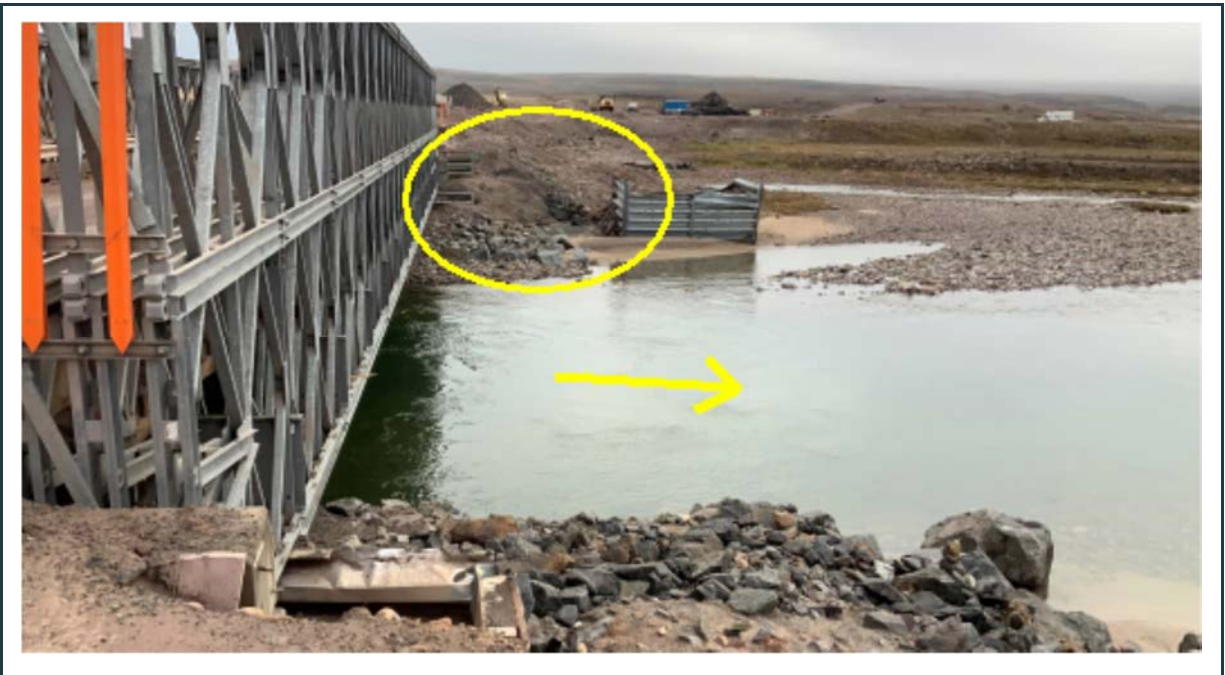
As shown in Figures 97 to 100, the abutments of this bridge appear to be stable and no scour in the riverbed around the foundations and approach embankments was noted during the August 2024 site visit. The abutments show no differential settlement or any structural discrepancy like deterioration of the foundation bins. There are areas at two locations, shown in the zoomed-in Figures of 98 and 100, where some additional rock fill should be placed over fine soils at the surface, to prevent erosion and migration of the finer material into the river.

Figure 97: View of the stable abutments at the west side of bridge KM 97. As shown, there is only one remaining old crib abutment present at this bridge. Note the area between the old and new abutments (yellow circle) where additional rock fill should be placed for erosion protection.

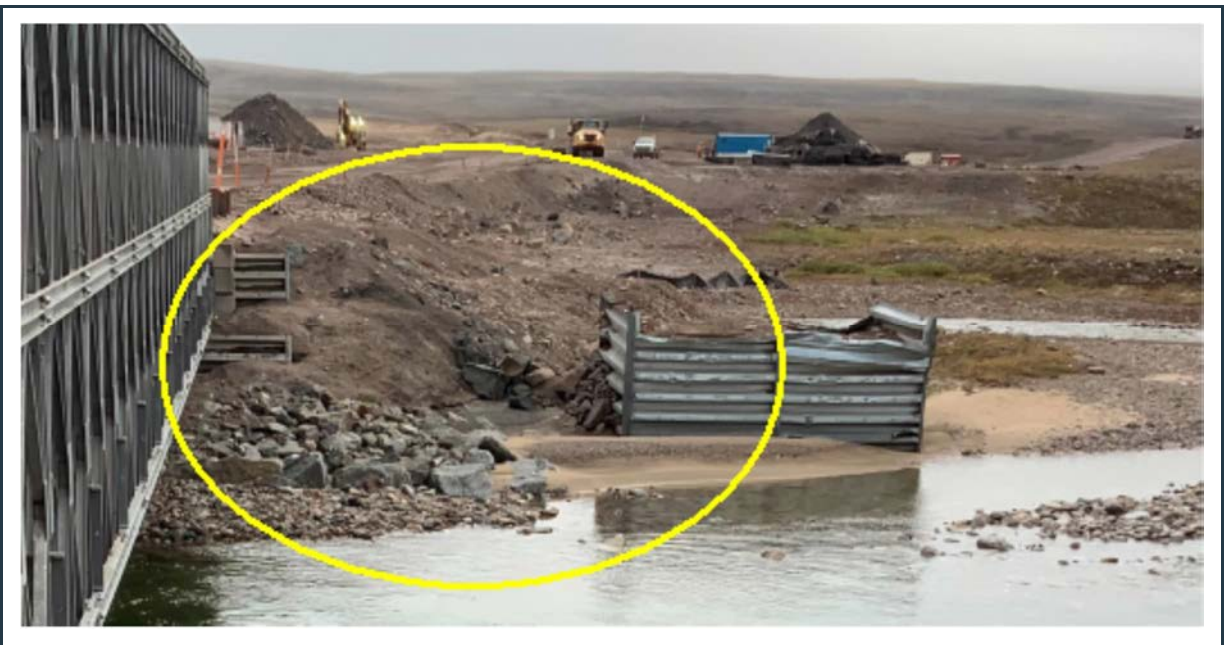
Figure 98: View the enlarged image of the area between the old and new abutments (yellow circle) where additional rock fill should be placed for erosion protection.

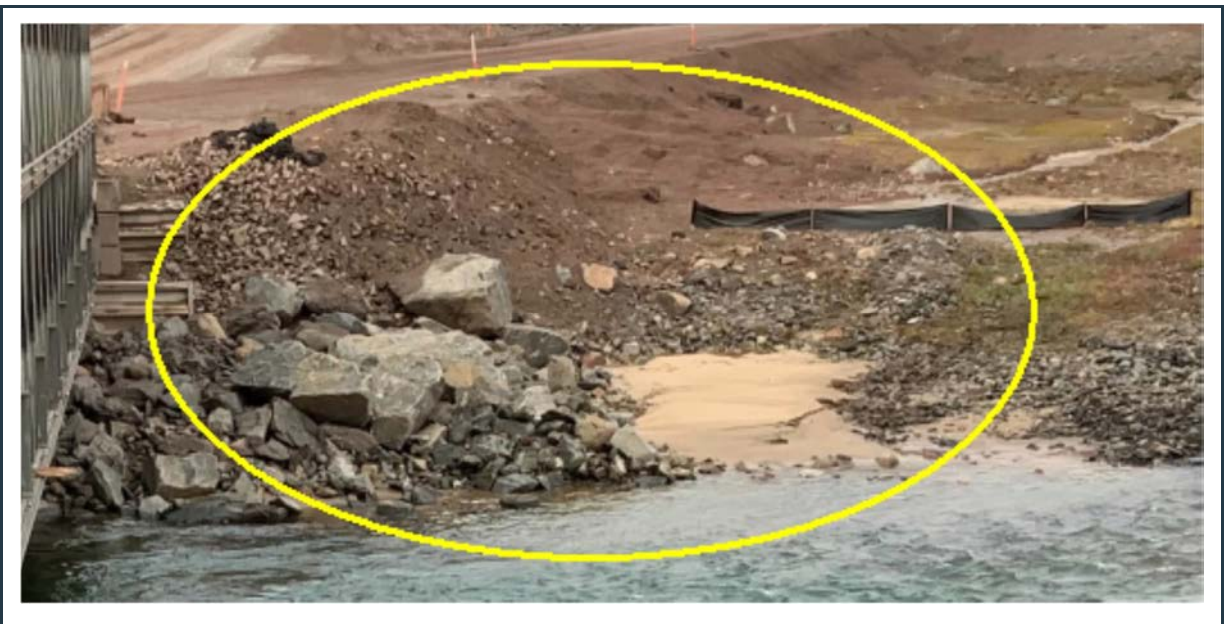
Figure 100: View of the enlarged image of the area marked by the yellow circle in Figure 99, where additional rock fill should be placed for erosion protection.

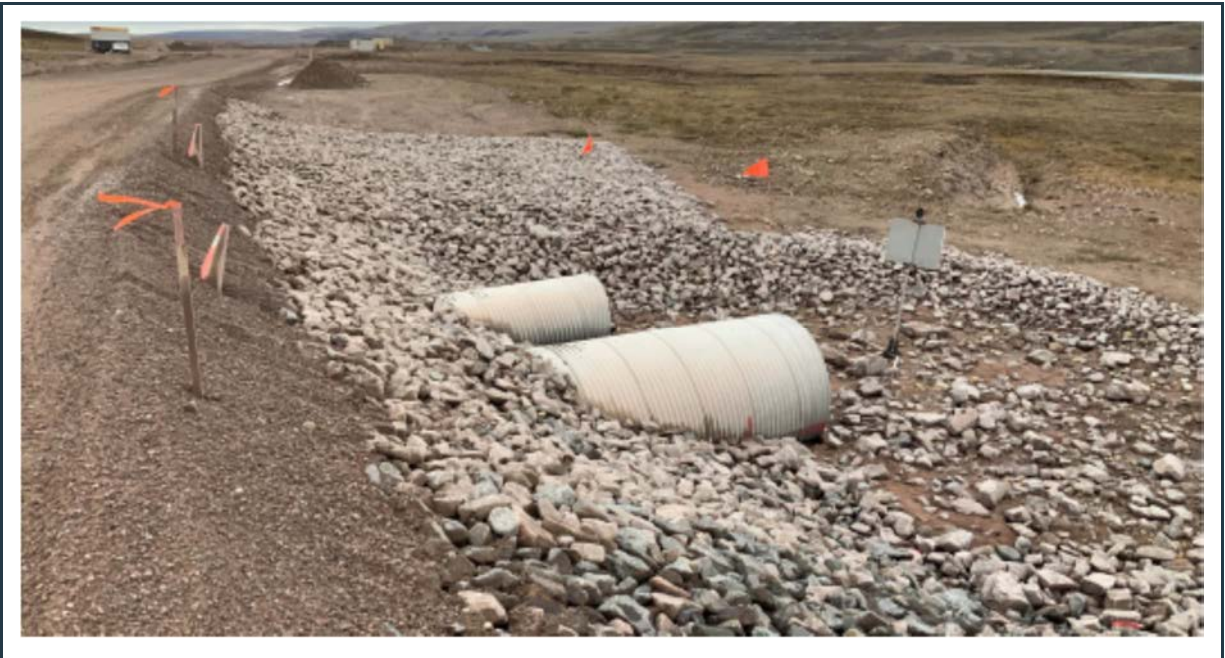
Figures 104 and 105 show the inlet and outlet of the twin culverts at KM 33+100. No water was flowing through the culverts during the August 2024 inspection. It was noted that some sagging of the corrugated pipes beneath the road has occurred at these culverts. It is likely that the subgrade beneath the culverts included ice-rich, thaw-unstable soils. Heat, transferred to this type of subgrade through the pipes during the start of the summer had resulted in thawing of the ice-rich soil, which in turn has resulted in the sagging (differential settlement) of the pipes under the weight of the road embankment. There is potential that these culverts will need to be reinstalled after the removal of the upper zone of the thaw-unstable ice-rich soil. The new culverts will need to be placed over thaw-stable, compacted granular fill as pipe bedding, with a thickness of at least 1.5 m.

Figure 105: View of the outlet of the twin culverts at KM 33+100. No water was flowing through the culverts that show some sagging in their centre, under the weight of the road embankment.

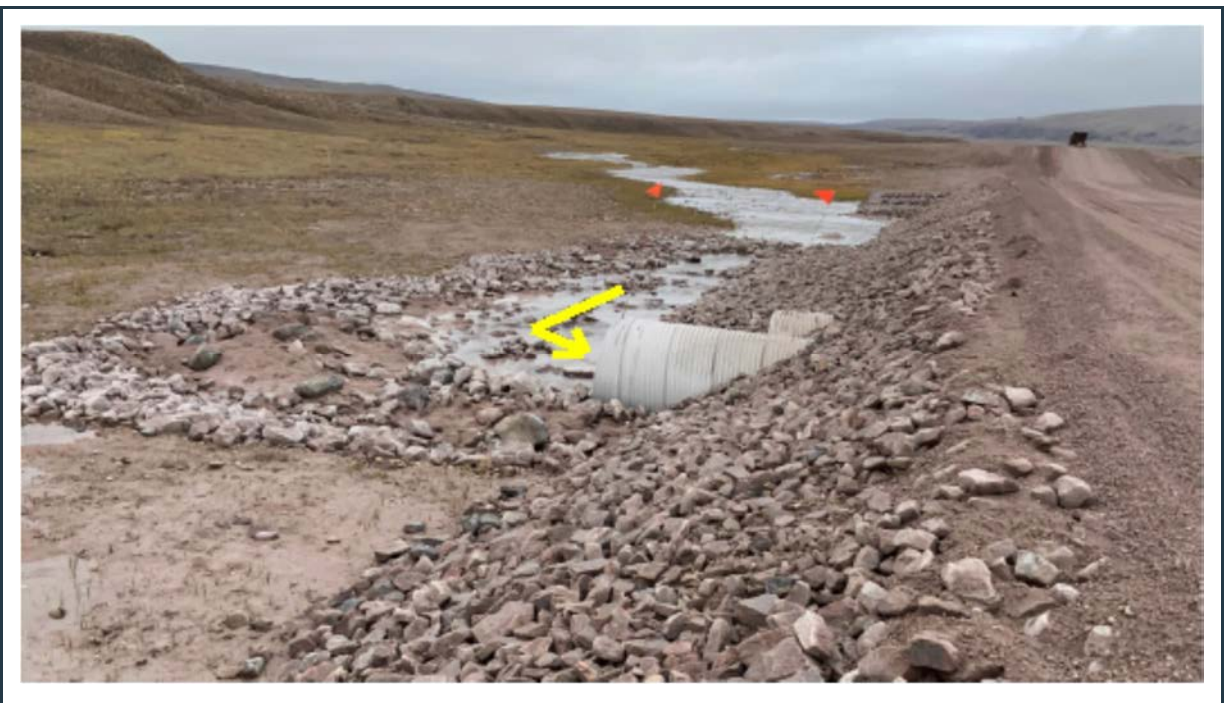
Figures 106 and 107 show the inlet and outlet of the twin culverts at KM 36+000. These culverts appear to be in good condition, and uninterrupted flow was visible through both pipes during the site visit.

Figure 106: View of the inlet of the twin culverts at KM 36+000, in good condition.
