**Submission of Annual Geotechnical Inspection – 2024, Mary River Project – Nunavut, Project # CA0039374.4332**

#### Mary River Project – Nunavut

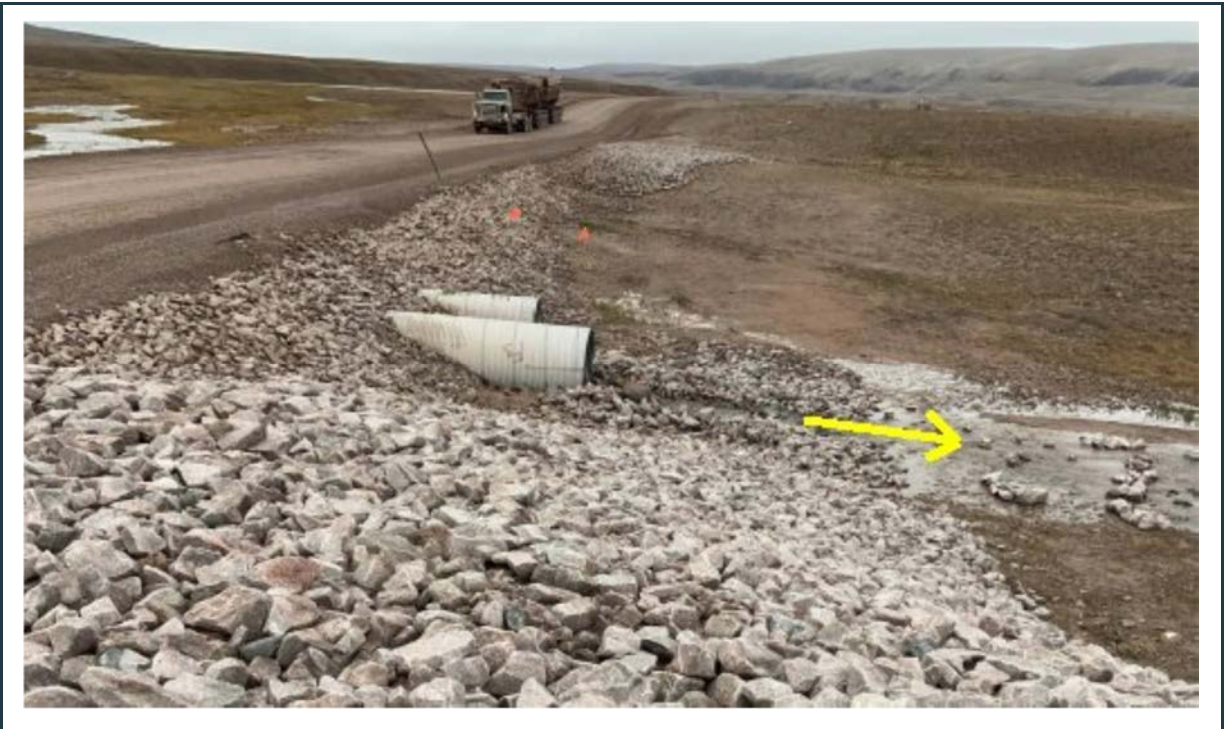
Figures 106 and 107 show the inlet and outlet of the twin culverts at KM 36+000. These culverts appear to be in good condition, and uninterrupted flow was visible through both pipes during the site visit.

Figure 107: View of the outlet of the twin culverts at KM 36+000, in good condition.

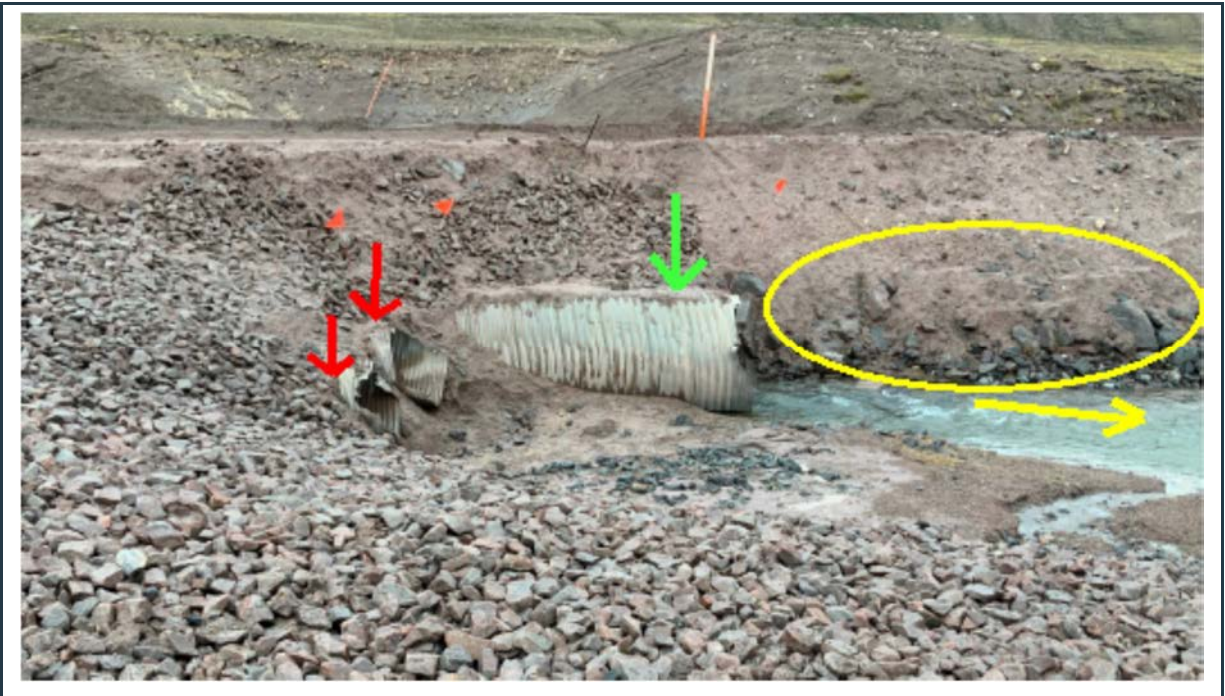
Figures 112 and 113 show the inlet and outlet of three corrugated pipe culverts, one relatively new (green arrow) and two old (red arrows) pipes. As shown in the images, only one of the three pipes is operational. Figure 113 also shows that the operational (green arrow) pipe is not perpendicular to the road, but follows the alignment of the stream, crossing the road at an angle (skewed barrel). Such culvert alignment may often result in increased erosion of the road embankment at the inlet and outlet ends of the culverts (note the yellow circle in Figure 113). It is suggested to closely monitor the embankment at both ends of this culvert and make appropriate steps (if needed) to prevent sloughing of the material at the toe of the road embankment, by lengthening the culvert at both ends, and by placement of additional riprap on the adjacent embankment slopes, particularly at the toe.

Figure 113: View of the outlet of three culverts at KM 90+100. Only one (green arrow) is operational.

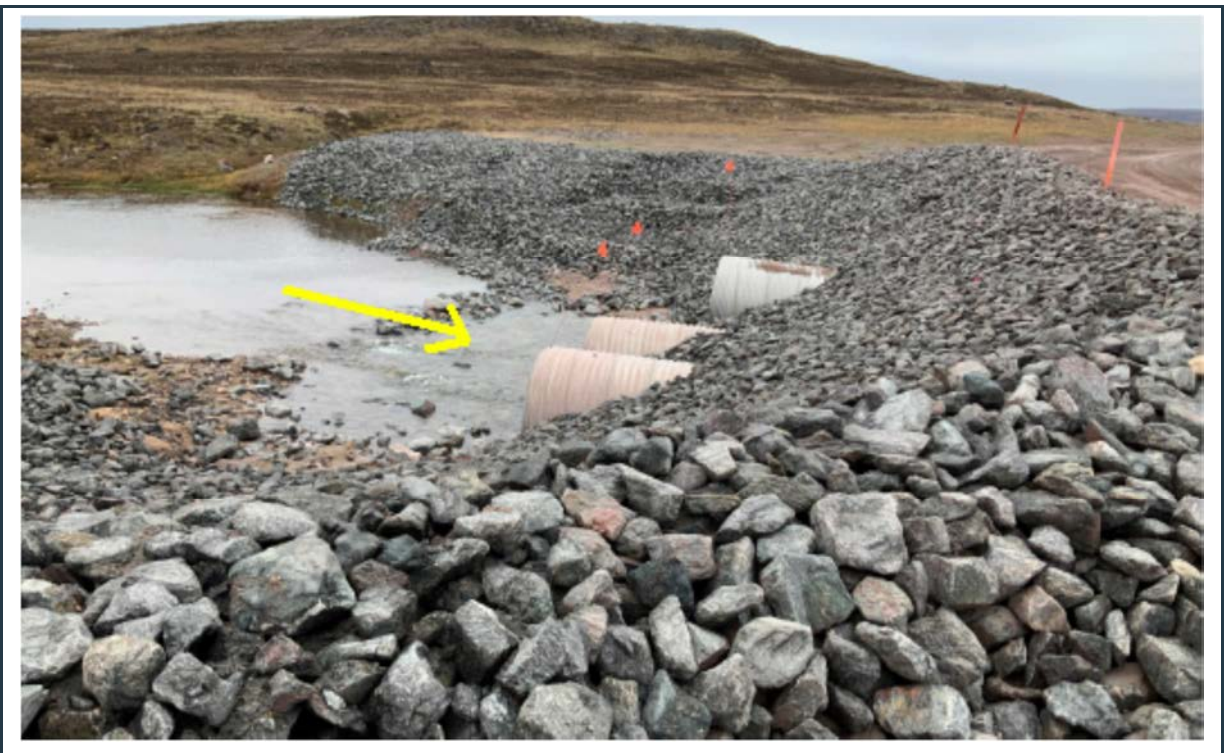
Figures 114 and 115 show the inlet and outlet of three culverts at KM 36+000. These culverts appear to be in good condition, and uninterrupted flow was visible through all three pipes during the site visit.

Figure 114: View of the inlet of three culverts at KM 94+060, in good condition.

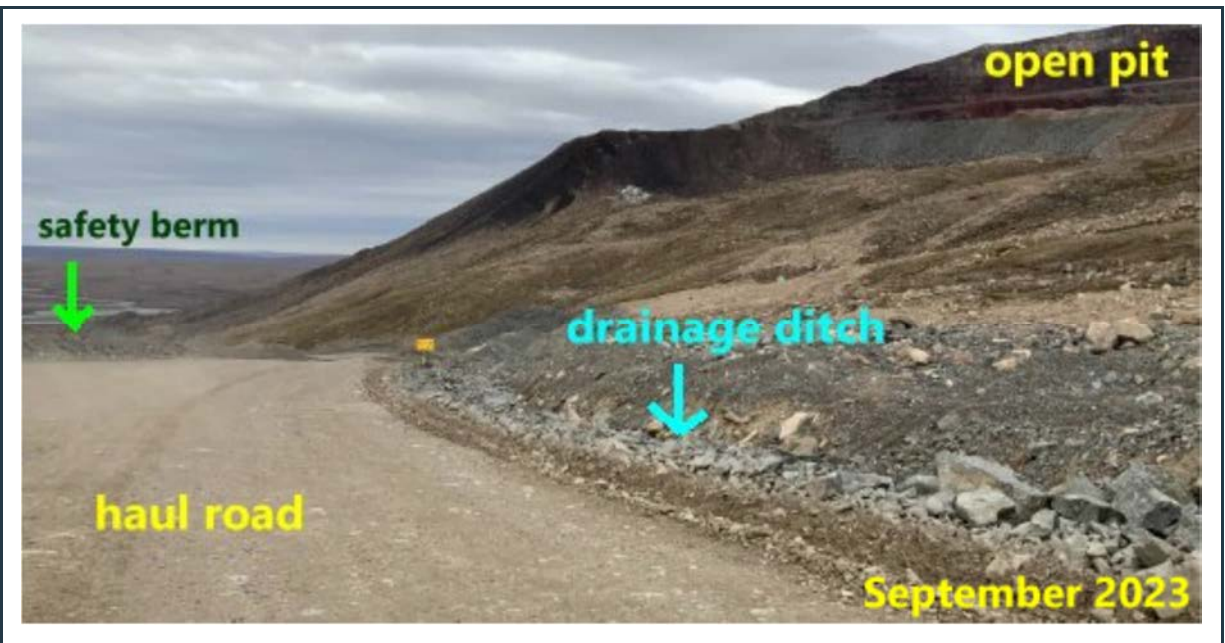
It was pointed out in WSP's previous (2023) inspection report that the drainage condition along the haul road between the crusher pad and the open pit was significantly improved recently to control potential surface erosion, to minimize the impact on the near surface zone of the permafrost, and to prevent any slope instability in the vicinity of the road alignment. The improvement included upgrading the side ditches along the uphill side of the haul road and the formation/construction of whoa-boys and cross ditches to capture surface water (run-off) flowing on the surface of the wide haul road and divert the water from the road to the side ditches, as shown in historic Figures 116 and 117 (2023 images).

Figure 116: View of a 2023 image of the well-maintained haul road between the crusher pad and the open pit around KM-107. Note the safety berm along the downslope side and the upgraded, erosion-controlled drainage ditch along the upslope side of the road with additional rock fill in critical areas.
