RE: Submission of Annual Geotechnical Inspection – 2025, Mary River Project – Nunavut, August 29, 2025; Project # CA0055338.6747

WSP Canada Inc., has completed the required geotechnical field inspection of 2025 at the Mary River Mining Project, which is a condition of the Nunavut Water Board's Renewed Type "A" Water Licence No: 2AM-MRY2540.

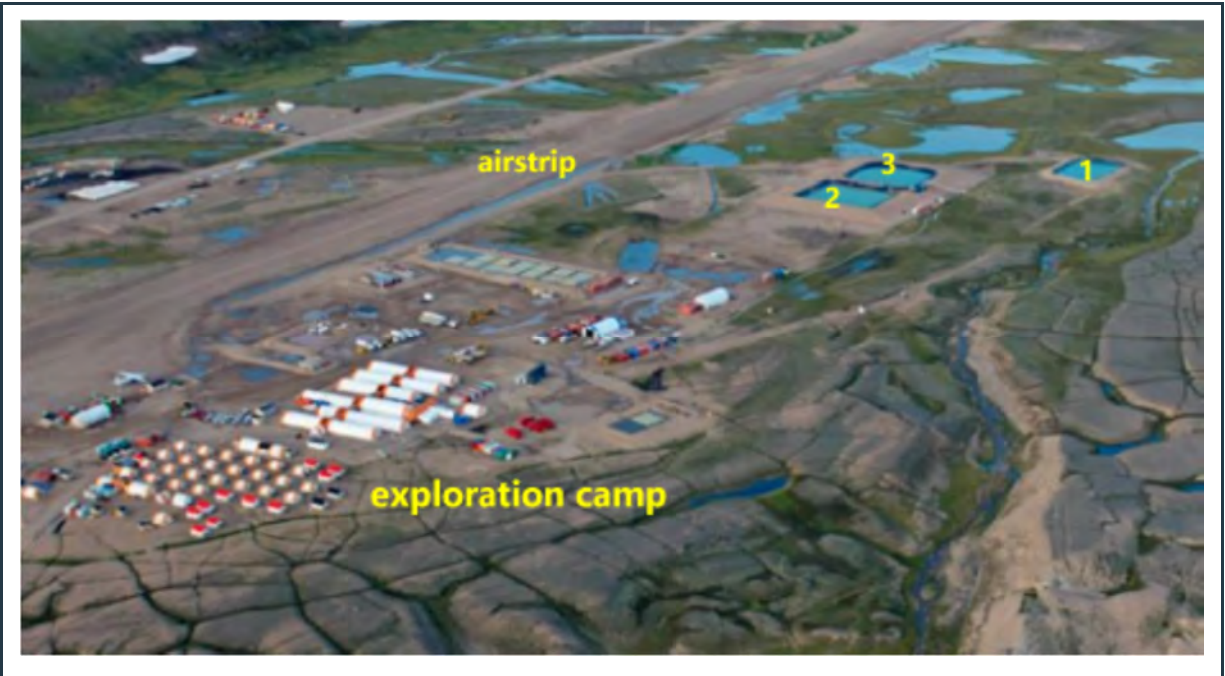
There are three (3) polishing waste stabilization (PWS) ponds, located adjacent to the airstrip, as shown in Figure 8. Pond #1 is a single structure, while Ponds #2 and #3 were constructed as twin-cells, as shown in Figure 12. The photograph in Figure 12 is a historic aerial image provided by BIM, showing the robust and stable berms around the three stabilization ponds. As mentioned in previous inspection reports, these ponds were associated with the exploration phase of the mine and currently serve as emergency holding ponds in case problems would arise, which would prevent the discharge of treated effluent directly to the receiving environment. The robust, stable berms around the ponds generally comprise granular materials (rock fill, sand, and gravel), with high density polyethylene (HDPE) geomembrane liners. No damage is visible on the membranes in the cells or on the upstream face of the slopes (see Figures 13 to 15).

Figure 12: Historic image of the three PWS ponds (1 – 3) with robust, stable berms near the historic exploration camp. – Source: BIM

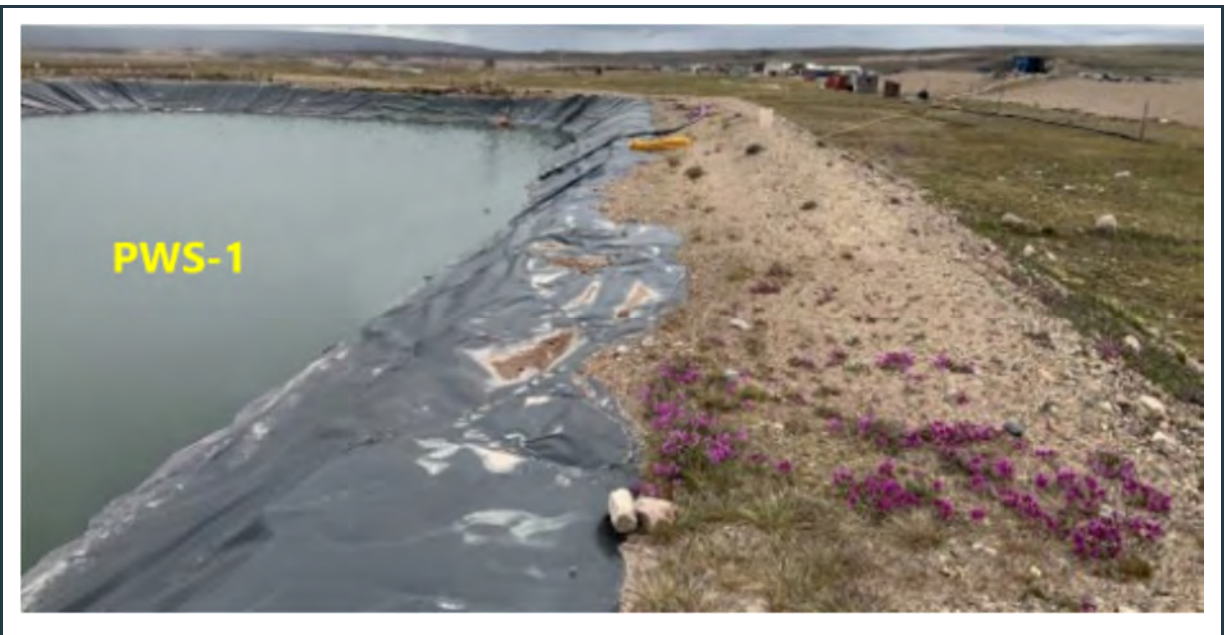
Figure 13: PWS pond #1. Well-maintained, stable perimeter berm and intact liner at the pond (July 2025).

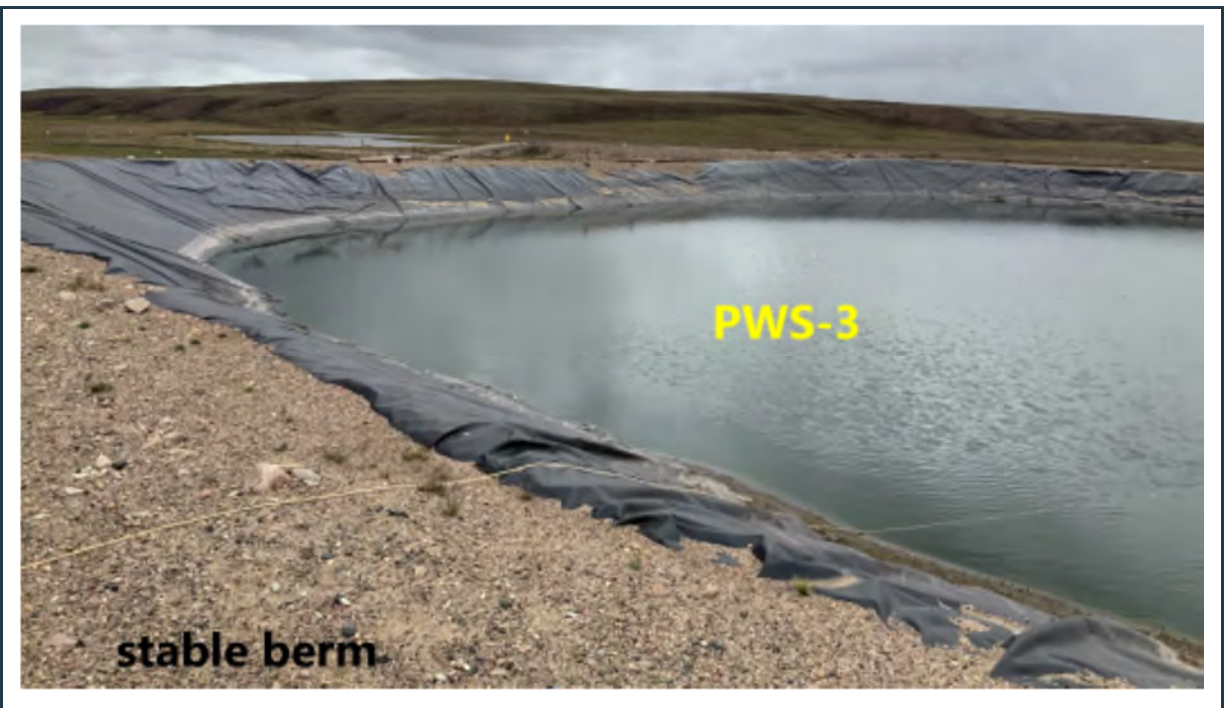
Figure 15: Robust, stable perimeter berms and intact liner at the PWS-3 pond.

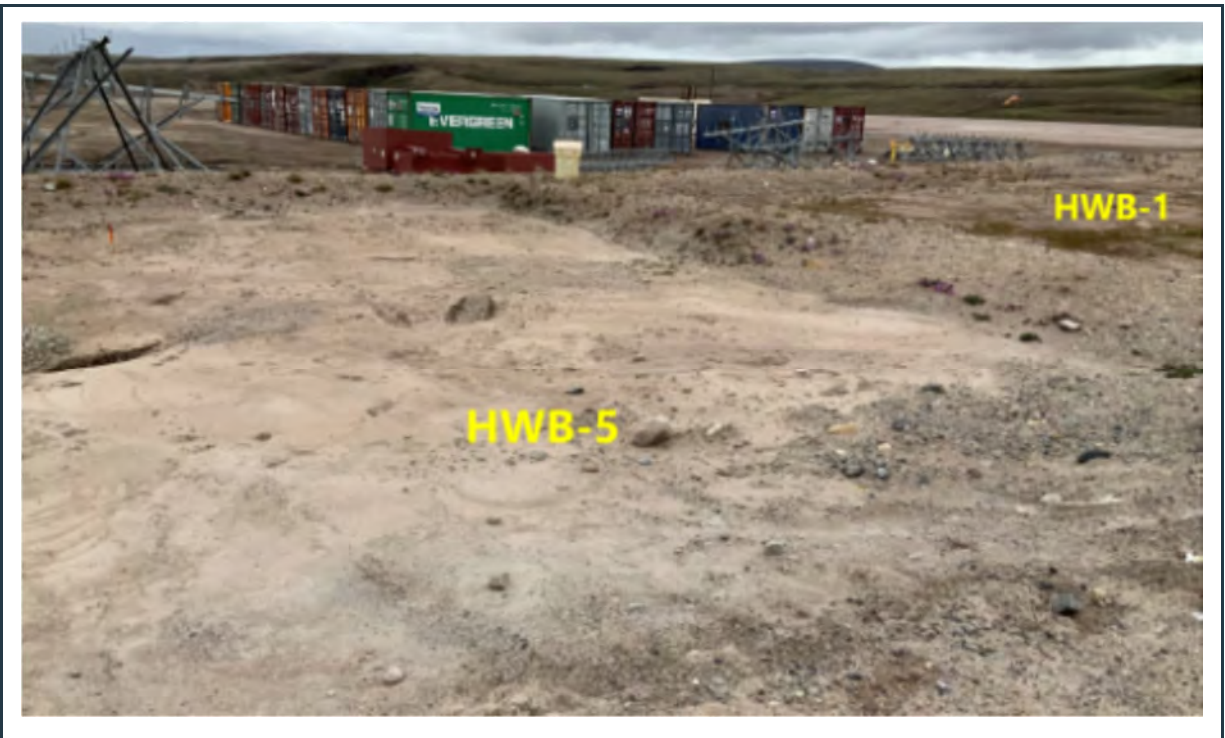
e) HWB-6

As shown in Figure 20, this cell is currently empty and has not been in use for years. The shallow berms around the cell appear to be stable, although the result of some surface erosion on the slopes is visible. No ponding water is visible in this cell indicating potential liner damage. As mentioned earlier for HWB-1, these two cells (1 and 5), together with cell 2, could be reconstructed as one large new cell with new berms and liner, should additional storage requirements for hazardous waste would become necessary at the site. The existing granular material from the current berms could be reused for the construction of new berms around a new enlarged cell, if so decided. However, the new cell would require the installation of new HDPE liner.

Figure 20: View of the empty HWB-5 cell, which has not been in use for years (like the adjacent HWB-1).

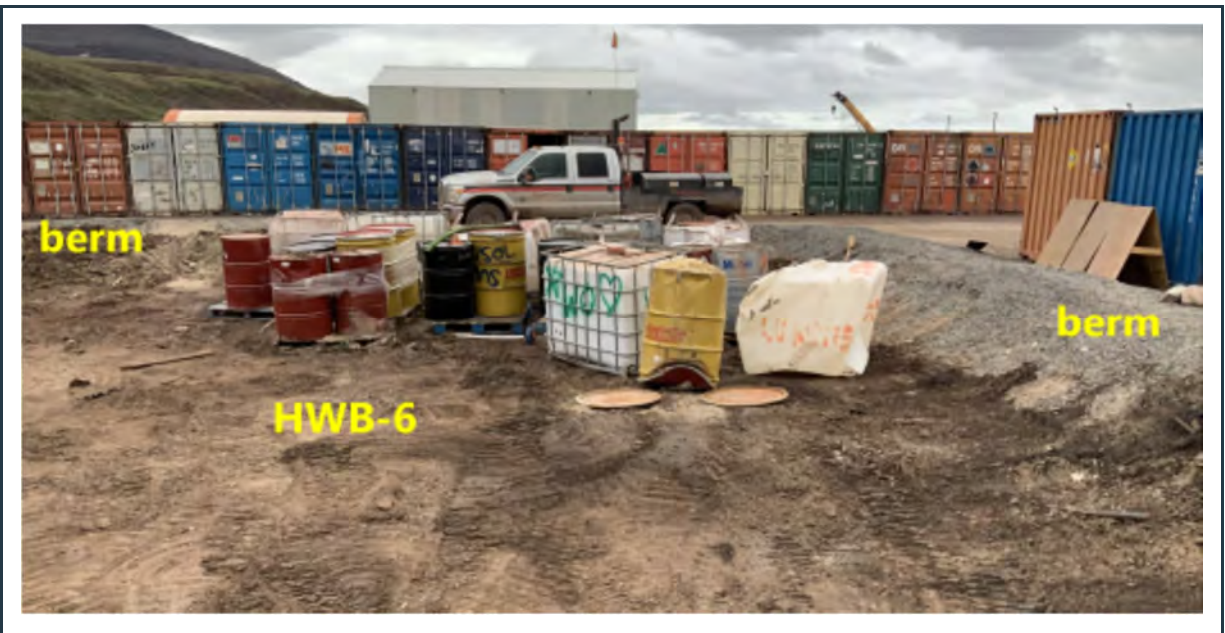
The stable berms around this cell and the internal “floor” of the cell have been regraded and stabilized recently using clean granular fill, as shown in Figure 21. The cell was generally filled to its capacity in the past; however, this year only limited quantity of waste material was stored in the cell, as shown in the image. No damage to the liner was noted during the field inspection in the cell and the access ramp is maintained in good condition.

Figure 21: View of the stable berm around the HWB-6 cell, near the incinerator.

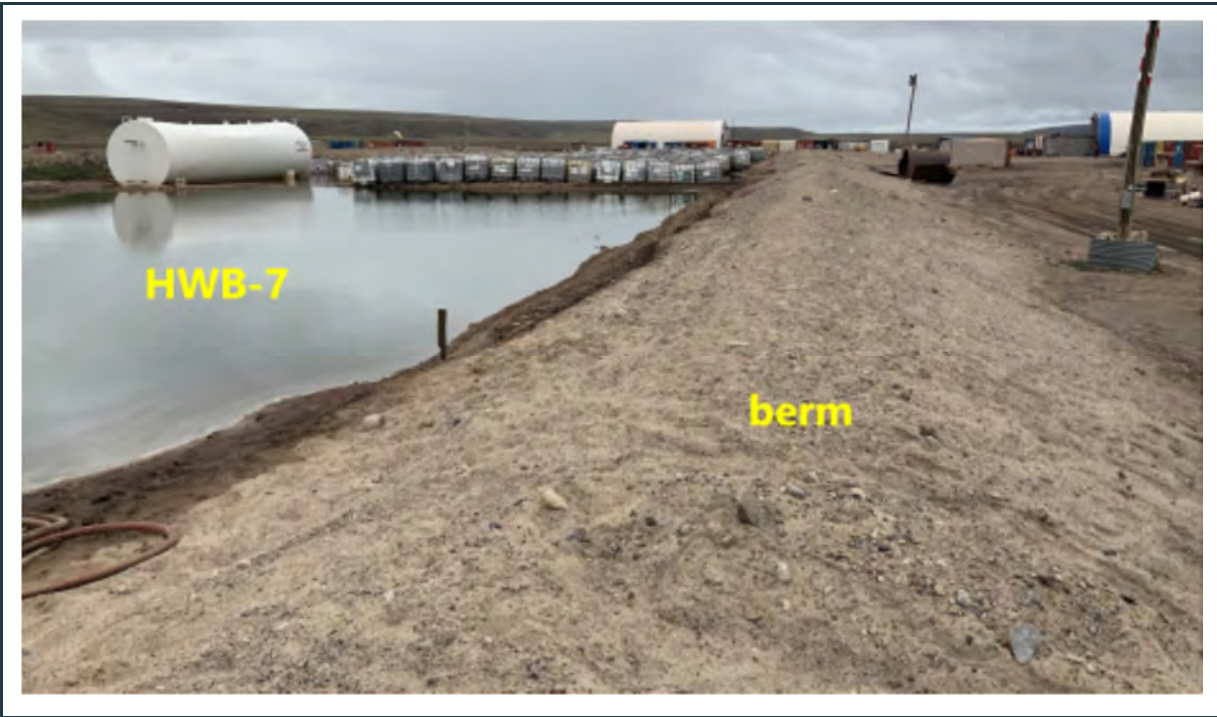
One (1) large fuel tank is stored in this cell together with hydrocarbon products in large number of containment totes, as shown in Figure 22. The perimeter berm around the cell appears to be stable and the ponding water within the cell is indicative of adequate liner performance.

Figure 22: View of the stable berm around the HWB-7 cell, with an old fuel tank and oil filled plastic containers stored in the cell. The ponding water indicates good liner performance.

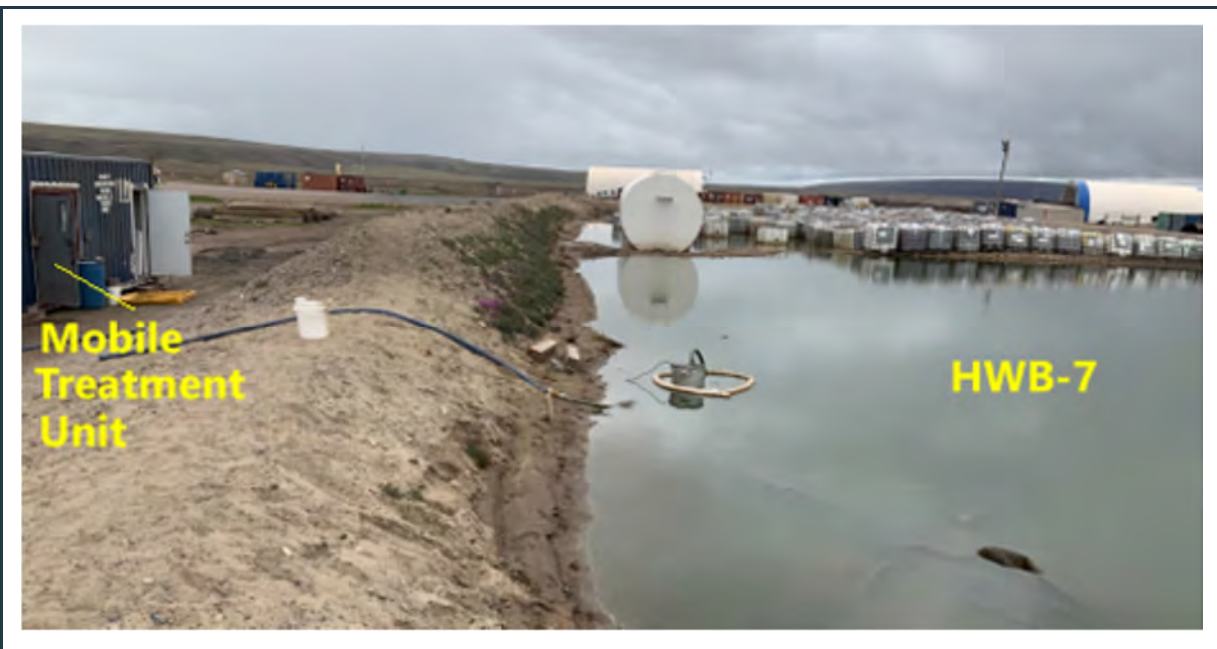
In the 2024 inspection report it was recommended that the level of ponding water in this cell should be monitored closely, and some of the water should be removed to prevent the potential for uncontrolled release of the water from the cell. Following that recommendation, a mobile treatment plant is now operated adjacent to the cell and the water level is well controlled in the cell, as shown in Figure 23.

Figure 23: View of the stable berm around the HWB-7 cell, with an old fuel tank and oil filled plastic containers stored in the cell. Note the mobile water treatment unit in operation adjacent to the cell.

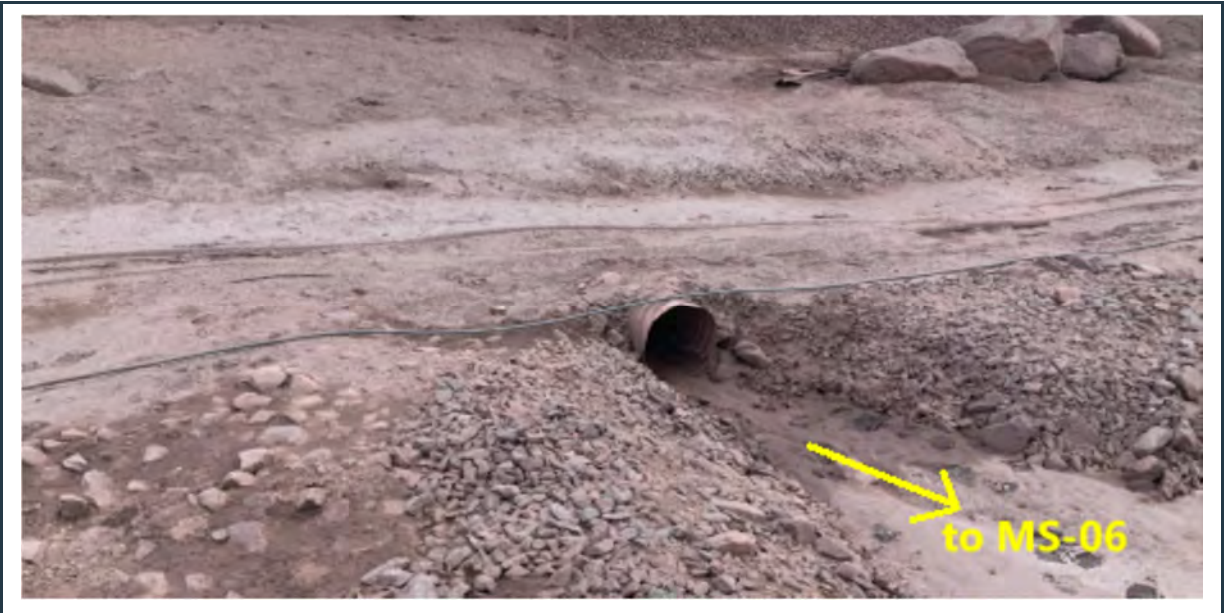
Figure 24: View of the discharge end of the recently cleaned culvert, draining the collected surface water from the crusher pad area to the MS-06 pond. See culvert A in Figure 2 for location.

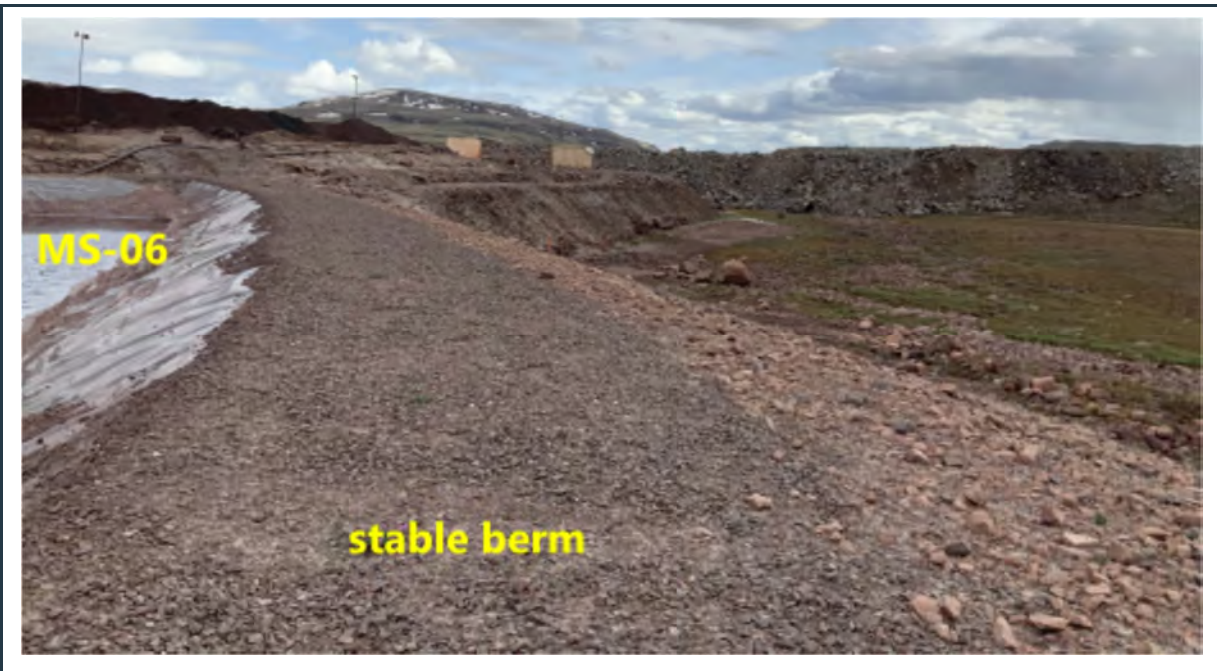
The MS-06 surface water management pond collects surface water from the area of the crusher pad. The surface water is collected in side-ditches around the crusher pad and conveyed into the MS-06 pond. One of the culverts (culvert A, marked in Figure 2) is located under the adjacent road at the crusher pad entrance and connecting one of the side ditches with the north corner of the MS-06 surface water management pond. The discharge end of the culvert appears to be well maintained (Figure 24); however, the intake end of the pipe is partially clogged, as shown in Figure 25. That end of the culvert should be cleaned as soon as practically possible to facilitate uninterrupted flow of water through the pipe. The liner within the pond and on the upstream slopes of the stable perimeter berm appears to be intact, shown in Figure 26.

Figure 26: View of the robust, stable berm around the MS-06 pond, with intact liner.

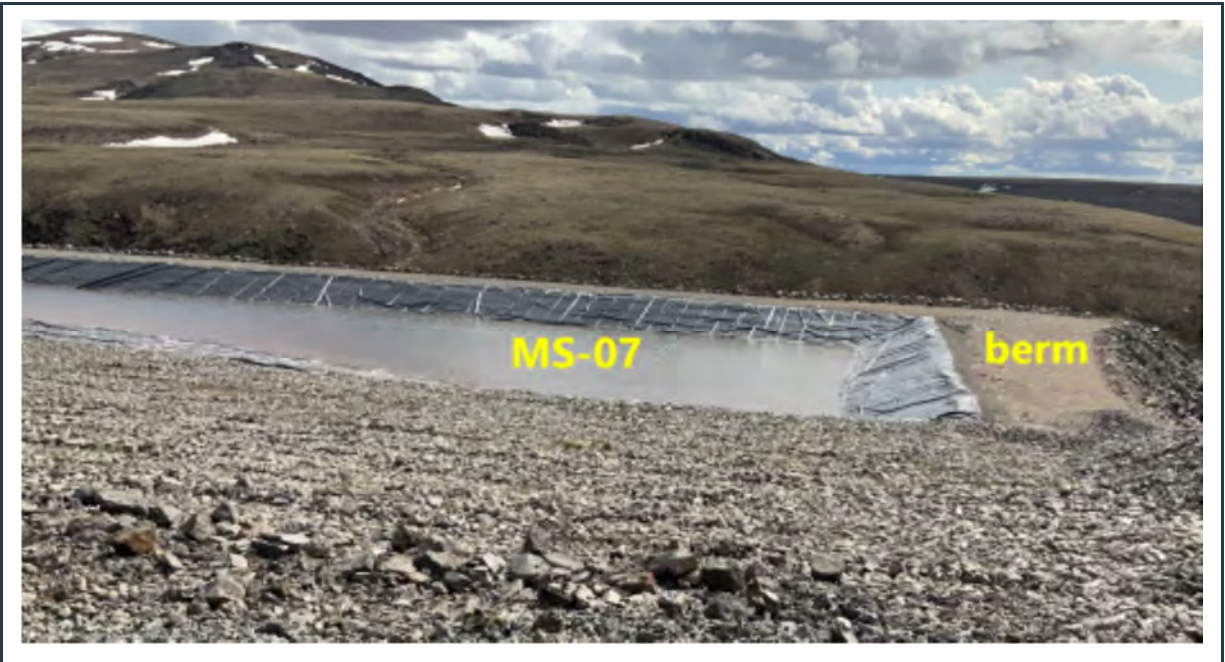
The MS-07 surface water management pond is located adjacent to the KM-106 ore stockpile area. The pond has robust, stable perimeter berm and intact geomembrane liner, as shown in Figure 28. No stability or seepage related problems were observed at this pond during the July 2025 site visit.

Figure 28: View of the robust, stable perimeter berm and intact liner at the MS-07 surface-water management pond at KM106.

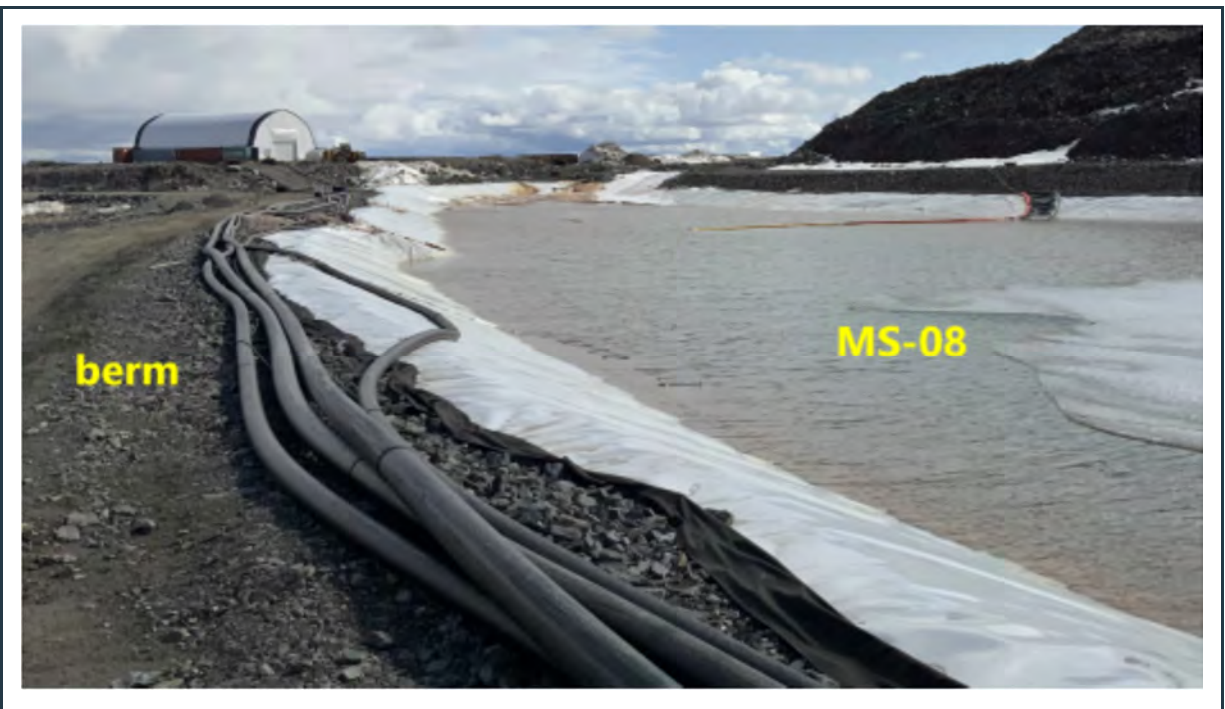
Figure 29: View of the stable, robust berm and intact liner at the MS-08 pond.

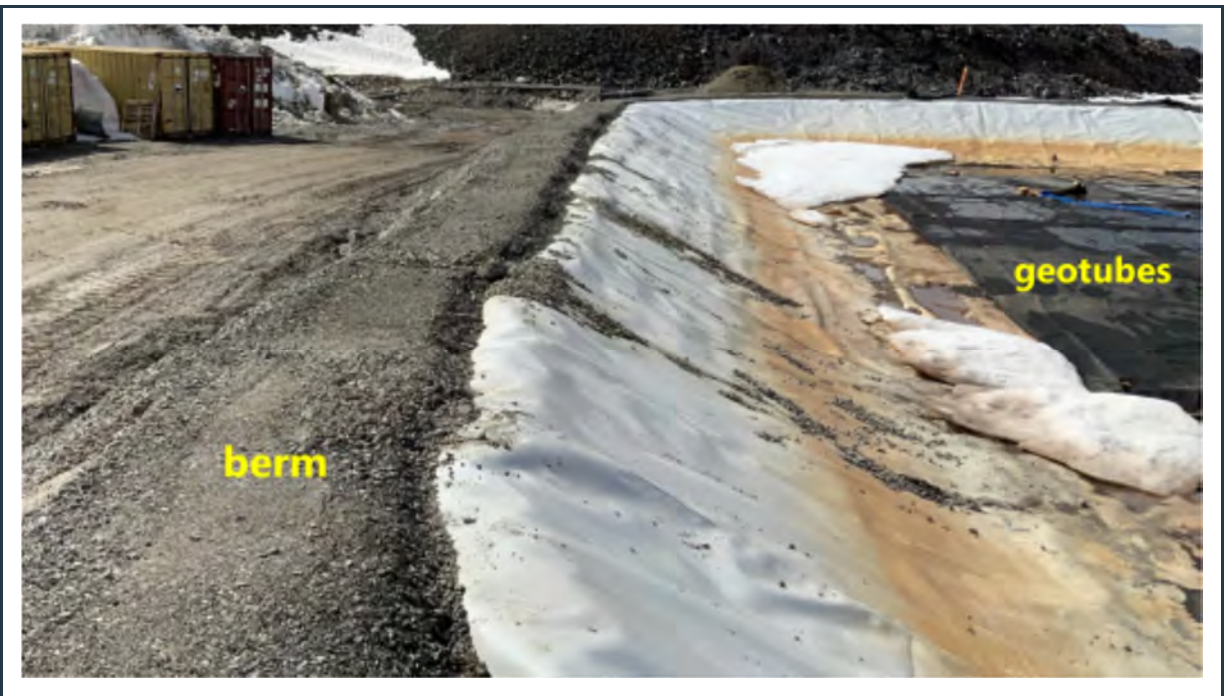
As shown in Figure 31, the berm around the geotube pond has recently been reconstructed and a new geomembrane liner was installed within the pond, all in excellent condition. The currently empty geotubes are visible on the floor of the lined cell.

Figure 31: View of the refurbished perimeter berm and new liner at the geotube pond, located adjacent to the water treatment plant.

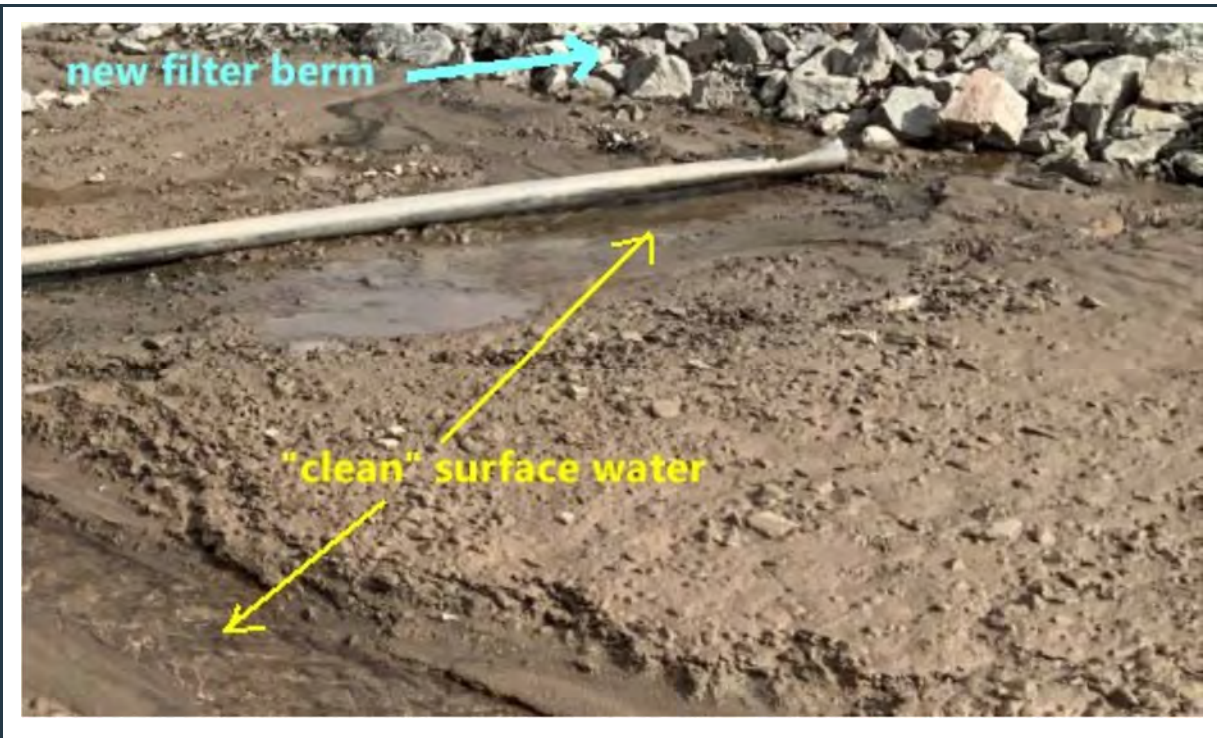
Figure 37: View of the "clean" surface water past the new filter berm in the south pond.

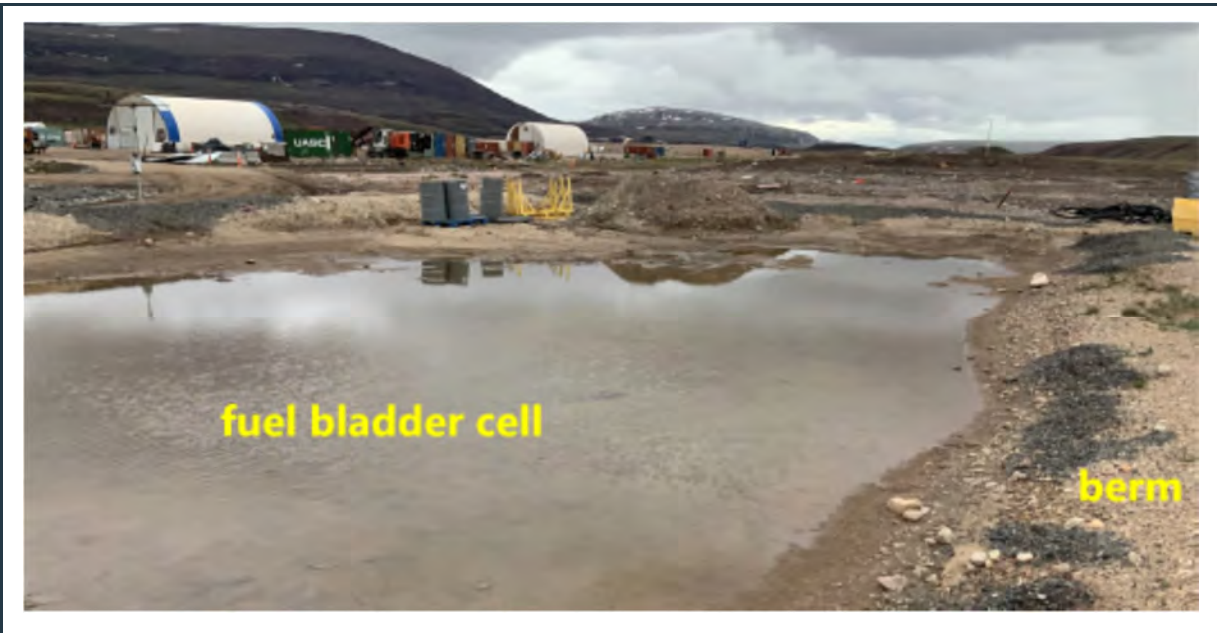
Figure 38: View of the stable perimeter berm around the practically empty “fuel bladder” cell. Note only three grey fuel barrels at the corner of the cell. The ponding water in the cell indicates good liner performance.

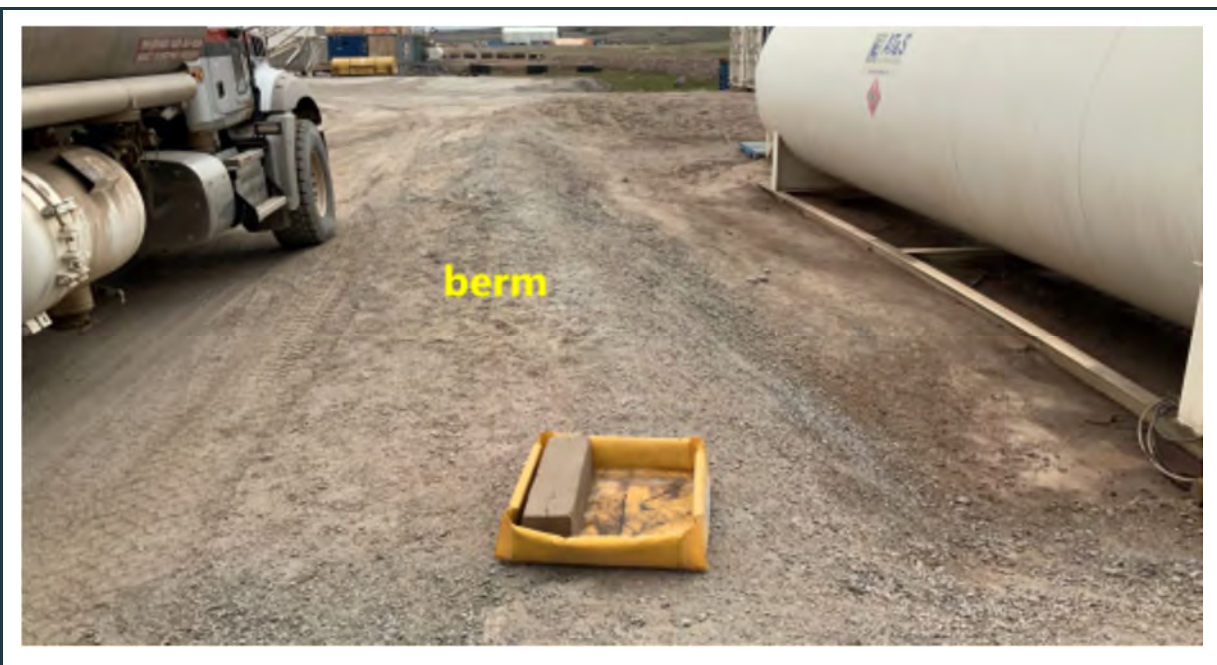
Figure 39: View of the well-maintained sand and gravel berm at the lined jet-fuel storage facility.

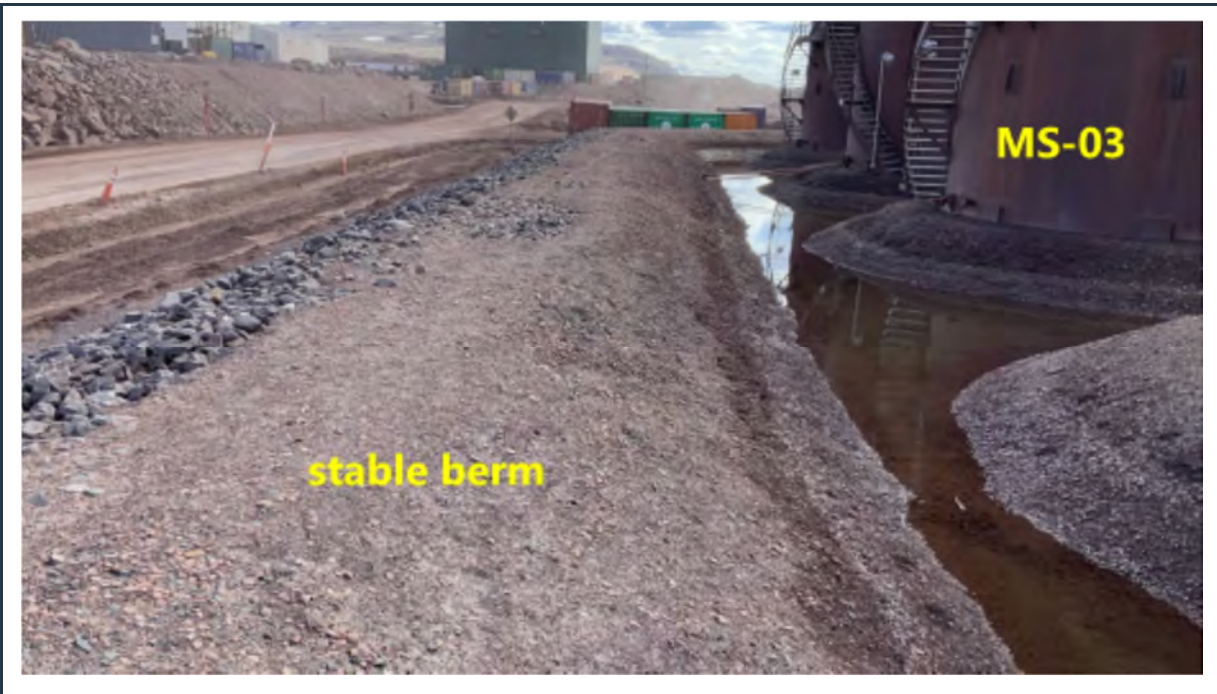
Figure 40: Well-maintained, stable berm around the MS-03 diesel fuel farm, with some ponding water, which is indication of good liner performance.

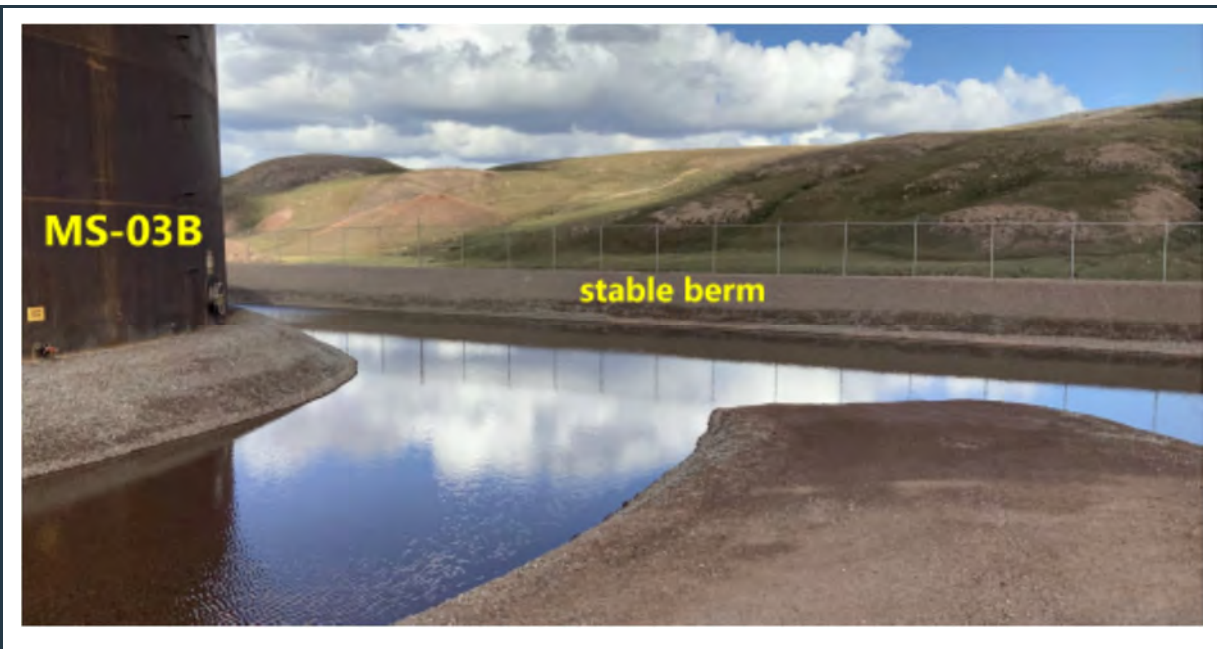
Figure 41: View of the well-maintained stable berm and interior granular fill over the liner at the new fuel tank farm. Note the ponding water in the cell, indicating good liner performance.

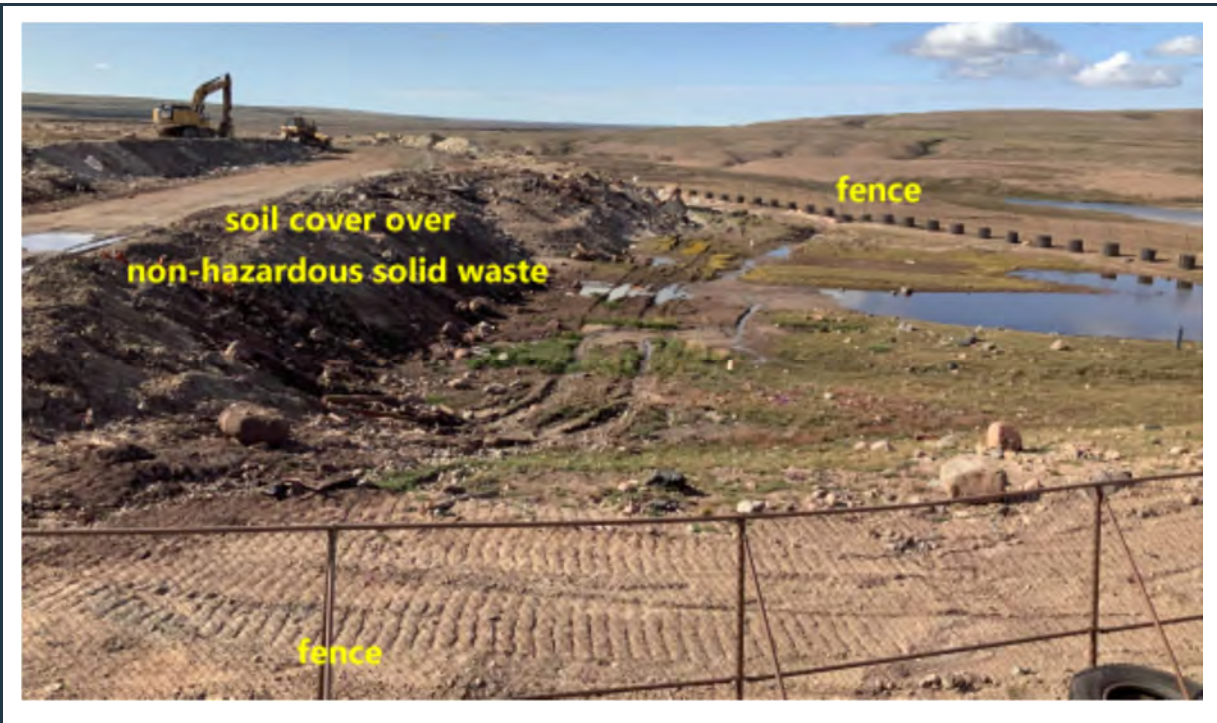
Figure 42: View of soil cover over non-hazardous solid waste in the fenced-in, gated landfill facility.

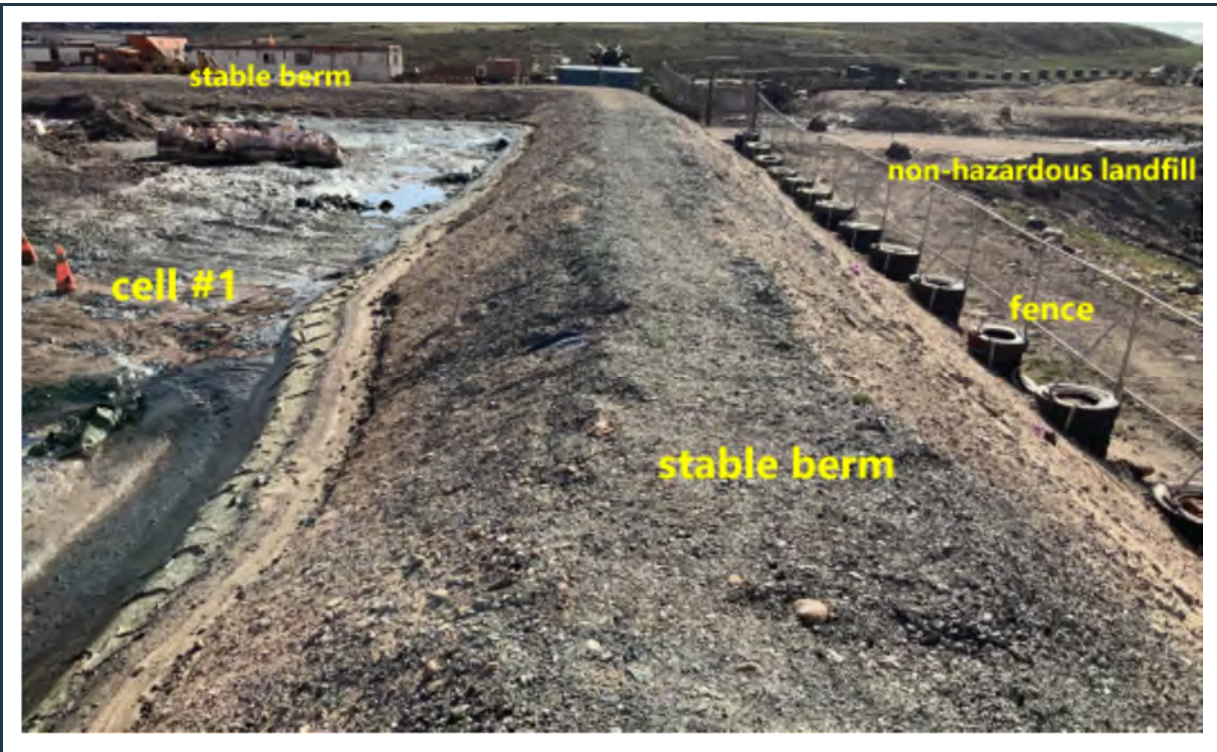
Figure 43: View of a section of the stable berm at the lined landfarm's cell #1.

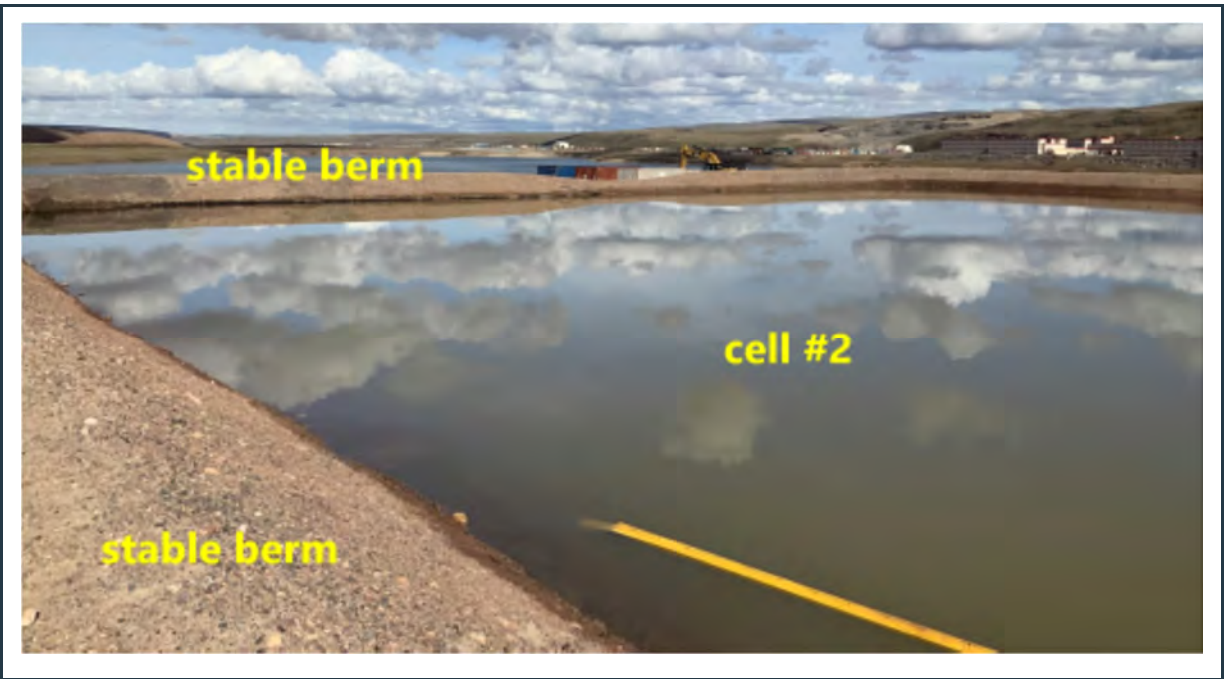
Figure 44: View of the stable berm around the currently empty, flooded cell #2 of the landfarm. The ponding water indicates good liner performance.

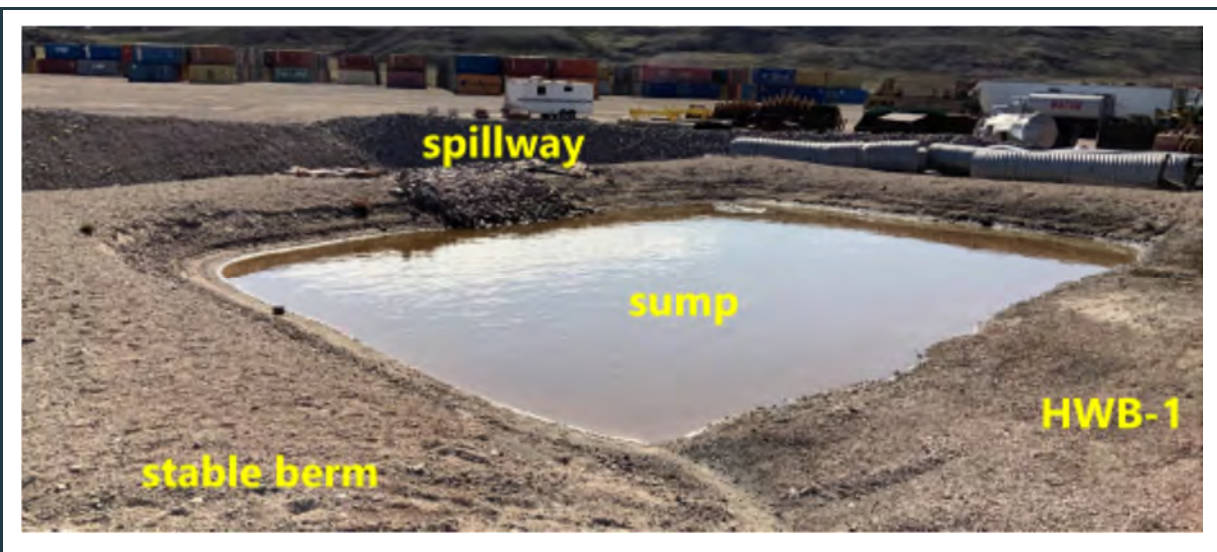
Figure 49: View of the sump and emergency spillway at the back of the HWB-1 cell with stable berm.

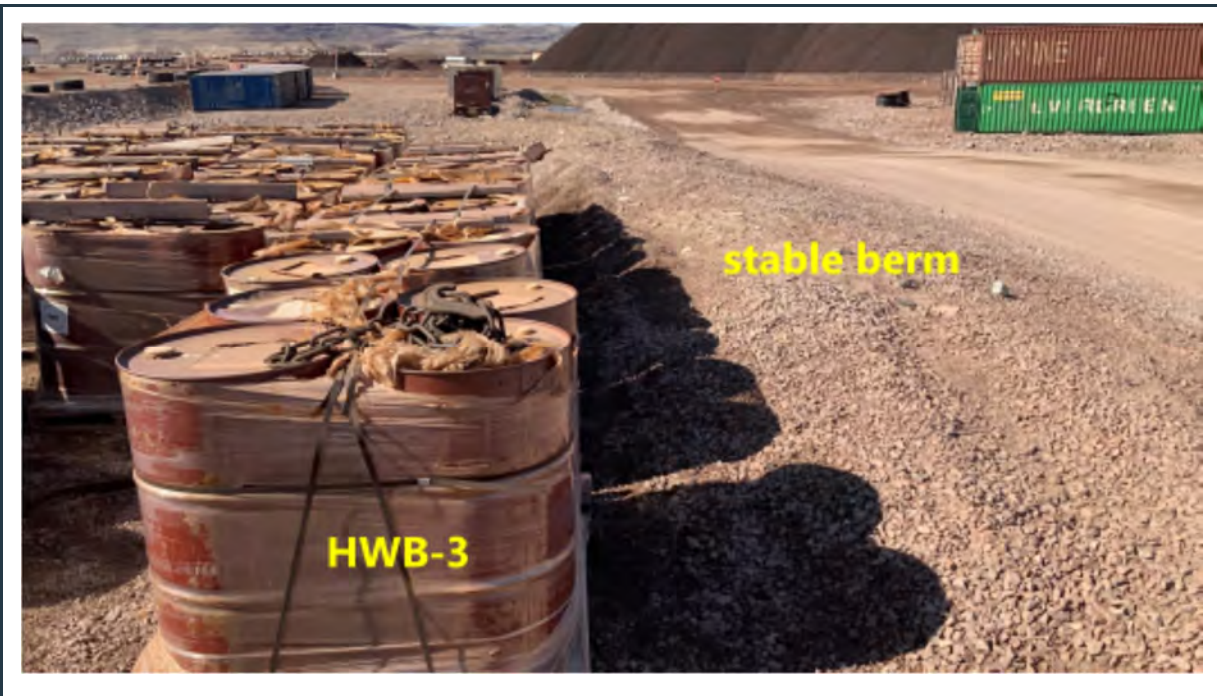
Figure 50: View of the well-maintained HWB-3 cell with stable berm, containing fuel barrels on pallets.

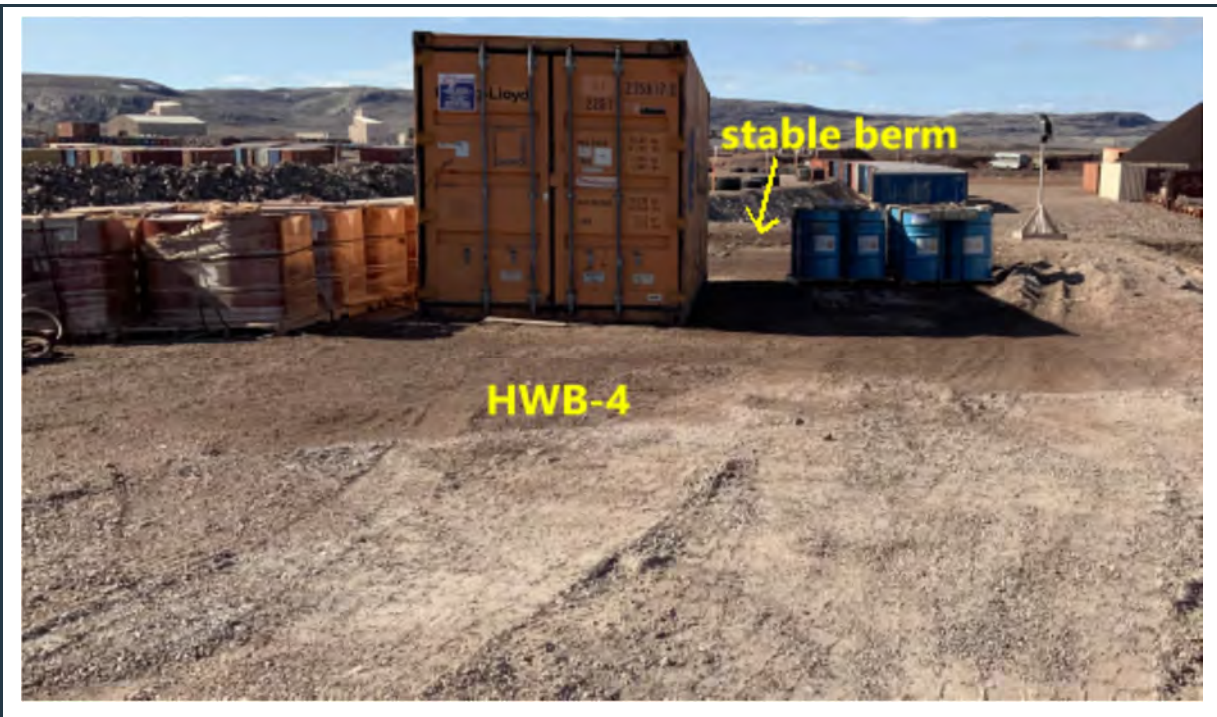
Figure 51: View of stable berm around the HWB-4 cell, storing jet fuel and a shipping container. Note the improved granular base within the cell, protecting the geomembrane liner.

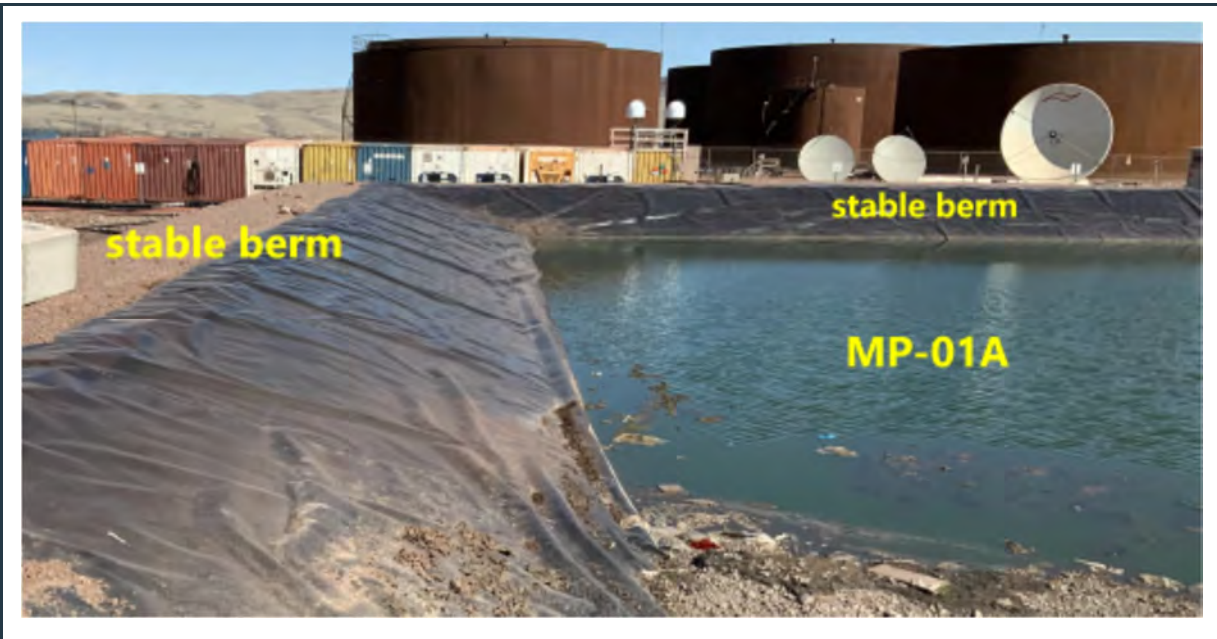
Figure 52: View of the robust, stable berm and intact liner at the MP-01A pond.

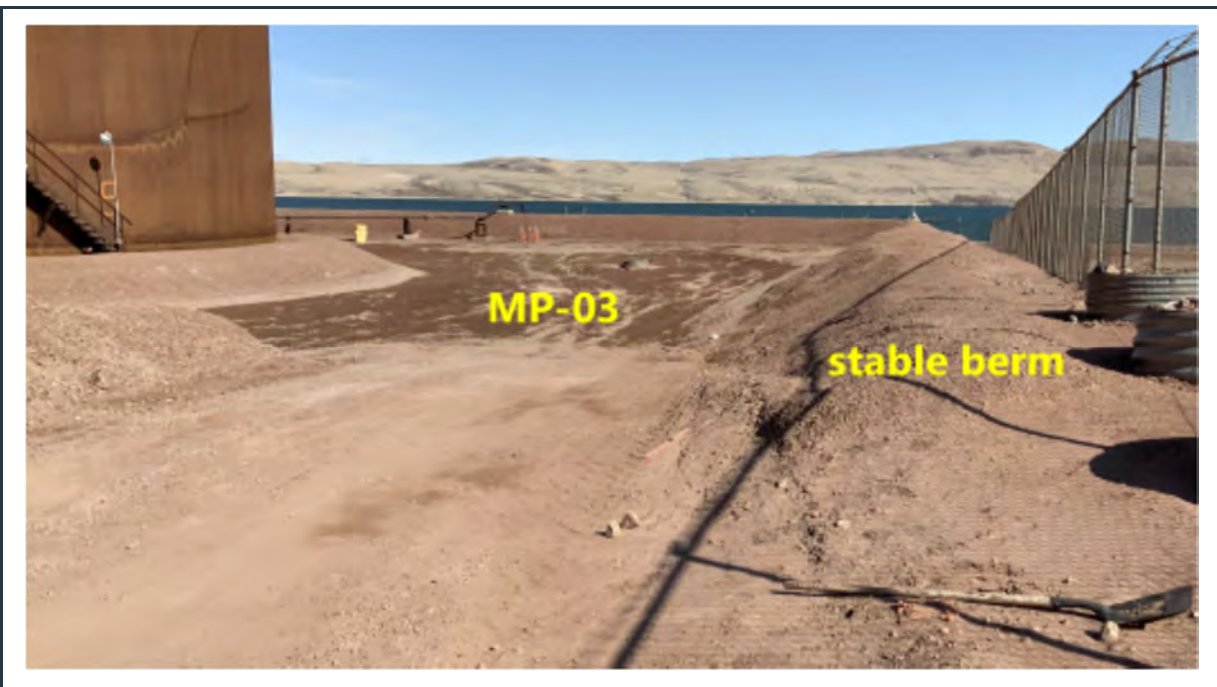
Figure 53: View of the well-maintained stable perimeter berm around the lined MP-03 fuel tank farm. Ponding water was recently removed from the facility.
