RE: Submission of Annual Geotechnical Inspection – 2025, Mary River Project – Nunavut, August 29, 2025; Project # CA0055338.6747

WSP Canada Inc., has completed the required geotechnical field inspection of 2025 at the Mary River Mining Project, which is a condition of the Nunavut Water Board's Renewed Type "A" Water Licence No: 2AM-MRY2540.

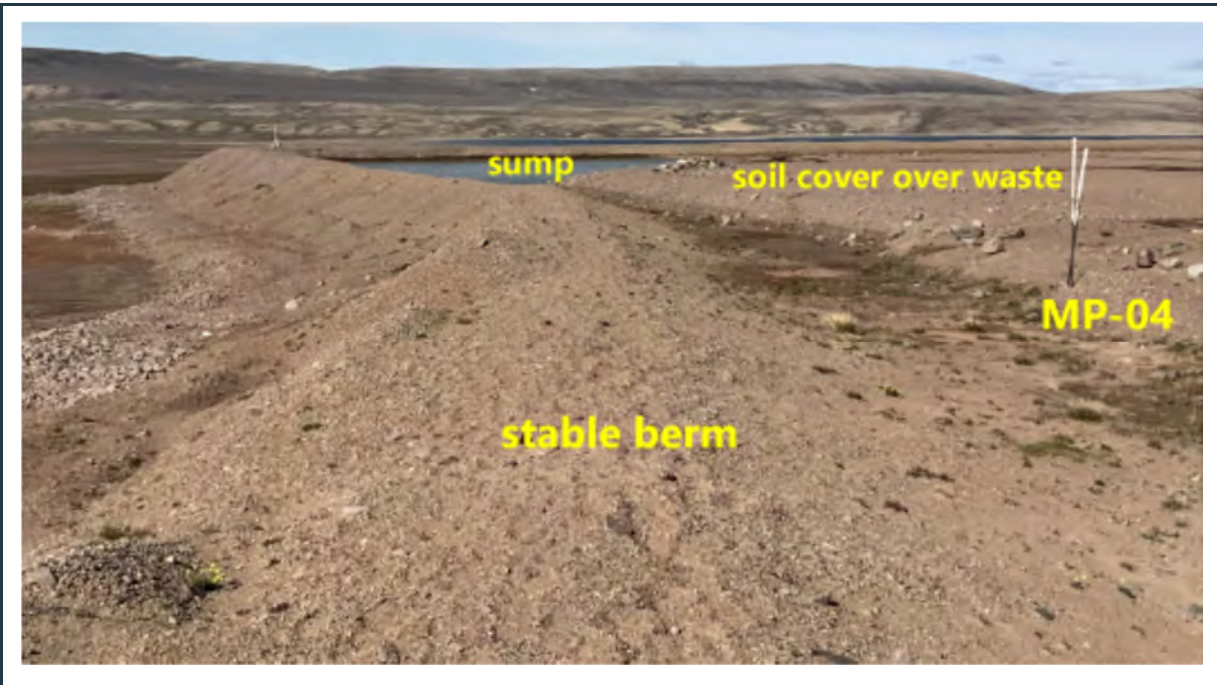
Figure 54: View of stable perimeter berm around the MP-04 landfarm, with ponding water in one corner of the cell (sump). Note the standard soil cover over the buried solid waste.

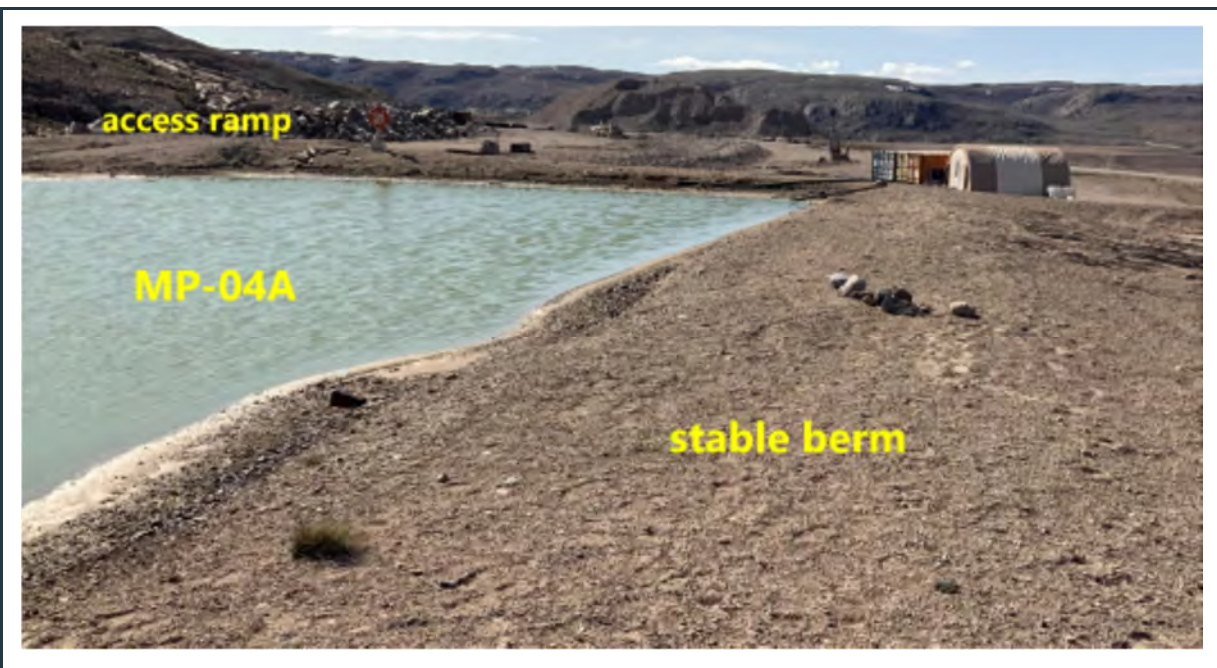
The MP-04A is a smaller cell, constructed immediately adjacent to cell MP-04 and is used generally for the disposal of contaminated snow. This pond is also bounded by a robust stable perimeter berm, as shown in Figure 55. No seepage from the cell was noted anywhere around the downstream toe of the berm, and the ponding water within the cell indicates that the liner is in good condition. As requested in an earlier report, an additional protective layer of sand and gravel fill was placed over the liner at the access ramp, which is in good condition.

Figure 55: View of the lined MP-04A contaminated snow disposal cell with robust, stable perimeter berm. The ponding water (melted snow) indicates good liner performance.

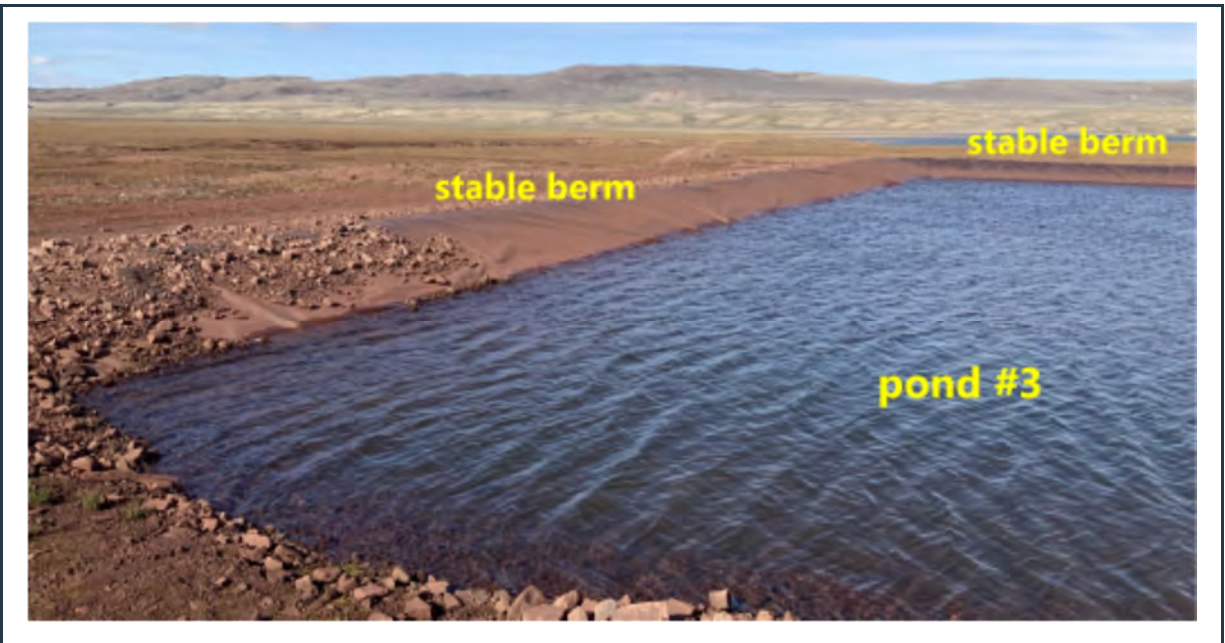
Surface Water Management Pond #3 is located west of the ore storage area, as shown in Figure 9. The pond is bounded along three (3) sides by lined stable berm (Figure 56) and contains two (2) sumps. The geomembrane liner and protective geotextile on the internal slope of the berms were designed to extend 2.5 m below the base of the pond and are anchored into the underlying permafrost zone to prevent any seepage from the pond into the ground below and to the surrounding environment. Based on observations during the July 2025 inspection, the berms and liner are in excellent condition. Excess water from the pond is frequently pumped into the nearby, large capacity MP-06 surface water management pond, whenever necessary.

Figure 56: View of surface water management pond #3, with lined, stable berms.

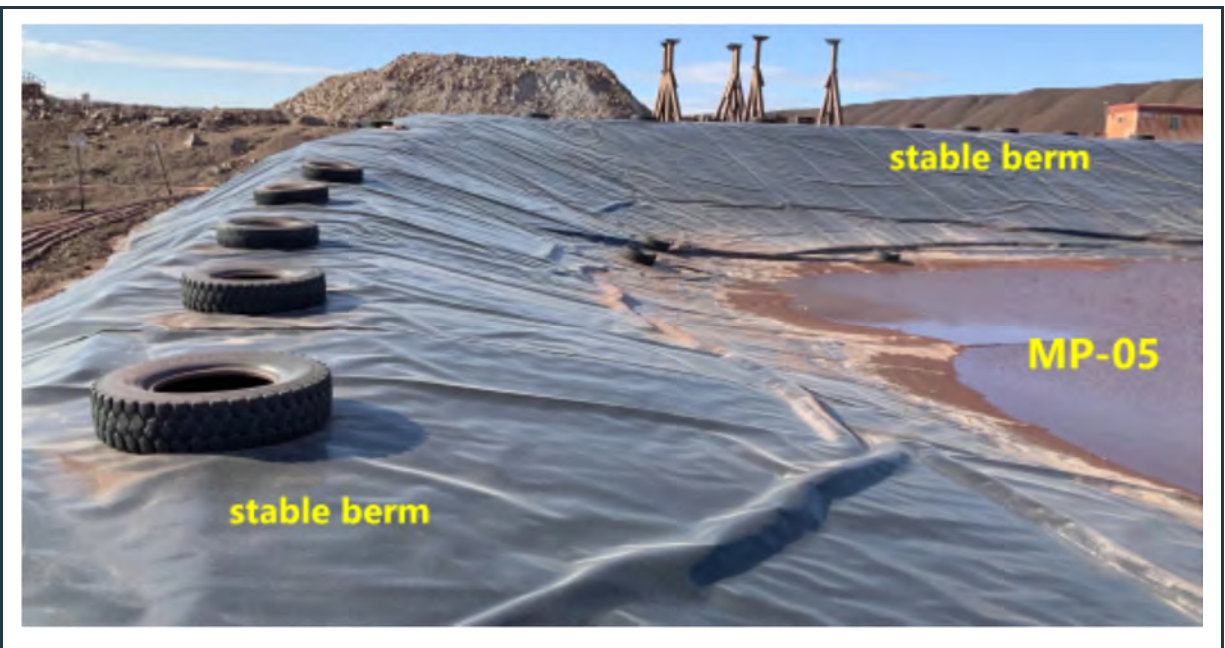
No instability, erosion or settlement was noted at the robust berms of the MP-05 pond and no toe seepage from the pond is visible anywhere around the pond's perimeter berm, as shown in Figure 57. The surface water from the ore stockpile is collected in well-maintained, clean drainage ditches, including the well-maintained east ditch.

Figure 57: View of the robust, stable perimeter berm and intact liner at the MP-05 pond.

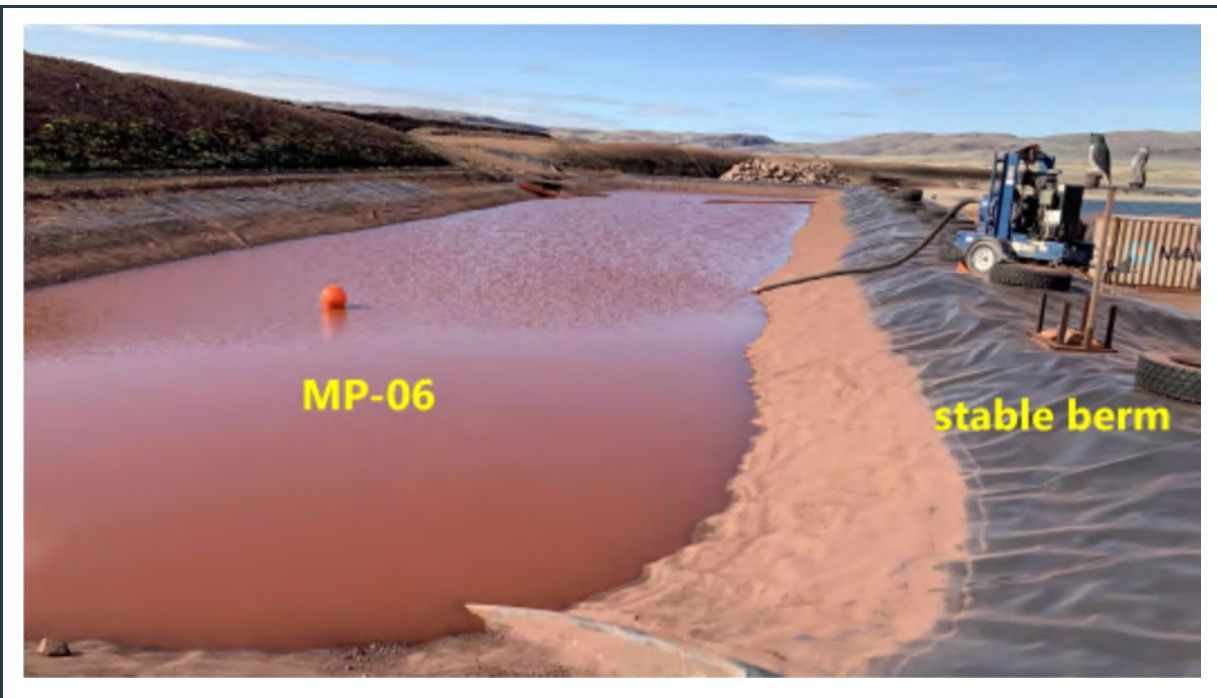
The large "twin" surface water management pond adjacent to the north-west corner of the ore stockpile area is divided into two (2) cells (MP-06 and MP-06A) by a liner-covered internal berm. The main (south) part of the pond is called MP-06 and is shown in Figure 59. The northern cell is called the "overflow pond" MP-06A, shown in Figure 60. The liner in the ponds and the stable, robust perimeter berm are in good condition, and no seepage was noted from the ponds, indicating good liner performance.

Figure 59: View of the lined MP-06 pond with robust, stable berm.

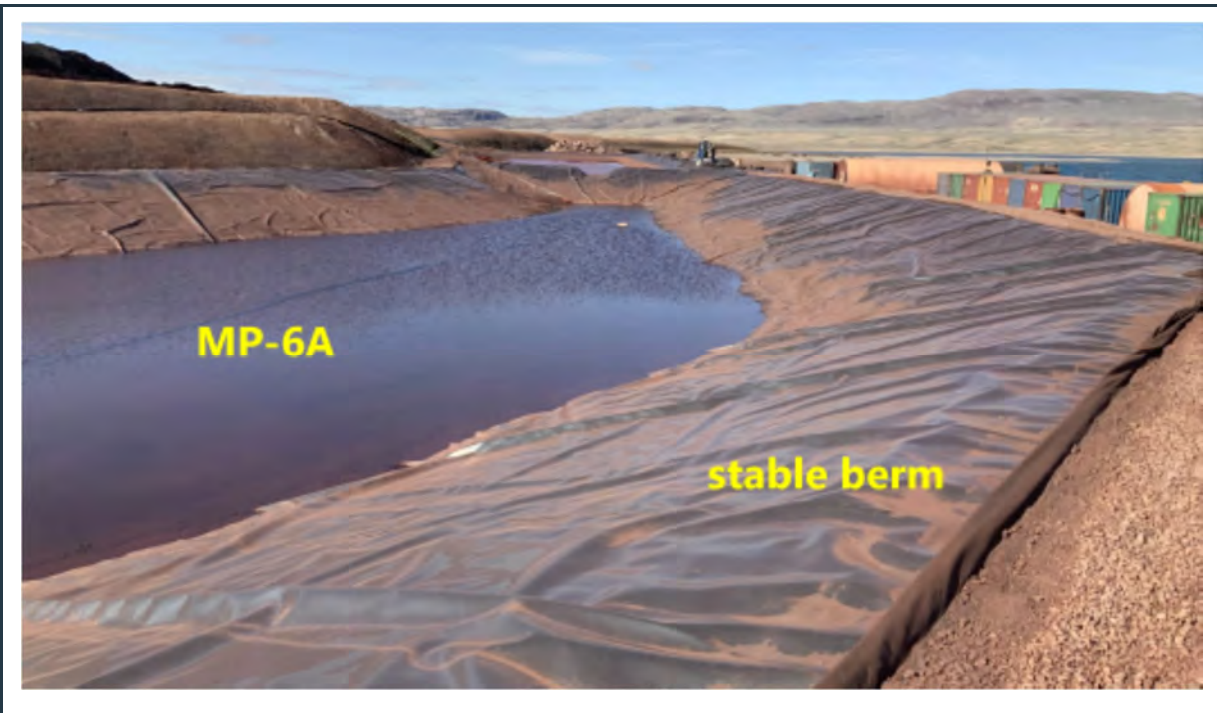
Figure 60: View of the lined MP-06A overflow pond with robust stable berms.
