October 28, 2022

**RE: Issued for Construction Drawings Submission – 2022/2023 Tote Road Culvert Upgrades  
Mary River Project - Type 'A' Water Licence 2AM-MRY1325 - Amend. No. 1 –  
Expedited NWB Review**

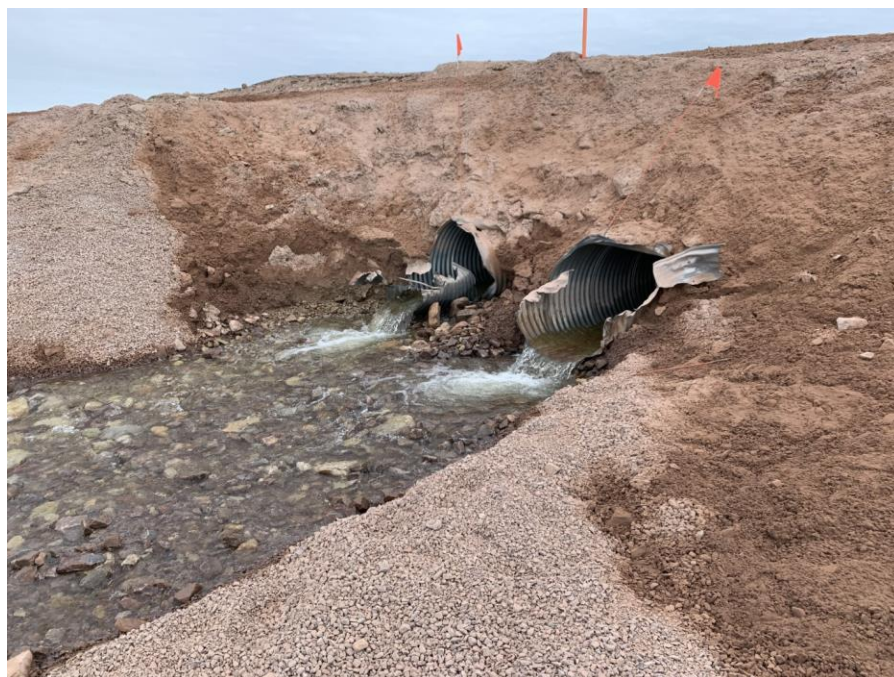
**Photo B1.2 CV-114 Culvert Outlet**

- Damaged Culverts - The culvert barrels appear to be damaged (Photo B1.1).
- Erosion of Slopes - The embankment slopes are steep, lack armouring and contain fines leading to erosion of the embankment slopes (Photos B1.1 and B1.2).
- Adequate Cover - Loading over culvert pipes should be in accordance with the design criteria with the minimum cover for culverts being 600 mm, or as required by the differing specific design vehicle (Hatch, 2018) (Photo B1.1).
- Perched Culverts - The culvert barrels are perched above the stream (Photo B1.2).

Peak Flow (m <sup>3</sup> /s)	5.86
Culvert diameter (mm)	1,200
Number of culvert barrels	3
Embeddedness	One-barrel embedded 40%
Culvert length (m)	26
Slope	5.08%
Minimum cover over barrels (mm)	600

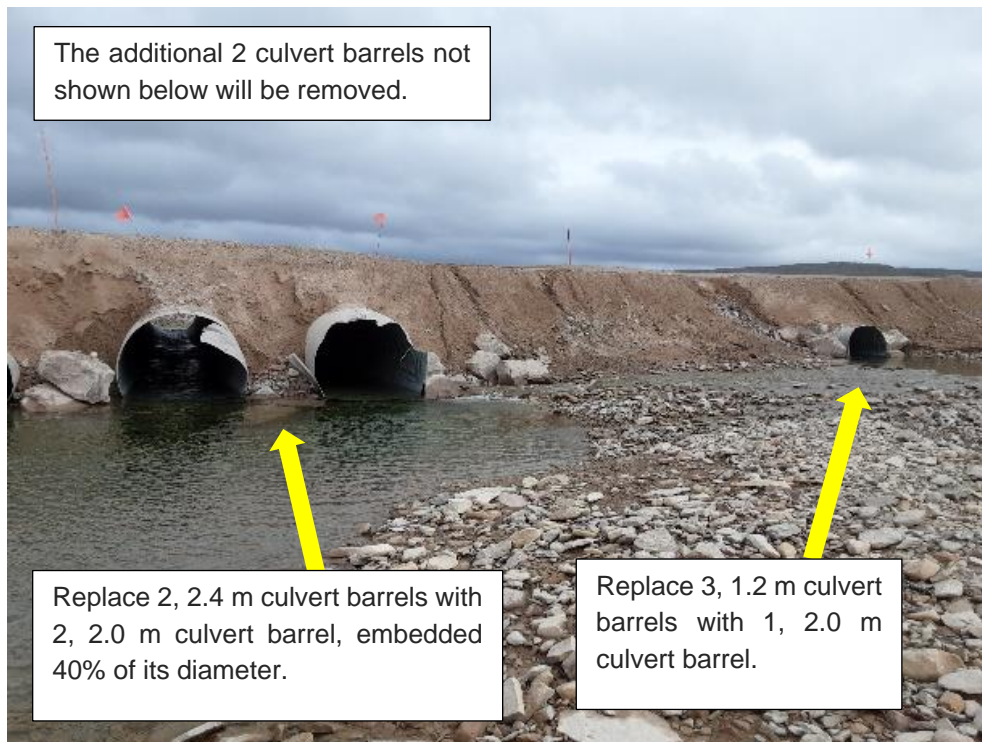
**Photo B7.1 CV-078 Culvert Inlet**

- Erosion of Slopes - The embankment slopes above the culvert barrels appears to be eroding (Photos B7.1 and B7.2).
- Perched Culvert - A slight perch is present at the downstream end of the smaller culvert barrels (Photo B7.2).
- No Embedment - At least one culvert barrel should be embedded 40% of its diameter (Photos B7.1 and B7.2).

The existing water crossing was rated high risk and was identified as a barrier to 88 mm Arctic Char fish passage (Appendix C).

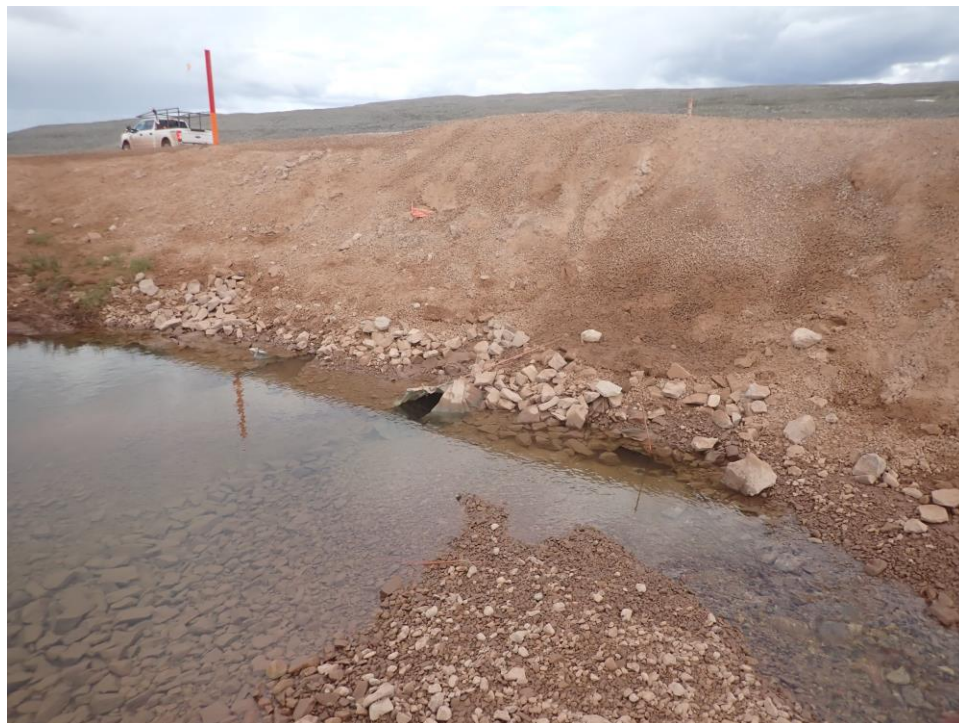
**Photo B8.2 CV-059 Culvert Outlet**

- Damaged and Plugged with Sediment - The culvert barrels appear to be damaged, collapsed and completely plugged with sediment resulting in ponded water (Photos B8.1 and B8.2).
- Erosion of Slopes - The embankment slope above the culvert barrels appears to be eroding (Photos B8.1 and B8.2).
- Minimum Diameter - The minimum diameter for fish bearing culverts should be 1 m (Hatch, 2018) (Photos B8.1 and B8.2).

Based on a review of the existing crossing conditions, design criteria and the fish passage assessment, the following remediation measures are recommended:

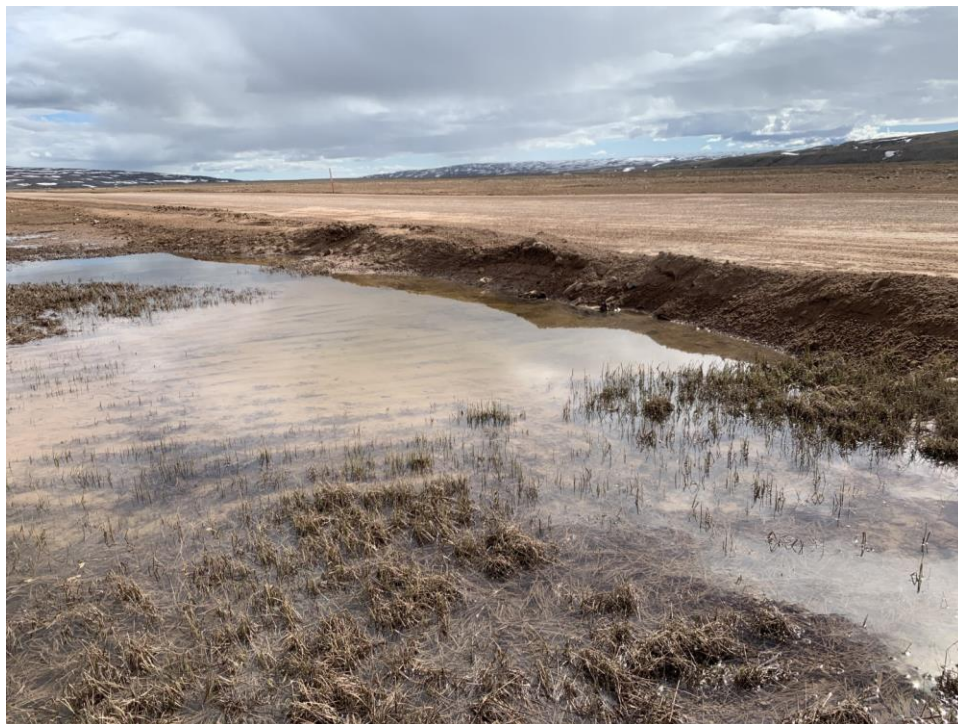
**Photo B9.2 CV-057 Culvert Outlet**

- Plugged with Sediment - The culvert barrels appear to be completely plugged with sediment resulting in ponded water (Photo B9.1).
- Erosion of Slopes - The embankment slope above the culvert barrels appears to be eroding (Photos B9.1 and B9.2).
- Damaged Culverts - The culvert barrels appear to be damaged, collapsing and beginning to be plugged with sediment (Photo B9.2).
- Adequate Cover - Loading over culvert pipes should be in accordance with the design criteria with the minimum cover for culverts being 600 mm, or as required by the differing specific design vehicle (Hatch, 2018) (Photos B9.1 and B9.2).
- Minimum Diameter - The minimum diameter for fish bearing culverts should be 1 m (Hatch, 2018) (Photos B9.1 and B9.2).

Based on a review of the existing crossing conditions, design criteria and the fish passage assessment, the following remediation measures are recommended:

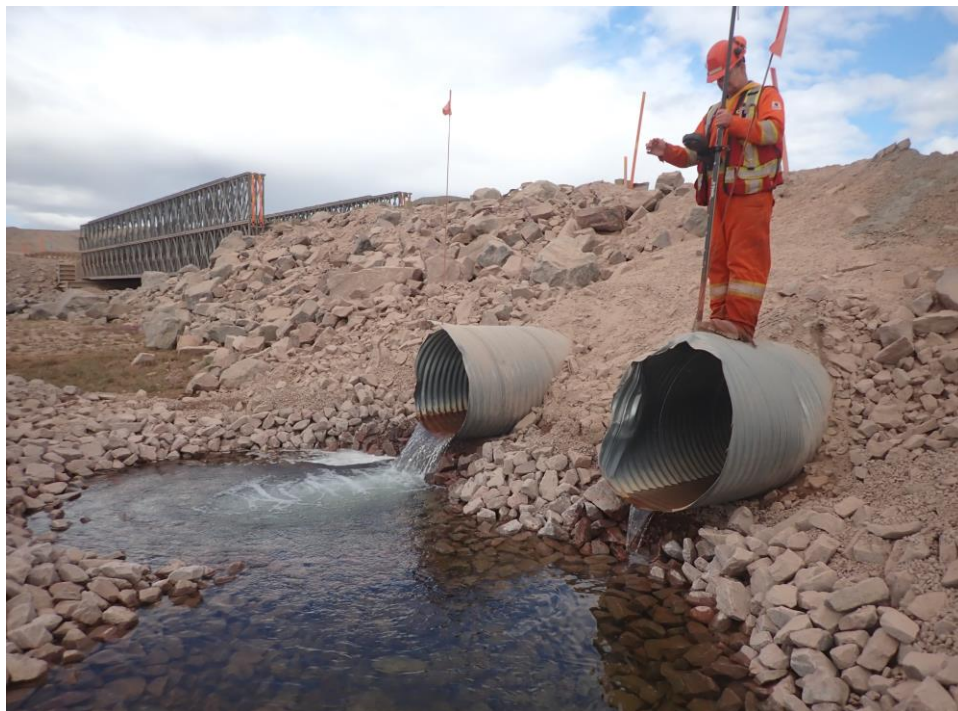
**Photo B10.2 BG-50 Culvert Outlet**

- Damaged Culverts - The culvert barrels appear to be damaged and collapsing (Photo B10.1).
- Perched Culverts - The culvert barrels are perched above the stream (Photo B10.2).
- Erosion of Slopes - The embankment slope above the culvert barrels appears to be eroding (Photos B10.1 and B10.2).

Based on a review of the existing crossing conditions, design criteria and the fish passage assessment, the following remediation measures are recommended:

It is noted that the stream is estimated to be approximately 10 m wide. For installation requirements to allow for the four culvert barrels to fit within the stream bed it is recommended that the culvert barrels are spaced approximately 0.5 m apart.

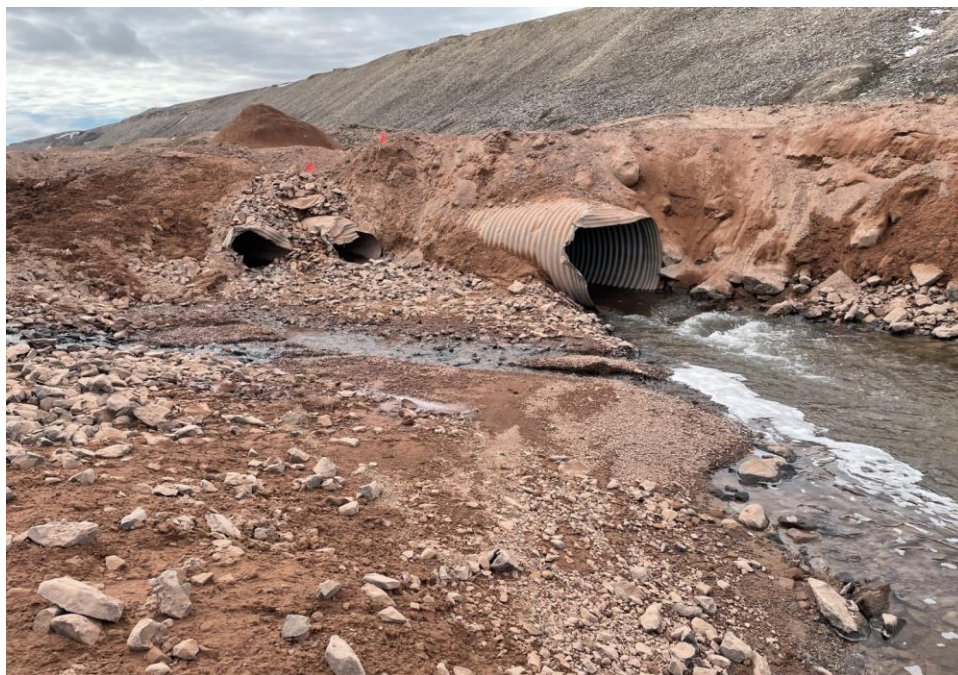
**Photo B15.2 BG-17 Culvert Outlet**

- Damaged Culverts - The two culvert barrels appear to be damaged and are perched above the stream (Photo B15.1).
- Erosion of Slopes - Erosion is occurring on the embankment slopes above and adjacent to the culvert barrels and due to the presence of fine material and steep embankment slopes (Photos B15.1 and B15.3).
- Perched Culverts - The perched culverts in Photo B15.1 are also perched and damaged in Photo B15.2.

Peak Flow (m <sup>3</sup> /s)	21.93
Culvert Diameter (mm)	1,800
Number of Culvert Barrels	3
Embeddedness	One-barrel embedded 40%
Culvert Length	52
Slope	0.54
Minimum Cover over Barrels (mm)	900

The above remediation measures will improve the fish passage risk rating to moderate at water crossing BG-17.

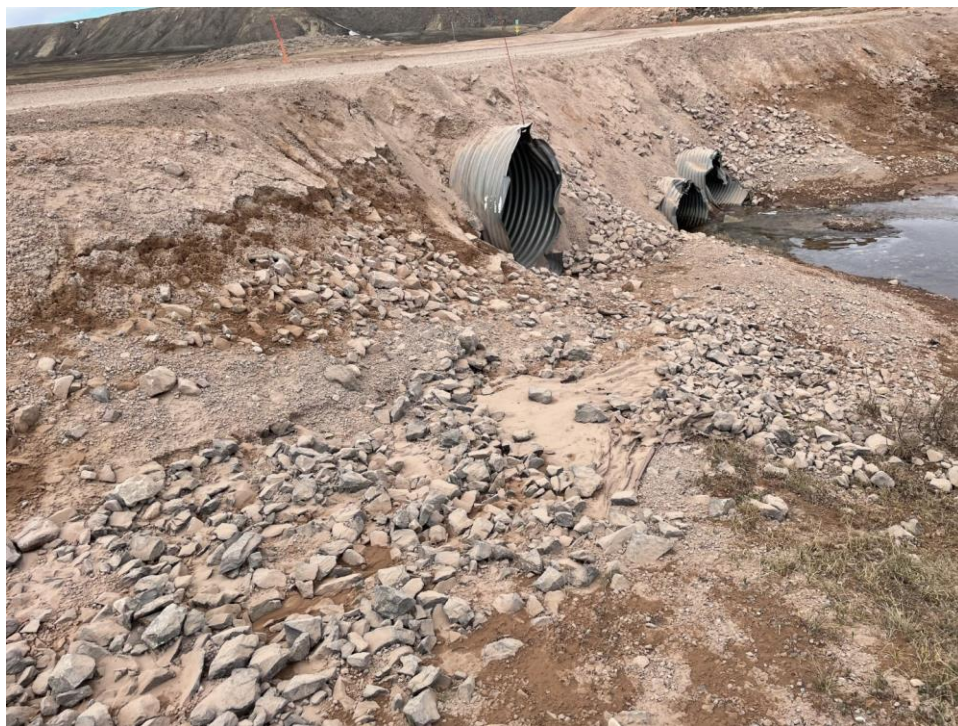
**Photo B16.2 BG-04 Culvert Inlet**

- Perched culvert - one of the culvert barrels are perched above the stream (Photo B16.3).
- Damaged Culverts - The two culvert barrels appear to be damaged and collapsing (Photo B16.1).
- Erosion of Slopes - Erosion of the embankment slopes is occurring due to the presence of fine material and steep embankment slopes (Photos B16.2 and B16.3).

Peak Flow (m <sup>3</sup> /s)	11.22
Culvert diameter (mm)	1,800
Number of culvert barrels	2
Embeddedness	One-barrel embedded 40%
Culvert length (m)	28
Slope	1.28%
Minimum cover over barrels (mm)	900

The above remediation measures will ensure the BG-04 water crossing meets the project design criteria. The proposed remediation plan will lower the fish passage risk assessment rating from high to moderate.

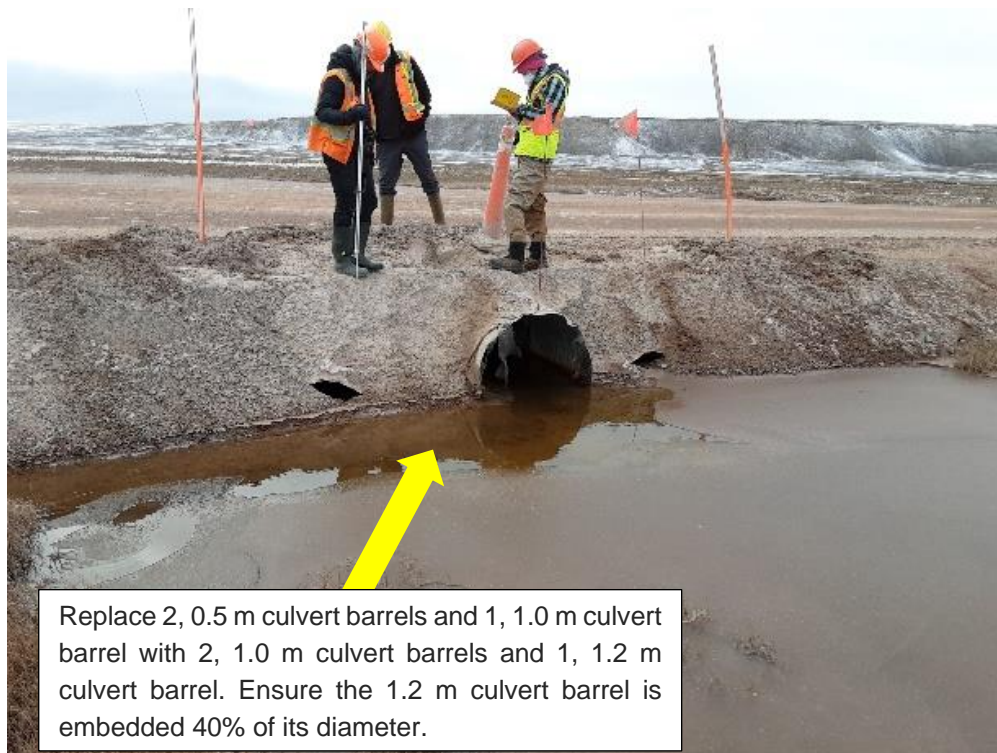
**Photo B17.1 CV-001 Culvert Inlet**

- Plugged with Sediment - The two 0.5 m culvert barrels appear to be plugged with sediment (Photos B17.1 and B17.2).
- Erosion of Slopes - The embankment slopes are steep and contain fines leading to erosion of the embankment slope (Photos B17.1 and B17.2).
- Perched Culvert - The culvert barrel is slightly perched above the stream (Photo B17.2).

The existing water crossing at CV-001 was rated high risk as a potential barrier to fish movement (Appendix C).

The fish passage risk assessment fish barrier risk rating of high decreases to moderate after implementation of the above remediation measures.

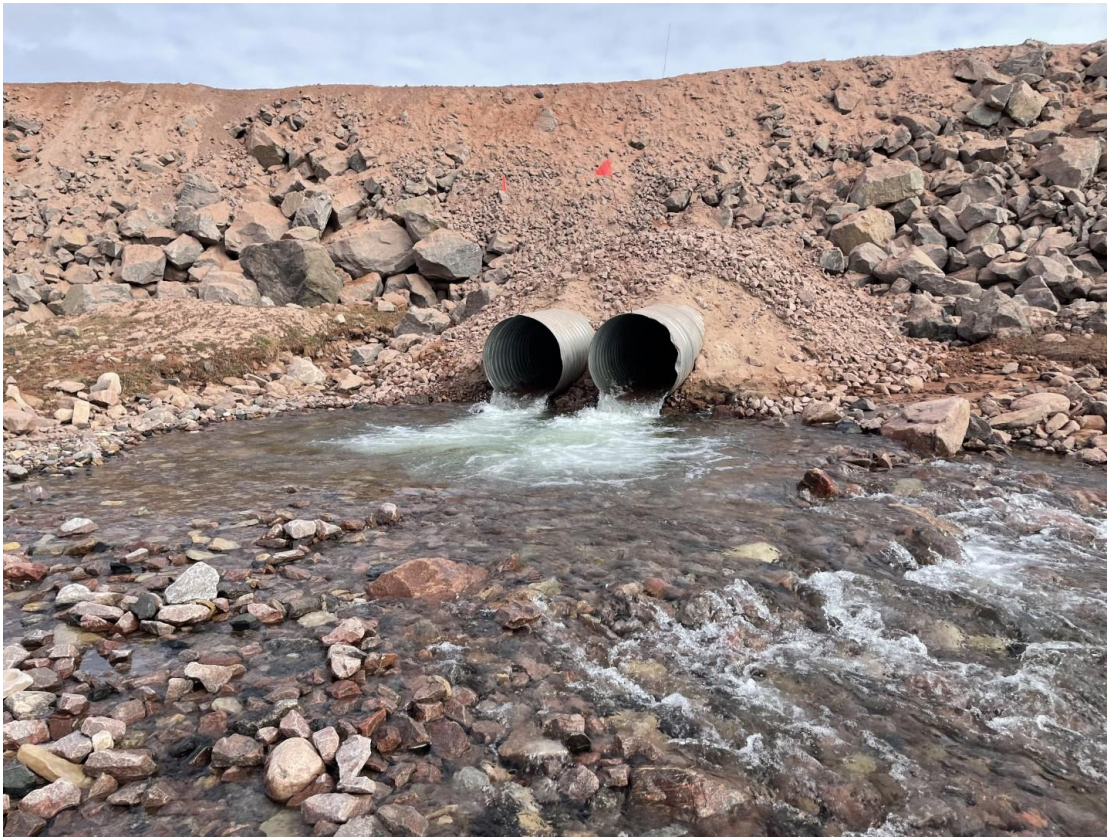
**Photo B19.2 CV-225 Culvert Outlet**

- Damaged Culverts - Culvert barrels are deformed and collapsed slightly (Photo B19.1).
- Perched culverts - Both culvert barrels are perched above the stream (Photo B19.2).
- Erosion of Slopes - Erosion of the embankment slopes is occurring due to the presence of fine material and steep embankment slopes (Photo B19.2).

Peak Flow (m <sup>3</sup> /s)	12.65
Culvert diameter (mm)	1,800
Number of barrels	2
Embeddedness	One-barrel embedded 40%
Culvert length (m)	45
Slope	0.98%
Minimum cover over barrels (mm)	900

The proposed remediation plan will improve fish passage and decreases the fish passage risk assessment rating from high to moderate. However, as described in Section 1 above, the habitat upstream the culvert includes high velocity flows that would also preclude small size class char from moving further upstream (Appendix B.2; NSC, 2021).

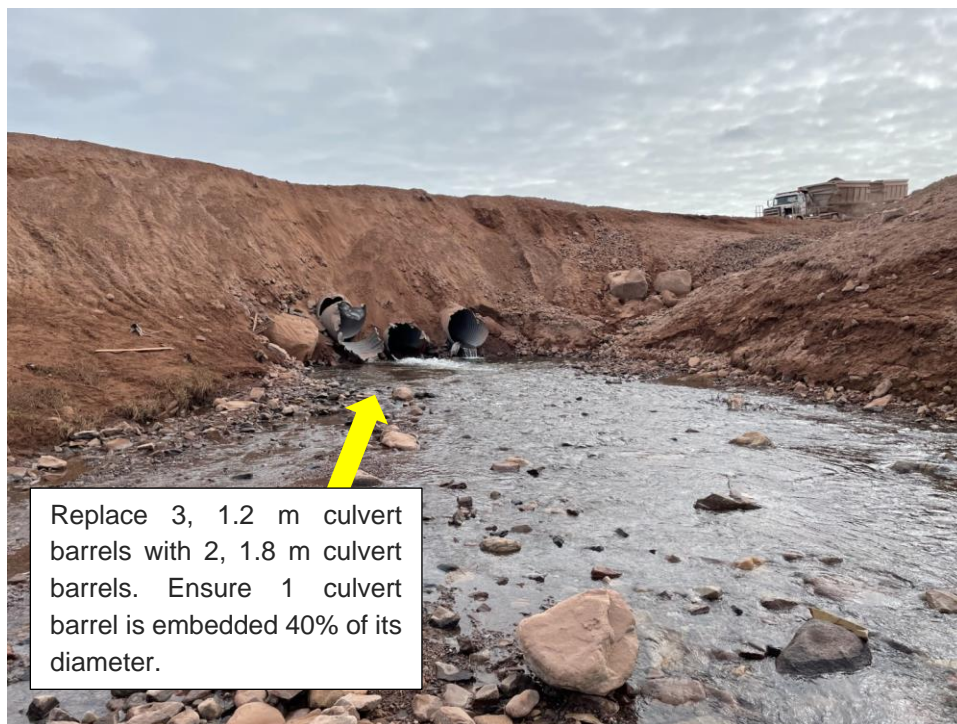
**Photo B20.2 BG-01 Culvert Outlet**

- Perched culverts - The inlet of the furthest culvert barrel in Photo B20.1 is perched above the stream, and the outlet of the left-most culvert barrel is perched above the stream and damaged (furthest culvert barrel in Photo B20.1).
- Erosion of Slopes - Erosion of the embankment slopes is occurring due to the presence of fine material and steep embankment slopes (Photo B20.2).

Peak Flow (m <sup>3</sup> /s)	9.27
Culvert diameter (mm)	1,800
Number of culvert barrels	2
Embeddedness	One barrel embedded 40%
Culvert length (m)	38
Culvert slope	1.7%
Minimum cover over barrels (mm)	900

The proposed remediation plan will lower the fish passage risk assessment rating from high to moderate.
