Re: Follow-up to Spill 14-137 Reported on May 6th, 2014 Mary River Project - Water Licence No. 2AM-MRY1325

Summary:

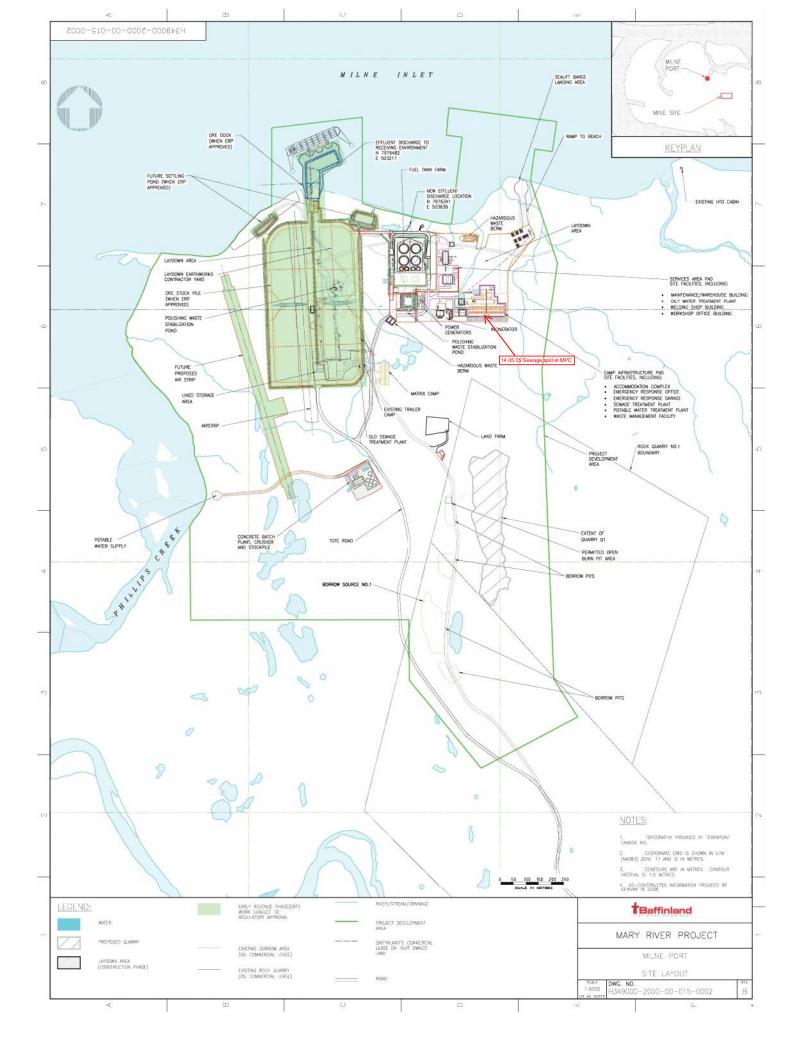
At approximately 20:40 HRS on May 5, 2014 a leak was detected at the main lift station of the Milne Port Complex. It appeared that a previously repaired breech in the tank failed again. An estimated 200 litres was discharged to the adjacent land surface, with an approximate impacted area of 8 square metres.

Figure 2. Sewage leak from Main Lift Station

This being the second incident related to the breech in the tank, the recommendation is to replace the tank with a new one.
