RE: Submission of 2022 Geotechnical Inspection Report No. 2 (September 2022)

Mary River Project – Nunavut

WSP Environment & Infrastructure Canada Ltd., (formerly Wood E&I Canada Ltd.), has completed the second geotechnical field inspection of 2022 at the Mary River Project, which is a condition of the Type "A" Water Licence No: 2AM-MRY1325 – Amendment No.1 ("Water Licence").

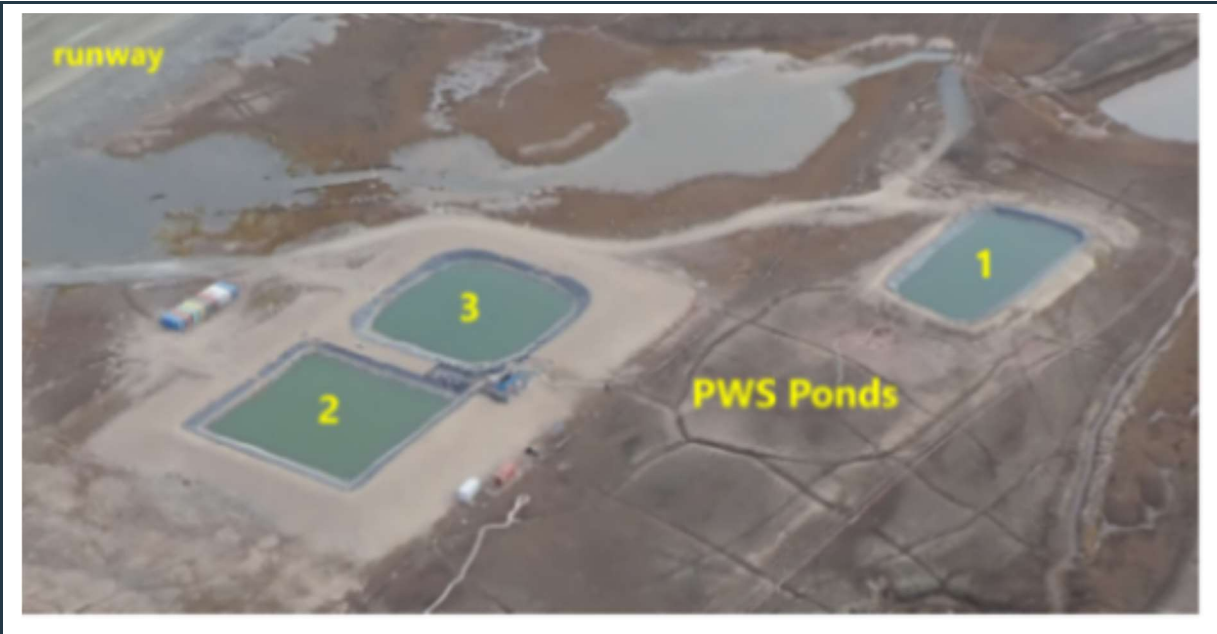
There are three (3) polishing/waste stabilization ponds, located adjacent to the airstrip, as shown in Figure 4. Pond #1 is a single structure, while Ponds #2 and #3 were constructed as twin-cells, as shown in Figure 9. The photograph in Figure 9 is a historic aerial image showing the robust and stable berms around the three ponds. As pointed out in previous inspection reports, these ponds were associated with the exploration phase of the mine, and currently serve as emergency holding ponds in case problems would arise, which would prevent the discharge of treated effluent directly to the receiving environment. The robust, stable berms around the ponds generally comprise granular materials (rock fill, sand, and gravel), supporting High Density Polyethylene (HDPE) geomembrane liners. The liners are secured in anchor trenches on the crest of the berms, and no damage is visible on the membranes in the cells or on the upstream face of the slopes (see Figures 10 to 12). Wrinkles noted on the liners are common features and do not present any potential problems to the resistance of the material against seepage.

Figure 9: Aerial view of the robust, stable berms around the three PWS ponds. (Historic image to show the layout of the three ponds).

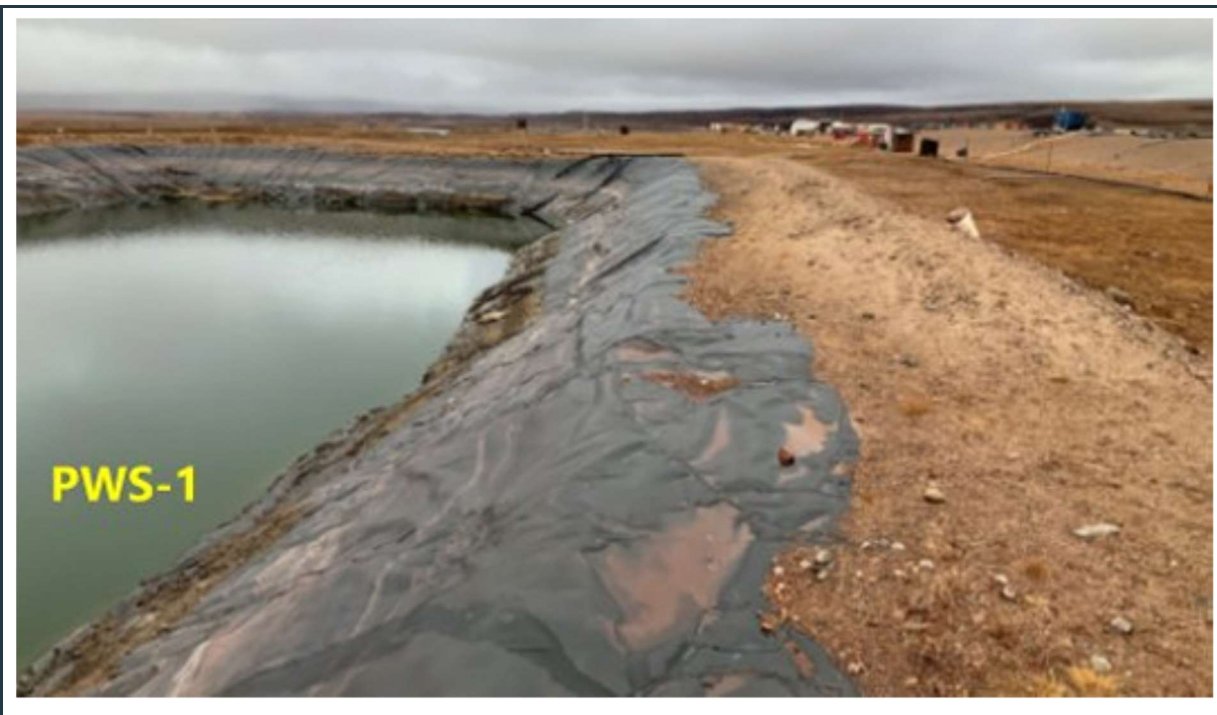
Figure 10: PWS pond #1. Well-maintained, stable perimeter berm and liner at the pond.

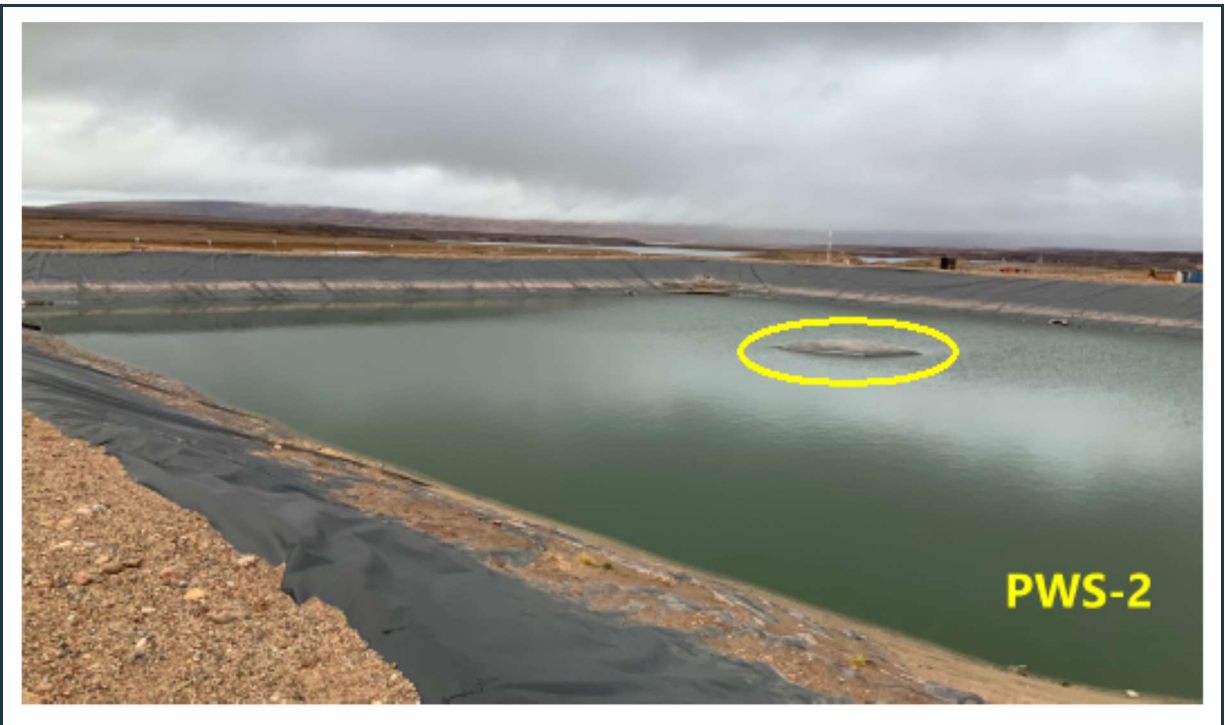
A relatively common issue (although not a problem) in water storage ponds is the appearance of so-called “whales” within the ponds. Whales are sections of the liners which have risen (float) above the surface of shallow water, particularly in shallow ponds, where the weight of water above the liner is minimal. Such small “whales” were visible during both June and September 2022 inspections at PWS ponds #2 and #3, as shown in Figure 11. Similar “whales” were noticed and recorded during previous inspections in the past; however, no damage to the liner or seepage from the ponds was visible, including during the latest inspection in September, 2022.

Figure 11: PWS pond #2 – Stable, well-maintained berm and liner. – A small section of the liner is visible in the center of the pond (yellow circle), which does not pose a risk to the integrity of the liner.

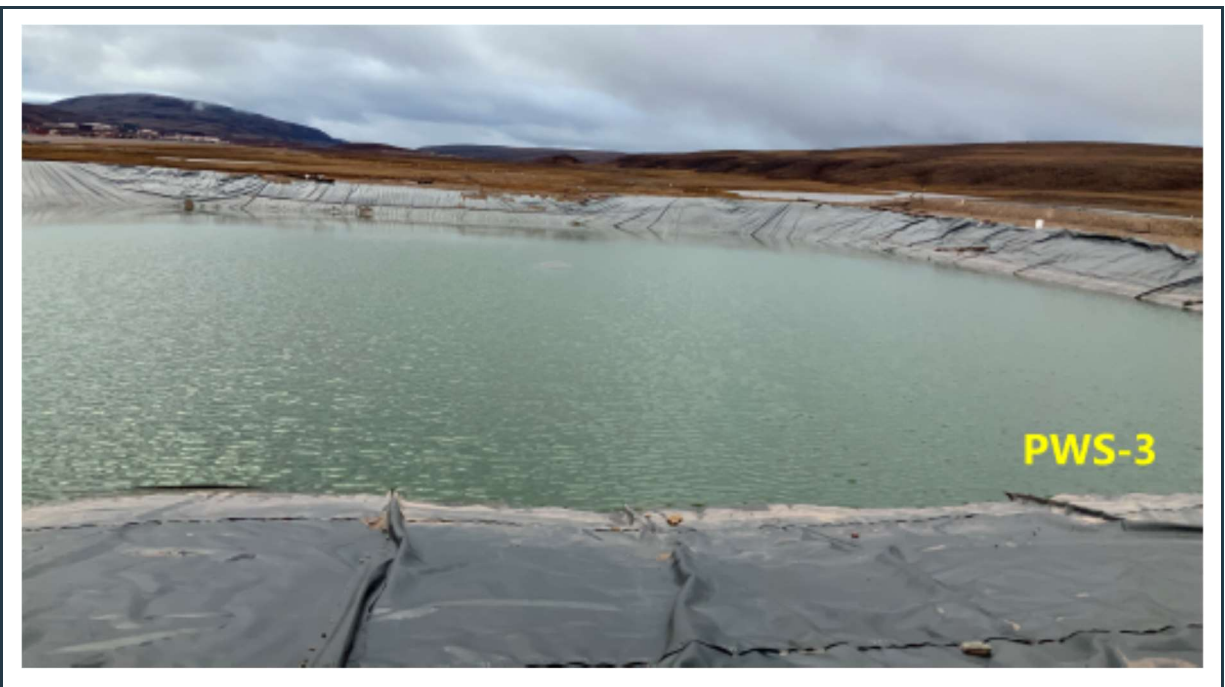
Figure 12: Robust, stable perimeter berms around PWS pond #3 – Wrinkles are common on exposed liners, but they do not pose a risk to the integrity of the high-strength HDPE liners.

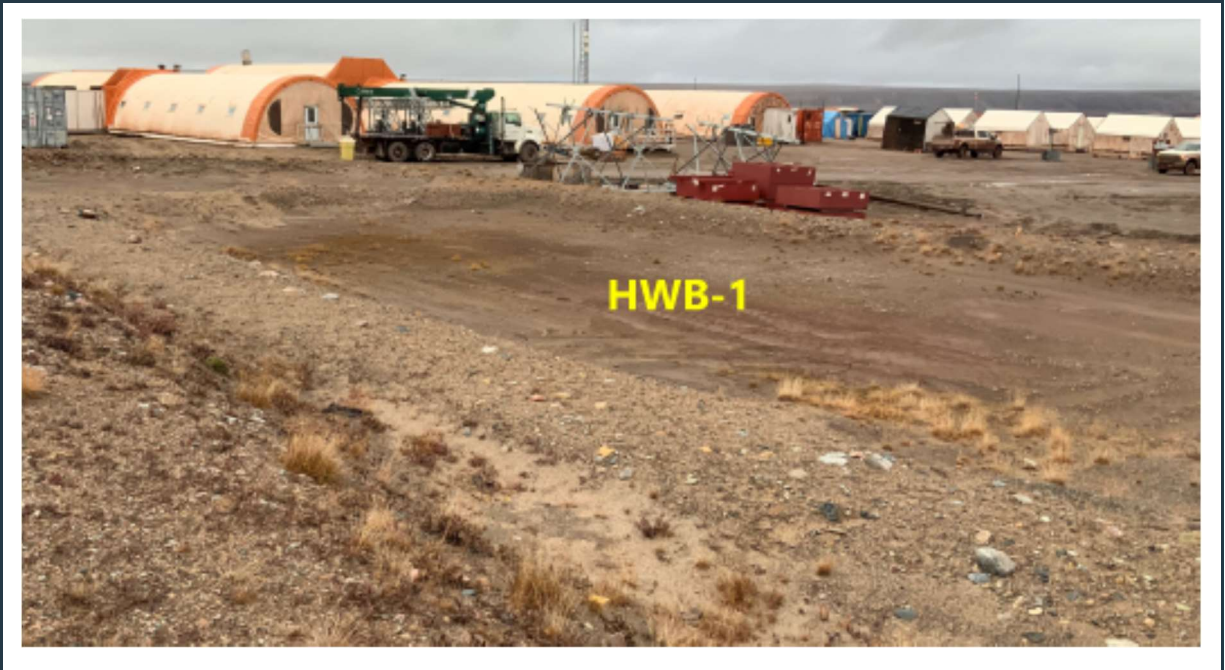
a) HWB-1

This cell is currently not in use, as shown in Figure 13. As reported previously, concerns had been raised in the past to suspected potential liner damage within this cell, and consequently no material has been stored in this cell since this concern was identified. Baffinland has previously committed to removing the old liner from this cell and replacing it with a new one should use of HWB-1 be required in the future, prior to storing material in this cell.

Figure 13: View of HWB-1 – Currently this cell is not in use.

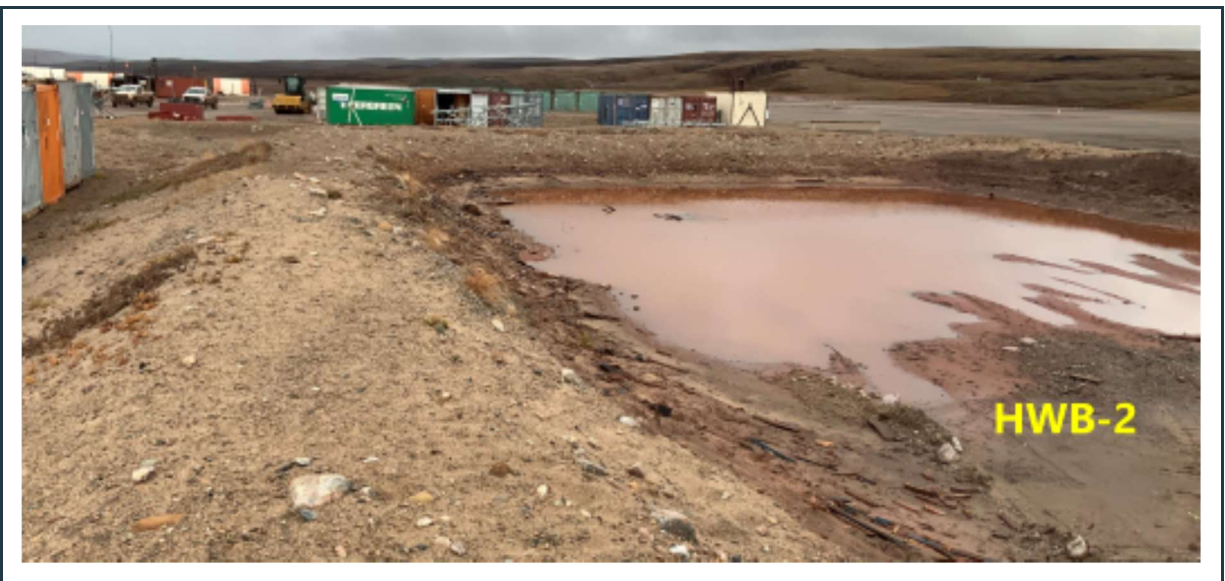
b) HWB-2

As shown in Figure 14, this cell is currently empty, holding only some rainwater. The perimeter berms around the cell appear to be stable and the presence of ponding water indicates good liner performance.

Figure 14: View of the robust, stable berms around HWB-2. The presence of water in the cell indicates good liner performance. No material is currently stored in this cell.

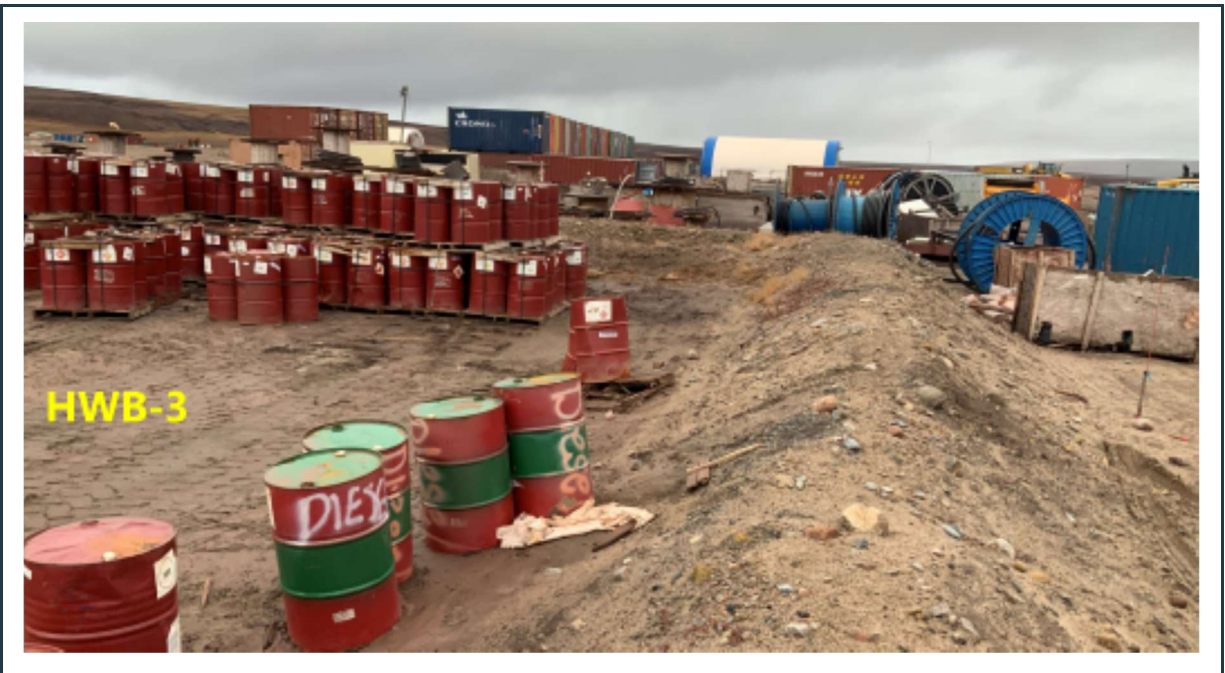
These cells were constructed as "twin-cells" and were called "Fuel Containment" cells. As shown in Figures 15 and 16, cell 3 is generally holding fuel barrels, stored on wooden pallets, (jet-fuel and diesel), and similar barrels are stored in cell 4. The berms and liner around and within the two cells appear to be in good condition and no seepage from either of the cells was noted during the inspection.

Figure 15: View of stable berms and stored fuel barrels in HWB-3.

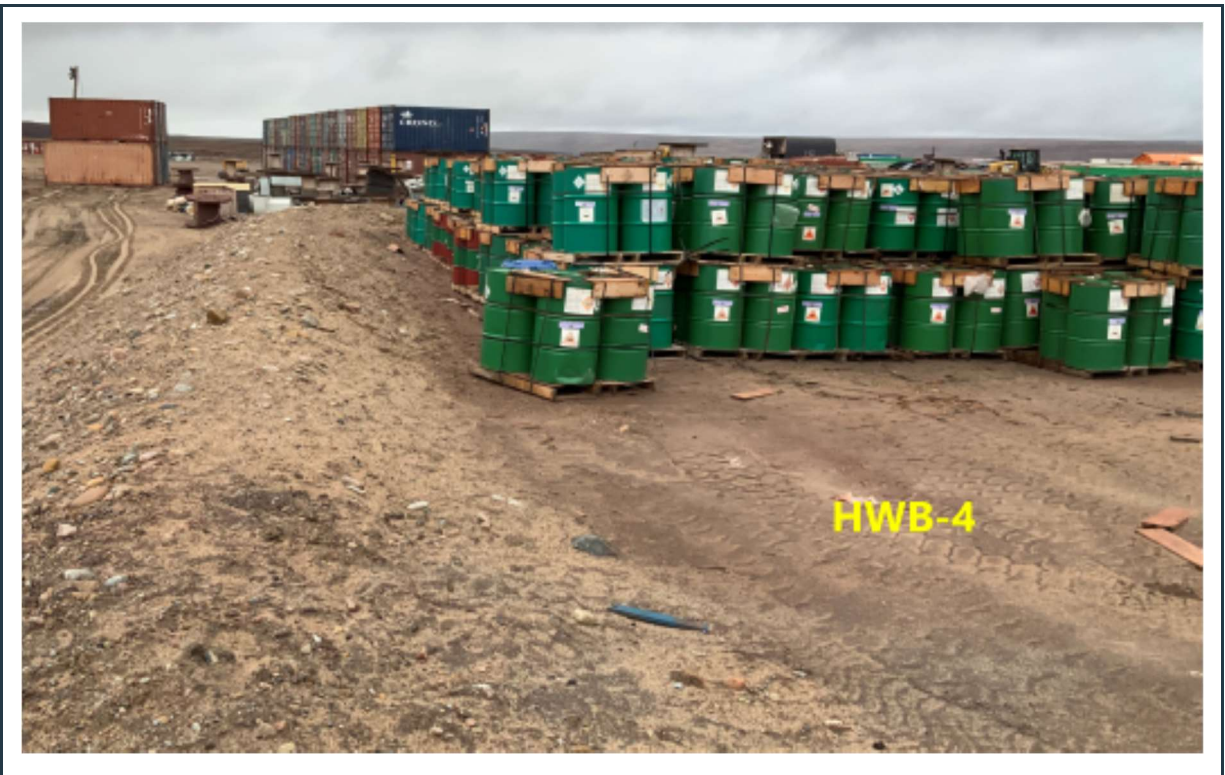
Figure 16: View of stable berms around the HWB-4 cell, with fuel barrels stored on wooden pallets.

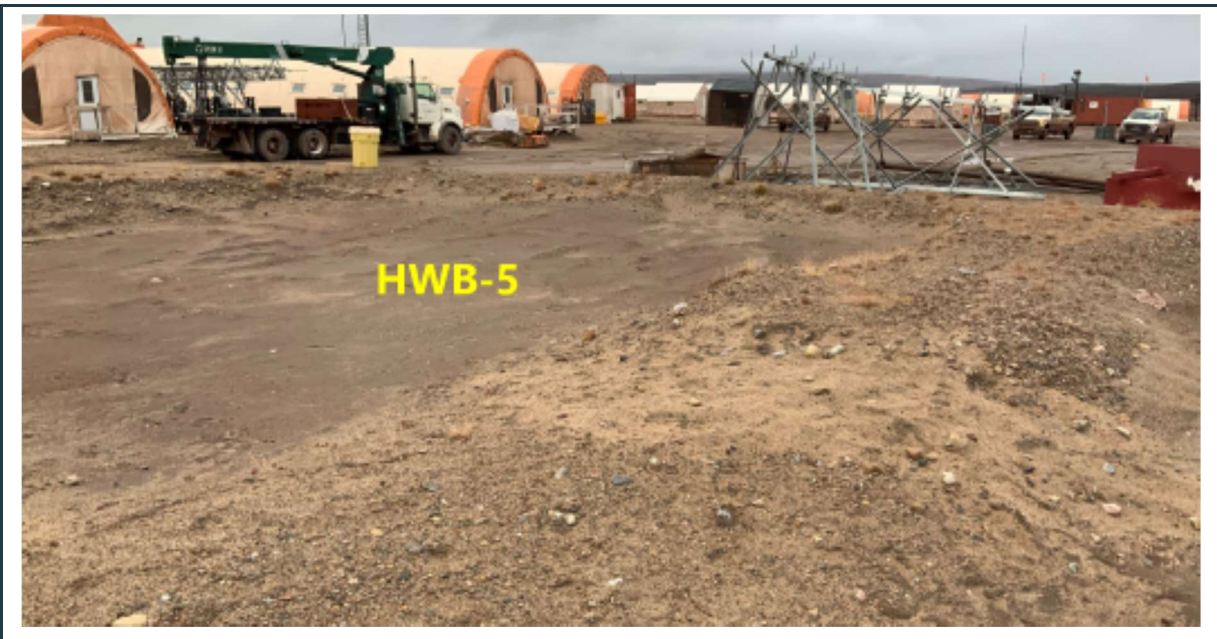
d) HWB-5

As shown in Figure 17, this cell is currently empty. The shallow berms around the cell appear to be stable and there is no visible liner damage in the cell. Baffinland has previously committed to removing the old liner from this cell and replacing it with a new one should use of this HWB-5 cell be required in the future.

Figure 17: View of stable berms around the empty (currently not in use) HWB-5 cell.

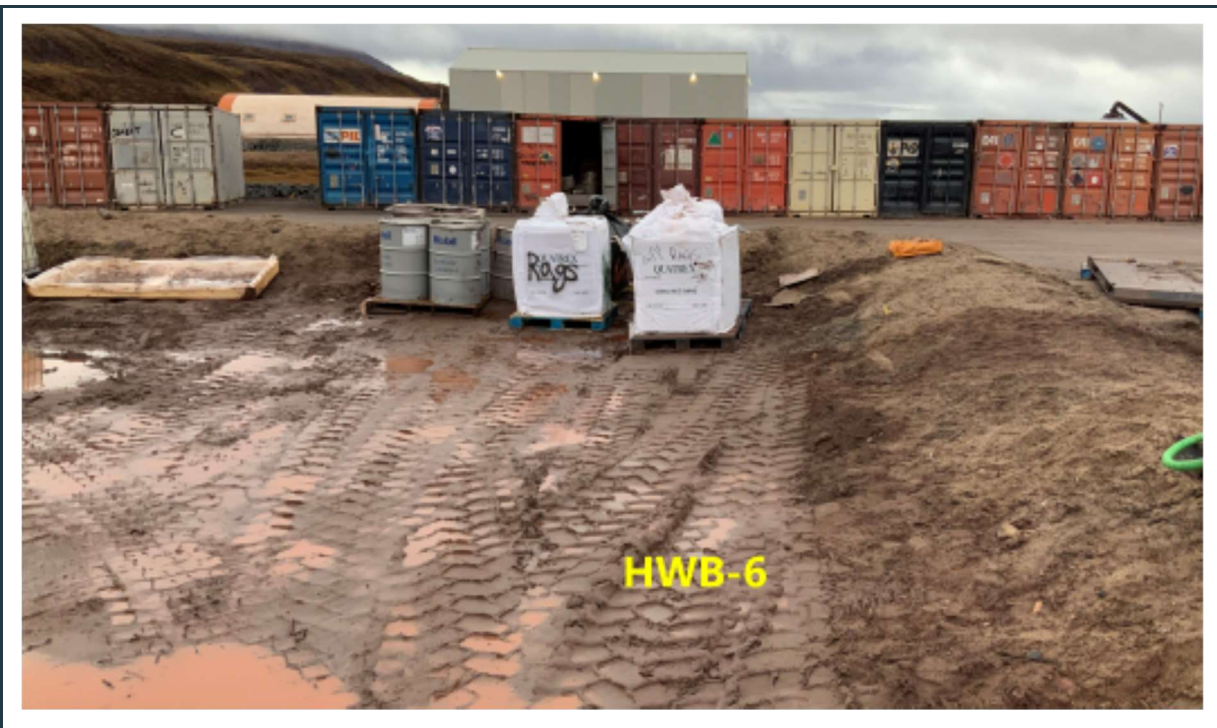
e) HWB-6

The berms around this cell and the internal "floor" have been regraded and stabilized recently using clean granular fill. As shown in Figure 18, the cell contained a few containers only at the time of the September inspection. The ponding rainwater in the cell indicates good liner performance.

Figure 18: View of stable berms around, and the regraded granular fill within the HWB-6 cell. The ponding rainwater in the cell indicates good liner performance.

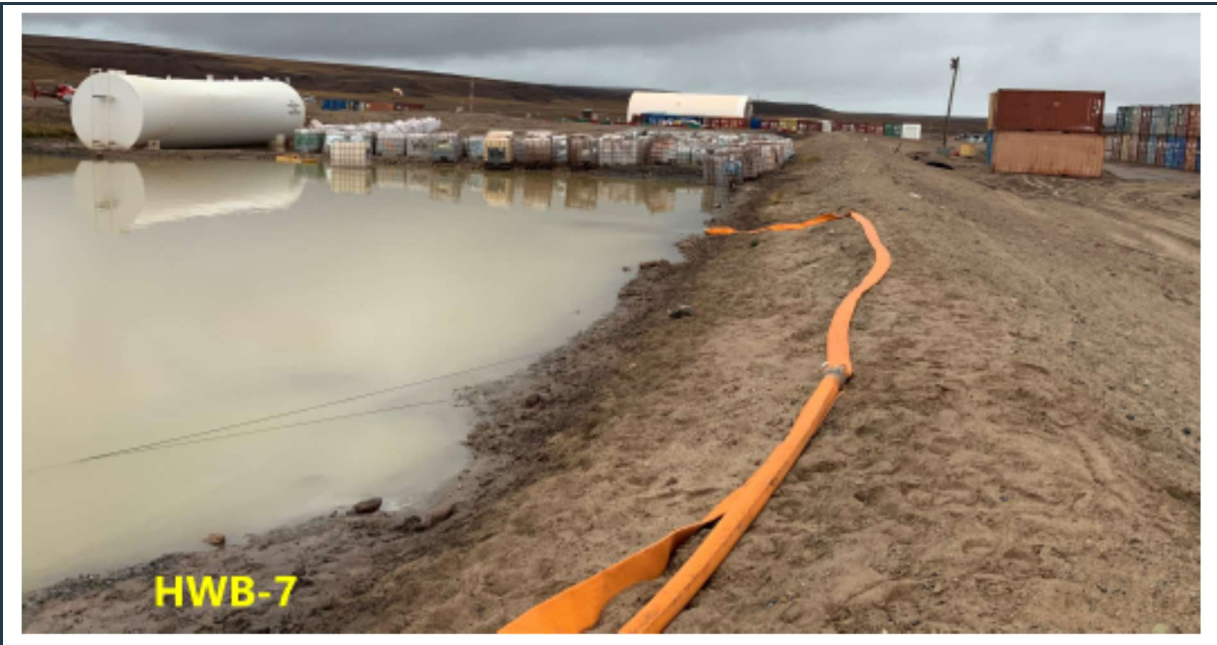
f) HWB-7

Only one (1) large fuel tank is stored in this cell with a few plastic containers, as shown in Figure 19 (white tank and containers). The perimeter berms around the cell appear to be stable and the ponding rainwater within the cell is indicative of adequate liner performance. At the time of the September inspection the ponding water was being gradually removed and treated.

Figure 19: View of the stable berm around the HWB-7 cell, with an old fuel tank and some plastic containers stored in the cell. The ponding water is being currently removed and treated.

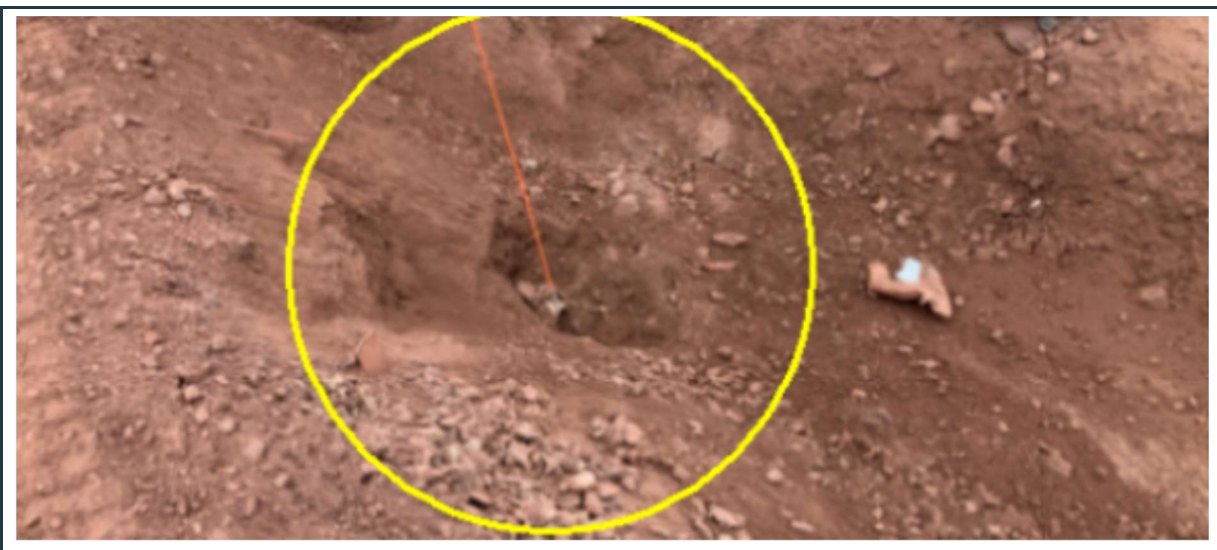
The MS-06 surface water management pond collects surface water from the area of the crusher pad. The surface water is collected in side-ditches, excavated around the crusher pad, and conveyed into the pond. There is one culvert under the crusher pad entrance that connects one (1) of the side ditches with the north corner of the surface water management pond. It was noted during the September 2022 inspection that the inlet-end of that culvert is still partly clogged with soil (see Figure 20). The location of the clogged end of the culvert is marked by a green dot in Figure 1 (within the yellow circle marking the MS-06 pond). The soil fill, blocking the flow of water through the culvert, must be completely removed to restore proper drainage through this culvert. Extension of the culvert is also suggested to prevent future clogging of this corrugated drainage pipe.

Figure 20: Drainage ditch next to the crusher plant leading to the MS-06 pond. The yellow circle indicates that the entry to the culvert that should drain the collected surface water from the ditch to the MS-06 pond is partly clogged (should be cleaned). Extending the culvert is also suggested.

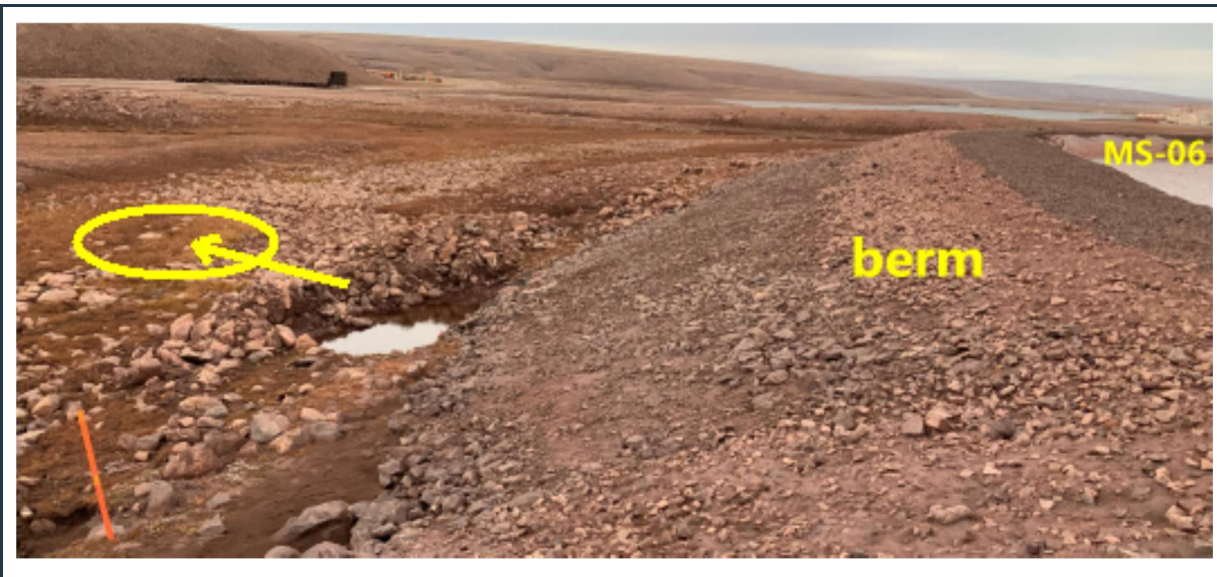
No wet downstream slopes or toe seepage from the pond were visible at the time of the inspection. However, seepage water within the relatively permeable, cobbly overburden (within the active layer) adjacent to the toe of the south berm of the pond was noted in a temporary containment sump (marked by a blue dot in Figure 1), which was excavated to contain the seepage water and pump it to the MS-06 surface water management pond, as shown in Figure 22. The water in the sump appears to be surface water, percolating down into the ground and flowing from higher elevations within the valley adjacent to the crusher pad toward the MS-06 pond. The excavated temporary containment sump could endanger the stability of the existing berm, and therefore should be backfilled with native soil, as soon as possible. To maintain the structural integrity of the pond's berms, no soil should be removed from the toe of the berms. Temporary containment sumps could; however, be excavated at least 10 m away from the toe of the berm, as suggested in Figure 22 (yellow circle).

Figure 22: Seepage water within the permeable, cobbly overburden adjacent to the area of the crusher pad and the MS-06 pond's berm. The excavated temporary sump at the toe of the berm should be filled and "relocated" away from the toe of berm (to the area of the yellow circle).

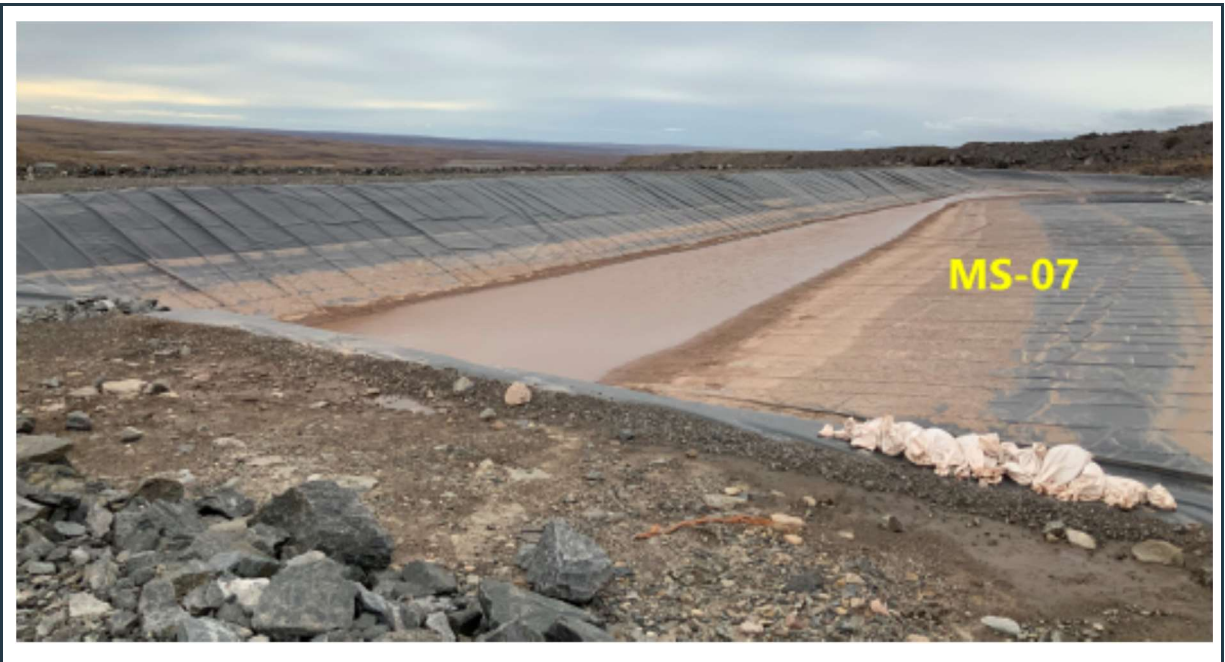
Figure 23: View of the robust, stable berms and intact liner at the MS-07 surface-water management pond. The pond was almost empty at the time of the September visit.

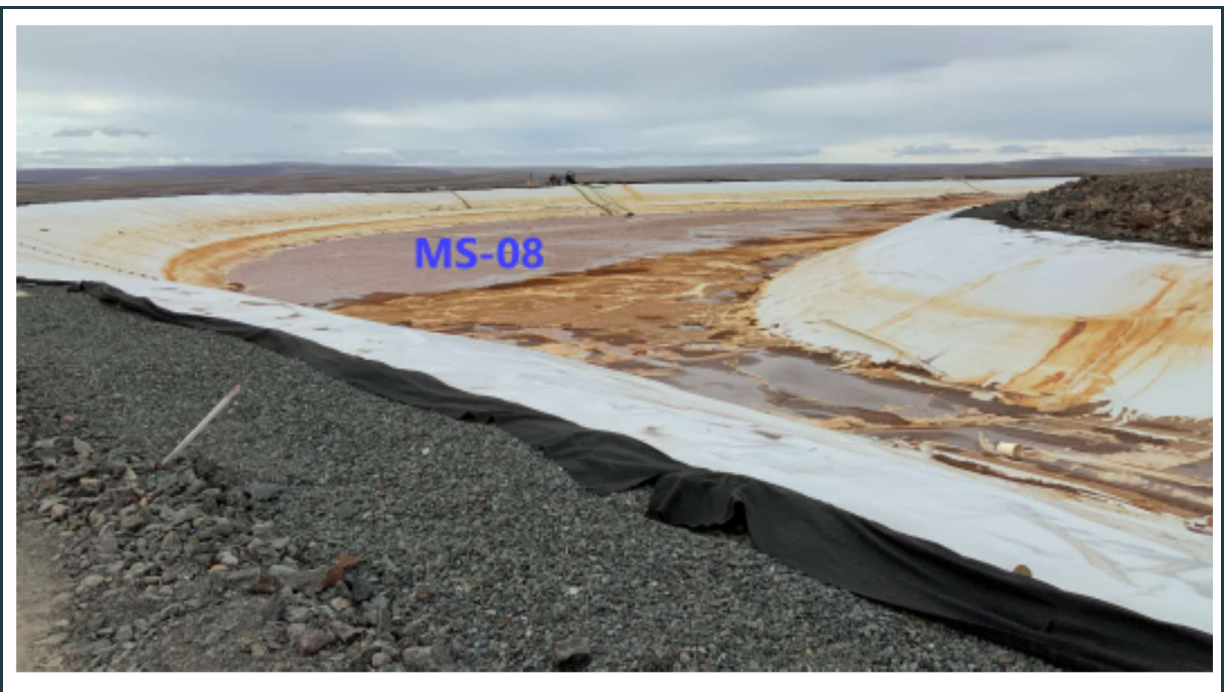
Figure 24: View of stable berm and intact liner at the MS-08 pond.

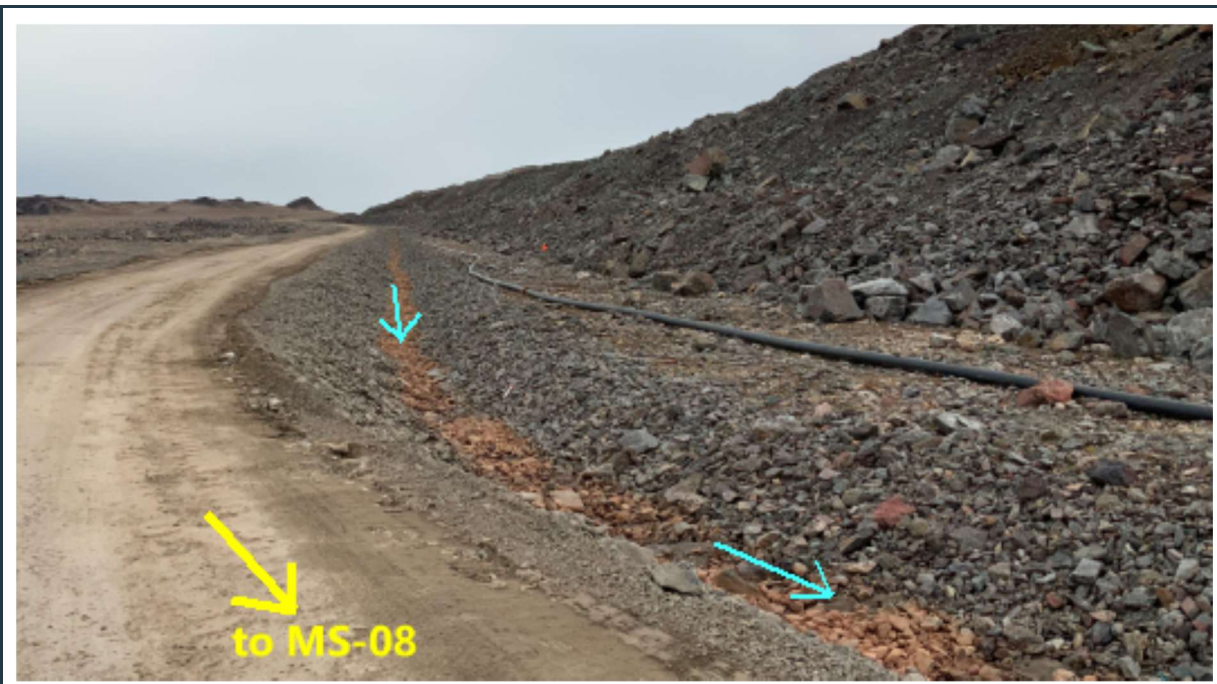
Figure 26: View of the clean drainage ditch around the east side of the waste rock facility, leading to the MS-08 pond.

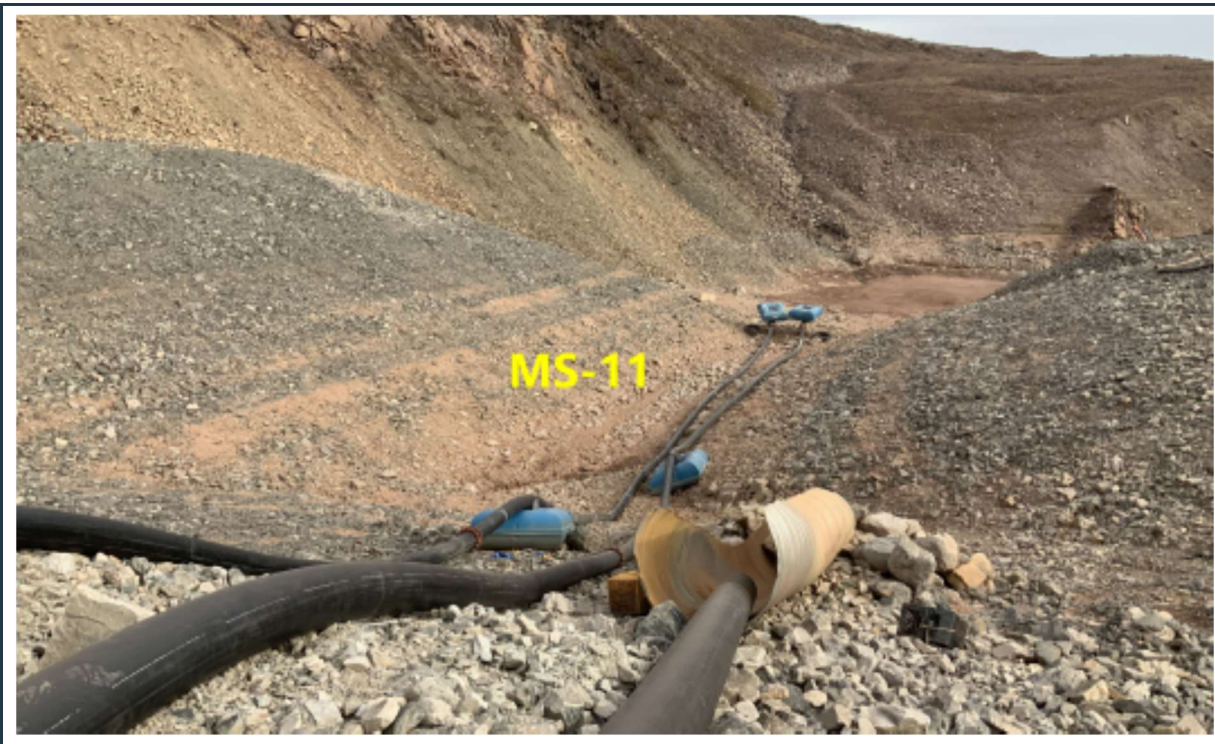
Figure 29: View of the internal area and the loss of water in the MS-11 pond at KM105.

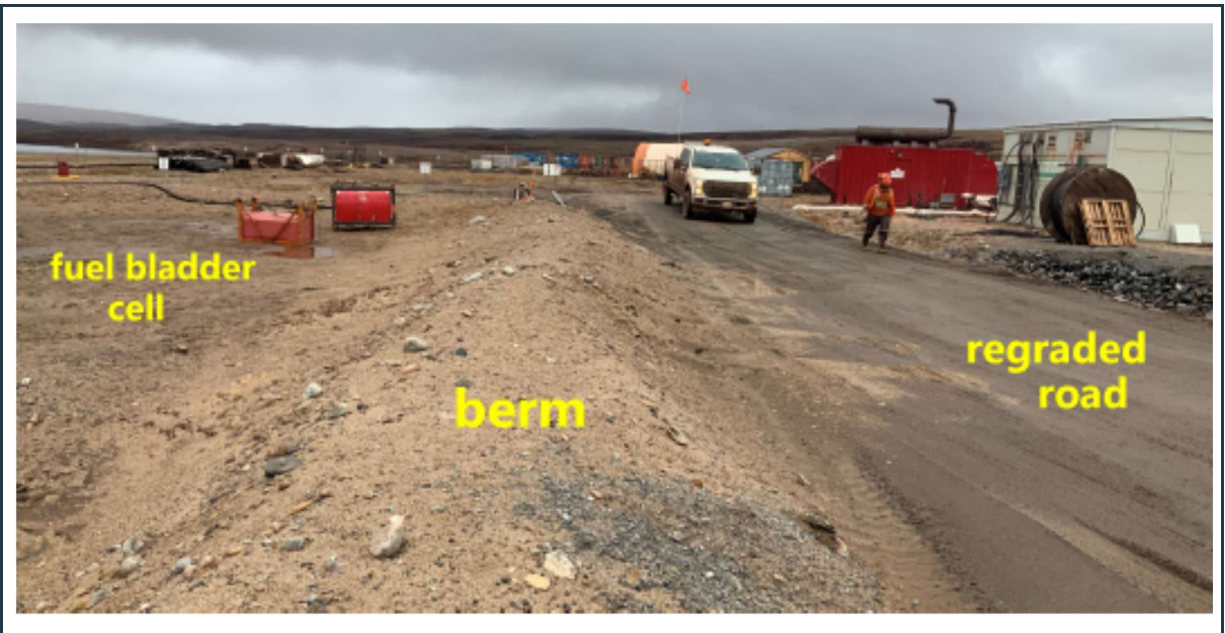
This cell has previously contained fuel bladders for the generators; however, it is currently storing a few mobile fuel tanks only. The cell is located immediately adjacent to the power generators, south-west of the hazardous waste cells (Figure 4). As shown in Figure 32, the stable perimeter berm around the cell

Figure 32: View of the stable berm around the "fuel bladder" cell. The adjacent road next to the east berm was recently regraded to improve surface drainage in the area.

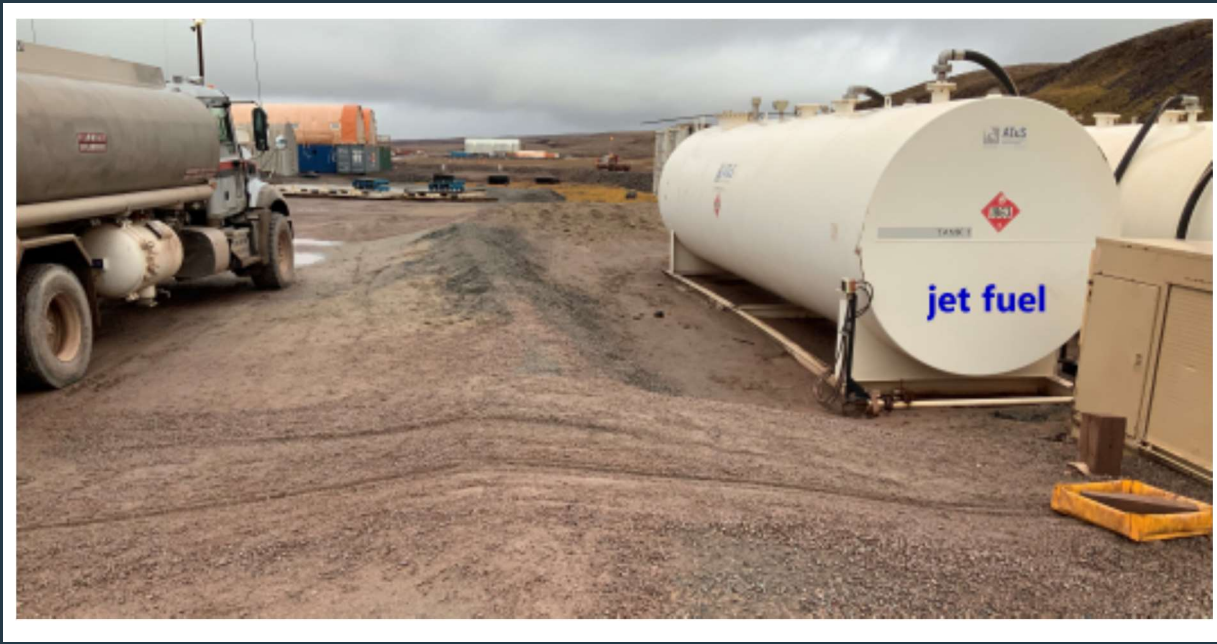
Figure 33: View of the well-maintained sand and gravel berm and access ramps at the lined jet-fuel storage facility.

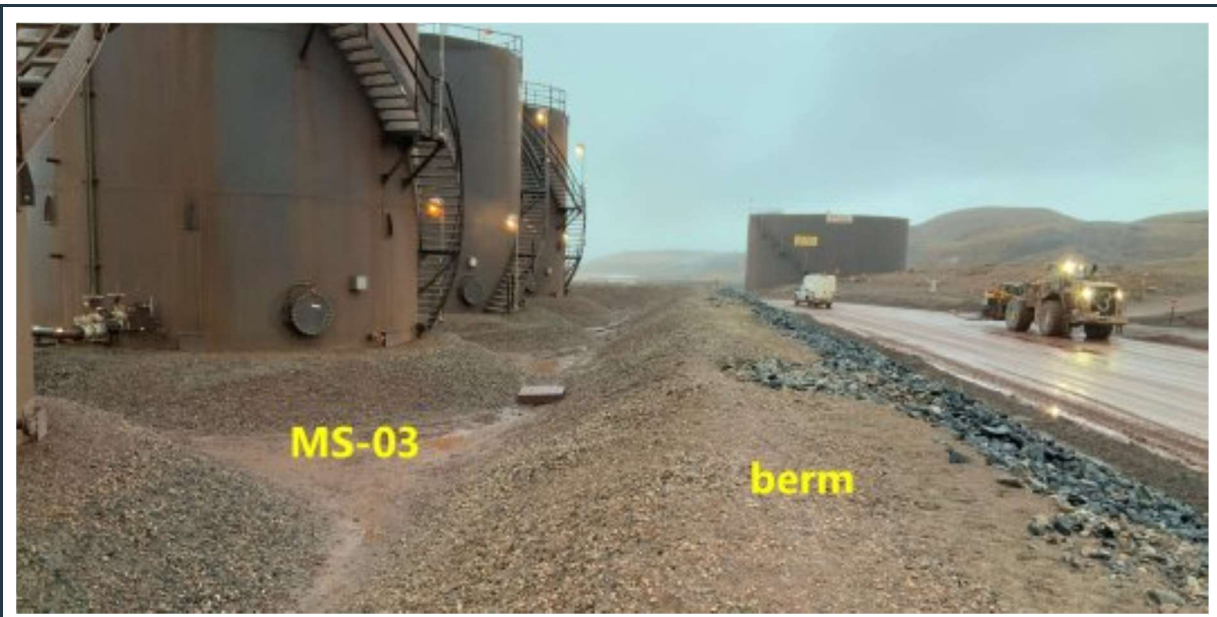
Figure 34: Well-maintained, stable berm around the MS-03 diesel fuel farm, with some ponding water. No problems with the liner were noted anywhere in this facility.

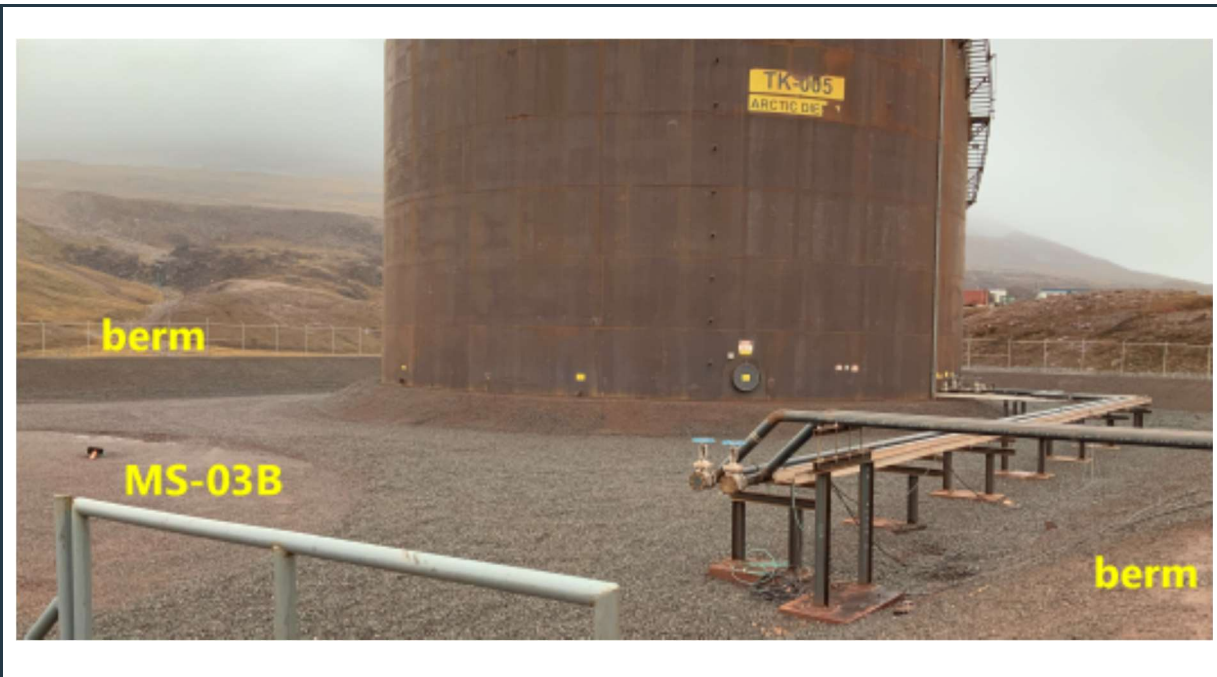
Figure 35: View of the well-maintained stable berm and interior granular fill over the liner at the new fuel tank farm. The locations of additional tanks are already prepared within the facility.

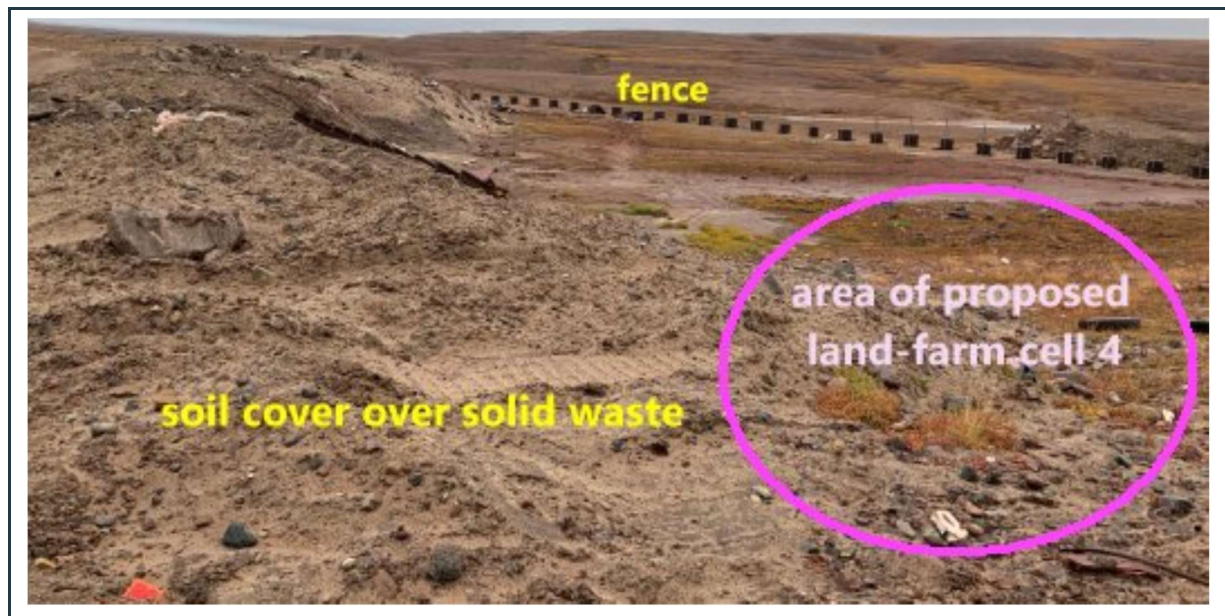
Figure 38: View of soil cover over solid waste in the landfill facility. Note the proposed area for land-farm Cell 4 (see Figure 34 for the entire land-farm cell layout).

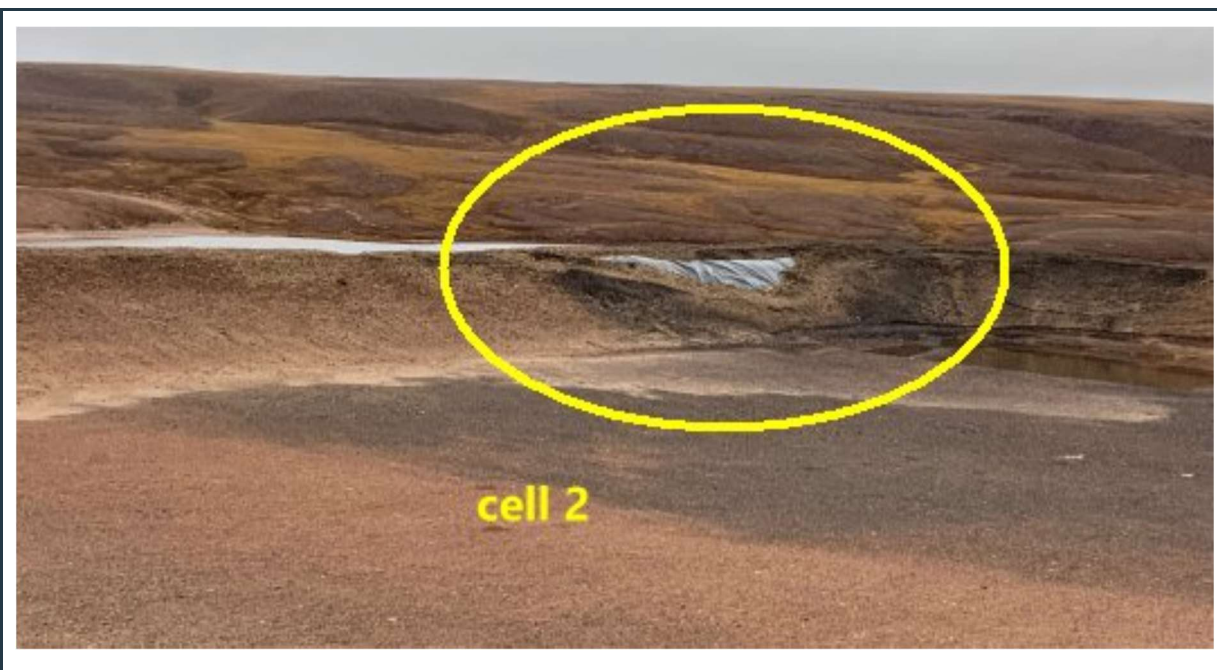
During the September 2022 inspection, the following deficiencies were noted at the two completed cells, shown in Figure 39 and Figure 40:

Figure 40: View of the currently empty Cell 2 at the land-farm. Note the exposed liner above the sump area. The slump of the soil cover is most likely related to the impact of the sump.

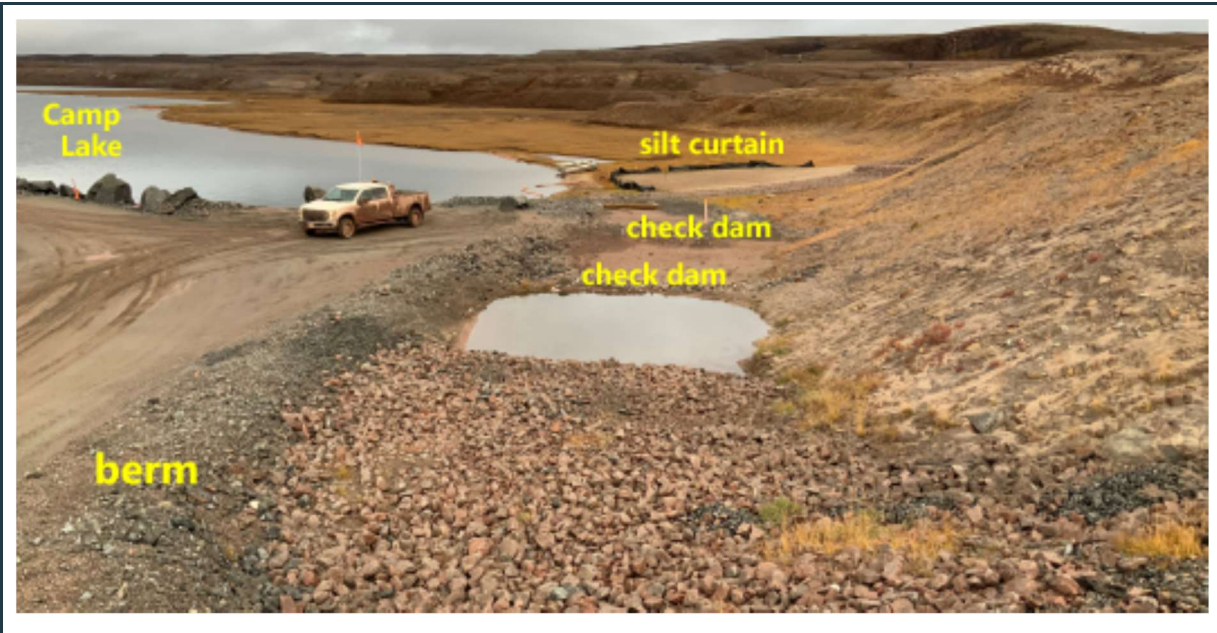
Figure 41: Camp Lake berm and check dams, constructed to form effective silt sedimentation cells. Note the silt curtain at the base of the slope for additional protection.
