RE: Submission of 2022 Geotechnical Inspection Report No. 2 (September 2022)

Mary River Project – Nunavut

WSP Environment & Infrastructure Canada Ltd., (formerly Wood E&I Canada Ltd.), has completed the second geotechnical field inspection of 2022 at the Mary River Project, which is a condition of the Type "A" Water Licence No: 2AM-MRY1325 – Amendment No.1 ("Water Licence").

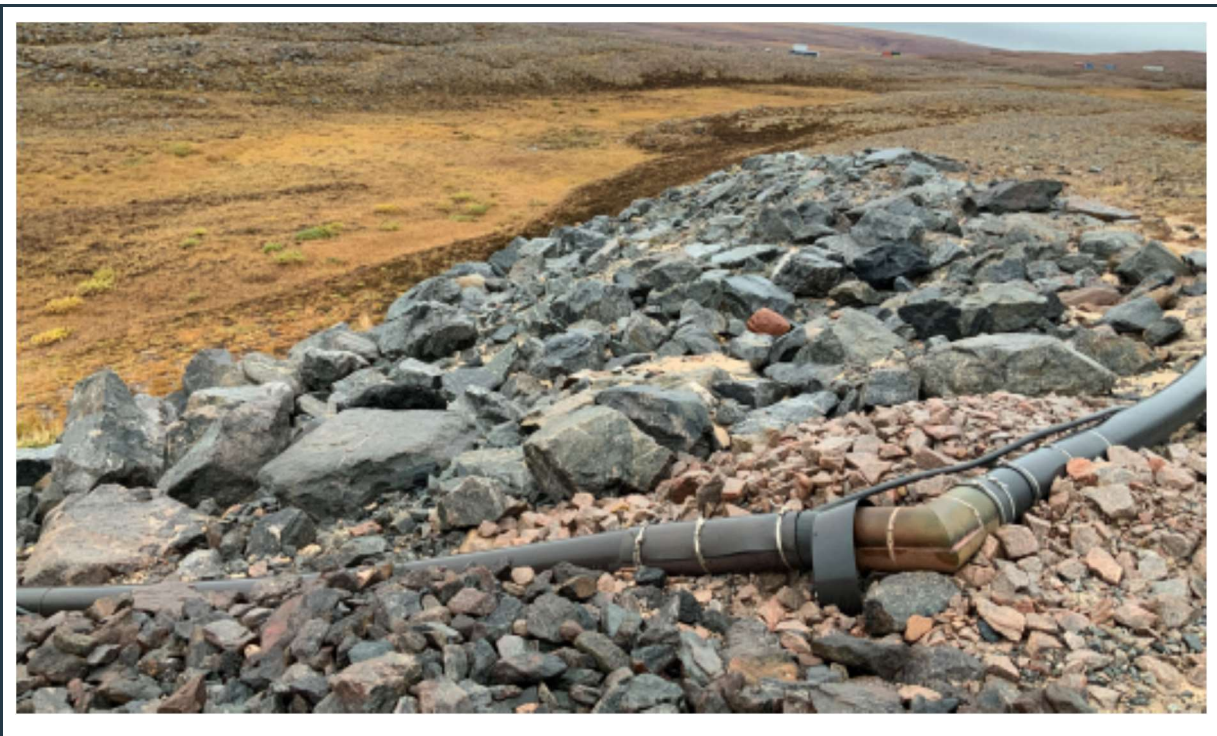
Figure 42: View of the stable rock fill riprap slope at the water discharge area.

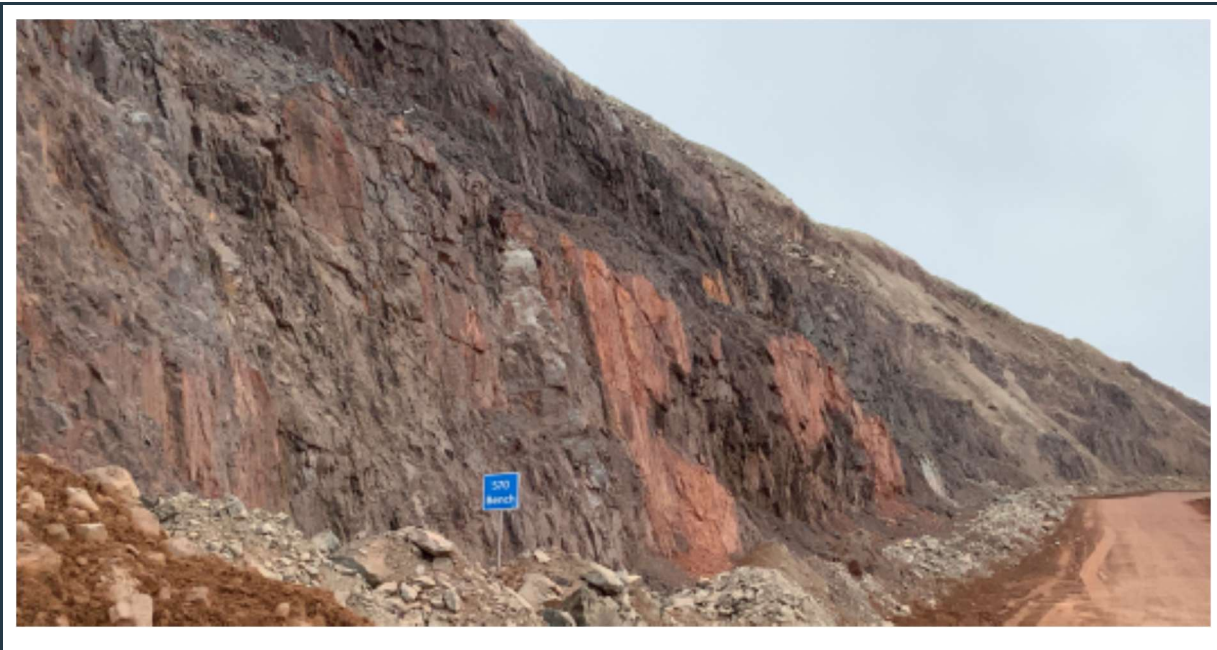
Figure 43: Stable deposit-1 pit-wall with minor rock weathering and erosion in limited areas.

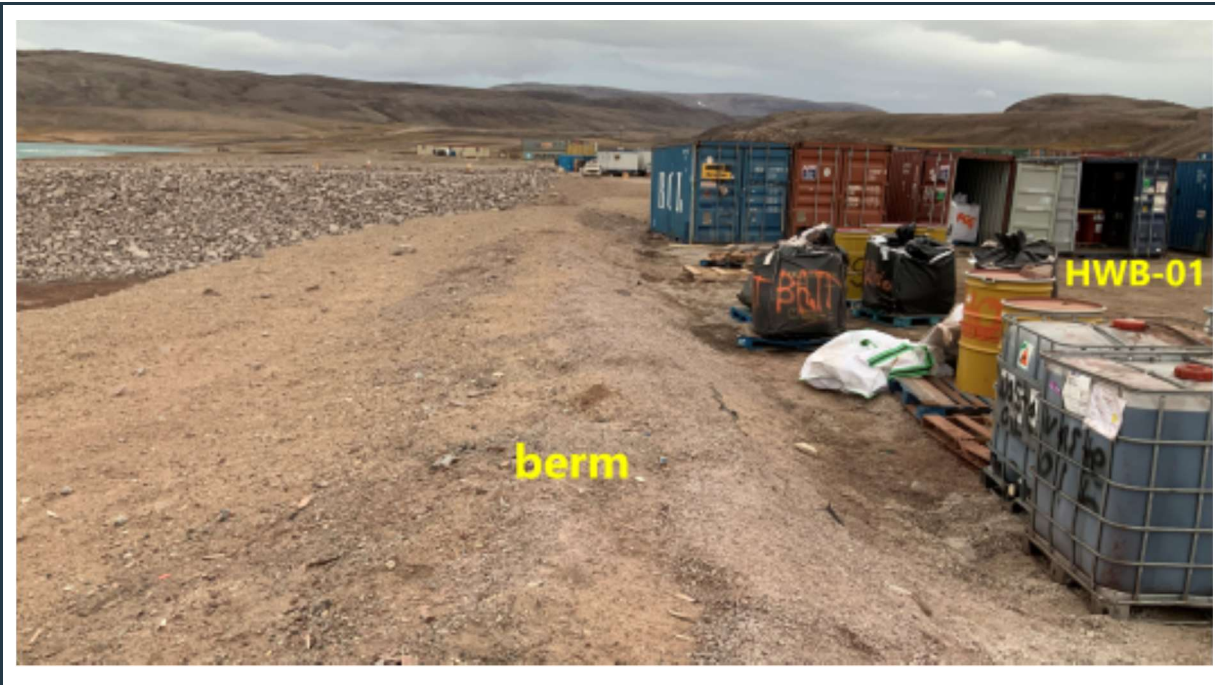
a) HWB-1

Figure 48: View of the robust, stable berm around the HWB-1 cell.

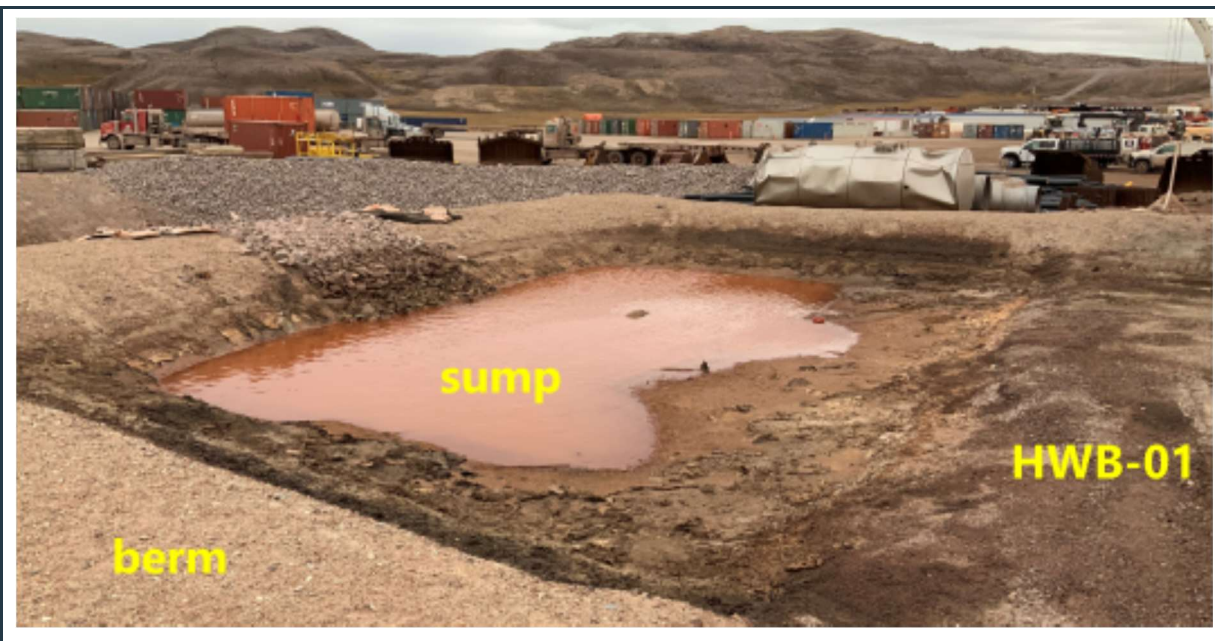
Figure 49: View of the sump at the back of the HWB-01 cell with stable berms.

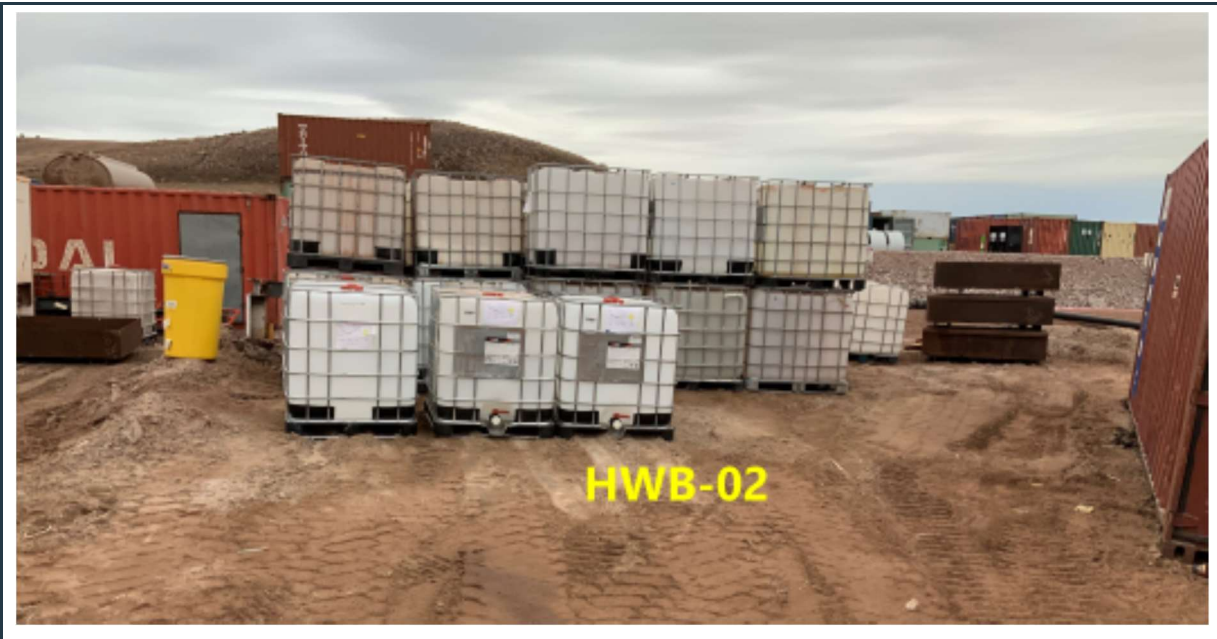
Figure 50: View of the former HWB-2 cell, with only a few empty containers stored on the top of clean sand and gravel fill pad. No hazardous waste is stored in this cell.

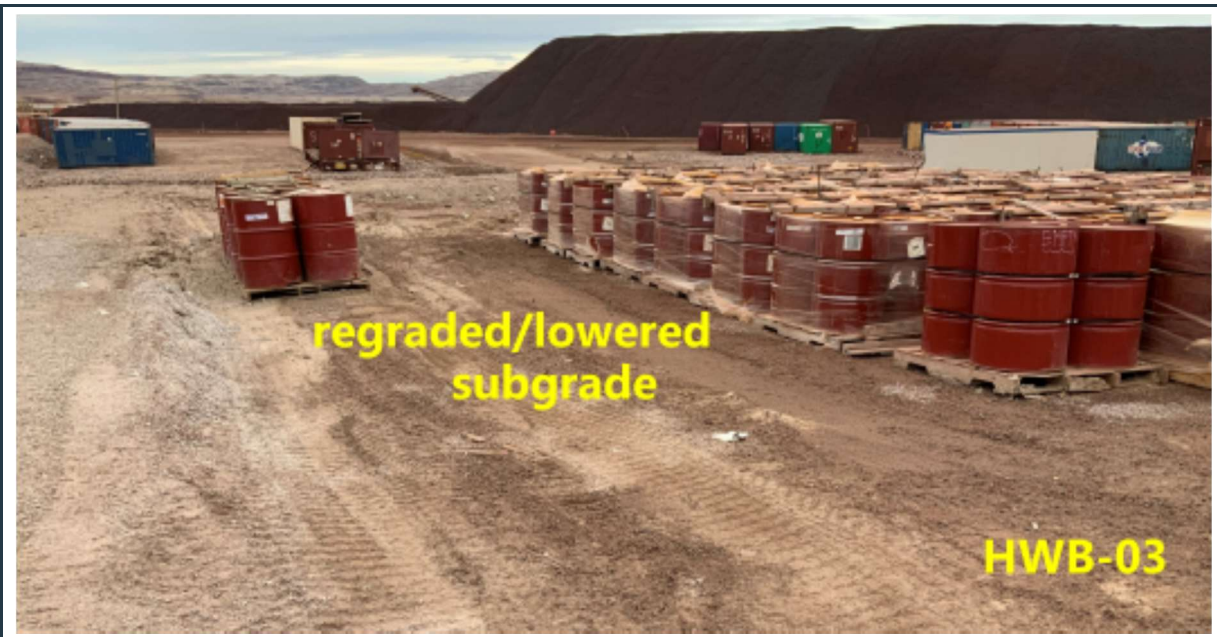
Figure 51: View of the HWB-3 cell with stable berms, containing fuel barrels. The interior subgrade has been regraded/lowered, as specified in the previous inspection report.

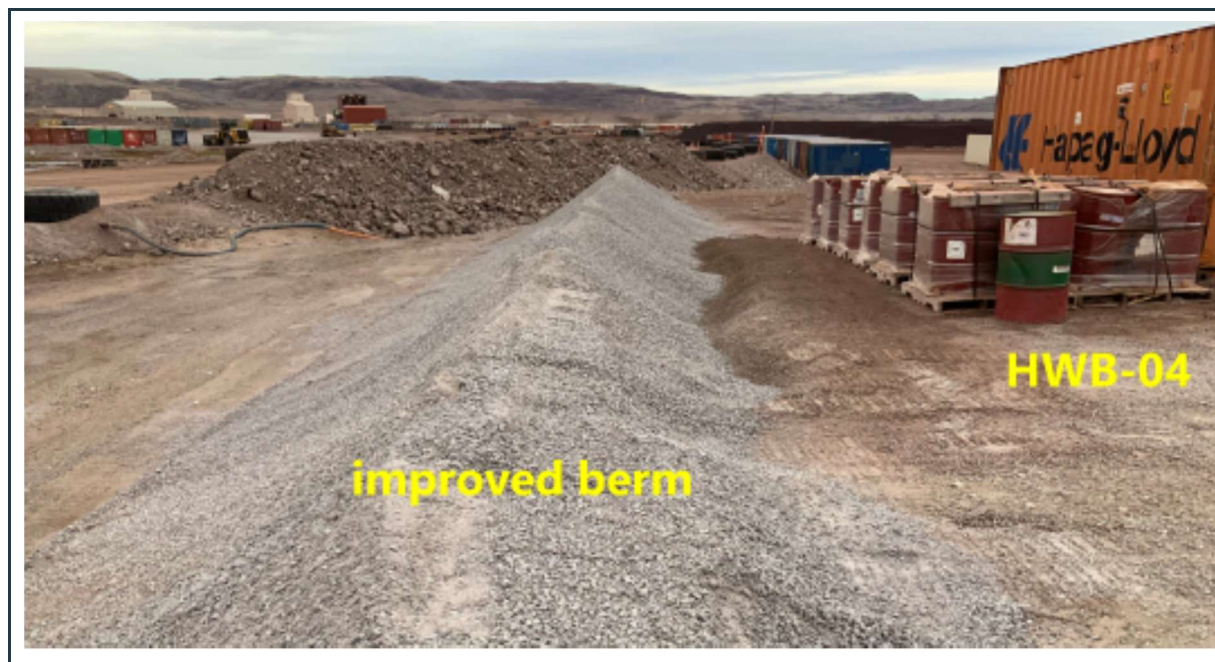
Figure 52: Recently improved (raised) berm at the HWB-4 cell, storing jet fuel and shipping containers.

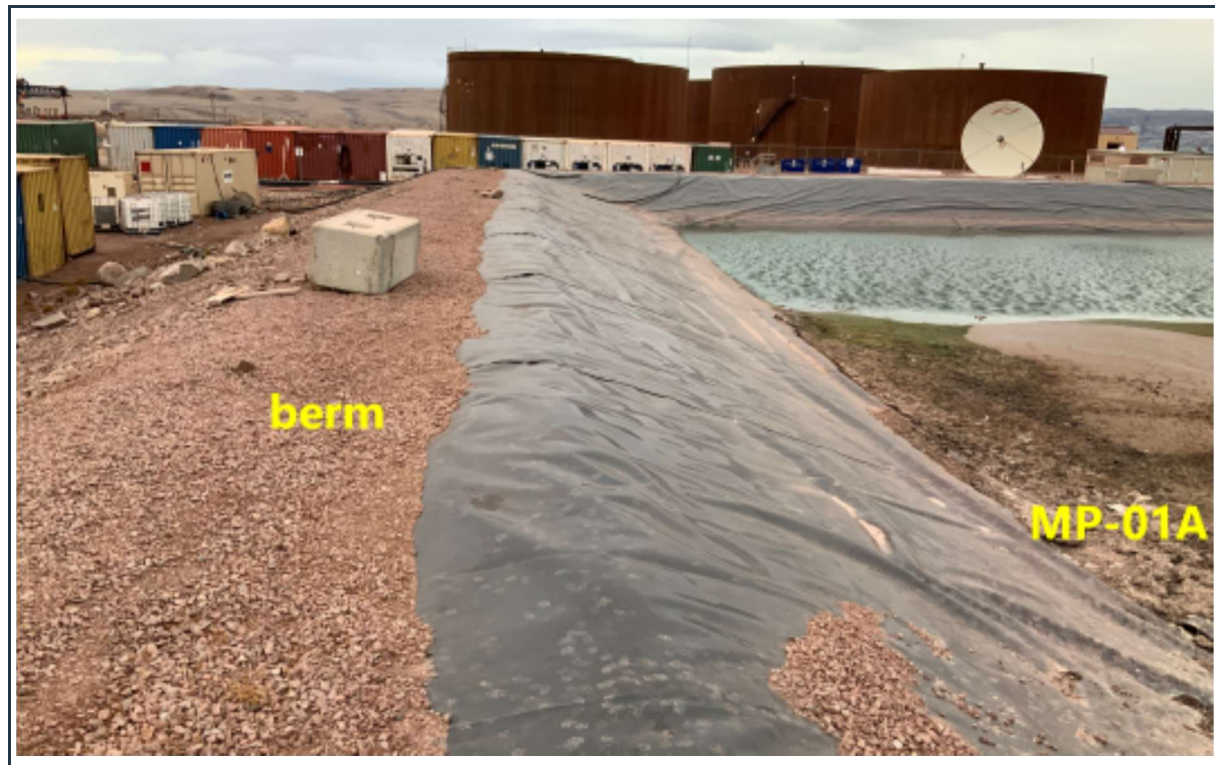
Figure 53: View of the robust, stable berms and intact liner in the MP-01A pond.

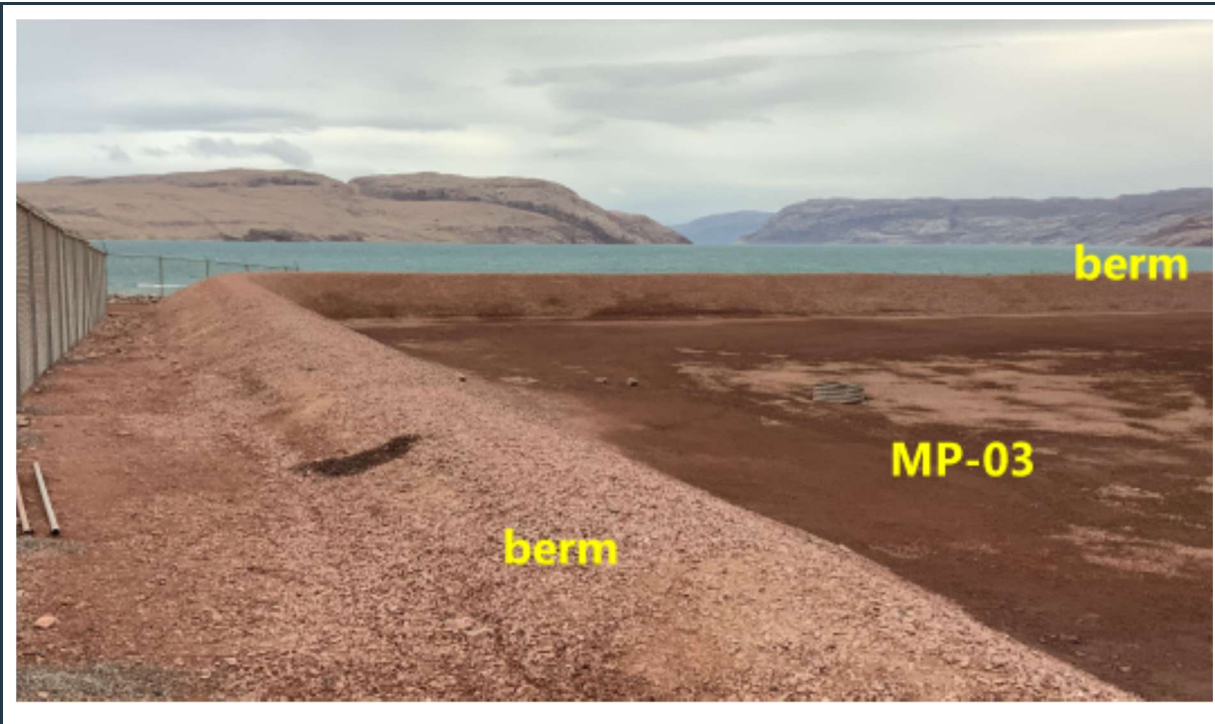
Figure 54: View of the well-maintained stable berms around the MP-03 fuel tank farm.

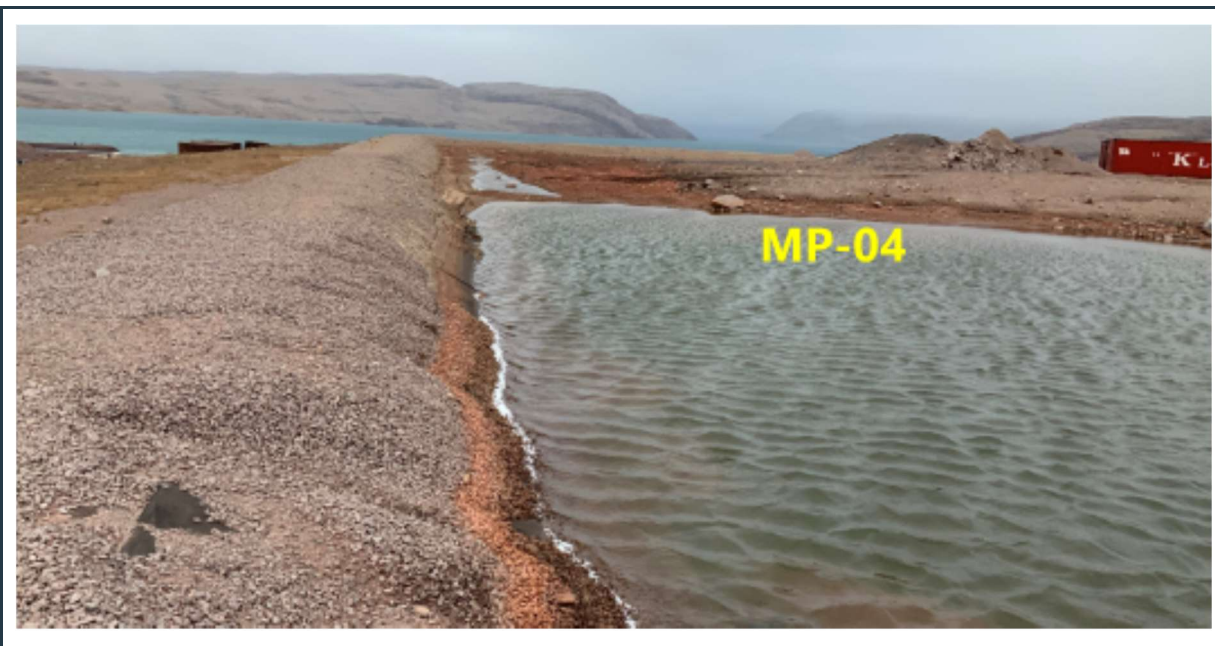
Figure 55: View of stable berm around the MP-04 land-farm, with ponding water in one corner of the cell.

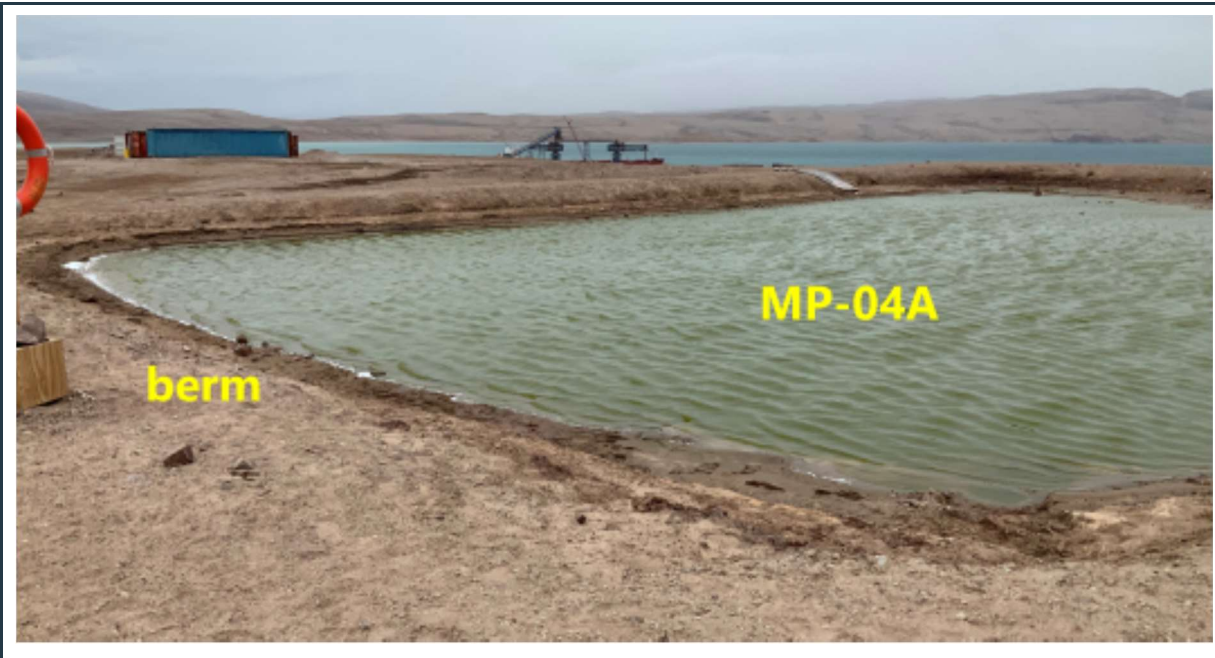
Figure 56: View of the MP-04A cell with stable berms. The ponding water indicates good liner performance.

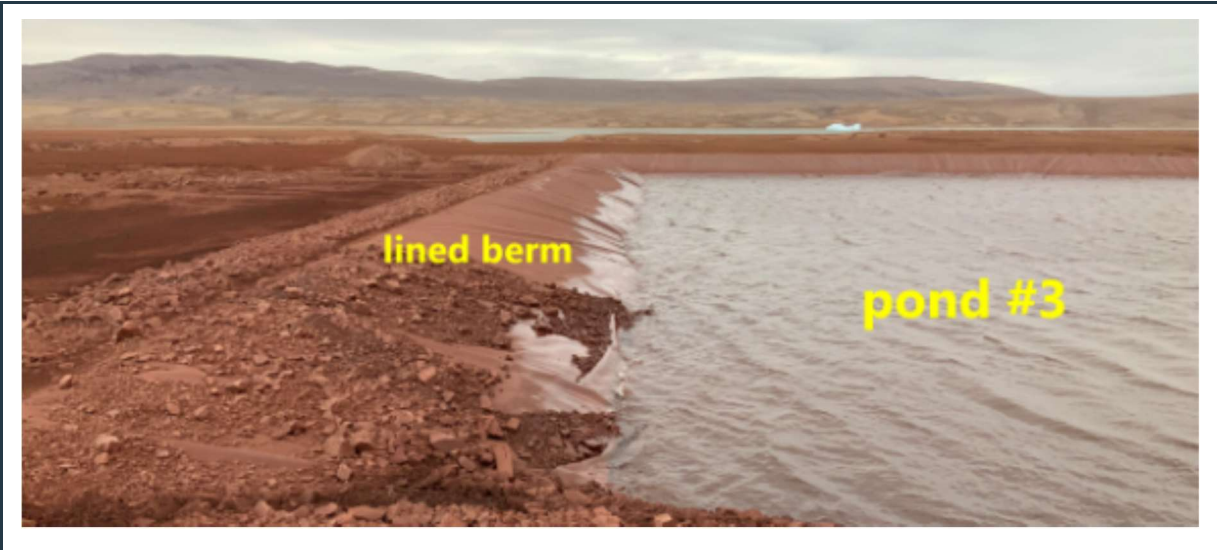
Figure 58: View of surface water management pond #3, with lined, stable berms along three sides of the pond.

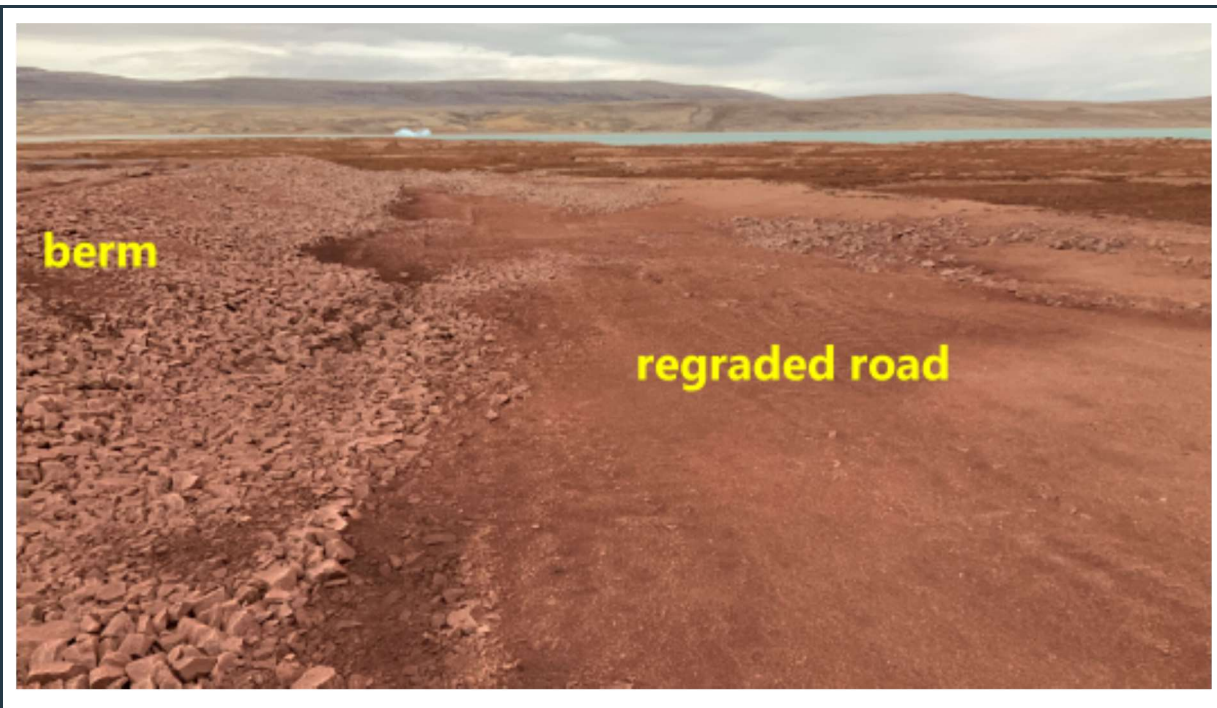
Figure 59: View of the north berm at settling pond #3, with the road regraded adjacent to the berm.

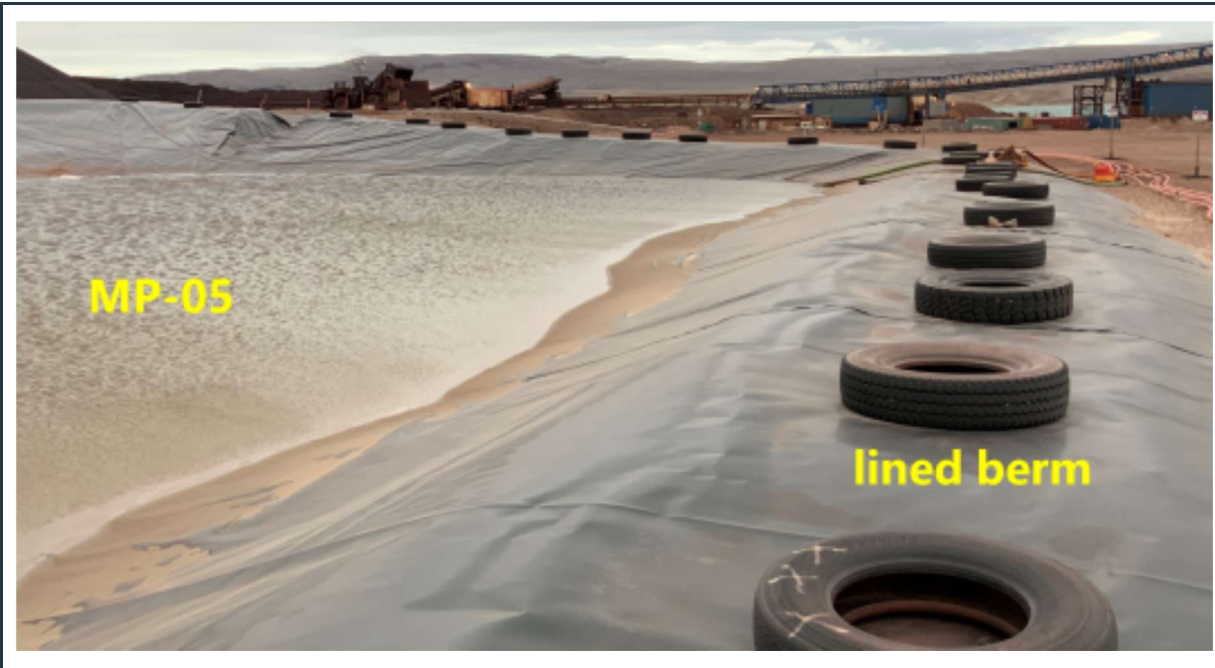
Figure 60: View of the robust, stable berms and intact liner at the MP-05 pond.

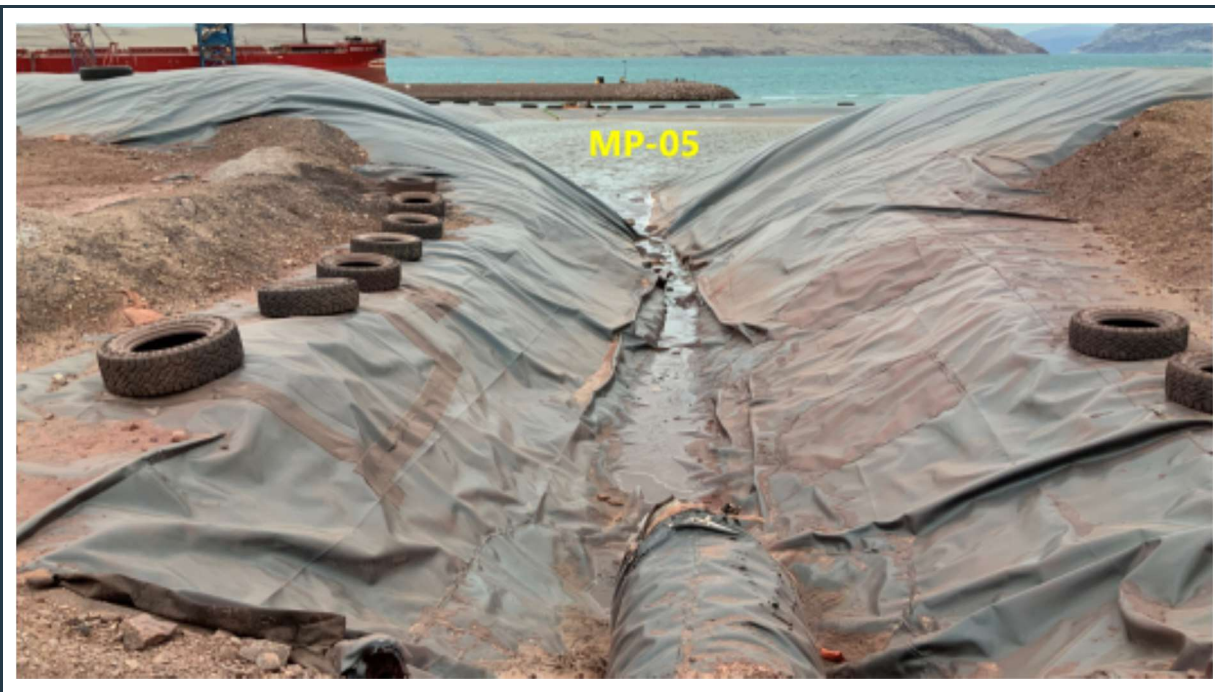
Figure 61: View of the repaired liners on both slopes of the southern inlet channel, discharging surface water into the MP-05 surface water management pond.

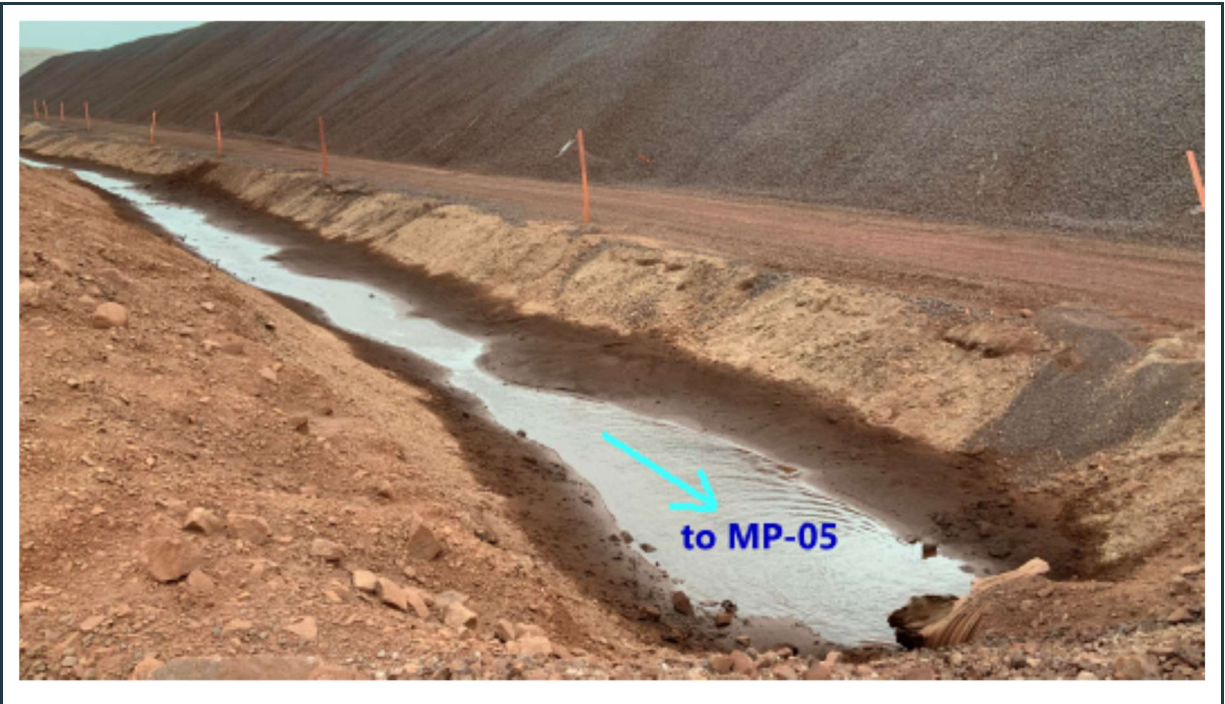
water from around the ore stockpile is collected in well-maintained drainage ditches. The slopes of the drainage ditch leading to the MP-05 pond appeared to be in good condition, as shown in Figure 62.

Figure 62: Surface water collection ditch adjacent (east) to the ore storage, draining to the MP-05 pond.

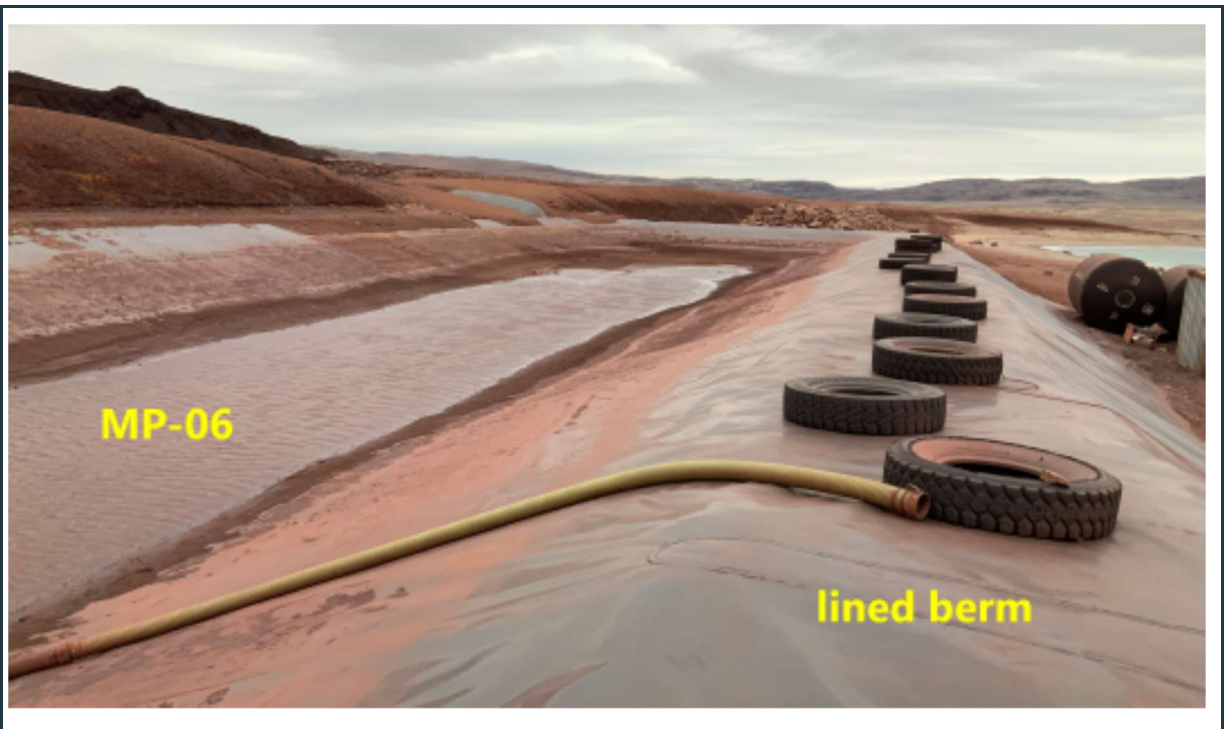
Figure 63: View of the lined MP-06 pond with robust, stable berms.

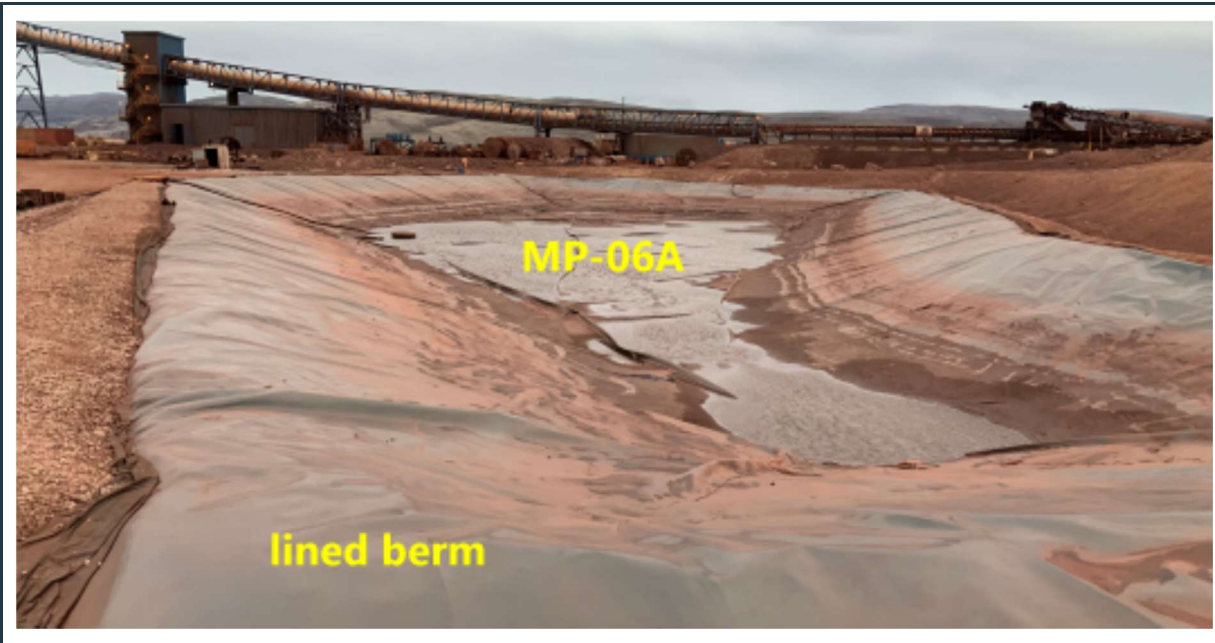
Figure 64: View of the lined MP-06A overflow pond with robust stable berms, adjacent to the ship loader.

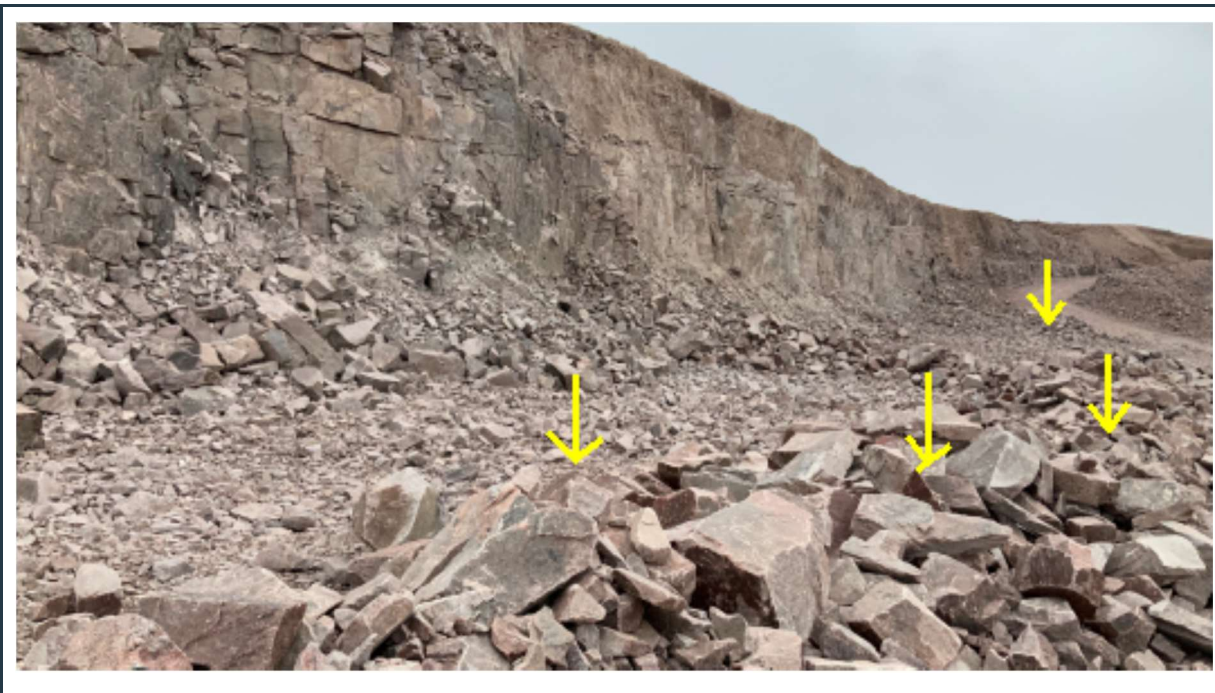
Figure 65: View of stable highwalls with minor weathering and bench erosion in the Q01 rock quarry. Note the safety berm between the access road and the face of the rock wall (yellow arrows).

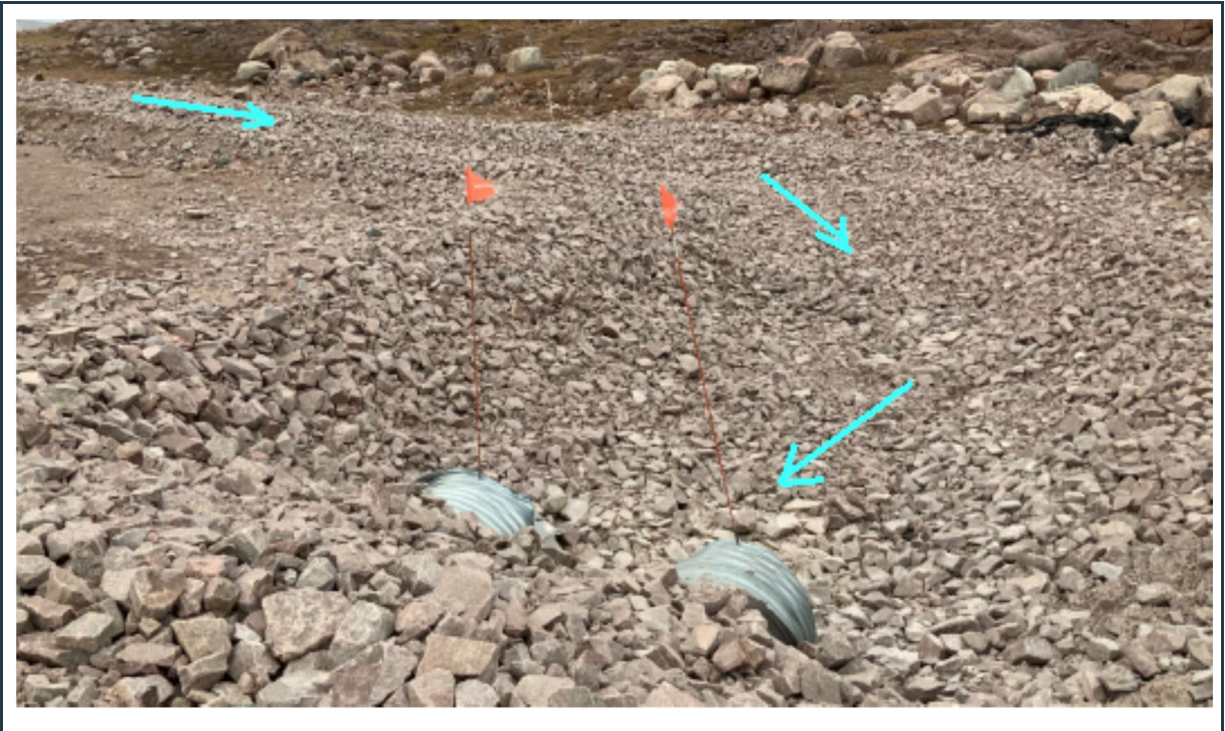
Figure 70: View of the south end of the rock fill lined P-SWD-6 surface water collection ditch.

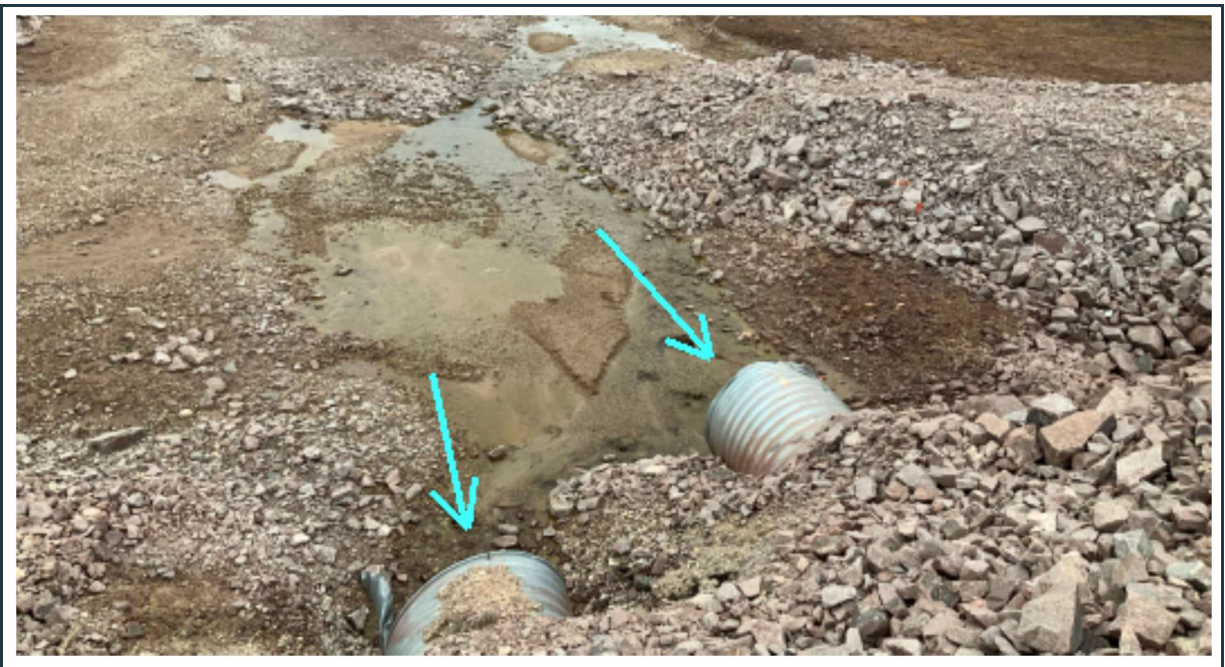
Figure 71: View of the P-SWD-7 surface water collection ditch and culverts (inlet).

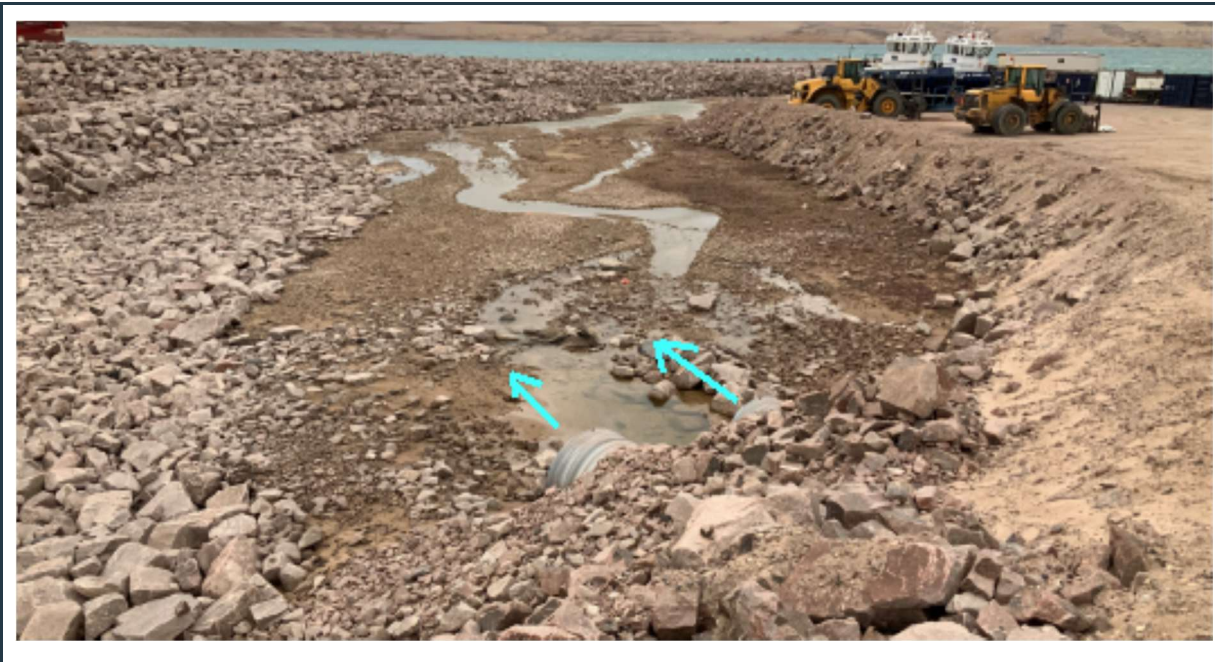
Figure 72: View of the well-maintained P-SWD-7 surface water collection ditch and culverts (outlet).

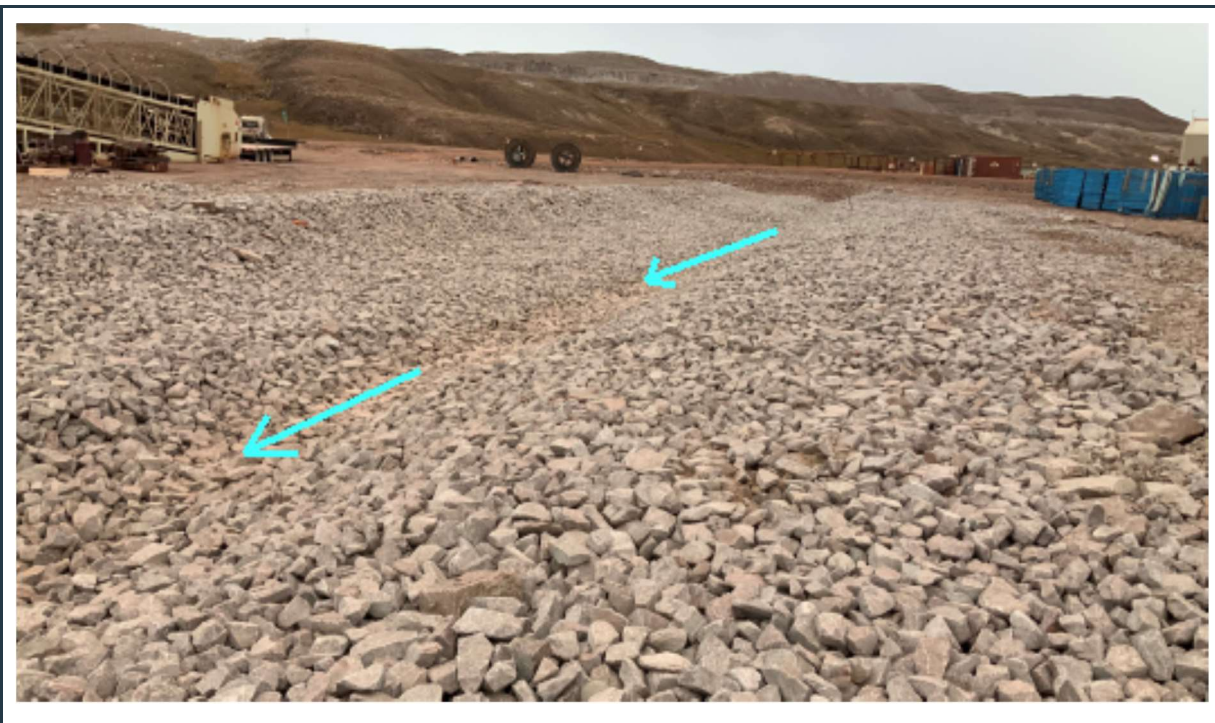
Figure 73: View of the recently completed W3/W14 surface water collection ditch with crushed rock riprap slope protection.

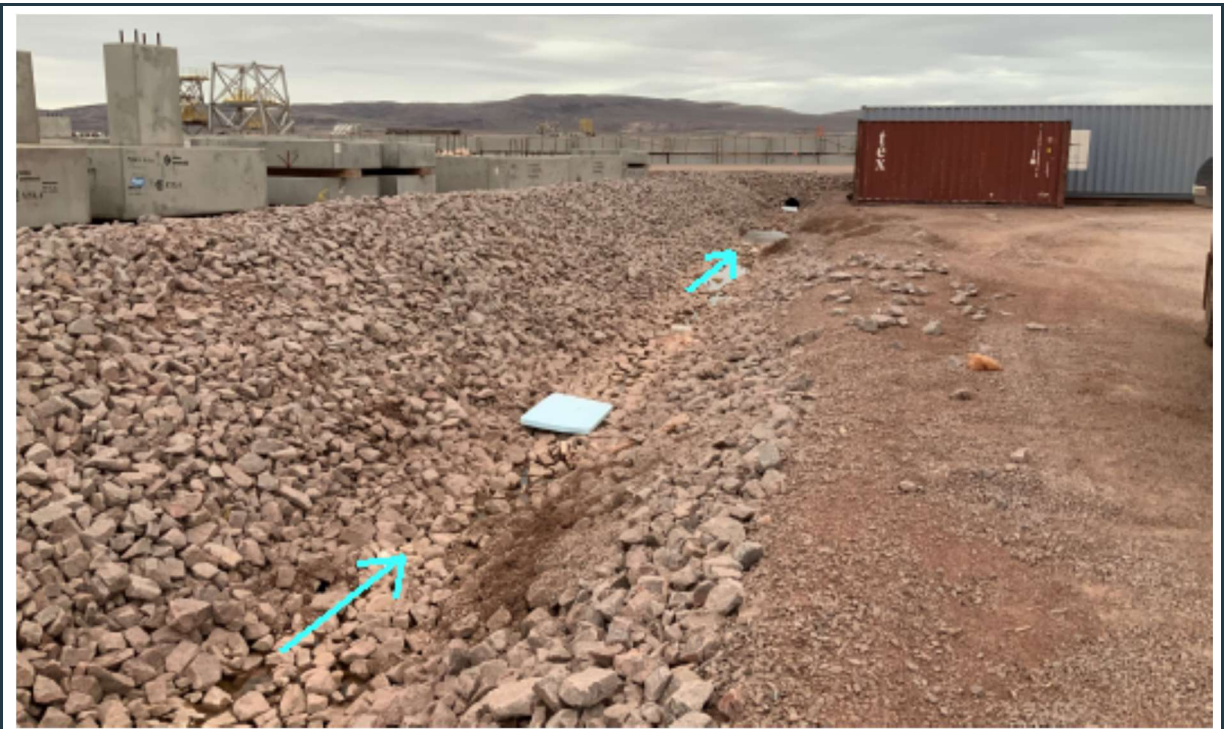
Figure 74: View of the south section of the 380-Person Camp surface water collection ditch.

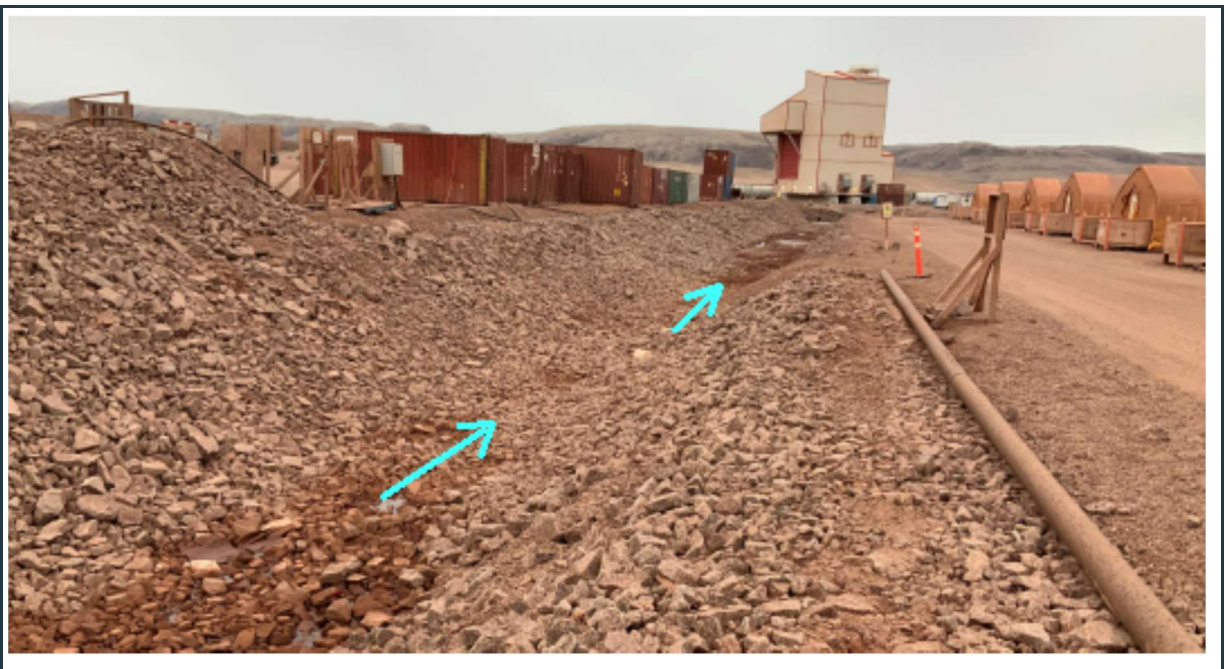
Figure 75: View of the east section of the 380-Person Camp surface water collection ditch in good condition.

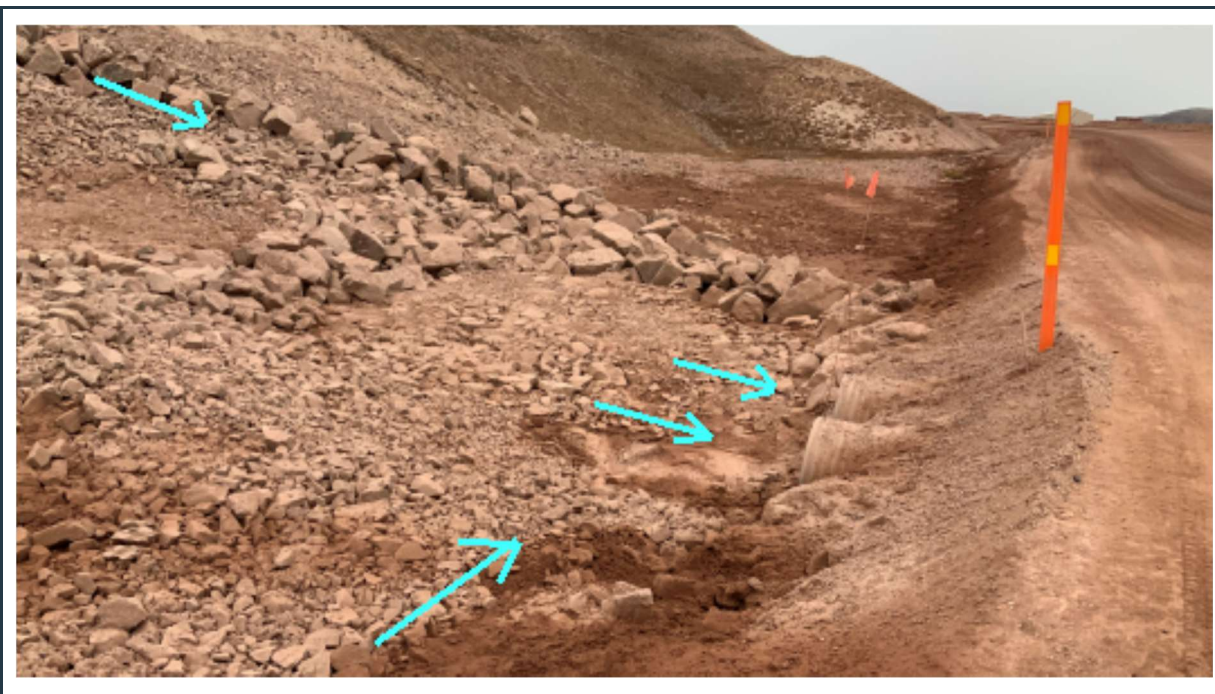
Surface water from the P-SWD-6 drainage ditch is conveyed down toward the Tote Road through corrugated galvanized steel culverts, installed under an access road to the quarry and then under the Tote Road (Figures 77 and 78). The collected water is conveyed through the Tote Road culverts to small natural ponds, located along the west side of the Tote Road. Only minor siltation is visible at the inlet of the culverts (Figure 77), but both culverts appear to be clean, and the seasonal flow through them is uninterrupted.

Figure 77: View of twin culverts, draining surface water from the quarry area under the tote road (inlet).
