RE: Submission of 2022 Geotechnical Inspection Report No. 2 (September 2022)

Mary River Project – Nunavut

WSP Environment & Infrastructure Canada Ltd., (formerly Wood E&I Canada Ltd.), has completed the second geotechnical field inspection of 2022 at the Mary River Project, which is a condition of the Type "A" Water Licence No: 2AM-MRY1325 – Amendment No.1 ("Water Licence").

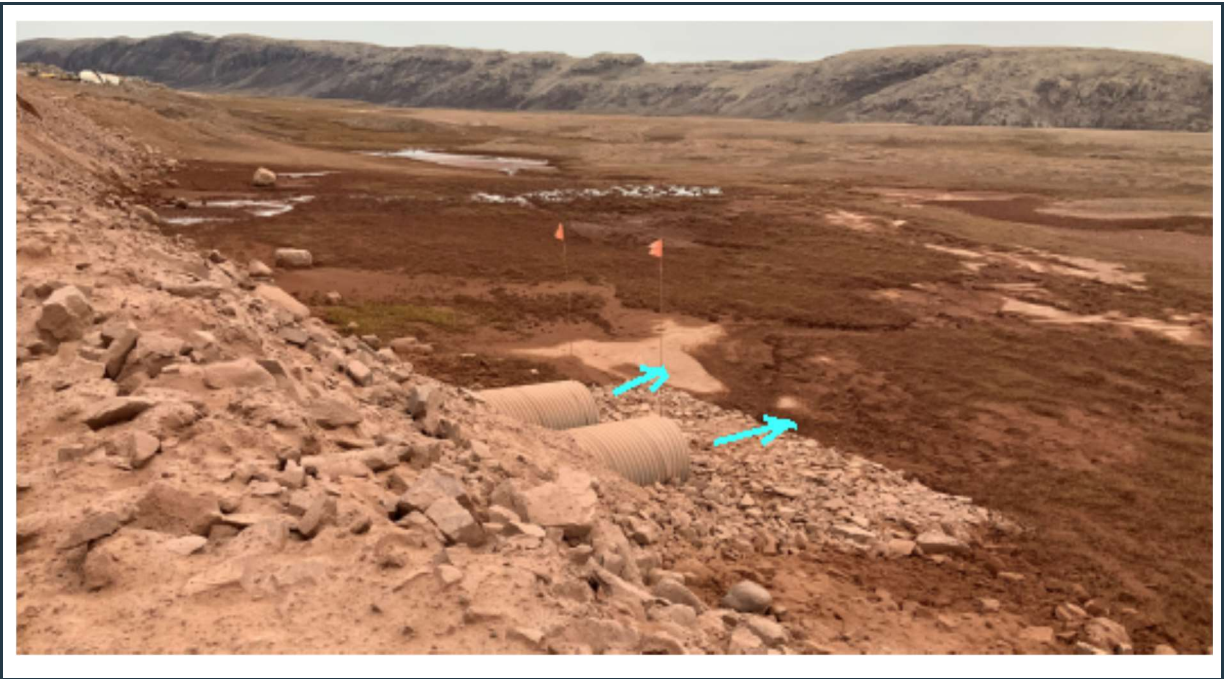
Surface water from the P-SWD-6 drainage ditch is conveyed down toward the Tote Road through corrugated galvanized steel culverts, installed under an access road to the quarry and then under the Tote Road (Figures 77 and 78). The collected water is conveyed through the Tote Road culverts to small natural ponds, located along the west side of the Tote Road. Only minor siltation is visible at the inlet of the culverts (Figure 77), but both culverts appear to be clean, and the seasonal flow through them is uninterrupted.

Figure 78: View of twin culverts, draining surface water from the quarry area (outlet).

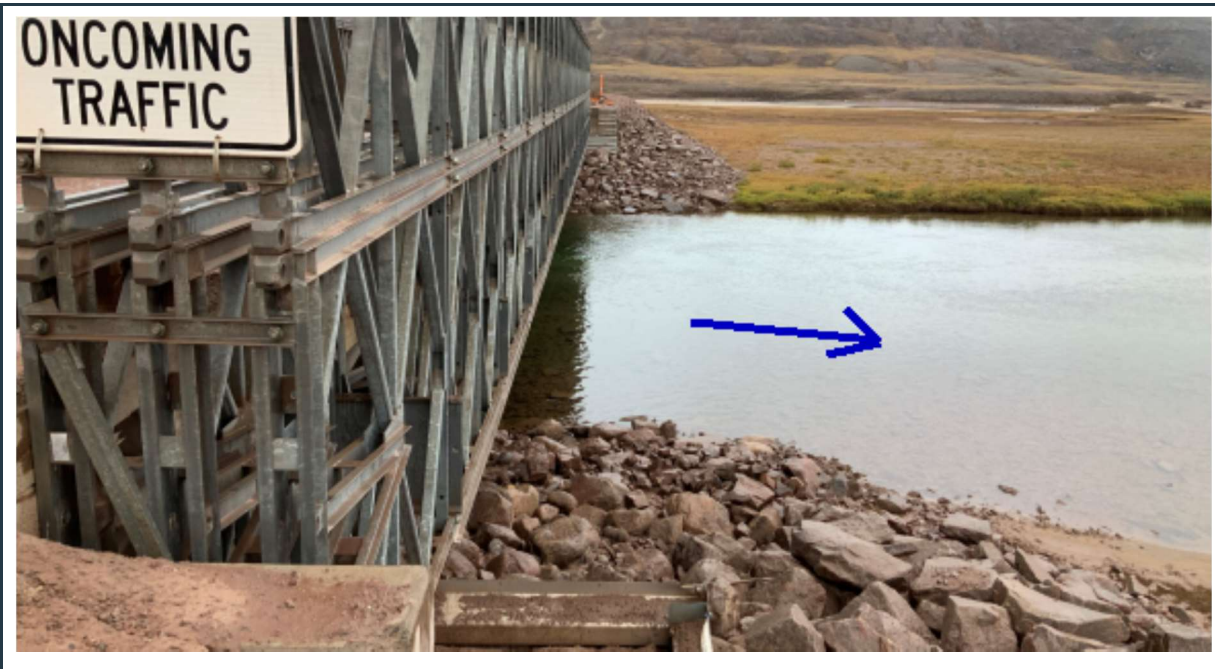
As shown in Figure 81 and Figure 82, the abutments of this bridge appear to be stable, and no scour was noted in the riverbed around the abutments during the recent site visit. The abutments show no visible differential settlement or any structural discrepancy like deterioration of the steel bolt-a-bin abutments or sloughing of the riprap rock fill. There are two (2) historic abutments located immediately adjacent to the “new” ones, one (1) of which is visible in Figure 82. As reported earlier and noted during the most recent visit, the metal bin structures of both “old” abutments have suffered damages in the past, most likely during the construction of the new abutments. As shown in Figure 82, some elements of the steel bolt-a-bin structure (not sheet piles) became damaged. The damaged elements should be removed, together with part of the sandy backfill from behind them (from the face of the abutment). The sand should then be replaced with clean crushed rock fill to prevent erosion of the finer soil from the old abutments (although the actual erosion from the abutments is insignificant). As recommended before, the two (2) old abutments should be kept in place since they provide additional support (even with the damaged steel box) to the adjacent “new” abutments and approach embankments.

Figure 81: View of the north side of "bridge 17", with stable riprap scour protection at the abutments.

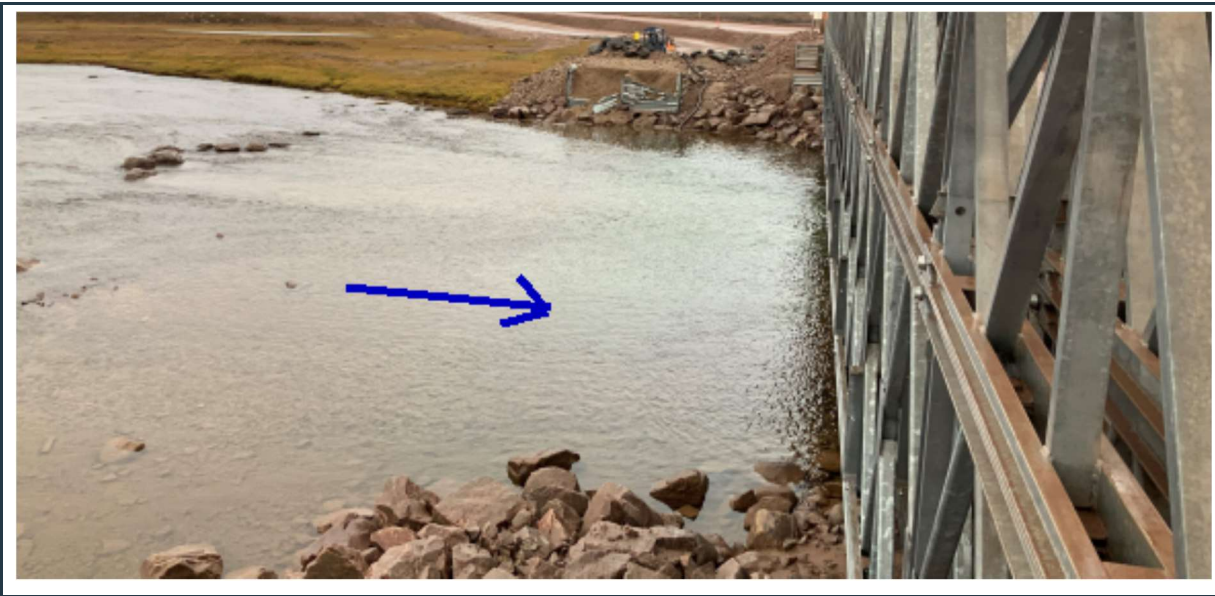
Figure 82: View of the stable abutments with riprap erosion protection at the south side of "bridge 17".

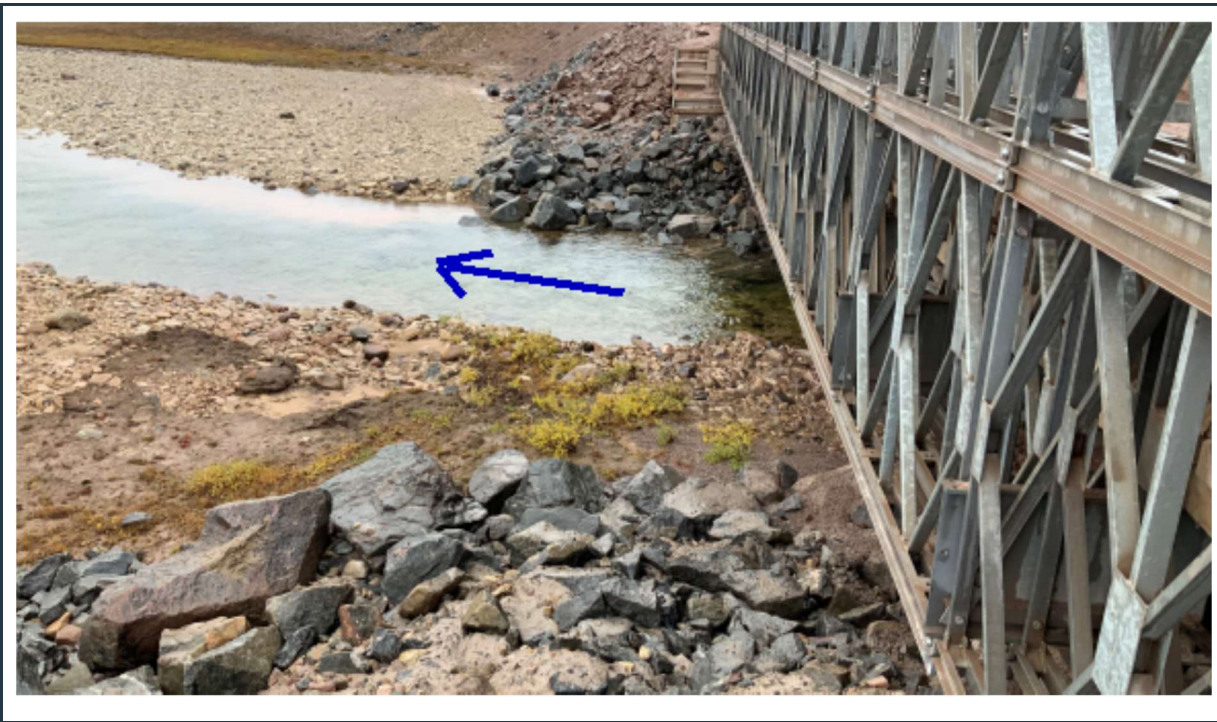
As shown in Figure 83 and Figure 84, the abutments of this bridge are stable and no scour around the abutments was noted during the site visit. The abutments show no visible differential settlement or any structural discrepancy like damages to the bolt-a-bin foundation cribs. Similar to bridge 17, there are the “remnants” of two (2) historic abutments (visible in Figure 84), located immediately adjacent to the “new” ones and damage to the metal bins of both old abutments are visible. In order to maintain the stability of the currently used bridge abutments and approach embankments, the two (2) old abutments should be kept in place since they provide support to the adjacent new structures.

Figure 83: View of the west side of bridge 63, with stable abutments.

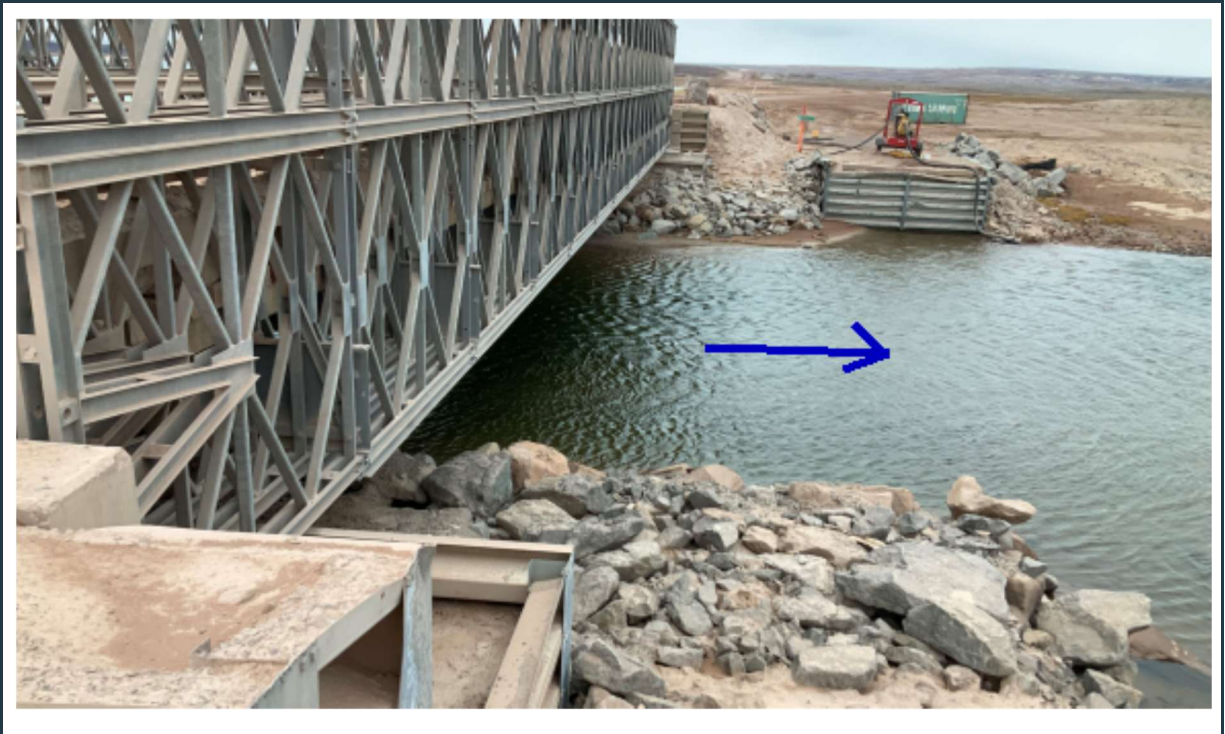
As shown in Figure 85 and Figure 86, the abutments of this bridge are stable and no scour in the riverbed and around the abutments was noted. The abutments show no differential settlement or any structural discrepancy like deterioration of the metal bolt-a-bin structures supporting the bridge. This is the bridge where the “old” bolt-a-bin abutments are still in relatively good condition, as shown in Figure 85.

Figure 85: View of the west side of bridge 80, with stable abutments and riprap scour protection.

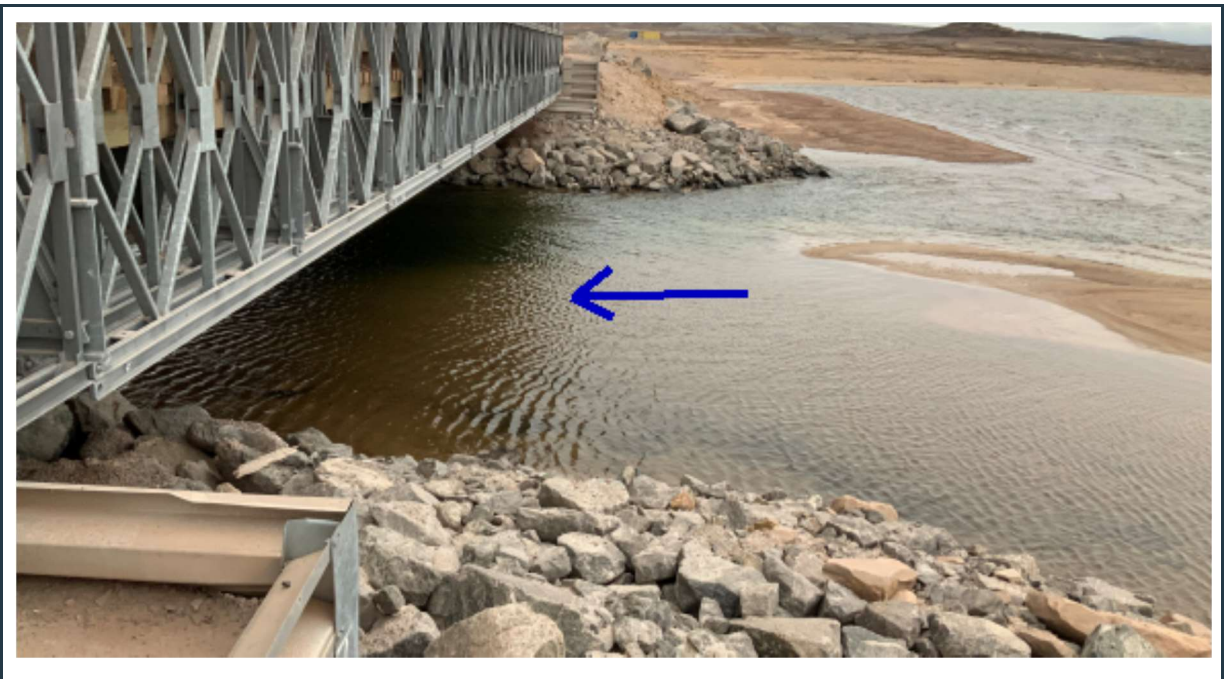
Figure 86: View of stable abutments with riprap scour protection at the east side of bridge 80.

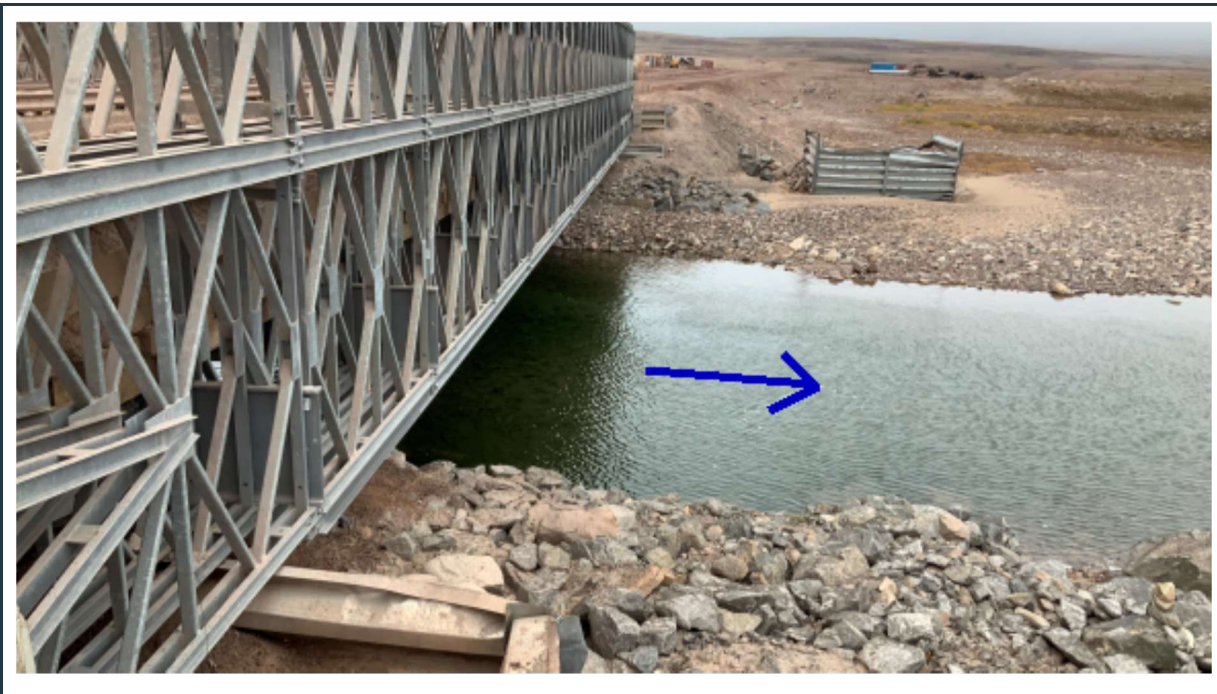
As shown in Figure 87 and Figure 88, the abutments of this bridge appear to be stable and no scour in the riverbed and around the approach embankments was noted during the site visit. The abutments show no differential settlement or any structural discrepancy like deterioration of the foundation bins.

Figure 87: View of the stable abutments with riprap scour protection at the west side of bridge 97.

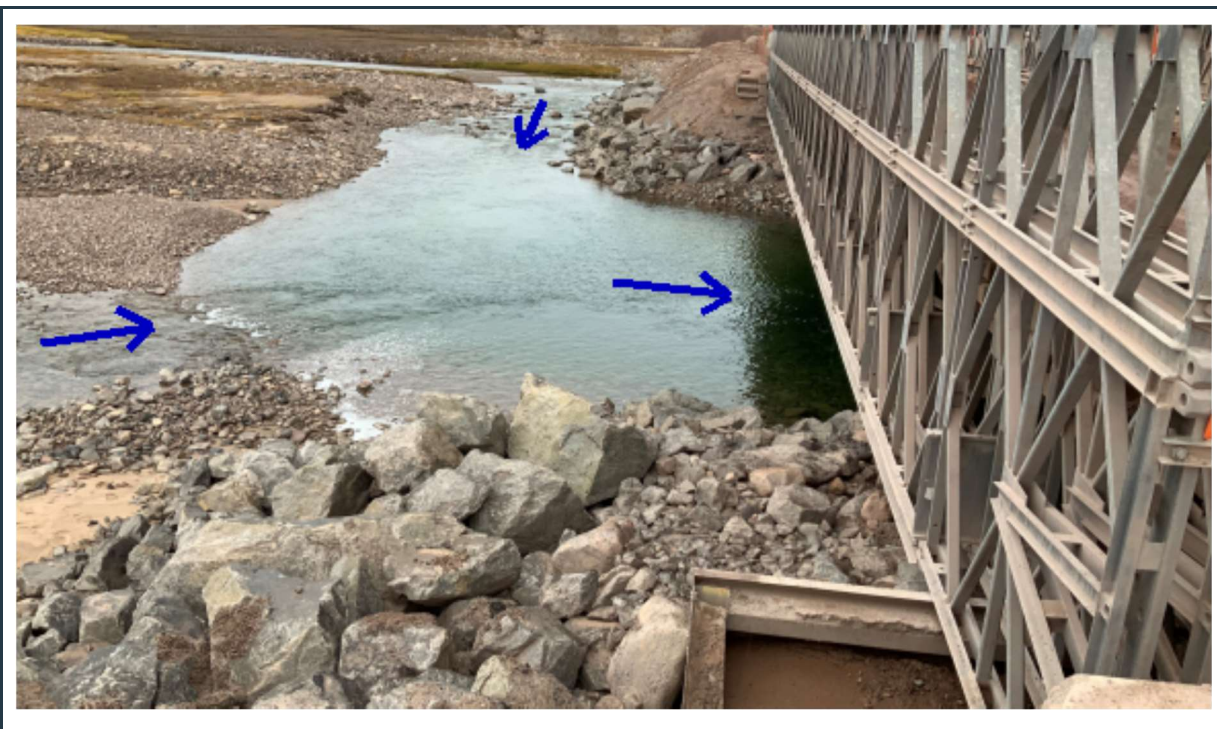
Figure 88: View of the two stable abutments with riprap scour protection at the east side of bridge 97.

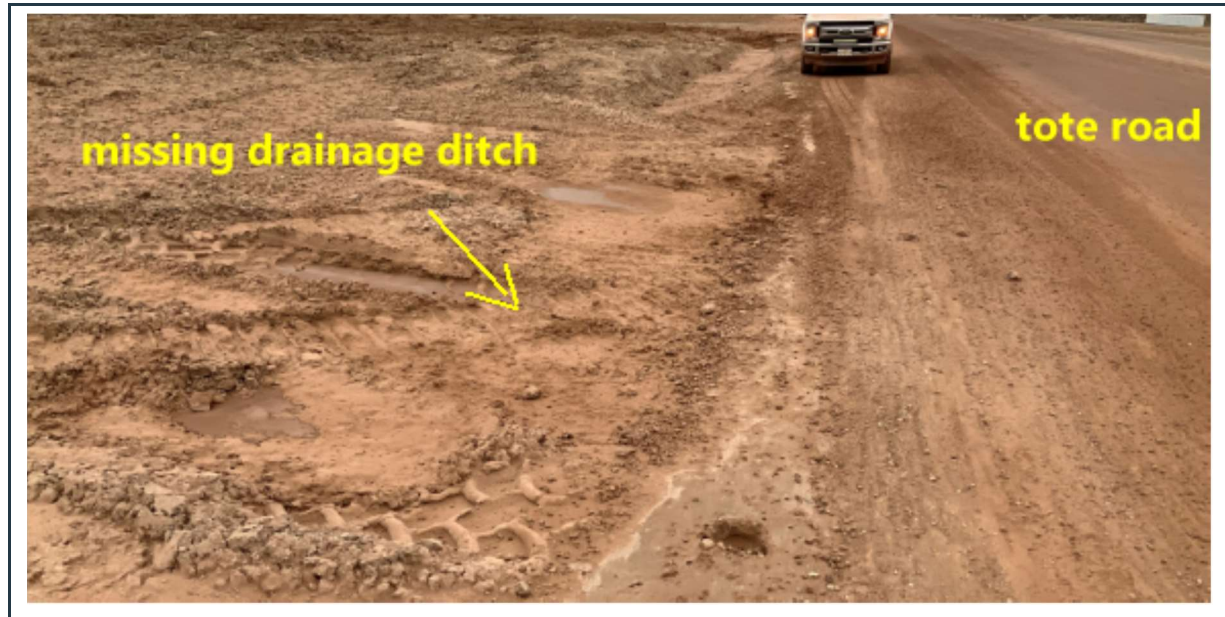
a) KM 06+900

Two locations (**KM 06+900** and **KM 07+700**) were inspected, and the actual conditions presented in Figure 89 and Figure 90. As shown in the images, these conditions presented poor grade and drainage control along the edge of the road. Once the soils from the borrow areas were extracted, the base of the borrow area was leveled/graded, just slightly above the crest elevation of the adjacent road. Unfortunately, no side ditches were excavated between the edge of the borrow area and the edge of the road in these areas. The poor grade control and lack of drainage ditch can result unwanted surface water flow onto the road from both sides, wherever the surface of the road is located at somewhat lower elevation, as shown in the two images. The surface water can be rainwater but more often melted snow, from the snow that is pushed to the sides of the road during winters and thaws during the early weeks of the summers. Flowing run-off water on the surface of the road may result in erosion of road-fills and present traffic safety issues, particularly when the snow is melting during sunny periods but freezes back again when the temperature is dropping back below zero. It is recommended that critical road sections with such poor grade and drainage controls be mapped, and the drainage conditions be improved by providing adequate side-ditches along the road, wherever the elevation of the road surface is located somewhat lower than the adjacent ground surface. The excavation of drainage ditches can be completed by the road maintenance team, as soon as practically possible. The drainage ditches should be constructed as specified in the Project's Civil Design Criteria and Drawings.

Figure 89: View of a section of the tote road around KM 06+900. No drainage ditch is provided although the ground level adjacent to the road is higher than the road level.

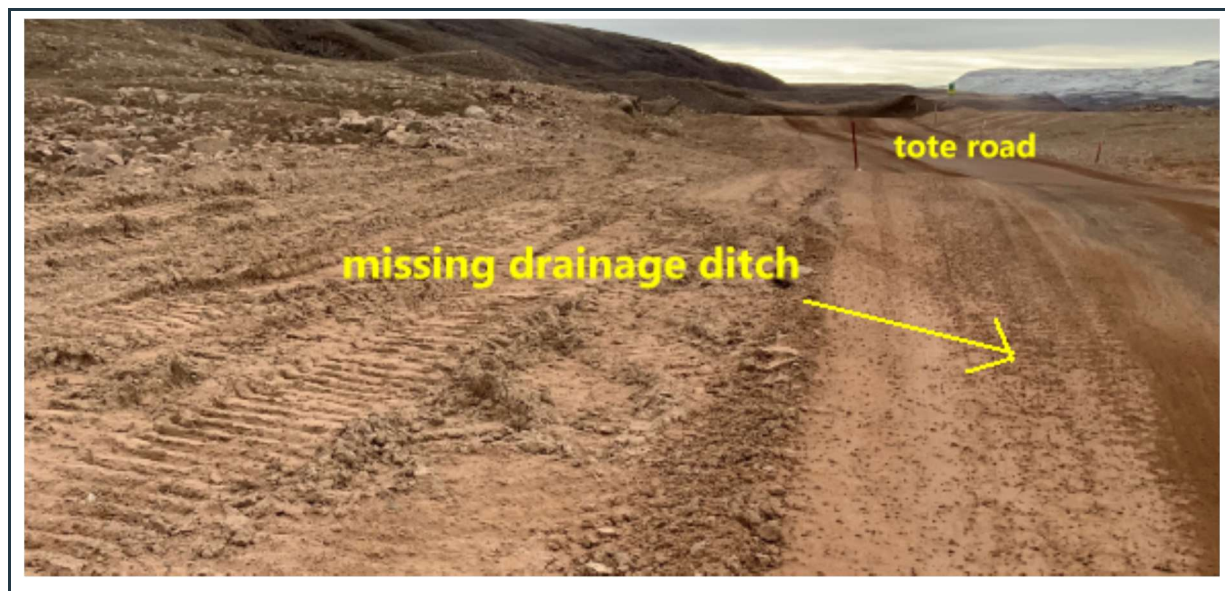
b) KM 07+700

Figure 90: View of a section of the tote road around KM 07+700. No drainage ditch is provided although the ground adjacent to the road is higher than the road level and sloping toward the road.

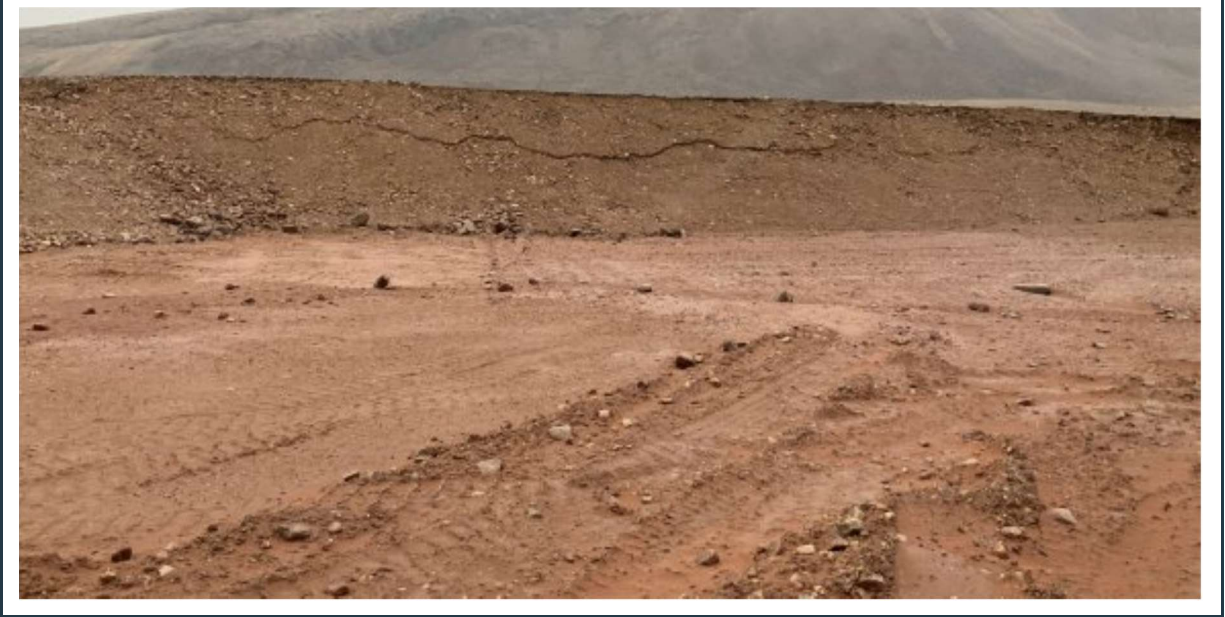
c) KM 09+700

Two former borrow areas at locations (**KM 09+700** and **KM 28+900 to KM 29+000**) were also inspected, where potential slope instability issues were identified in the past. Slope conditions at these two locations are presented in figures 91 to 94. At the KM 09+700 location, the subject slope (with an approximate inclination of 1.5H:1V) is located well away from the edge of the road, as shown in Figure 91. As shown in Figure 92, slumping/spalling/raveling of the slope's materials (generally comprising soil particles with sizes of silt to boulders) are trickling/rolling down on sections of the face of the slope without endangering the traffic on the Tote Road, located well away from the slope. Wherever slopes in cut areas of road construction are located immediately adjacent to the edge of the road, soil slopes are generally cut back to inclinations between 1.5H:1V to 3H:1V, depending on the internal shearing resistance of the soils forming the slopes. Slopes, located away from roads, particularly in rural, remote areas are generally left with inclinations close to their angle of repose. At that angle, the materials on the slope's face are on the verge of sliding. As a result of freezing, thawing, snow and rain, such slopes experience some degradation

Figure 91: View of the face of the slope at KM 09+700. Note the large distance of the exposed slope from the tote road (the picture was taken by standing near the edge of the road).

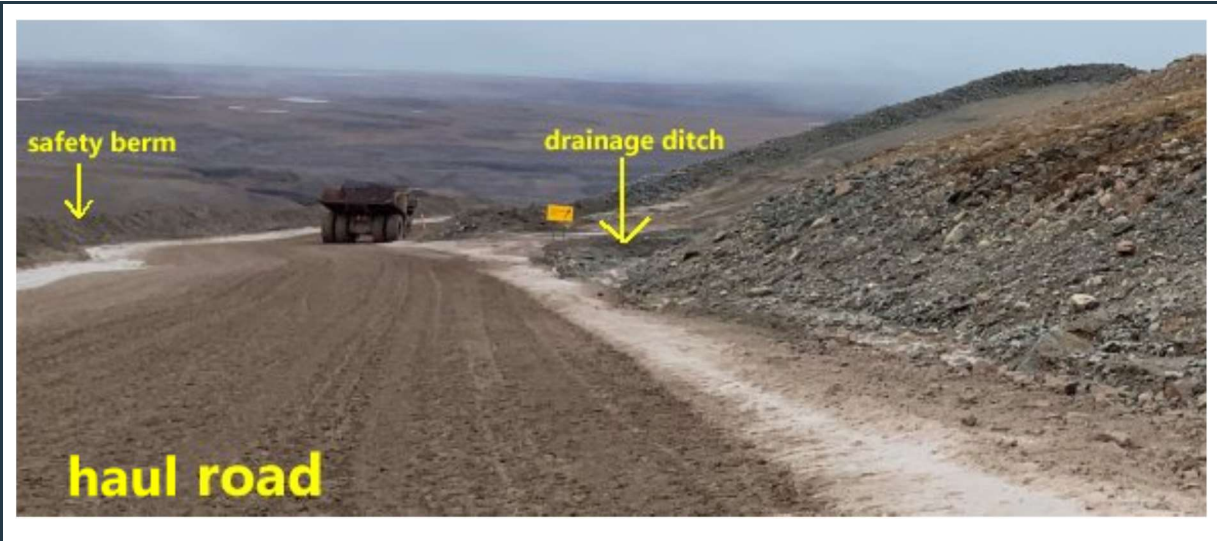
The drainage condition along a section of the haul road between the crusher pad and the open pit was also reviewed during the September inspection. As it was pointed out in the 2019 Tetra Tech report, several large erosion channels were visible downslope from the open pit along the upslope side of the haul road. Such large erosion channels are quite common in other areas as well, with steep natural slopes. The report has suggested that blankets of riprap should be installed on slopes along critical road sections and below culvert outlets. Such riprap would encourage sheet flow rather than concentrated flow occurring during snow melt and rain. As shown in Figure 95 and Figure 96, excavation of drainage ditch along the upslope side of the haul road is in progress and riprap blanket is also being placed on the upslope side of the ditch to encourage sheet flow of surface water and minimize erosion of the finer soil particles. Placement of riprap into the drainage ditch and to the discharge ends of culverts is also in progress and the collected water is directed into the new surface water management pond at KM-105.

Figure 95: View of the haul road between the crusher pad and the open pit around KM-107. Note the standard road components in the image, the safety berm along the fill (left) side of the road and the drainage ditch along the cut side (right) of the road.

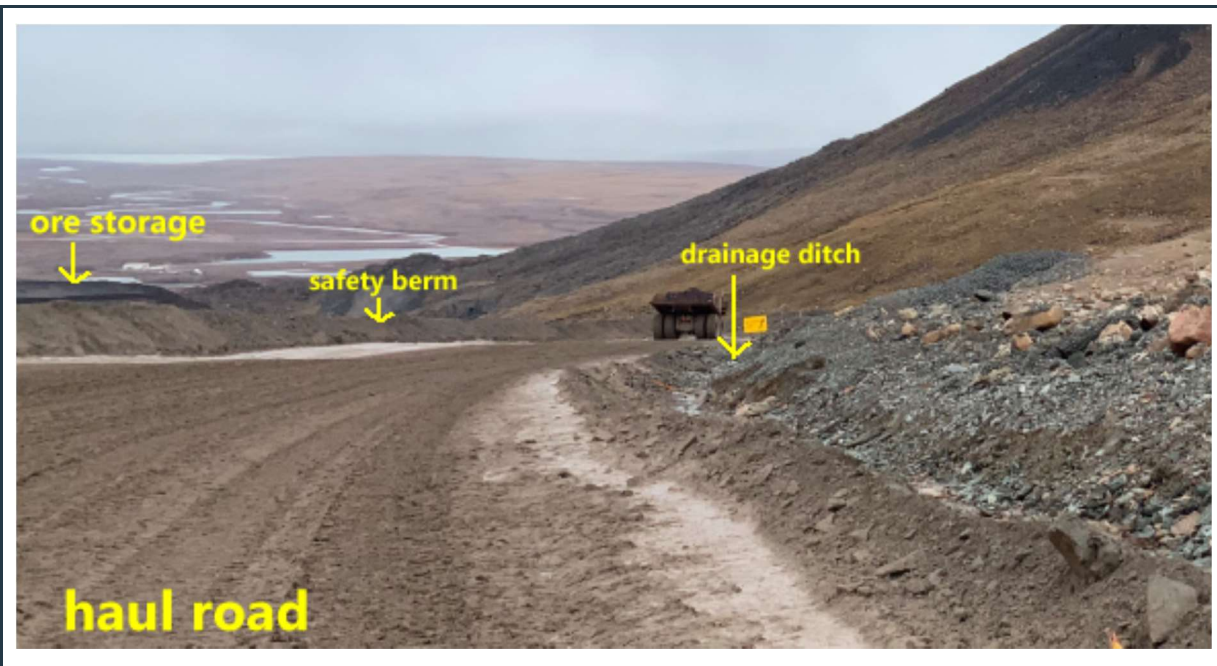
Figure 96: View of the haul road between the crusher pad and the open pit, near the ore storage at KM 106. Note the standard road components in the image, the safety berm along the fill side and the drainage ditch along the cut side of the road.
