2020 Site Update Report

Meadowbank Gold Mine Project (NIRB File No. 03MN107) & *Whale Tail Pit Project* (NIRB File No. 16MN056)

Agnico Eagle Mines Limited

October 2020

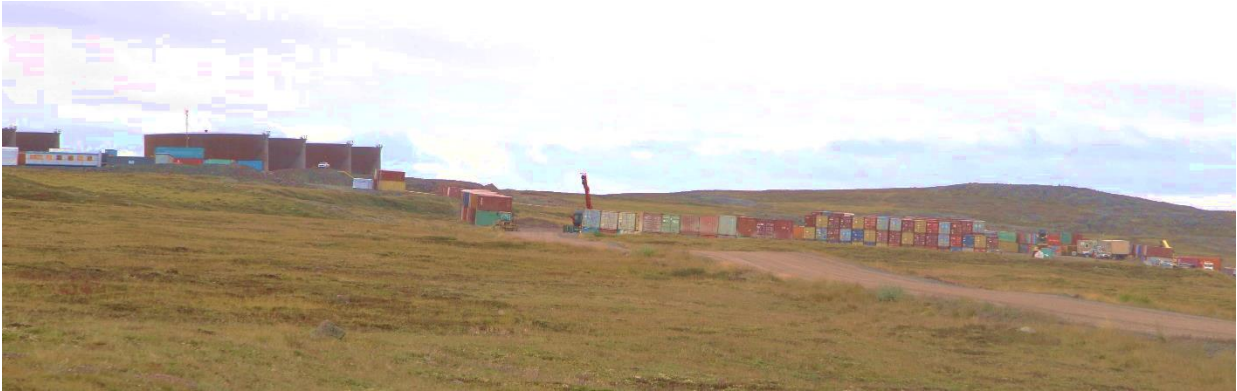
Photo 2: Baker Lake Marshalling Facility

- a) NIRB staff noticed that the Baker Lake marshalling facility was busy with trucks driving seacans to and from the Mine Site ([Photo 2](#), Photo 3).
- b) There are currently four (4) emergency seacans located at the Baker Lake Tank farm including a new seacan installed in 2020 to meet the updated Oil Pollution Emergency Plan, Version 11 (Photo 4).

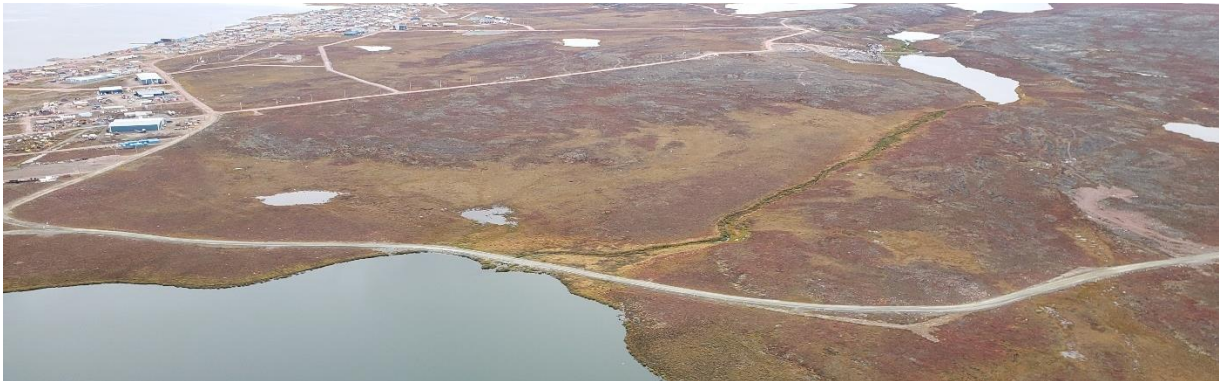
Photo 7: All Weather Access Road

- a) There is a manned gatehouse at kilometre (km) 5 (Photo 8).
- b) The AWAR (Photo 7) has snowmobile crossings at kilometre (km) 10 and 98 with signage (Photo 9). There are no designated wildlife crossings.

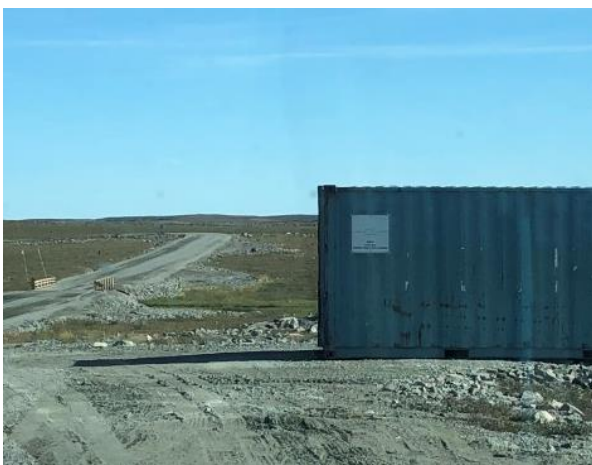
Photo 10: Emergency Seacan at Bridge

- a) Seacans with emergency spill response equipment are located at every bridge crossing (Photo 10).
- b) The spawning habitat rock structure located at the first bridge (Photo 11) was monitored in 2019 (see *2019 Annual Report*) with the next monitoring campaign planned for 2021.

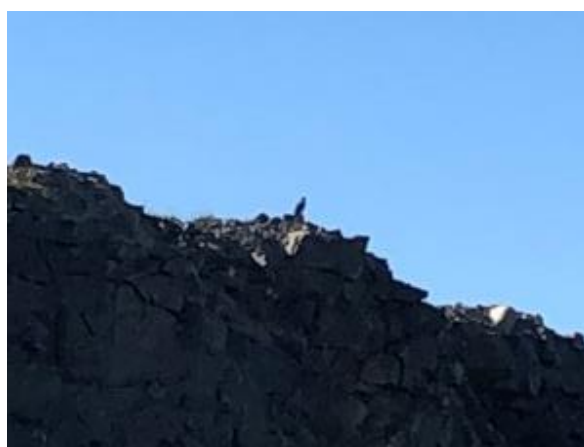
Photo 13: Bird Deterrent at Quarry 22

- e) Remediation has been ongoing at Quarry 22 following storage of contaminated hydrocarbon soil in previous years with the soil/gravel still testing positive for hydrocarbons (Photo 12). In 2020 Agnico Eagle tried to prevent nesting with a bird decoy (Photo 13) and bird cannon; however, the birds were not deterred and nested in 2020 and the equipment was removed.

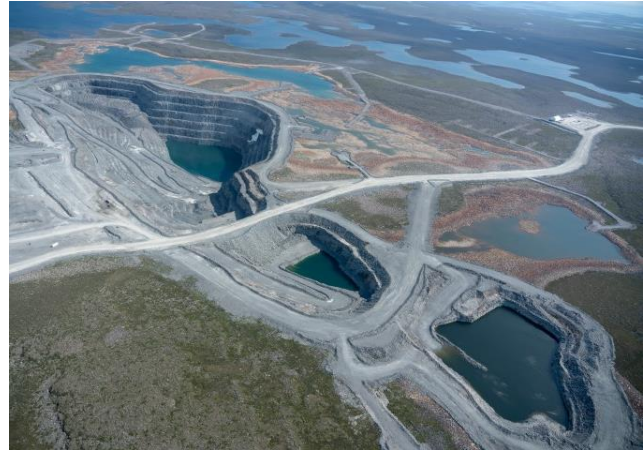
Photo 15: Vault, Phaser and BB Phaser Pits

- a) Active mining was completed at all pits by the end of fourth quarter in 2019. Some residual stockpiles are still being processed at the mill.
- b) Mining completed in Vault Pit in March 2019. As observed in previous years, an ice sheet had formed on the walls of the Vault Pit and remains present in 2020 (Photo 14 and Photo 15).

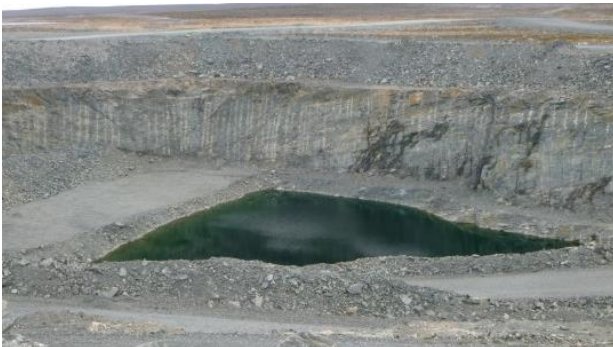
Photo 16: Phaser Pit

- c) Phaser Pit and BB Phaser Pit in October 2018 and June 2019, respectively, and are now naturally reflooding (Photo 16, Photo 17, and Photo 17).

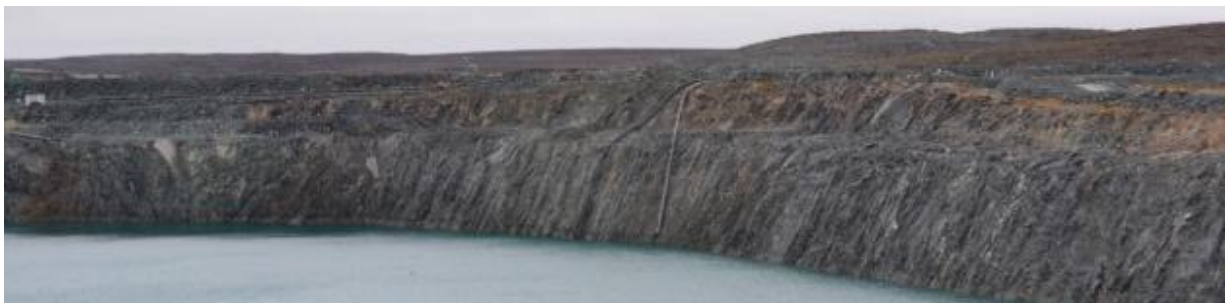
- d) Mining at Goose Pit was completed in April 2015. Tailings continue to be deposited into the mined-out pit (Photo 18).

Photo 18: Goose Pit (black pipe used for in-pit tailings)

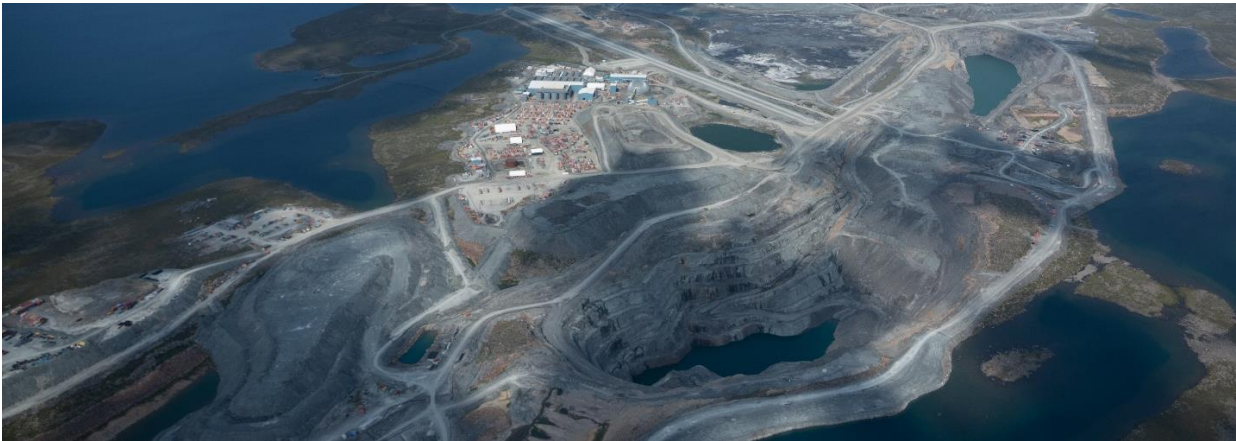
Photo 19: Portage Pit

- e) Mining at Portage Pit A was completed in March 2018, and Portage Pit E in October 2019 (Photo 19). Tailings Deposition started in Portage Pit E in 2020 (Photo 20).

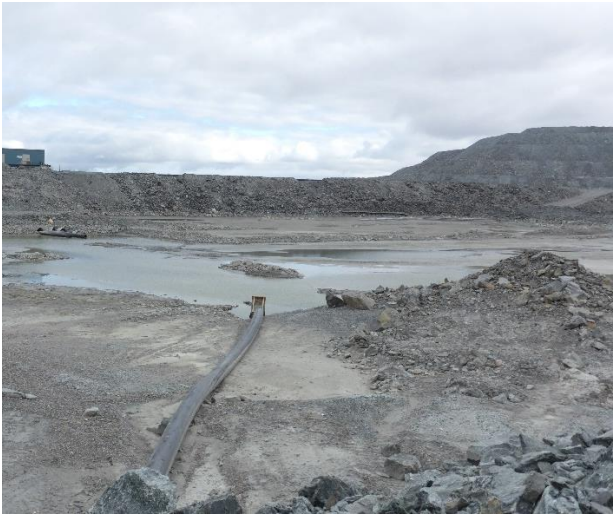
Photo 22: Landfarm 1

- g) The original landfarm, developed in 2013 and located next to the South Cell Tailings Facility, was flooded with tailings in 2017 (Photo 22). The second landfarm located to the east of landfarm 1, remains in use (Photo 23).

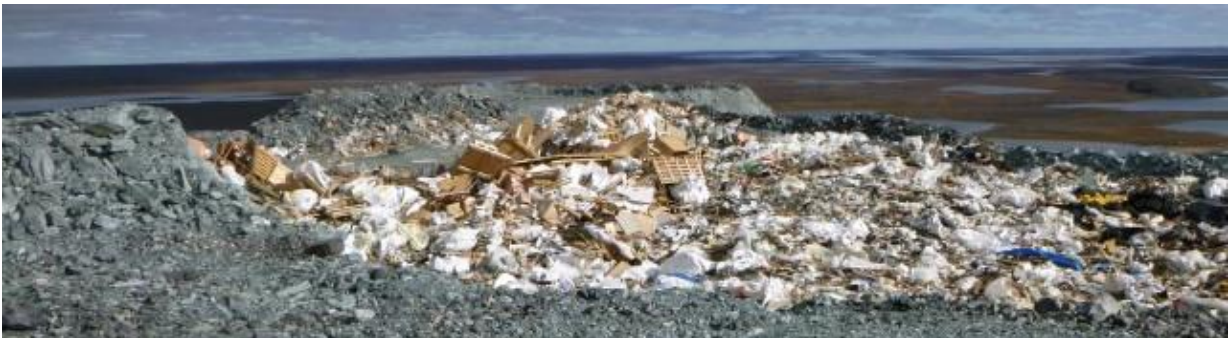
Photo 24: Landfill

- h) The Meadowbank landfill continues to be in operation (Photo 25 and Photo 25) and is extending into a new area at the base of the Waste Rock Storage Facility. Previously used landfills are progressively capped (Photo 25).

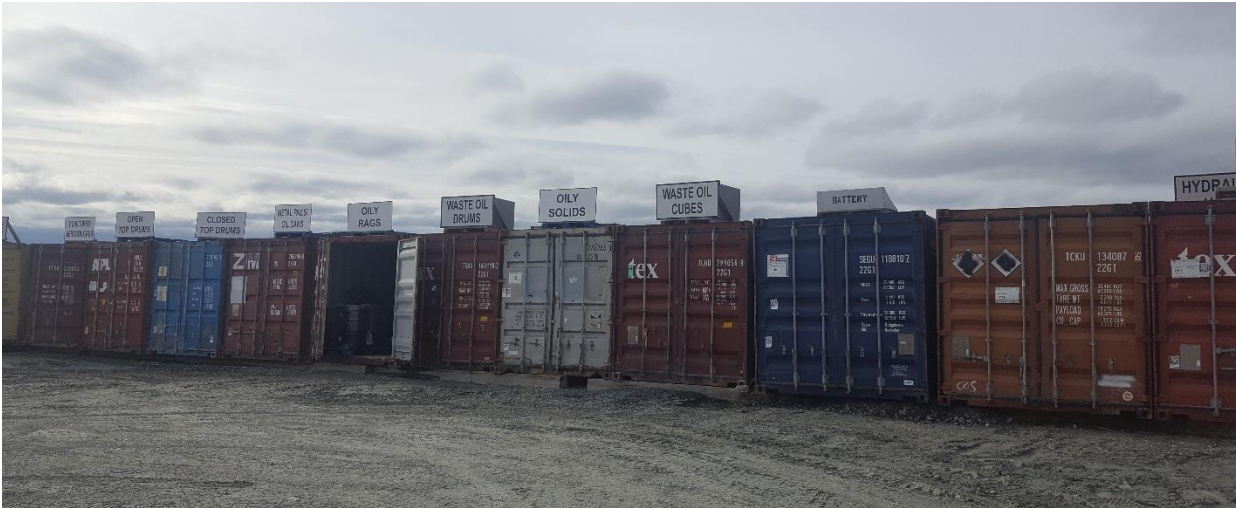
- i) Agnico Eagle confirmed that it continues to segregate and store all domestic, hazardous, and combustible wastes in marked seacans prior to these materials being incinerated or shipped to the appropriate and approved off-site disposal facilities (Photo 26).

Photo 26: Seacans used for waste segregation and storage area at Meadowbank Mine Site

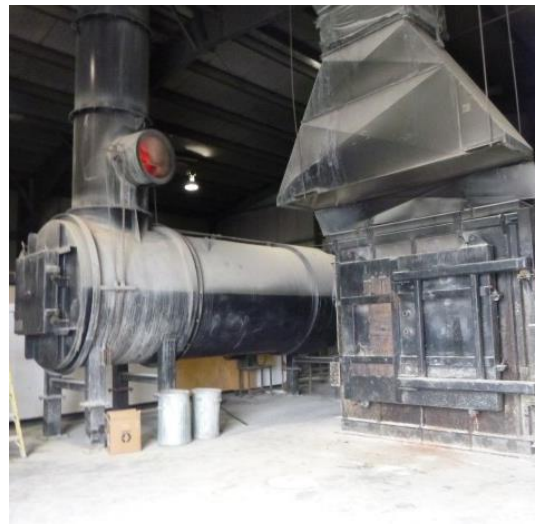
Photo 28: Incinerator

- j) Agnico Eagle stated that the landfill is frequently inspected by employees to ward off any wildlife that may be present, to ensure wastes are segregated appropriately, and that wastes designated to the incinerator or metal dump do not end up in the landfill.
- k) In 2019 Agnico Eagle started a composting program located at the incinerator building with the compost materials being disposed of at the landfill (Photo 27). The composter was installed to reduce the quantity of waste burned by the incinerator.
- l) Agnico Eagle observed that wastes are segregated in front of the incinerator (Photo 28) and only organic matter is incinerated.

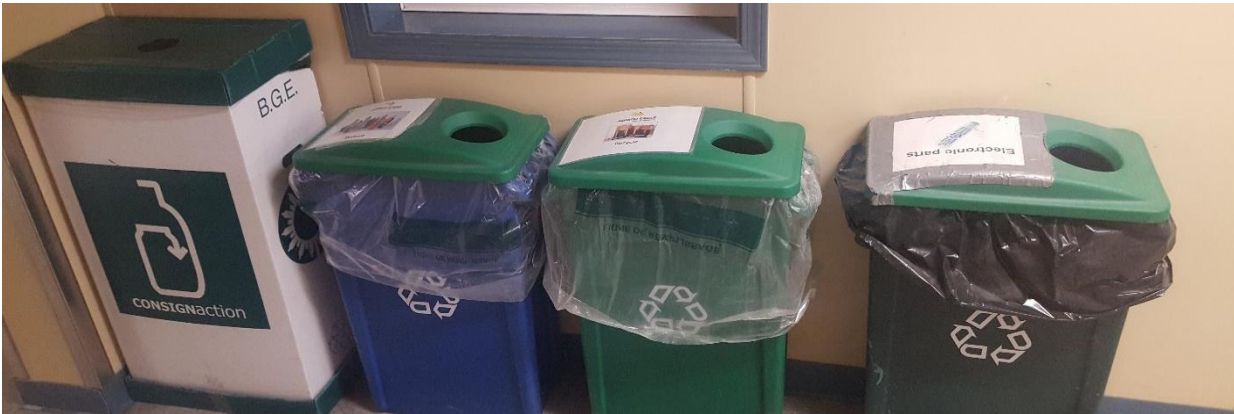
Photo 29: Internal Waste Segregation

m) Agnico Eagle noted waste segregation is common practice at the mine site (Photo 29).

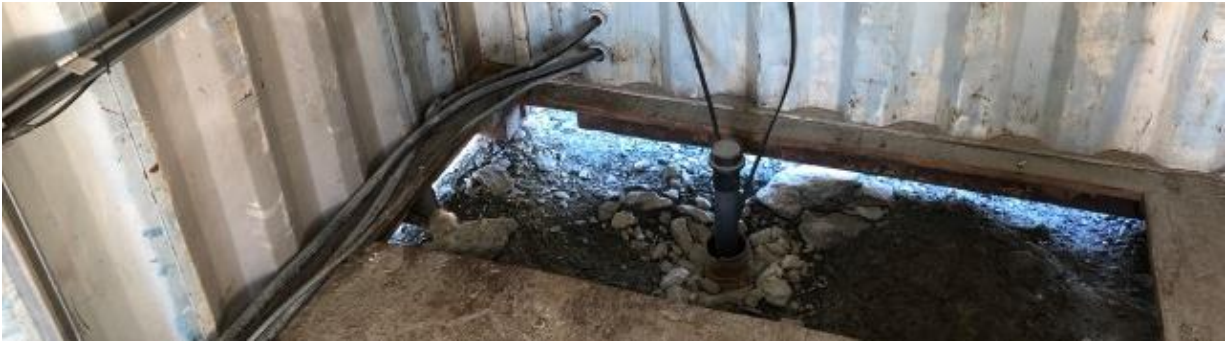
Photo 30: Groundwater Monitoring Well MW-IPD-07

Agnico Eagle confirmed that five (5) groundwater monitoring wells continue to be operational at site: MW-16-01, MW-IPD-01 (s), MW-IPD-01 (d), MW-IPD-07 (Photo 30) MW-IPD-07 2020-08-24), and MW-IPD-09. The 2020 groundwater sampling campaign was planned for September.

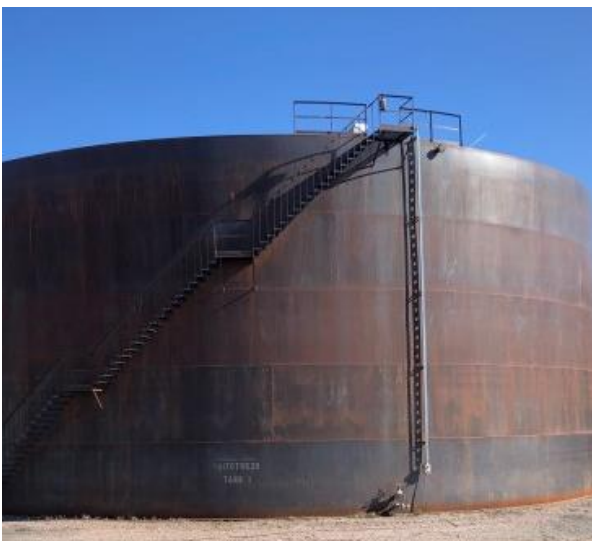
Photo 33: Bird deterrent at Baker Lake Marshalling Facility

Agnico Eagle noted that bird deterrents, including effigies and/or bird cannons, were used at the Baker Lake Marshalling Facility (Photo 33), Meadowbank fuel tank farm (Photo 34), Tailings Storage Facility, and Quarry 22. Only manual wildlife deterrents are used at the landfill.

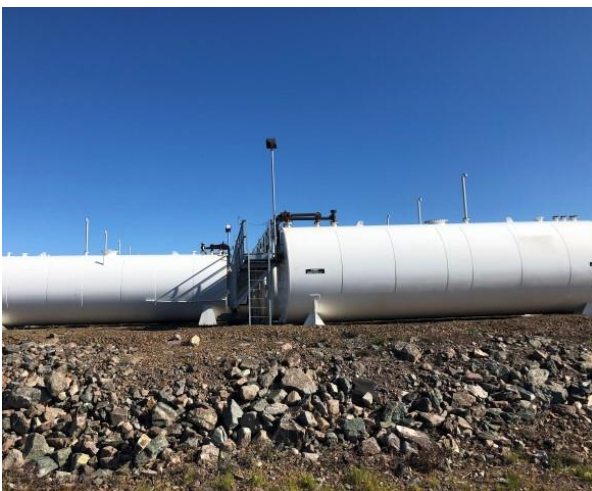
Photo 35: Jet-A Storage

At the Baker Lake Marshalling Facility there is a total of 18 Jet-A tanks still in use (Photo 35). A new fuel tank (Fuel Tank 7; Photo 36) was constructed in 2019 at this facility.

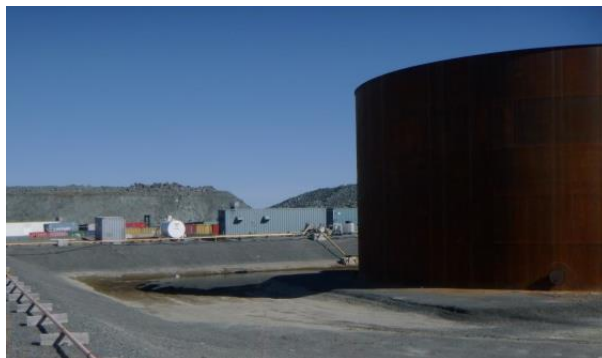
Photo 38: Water in Secondary Containment

During their 2019 site visit NIRB staff noted that the liner at the Baker Lake Fuel Storage facility was exposed and Agnico Eagle informed the NIRB that it continues to be exposed in 2020 (Photo 37). Agnico Eagle noted no liner is seen exposed at the Meadowbank Tank Farm. As with 2019, water pooled within the secondary containment facility at the Meadowbank fuel tank farm in 2020 (Photo 38). This water is discharged towards the Stormwater Management Pond which is then directed to the Tailings Storage Facility.

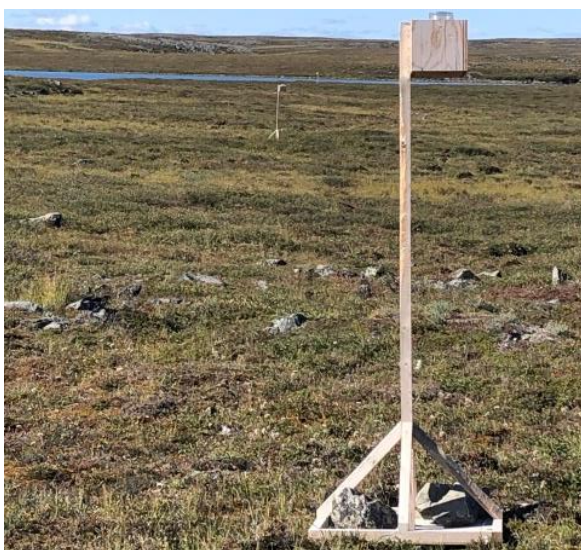
Photo 39: Dust Fall Transect

Agnico Eagle staff indicated that it continues to apply calcium chloride dust suppressant along three (3) critical areas and two (2) additional areas for two (2) km sections of the AWAR. Along each of the five (5) sites, Agnico Eagle also continues to conduct dust sampling to assess dustfall rates in the dust suppression locations, as well as two (2) reference sites without dust suppression (km 18 and 78). In 2019 dustfall monitoring stations were moved from the ground to poles with one transect continuing to have on the ground collectors for comparison (Photo 39 and Photo 40).

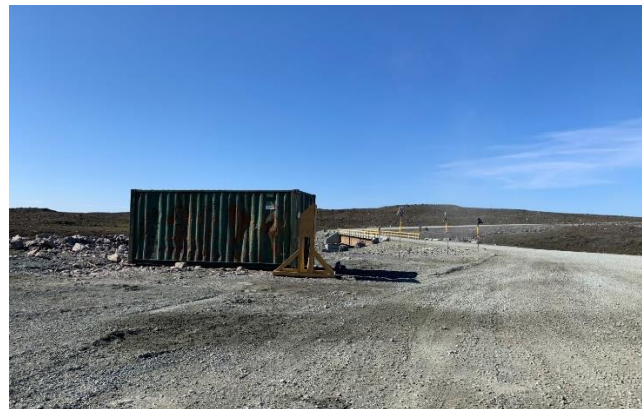
Photo 42: Emergency Seacan at Bridge

- a) Resloping was done along the Whale Tail Haul Road (WTHR).
- b) No widening of the WTHR has occurred in 2020 thus far.
- c) The one (1) snowmobile crossing is located along the Haul-road near km 127 with signage which also acts as a wildlife crossing (Photo 43).
- d) During their 2019 site visit the NIRB staff observed that environmental emergency seacans with spill kits were not available at the bridges along the WTHR. Agnico Eagle confirmed that there are now emergency seacans located at kilometre (km) 125.5 and 146 and three (3) more will be placed by the end of 2020 (Photo 42).
- e) No new road eskers or quarries were created in 2020.

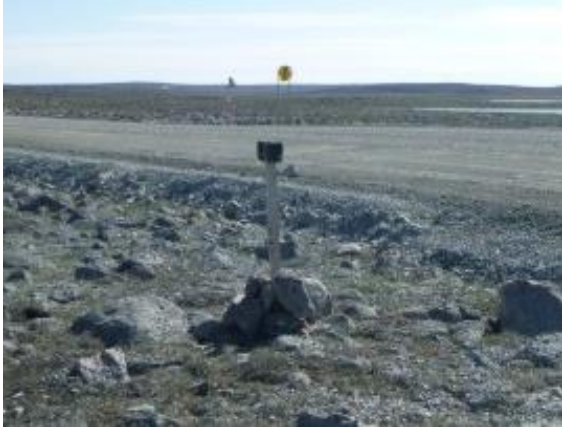
Photo 44: Wildlife Camera Along WTHR

- f) A remote wildlife camera was installed at km 158 monitoring caribou migration across the WTHR (Photo 44).
- g) There is two (2) noise monitoring stations along the WTHR that were monitored in 2020: R6 and R7 (Photo 45).

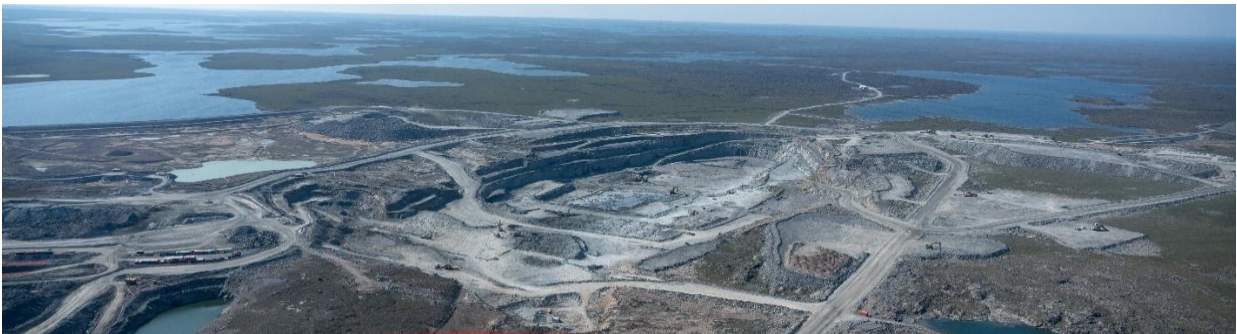
Photo 46: Whale Tail Pit Footprint

- a) Whale Tail Pit is still within the original footprint. Expansion into the increased footprint described in the Whale Tail Pit Expansion amendment has not yet occurred (Photo 46 and Photo 47).

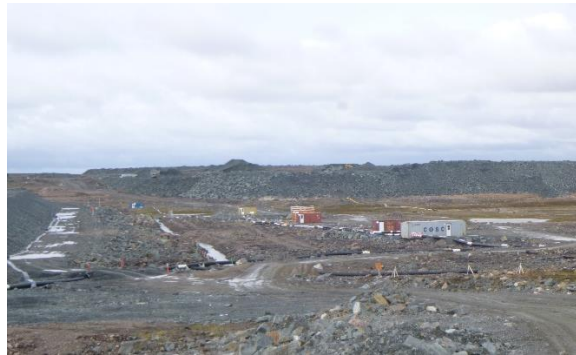
Photo 51: Construction of Whale Tail Dike Seepage Collection System

- b) Whale Tail Dewatering was completed for the Whale Tail North Basin, and northeast pond Sector.
- c) The Whale Tail South Channel with inlet in the Whale Tail Lake South Basin is performing as designed in 2020 ([Photo 51](#) and Photo 49).
- d) Agnico Eagle noted that seepage is observed at the toe of Whale Tail Dike. At present, seepage water is treated as part of the Whale Tail Attenuation Pond. Grouting was completed on Whale Tail Dike to reduce the flow of seepage and a collection system is currently under construction to discharge water back to Whale Tail South ([Photo 53](#) and Photo 51).

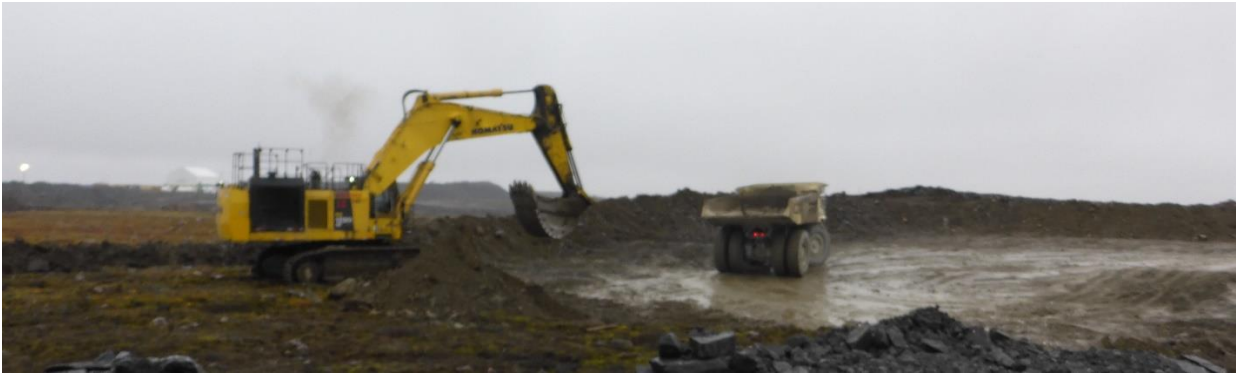
Photo 54: Prestripping of IVR Pit

- e) Prestripping of the IVR Pit began in September 2020 (Photo 54).

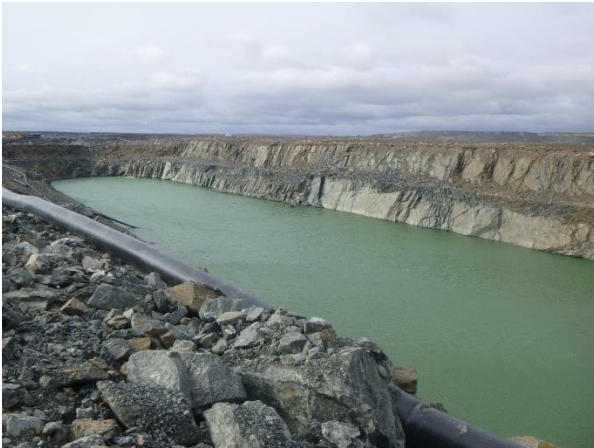
Photo 55: GSP-1

- f) Groundwater is managed in the groundwater storage pond GSP-1 (Photo 55). Additional groundwater storage ponds GSP-2 and GSP-3 have not yet been constructed.
- g) Lake A53 is not yet commissioned. Agnico Eagle noted that fish were removed and dewatering started in September 2020 (Photo 56).

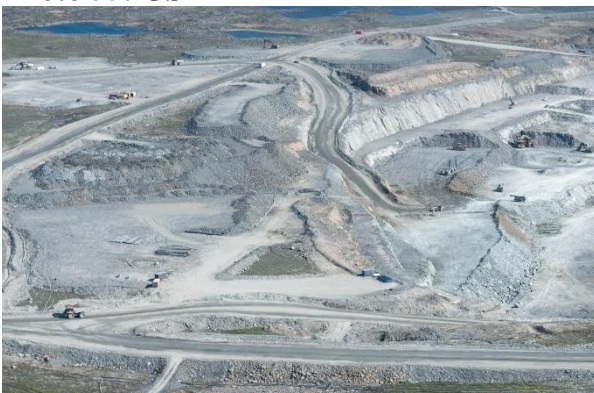
Photo 57: Ore Stockpile 4

- h) As of September 2020, no ore is currently stockpiled in Ore stockpile 4 ([Photo 57](#)).
- i) Agnico Eagle noted ore stockpiles do not have a contact water collection system as water naturally drains towards the attenuation ponds.
- j) The underground ore stockpile is currently not planned to be constructed in 2020.

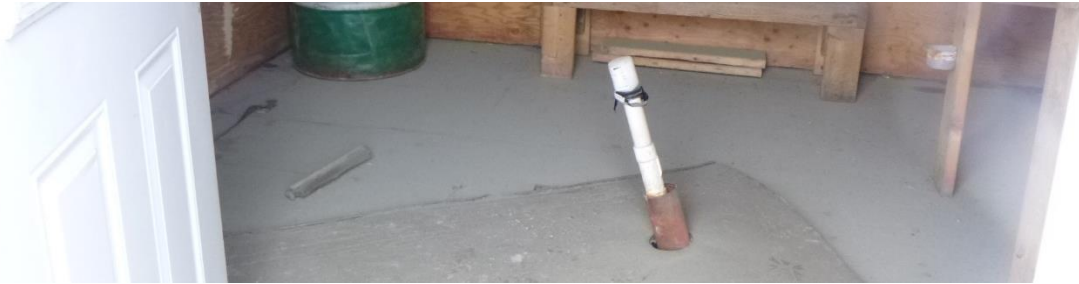
Photo 58: Groundwater Monitoring Well

- k) The IVR Waste Rock Storage Facility has not yet been constructed; however, dewatering is currently ongoing for the lake in the footprint of the future IVR Attenuation Pond and IVR Waste Rock Storage Facility.
- l) Agnico Eagle noted that the groundwater monitoring campaign is planned for October 2020 (Photo 58).

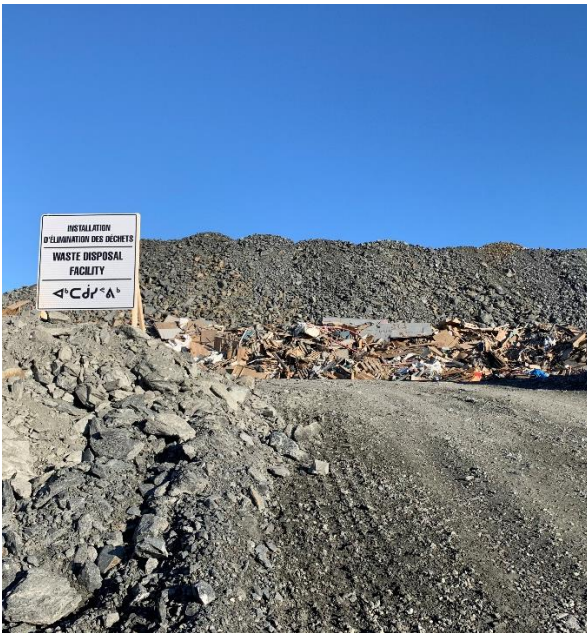
Photo 59: Landfill

- m) Agnico Eagle noted that, like Meadowbank, wastes are segregated before final disposal in the landfill (Photo 59).
- n) There is a diesel fuel tank and refueling station located on site (Photo 60).

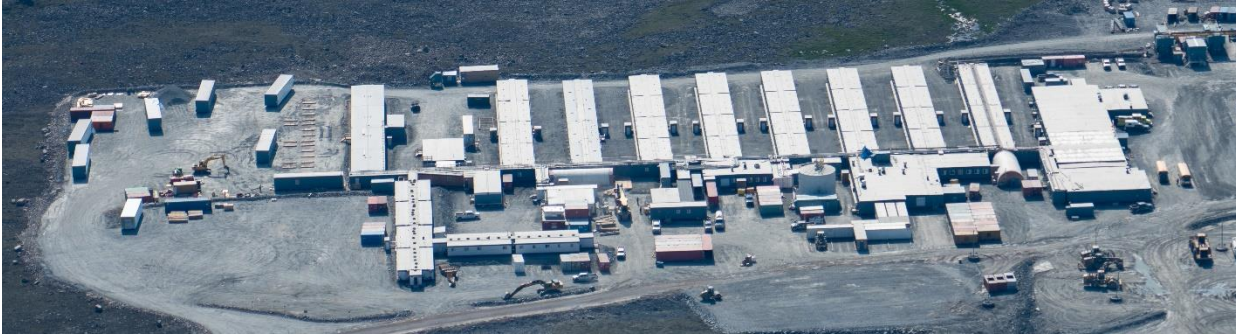
Photo 61: Permanent Camp

- o) There is currently nine (9) wings at the permanent camp and Agnico Eagle noted that the camp will be extended to 12 wings by the end of 2020 (Photo 61).
- p) Agnico Eagle noted that the exploration camp is currently being dismantled and will be decommissioned by early October (Photo 62).

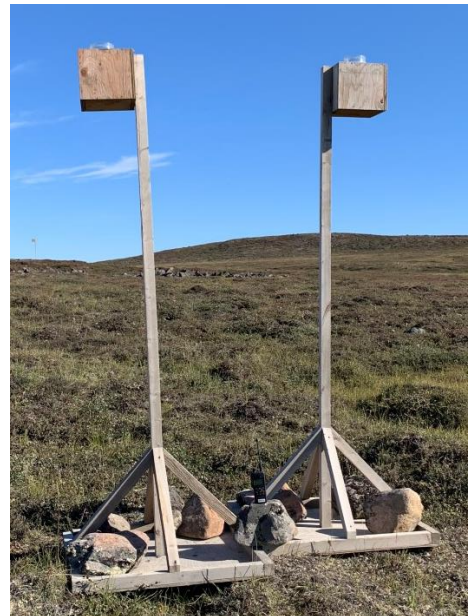
Photo 68: Dust Monitoring Stations

During their 2019 site visit, NIRB staff observed that dust suppressant was not being applied to the whole AWAR (see section 2.1.2.2), along the Whale Tail Haul Road (WTHR) nor at the Whale Tail site. In 2020 Agnico Eagle noted that calcium chloride dust suppressant was applied to the entire length of the WTHR (Photo 67). Also similar to the AWAR, dust monitoring stations have

been moved to two (2) metre (m) stands with one (1) replicate on the ground for comparison (Photo 68).
