Meadowbank and Whale Tail 2018 Annual Geotechnical Inspection

2018 Annual Geotechnical Inspection

Meadowbank Gold Mine, Nunavut

18101627-1583-R-Rev0

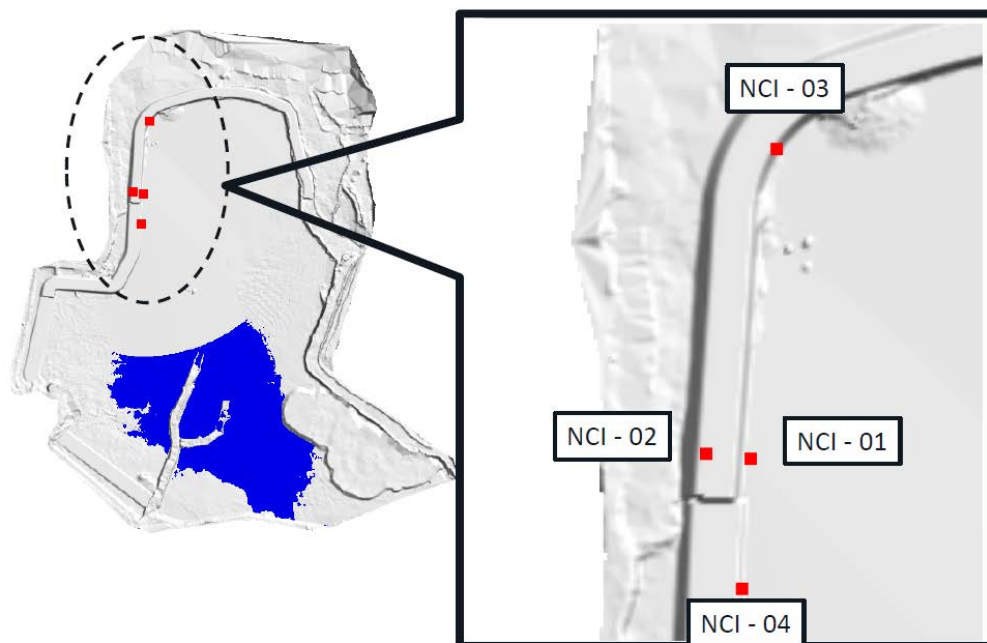
Figure 2: Locations of the thermistors installed in the North Cell Internal Structure (source: AEM)

Four vertical thermistor strings (NCIS-01 to NCIS-04) are installed in the North Cell Internal Structure to monitor the thermal condition within the structure and its foundation constituted of rockfill capping and/or tailings depending on the sections. Three instruments are located around a deposition point in the section where the structure is built at the El. 154 m entirely on exposed tailings, while the fourth instrument is located further north where the structure is built at the El. 154 m over the rockfill capping (see Figure 2 below).

Four vertical thermistor strings were installed on the crest of the North Cell Internal Structure in August 2018 (NCIS-01, NCIS-02, NCIS-03 and NCIS-04), as detailed in Figure 2 in Section 4.4. NCIS-01, NCIS-02 and NCIS-04 are installed on the upstream side of the dike whereas NCIS-02 is installed on the downstream side.. At the time of the inspection, the instruments had just been installed and the data reviewed by Golder included early August to the end of September 2018. NCIS-01, NCIS-02 and NCIS-03 show frozen tailings and an active layer within the entire layer of rockfill, while NCIS-04 indicates that the active layer extends into the first 0.5 m of the tailings.. It will be important to continue following the performance of the structure as the North Cell Internal Structure is now operational and retaining tailings and has only been recently built.

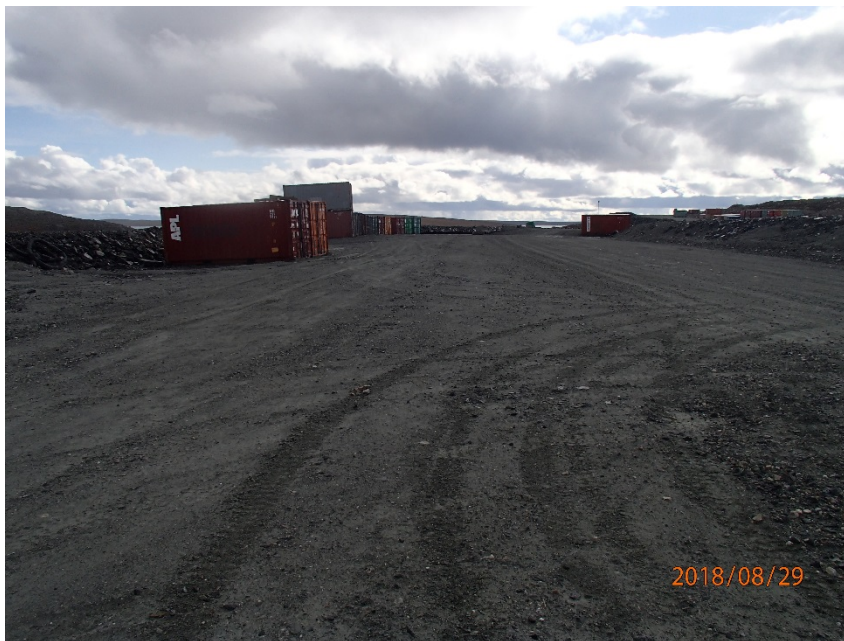
Photograph A1-1 East Dike

Description: From approximately Sta. 60+375, looking south at the crest.

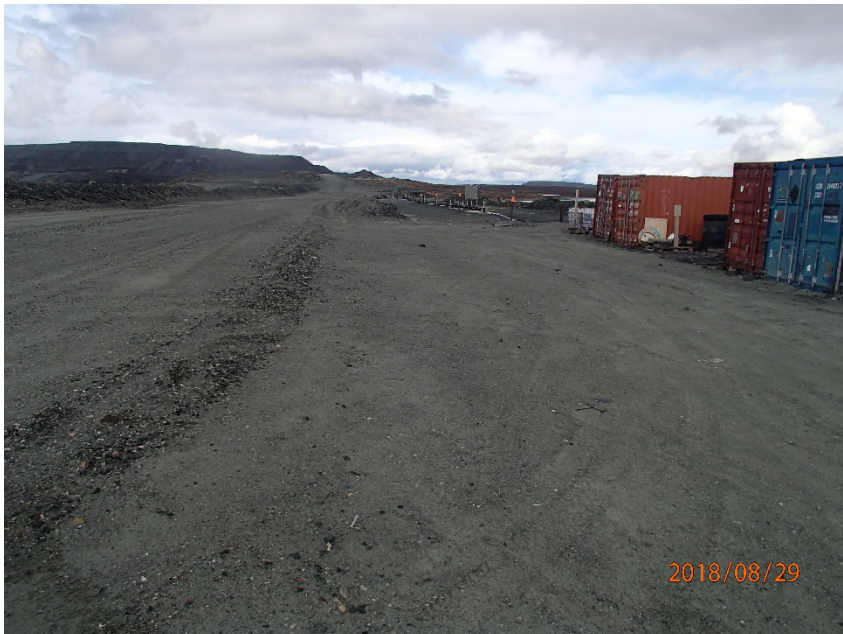
Photograph A1-2 East Dike

Description: From approximately Sta. 60+410, looking north at the crest.

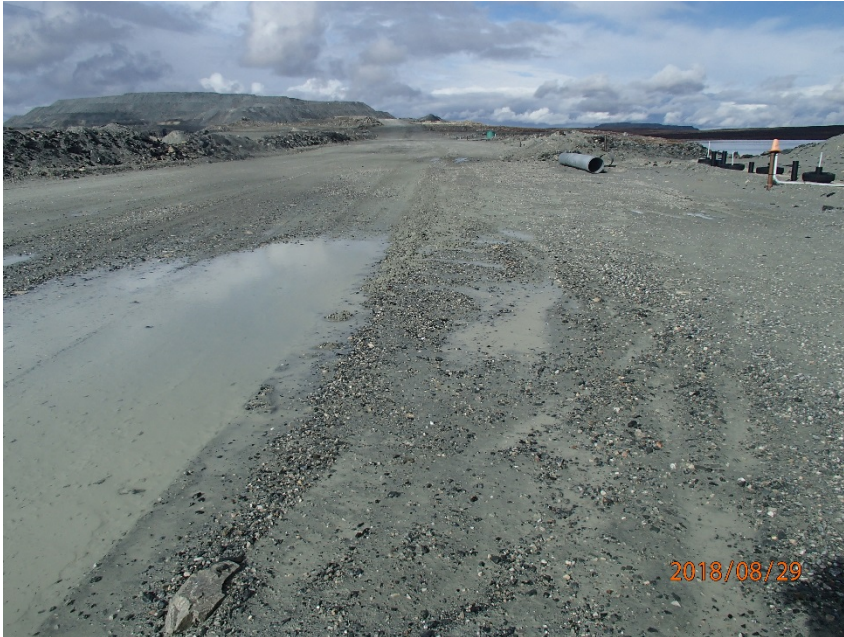
Photograph A1-3 East Dike

Description: From approximately Sta. 60+560, looking north at the crest.

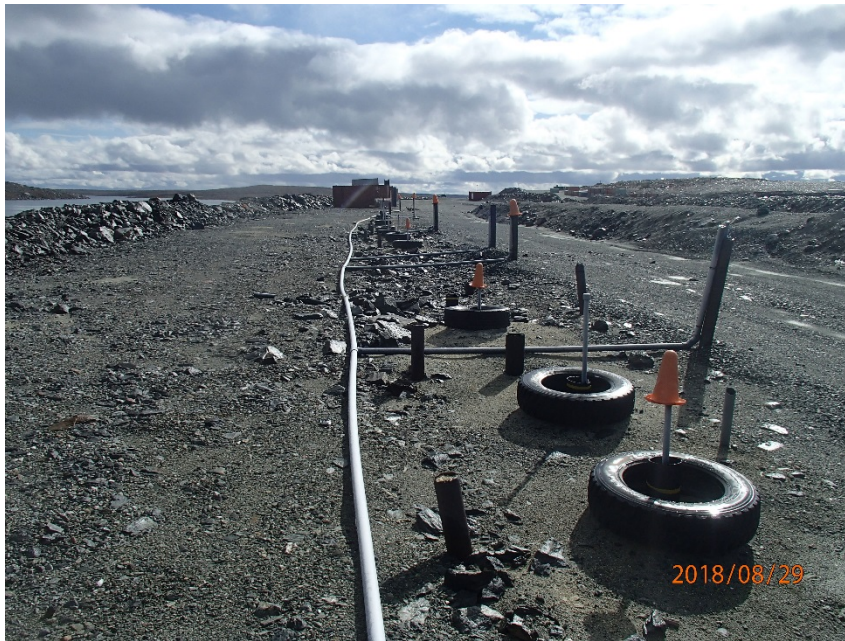
Photograph A1-5 East Dike

Description: From approximately Sta. 60+540 upstream, looking south at the crest and the upstream slope.

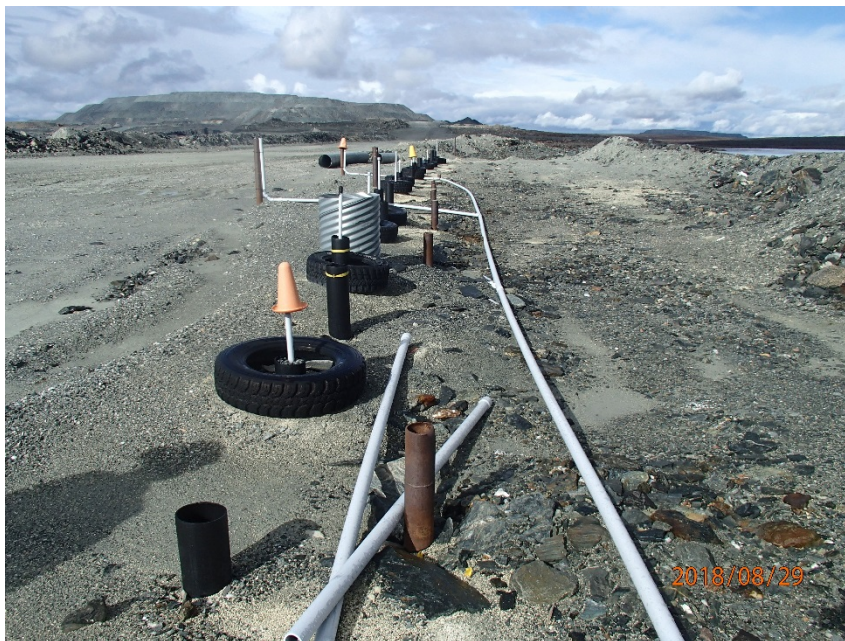
Photograph A1-6 East Dike

Description: From approximately Sta. 60+560 upstream, looking north at the crest and the upstream slope.

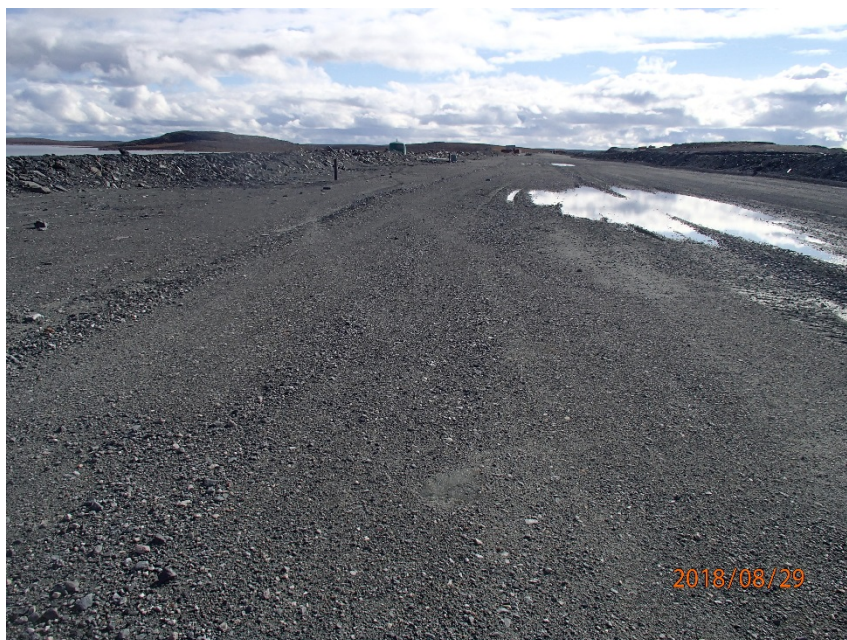
Photograph A1-7 East Dike

Description: From approximately Sta. 60+810, looking south at the crest.

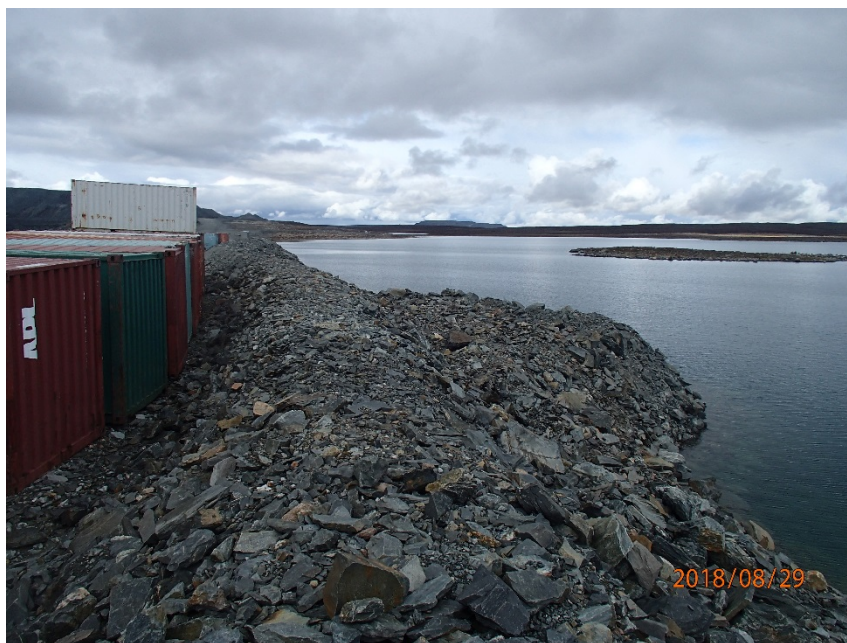
Photograph A1-8 East Dike

Description: From Sta. 60+300 upstream, looking north along the upstream slope.

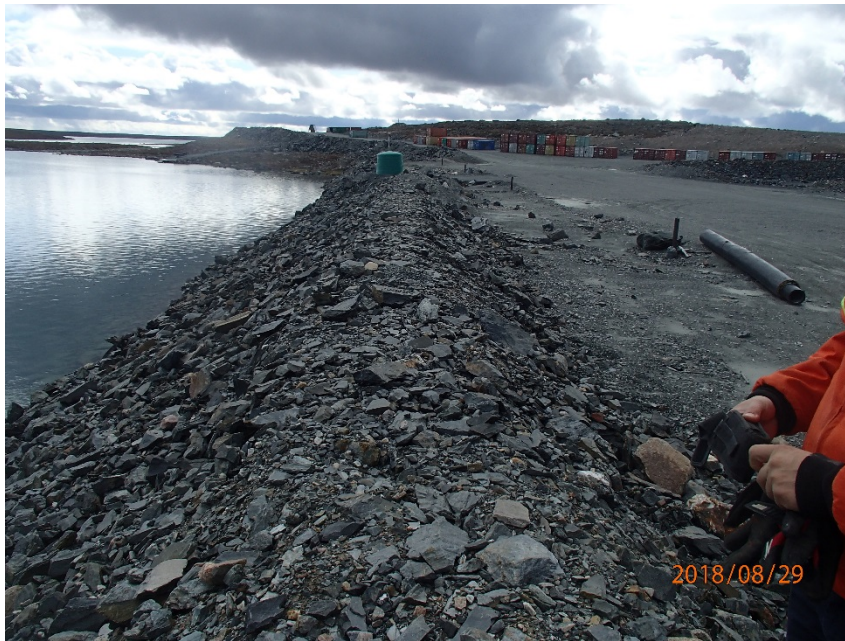
Photograph A1-9 East Dike

Description: From approximately Sta. 60+250 upstream, looking south at the crest and the upstream slope.

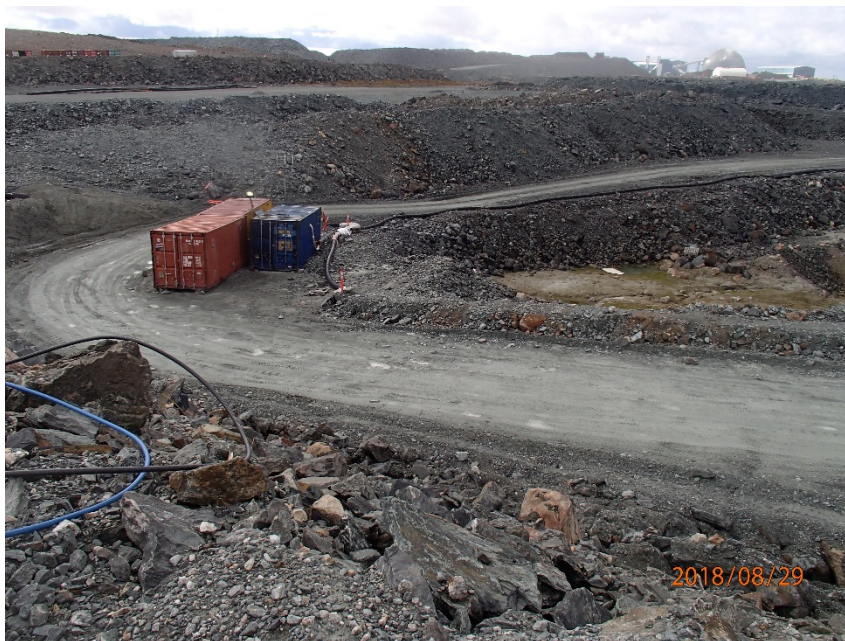
Photograph A1-10 East Dike

Description: From approximately Sta. 60+250, looking west at the downstream side and toe.

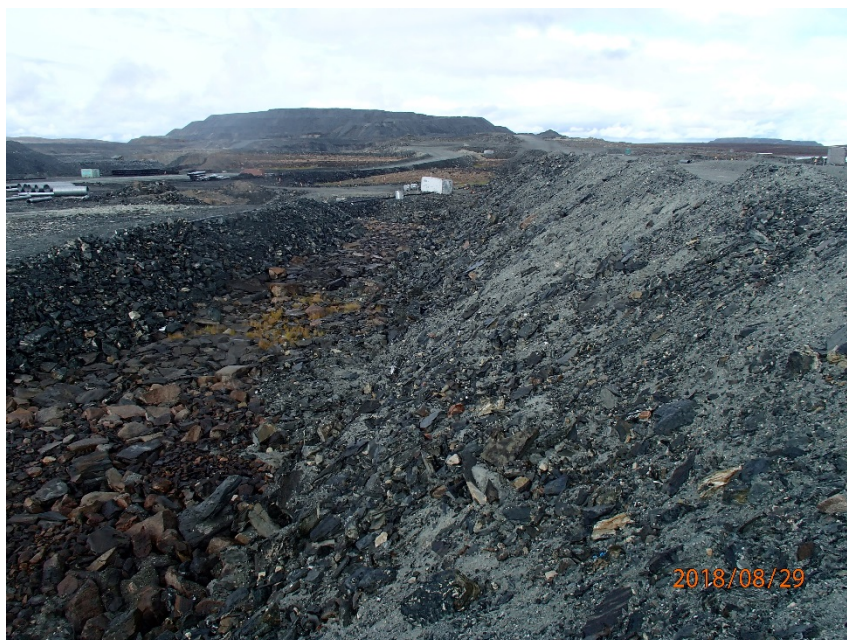
Photograph A1-11 East Dike

Description: From approximately Sta. 60+380, looking north at the downstream side.

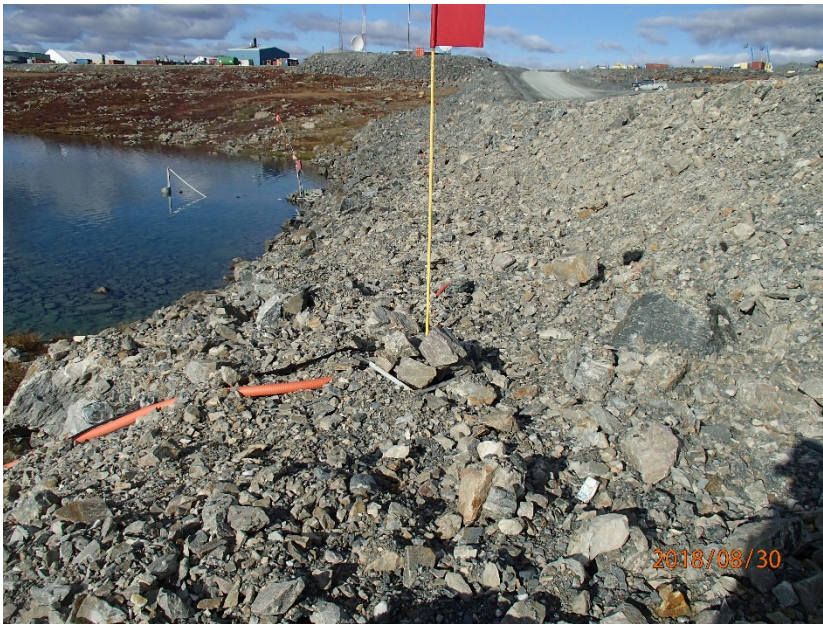
Photograph A2-1 South Camp Dike

Description: From the south abutment, looking north at the upstream slope and the thermistors instrumentation set-up.

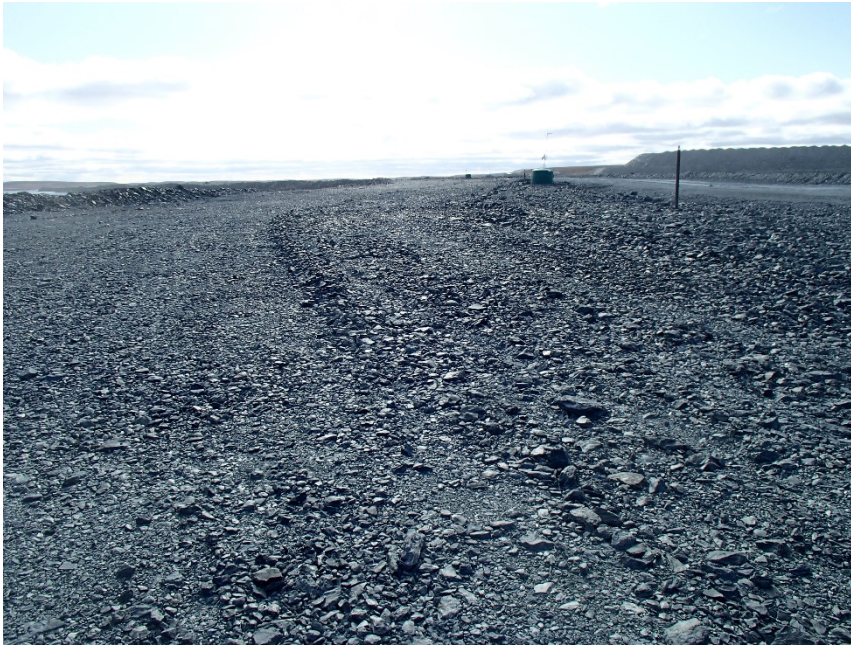
Photograph A3-1 Bay Goose Dike

Description: From approximately Sta. 30+142 (north abutment) looking southwest at the crest.

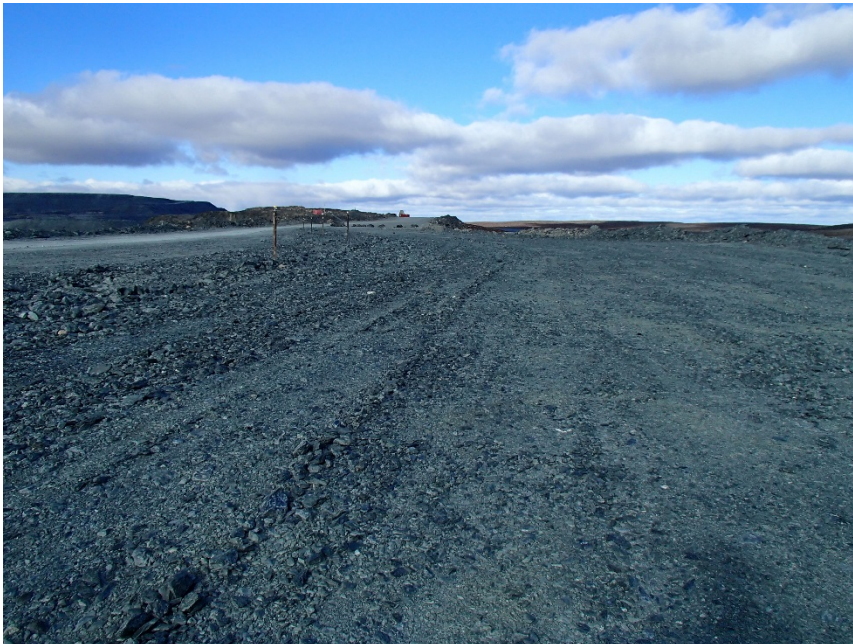
Photograph A3-2 Bay Goose Dike

Description: From approximately Sta. 30+130 (north abutment), looking north at the crest.

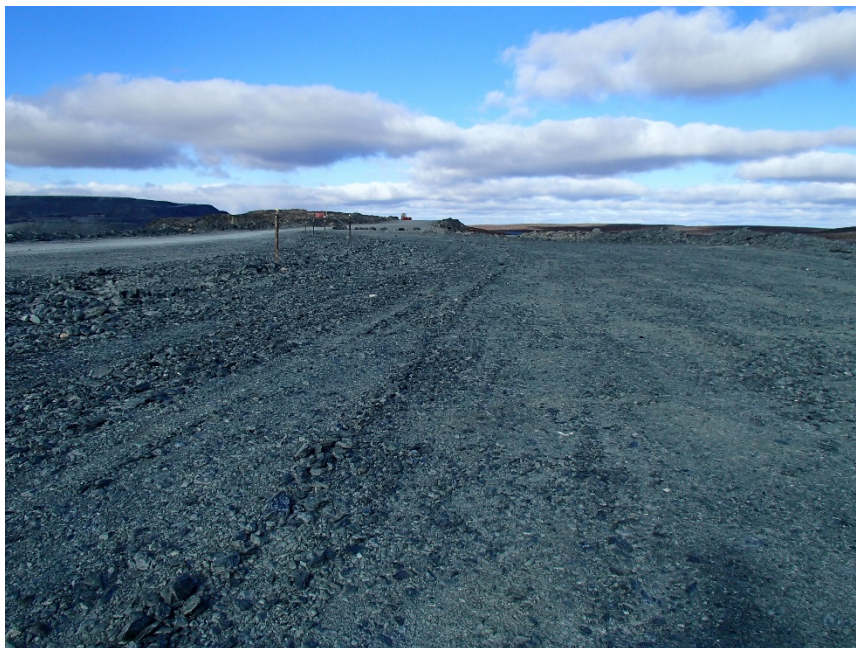
Photograph A3-3 Bay Goose Dike

Description: From approximately Sta. 30+075 (north abutment), looking north at the downstream toe.

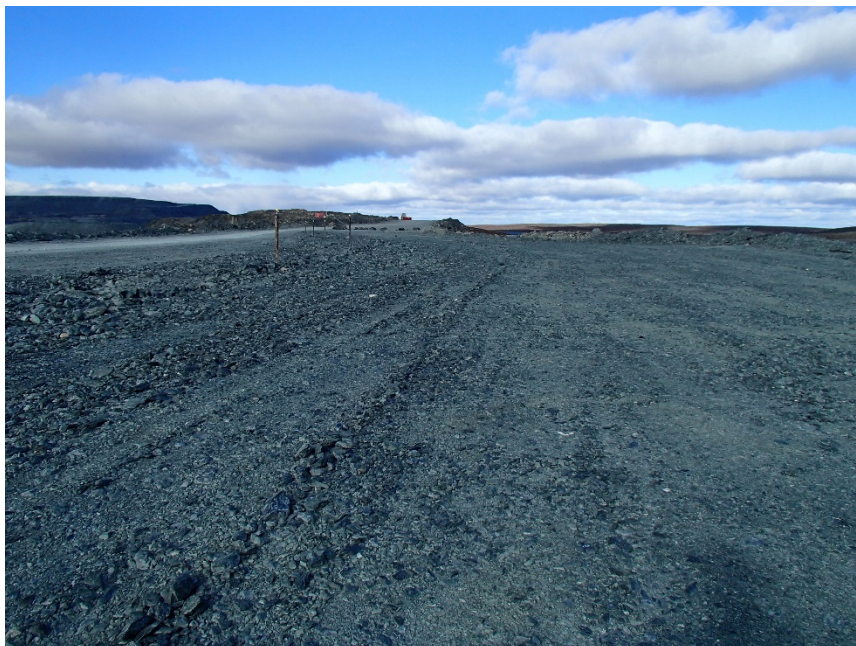
Photograph A3-4 Bay Goose Dike

Description: From approximately Sta. 30+075 (north abutment), looking south at the downstream toe.

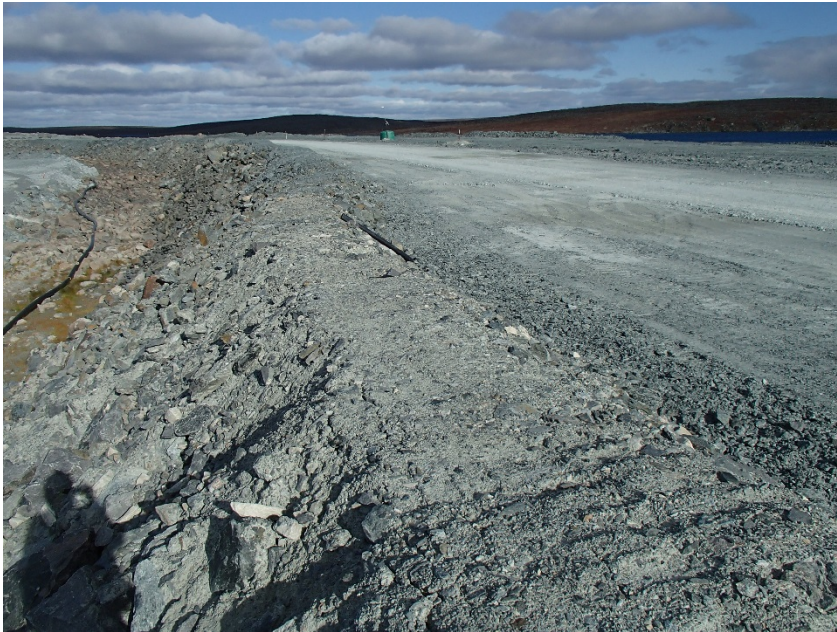
Photograph A3-5 Bay Goose Dike

Description: From approximately Sta. 30+340 on the crest, looking northeast at the dam crest and downstream slope

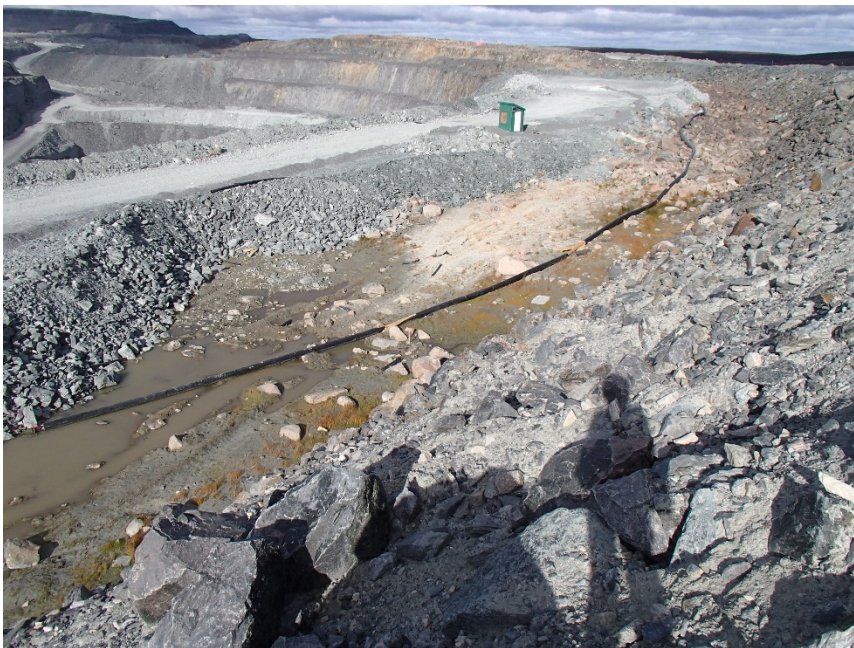
Photograph A3-6 Bay Goose Dike

Description: From approximately Sta. 30+340, looking northwest at the north seepage channel.

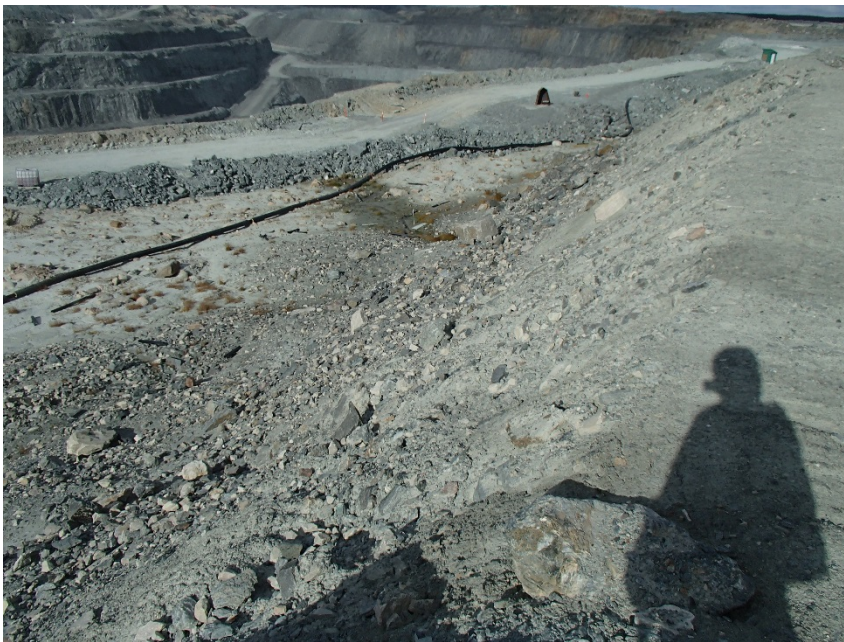
Photograph A3-8 Bay Goose Dike

Description: From approximately Sta. 30+450, looking north at the crest and the downstream slope.

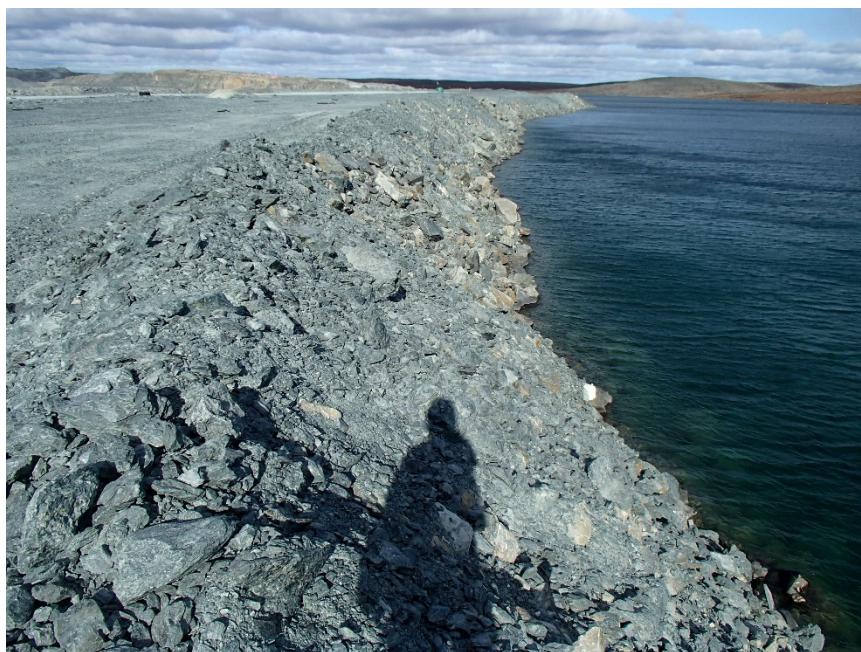
Photograph A3-9 Bay Goose Dike

Description: From Sta. 30+500, looking northeast at the crest and the upstream slope.

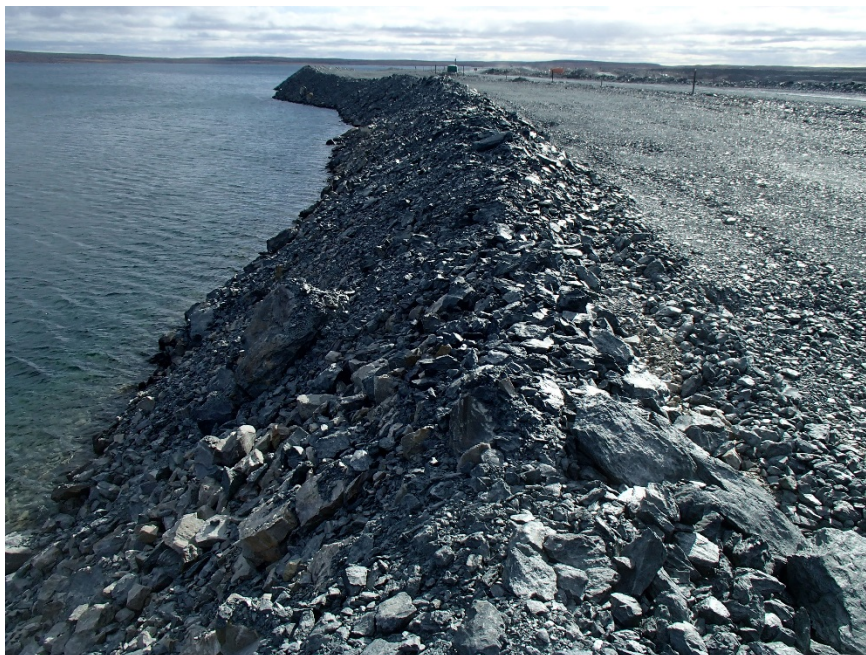
Photograph A3-10 Bay Goose Dike

Description: From Sta. 30+500, looking south at the crest and the upstream slope.

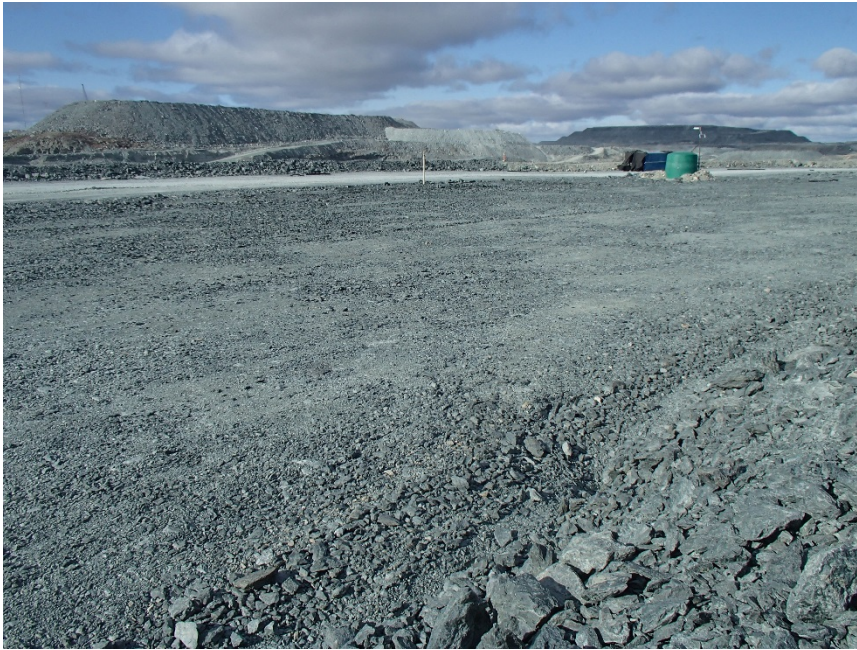
Photograph A3-11 Bay Goose Dike

Description: From Sta. 30+500, looking west at the downstream slope.

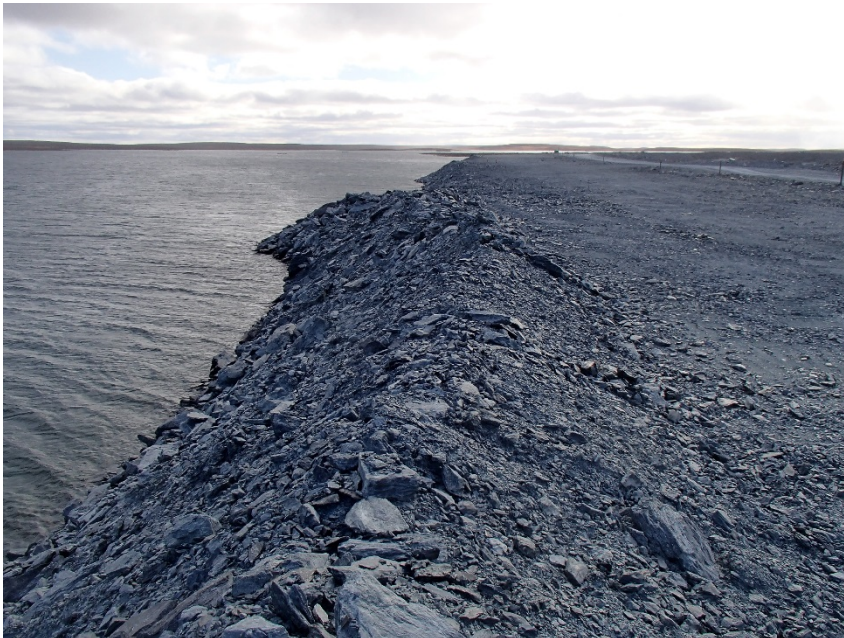
Photograph A3-12 Bay Goose Dike

Description: From Sta. 30+700, looking south at the crest and the upstream slope.

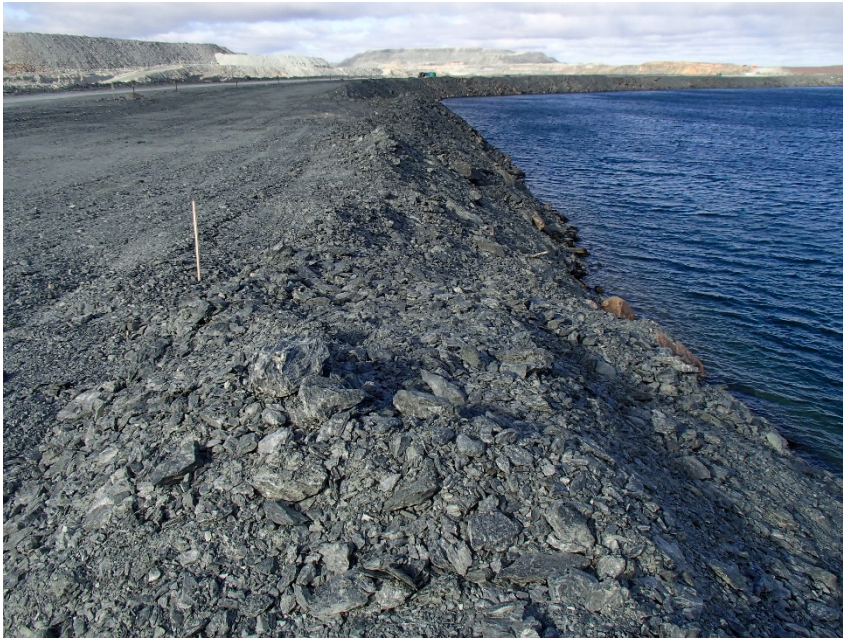
Photograph A3-13 Bay Goose Dike

Description: From approximately Sta. 30+680, looking north at the crest and the upstream slope.

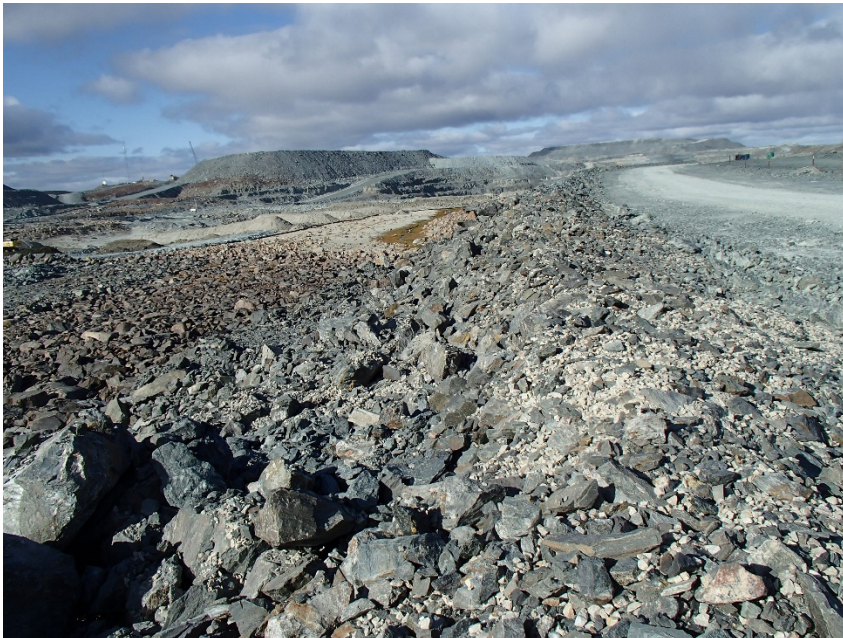
Photograph A3-14 Bay Goose Dike

Description: From approximately Sta. 30+680 on the crest, looking north at the downstream slope and toe.

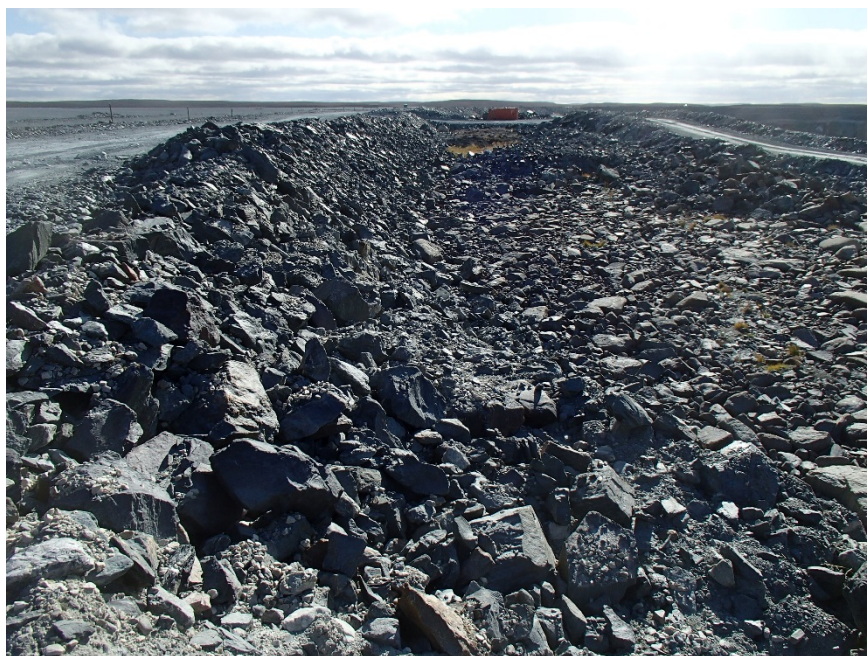
Photograph A3-15 Bay Goose Dike

Description: From approximately Sta. 30+680 on the crest, looking south at the downstream slope and toe.

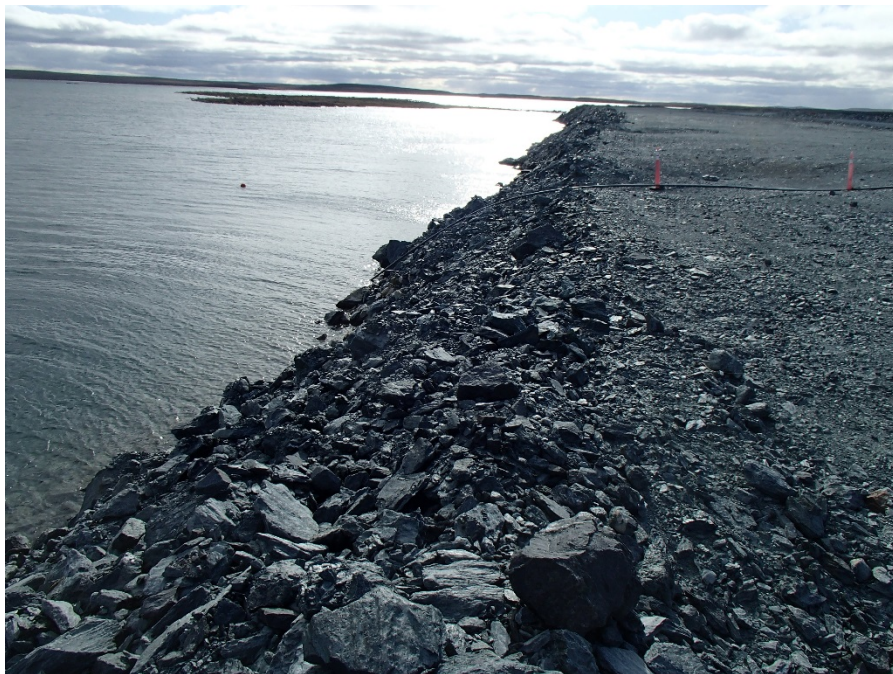
Photograph A3-16 Bay Goose Dike

Description: From approximately Sta. 31+130, looking south at the crest and upstream slope.

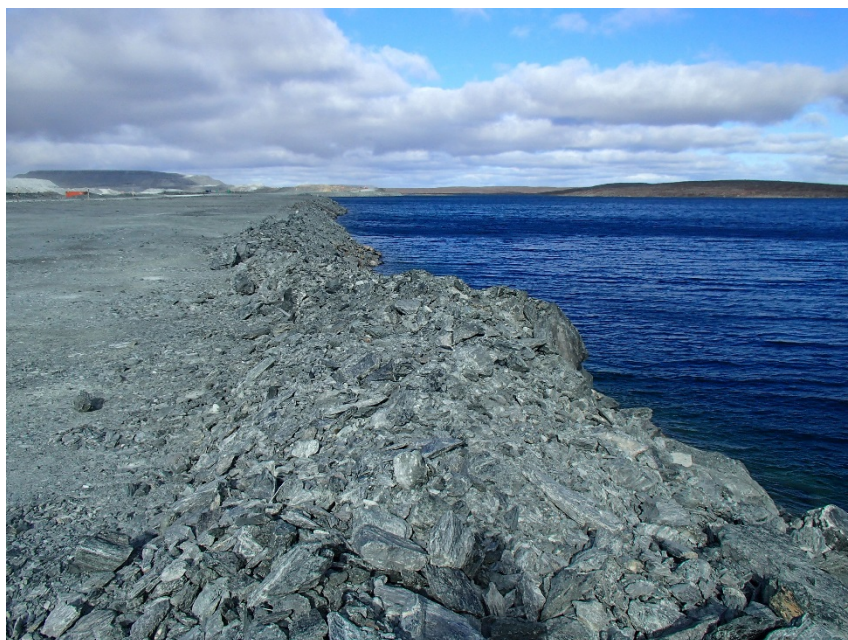
Photograph A3-17 Bay Goose Dike

Description: From approximately Sta. 31+130, looking north at the crest and upstream slope.

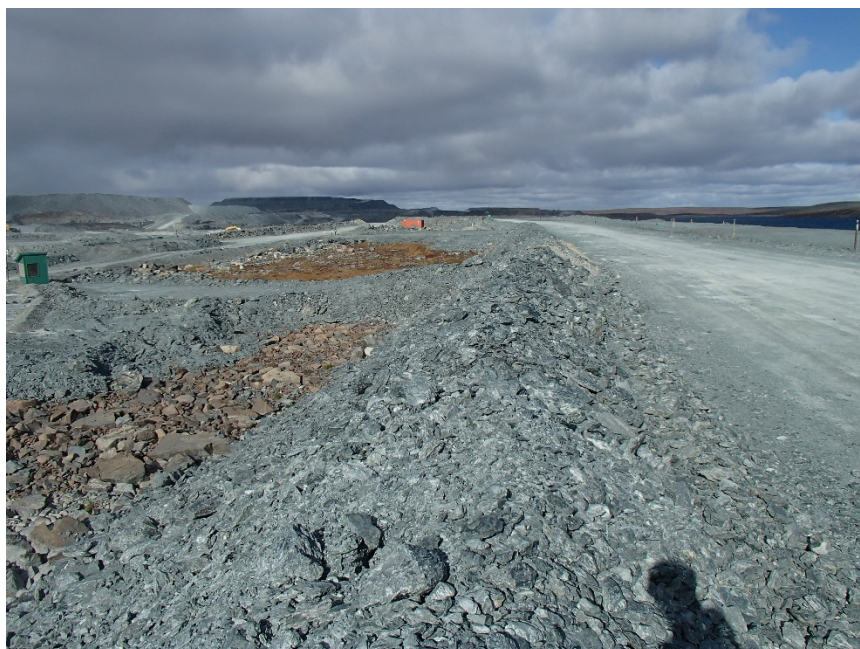
Photograph A3-18 Bay Goose Dike

Description: From approximately Sta. 31+080 on the crest, looking north at the downstream slope and toe.

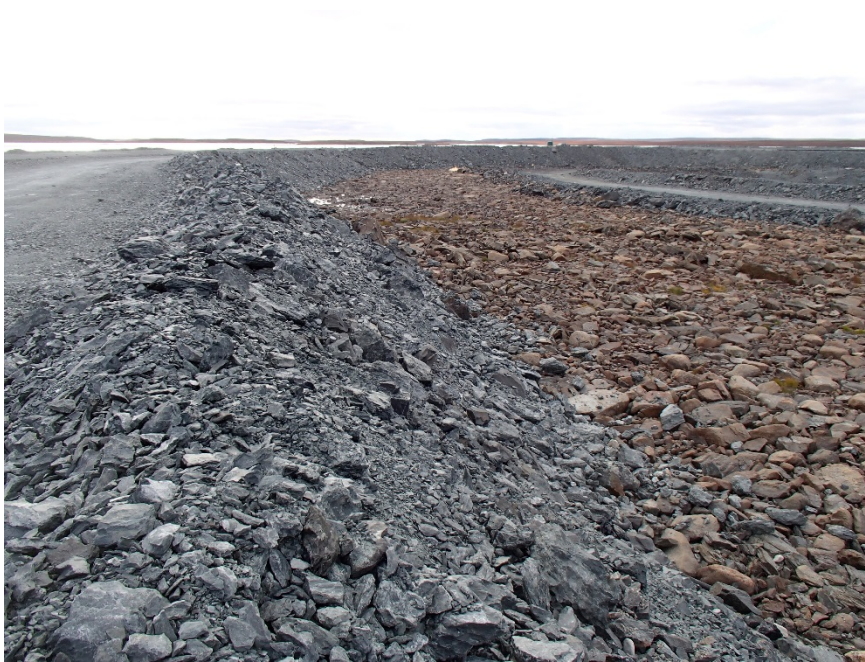
Photograph A3-23 Bay Goose Dike

Description: From approximately Sta. 31+280 on the crest, looking southwest at the downstream slope and the water pond at the downstream toe at Sta. 31+350.

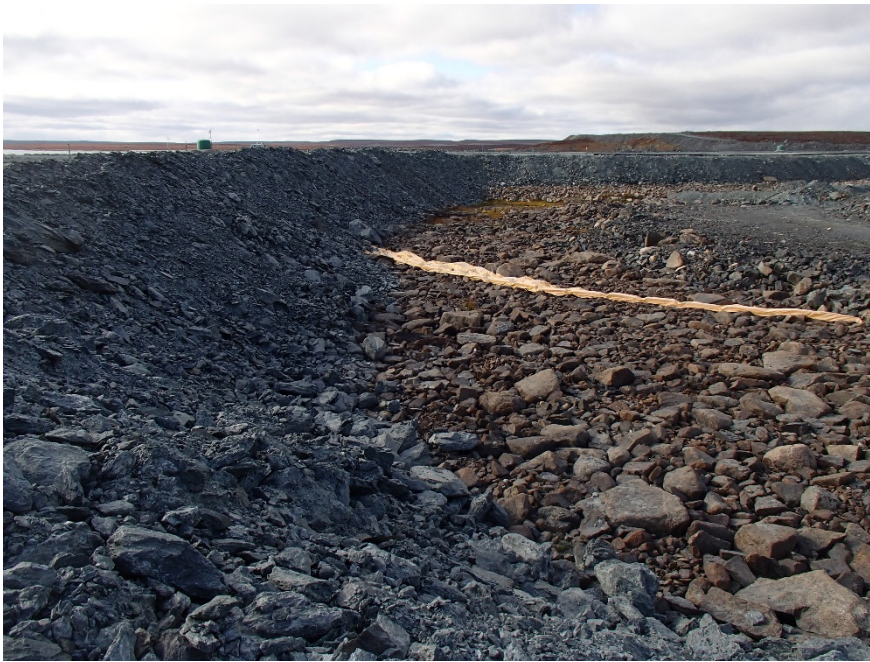
Photograph A3-27 Bay Goose Dike

Description: From approximately Sta. 31+490, looking west toward Channel 3.

INSPECTION ITEM	OBSERVATIONS DATA	PHOTO	COMMENTS & OTHER DATA
	Channel 3	246, 251, 255	Light flow observed during inspection. Monitored by station 6.
	Channel 1	237, 236	This seepage channel was not flowing at the time of the inspection.
	Water Ponds	247	Presence of water pond with no sign of seepage. Located at 31+750. Water was observed downstream of Channel 1 ponding against the ring road of Goose Pit.

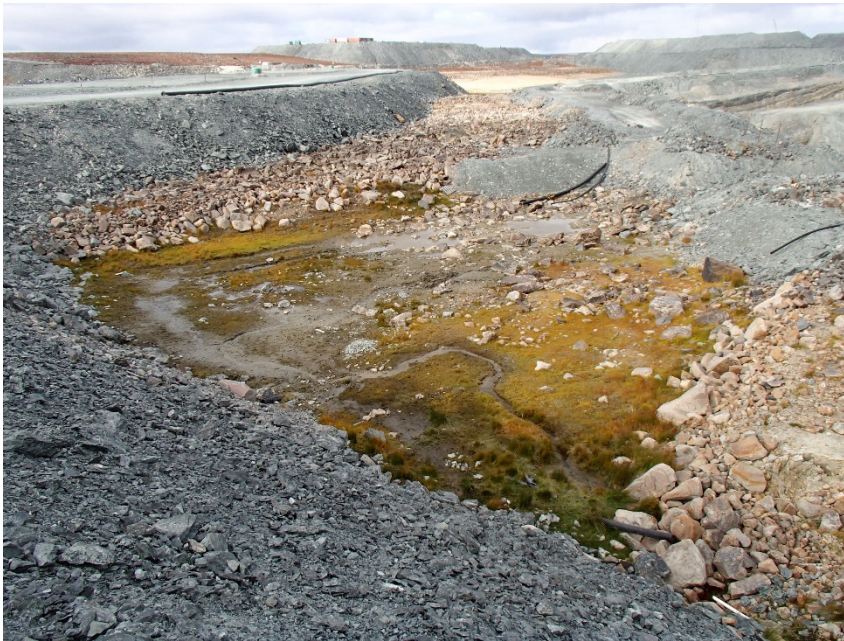
Photograph A3-30 Bay Goose Dike

Description: From approximately Sta. 31+570, looking north toward Channel 3.

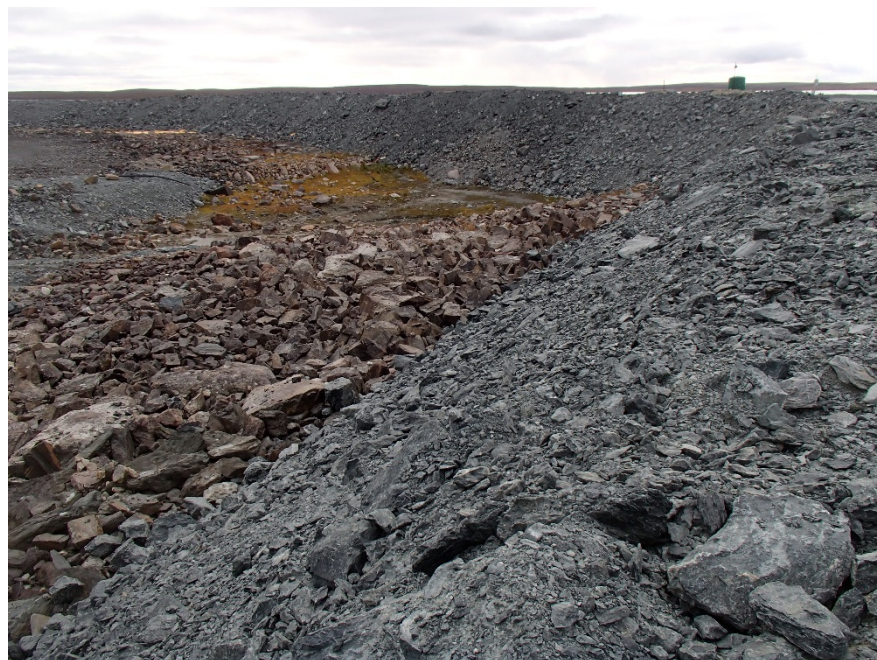
Photograph A3-34 Bay Goose Dike

Description: From the crest at approximately Sta. 31+740. Looking southeast downstream toward Channel 3.

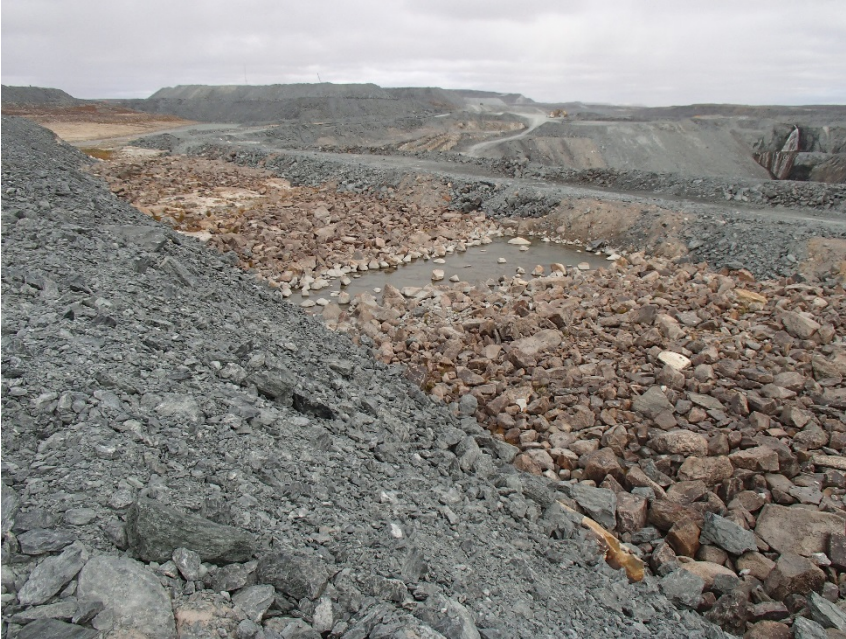
Photograph A3-35 Bay Goose Dike

Description: From the crest at approximately Sta. 31+740, looking north downstream at the water pond at Sta. 31+750.

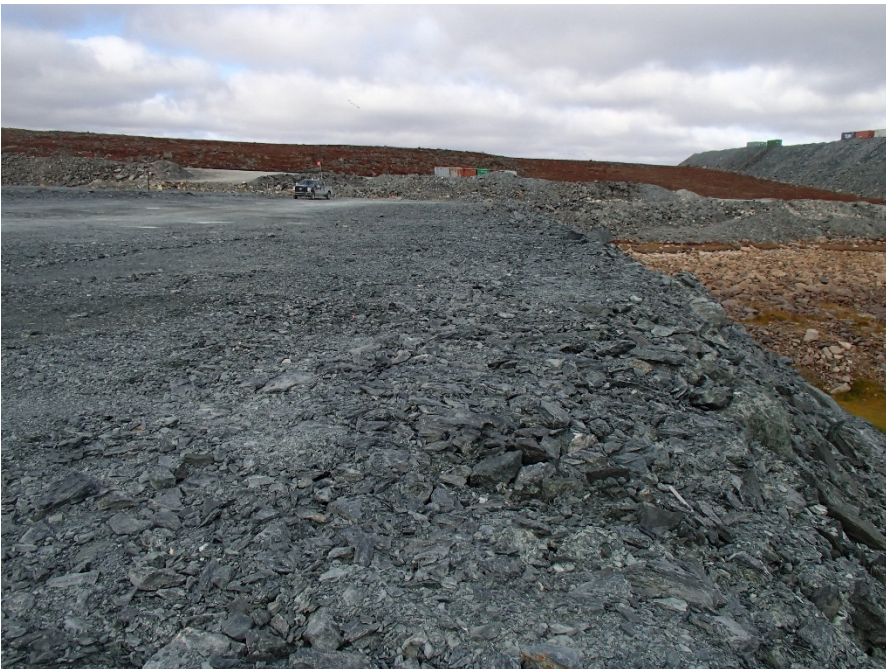
Photograph A3-44 Bay Goose Dike

Description: From approximately Sta. 32+030 downstream, looking north at the downstream slope.

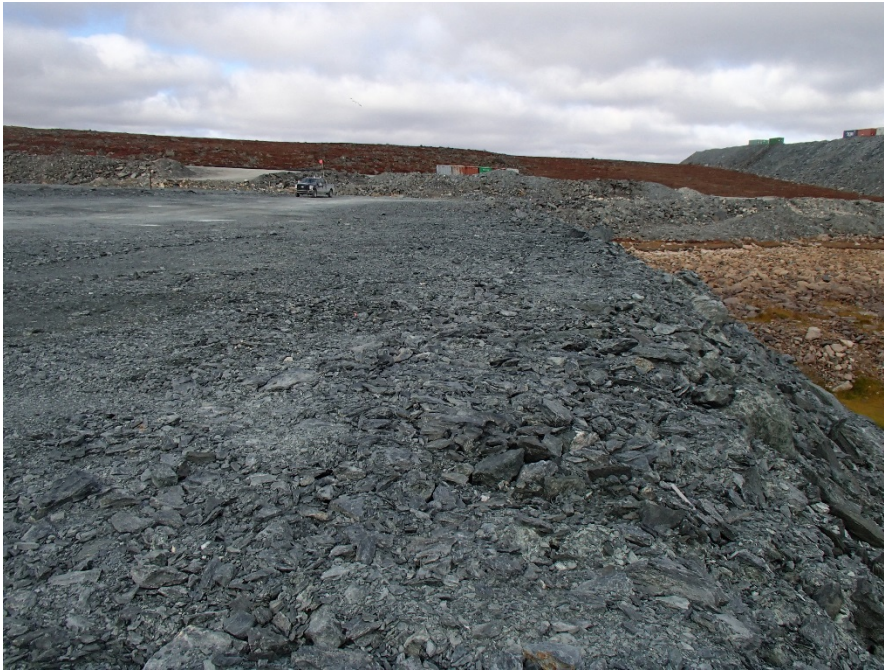
Photograph A3-45 Bay Goose Dike

Description: From approximately Sta. 32+030 downstream, looking southeast at the downstream slope.

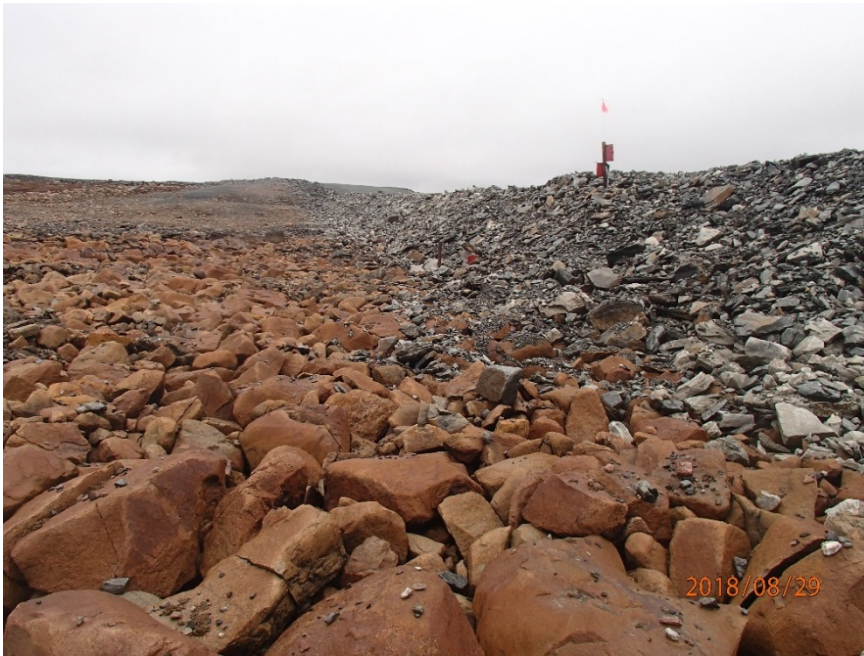
Photograph A4-3 Vault Dike

Description: From downstream, looking southeast at the downstream toe.

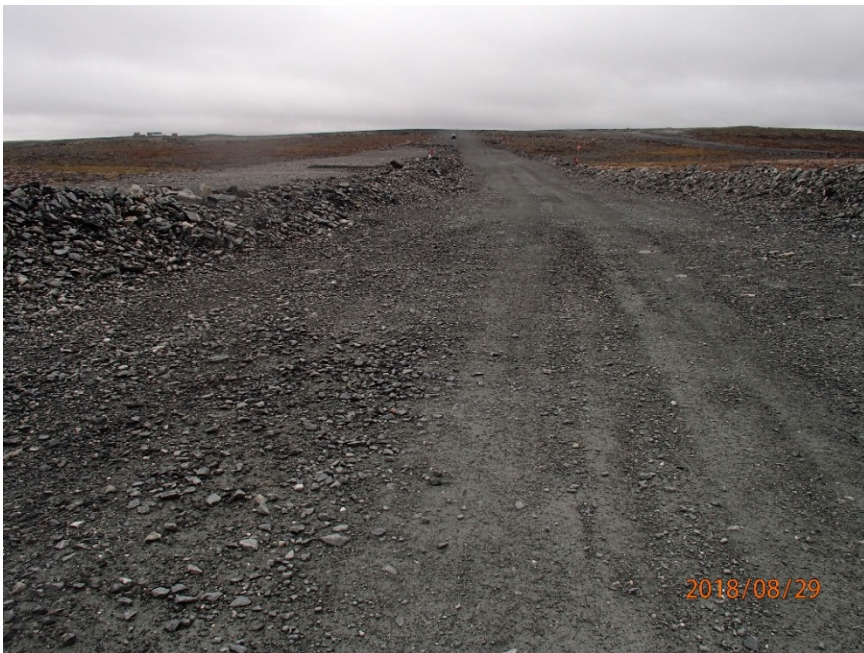
Photograph A4-4 Vault Dike

Description: From downstream, looking northwest at the downstream toe.
