Meadowbank and Whale Tail 2018 Annual Geotechnical Inspection

2018 Annual Geotechnical Inspection

Meadowbank Gold Mine, Nunavut

18101627-1583-R-Rev0

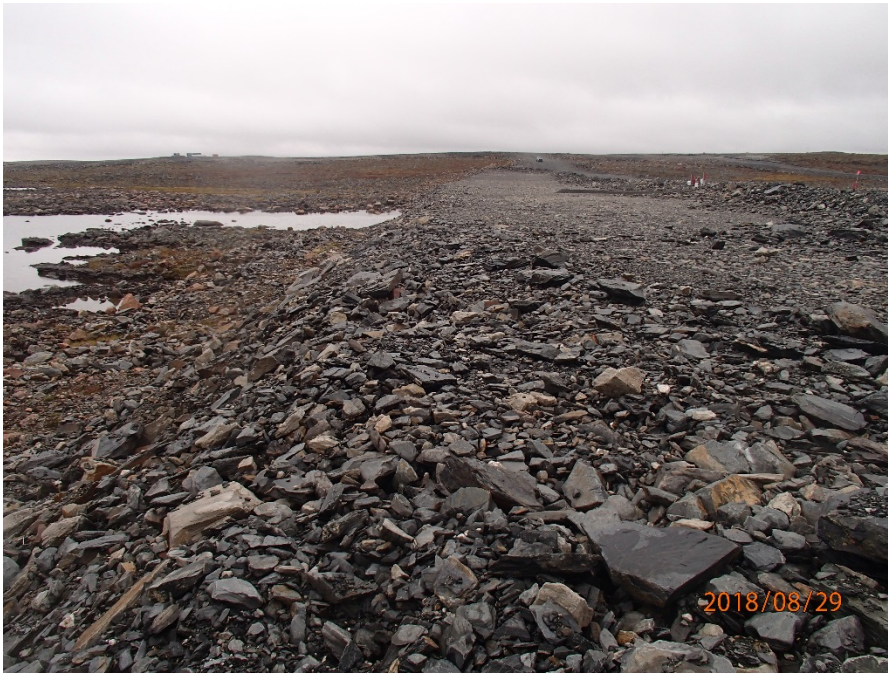
Photograph A4-5 Vault Dike

Description: From the west abutment, looking southeast at the crest.

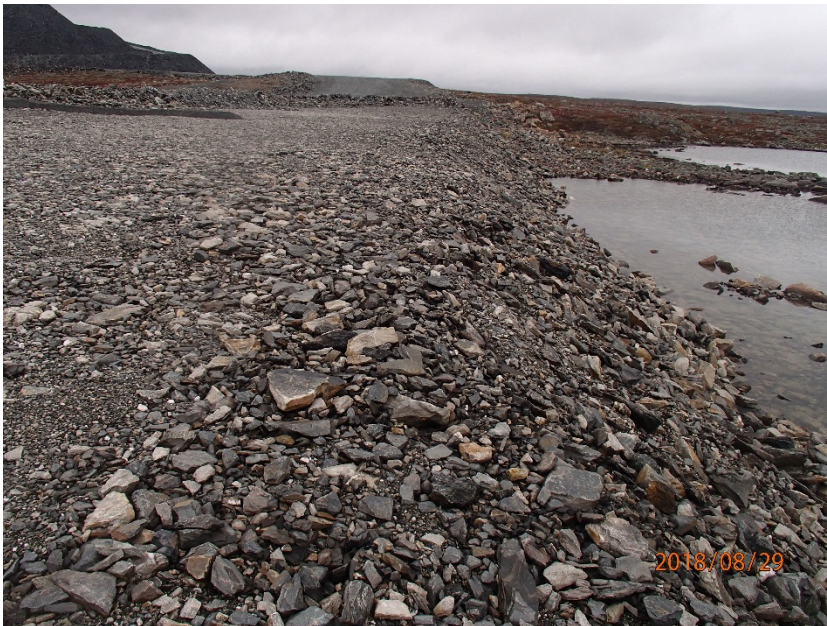
Photograph A4-6 Vault Dike

Description: From the upstream side, looking southeast at the upstream slope.

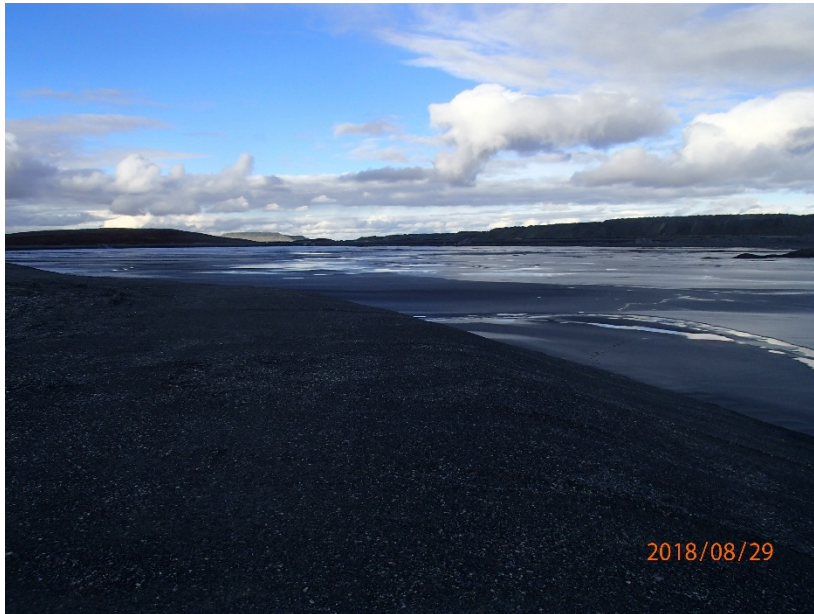
Photograph B1-5 Tailings Storage Facility

Description: From Stormwater Dike, looking north at the North Cell tailings pond. Adequate tailings beach against Stormwater Dike.

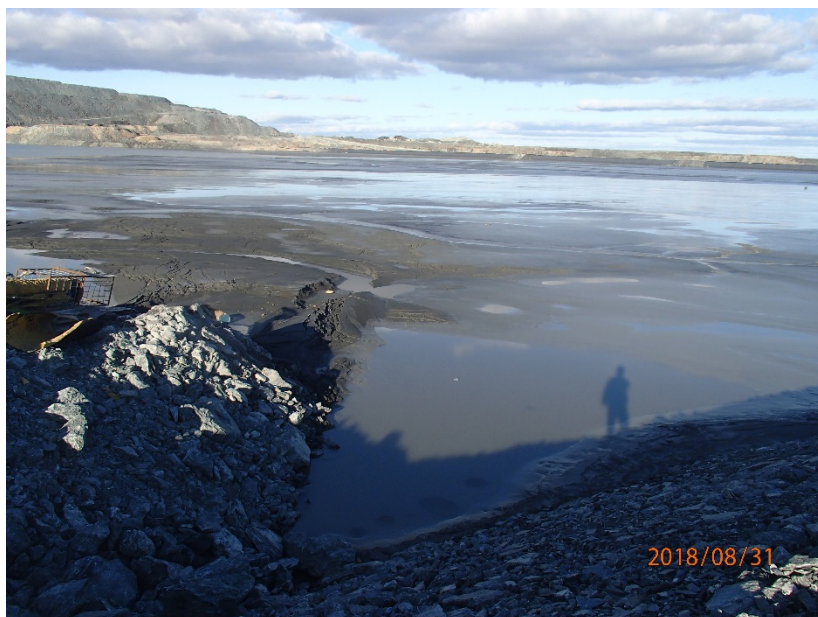
Photograph B1-22 Tailings Storage Facility

Description: From Central Dike looking west at the South Cell. A shallow pond is present in the tailings against the dike.

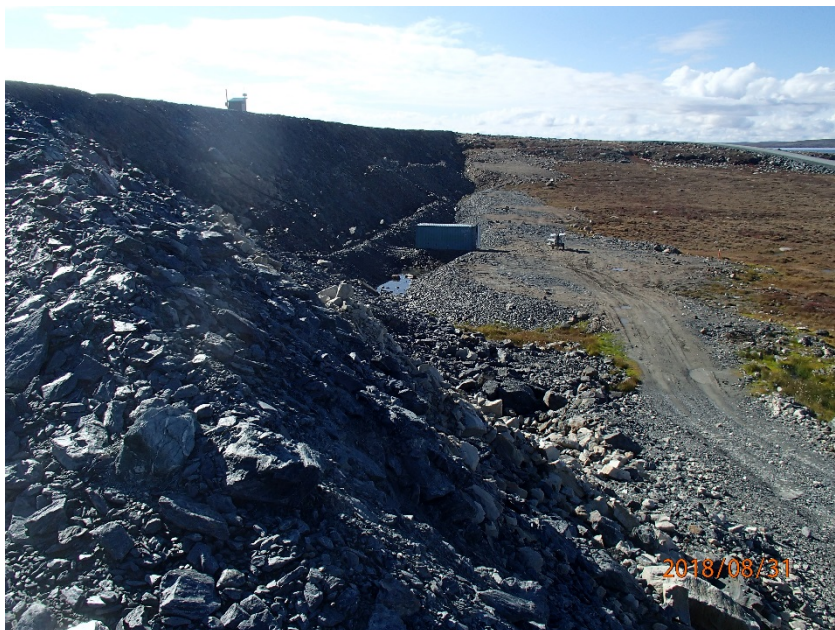
Photograph B2-2 Saddle Dam 1

Description: From the south abutment (Sta. 0+350) looking north at the downstream face. Notice the sea-can container where a sump is installed.

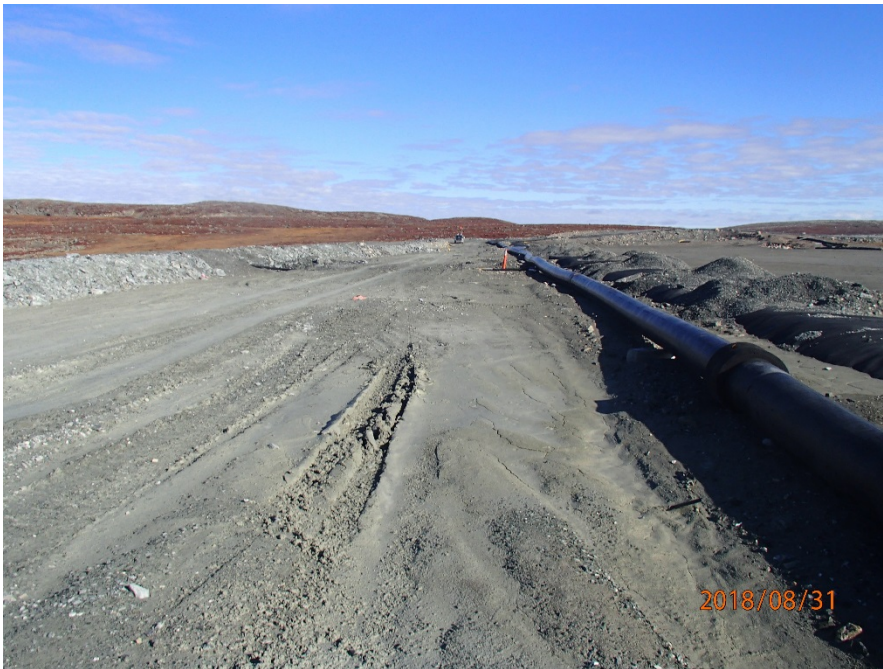
Photograph B2-3 Saddle Dam 1

Description: From Sta. 0+150 looking south at the downstream face. Notice the sea-can container where a sump is installed.

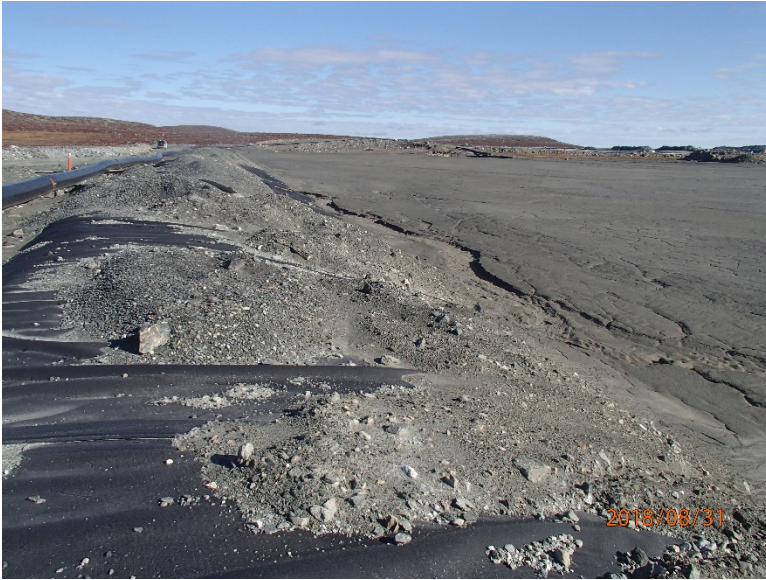
Photograph B2-7 Saddle Dam 1

Description: From approximately Sta. 0+195 upstream, looking south at the upstream slope. Adequate tailings beach against SD1. A small pond of water is present at the surface of the tailings and is not a concern.

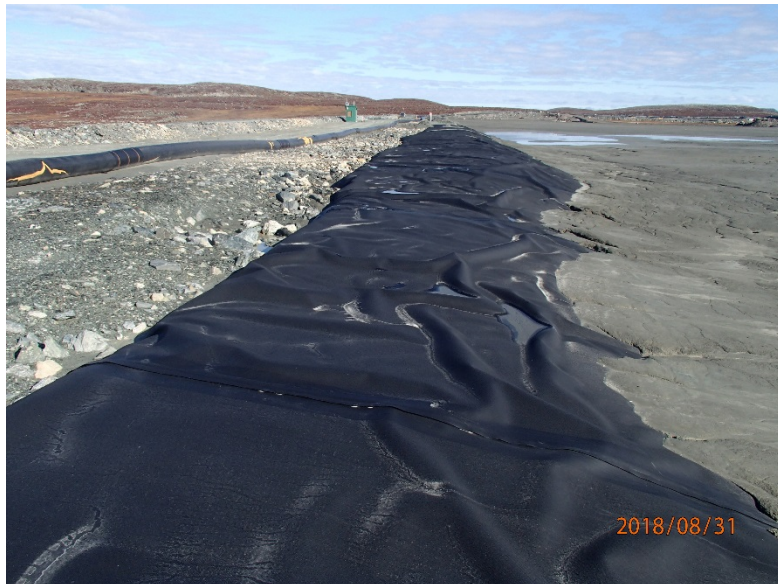
Photograph B2-8 Saddle Dam 1

Description: From approximately Sta. 0+195 upstream, looking north at the upstream slope. Adequate tailings beach against SD1.

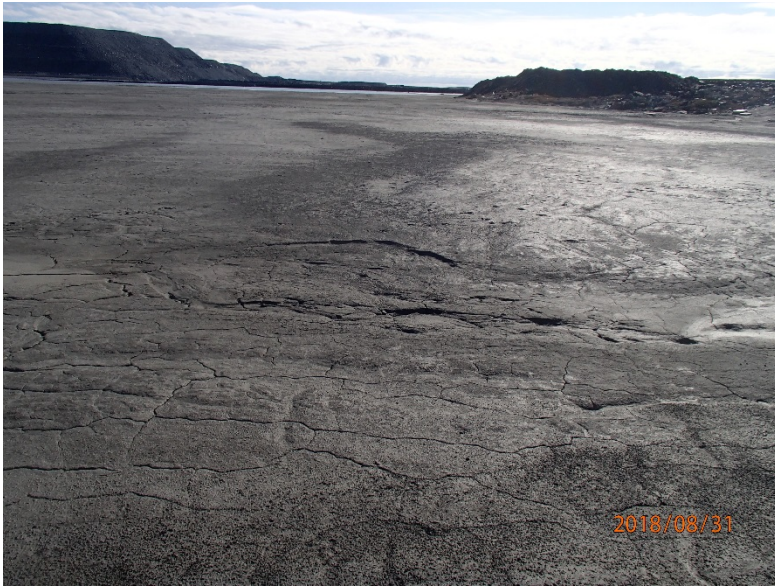
Photograph B2-9 Saddle Dam 1

Description: From the south abutment looking north at the upstream slope. Adequate tailings beach against SD1.

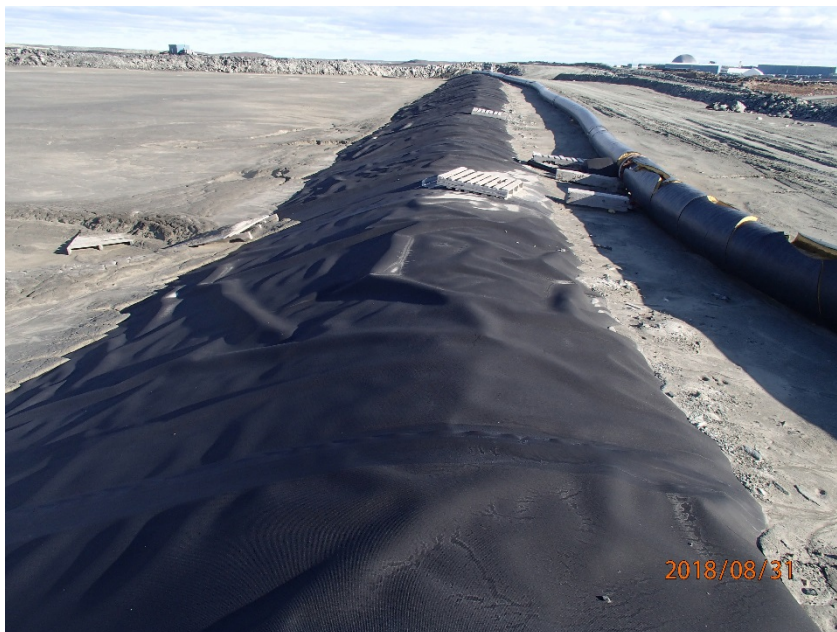
Photograph B3-2 Saddle Dam 2

Description: From Saddle Dam 2 (approximately Sta. 20+110) looking southeast at the crest and upstream slope of Saddle Dam 2. The tailings beach against SD2 is adequate.

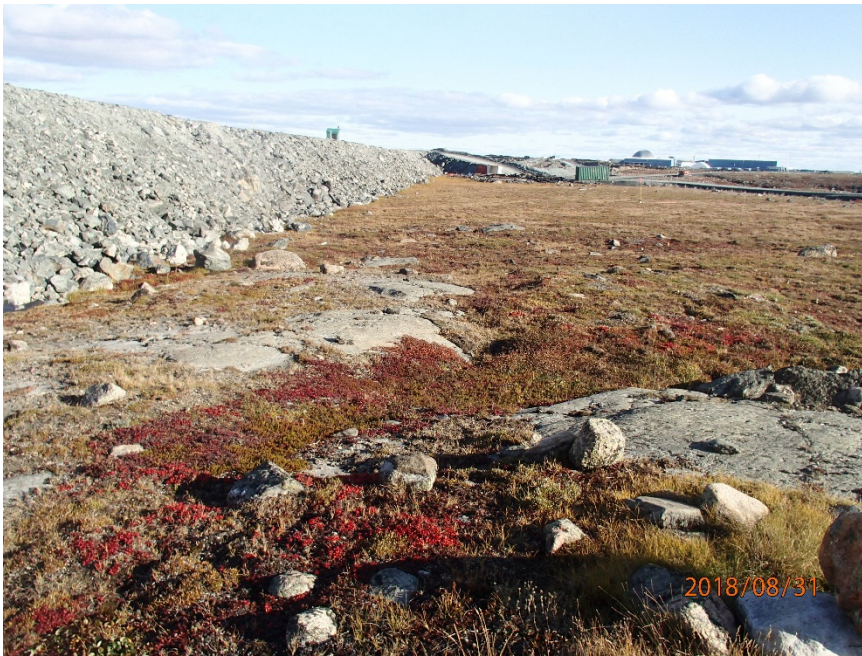
Photograph B3-5 Saddle Dam 2

Description: From approximately Sta. 20+250 downstream, looking northwest at the downstream toe.

4.4 Discoloration/staining	No		
4.5 Outlet operating problem (if applicable)	Not applicable		
4.6 Other unusual conditions	Yes		Water is still ponding within the rockfill embankment between 20+275 to 20+475 approximately.

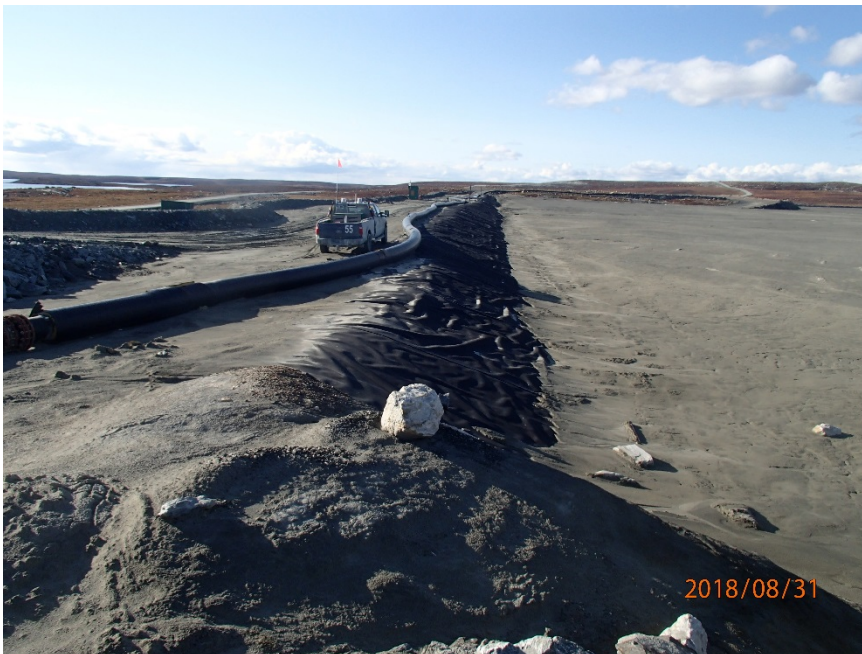
Photograph B3-6 Saddle Dam 2

Description: From approximately Sta. 20+250 downstream, looking southeast at the downstream toe.

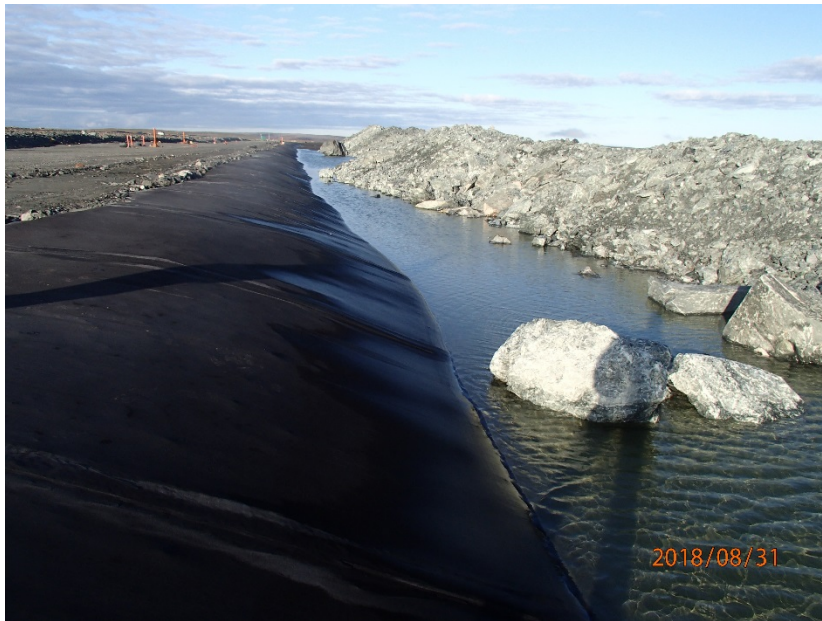
Photograph B4-1 Stormwater Dike

Description: From the east abutment (11+100 approximately), looking west at the upstream face and the rockfill cover of the North Cell. Shallow water ponding against portion of the dike (less than 30 cm deep). Large rocks are present near the liner.

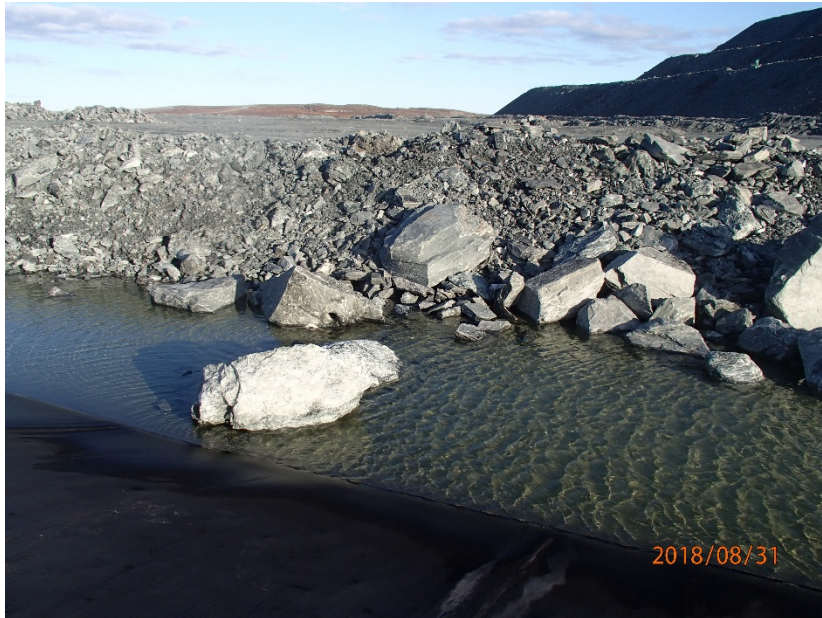
Photograph B4-2 Stormwater Dike

Description: From the east abutment (11+100 approximately), looking northwest at the North Cell and the rockfill cover. Large rocks are present near the liner.

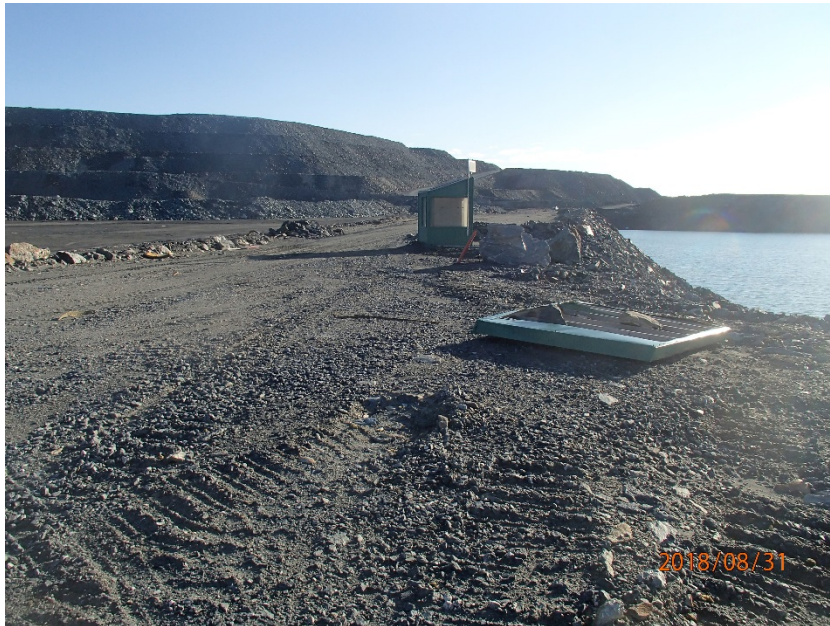
Photograph B4-3 Stormwater Dike

Description: From Sta. 10+650 looking east at the crest.

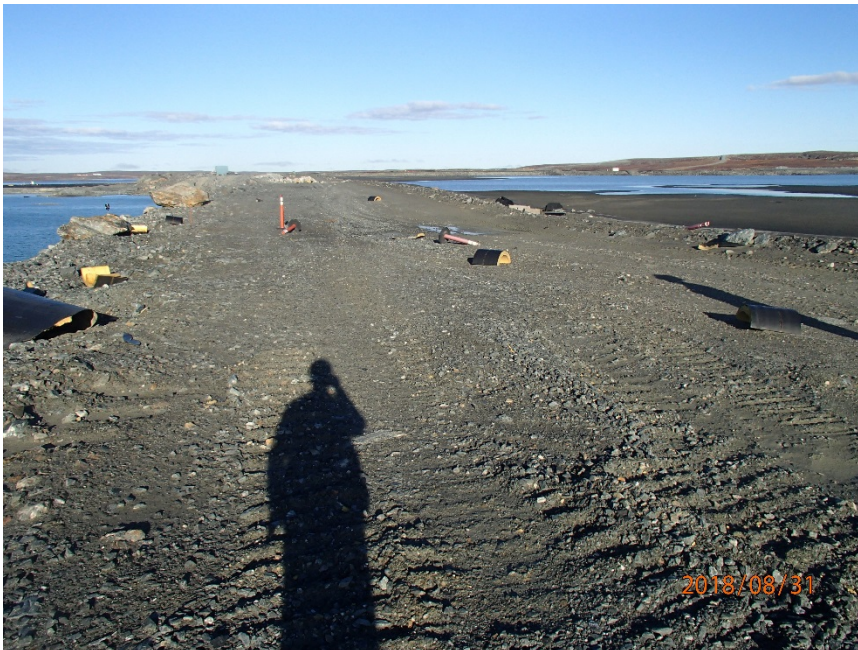
Photograph B4-4 Stormwater Dike

Description: From Sta. 10+650 looking west at the crest. Shallow water against portion of Stormwater Dike.

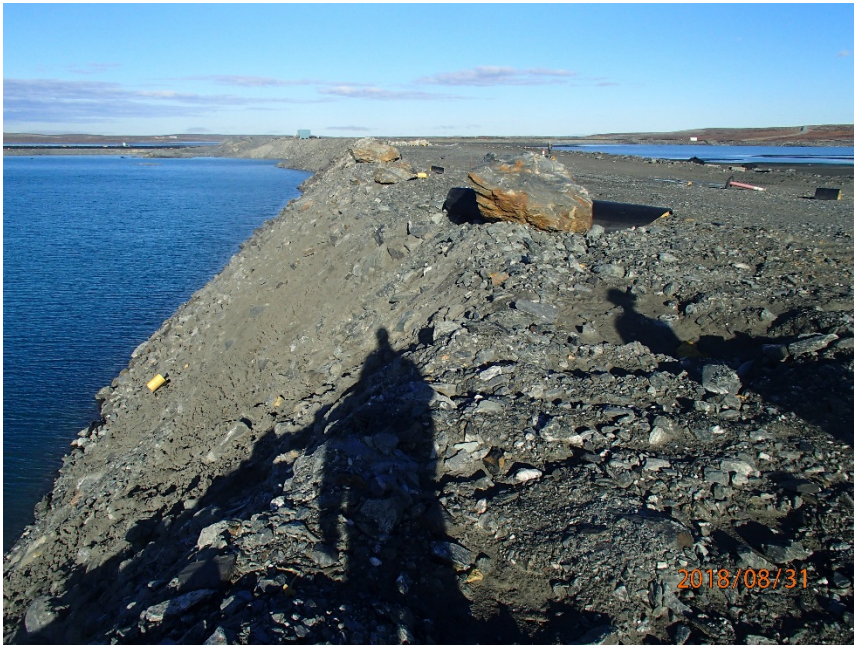
Photograph B4-5 Stormwater Dike

Description: From approximately Sta. 10+650 looking west at the downstream slope.

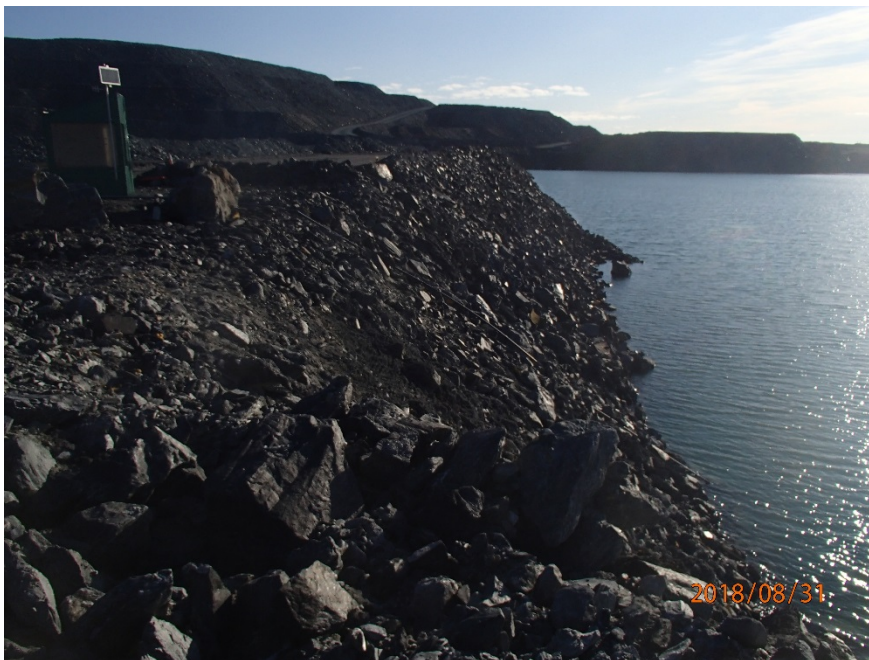
Photograph B4-6 Stormwater Dike

Description: From approximately Sta. 10+650 looking east at the downstream slope.

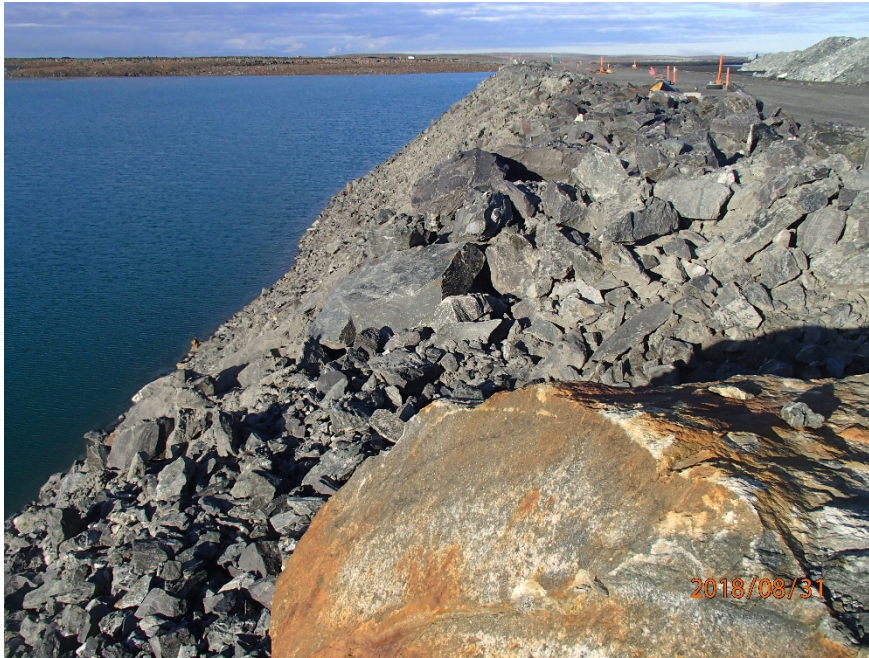
Photograph B4-7 Stormwater Dike

Description: From approximately Sta. 11+000, looking southwest at the downstream slope.

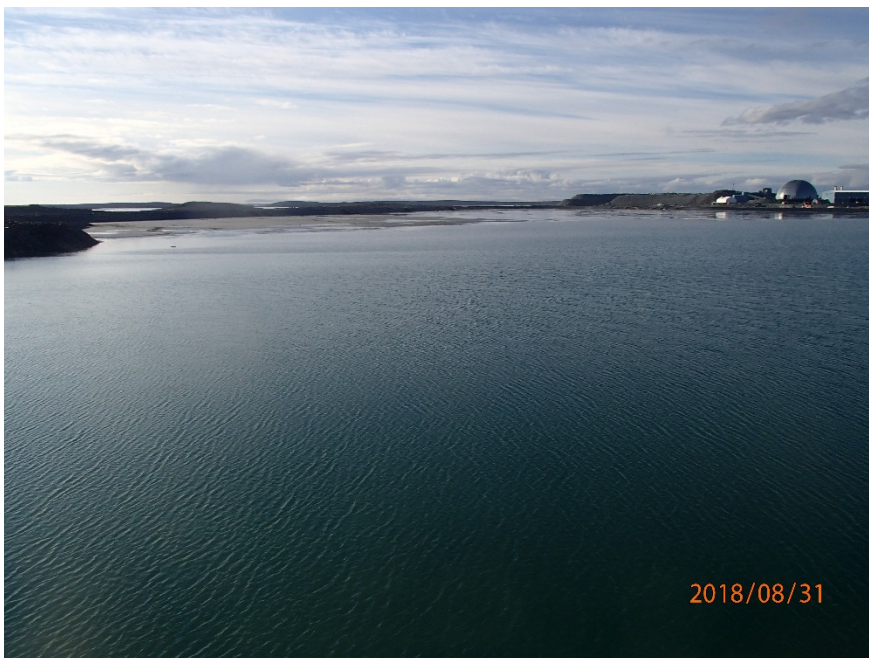
Photograph B4-8 Stormwater Dike

Description: From approximately Sta. 10+875, looking southeast at the South Cell.

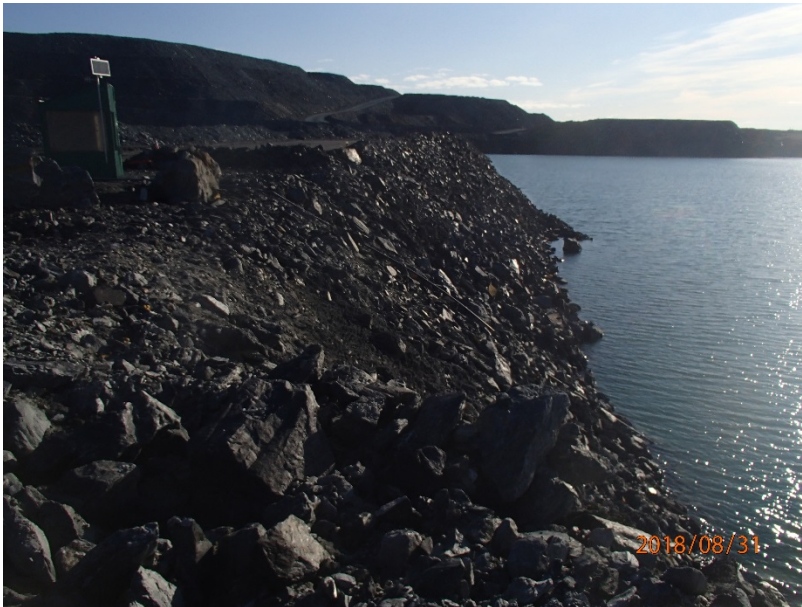
Photograph B4-9 Stormwater Dike

Description: From Sta.10+650, looking east at the crest and the downstream slope.

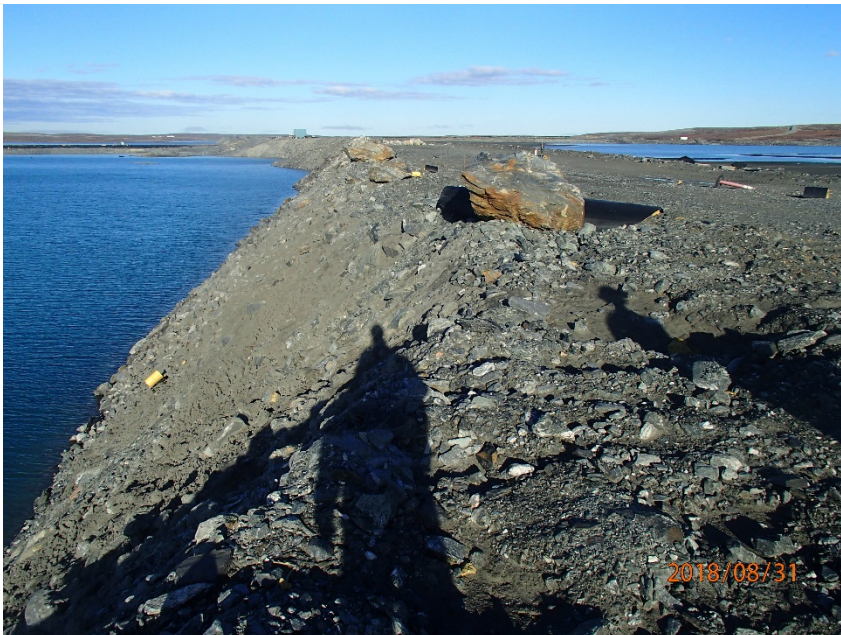
Photograph B4-10 Stormwater Dike

Description: From Sta.10+650, looking west at the crest and the downstream slope.

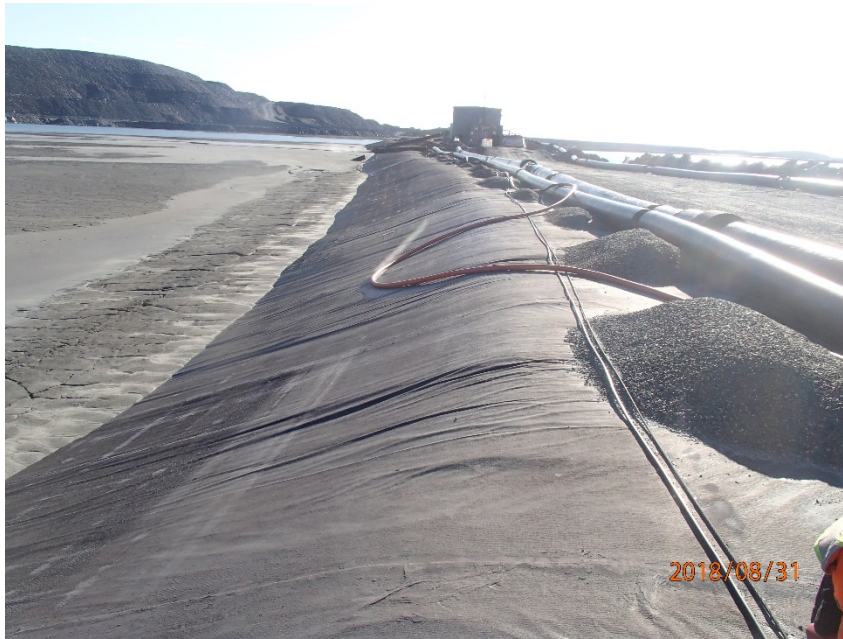
Photograph B4-11 Stormwater Dike

Description: From Sta.10+175, looking east at the upstream slope. The tailings beach is adequate.
