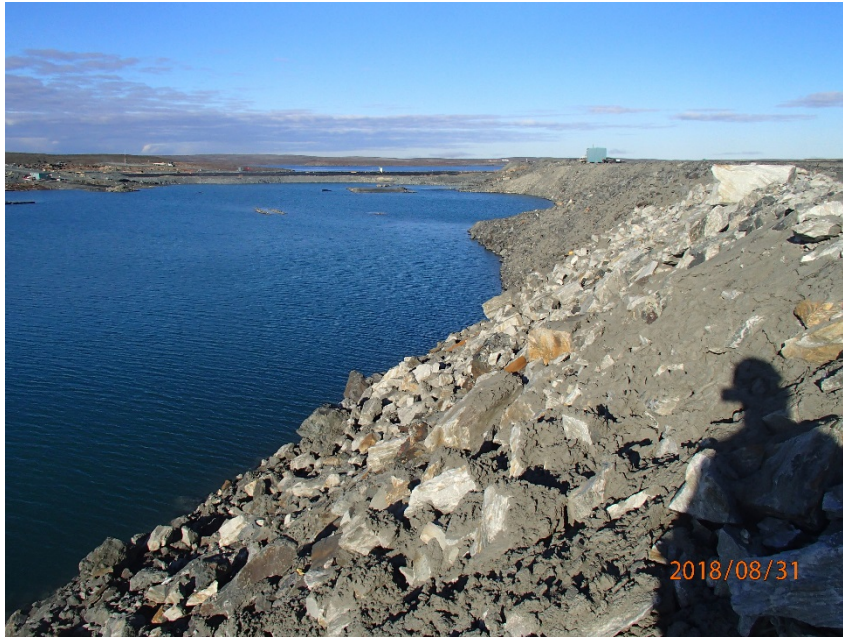
**Description:** From Sta.10+175, looking north at the upstream slope and the North Cell. The tailings beach is adequate.

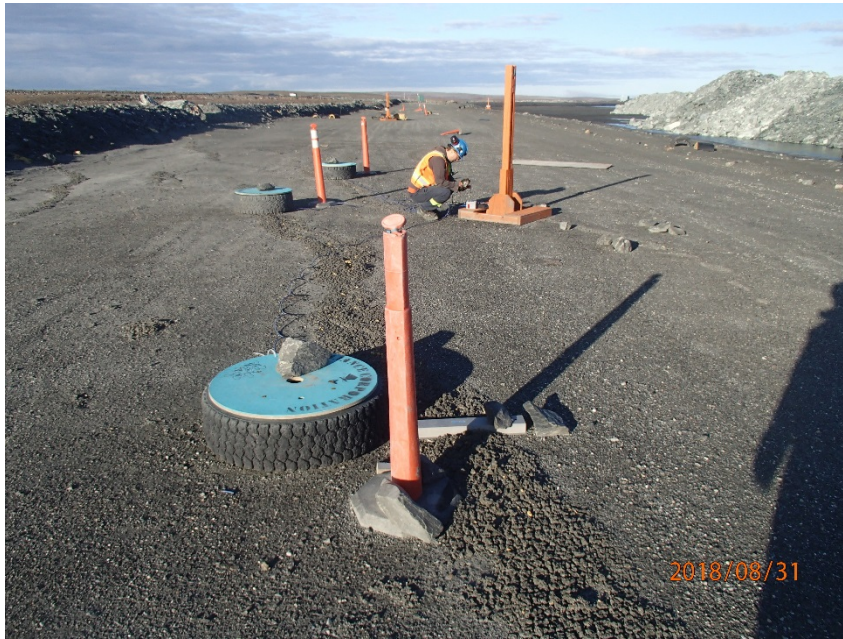
**Photograph B4-17 Stormwater Dike**

**Description:** From Sta.10+975, looking southwest at the crest. View of the crackmeters and wire extensometers installed in the previous settlement zone active in the spring.

| INSPECTION ITEM | OBSERVATIONS DATA | PHOTO | COMMENTS & OTHER DATA |
|---|---|---|---|
| 1.4 Surface cracking | Yes | 276 | |

| INSPECTION ITEM | OBSERVATIONS DATA | PHOTO | COMMENTS & OTHER DATA |
|---|---|---|---|
| 1.5 Unexpected settlement | No | | Tension cracks and unexpected movement were observed (oblique tension cracks extending side to side). They are concentrated from 10+700 to 11+000 and appeared in May before the freshet. They have since been filled with bentonite. No movement has been observed in the zone where a buttress was constructed at the toe in the South Cell. The buttress is covered by the pond. |

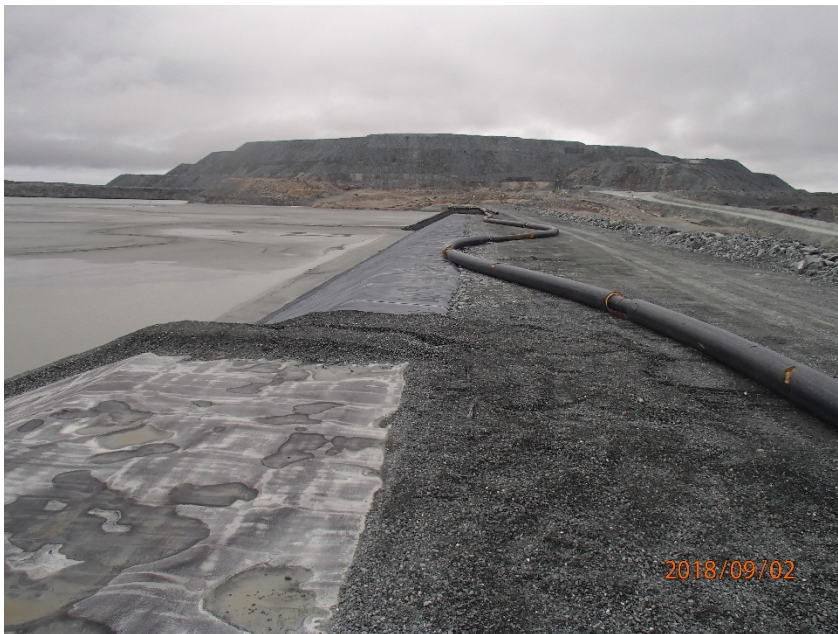
**Photograph B7-2 Central Dike and Saddle Dam 5**

**Description:** From approximately Sta. 0+525 looking northwest at the upstream slope. Adequate tailings beach against the south section of the structure.

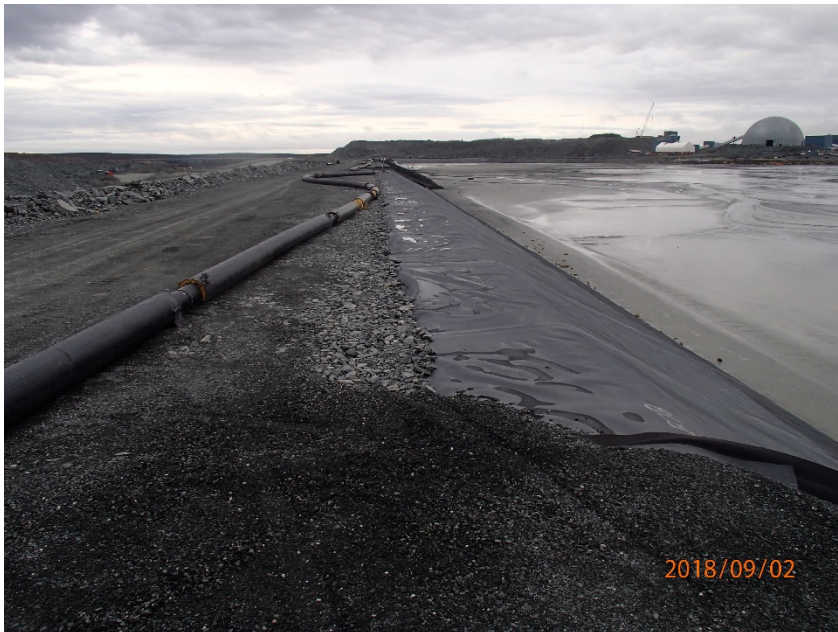
**Photograph B7-3 Central Dike and Saddle Dam 5**

**Description:** From approximately Sta. 0+525 looking southwest at the upstream slope. Adequate tailings beach against the south section of the structure.

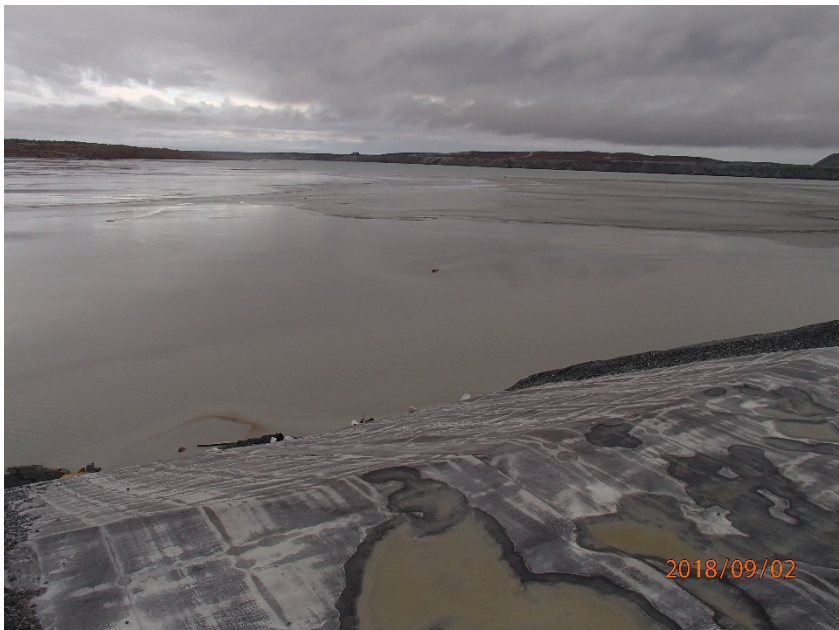
**Photograph B7-4 Central Dike and Saddle Dam 5**

**Description:** From approximately Sta. 0+525 looking at the deposition finger. The LLDPE liner is well protected and the tailing beach against the structure is adequate.

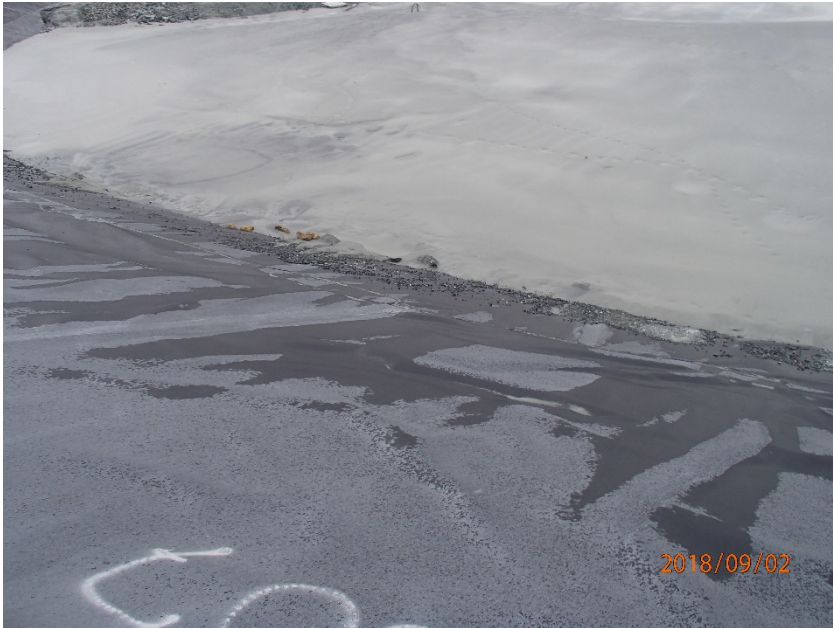
**Photograph B7-11 Central Dike and Saddle Dam 5**

**Description:** From approximately Sta. 1+075 upstream. Presence of gravel on the LLDPE liner.

| INSPECTION ITEM | OBSERVATIONS DATA | PHOTO | COMMENTS & OTHER DATA |
|---|---|---|---|
| 2.5 Face liner condition<br>(if applicable) | | 382 | Liner covered by a granular<br>protection layer up to El. 128 m and<br>well protected underneath deposition<br>fingers.<br>Presence of gravel on the liner on<br>the sides of the deposition points. |

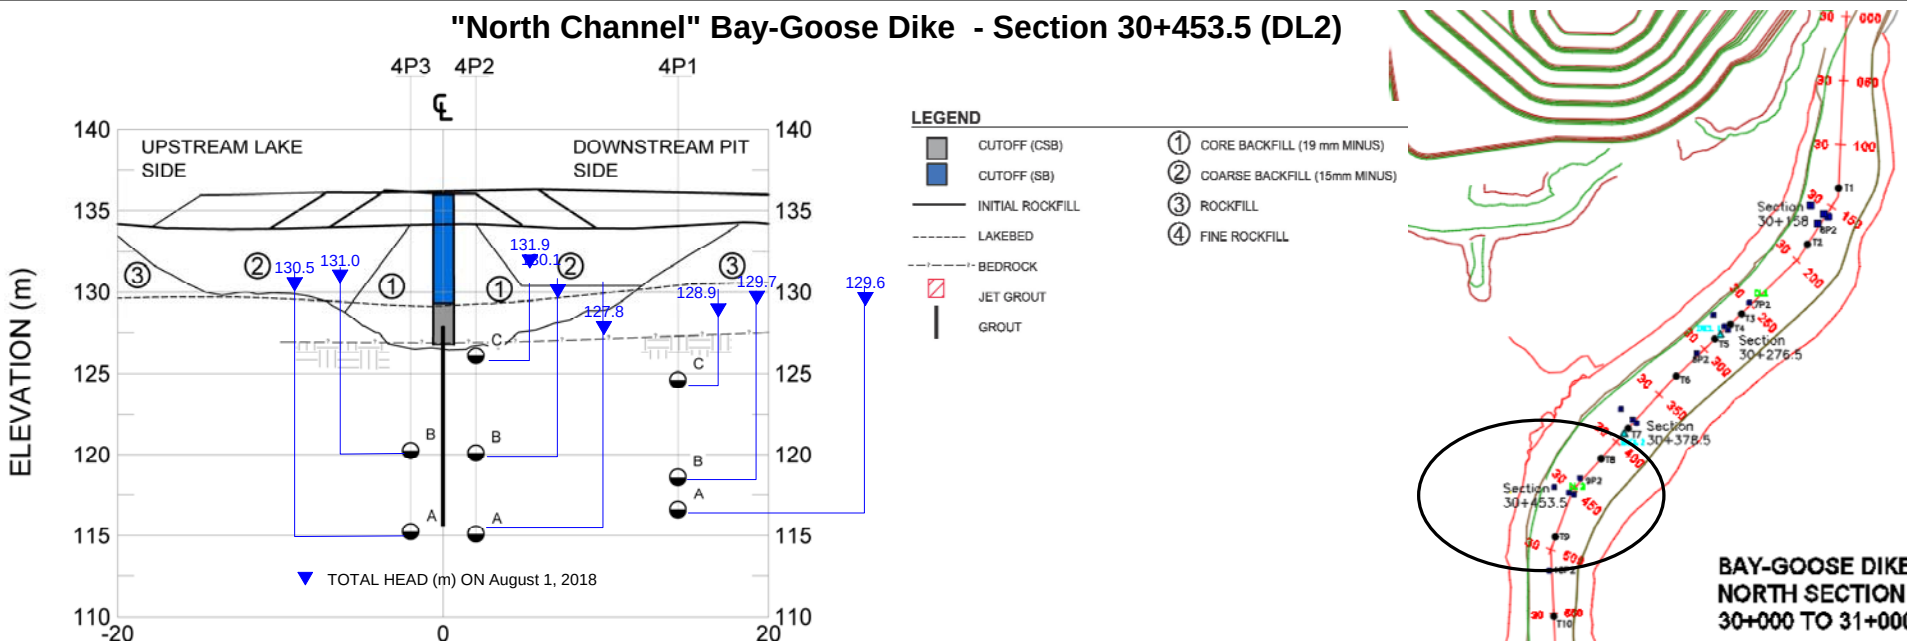
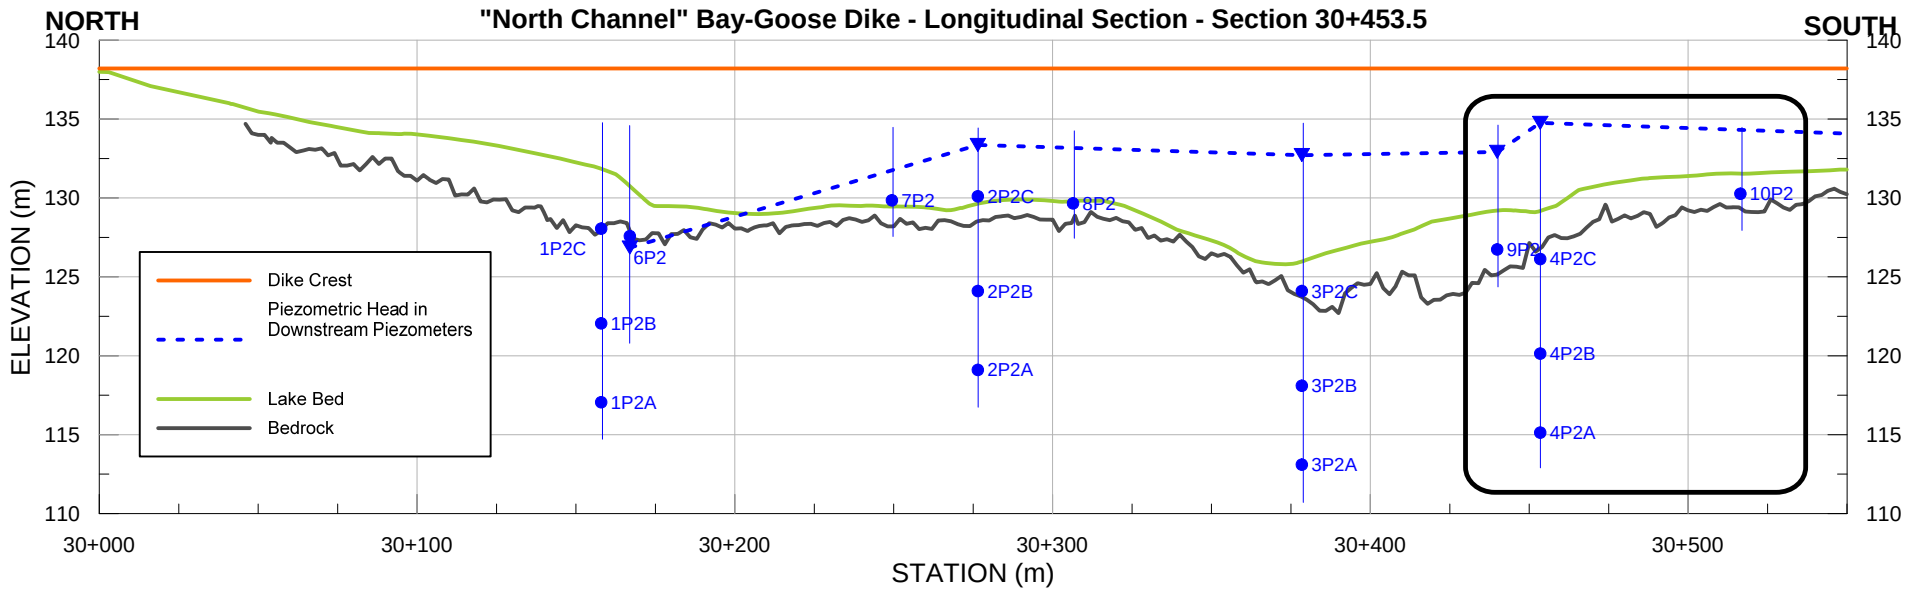
| FIGURE 6 | | | | |

- All 4P1, 4P2C and 10P2 is given unstable readings and since the temperature either shows a negative reading or is close to a negative reading it is assumed to be frozen.
- Pressure changes are attributed to the drill and blast in Portage Pit E5 along with ice buildup that occurs.
- Some of the PWP that are over the Upstream Water Level can be attributed to having a negative temperature and assumed frozen.
- Gap in data in December is due to a low battery. Battery was changed the following day.

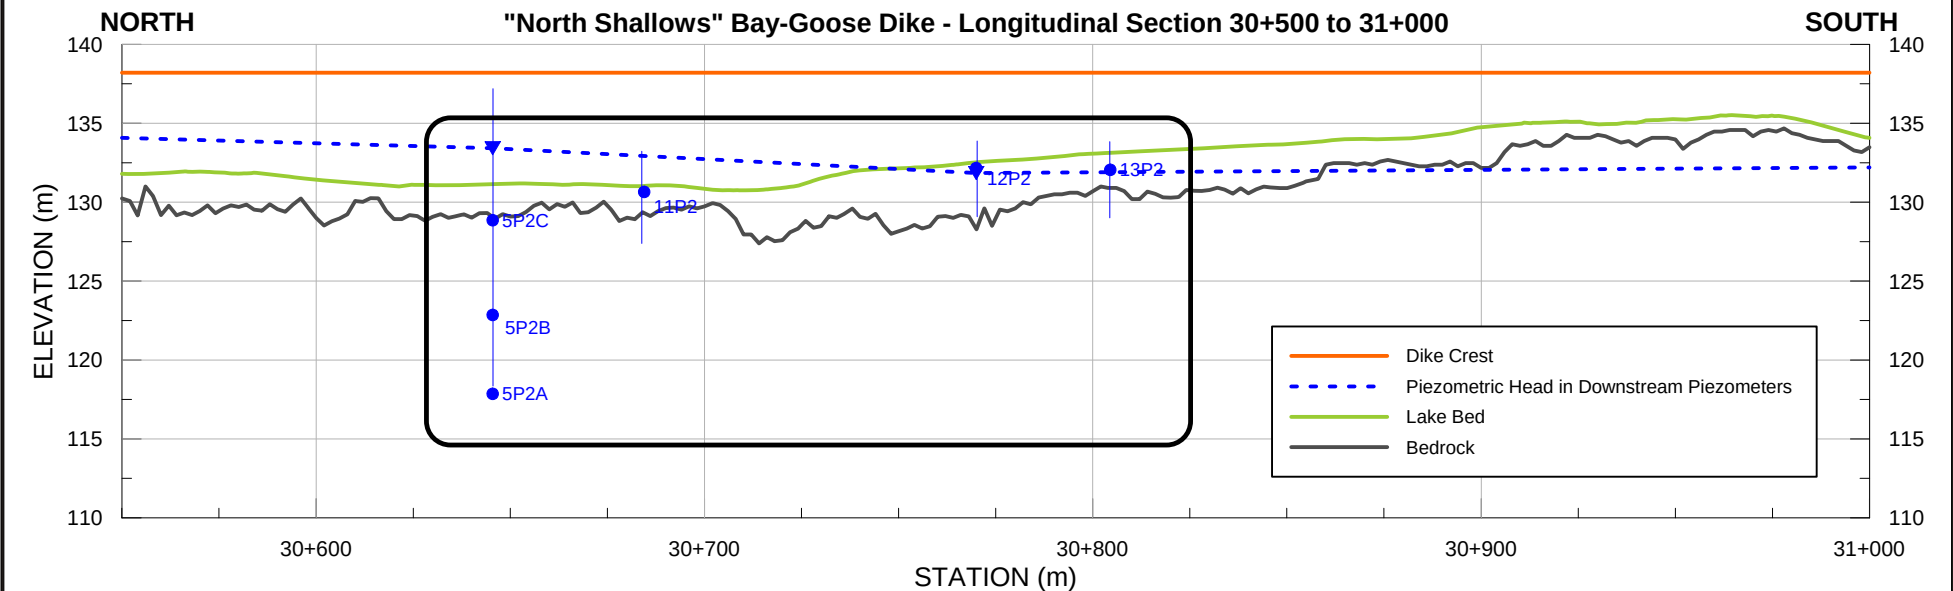
- 5P1A, 5P1B, 5P1C, 5P2C and 11P2 are giving unstable readings and since the temperature shows a negative reading it is assumed to be frozen.
- A spike in temperature also has been corrected and stabilized due to a faulty MUX board.
- Gap in data in December was due to a low battery. Battery was changed the following day.

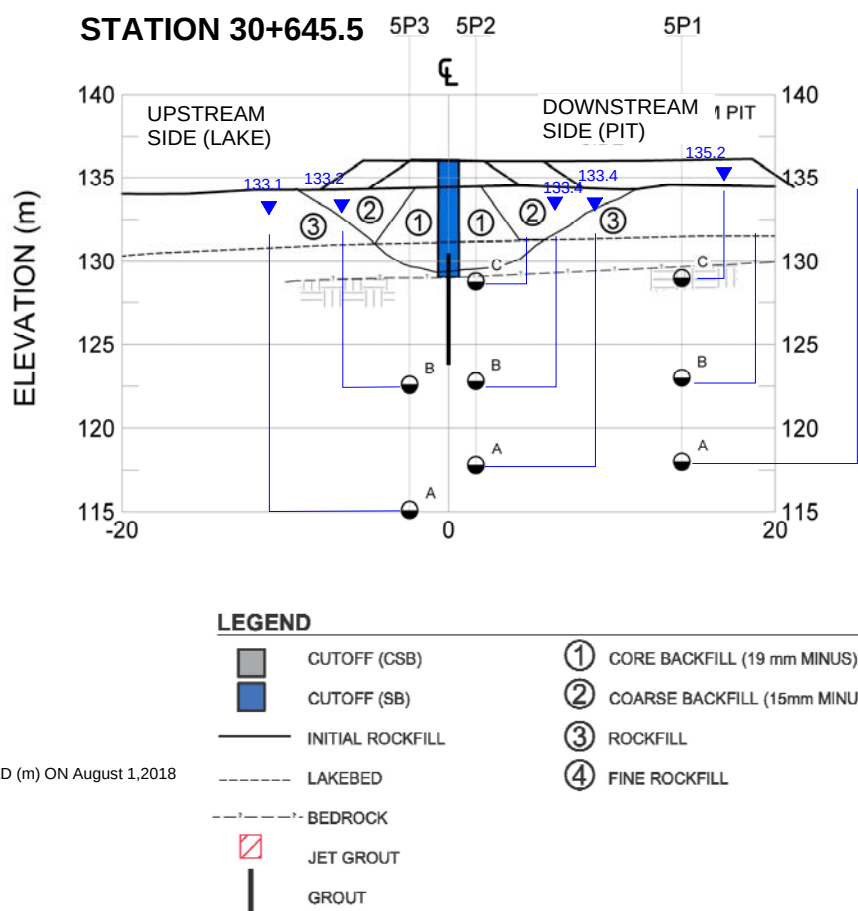
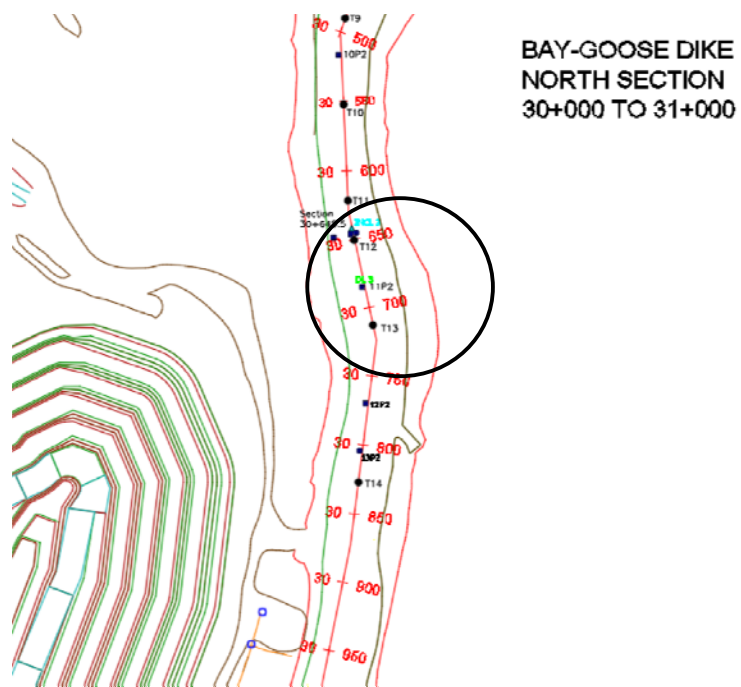
| | | | | <b>FIGURE 9</b> |

- 5P1A, 5P1B, 5P1C, 5P2C are giving unstable readings and since the temperature shows a negative reading it is assumed to be frozen.
- A spike in temperature also has been corrected and stabilized due to a faulty MUX board.
- Gap in data in December was due to a low battery. Battery was changed the following day.

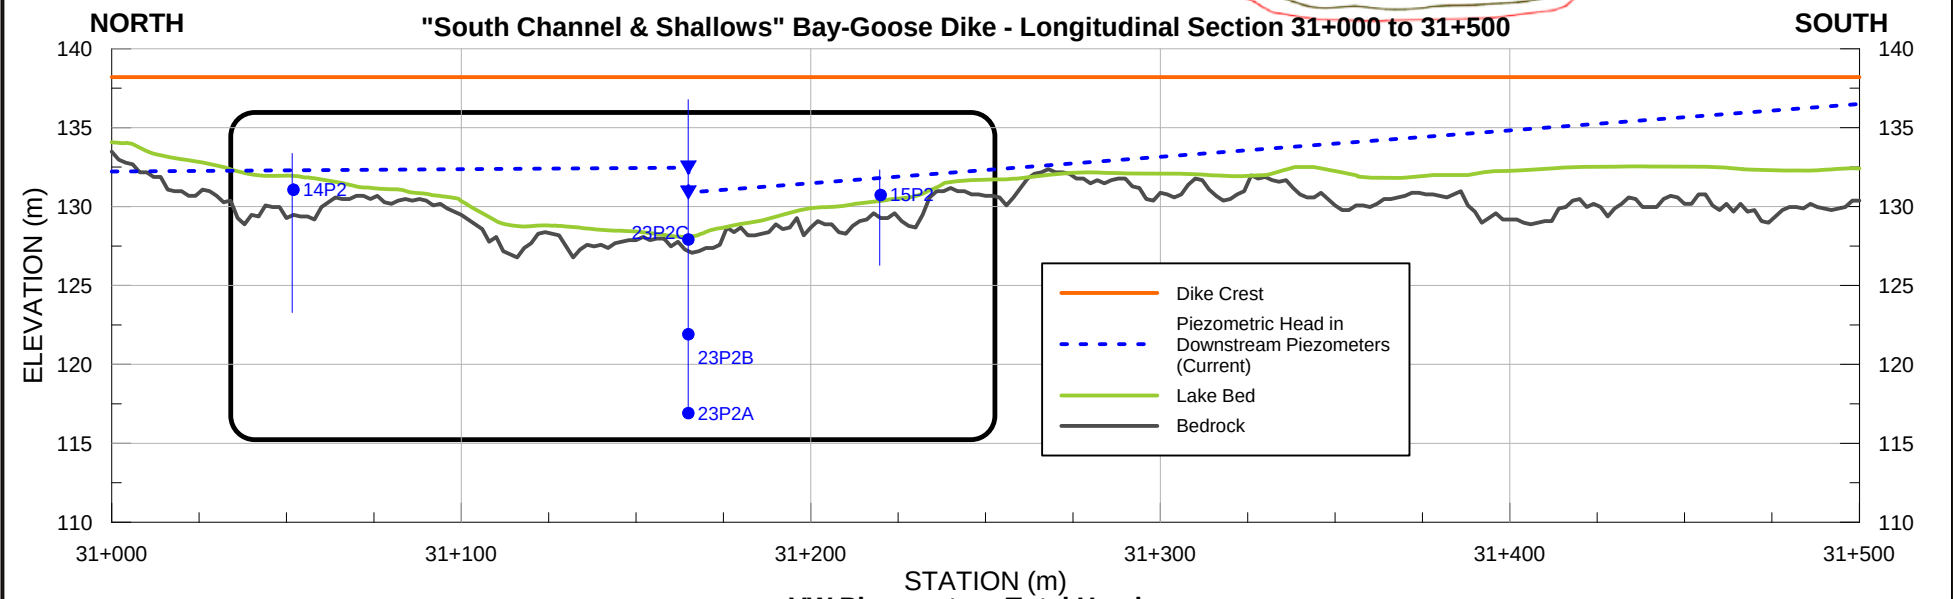
| | | | | | <b>FIGURE 10</b> |

1. 14P2 and 15P2 are given unstable readings and since the temperature shows a negative reading it is assumed to be frozen.
2. PWP rises and falls due to ponding in the area and continuous pumping, and allowing the ponding to raise. The steady increase is when the ponding area freezes, and no pumping is done till the thawing of the area.
3. Gap in data in December is due to low battery. Battery was changed the following day.

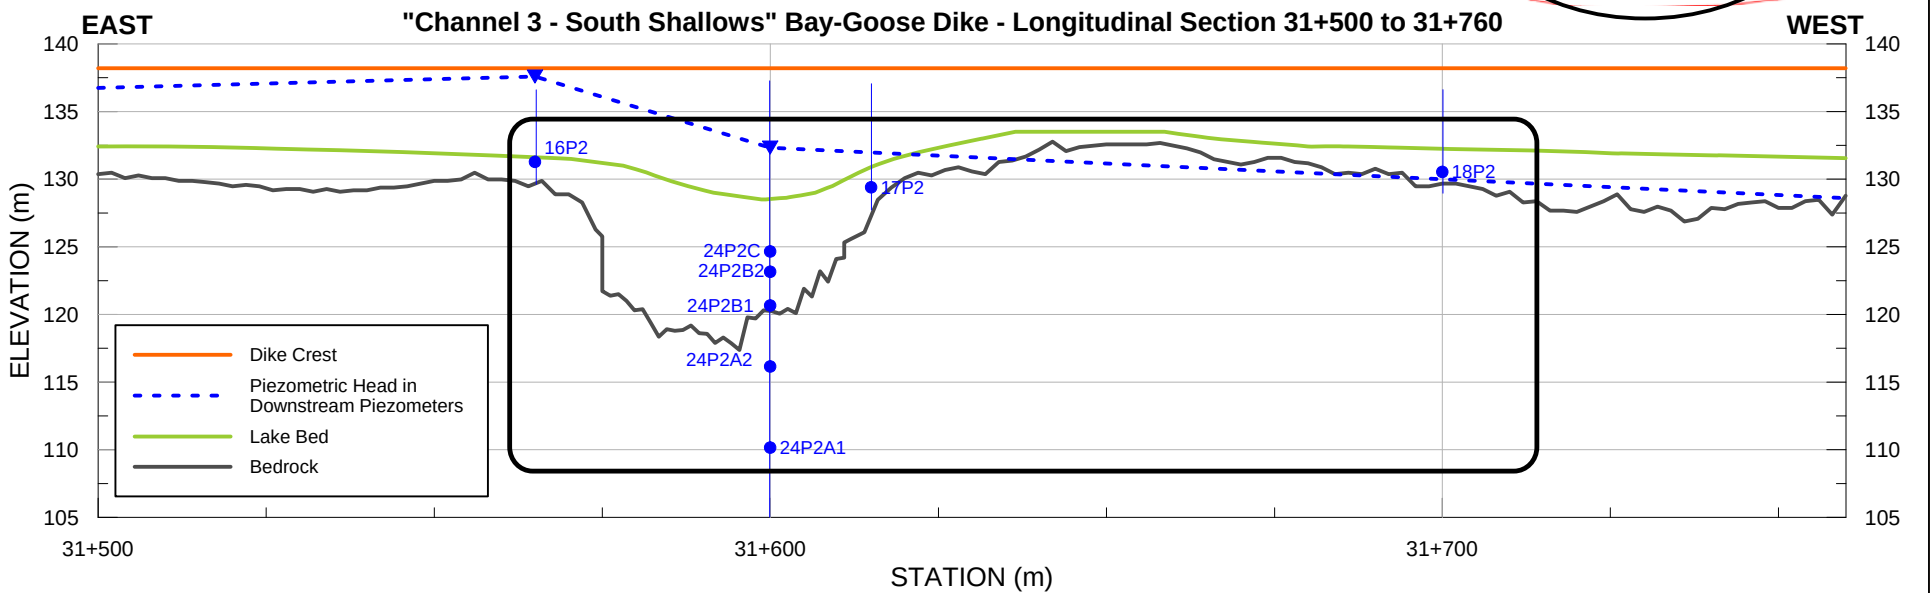
"Channel 3 - South Shallows" Bay-Goose Dike - Section 31+500 to 31+760 (DL5)

- 16P2, 17P2 and 18P2 are given unstable readings and since the temperature shows a negative reading it is assumed to be frozen.
- PWP is following same trend as previous years. When ice builds the pressure increases and when it melts in summer the pressure decreases
- Gap in data in December is due to low battery. Battery was changed the following day.

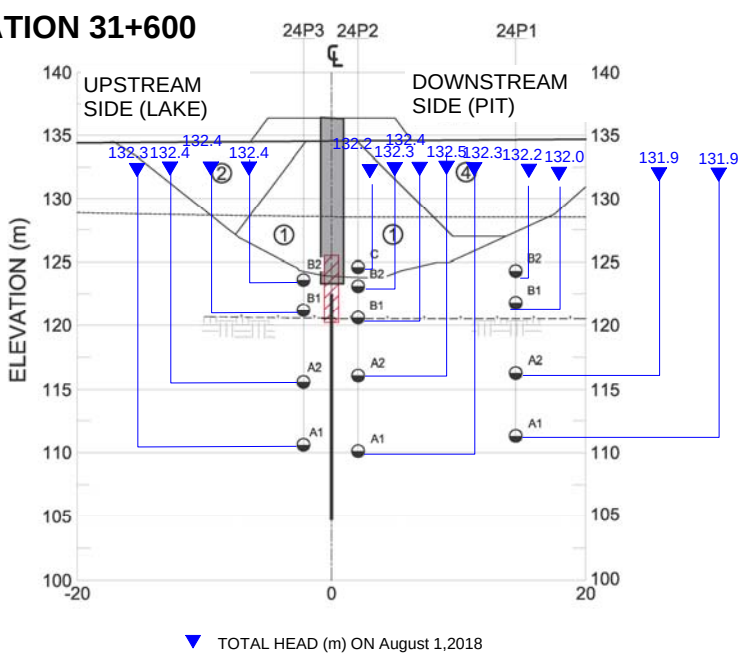
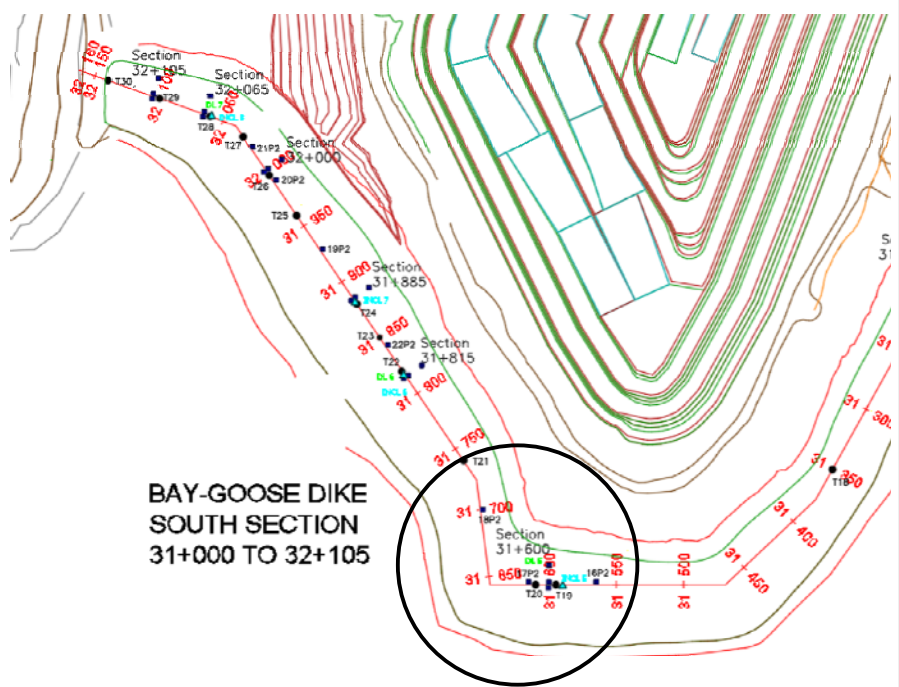
STATION 31+600

1. The rise in temperature and PWP was interpreted as the permafrost at the toe of the dike blocking the seepage path which led to this events. Will continue to monitor in the field and the instruments. Since the snow melt the blockage is not longer there and the PWP is on a downtrend.
2. There is a signal loss since March 7/18 which is due to the snow accumulating on the Goose Waste Dump pile. Since the snow melt signal is back.

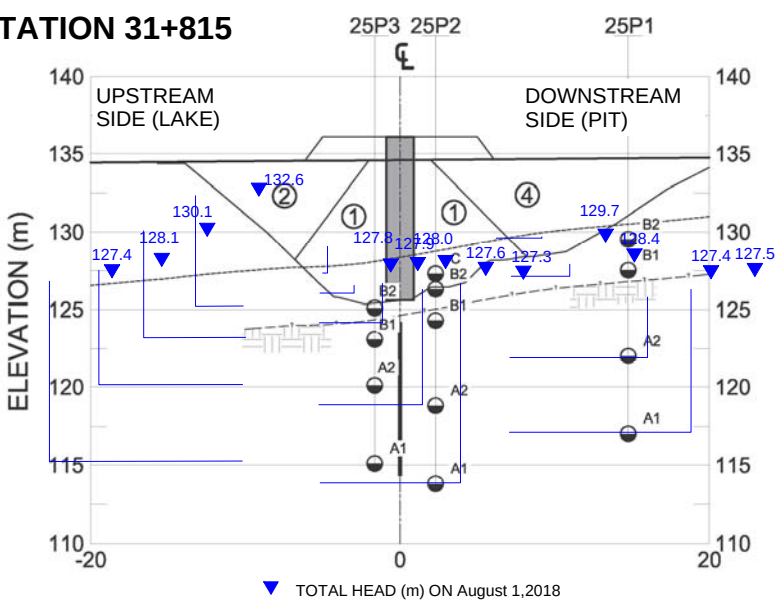
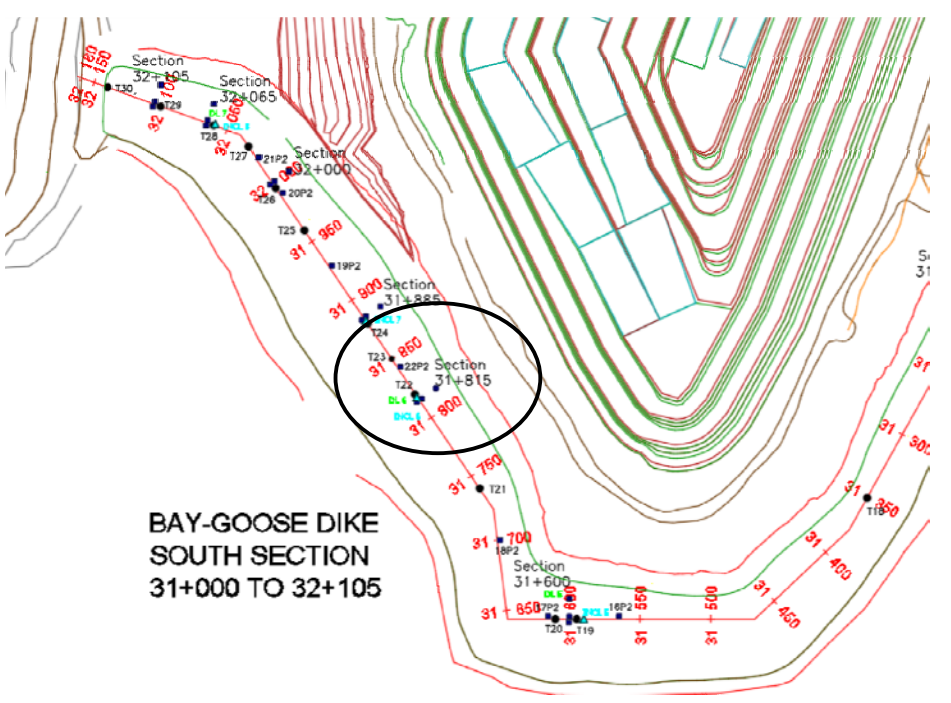
STATION 31+815

- The rise in temperature and PWP was interpreted as the permafrost at the toe of the dike blocking the seepage path which led to this events. Will continue to monitor in the field and the instruments. Since the snow melt the blockage is no longer there and the PWP is on a downtrend.
- There is a signal loss since March 7/18 which is due to the snow accumulating on the Goose Waste Dump pile. Since the snow melt signal is back.

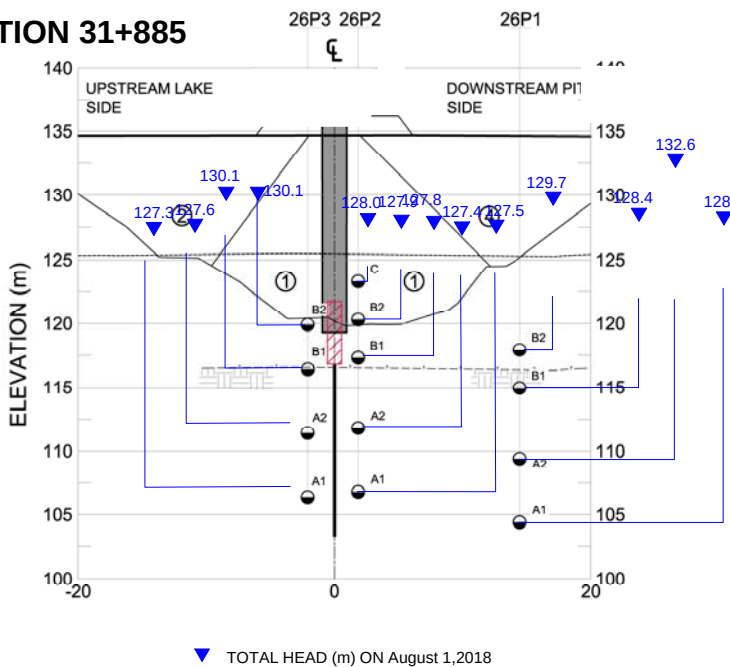
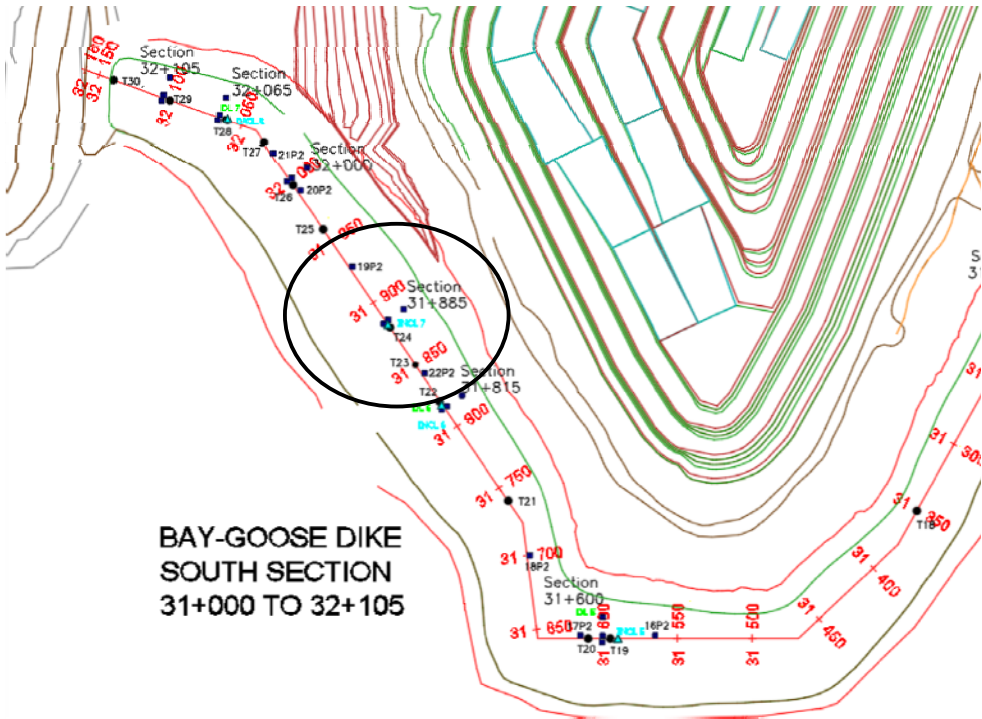
STATION 31+885

- The rise in temperature and PWP was interpreted as the permafrost at the toe of the dike blocking the seepage path which led to this events. Will continue to monitor in the field and the instruments. Now that ice has melted the PWP has decreased as the seepage path is no longer blocked.
- There is a signal loss since March 7/18 which is due to the snow accumulating on the Goose Waste Dump pile. Signal since snow melt has resumed.

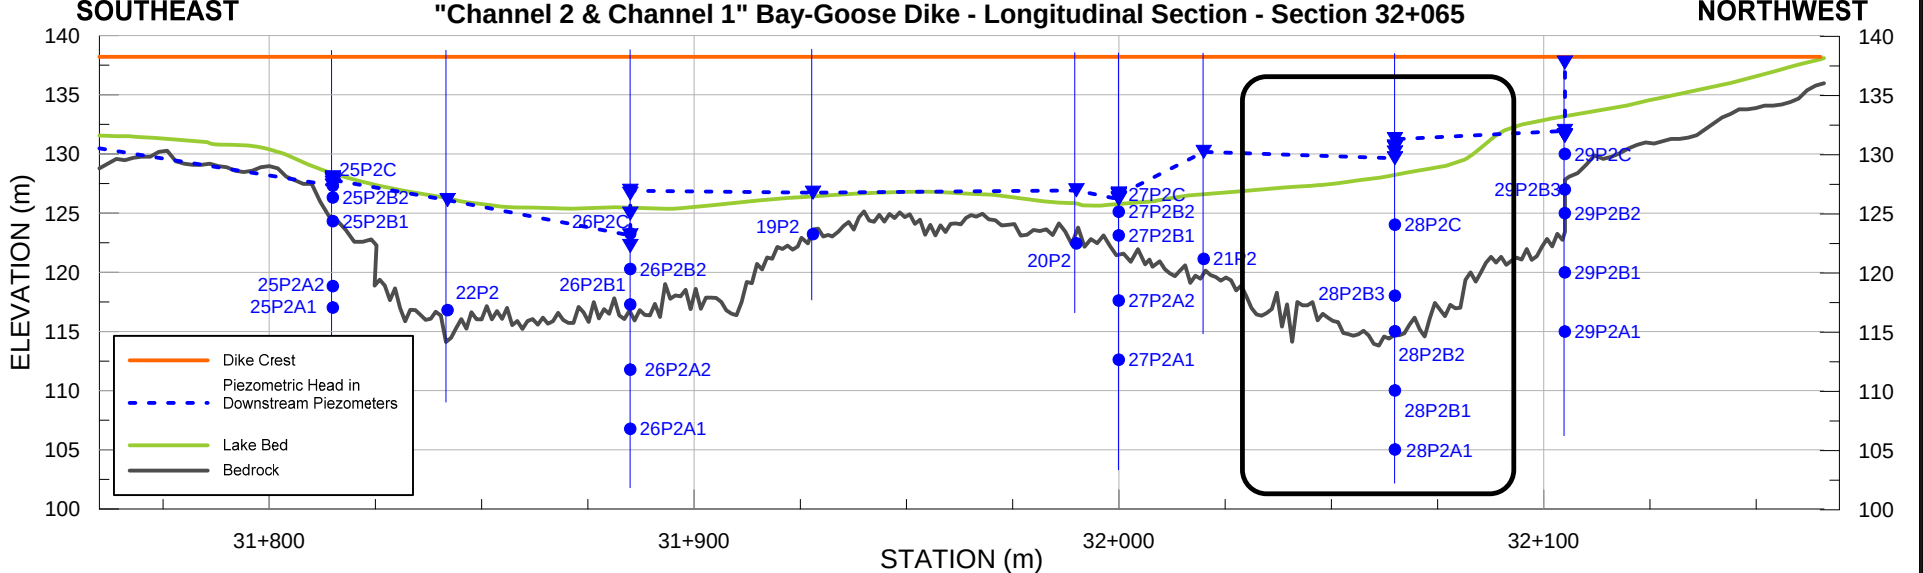
"Channel 2 & Channel 1" Bay-Goose Dike - Section 32+065 (DL7)

1. There are some anomaly readings from Dec. 10 to Dec. 11 which is due to low battery, which was changed.
2. There is a signal loss since March 7/18 which is due to the snow accumulating on the Goose Waste Dump pile. Since the snow melt the signal has returned.
3. Gap in data in December and January is due to low battery. Battery was changed the following day after.

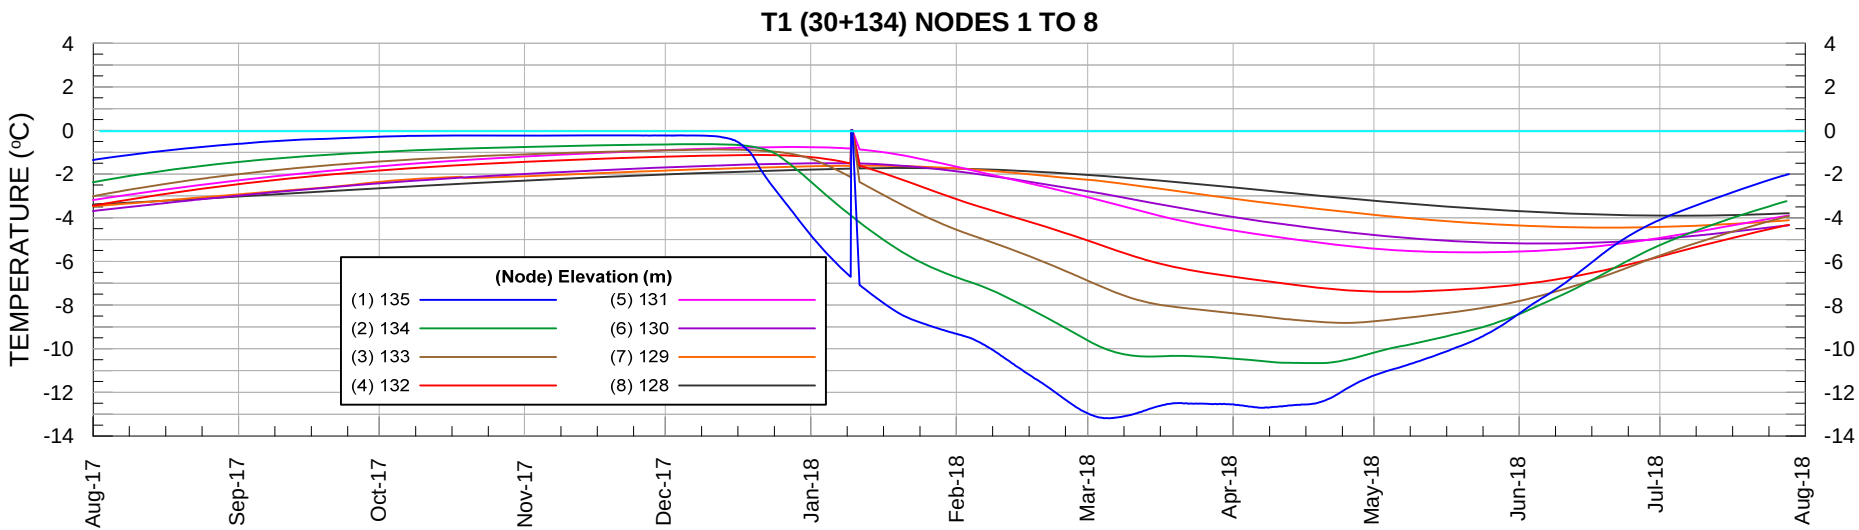
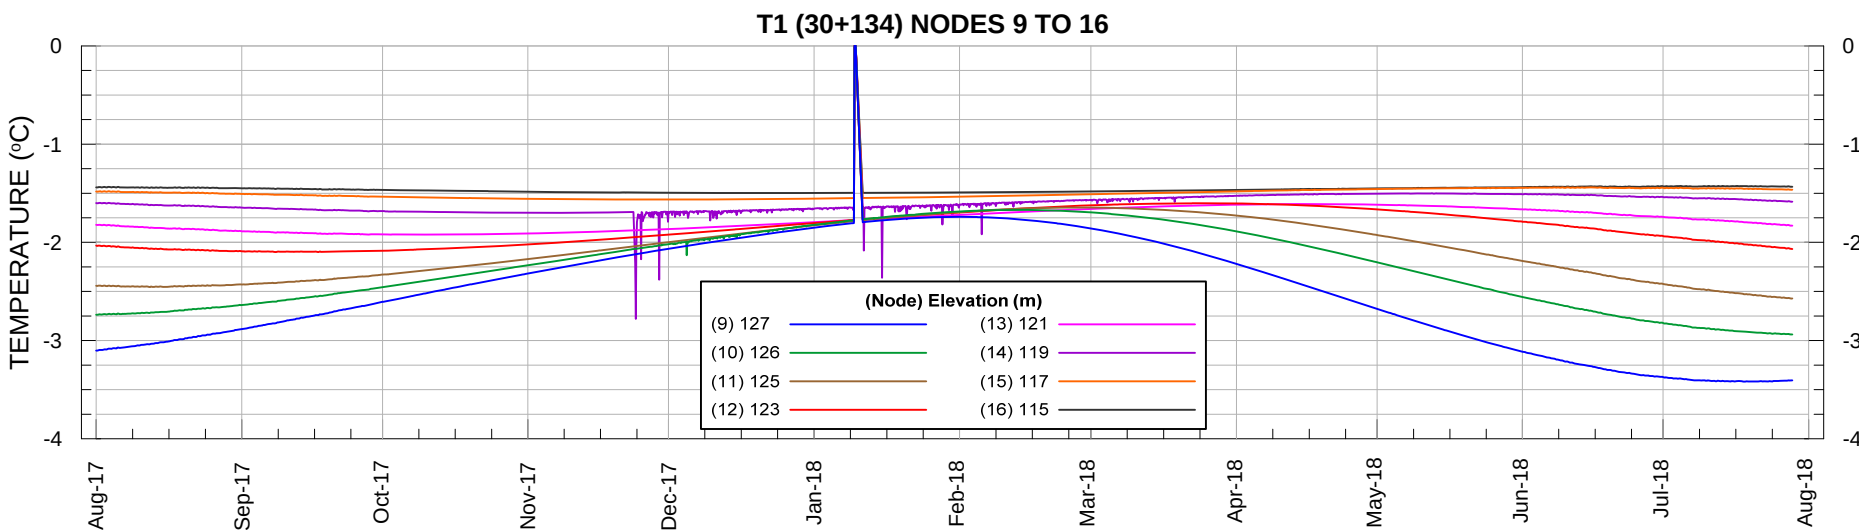
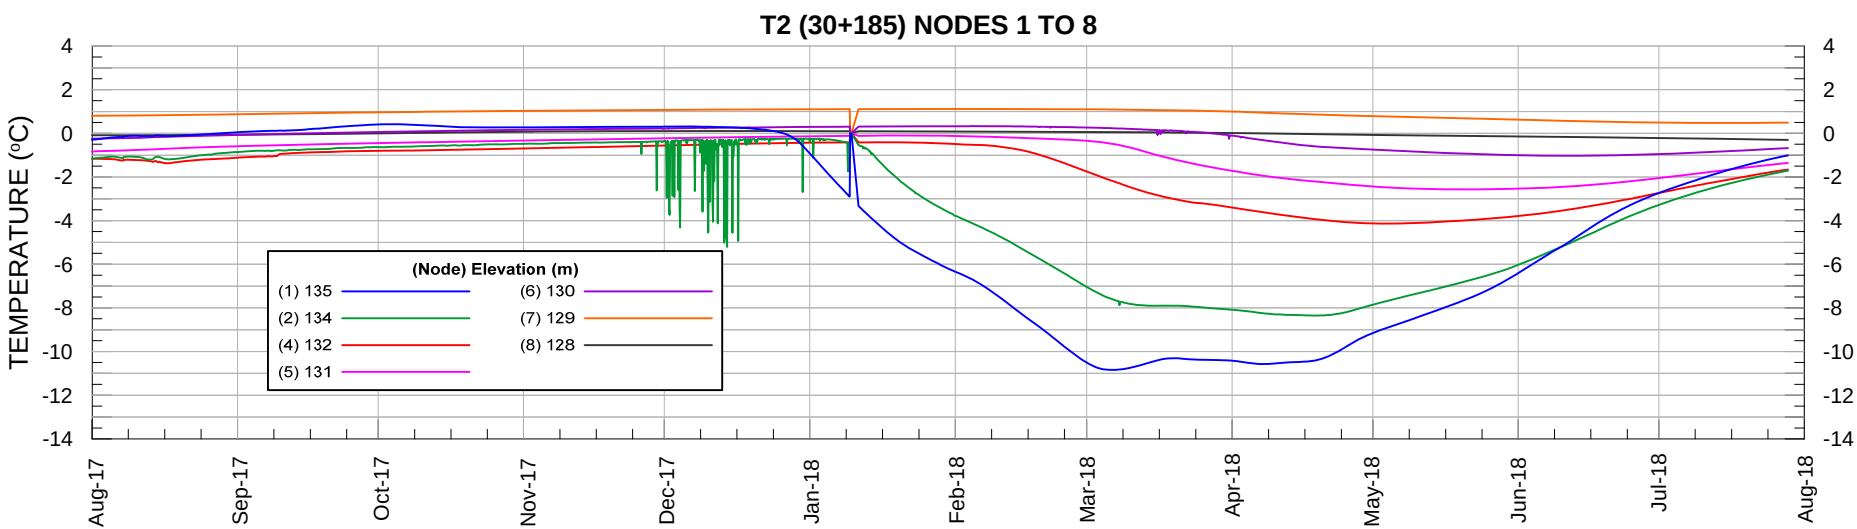
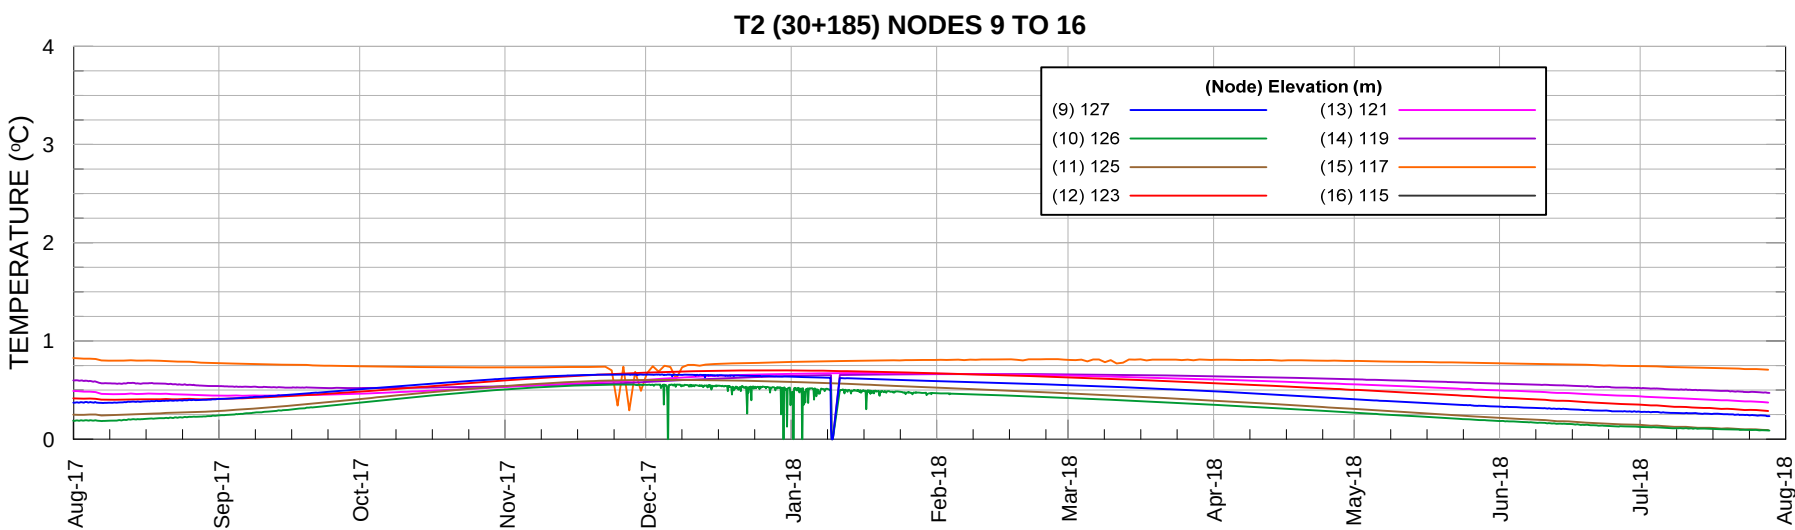
1. T1 (30+134) - values less than -0.5°C are not shown for Node 8 at elevation 128 m from June 24, 2011 to June 30, 2011 as these values are believed to be inaccurate.

3. T1 and T2 thermistors stopped transmitting data on June 10, 2015. Inspecting areas to determine a cause.

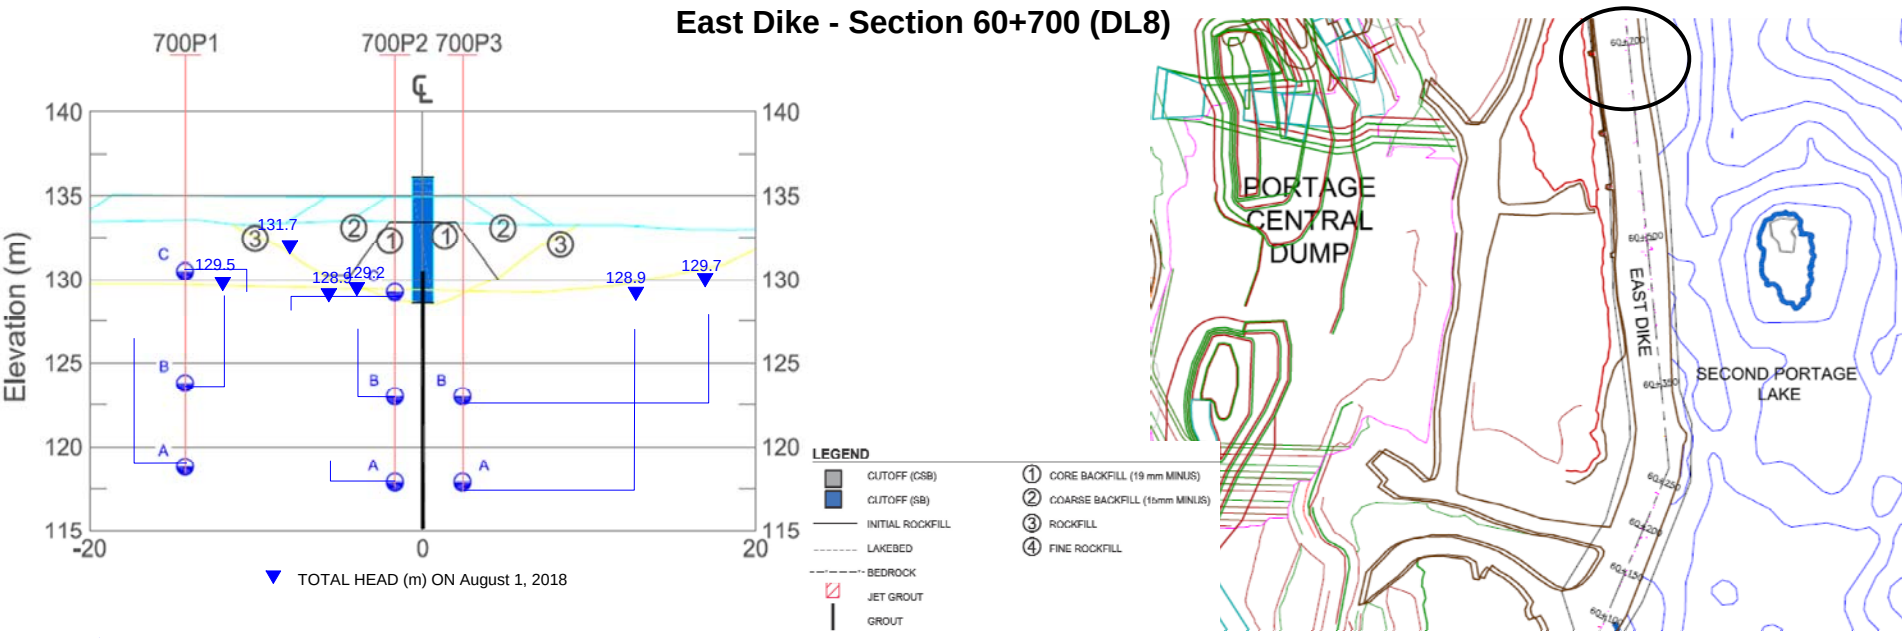
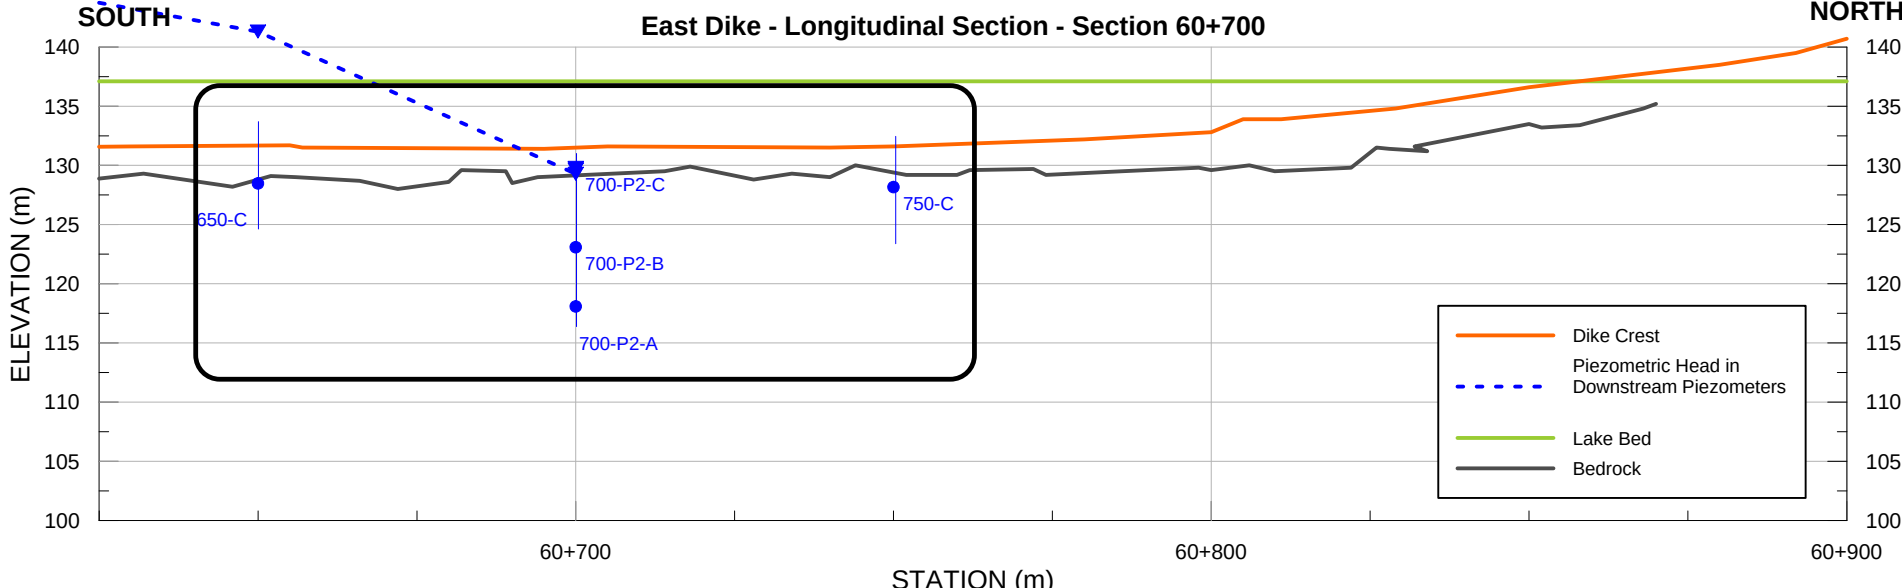
- 1: 700-P1-B and 750-C are giving anomaly readings and with a negative temperature are assumed to be frozen.
2. There was a rise in PWP in June. This was an unknown reason as there were no indications in the field.
