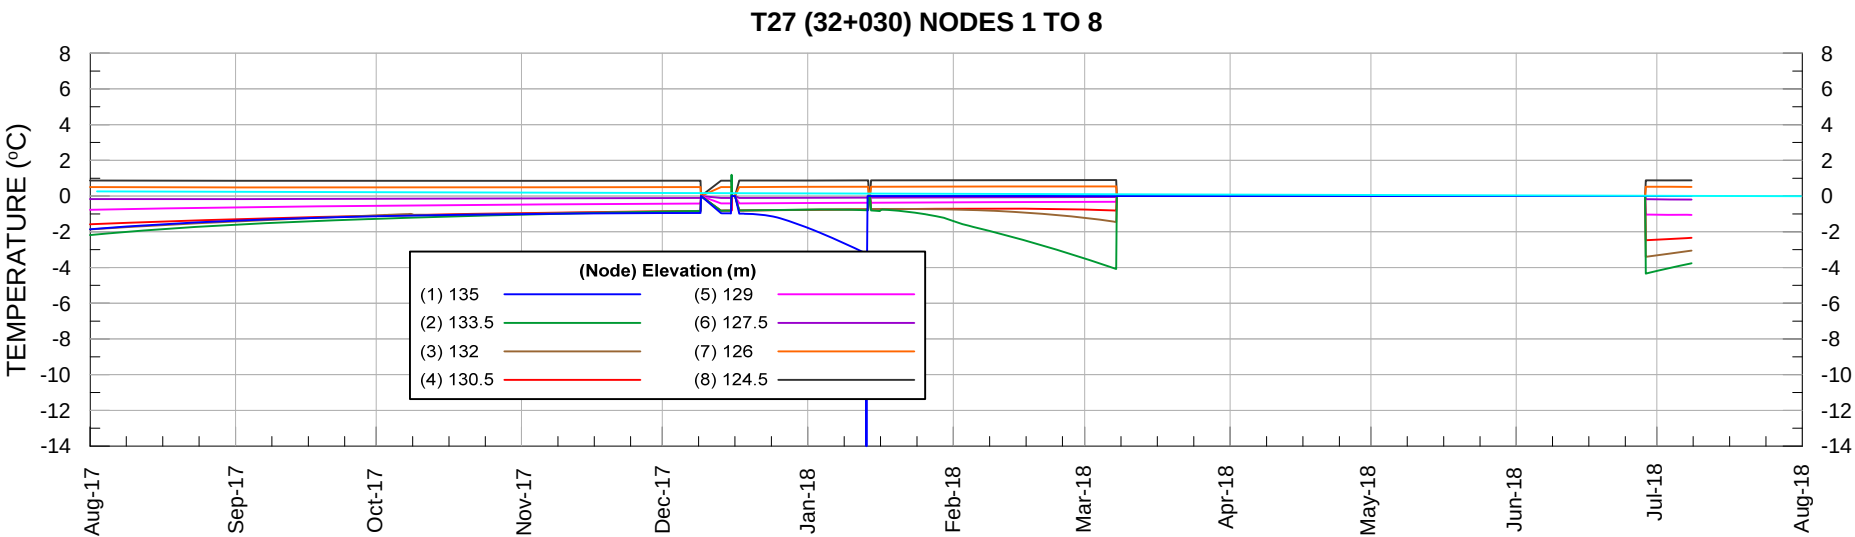
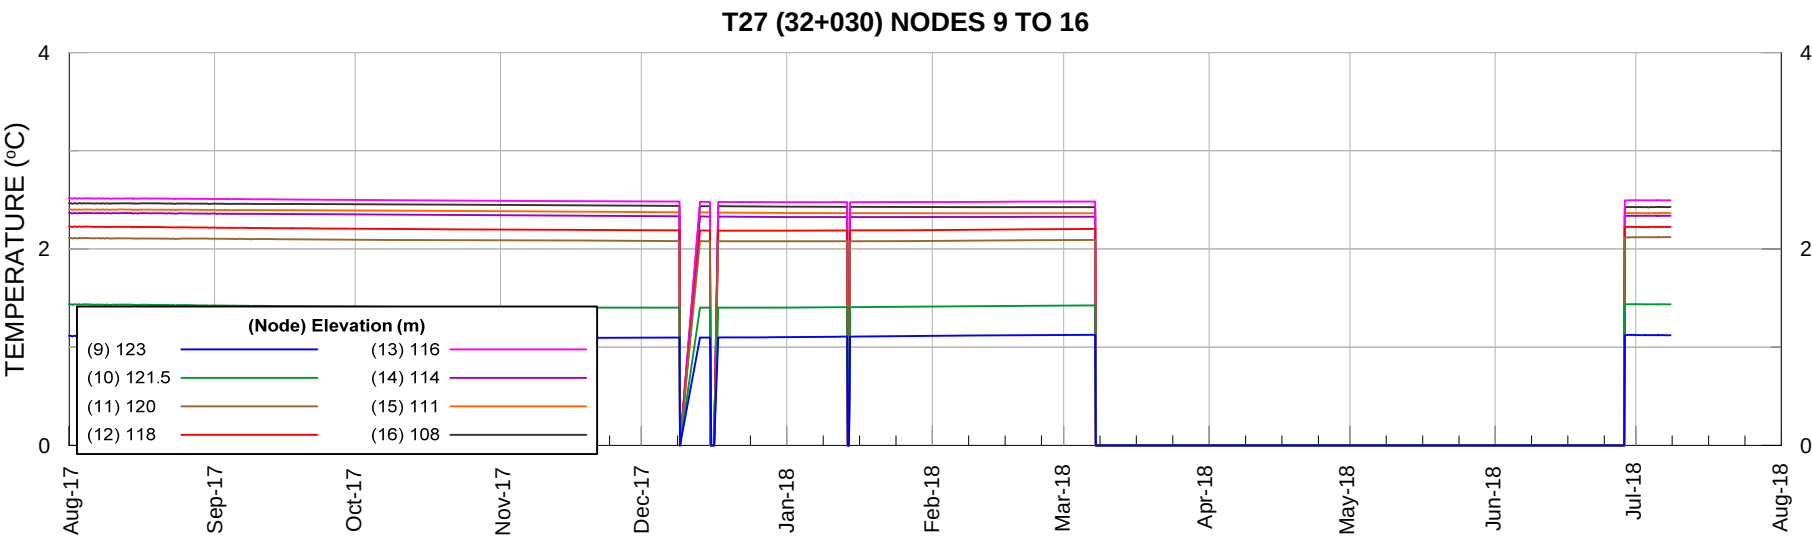
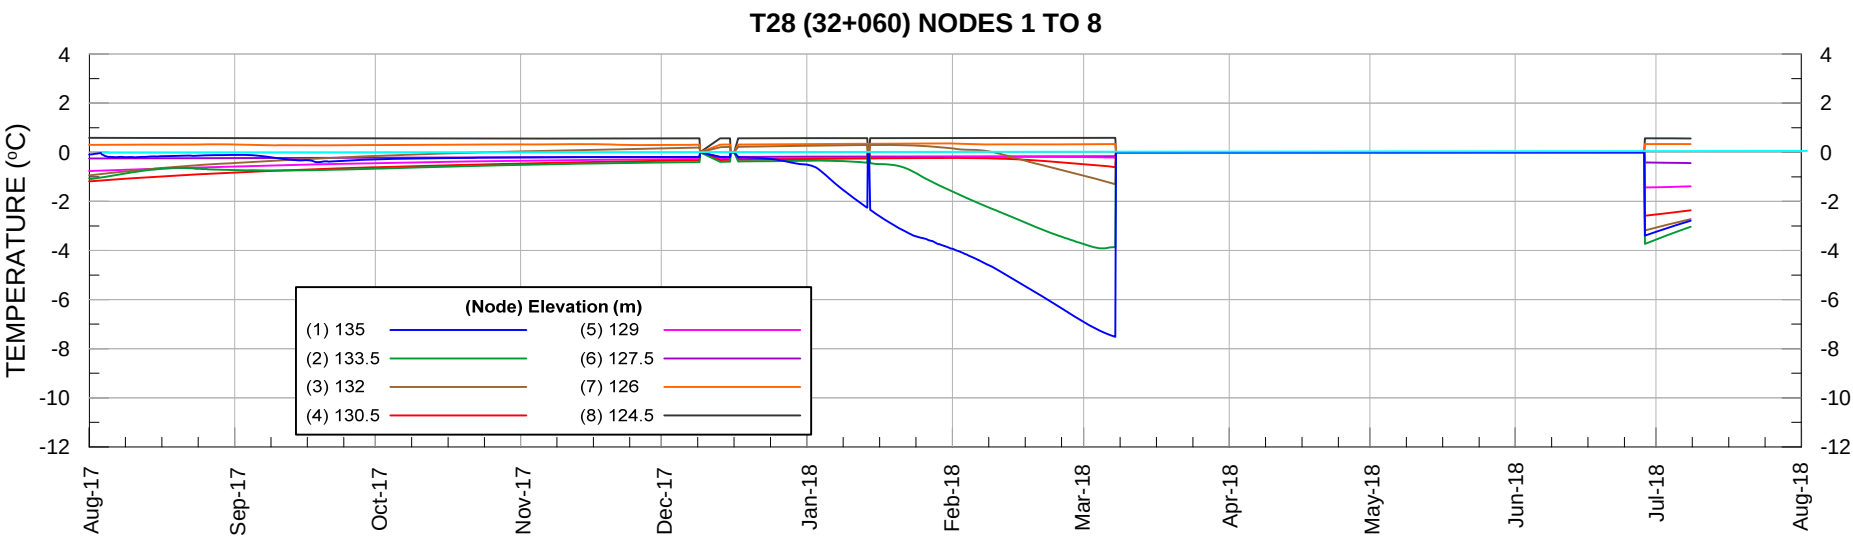
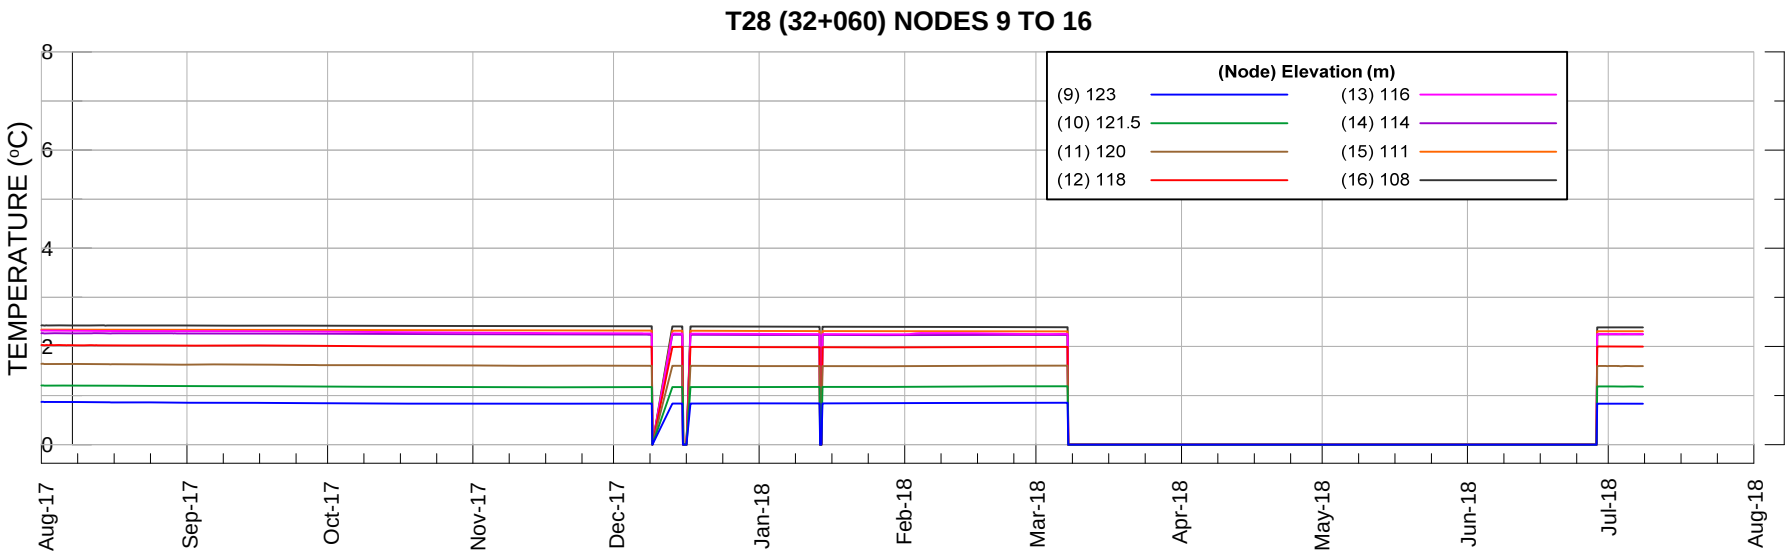
| | CHECK | | | FIGURE 42 | |

Note: The jump in temperature is an error with the instrument. Inspections in the field yielded no results.

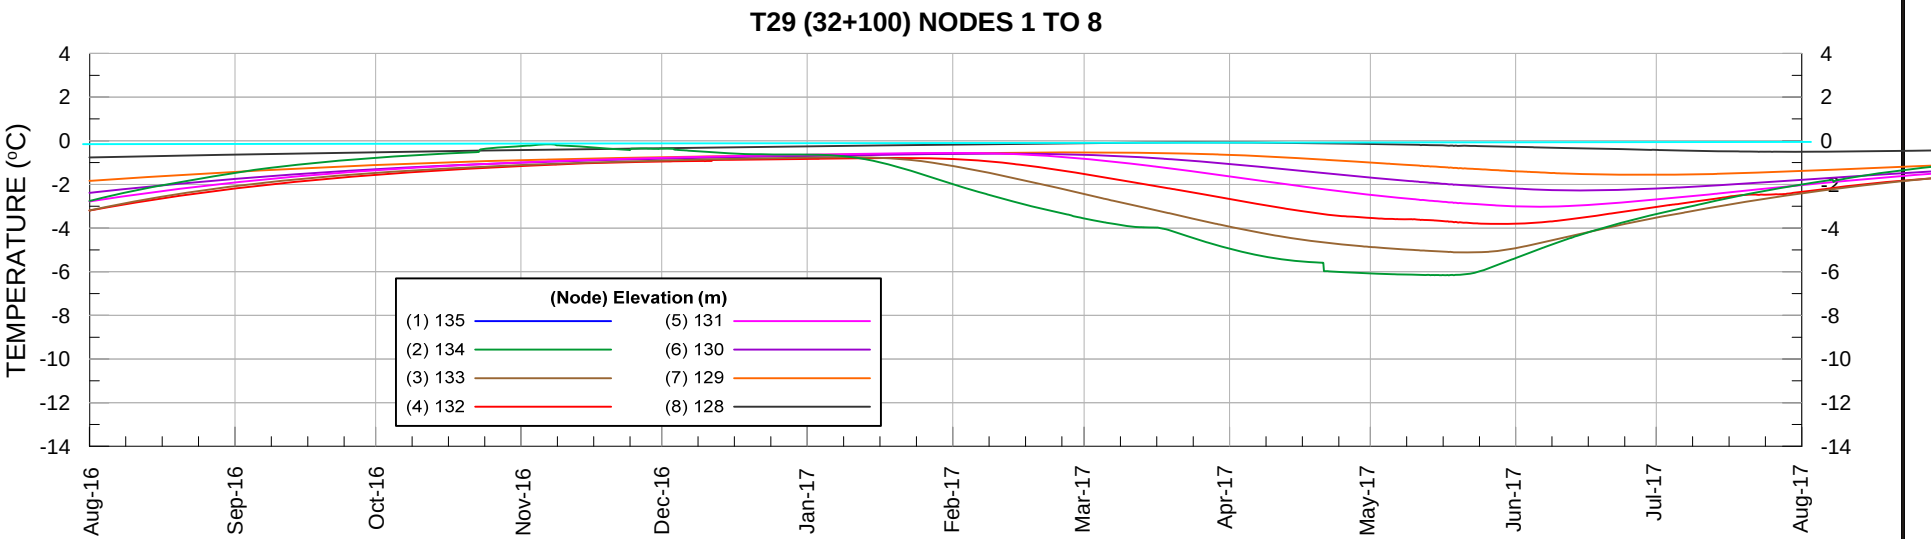
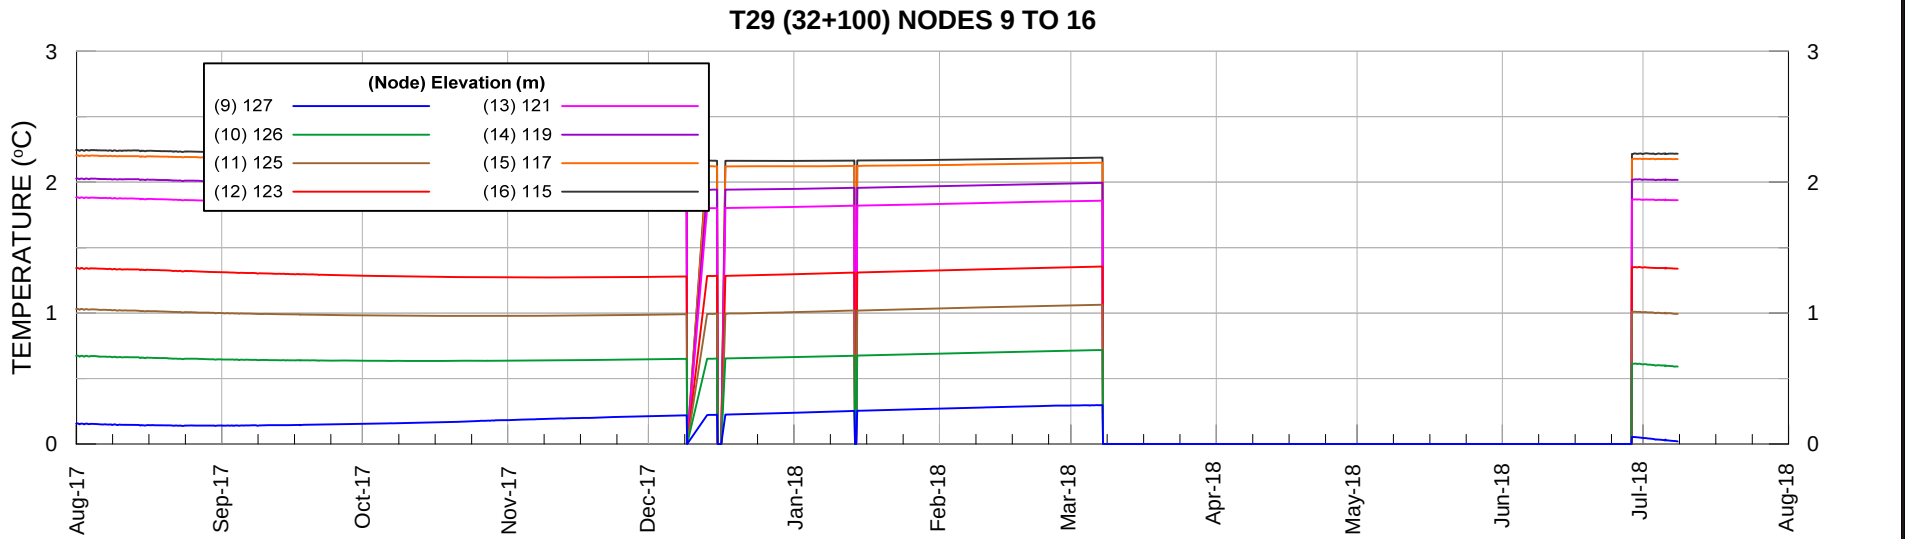
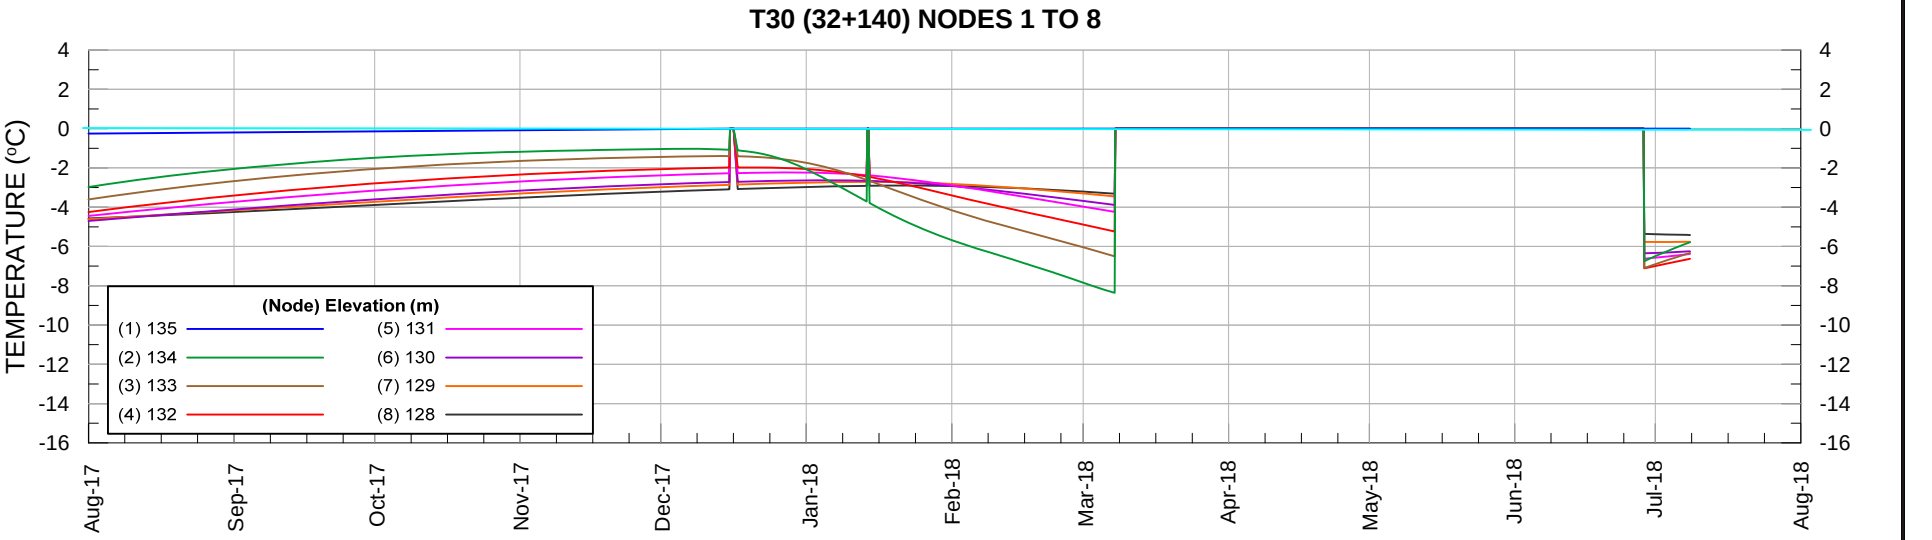
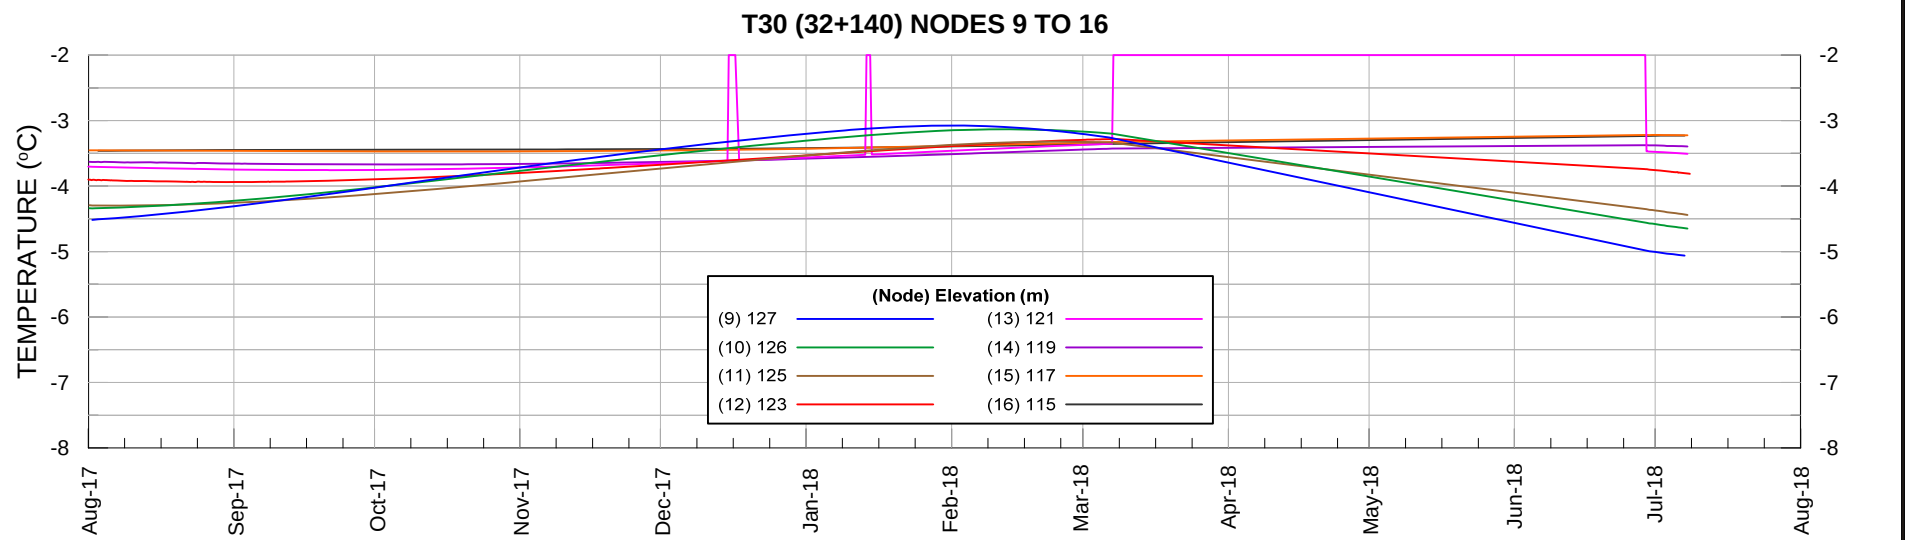
| | CHECK | | | FIGURE 43 | |

Note: The jump in temperature is an error with the instrument. Inspections in the field yielded no results.

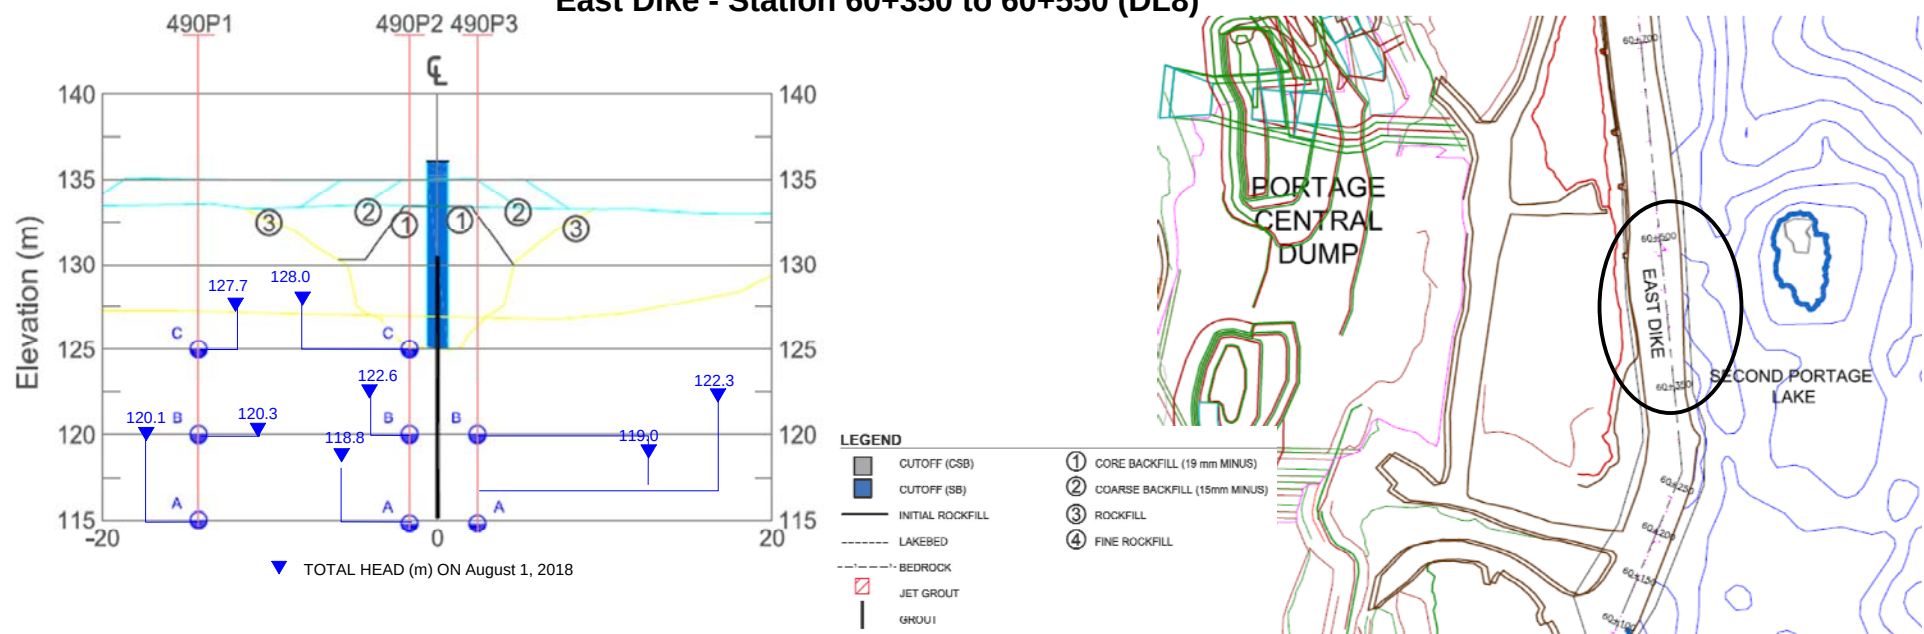
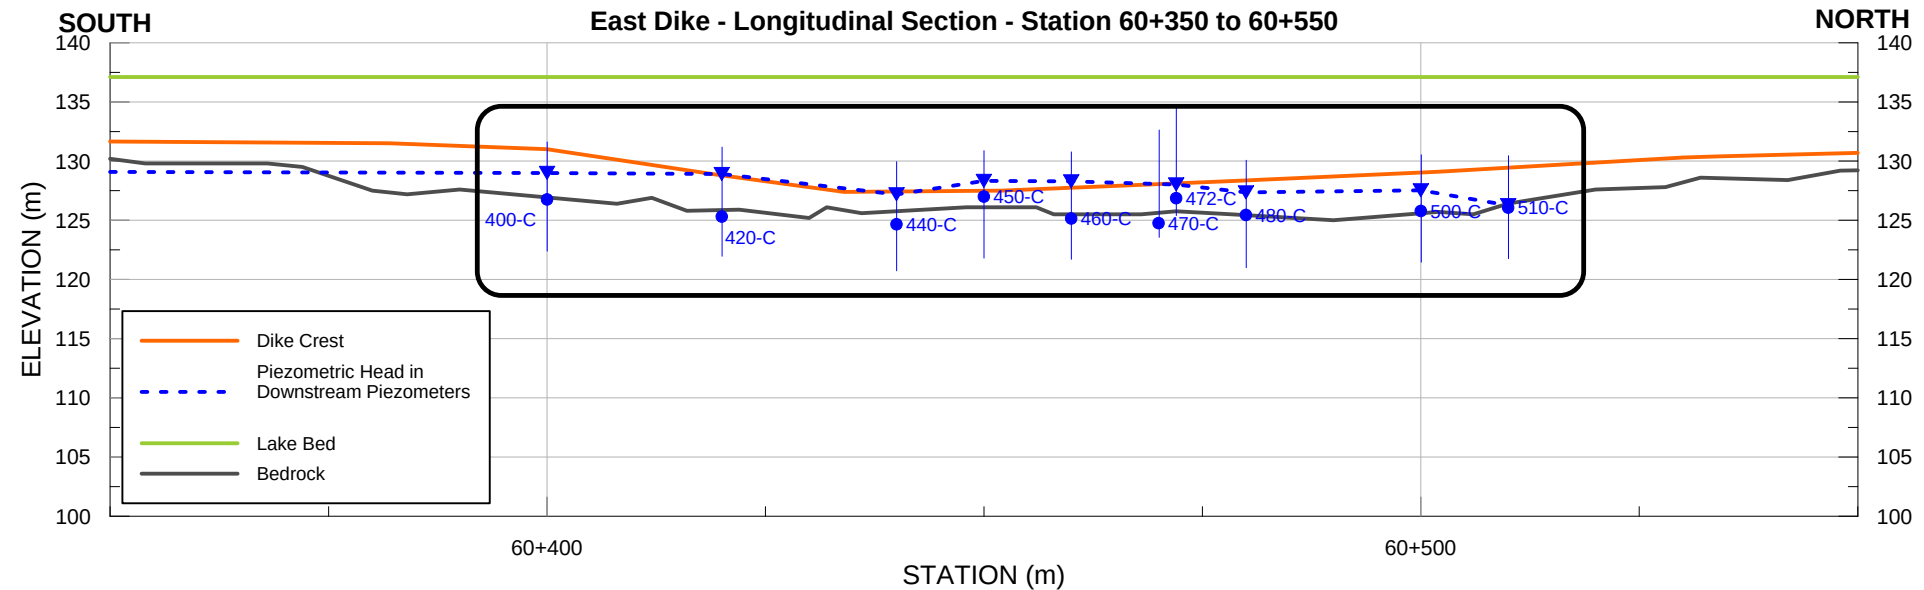
East Dike - Station 60+350 to 60+550 (DL8)

**NOTES:**  
1. As seen in the graph on the side, the progression of the temperature in the Pz follows the lake temperature closely. Usually it takes approximately one to two weeks to see the trend following the lake temperature.

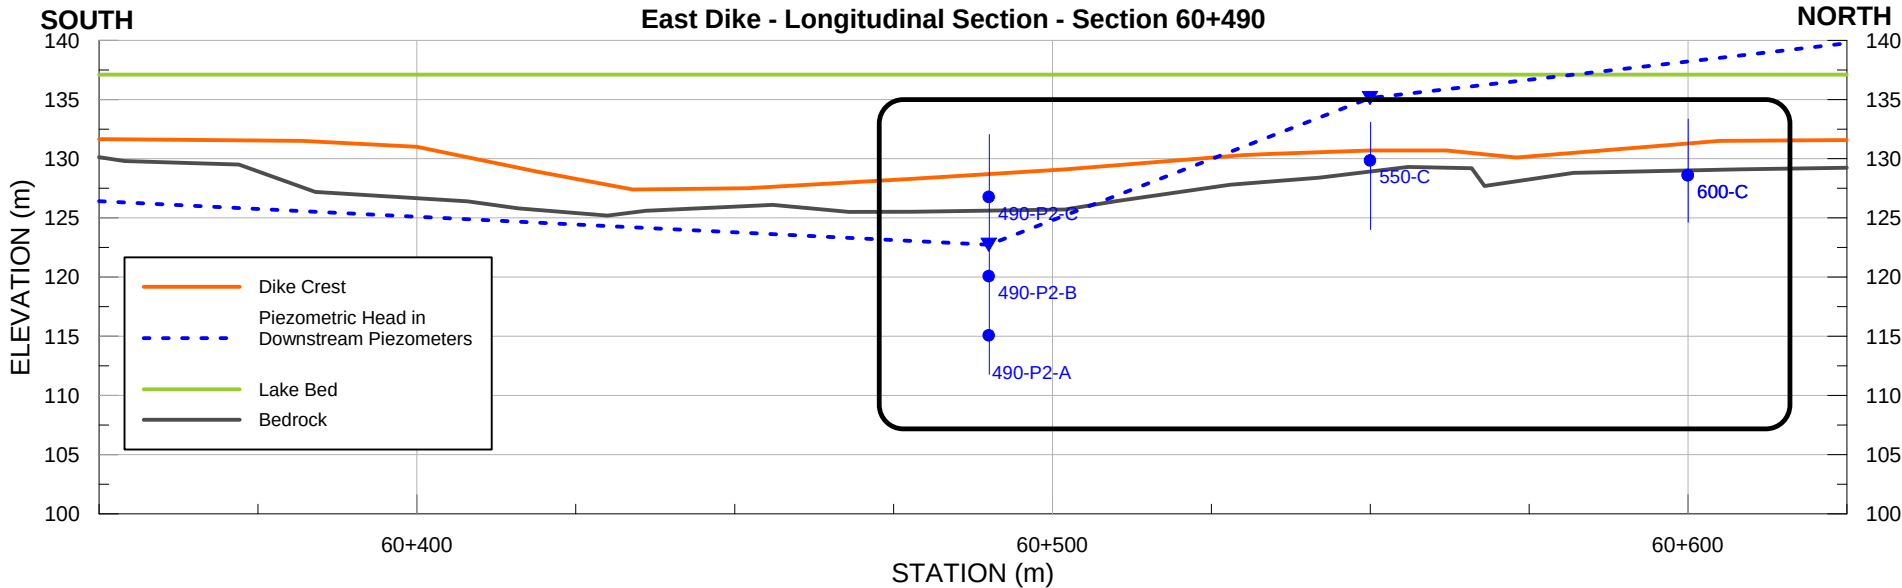
1: 550-C and 600-C are giving anomaly readings and with a negative temperature are assumed to be frozen.
