APPENDIX F

Amaruq Road Photographic Log

APPENDIX G1

**Baker Lake Tank Farm
Photographic Log**

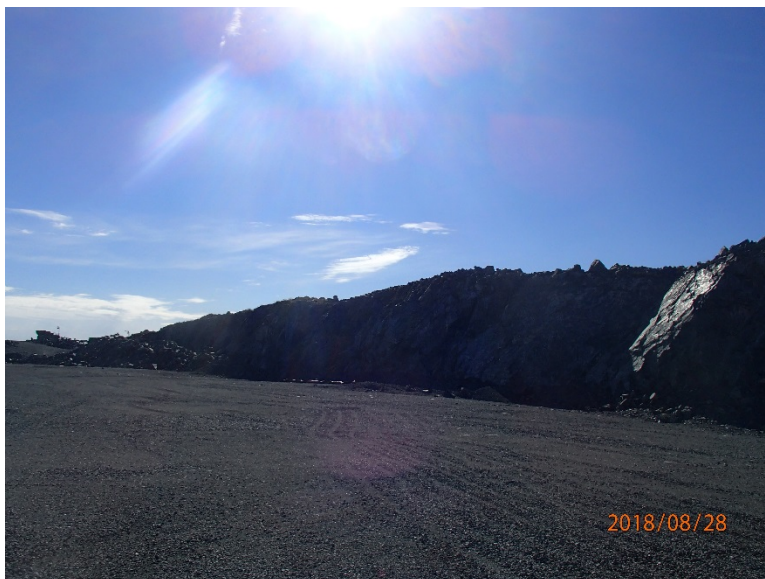
Photograph F1-6: Quarry 3 – km 23+700

Description: View of west wall. Presence of loose rock along steep wall.

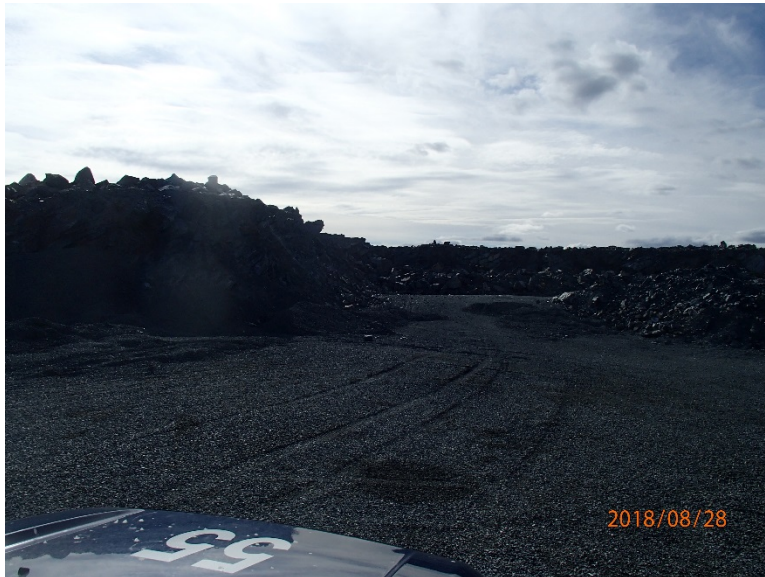
Photograph F1-11: Quarry 8 – km 42+950

Description: View of south wall. Presence of loose blocks.

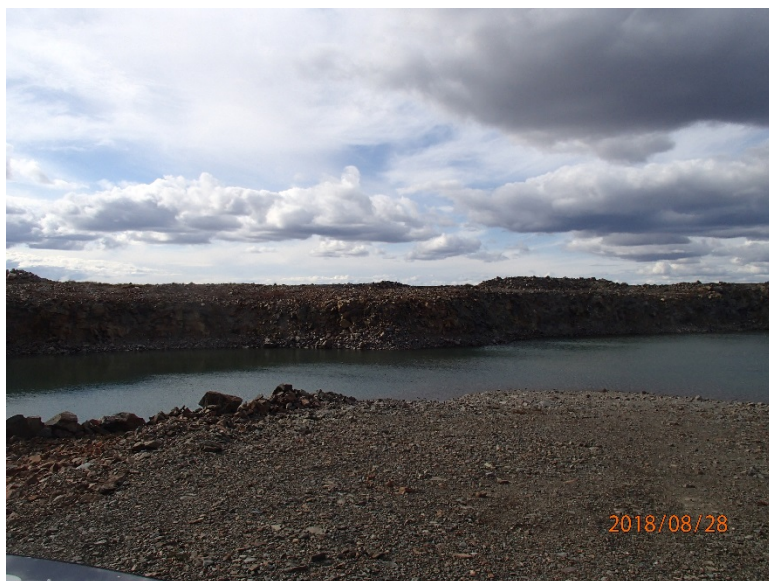
Photograph F1-23: Quarry 14 – km 65+700

Description: View of west and south walls. Quarry flooded.

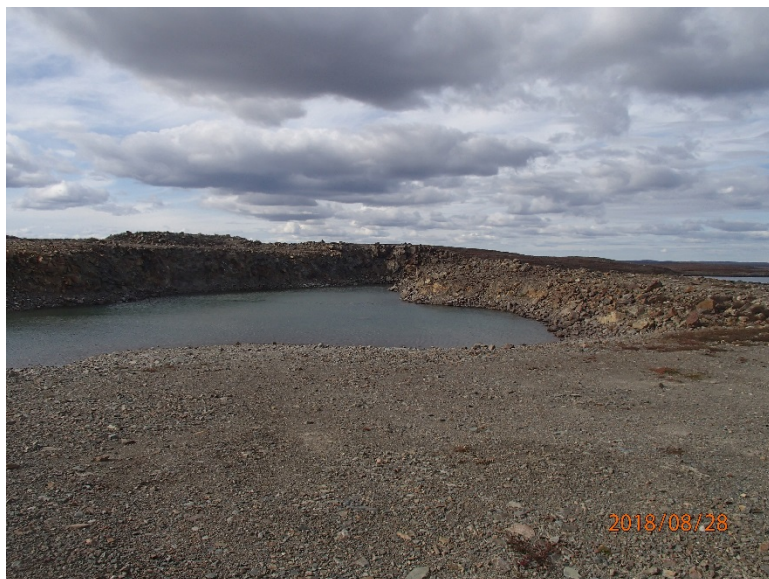
Photograph F1-24: Quarry 14 – km 65+700

Description: View of north and west walls. Quarry flooded.

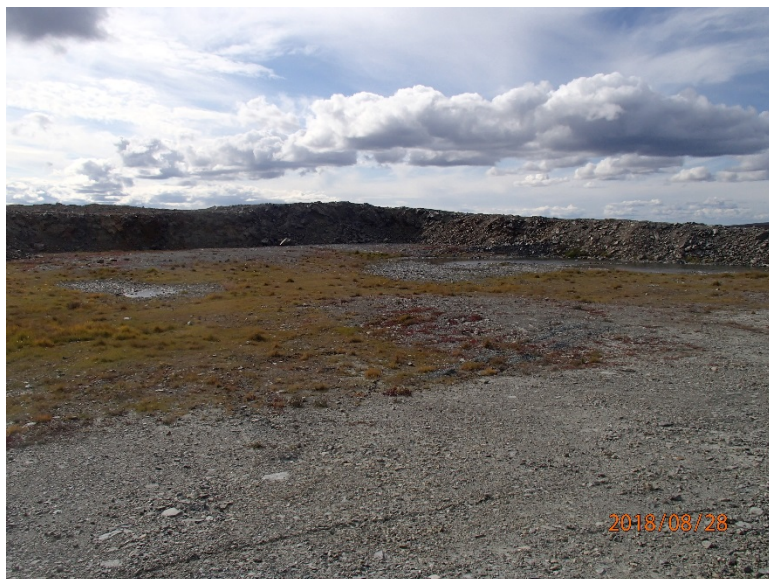
Photograph F1-26: Quarry 15 – km 67+600

Description: View of the north and west walls. Accumulation of water inside the quarry.

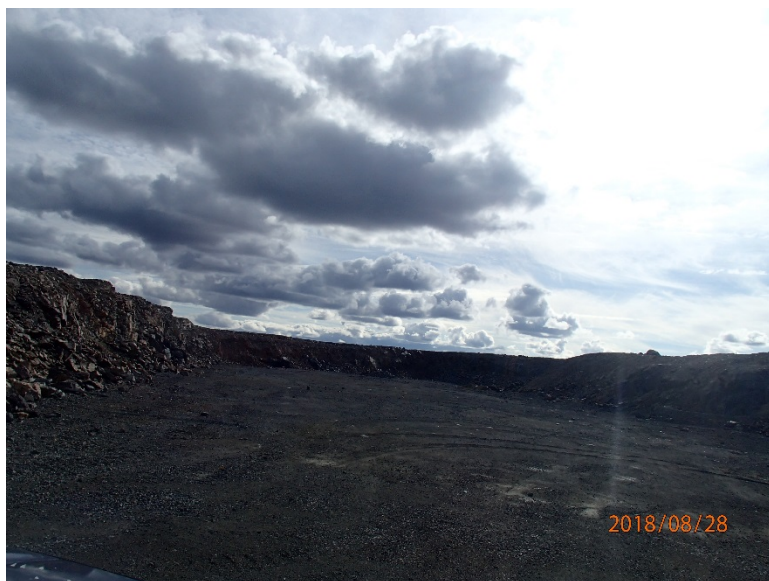
Photograph F1-27: Quarry 16 – km 70+400

Description: View of the south and west walls. Presence of loose rocks on steep wall.

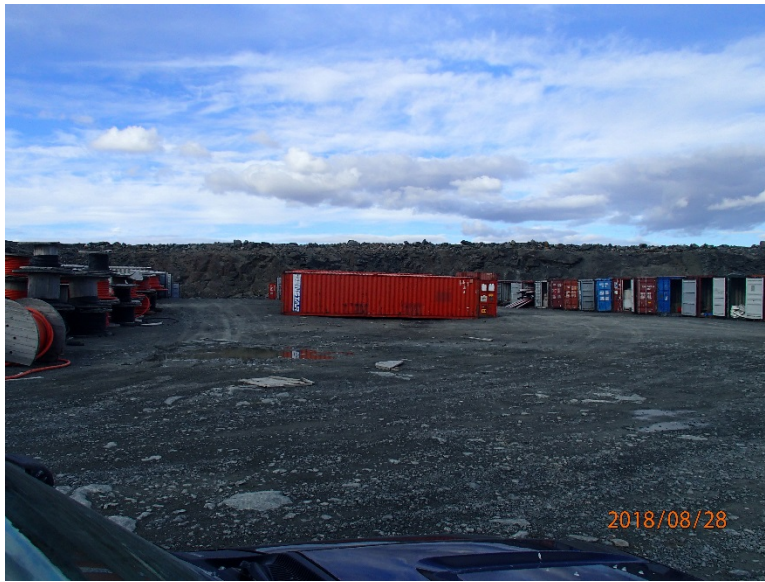
Photograph F1-39: Quarry 23 (Airstrip Quarry)

Description: Looking at the north wall. Presence of loose rocks along steep wall.

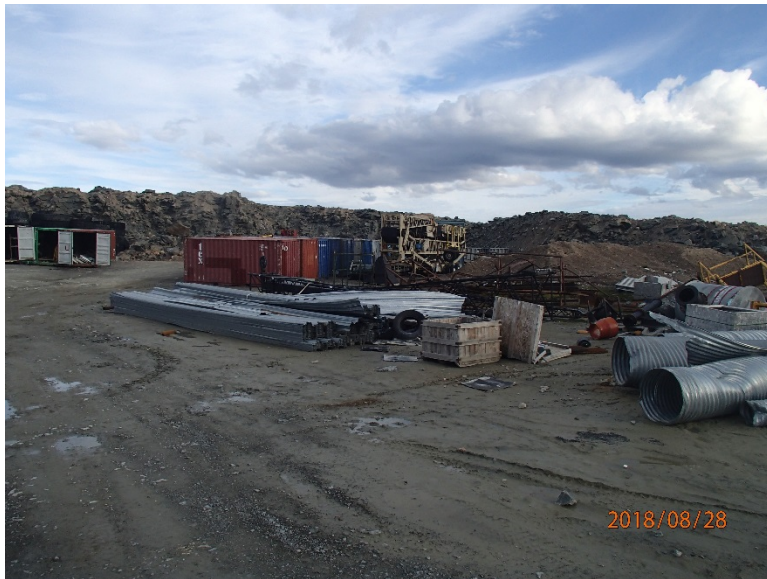
Photograph F1-41: Quarry 23 (Airstrip Quarry)

Description: Looking at the south and east walls.

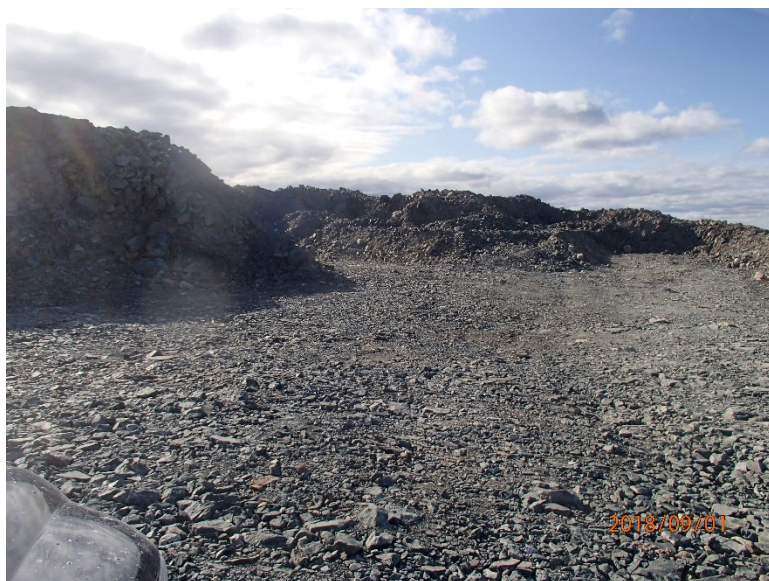
Photograph F2-1 Eskers and Quarries 1 – km 10+500

Description: View of Quarry 10.5. Loose rock is present on the steep wall.

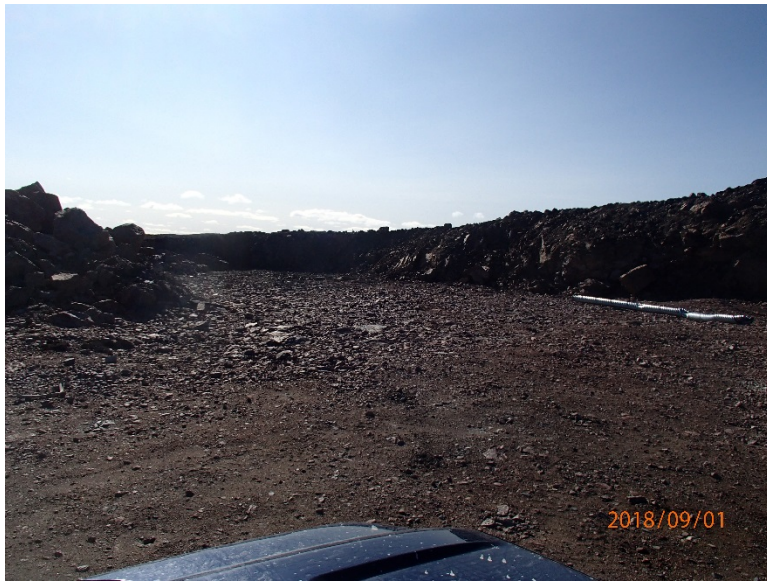
Photograph F2-7 Eskers and Quarries 5 – km 52+000

Description: View of the rock quarry at km 52. In good conditions with loose blocks and cobbles on the north wall.

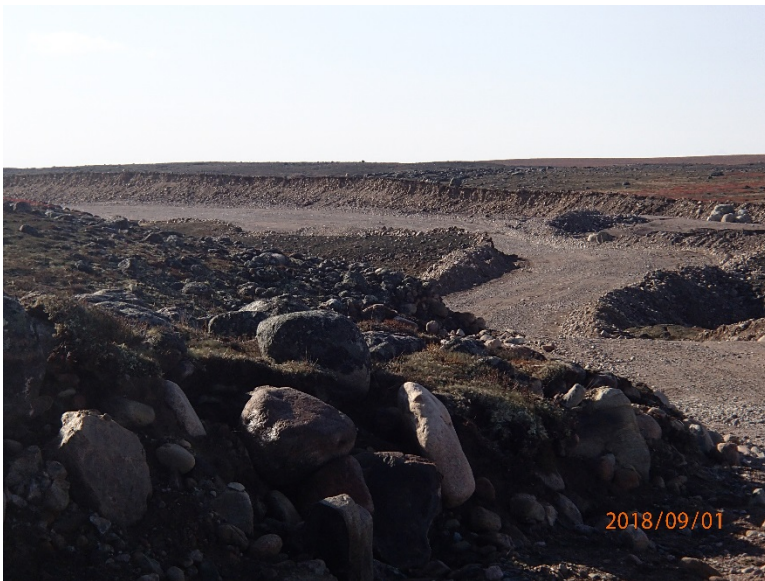
Photograph F2-10 Eskers and Quarries 6 – km 62+500

Description: View of esker #6. The 2-m high steep soil slopes are unstable.

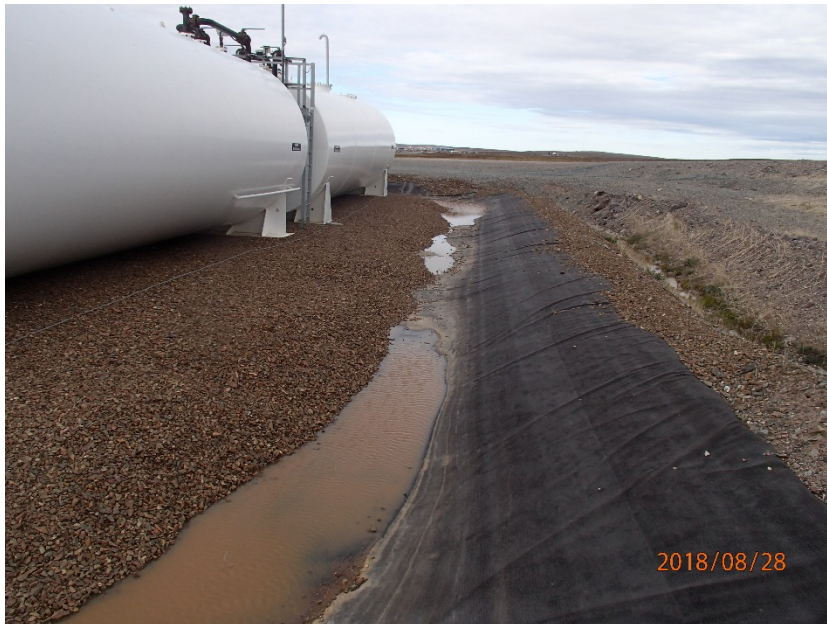
Photograph G1-23 Baker Lake Tank Farm

Description: From the northeastern corner of the Jet A fuel tanks looking west. Presence of exposed geomembrane.

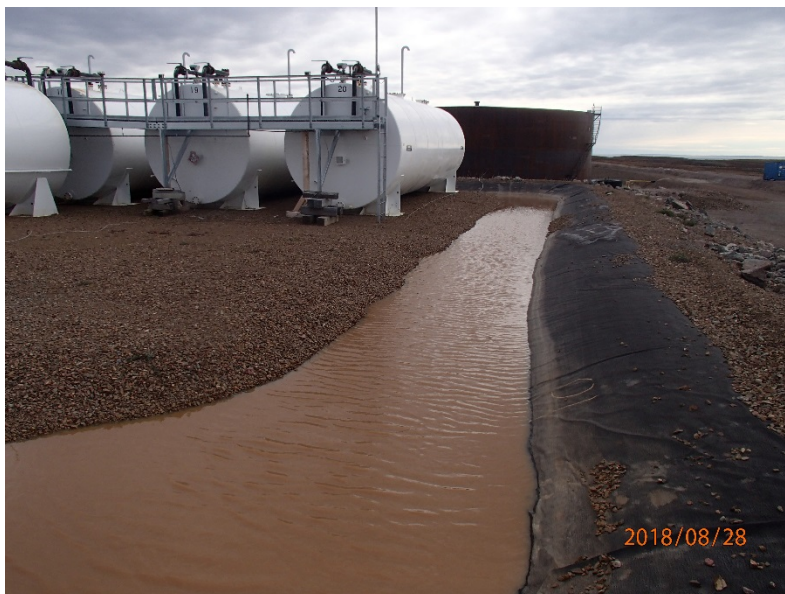
Photograph G1-24 Baker Lake Tank Farm

Description: From the southwestern corner of the Jet A fuel tanks looking east. Presence of exposed geomembrane and water ponding.

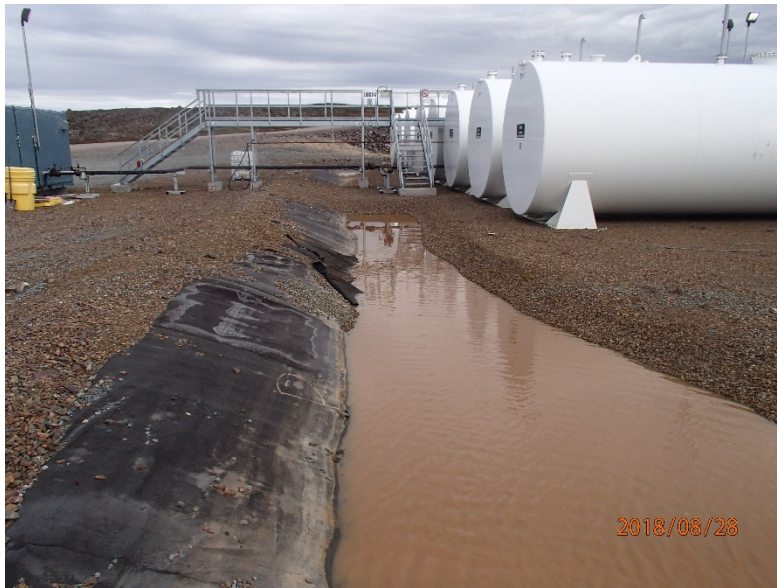
Photograph G1-25 Baker Lake Tank Farm

Description: From the southwestern corner of the Jet A fuel tanks looking north. Presence of exposed geomembrane and water ponding.

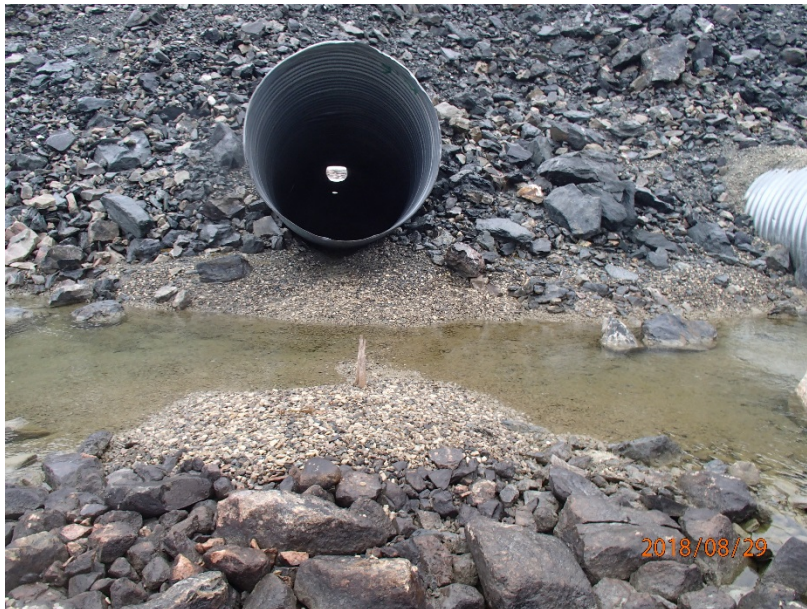
Photograph H1-1 Vault Road Culverts

Description: Looking at the outlet of the three culverts located on Vault Road at 640964E/7217466N. All of them are deformed in the middle.

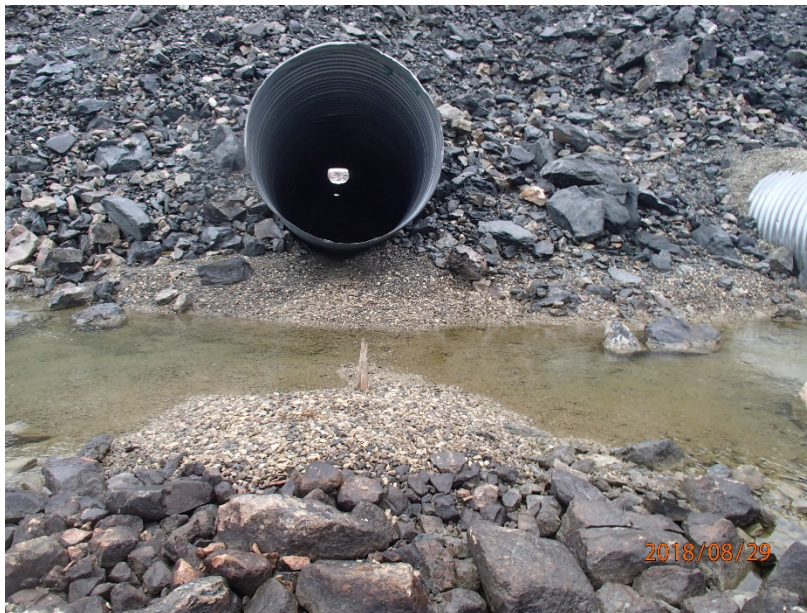
Photograph H1-2 Vault Road Culverts

Description: From the inlet side of the three culverts located on Vault Road at 640964E/7217466N. Looking inside the southern culvert. The culvert is slightly deformed on top in the middle.

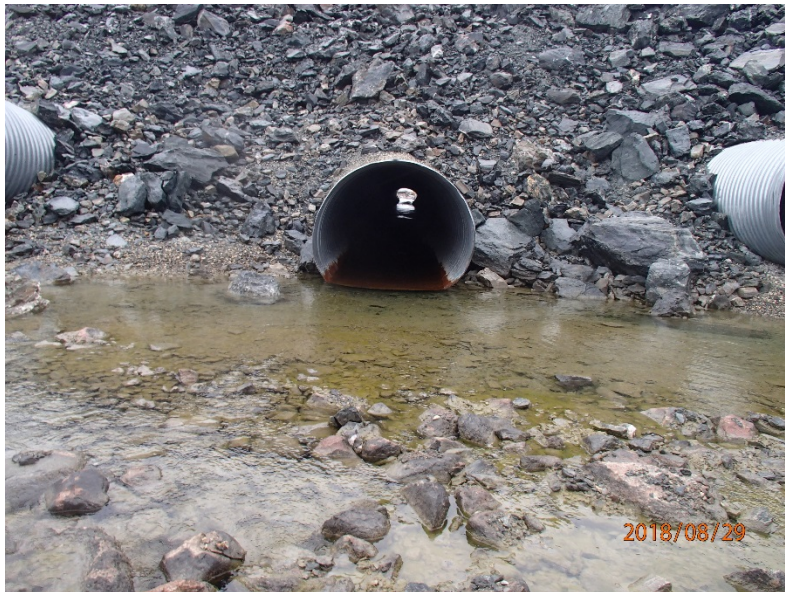
Photograph H1-3 Vault Road Culverts

Description: From the inlet side of the three culverts located on Vault Road at 640964E/7217466N. Looking inside the central culvert. The culvert is slightly deformed on top in the middle.

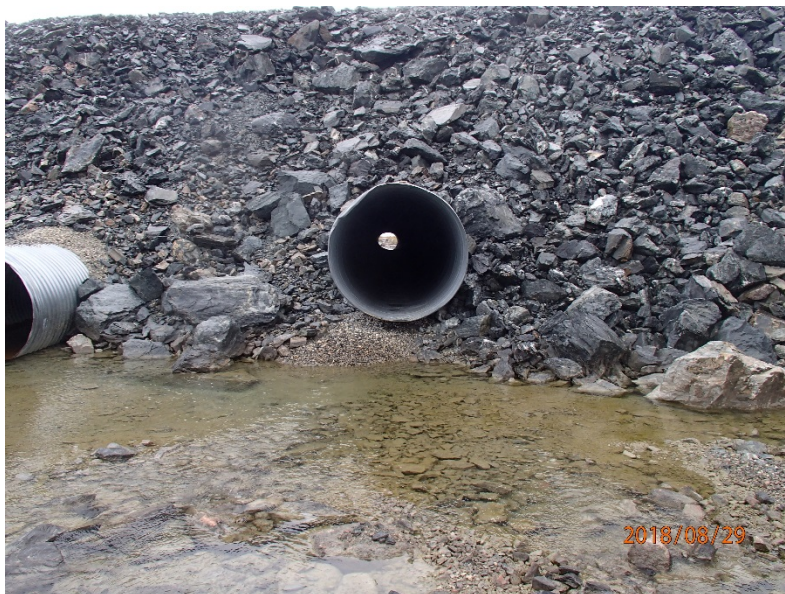
Photograph H1-4 Vault Road Culverts

Description: From the inlet side of the three culverts located on Vault Road at 640964E/7217466N. Looking inside the northern culvert. The culvert is slightly deformed on top in the middle.

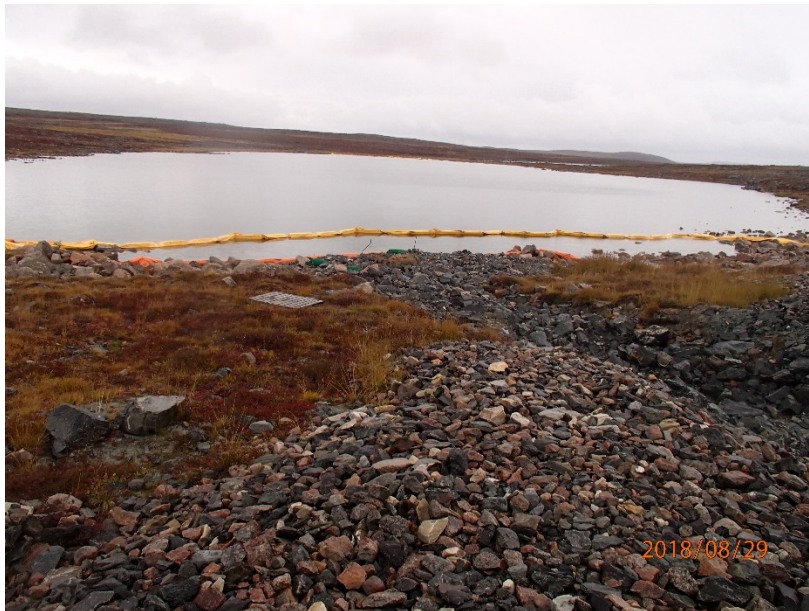
Photograph H2-1 Diversion Ditch and its Sediment and Erosion Protection Structure

Description: Looking south toward Lake NP1 at the sediment and erosion protection structure. Presence of 2 silt curtains and 3 wooden barrier.

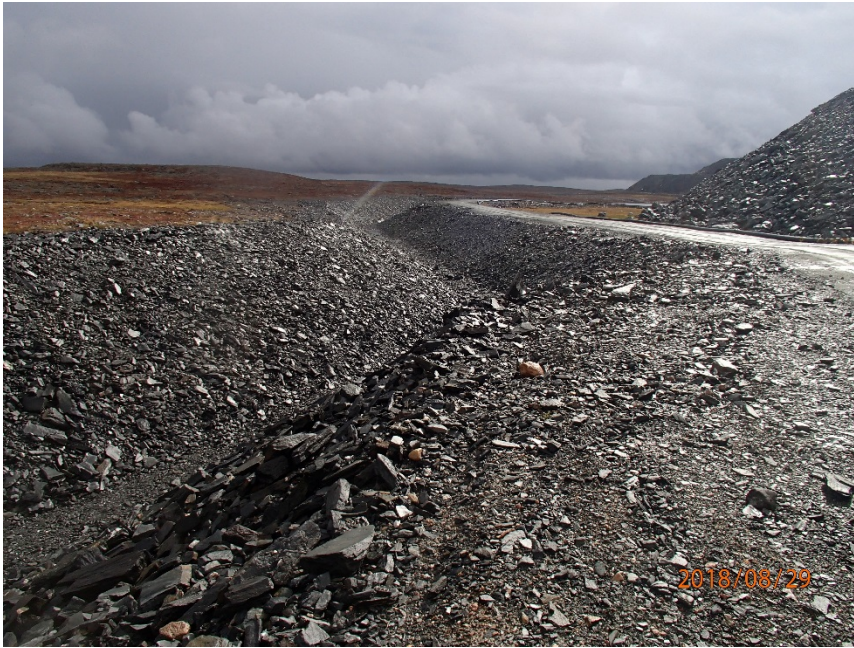
Photograph H2-5 Diversion Ditch and its Sediment and Erosion Protection Structure

Description: From the eastern diversion ditch, looking east.

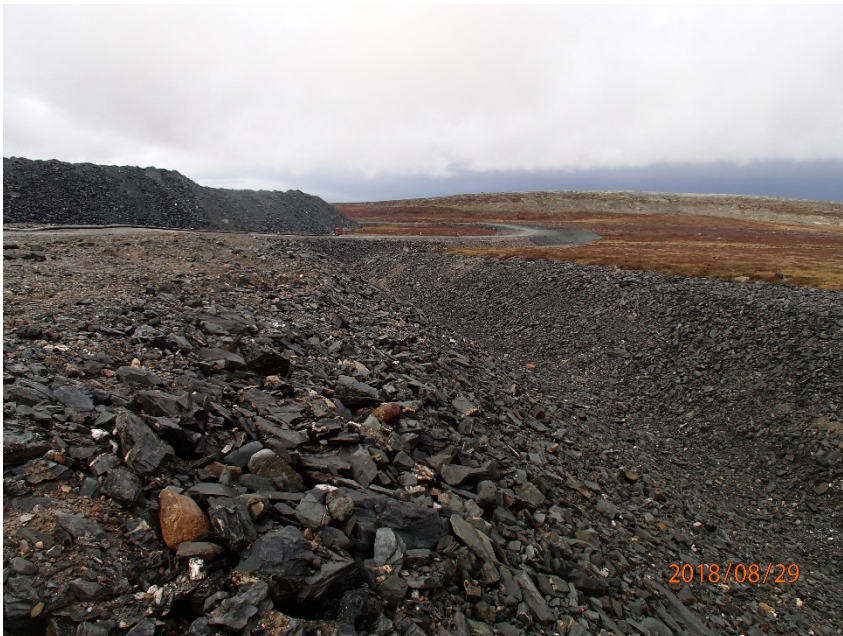
Photograph H2-6 Diversion Ditch and its Sediment and Erosion Protection Structure

Description: From the eastern diversion ditch, looking northwest.

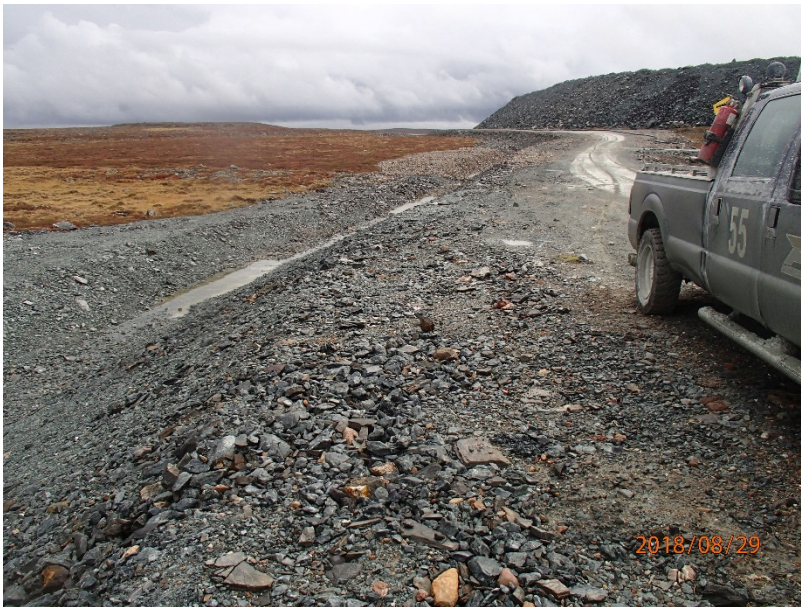
Photograph H2-7 Diversion Ditch and its Sediment and Erosion Protection Structure

Description: From the northern diversion ditch looking southeast.

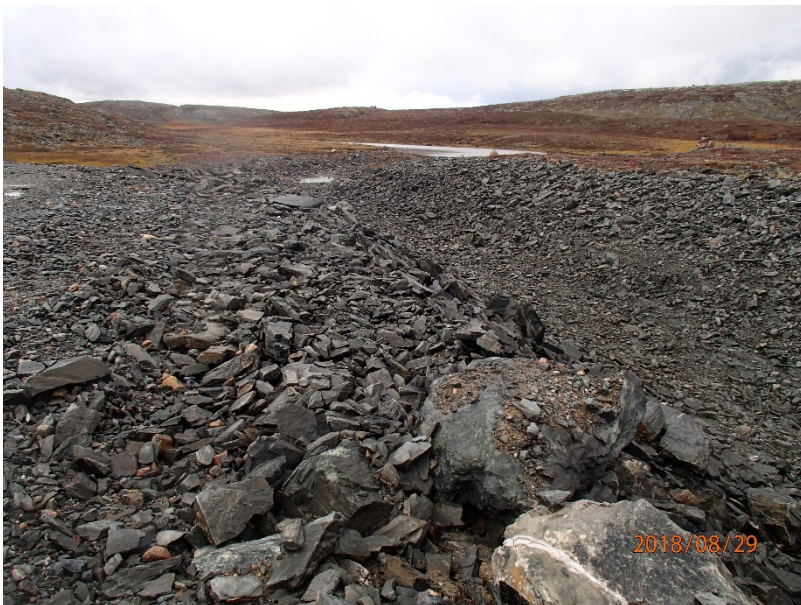
Photograph H2-8 Diversion Ditch and its Sediment and Erosion Protection Structure

Description: From the northern diversion ditch looking west.

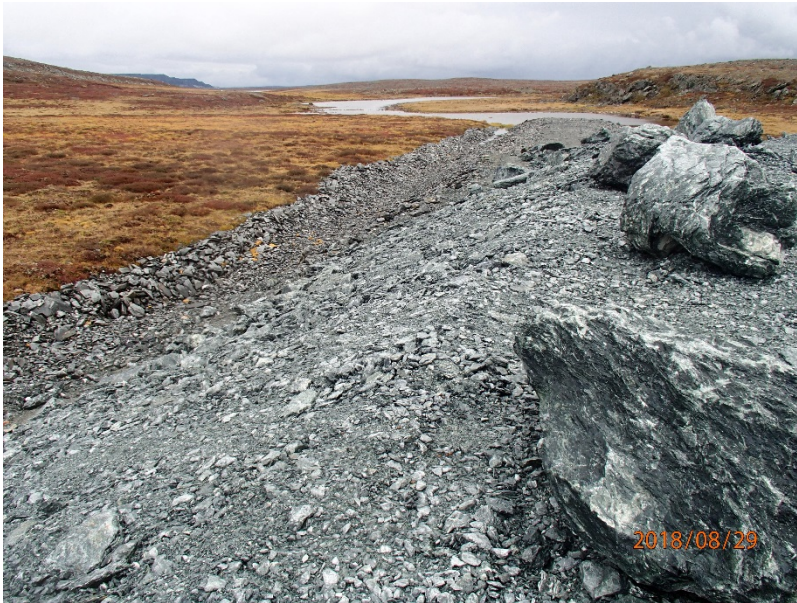
Photograph H2-9 Diversion Ditch and its Sediment and Erosion Protection Structure

From the northern diversion ditch looking east.

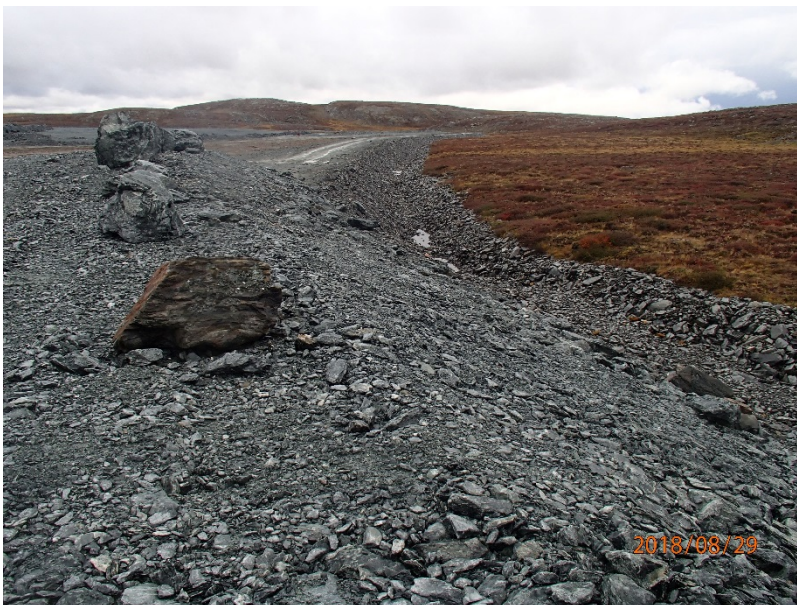
Photograph H2-10 Diversion Ditch and its Sediment and Erosion Protection Structure

From the northern diversion ditch looking west.

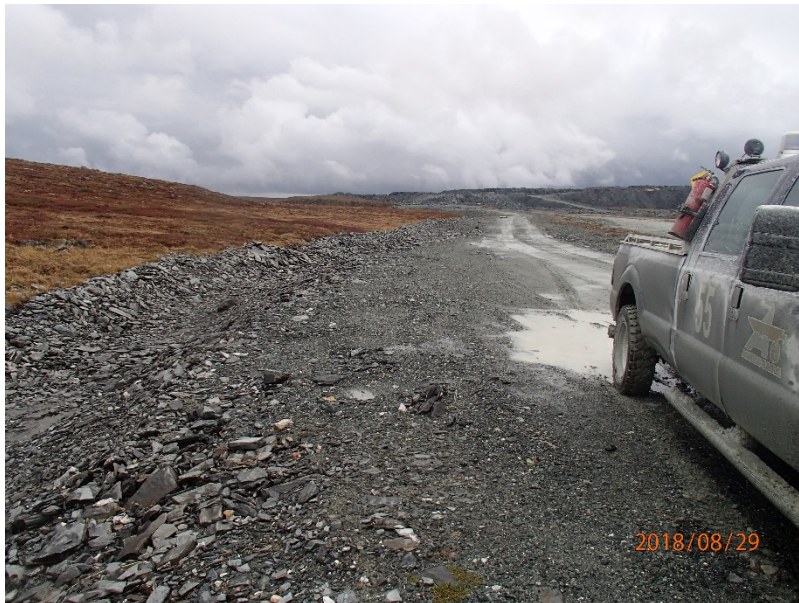
Photograph H2-11 Diversion Ditch and its Sediment and Erosion Protection Structure

Description: From the northern diversion ditch looking east.

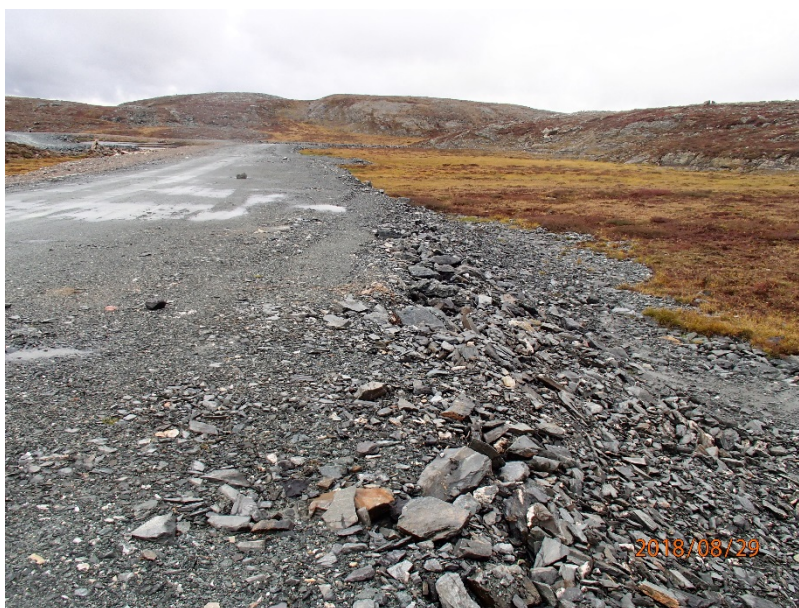
Photograph H2-12 Diversion Ditch and its Sediment and Erosion Protection Structure

Description: From the northern diversion ditch looking west.

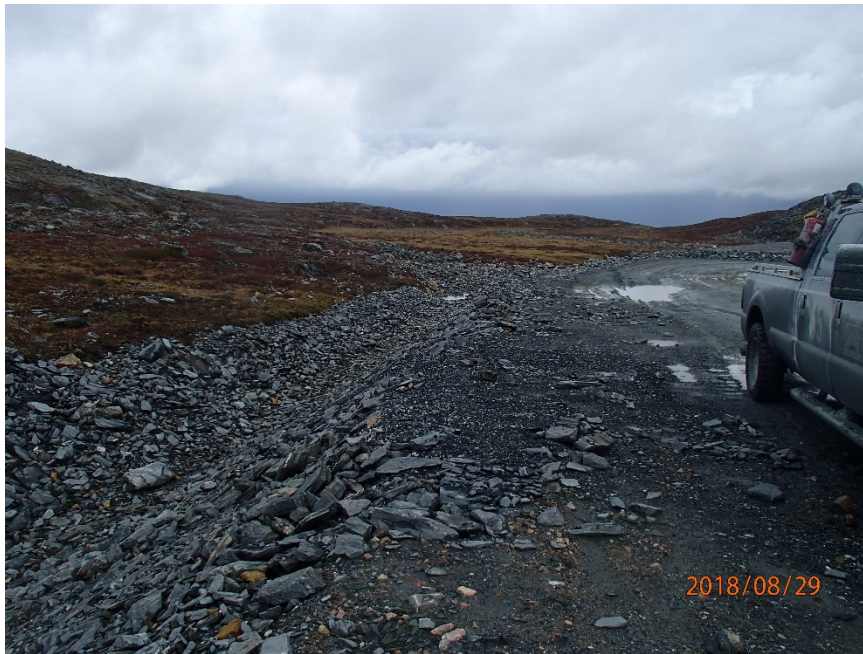
Photograph H2-13 Diversion Ditch and its Sediment and Erosion Protection Structure

Description: From 637281E/7216790N, looking north. View of the western diversion ditch.

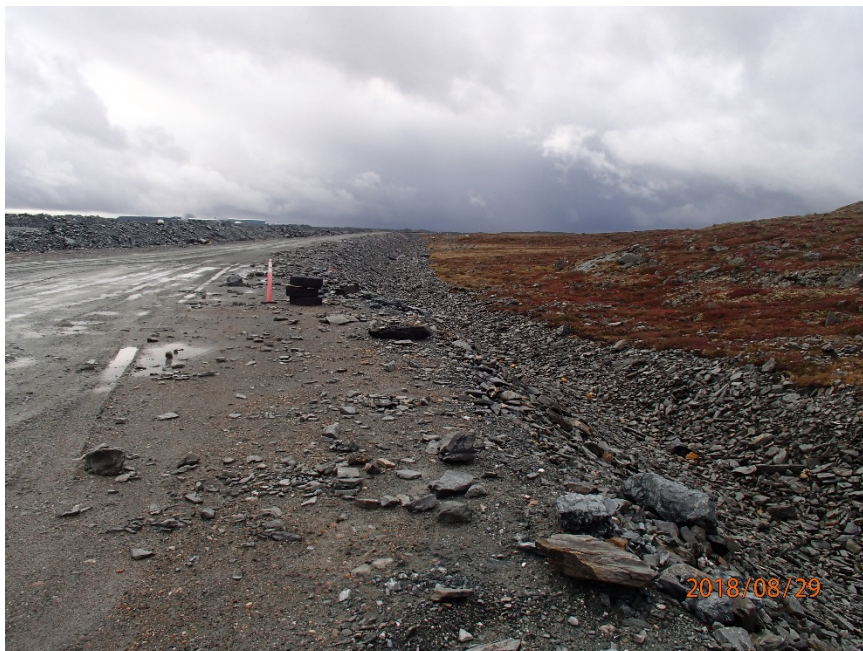
Photograph H2-14 Diversion Ditch and its Sediment and Erosion Protection Structure

Description: From 637281E/7216790N, looking south at the western diversion ditch.

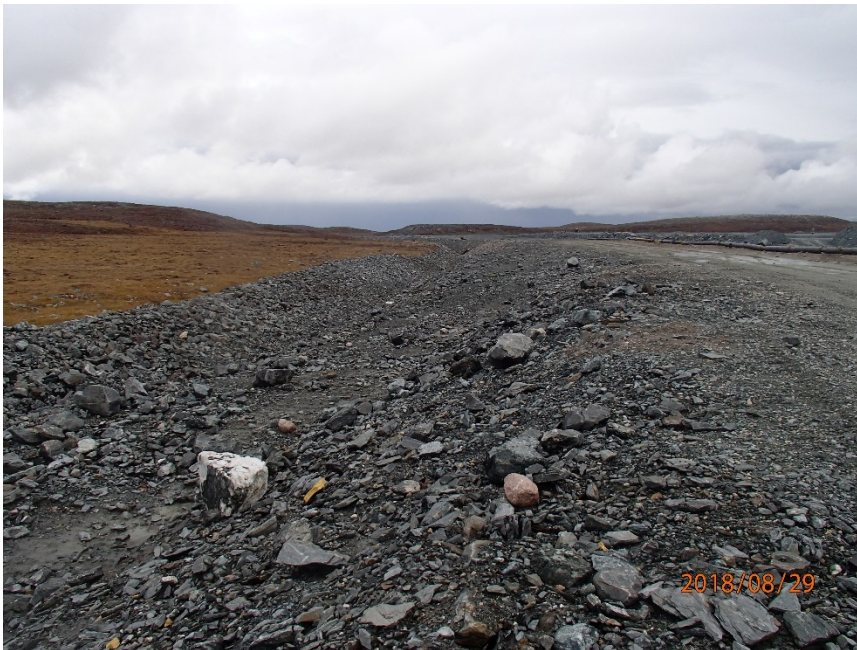
Photograph H2-15 Diversion Ditch and its Sediment and Erosion Protection Structure

Description: From 637251E/7216171N, looking north at the western diversion ditch.

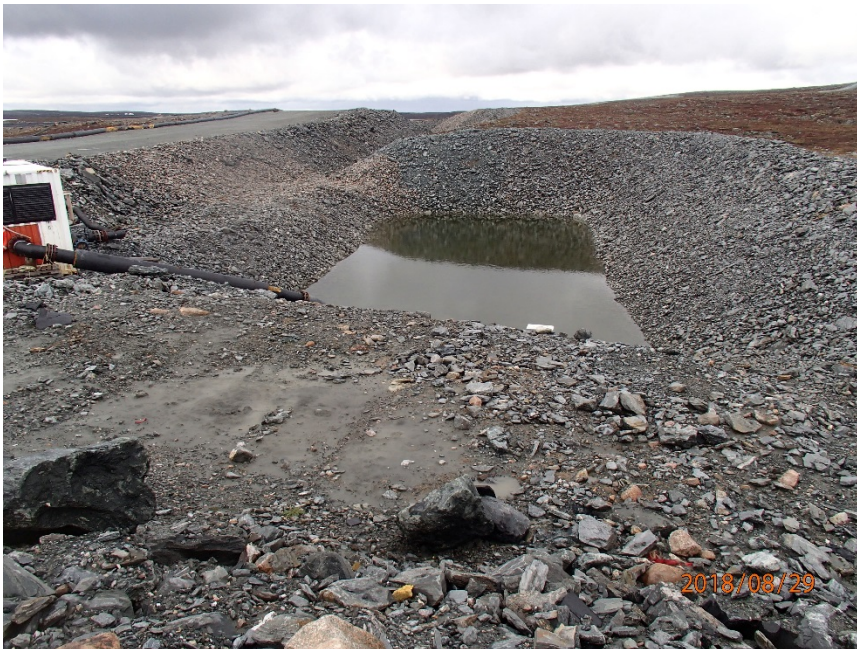
Photograph H2-16 Diversion Ditch and its Sediment and Erosion Protection Structure

Description: From 637251E/7216171N, looking west at the western diversion ditch and its retention basin.

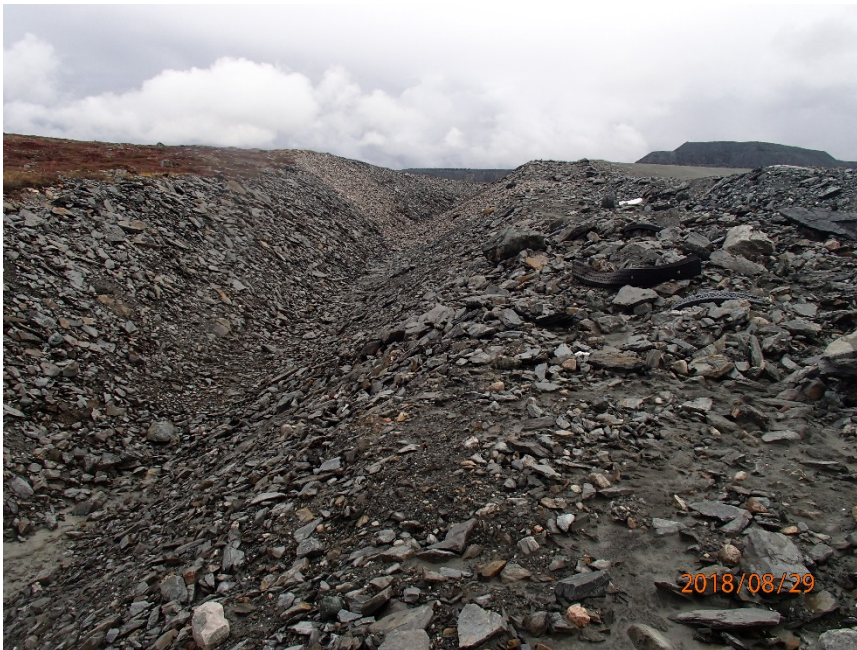
Photograph H2-17 Diversion Ditch and its Sediment and Erosion Protection Structure

Description: From 637074E/7216157N, looking east at the western diversion ditch.

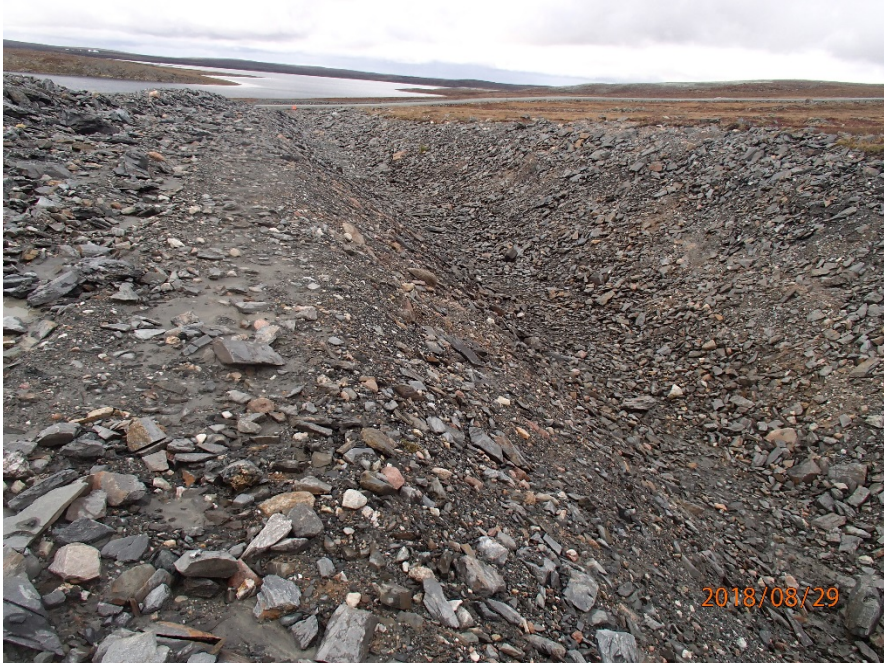
Photograph H2-18 Diversion Ditch and its Sediment and Erosion Protection Structure

Description: From 637074E/7216157N, looking west at the western diversion ditch.

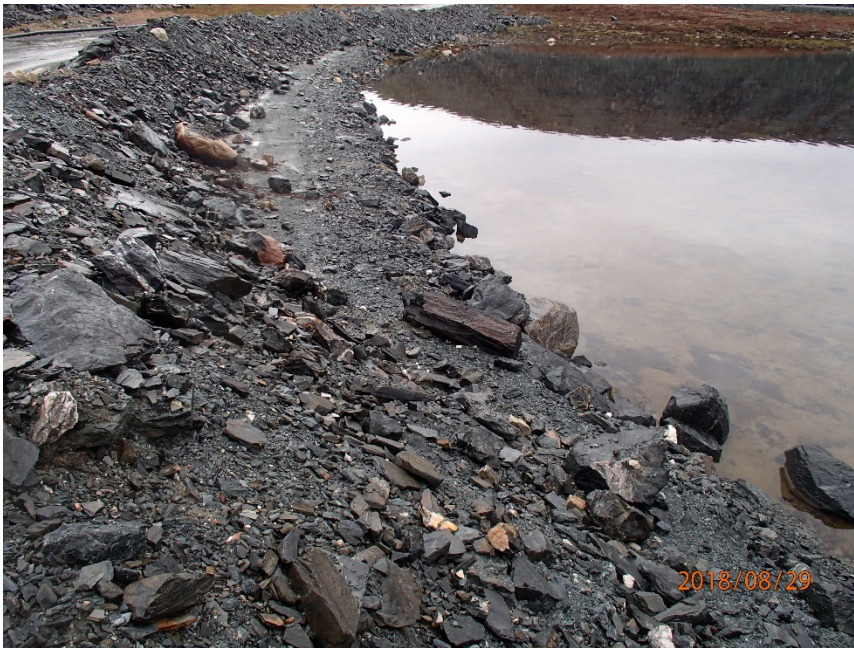
Photograph H3-1 RSF Till Plug

Description: From the south side of NP2 Lake (north of the diversion ditch) looking west at the RSF till plug.

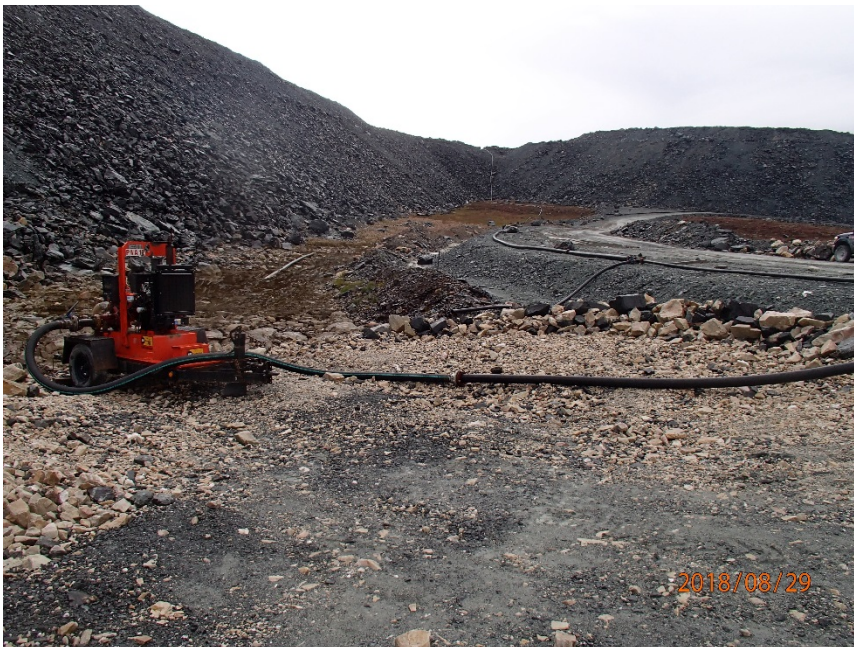
Photograph H3-2 RSF Till Plug

Description: From the south side of NP2 Lake (south of the diversion ditch) looking west at the RSF till plug.

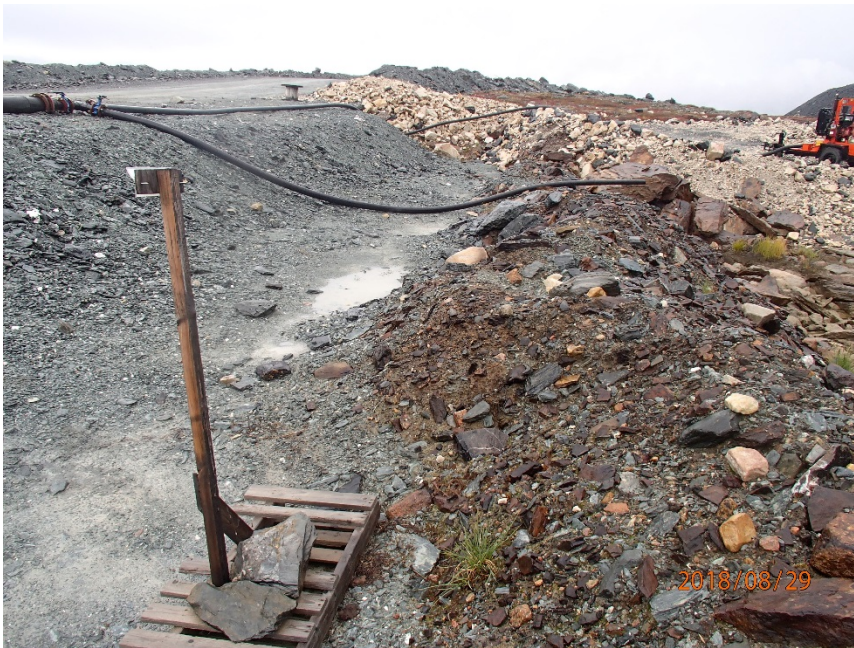
Photograph H3-3 RSF Till Plug

Description: From the south side of NP2 Lake (south of the diversion ditch) looking southeast at the RSF till plug.

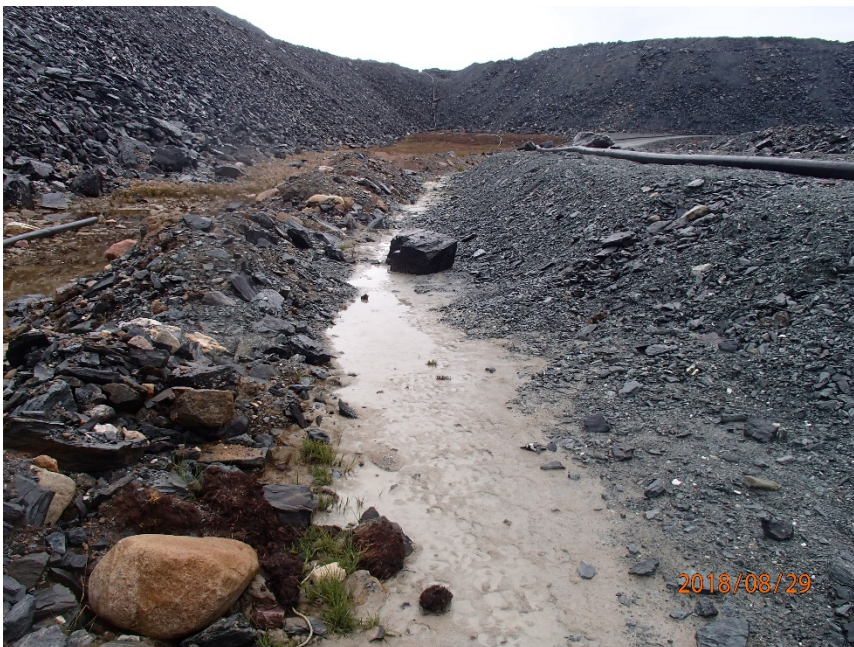
Photograph H3-4 RSF Till Plug

Description: From the south side of NP2 Lake (south of the diversion ditch) looking northwest at the RSF till plug.

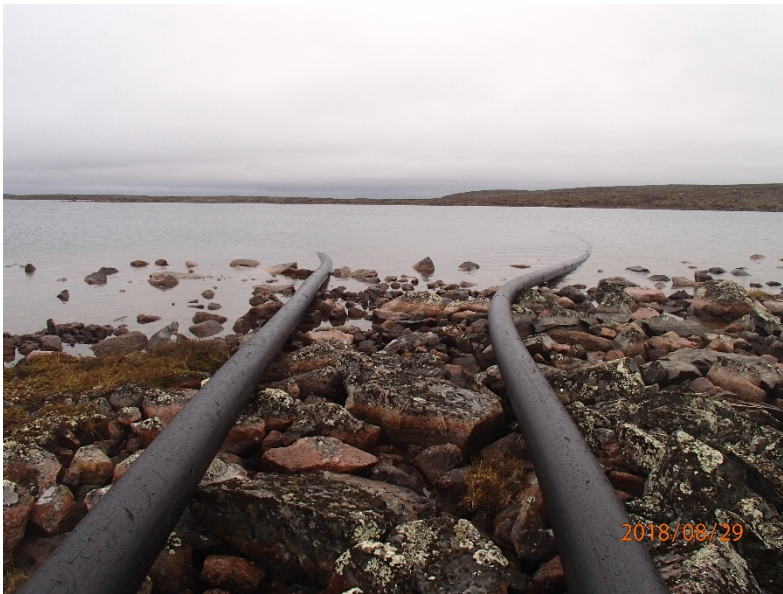
Photograph H4-1 Diffusers – Vault Diffuser

Description: Looking at the Diffuser at Vault. In good condition.

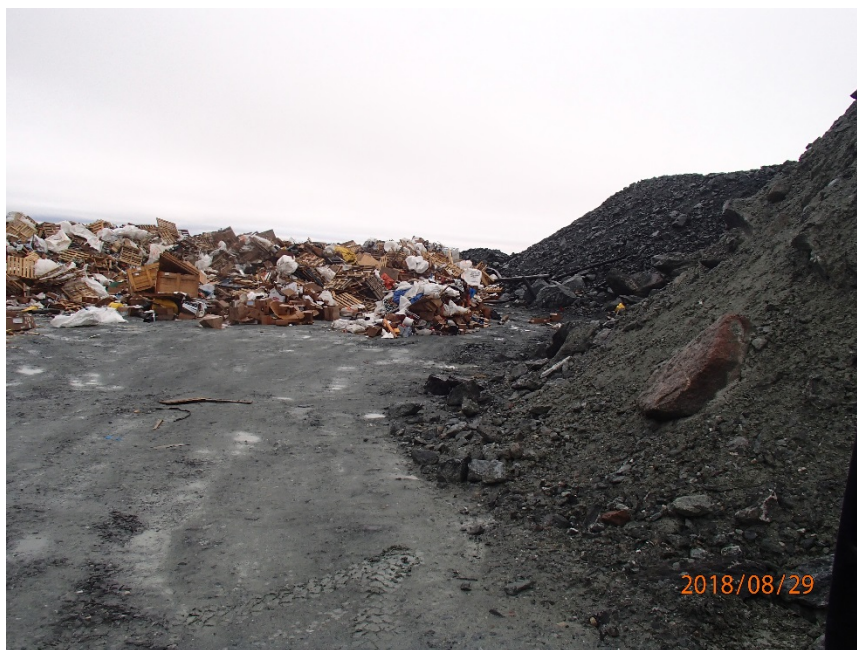
Photograph H5-1 Landfill

Description: From 638857E/7215767N, looking north at the landfill.

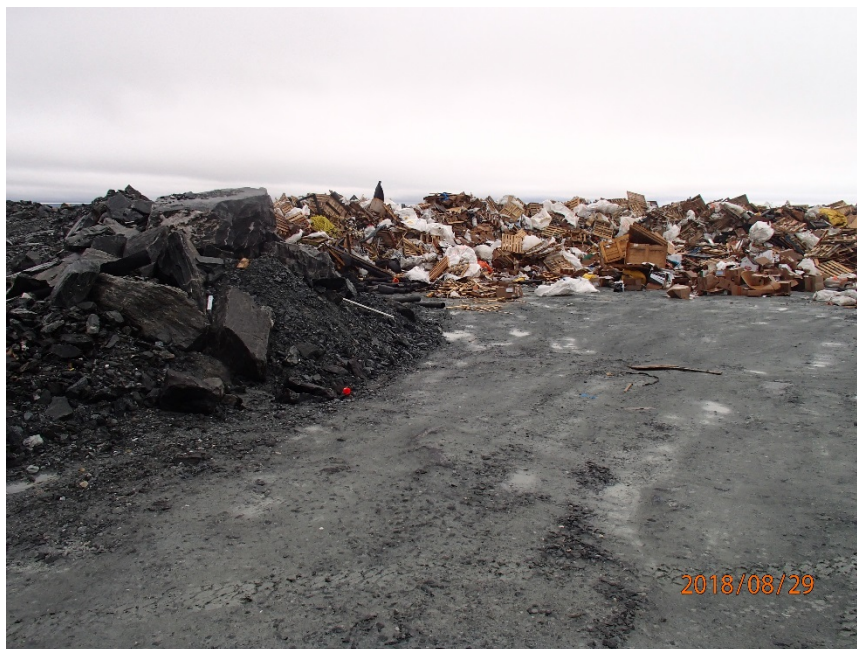
Photograph H5-2 Landfill

Description: From 638857E/7215767N, looking northwest at the landfill.

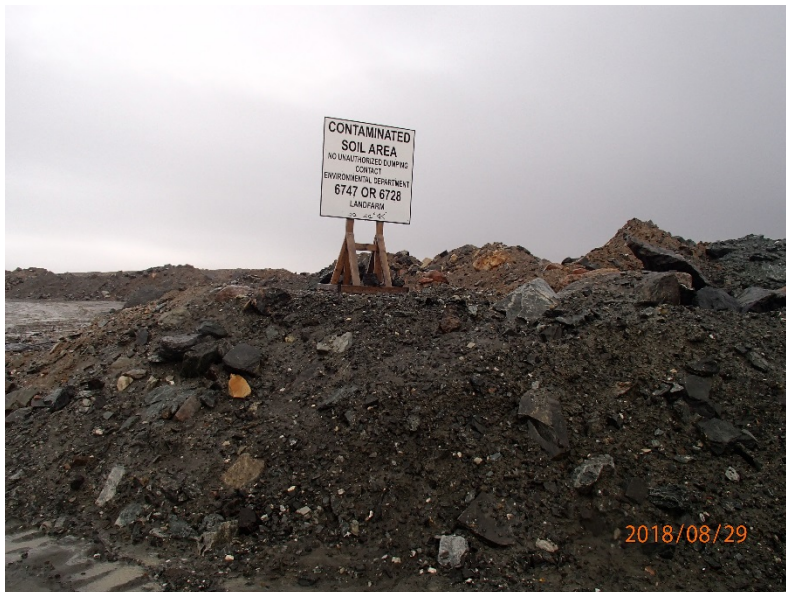
Photograph H6-1 Contaminated Soil Storage and Bioremedial Landfarm Facility

Description: From the northeast extremity of the South Cell, looking northwest at the Contaminated Soil Storage and Bioremedial Landfarm Facility located within the South Cell of the TSF, north of Central Dike.

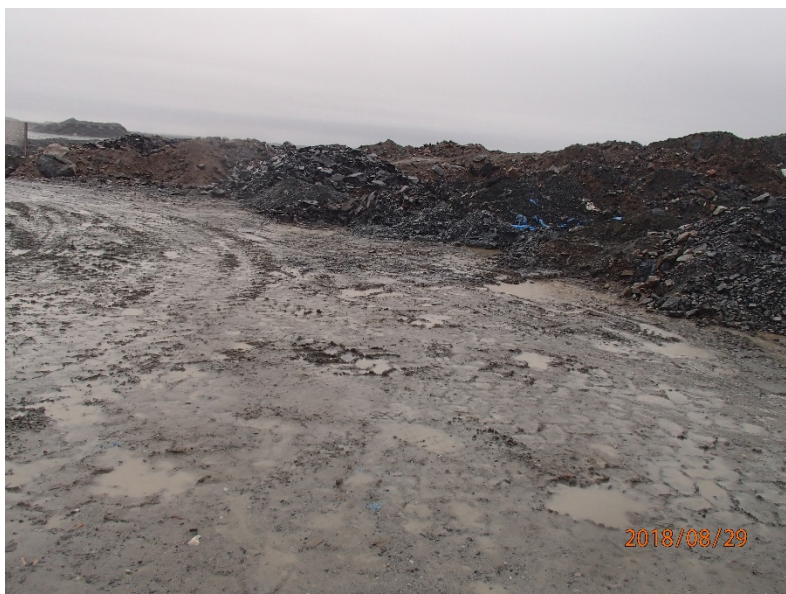
Photograph H6-2 Contaminated Soil Storage and Bioremedial Landfarm Facility

Description: From the northeast extremity of the South Cell, looking northwest at the Contaminated Soil Storage and Bioremedial Landfarm Facility.

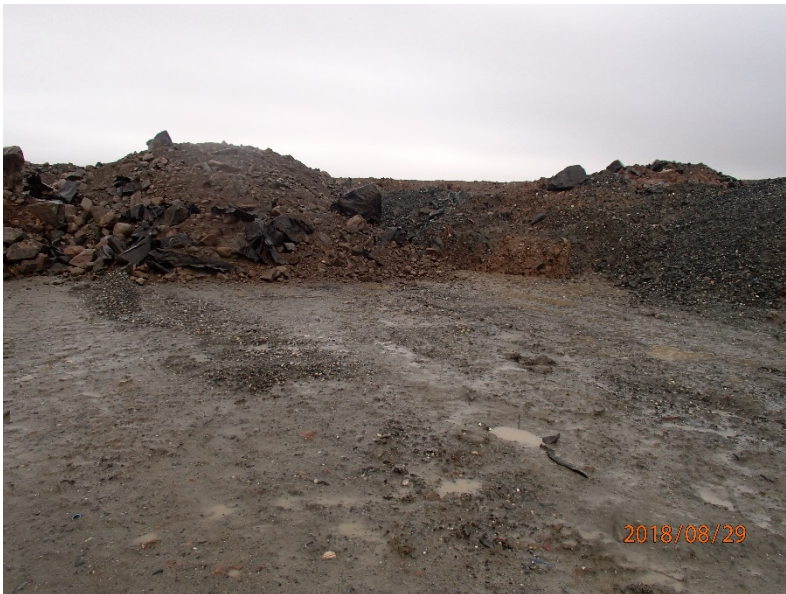
Photograph H6-3 Contaminated Soil Storage and Bioremedial Landfarm Facility

Description: From the northeast extremity of the South Cell, looking northwest at the Contaminated Soil Storage and Bioremedial Landfarm Facility.
