APPENDIX F

Amaruq Road Photographic Log

APPENDIX G1

**Baker Lake Tank Farm
Photographic Log**

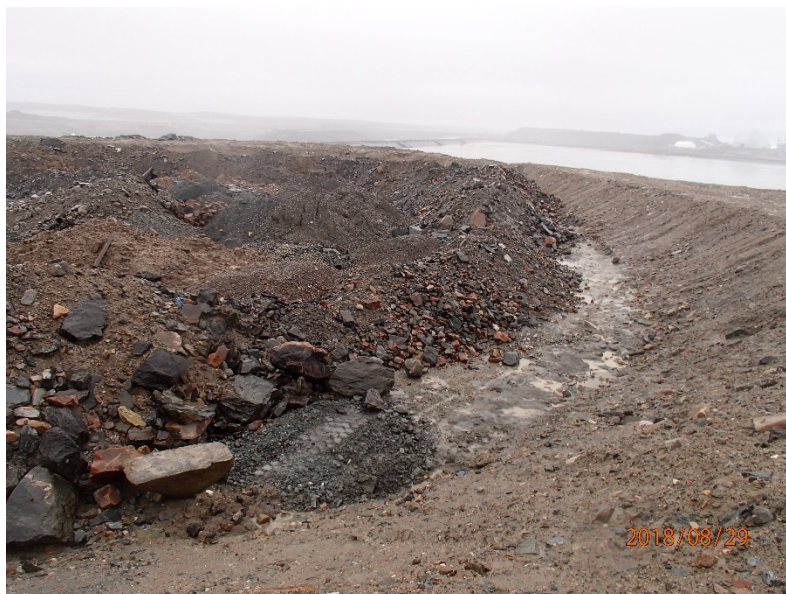
Photograph H6-4 Contaminated Soil Storage and Bioremedial Landfarm Facility

Description: From the northeast extremity of the South Cell, looking southeast at the Contaminated Soil Storage and Bioremedial Landfarm Facility.

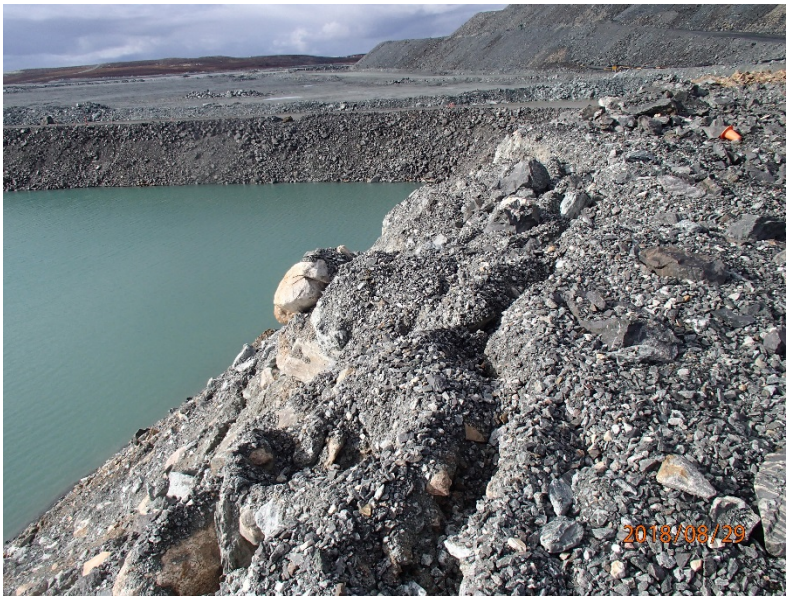
Photograph H6-5 Contaminated Soil Storage and Bioremedial Landfarm Facility

Description: From the northeast extremity of the South Cell, looking northwest at the Contaminated Soil Storage and Bioremedial Landfarm Facility. Sign of superficial slope failure.

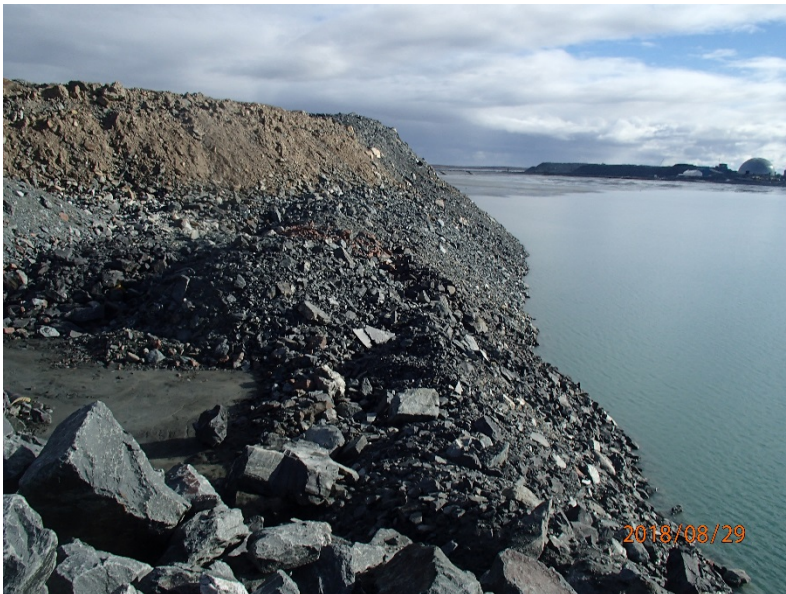
Photograph H6-6 Contaminated Soil Storage and Bioremedial Landfarm Facility

Description: From Stormwater Dike, looking southeast at the Contaminated Soil Storage and Bioremedial Landfarm Facility. Rockfill was placed on overburden fill material which is probably founded on a steep natural slope.

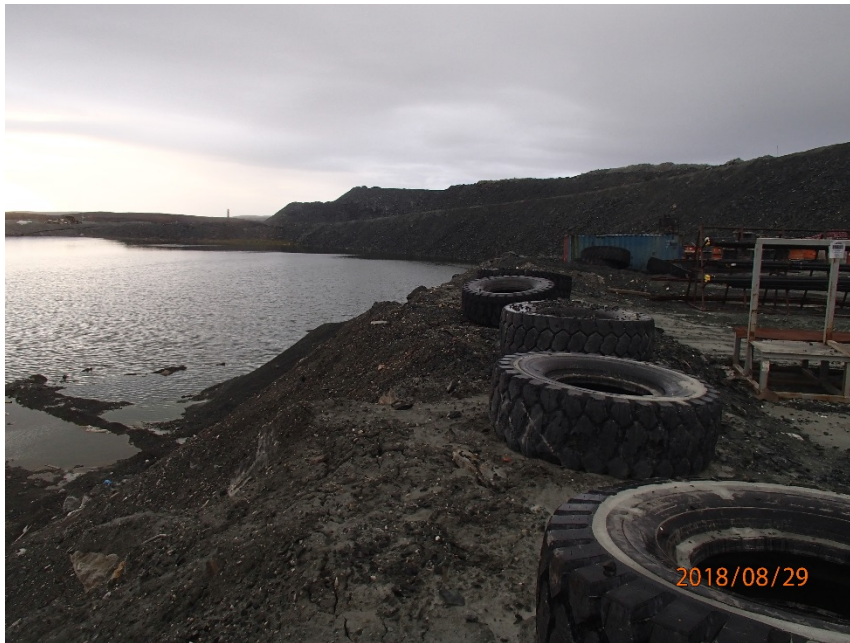
Photograph H7-1 Stormwater Pond

Description: From the northwestern side of the pond, looking southeast at Stormwater Pond.

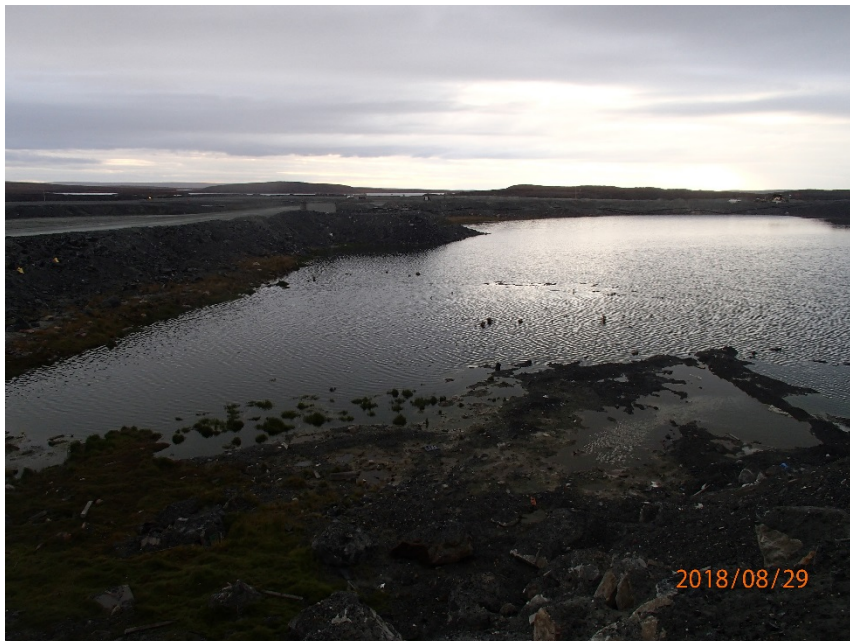
Photograph H7-2 Stormwater Pond

Description: From the northwestern side of the pond, looking southeast at Stormwater Pond.

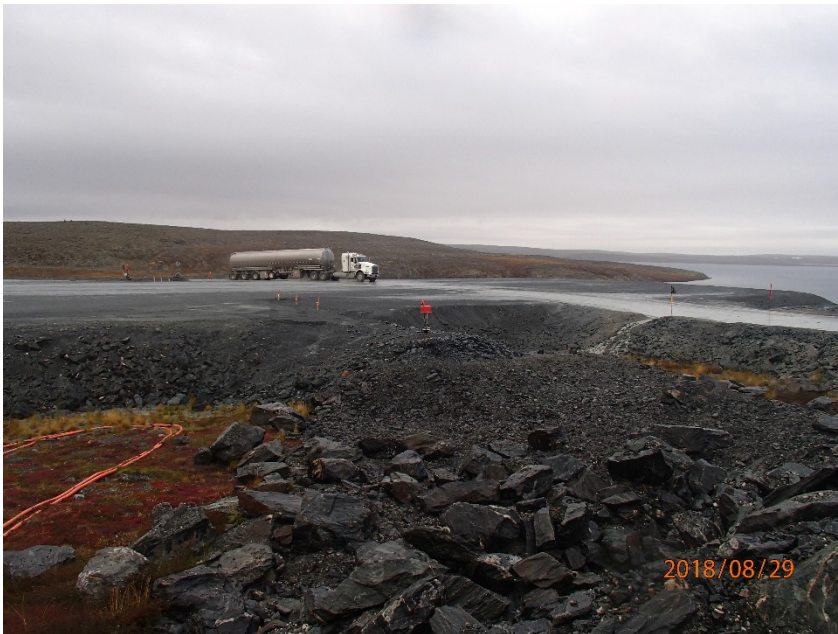
Photograph H8-1 Airstrip

Description: Looking west at the extremity of the airstrip located within Third Portage Lake.

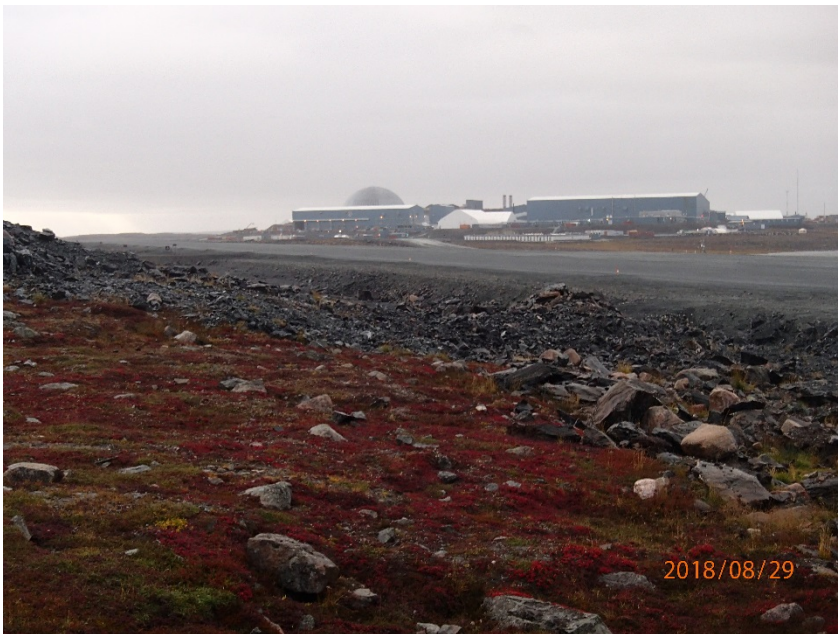
Photograph H8-2 Airstrip

Description: From the extremity of the airstrip located within Third Portage Lake, looking southeast.

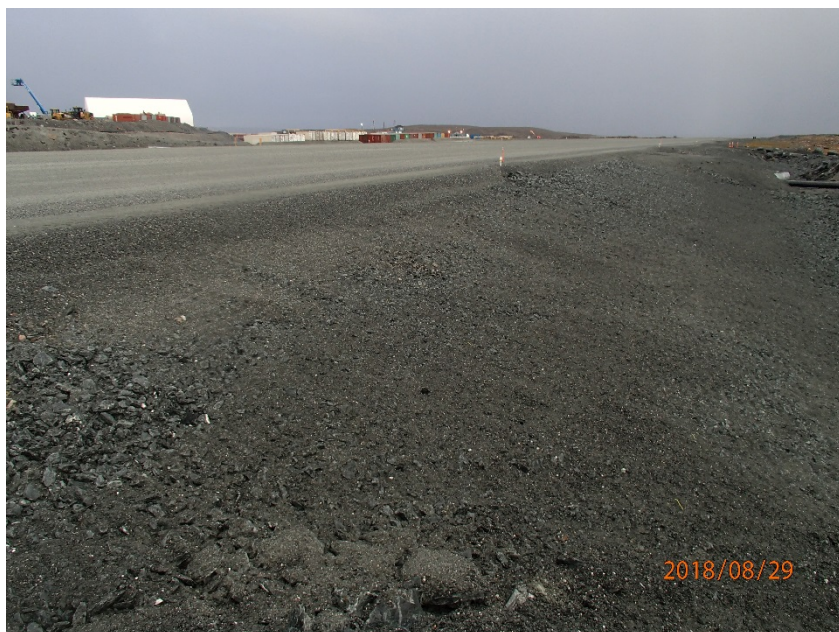
Photograph H8-3 Airstrip

Description: From the northeast side of the airstrip looking northwest.

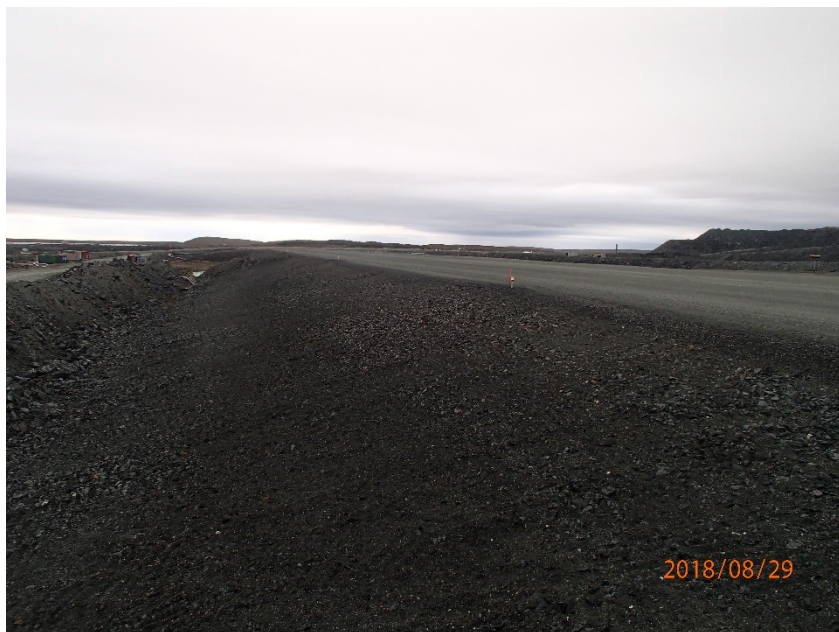
Photograph H8-4 Airstrip

Description: From the northeast side of the airstrip looking southeast.

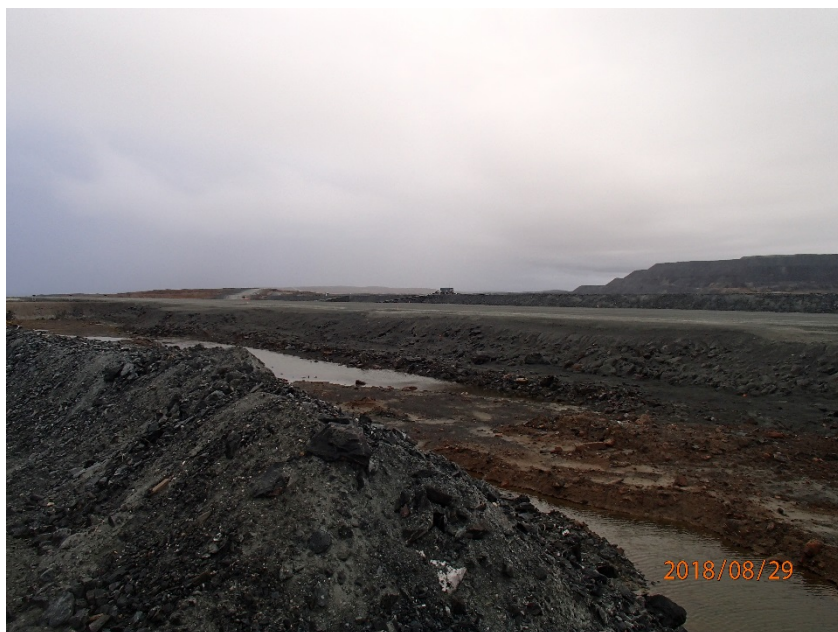
Photograph H8-5 Airstrip

Description: From the southeast side of the airstrip looking northwest.
