# **Meadowbank and Whale Tail 2024 Annual Geotechnical Inspection**

# 2024 Annual Geotechnical Inspection

*Meadowbank Complex, NU*

Reference No. CA0038946.6657-1630-R-Rev0

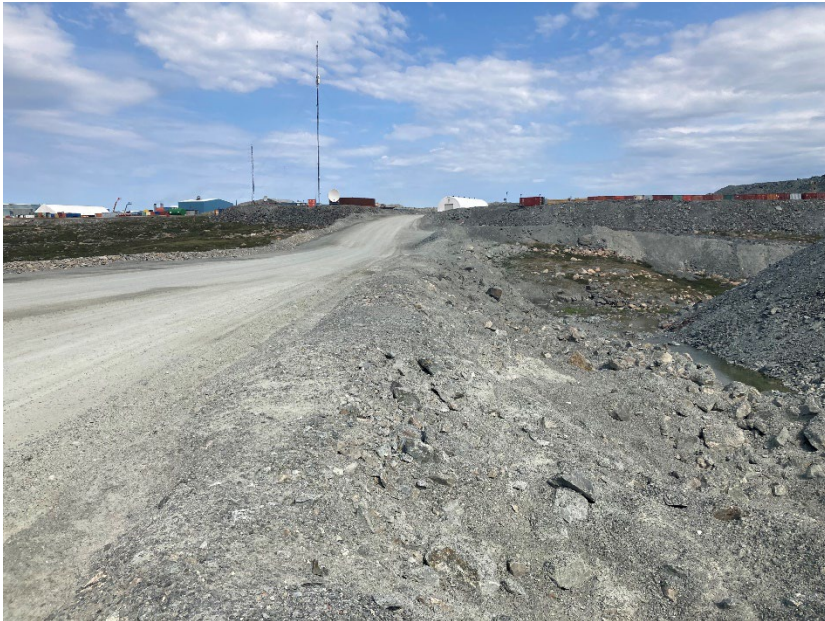
**Photograph A2-06 South Camp Dike**

**Description:** From the south abutment, looking north at the downstream slope. There is some water ponding, from run-off.

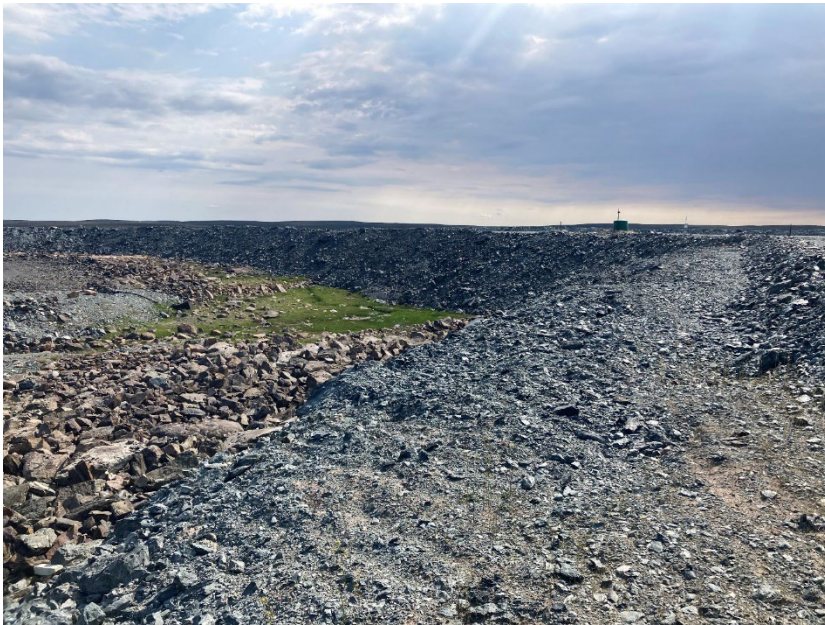
**Photograph A3-10 Bay Goose Dike**

INSPECTION ITEM	OBSERVATIONS DATA	PHOTO	COMMENTS & OTHER DATA
	North Channel		Monitored by stations 8 (30+420). Water flowing was observed during the inspection.
	Central Shallow		Presence of 2 seepage channels at 30+650 and 30+625. Flow was observed during inspection at 30+655. Monitored by station 7.
	Central Channel		Presence of a seepage channel at Sta. 31+165. Water ponding was observed at the time of the inspection. It was pumped once after freshet only.
	Channel 3		Light flow observed during inspection at Sta 31+500 m. Monitored by station 6.
	Channel 1		This seepage channel was not flowing at the time of the inspection.
	Water Ponds		Presence of water pond with no sign of seepage. Located at 31+750. between Channels 1 and 2.

**Description:** From the crest at approximately Sta. 31+740, looking north at downstream slope and toe, note the water pond at Sta. 31+750.

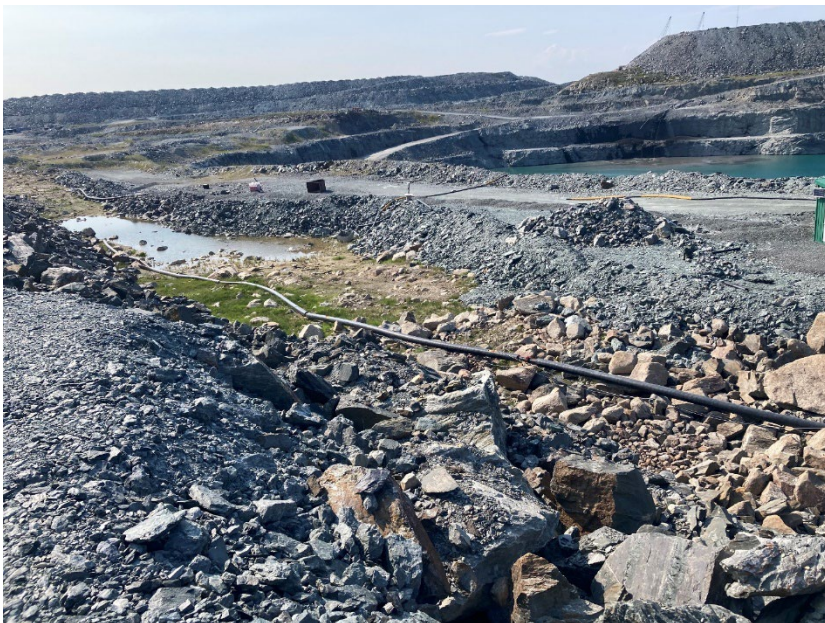
**Photograph A3-34 Bay Goose Dike**

**Description:** From approximately Sta. 30+340, looking northwest at the north seepage channel.

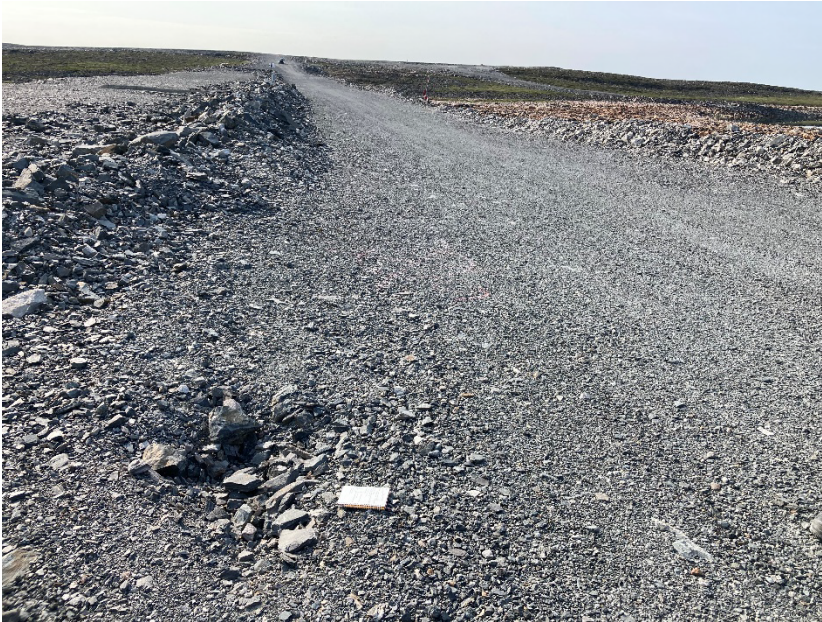
**Photograph A4-3 Vault Dike**

**Description:** From the west abutment, looking southeast at the crest. Presence of a surficial depressions in the crest (diameter around 250 mm).

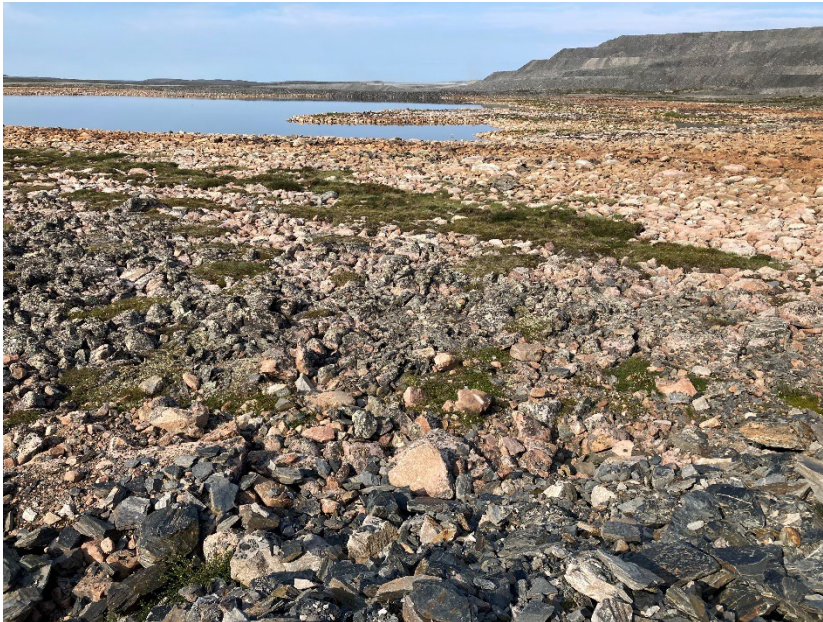
**Photograph A4-6 Vault Dike**

**Description:** From the downstream side, looking southwest towards Vault Pit.

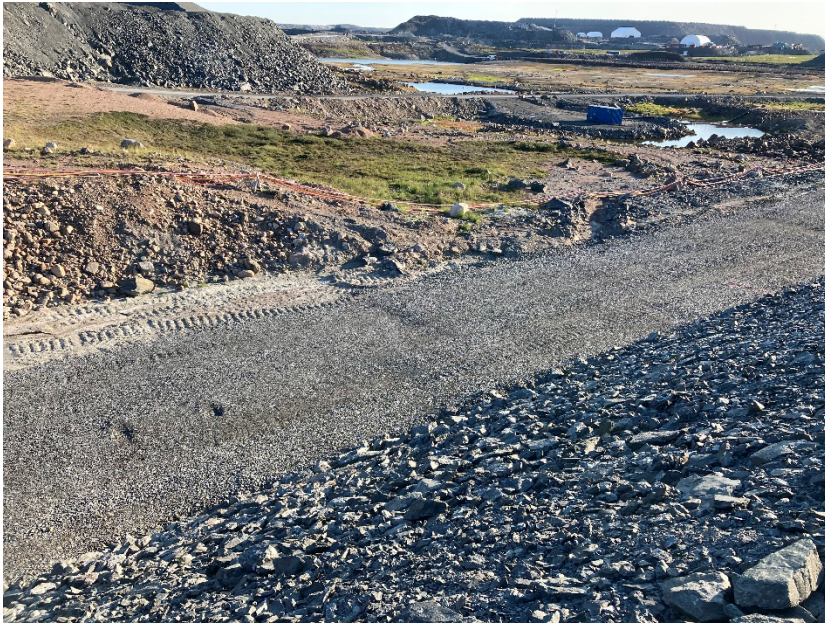
**Photograph A5-3 Whale Tail Dike**

3.3 Signs of movement (deformation)	None observed		
3.4 Cracks	None observed		
3.5 Seepage or wet areas	None observed		
3.6 Vegetation growth	No		
3.7 Other unusual conditions	Yes	96, 115	Depression in downstream platform (~150 mm), seems inactive
<b>4. DOWNSTREAM TOE AREA</b>		111, 116, 117, 118, 119, 120, 121, 122

**Description:** From approx. Sta. 0+200 (west abutment), looking northeast at the downstream slope and downstream platform. Depressions are observed in downstream platform (~150 mm, seem inactive).

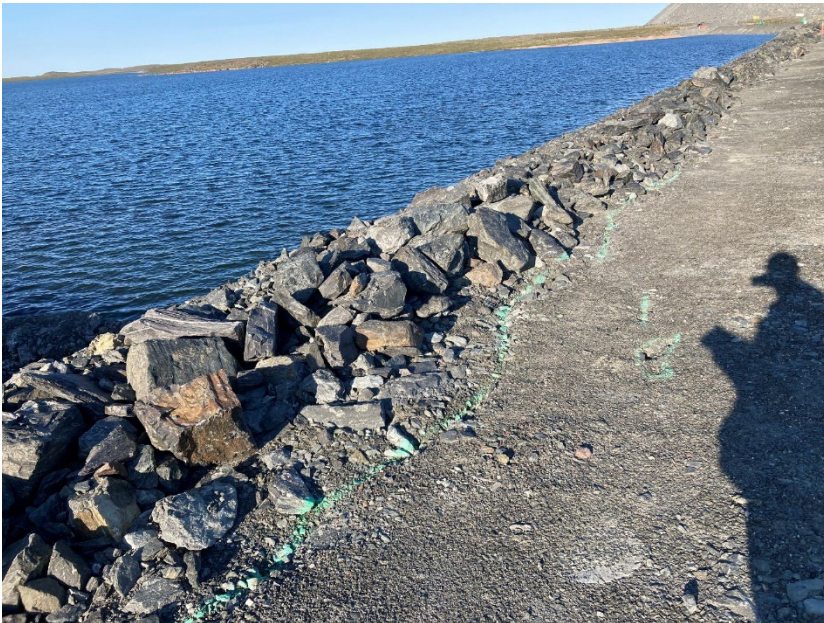
**Photograph A5-16 Whale Tail Dike**

INSPECTION ITEM	OBSERVATIONS DATA	PHOTO	COMMENTS & OTHER DATA
1.4 Surface cracking	Yes	109, 112	Associated to foundation thawing. Cracks parallel to center line (20 mm wide) depressions (500-700 mm) with some perpendicular to center line. Seem inactive and less visible than 2023. Circular cracks in crest at Sta. 0+725 and 0+775 (1-3 m long, 5-10 mm wide)

**Description:** From approx. Sta. 0+775 upstream, looking west at the crest platform where tension cracks are visible

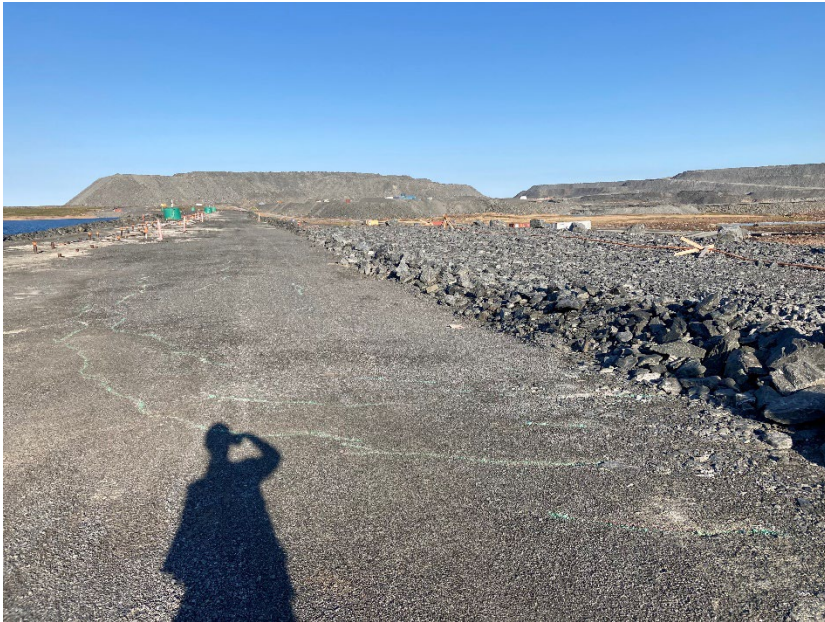
**Photograph A5-19 Whale Tail Dike**

**Description:** From approx. Sta. 0+725 downstream, looking northwest at the downstream side of the crest where tension cracks are visible.

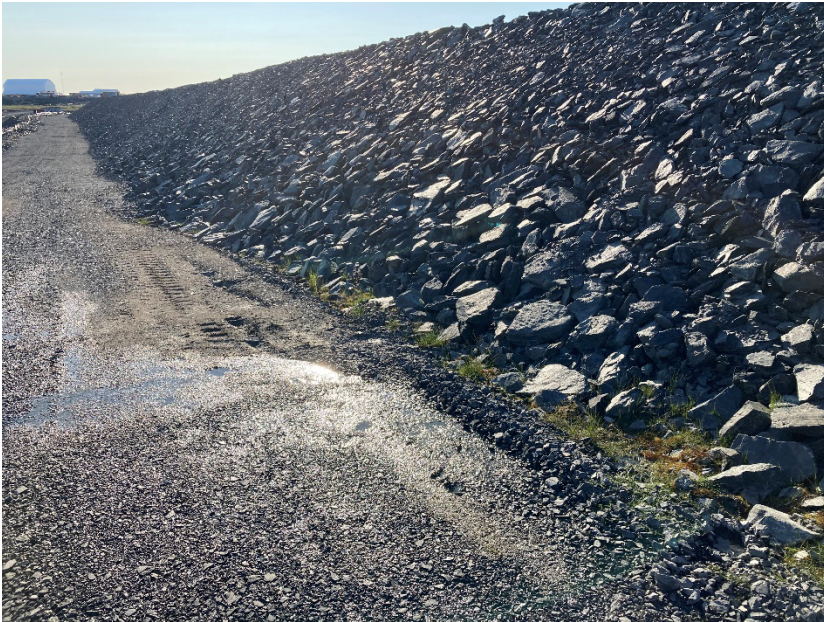
**Photograph A5-21 Whale Tail Dike**

**Description:** From approx. Sta. 0+160 downstream, looking east at the downstream slope and platform. Wet area observed at previous location of water resurgence.

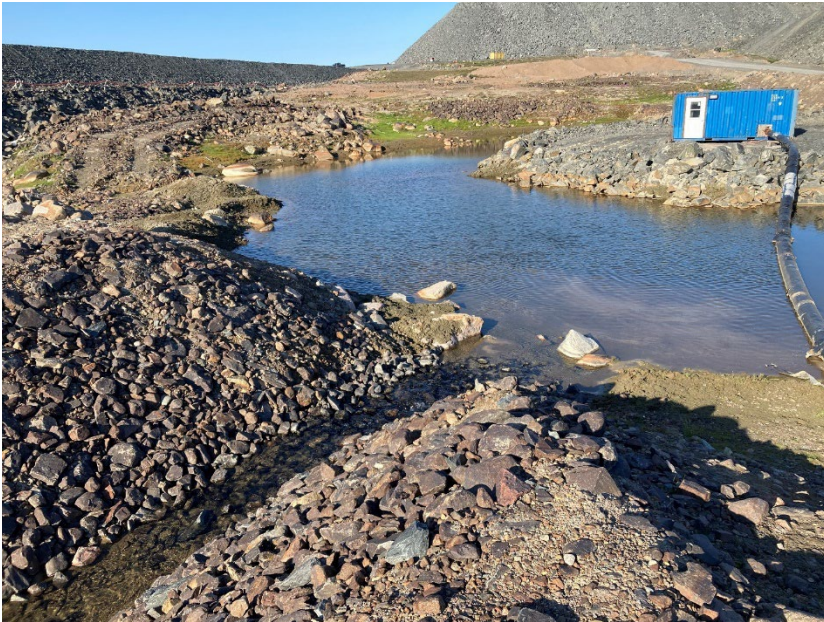
**Photograph A5-27 Whale Tail Dike**

**Description:** From approx. Sta. 0+250 downstream (P4 pumping station), looking southwest. A large amount of water is ponding.

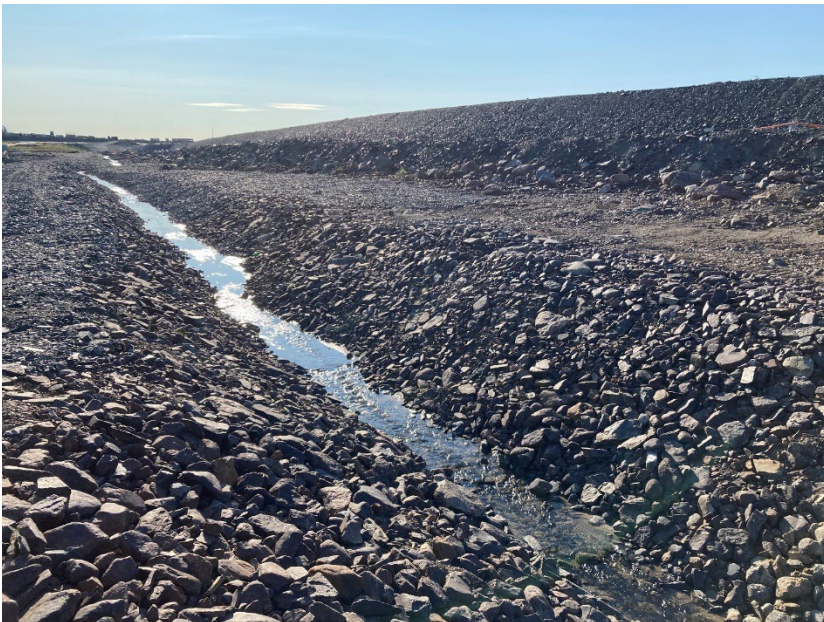
**Photograph A5-28 Whale Tail Dike**

**Description:** From approx. Sta. 0+250 downstream (P4 pumping station), looking southeast. Seepage collection trench in good condition.

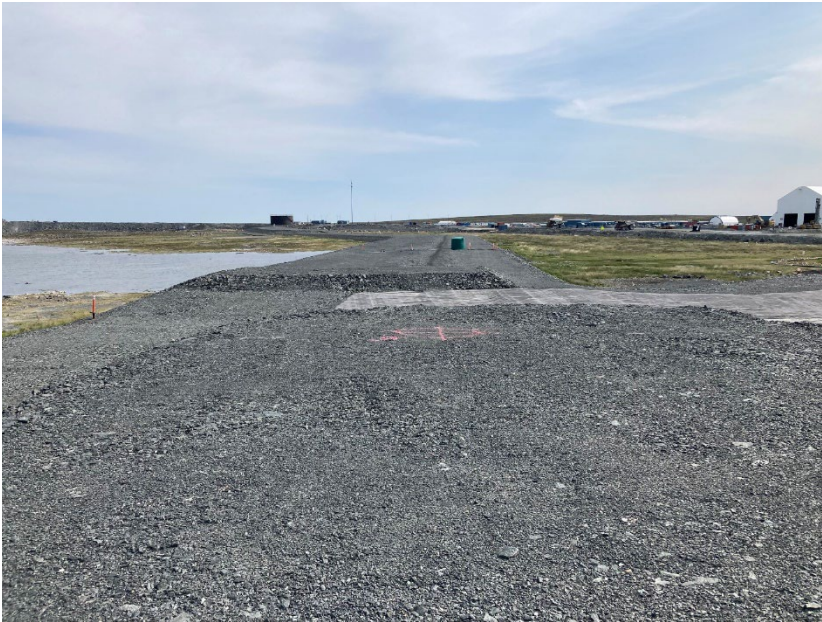
**Photograph A6-1 IVR Dike D-1**

1.5 Unexpected settlement	Yes	59	Likely related to rockfill, esker and shallow foundation thawing after winter construction. Settlement of about 300 to 500 mm (2023). A large area of the dike between Sta. 0+100 and 0+340 show settlement (up to about 300 mm), roughly in the footprint of the former water channel.

**Description:** From approx. Sta. 0+030 (west abutment), looking southeast at the crest. Presence of settlement in the rockfill surface.

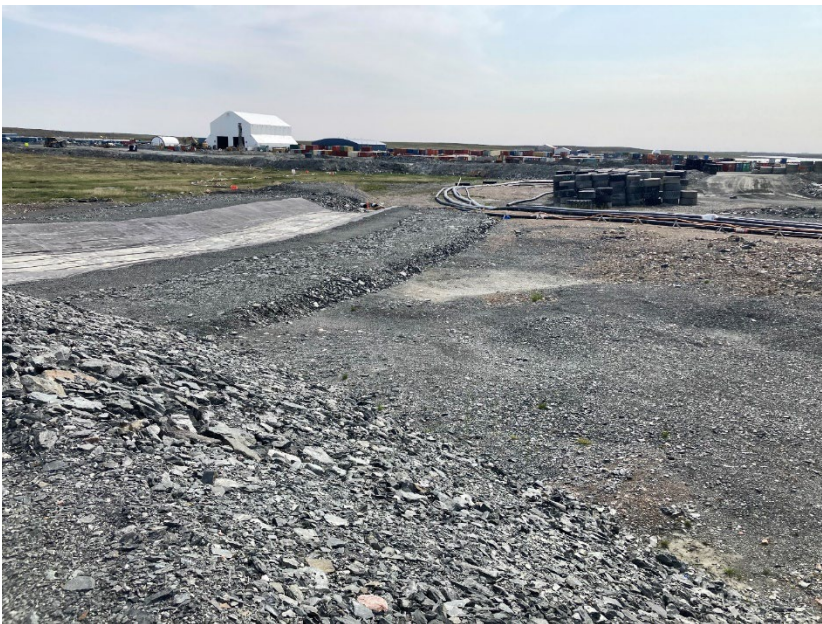
**Photograph A6-2 IVR Dike D-1**

INSPECTION ITEM	OBSERVATIONS DATA	PHOTO	COMMENTS & OTHER DATA
7.6 Presence of debris or blockage	Yes, piping in the lower spillway		
7.7 Closure mechanism operational	None		
7.8 Slope protection	None		
7.9 Instability of side slopes	None		
7.10 Other unusual conditions	Yes		Section of spillway on upstream side appears shallow.
<b>8. INSTRUMENTATION</b>			
8.1 Piezometers	No		
8.2 Settlement cells	No		
8.3 Thermistors	Yes		See Section 4.3.2 of the report.
8.4 Settlement monuments	No		
8.5 Seismograph	No		
8.6 Inclinator	No		
8.7 Weirs and flow monitors	No		
8.8 Data logger(s)	Yes		
8.9 Other	No		
<b>9. DOCUMENTATION</b>			
9.1 Operation, Maintenance and Surveillance (OMS) Plan			
9.1.1 OMS Plan exists	Yes		
9.1.2 OMS Plan reflects current dam conditions	Yes		
9.1.3 Date of last revision	January 2024

**Description:** From approx. Sta. 0+050, looking south at the spillway. Presence of piping at the outlet of the spillway.

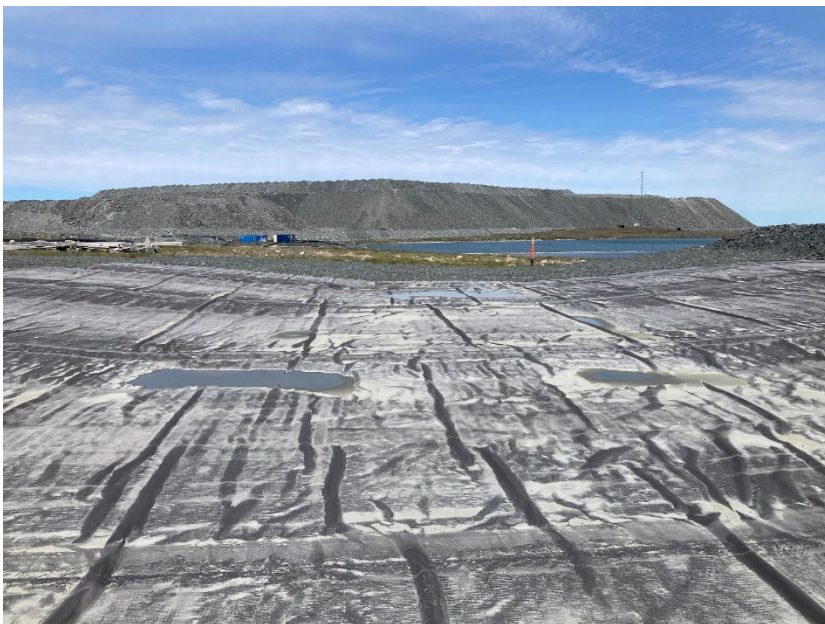
**Photograph A6-4 IVR Dike D-1**

**Description:** From approx. Sta. 0+080, looking northeast at the upstream side emergency spillway on the Upstream side. The spillway section appears shallow.

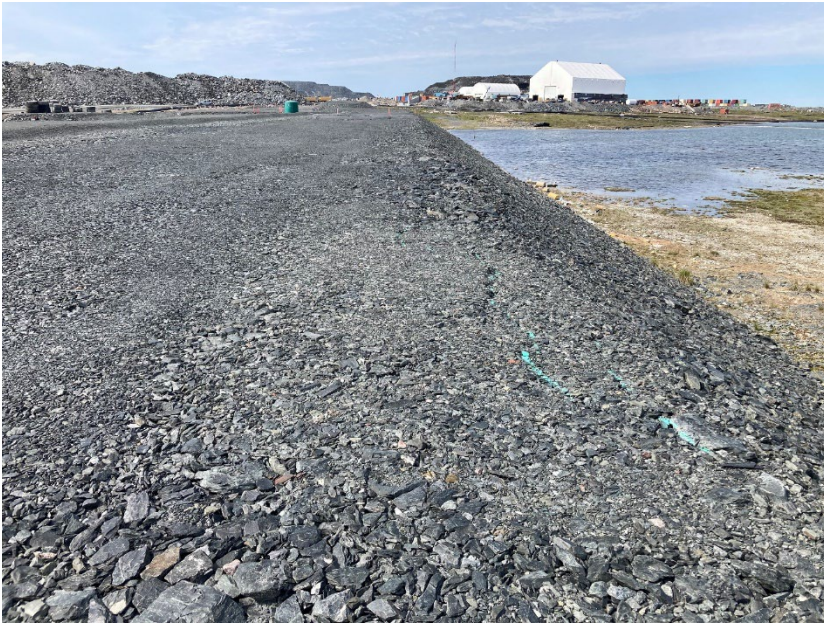
Photograph A6-7 IVR Dike D-1

INSPECTION ITEM	OBSERVATIONS DATA	PHOTO	COMMENTS & OTHER DATA
1.4 Surface cracking	Yes	65, 66, 67, 68, 71,72.  75, 75b.	<p>Presence of inactive old tension cracks (30mm-100mm wide and up to 5 m long).</p> <p>Tension cracks were still present in the rockfill near the downstream and upstream edges of the crest in the southeastern part of the dike (southeast of Sta. 0+240). Deformations visually seem to be similar to 2023; however, this should be confirmed with detailed survey of the dike crest, which is in progress by AEM.</p>

**Description:** From approx. Sta. 0+430, looking west at the crest and upstream slope. Presence of tension cracks (inactive).

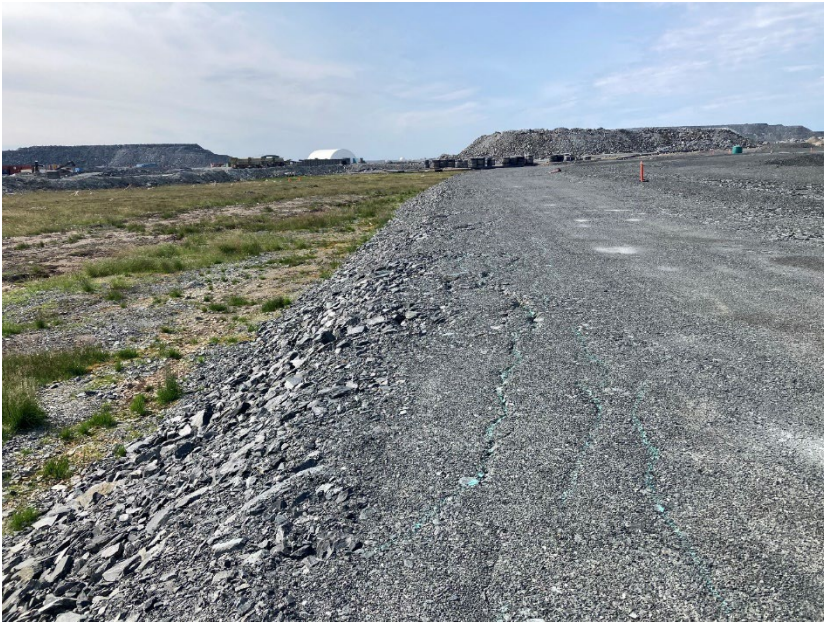
**Photograph A6-13 IVR Dike D-1**

**Description:** From approx. Sta. 0+430, looking west at the crest and downstream slope. Presence of tension cracks (inactive).

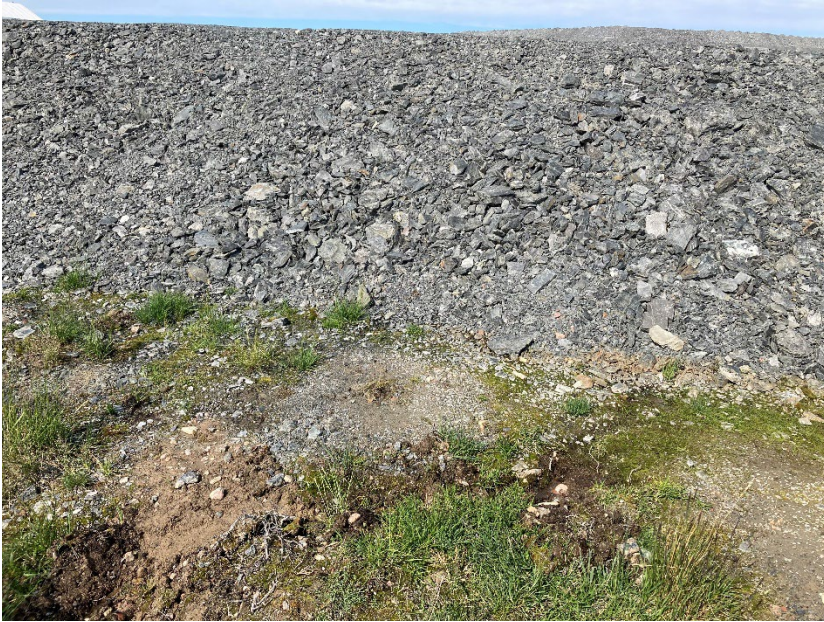
**Photograph A6-15 IVR Dike D-1**

**Description:** From approx. Sta. 0+320, looking north at the crest and upstream slope. Traces of flow. Presence of two zones of seepage at toe likely related to runoff exiting the rockfill.

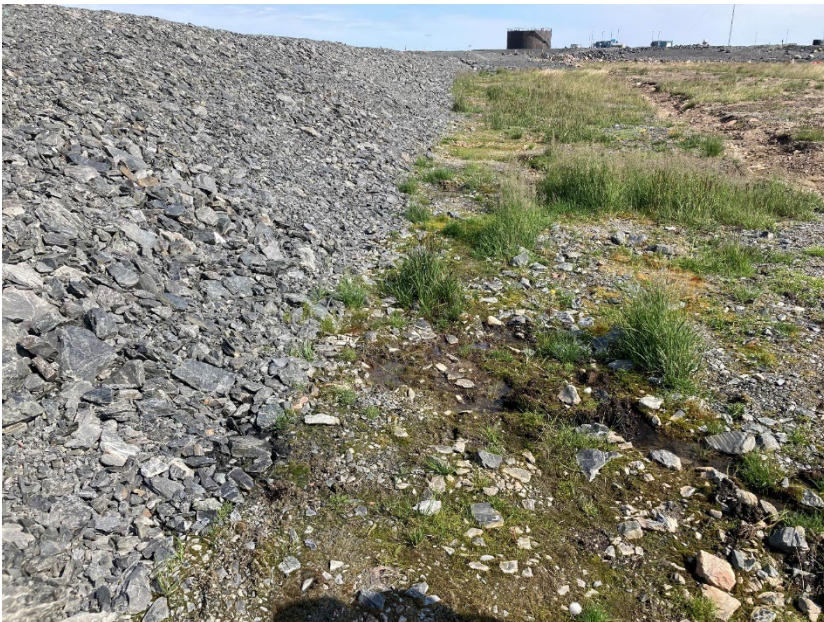
**Photograph A6-16 IVR Dike D-1**

**Description:** From approx. Sta. 0+300, looking east at the crest and downstream slope. Traces of flow. Presence of two zones of seepage at toe likely related to runoff exiting the rockfill.

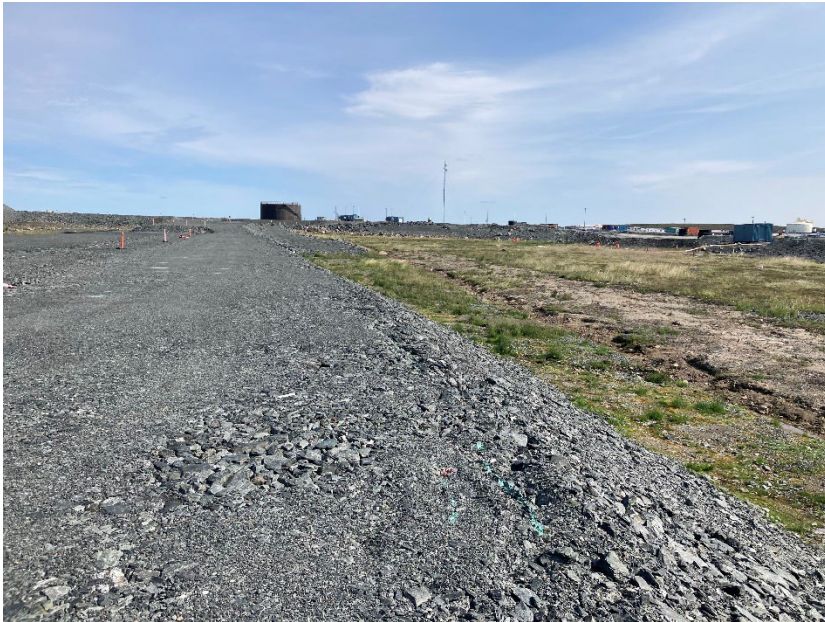
**Photograph A6-17 IVR Dike D-1**

**Description:** From approx. Sta. 0+290, looking east at the crest and downstream slope. Presence of tension cracks.

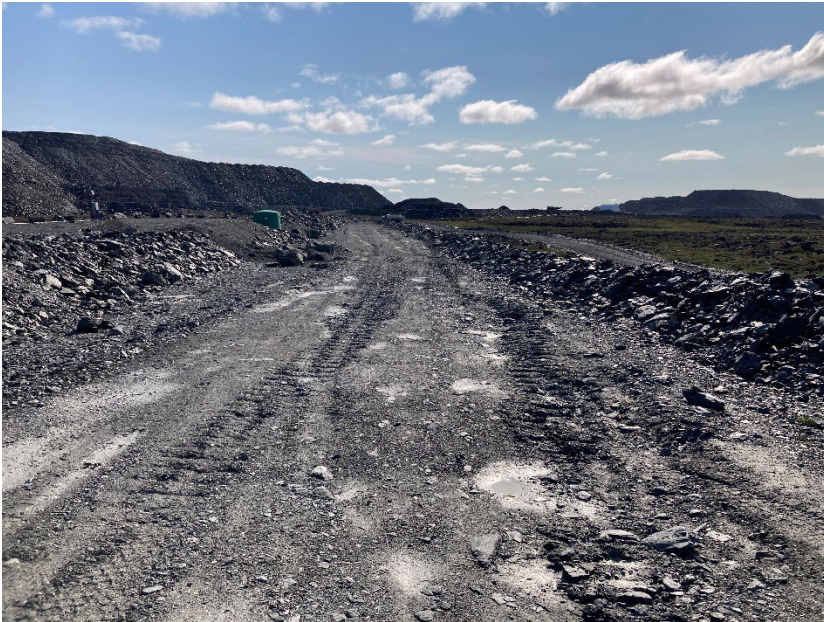
**Photograph A7-8 WRSF Dike**

INSPECTION ITEM	OBSERVATIONS DATA	PHOTO	COMMENTS & OTHER DATA
1.7 Other unusual conditions	Yes	41	Depression (300 mm deep) at upstream thermal berm crest.
<b>2. UPSTREAM SLOPE</b>		37, 38, 39, 40, 41

**Description:** From approx. Sta. 0+080 (west abutment), looking east at the upstream thermal berm crest. Presence of depressions (approx. 300mm), likely from a drill rig or equipment.

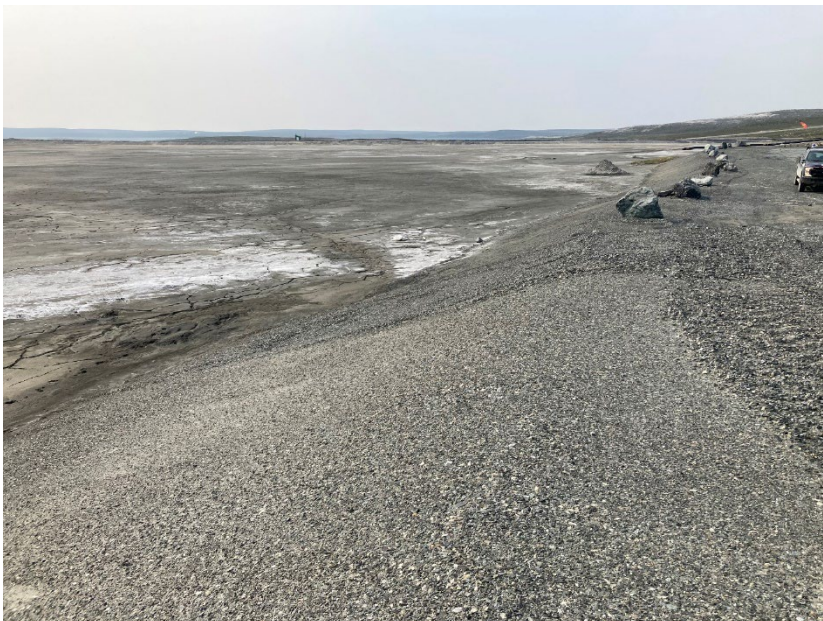
**Photo Number:** 310

2.3 Signs of movement (deformation)	None		
2.4 Cracks	Yes	310,319	Surface repaired in 2021. Tension cracks in fine filter slope (up to 20 mm wide).
2.5 Face liner condition (if applicable)	In good condition

**Description:** From the North Cell Internal Structure, looking west at upstream slope. Tension cracks in fine filter slope (~ 0- 20 mm wide).

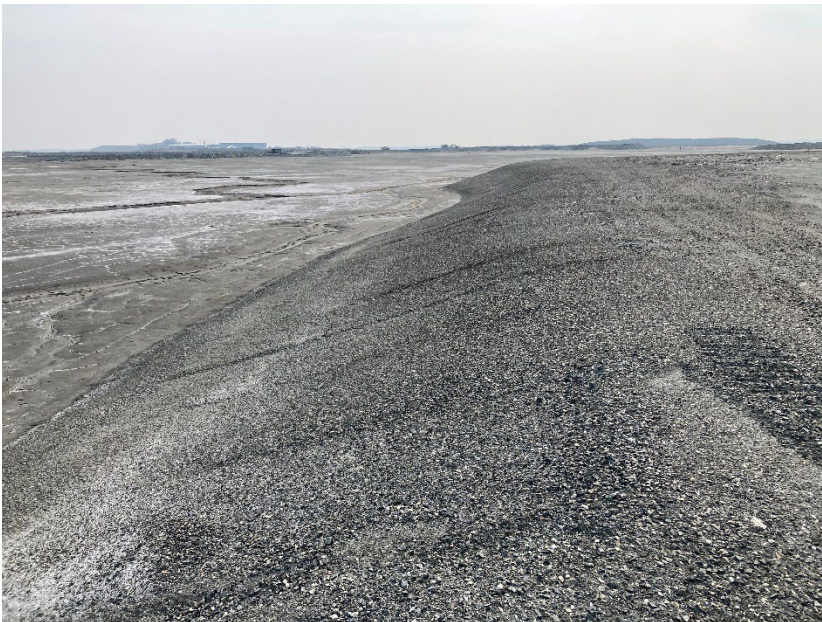
**Photo Number:** 312

**Description:** From the North Cell Internal Structure, looking north toward the diversion ditch. Small tension cracks in ditch slope.

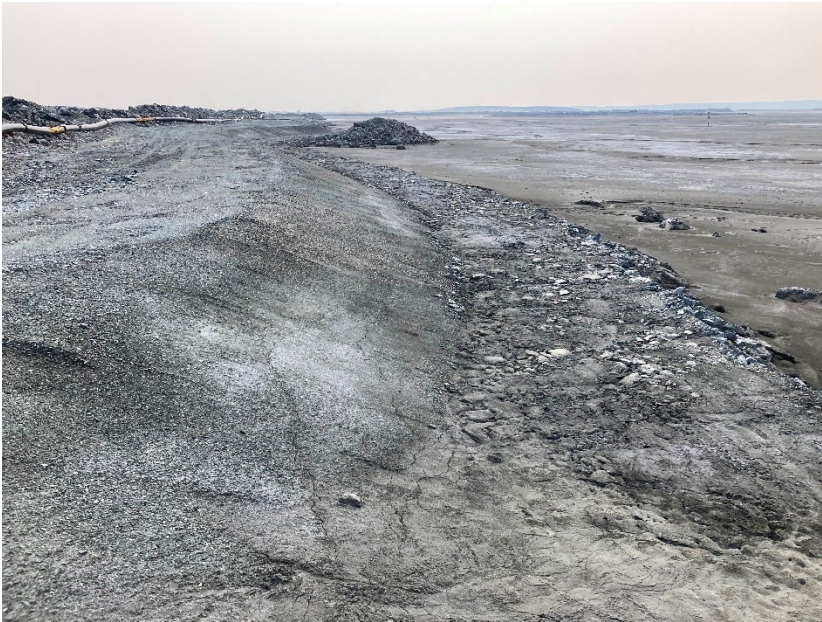
**Photo Number:** 321

**Description:** From the North Cell Internal Structure, looking south at the upstream slope. Presence of tension crack on upstream slope (approx. 10-20 mm wide), water channeling at the toe.

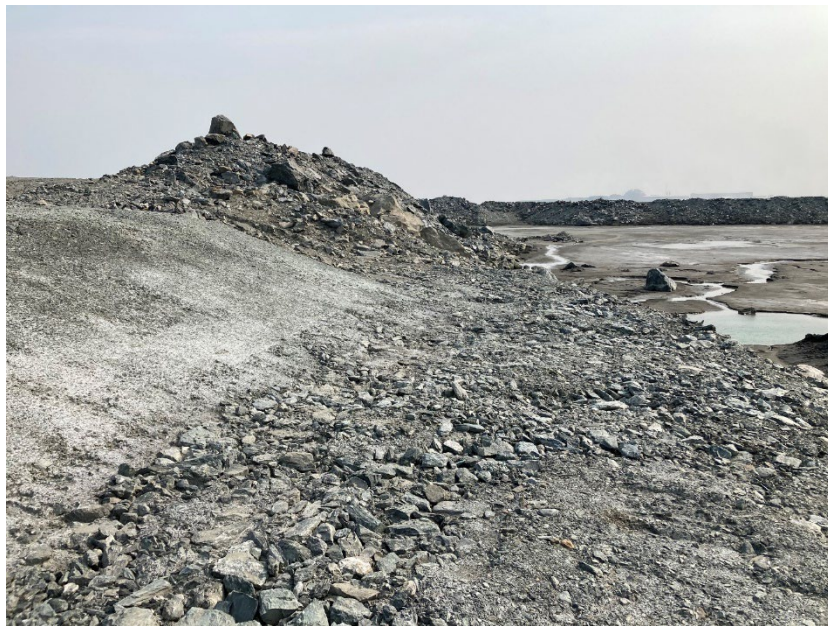
**Photo Number:** 323

**Description:** From the North Cell Internal Structure, looking northeast at the upstream slope and water channelling at the toe.

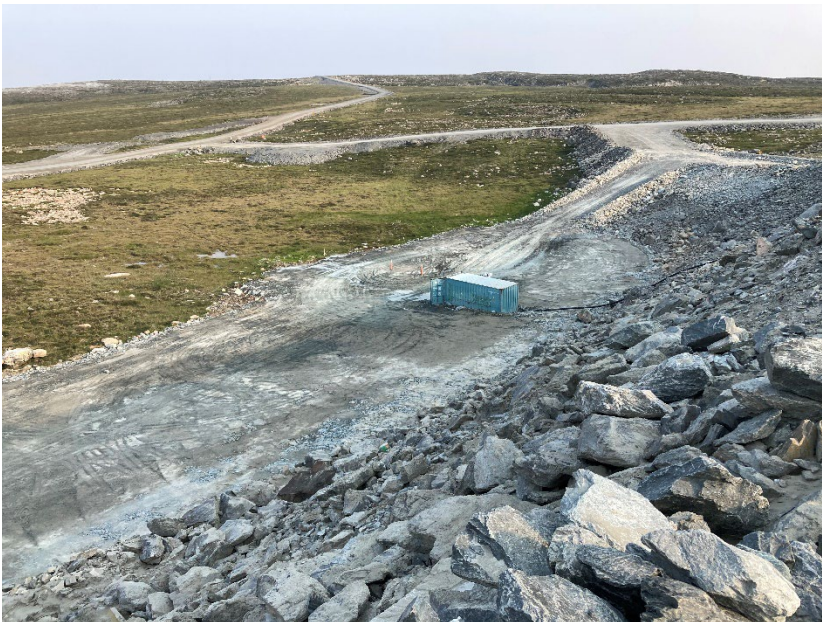
**Photo Number:** 263

INSPECTION ITEM	OBSERVATIONS DATA	PHOTO	COMMENTS & OTHER DATA
<b>4. DOWNSTREAM TOE AREA</b>		262, 263, 264, 265	
4.1 Seepage from dam	Uncertain	263, 264, 265	A dewatering sump is installed downstream. Water flowing out of sump on rockfill platform was observed ponding in that area.

**Description:** From Sta. 0+150 looking west at the downstream face. Notice the sea-can container where a sump is installed. Presence of water flowing out of sump on rockfill platform.

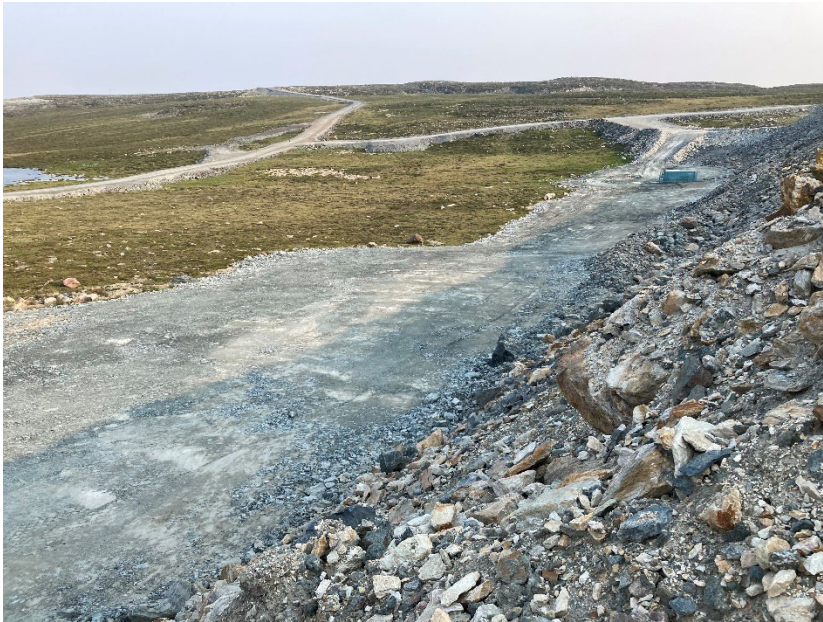
**Photo Number:** 264

**Description:** From Sta. 0+150 looking northwest at the downstream face. Notice the sea-can container where a sump is installed.

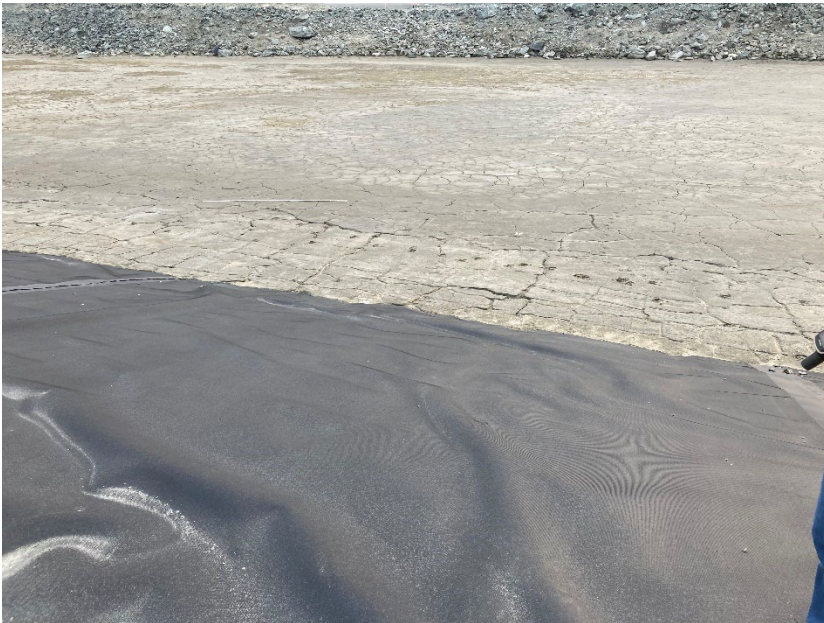
**Photograph B3-02 Saddle Dam 2**

**Description:** From approximately Sta. 20+475, looking northeast at the upstream slope.

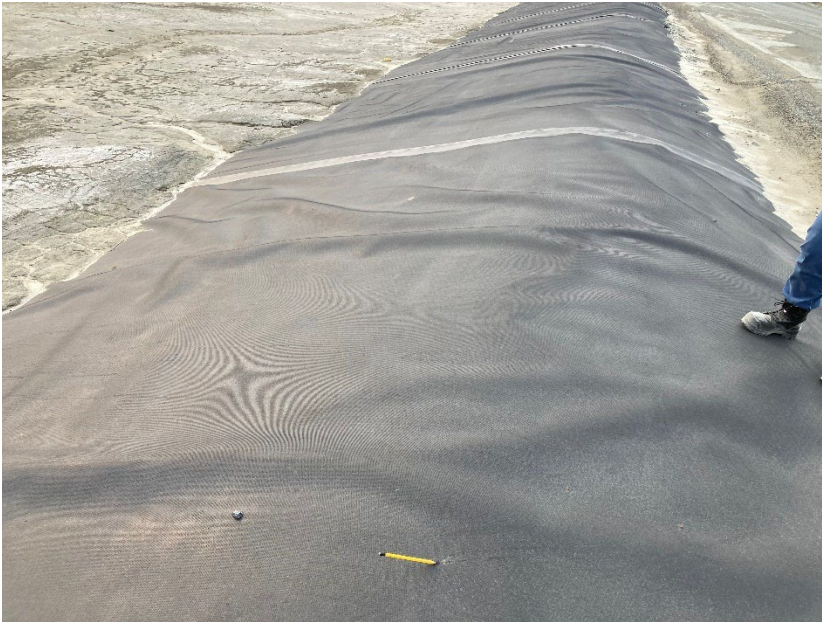
**Photograph B3-03 Saddle Dam 2**

**Description:** From approximately Sta. 20+370 looking southeast at the crest and the downstream slope. Small holes on the top of slope and crest are observed.

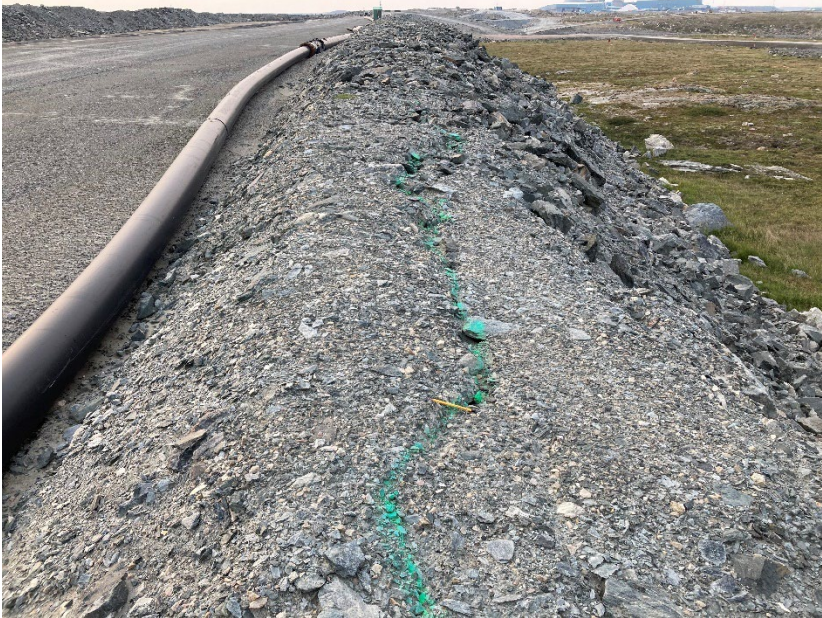
**Photograph B3-09 Saddle Dam 2**

**Description:** From Saddle Dam 2 (approximately Sta. 20+110) looking southeast at the crest and downstream slope. Cracks in berm are observed.

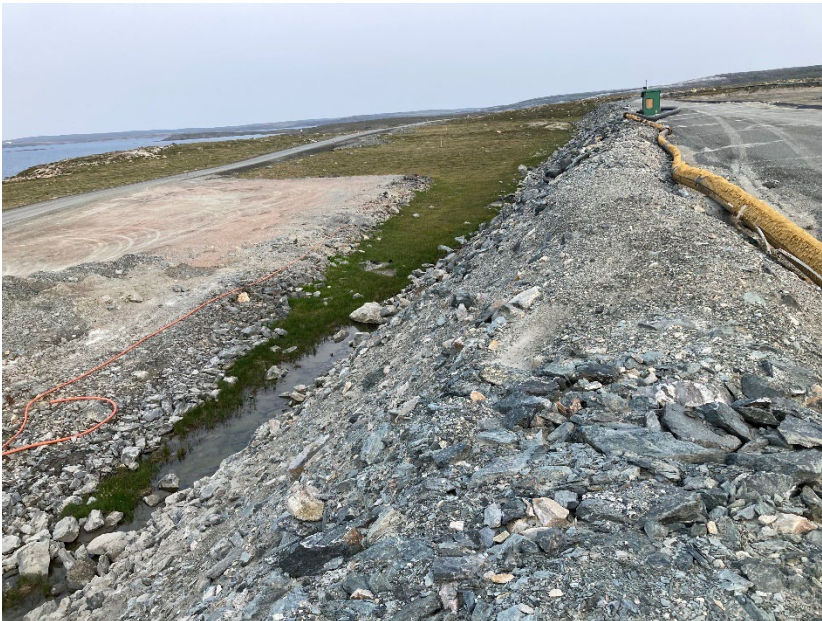
**Photograph B3-10 Saddle Dam 2**

**Description:** From Saddle Dam 2 (approximately Sta. 20+500) downstream, looking northwest at the downstream toe and slope of Saddle Dam 2. Presence of water ponding at the toe and small cracks on the berm.

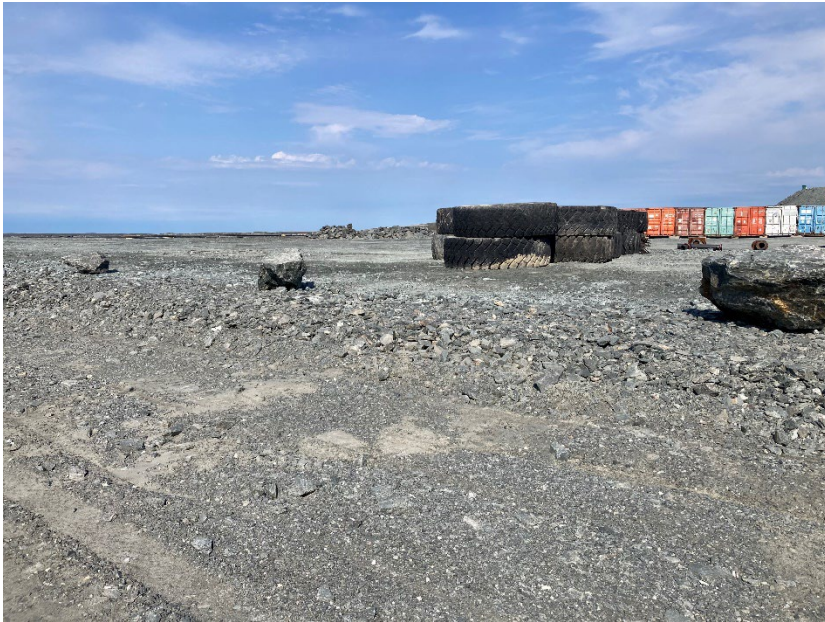
**Photograph B4-01 Stormwater Dike**

1.6 Lateral movement	No		
1.7 Other unusual conditions	Yes	157, 158, 159, 160, 161	Capping has reached the dike crest (from approx. 10+525 to 11+100)
<b>2. UPSTREAM SLOPE</b>		157, 158, 159, 160, 161, 164, 165, 166, 167

**Description:** From the east abutment (11+100 approximately), looking north at the upstream face and the rockfill cover of the North Cell. Capping has reached the dike crest.

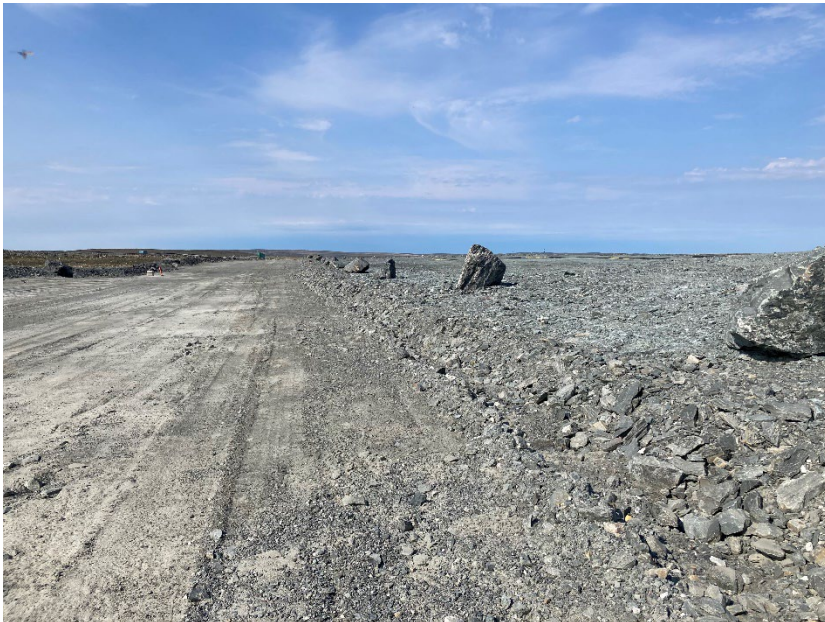
**Photograph B4-02 Stormwater Dike**

**Description:** From the east abutment (10+975 approximately), looking west at the upstream slope. Capping has reached the dike crest.

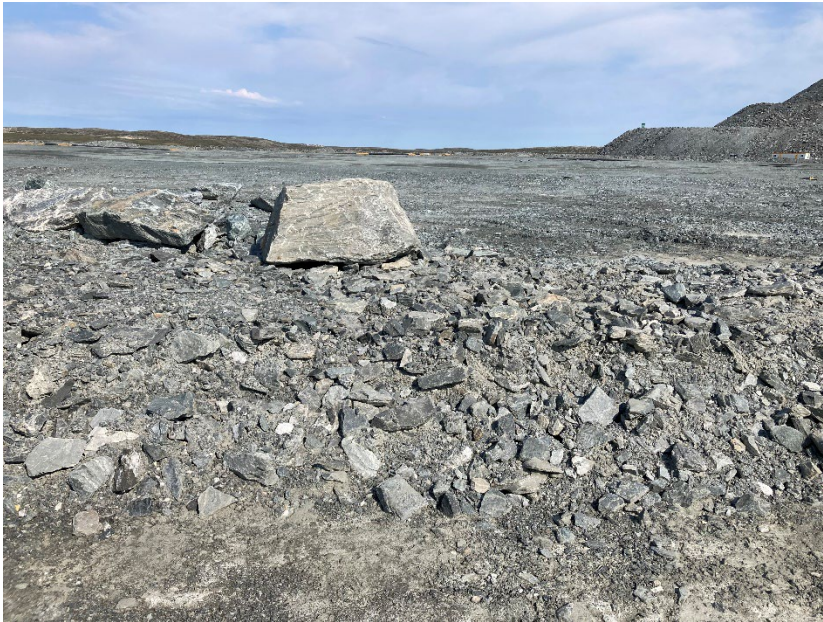
**Photograph B4-03 Stormwater Dike**

**Description:** From the east abutment (10+800 approximately), looking northwest at the upstream slope. Capping has reached the dike crest.

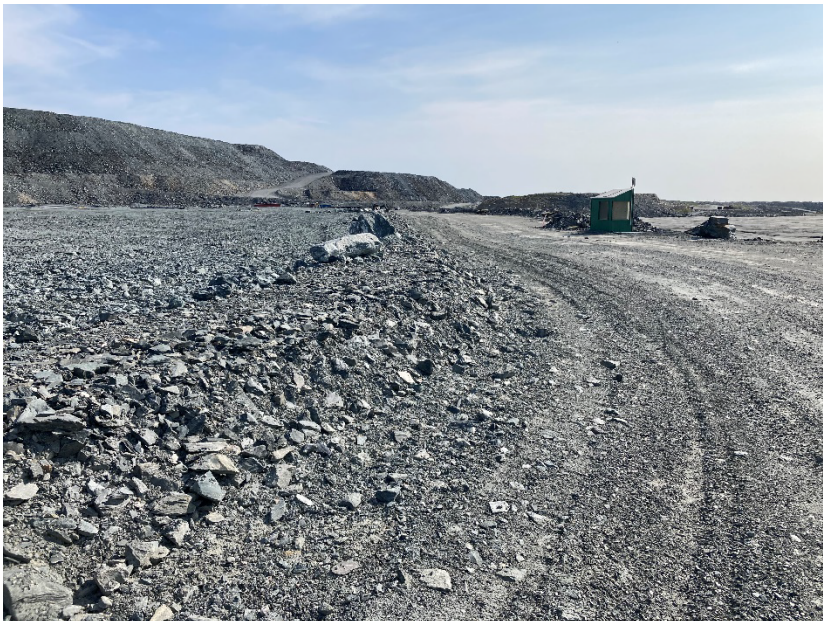
**Photograph B4-04 Stormwater Dike**

**Description:** From Sta. 10+650 looking east at the crest and upstream slope. Capping has reached the dike crest.

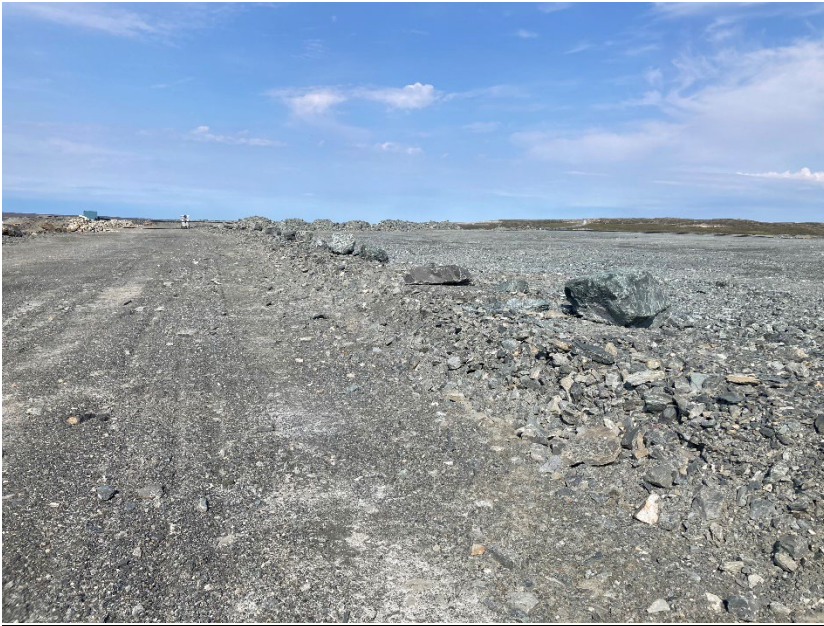
**Photograph B4-05 Stormwater Dike**

**Description:** From Sta. 10+650 looking west at the crest and upstream slope. Capping has reached the dike crest.

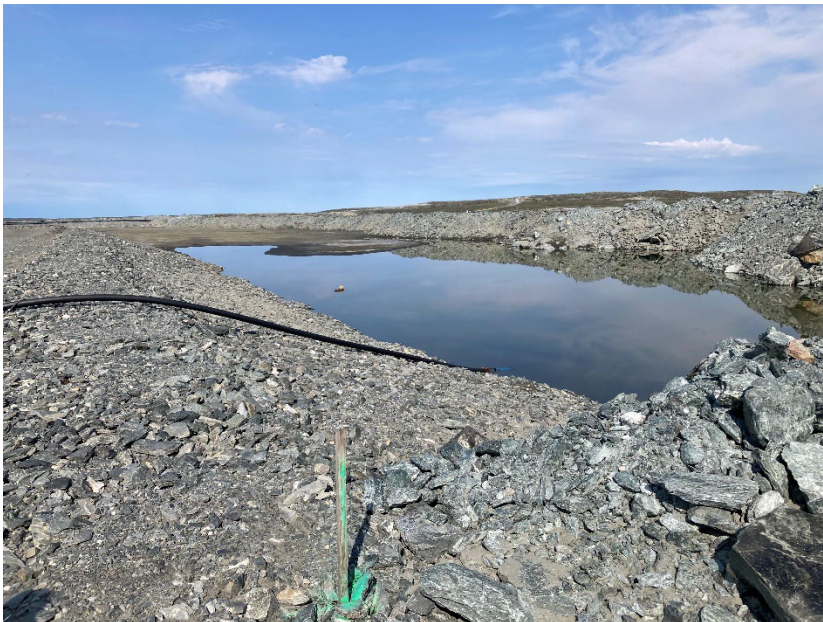
**Photograph B4-08 Stormwater Dike**

2.5 Face liner condition (if applicable)	Good conditions.		
2.6 Other unusual conditions	Yes	164, 165, 166	Large rocks on liner and several open liner welds from approx. 10+100 to 10+600). Water ponding at approx. 10+550
<b>3. DOWNSTREAM SLOPE</b>		165, 168, 169, 170

**Description:** From approximately Sta. 10+550 looking northwest. The liner was covered with granular material for protection from capping. Presence of water pond.

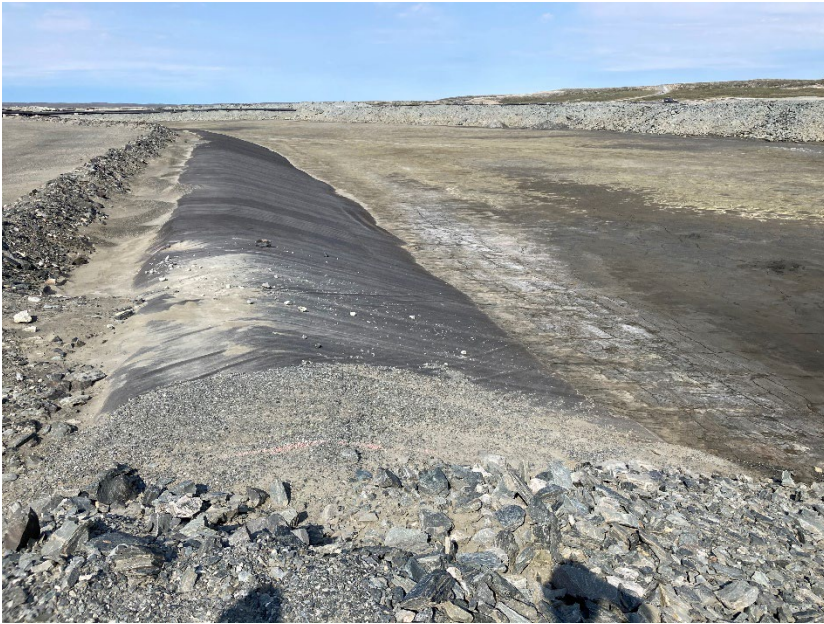
**Photograph B4-09 Stormwater Dike**

**Description:** From approximately Sta. 10+575 looking northwest at upstream slope. Presence of large rocks on liner.

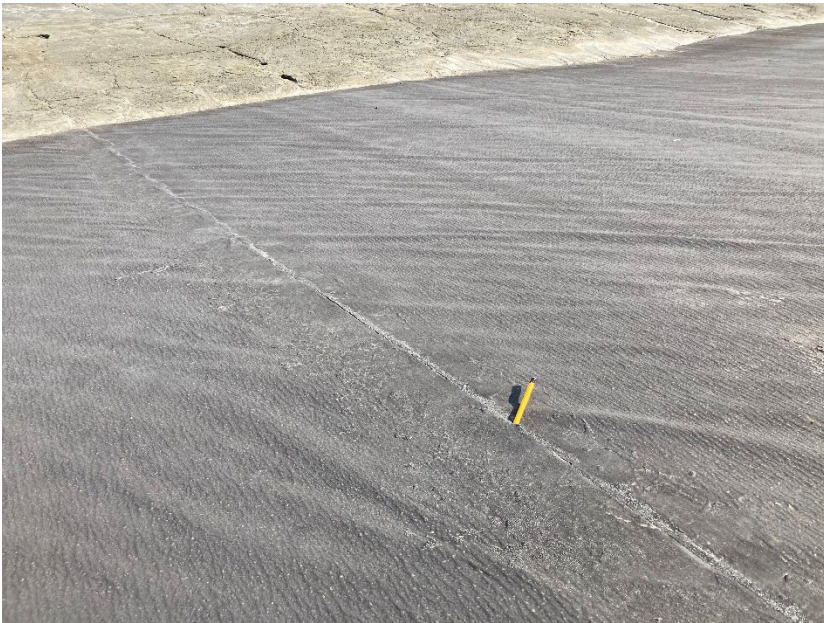
**Photograph B4-10 Stormwater Dike**

**Description:** From approximately Sta. 10+575 looking northwest. Presence of open liner welds.
