# **Meadowbank and Whale Tail 2024 Annual Geotechnical Inspection**

# 2024 Annual Geotechnical Inspection

*Meadowbank Complex, NU*

Reference No. CA0038946.6657-1630-R-Rev0

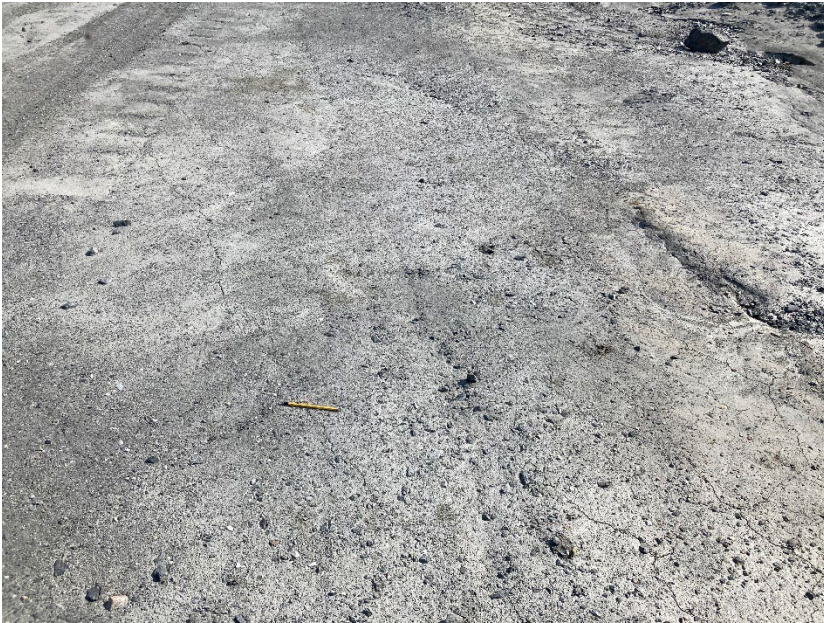
**Photograph B4-14 Stormwater Dike**

INSPECTION ITEM	OBSERVATIONS DATA	PHOTO	COMMENTS & OTHER DATA
1.5 Unexpected settlement	No		Old tension cracks (mostly around 10+300) are inactive and are disappearing. They have since been filled with bentonite. Presence of small new cracks (~ 5mm wide, 4-5 m long) in 2024.

**Description:** From the east abutment (10+900 approximately), looking northeast at the downstream slope. Old cracks still visible (seems inactive and healing). Presence of small new cracks (~ 5mm wide, 4-5 m long).

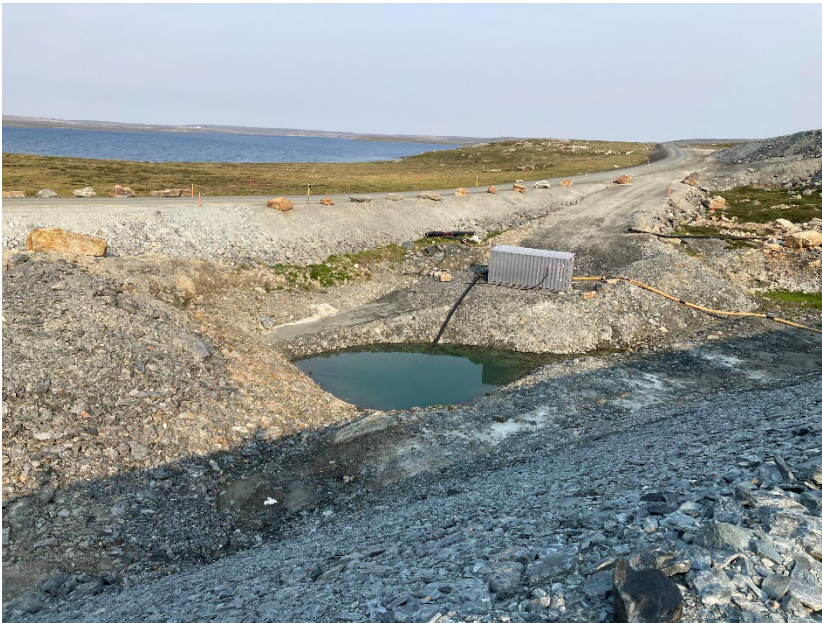
**Photograph B5-04 Saddle Dam 3**

INSPECTION ITEM	OBSERVATIONS DATA	PHOTO	COMMENTS & OTHER DATA
4.5 Outlet operating problem (if applicable)	Not applicable		
4.6 Other Conditions	Yes	269	A sump was constructed on the downstream side to collect the ponding water, so its level does not exceed the elevation of the granular layer of the upstream toe liner tie-in. Water pond at approx. 20+625 in downstream area.
<b>5. ABUTMENTS</b>

**Description:** From Sta. 20+610, looking west at the downstream slope and sump. Presence of water pond.

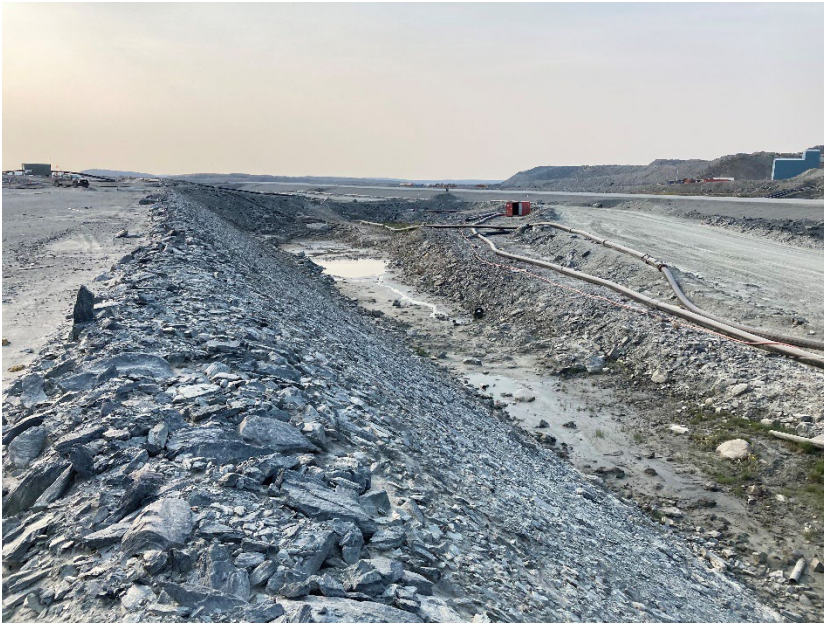
**Photograph B6-01 Saddle Dam 4**

4.6 Other Conditions	Yes	271, 272	Runoff water accumulate at the downstream side of the structure. It is pumped out so that the water level does not exceed the elevation of the granular layer of the upstream toe liner tie-in.
<b>5. ABUTMENTS</b>

**Description:** Looking southeast at the downstream slope and toe. There is some water ponding at the toe.

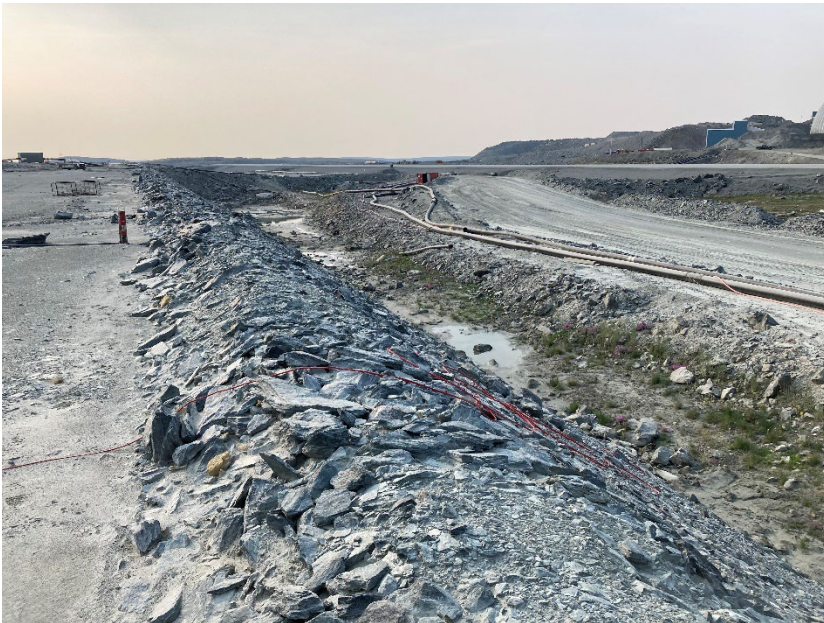
**Photograph B6-02 Saddle Dam 4**

**Description:** From the crest looking southeast at the crest and the downstream slope and toe. There is some water ponding at the toe.

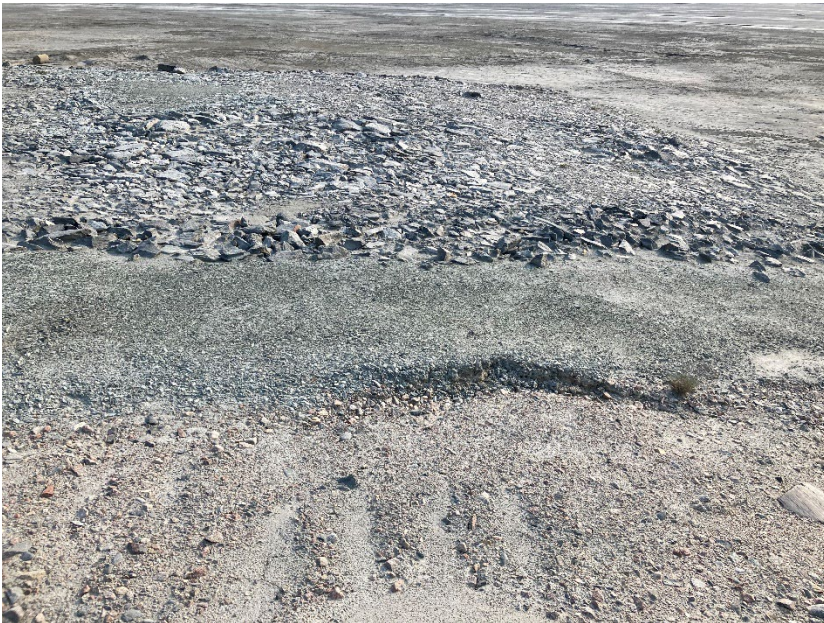
**Photograph B6-04 Saddle Dam 4**

**Description:** Looking northeast at the upstream slope. Some erosion of the liner protection till layer.

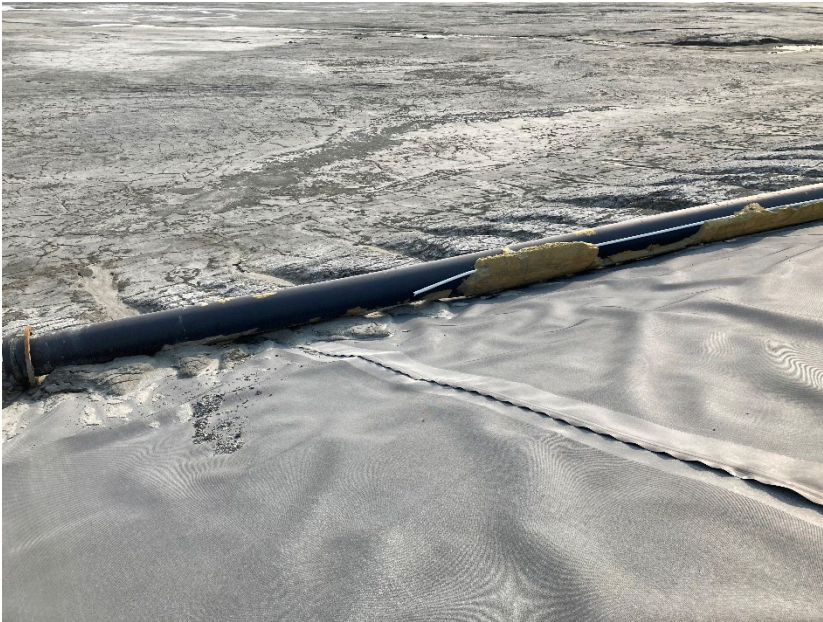
**Photograph B6-07 Saddle Dam 4**

**Description:** Looking southeast at the upstream slope. Presence of a pipe on the liner.

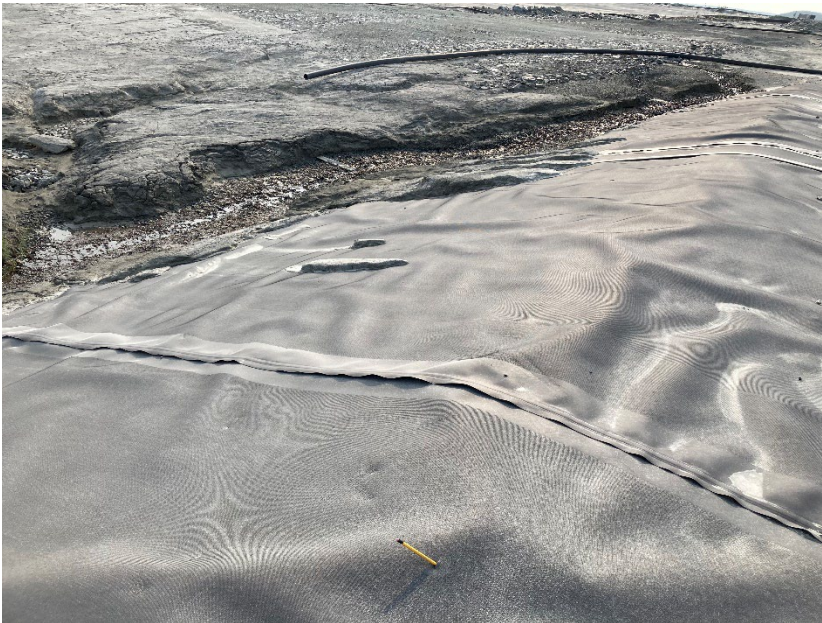
**Photograph B6-08 Saddle Dam 4**

2.3 Signs of Movement (Deformation)	None observed		
2.4 Cracks	None observed		
2.5 Face liner condition (if applicable)	Good	279	Presence of small holes in the liner close to eastern abutment.

**Description:** From the eastern abutment, looking northeast at the upstream toe area. Water discharged on the liner tie-in are eroding the tailings but the granular materials of the tie-in cover are in good condition. Some holes in the liner.

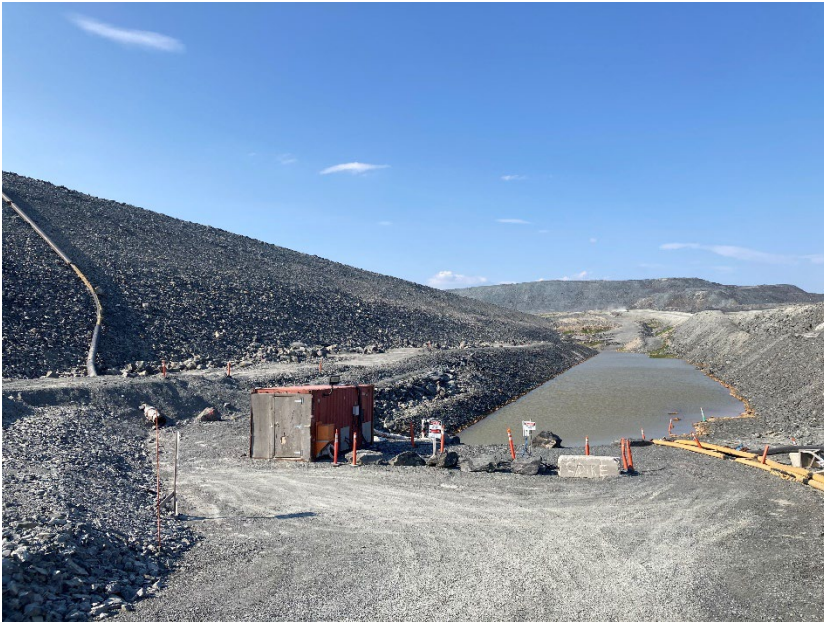
**Photograph B7-01 Central Dike and Saddle Dam 5**

INSPECTION ITEM	OBSERVATIONS DATA	PHOTO	COMMENTS & OTHER DATA
3.7 Other Unusual Conditions	None		
<b>4. DOWNSTREAM TOE AREA</b>		232, 234	
4.1 Seepage from Dam	Yes	232, 234	<p>Presence of a water pond formed by seepage on the downstream side between the downstream toe and West Road (0+300 to 0+830 approximately). The pond is pumped back to the South Cell and maintained at El. 115 m. The pumping rate was 150 m<sup>3</sup>/h at the time of the inspection.</p> <p>Presence of water pond approx. 0+100 Sta (runoff).</p>

4.2 Signs of Erosion	None observed		
4.3 Signs of Turbidity in Seepage Water	Yes		High turbidity events observed in the pond and an orange coloration was observed periodically.

**Description:** From approximately Sta. 0+900 downstream, looking north at the downstream water pond.

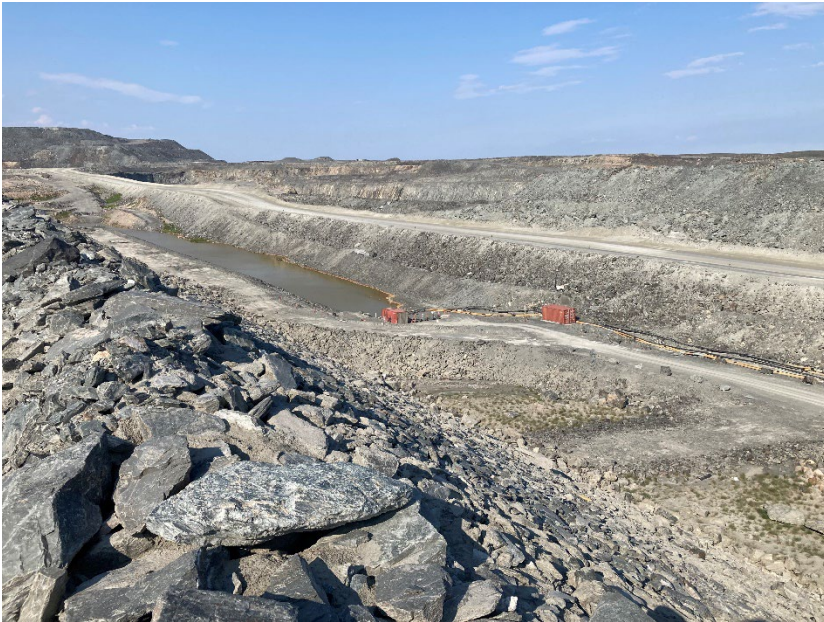
**Photograph B7-03 Central Dike and Saddle Dam 5**

**Description:** From approximately Sta. 0+875, looking northeast at the downstream slope, toe and water pond.

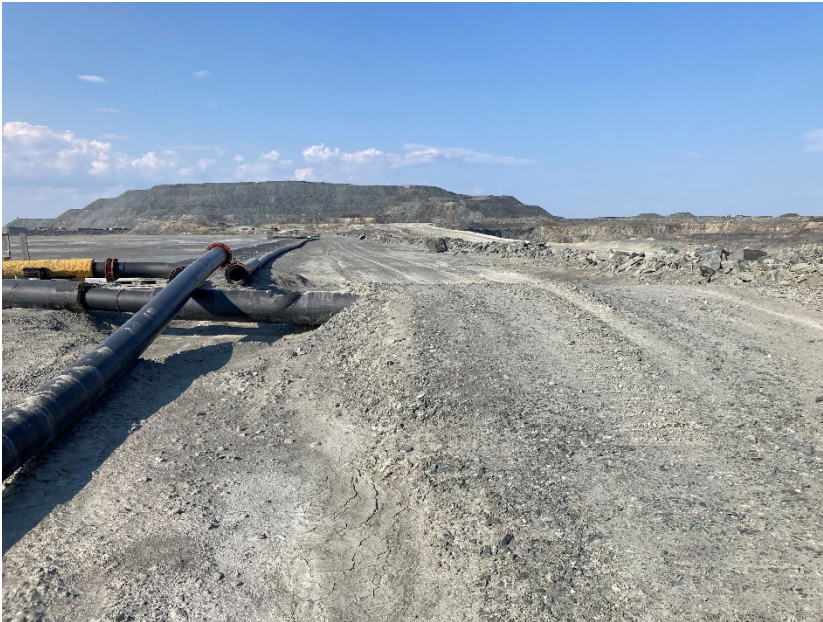
**Photograph B7-05 Central Dike and Saddle Dam 5**

**Description:** From approximately Sta. 0+800, looking north at the crest and the upstream slope. Gravel overspilling from deposition on liner.

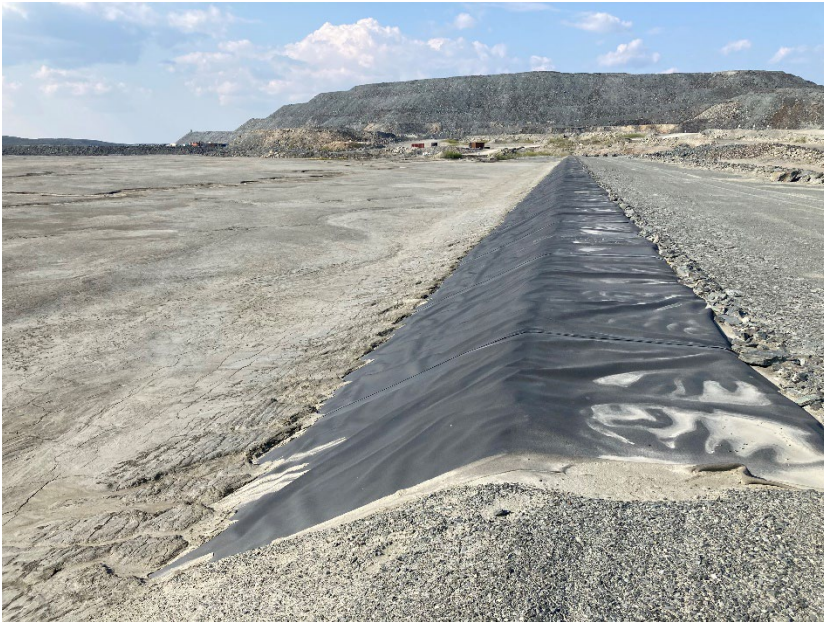
**Photograph B7-11 Central Dike and Saddle Dam 5**

**Description:** From approximately Sta. 0+400 (deposition point) looking southwest at the crest and upstream slope. Adequate tailings beach against the south section of the structure.

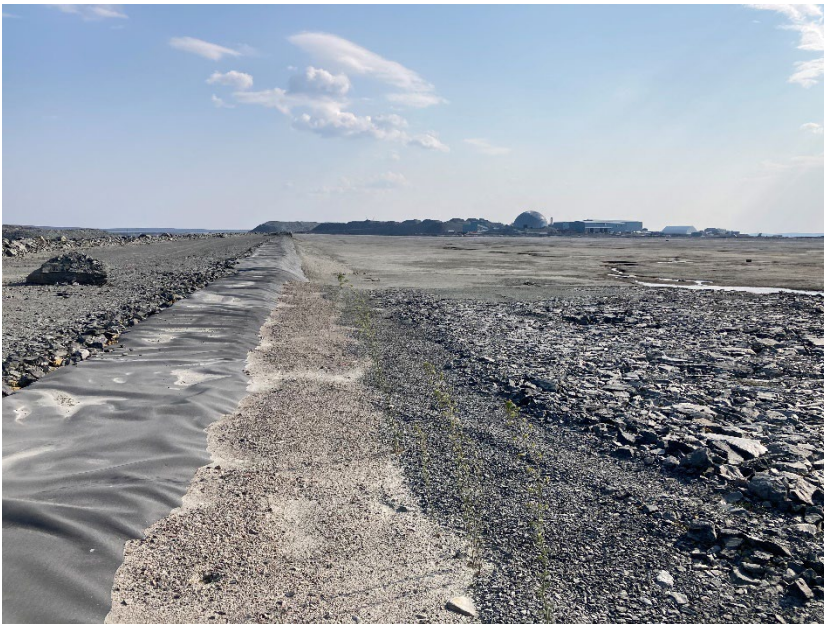
**Photograph B7-12 Central Dike and Saddle Dam 5**

**Description:** From approximately Sta. 0+400 (deposition point) looking northwest at the upstream slope and South Cell. Adequate tailings beach against the south section of the structure.

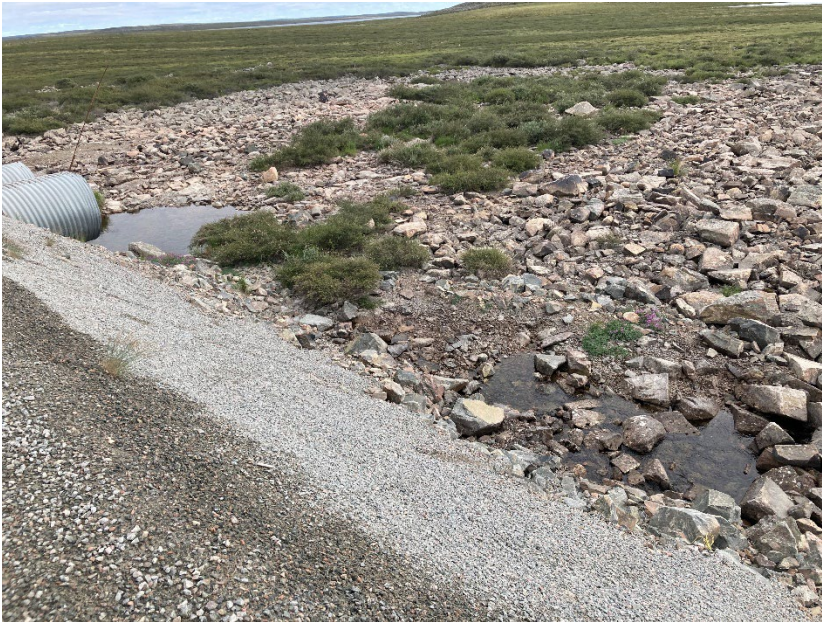
**Photograph D2-01: PC-17A km 8+830**

8+830	PC-17A	2x1800 mm CSP	Sign of erosion beneath the inlet and flow of water occurring beneath the culvert. The 1800 CSP were installed too high. While conditions are not perfect, they have proven stable over the past years. No sign of degradation from last year on both the inlet and outlet sides. Flow was observed beneath the culvert in the past, but in 2019 the flow moved further south (5-10 m from culvert). Stable, to keep monitoring for evolution.
8+850	PC-17	2x1200 mm CSP	The inlet is damaged but functional.
9+952	PC-1	1x600 mm CSP	In good condition
10+580	R-03	1x600 mm CSP	In good condition

**Description:** View of the culverts. No sign of degradation and the flow is stable south of the culverts (5-10 m away).

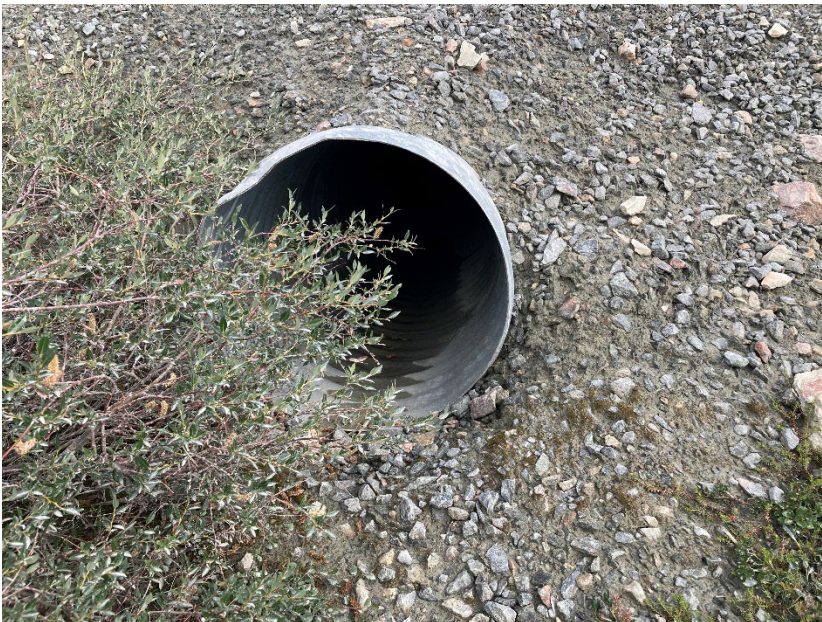
**Photograph D2-02: PC-11 km 39+552**

**Description:** View of the culvert inlet. Installed high but in good condition.

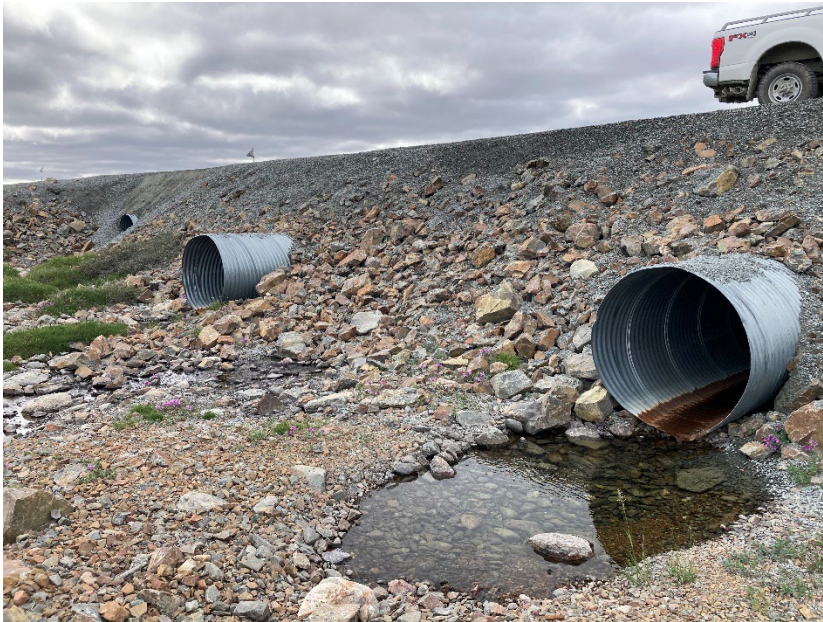
**Photograph D2-03: R-14 km 67+840**

**Description:** View of the culvert outlets. Water is flowing beneath the road between the culverts, but no sign of erosion.

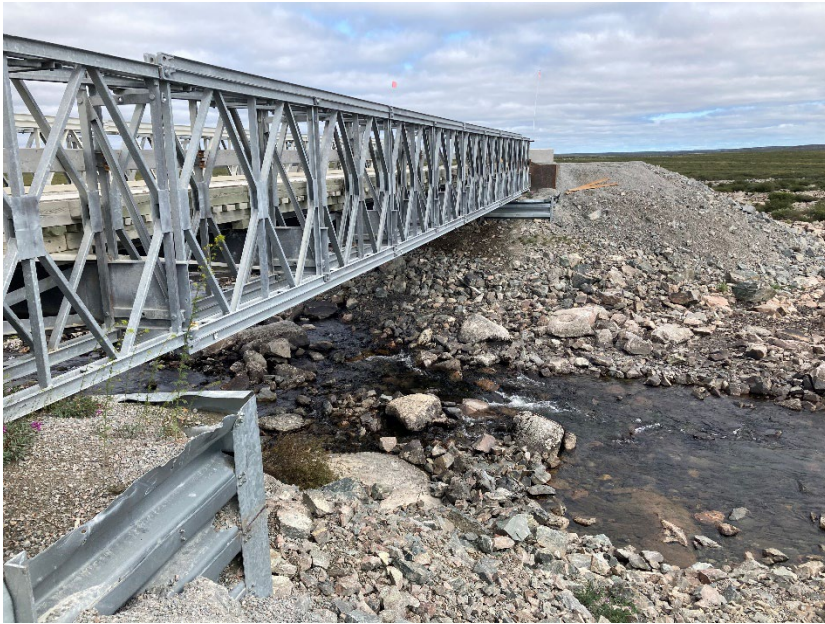
**Photograph D3-1 Bridges 1 – R02 km 8+750**

**Description:** Looking at the north abutment. The corrugated steel bin shows deformation under the weight of the bridge.

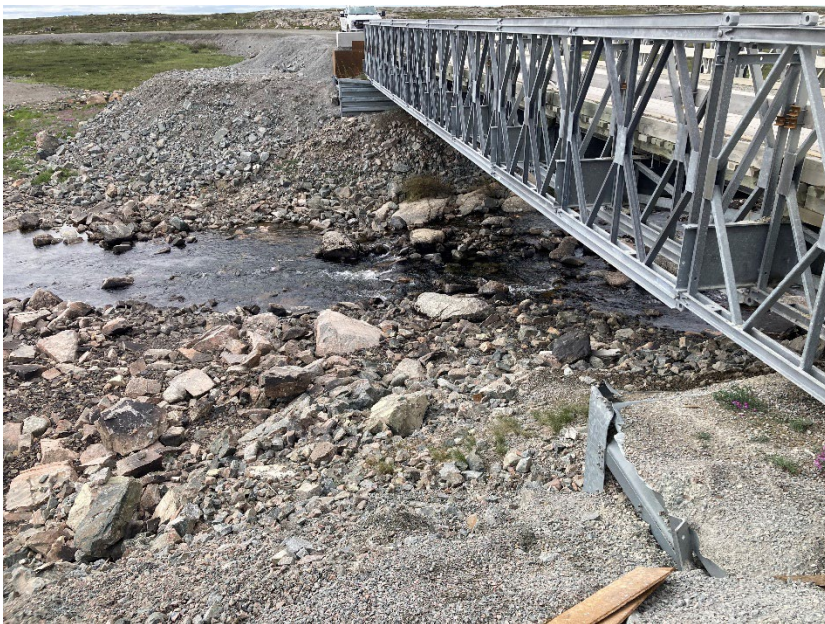
**Photograph D3-2 Bridges 1 – R02 km 8+750**

**Description:** Looking at the south abutment. The corrugated steel bin shows deformation under the weight of the bridge.

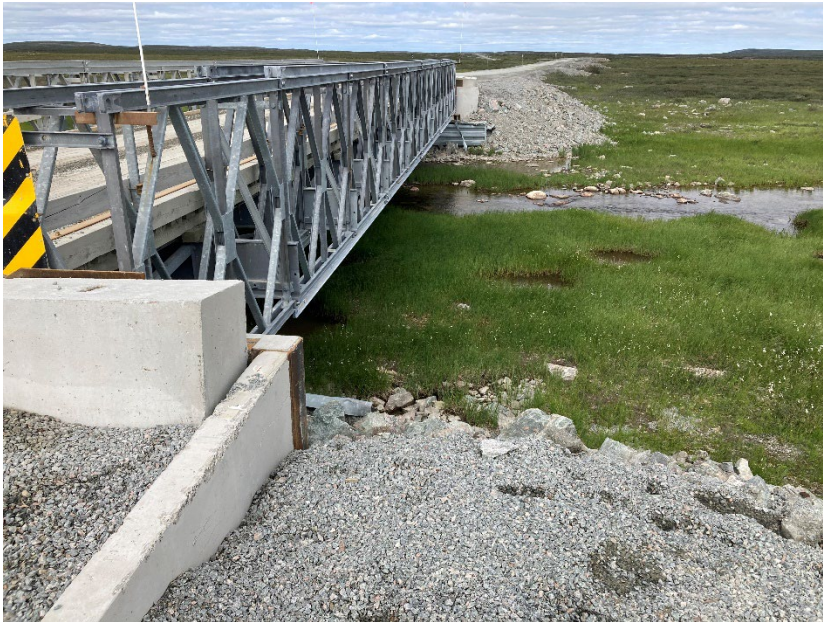
**Photograph D3-3 Bridges 2 – R05 km 17+600**

Deformation in uncompacted granular material on abutments surface.

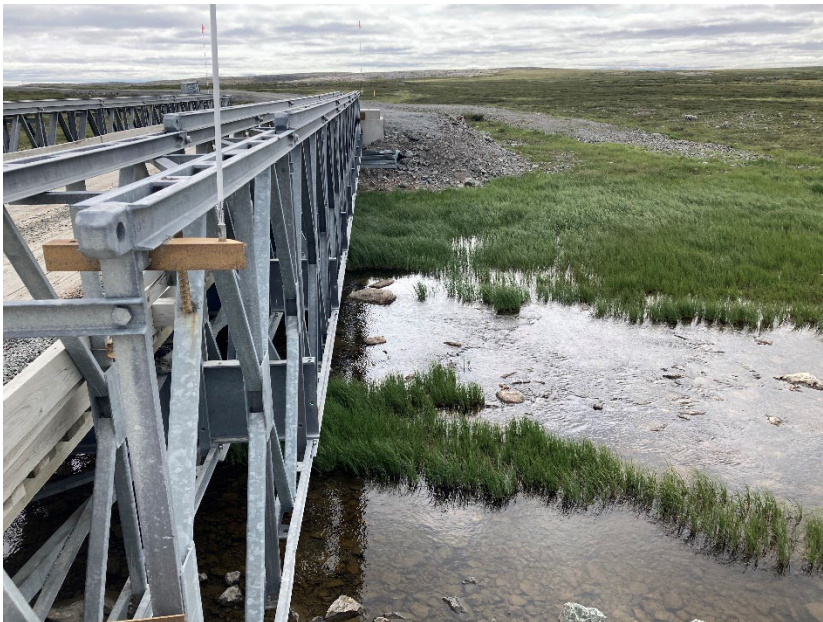
**Photograph D3-4 Bridges 2 – R05 km 17+600**

**Description:** Looking at the south abutment. Minor damage to the bin wall. Deformation in uncompacted granular material on abutments surface.

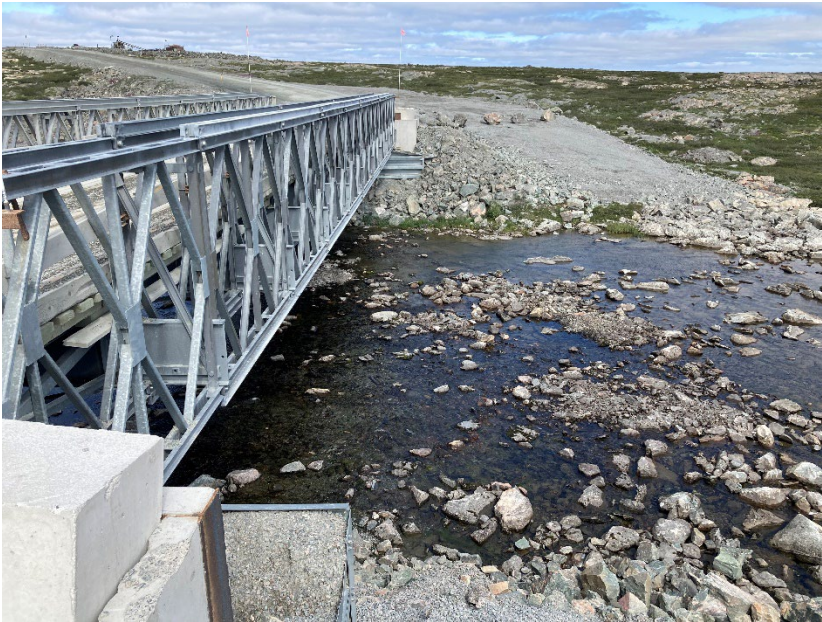
**Photograph D3-5 Bridges 3 – R06 km 23+100**

**Description:** Looking at the north abutment. Some tension cracks in granular material on abutments.

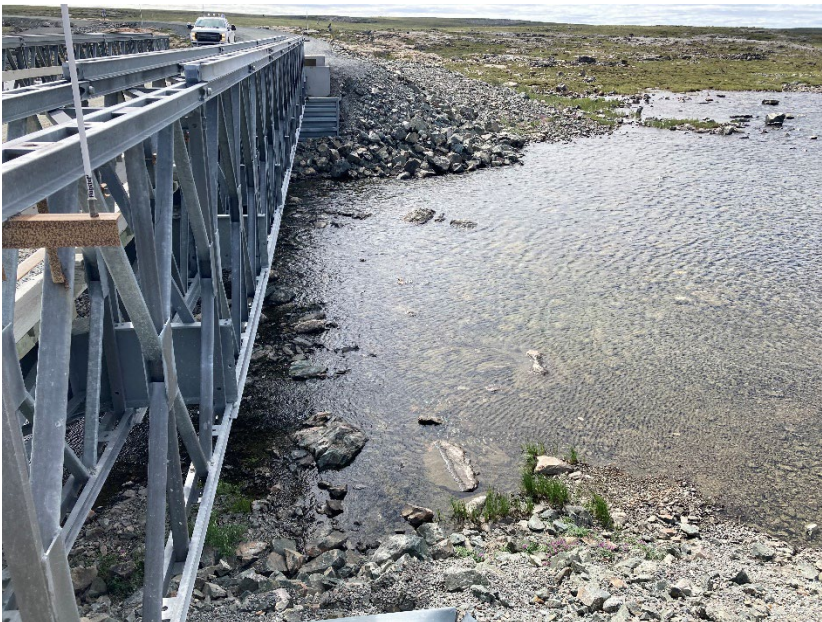
**Photograph D3-6 Bridges 3 – R06 km 23+100**

**Description:** Looking at the south abutment. Some tension cracks in granular material on abutments.

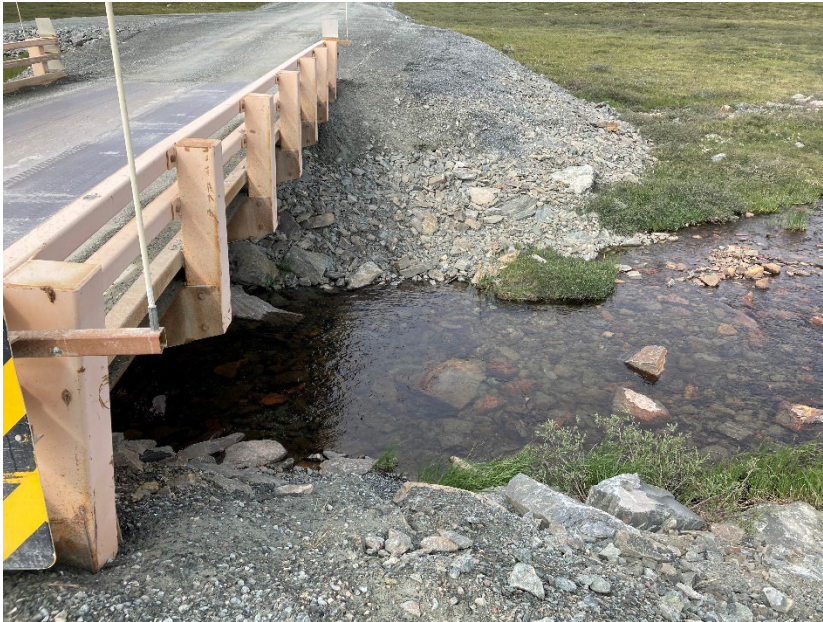
**Photograph D3-7 Bridges 4 – R09 km 48+500**

48+500	R09 Center Bridge	12m Rapid Span Bridge	In good general condition. Some water is flowing under the northeast abutment, but no sign of erosion.
48+900	Quarry 10		The steep west rock wall is unstable.
53+500	Quarry 11		Rock walls are clean and stable.
54+950	PC-16	1x600 mm CSP	Not observed since 2021. Probably buried.
58+300	Quarry 12		In general good, stable condition.
62+060	R13 Center Bridge	12 m Rapid Span Bridge	In general good condition. Tension cracks on SE, SW and NE abutments.
62+350	Quarry 13		Loose blocks were observed in some portions of the rock wall, but the quarry is in general good condition. Some water ponding.
65+700	Quarry 14		Quarry flooded. Loose blocks were observed in some portions of the rock wall, but in general good condition. Access closed.
67+600	Quarry 15		Steep rock wall in relatively stable condition. Some water ponding.
67+840	R-14	3x1200 mm CSP	Middle and northern culverts show small sign of erosion at the outlet and have been damaged (collapsed) inside, below the road, but it is anticipated that they will continue to perform well. The South outlet is partly buried in gravel. All of them were installed too high but function well. Water is flowing under the road between the culverts, but no sign of erosion. No action required.

**Description:** Looking at the north abutment. In good general condition. Some water flowing under the northeast abutment, but no sign of erosion.

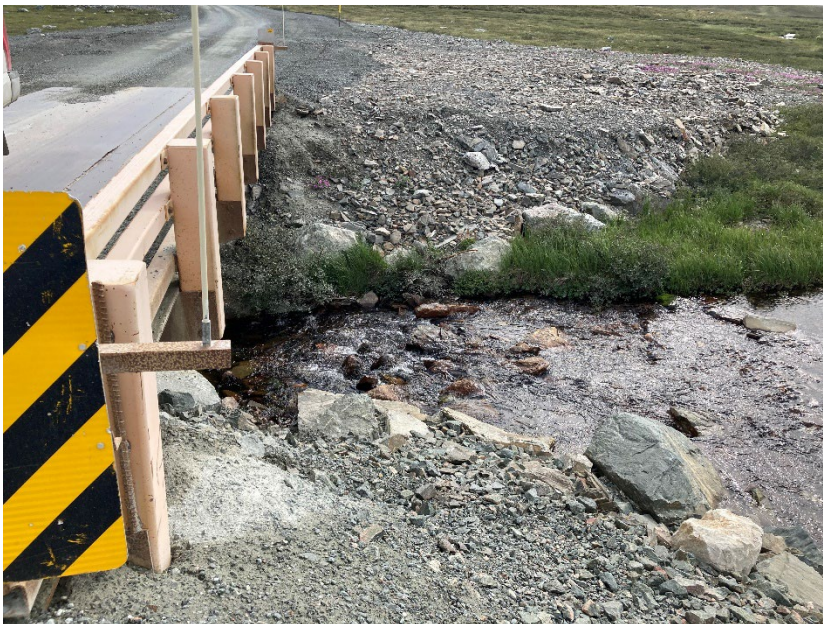
**Photograph D3-8 Bridges 4 – R09 km 48+500**

**Description:** Looking at the south abutment. In good general condition. Some water flowing under the northeast abutment, but no sign of erosion.

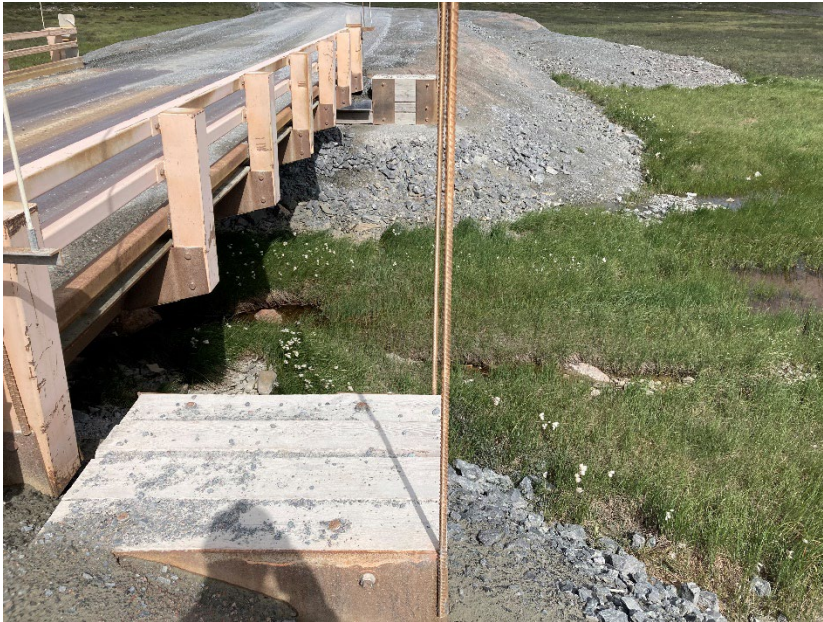
**Photograph D3-9 Bridges 5 – R13 km 62+060**

**Description:** Looking at the north abutment. In general good condition. Tension cracks on southeast, southwest and northeast abutments.

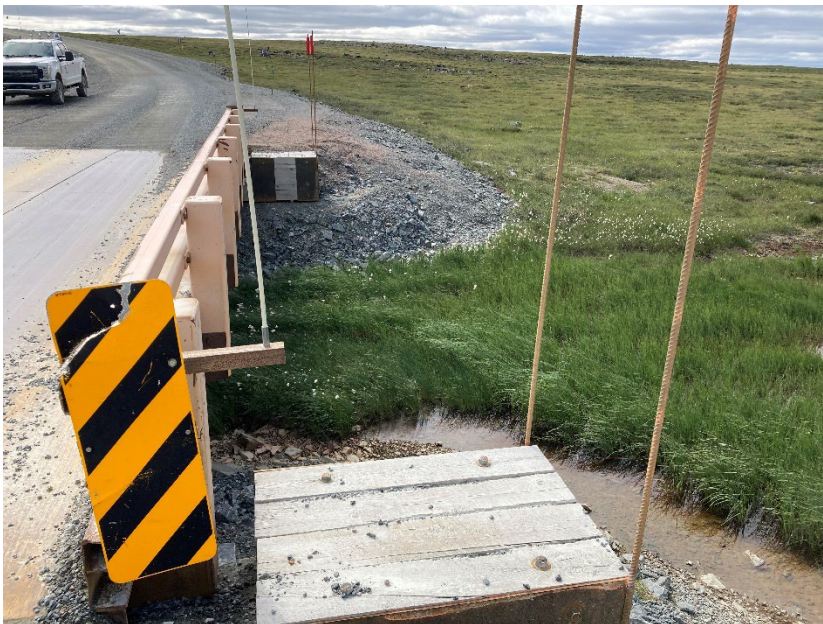
**Photograph D3-10 Bridges 5 – R13 km 62+060**

**Description:** Looking at the south abutment. In general good condition. Tension cracks on south and northeast abutments.

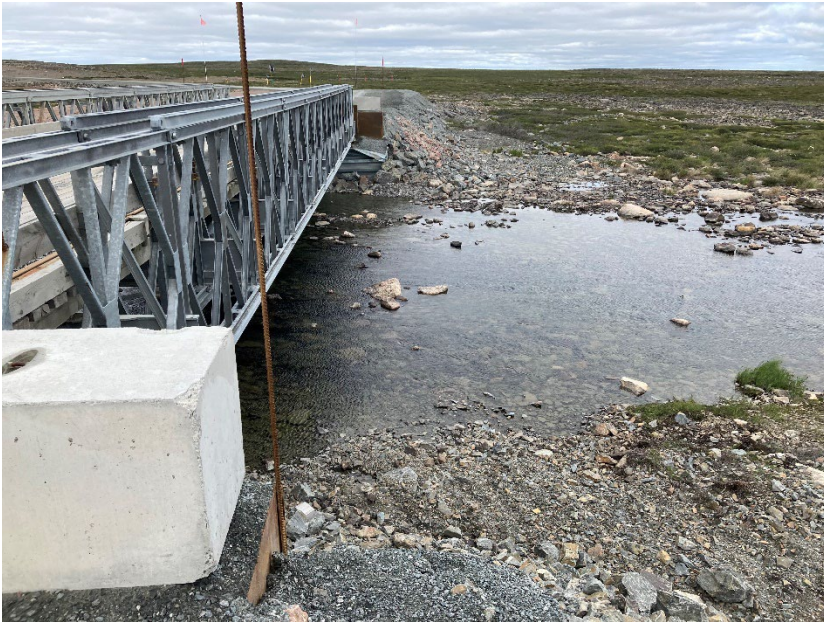
**Photograph D3-11 Bridges 6 – R15 km 69+200**

Station	Name	Structure Description	Comments
69+200	R15 Centre Bridge	30 m Acrow Panel Bridge	. New bridge, in good condition. North metal bin damaged due to snow removal, but not an issue.
70+400	Quarry 16		Presence of unstable loose rocks and boulders but in general good condition. Some water ponding.
72+800	Quarry 17		Steep rock wall in stable conditions.
73+800	R16 Centre Bridge	12m Rapid Span Bridge	In good condition. Flow usually observed under the North abutment, but no sign of erosion at the toe (dry in 2024). Surficial erosion of the granular material on the SE abutment.
77+440	R-17	1x1200 mm CSP	In good condition
79+500	R18 Centre Bridge	12 m Rapid Span Bridge	In good condition.
80+200	Quarry 18		In general good condition, south wall is high (about 8 m) with some loose blocks. Access closed due to falcons.
80+950	R-18A	3x1200 mm CSP	In good condition.
	R-18B	1X600 mm CSP	In good condition, installed above ground surface (water can flow below culvert).

**Description:** New bridge, in good condition. North metal bin damaged due to snow removal, but not an issue.

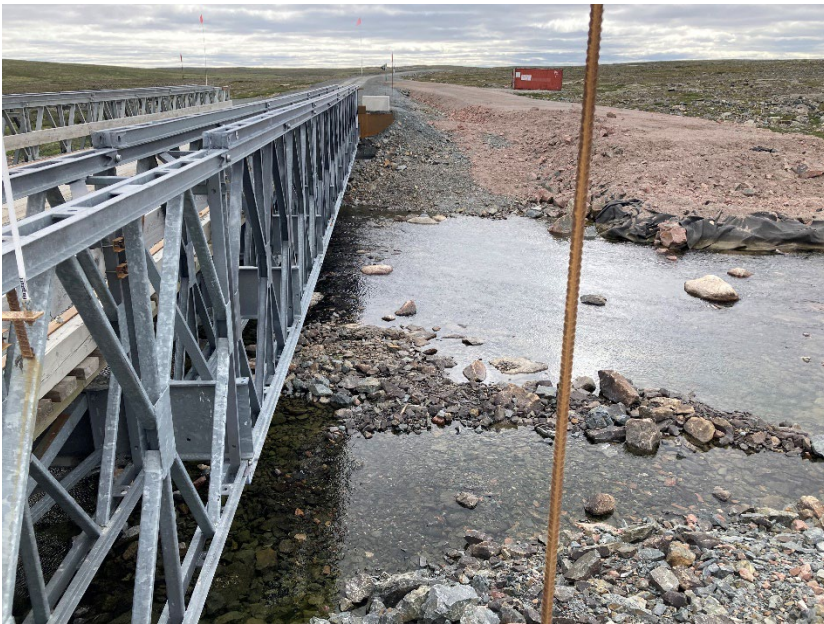
**Photograph D3-12 Bridges 6 – R15 km 69+200**

**Description:** New bridge, in good condition. North metal bin damaged due to snow removal, but not an issue.

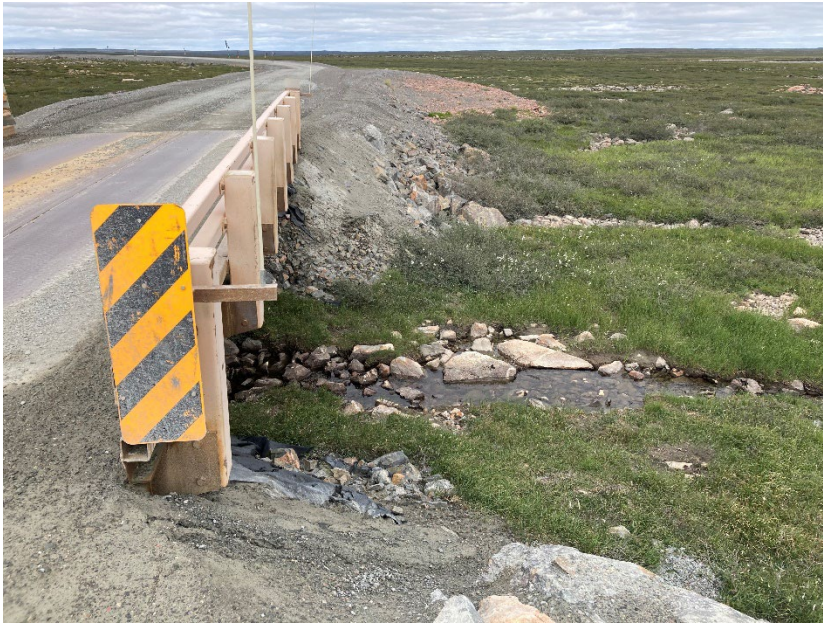
**Photograph D3-13 Bridges 7 – R16 km 73+800**

**Description:** Looking at the north abutment. In good condition. The flow usually observed under the north abutment has dry in 2024. No sign of erosion at the toe.

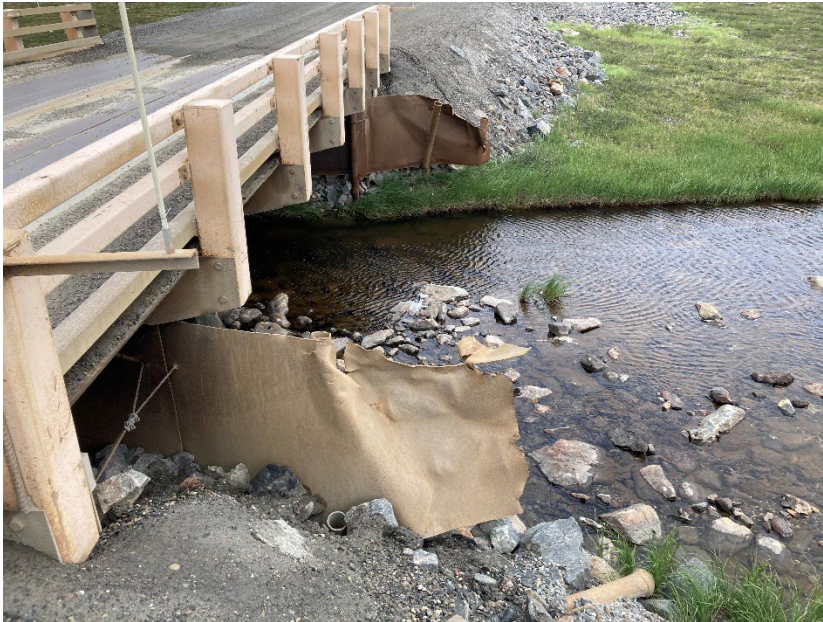
**Photograph D3-17 Bridges 9 – R19 km 83+150**

83-150	R19 Centre	12m Rapid Span Bridge	Some damage to the steel containment plates and to one pile was observed, which may be associated with snow removal activity. The damage is minor and does not affect the geotechnical integrity of the bridge. Minor tension cracks in the top surface on the north and southwest abutments. To monitor.
84+300	Quarry 19		Rock walls are in good condition.
85+490	R-20	1x1200 mm CSP	Outlet of the culvert is slightly twisted. The middle of the culvert is slightly collapsed. The inlet is installed above the ground surface and water is able to flow beneath the culvert. No follow-up required, in stable conditions.
87+300	R-21	2x1200 mm CSP	Both culverts are slightly collapsed in the middle. Should have been installed lower to avoid erosion issue. In stable condition.
89+550	Quarry 20		Quarry walls are in good condition. Active at the time of the inspection with material loading.

**Description:** Looking at the north abutment. Minor damage to steel plate due to snow removal activity. Minor tension cracks in the top surface on the north and southwest abutments. To monitor.

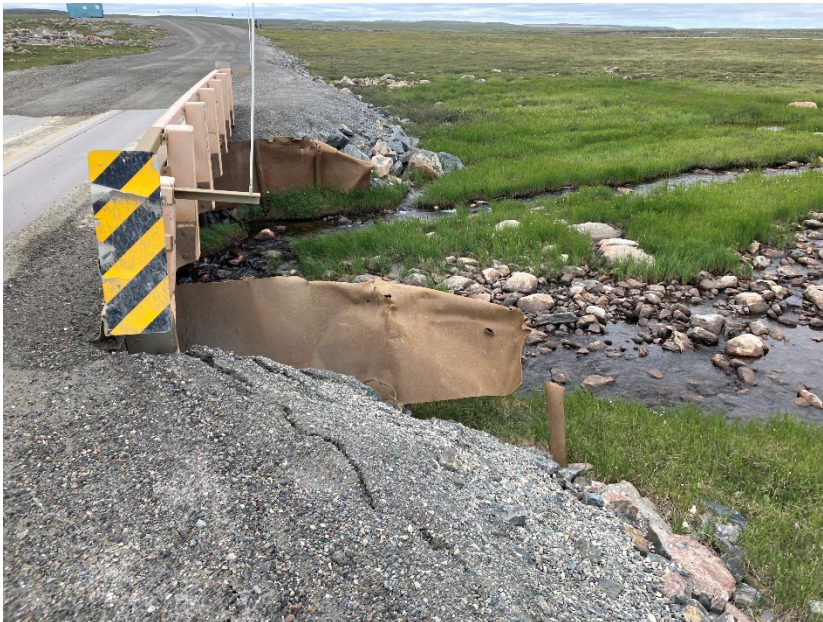
**Photograph D3-18 Bridges 9 – R19 km 83+150**

**Description:** Looking at the south abutment. Minor damage to steel plate due to snow removal activity. Minor tension cracks in the top surface on the north and southwest abutments. To monitor.

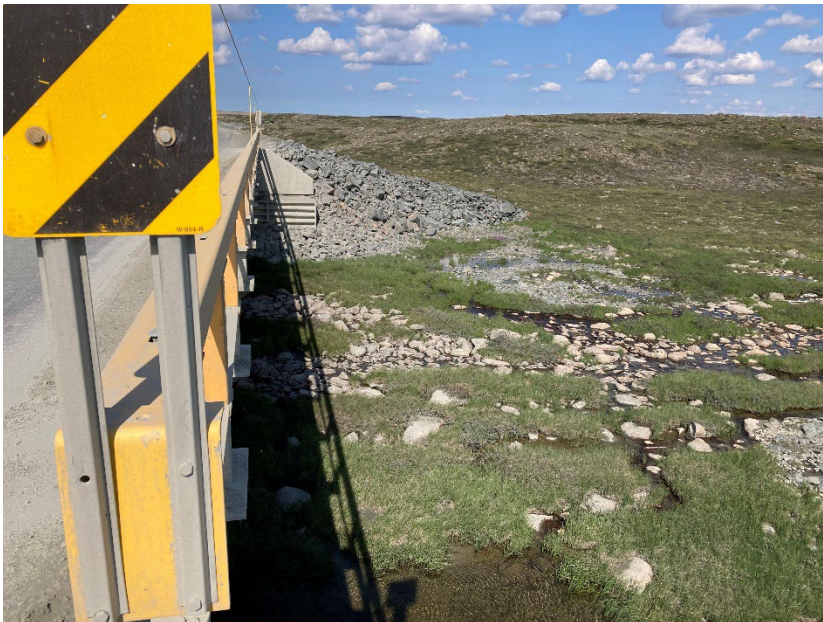
**Photograph E2-19 Bridges 9 – km 160+800**

**Description:** Looking at the south abutment. Surficial erosion of the granular material behind the concrete wall.

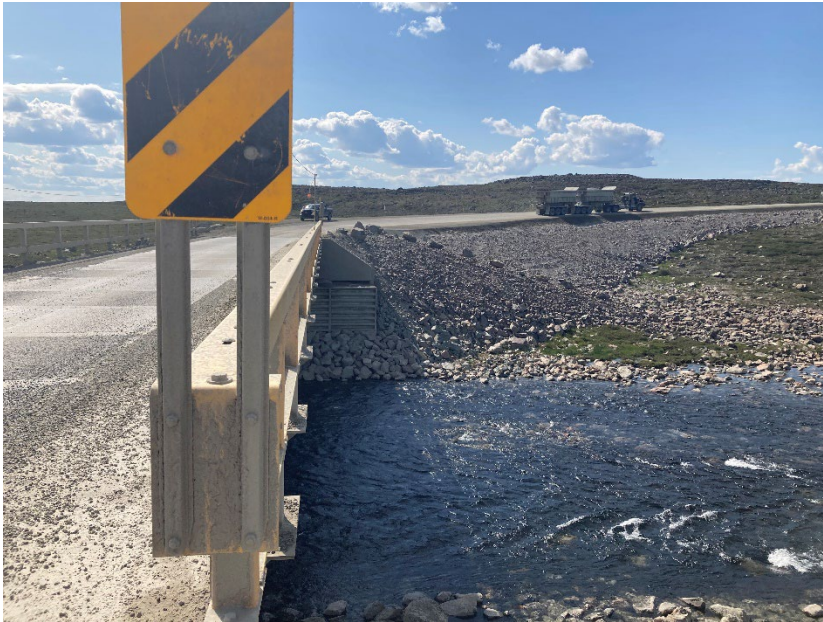
**Photograph E2-14 Bridges 7 – km 148+300**

**Description:** Looking at the southwest abutment. Surficial erosion of the granular material behind the concrete wall.

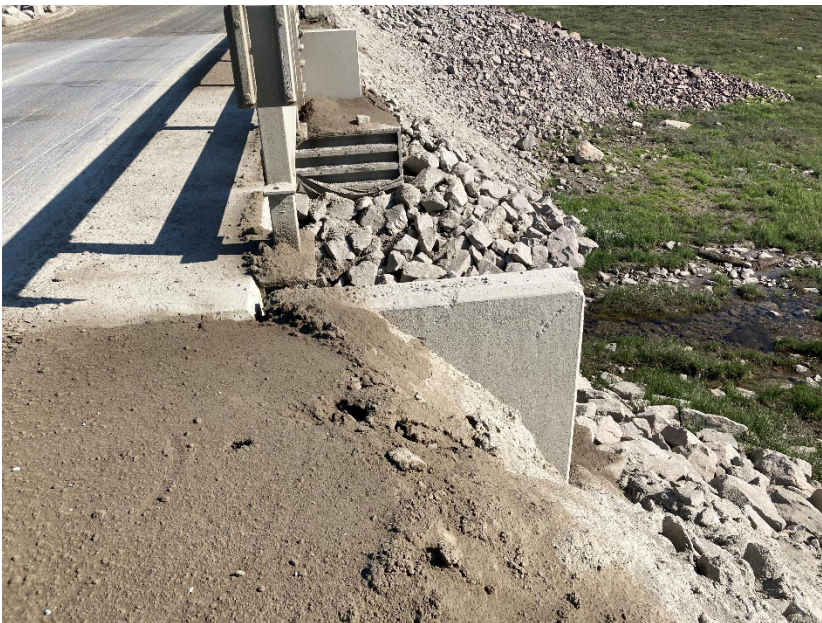
**Photograph E2-8 Bridges 4 – km 136+000**

**Description:** Looking at the north abutment. Surficial erosion of the granular material behind the concrete wall.

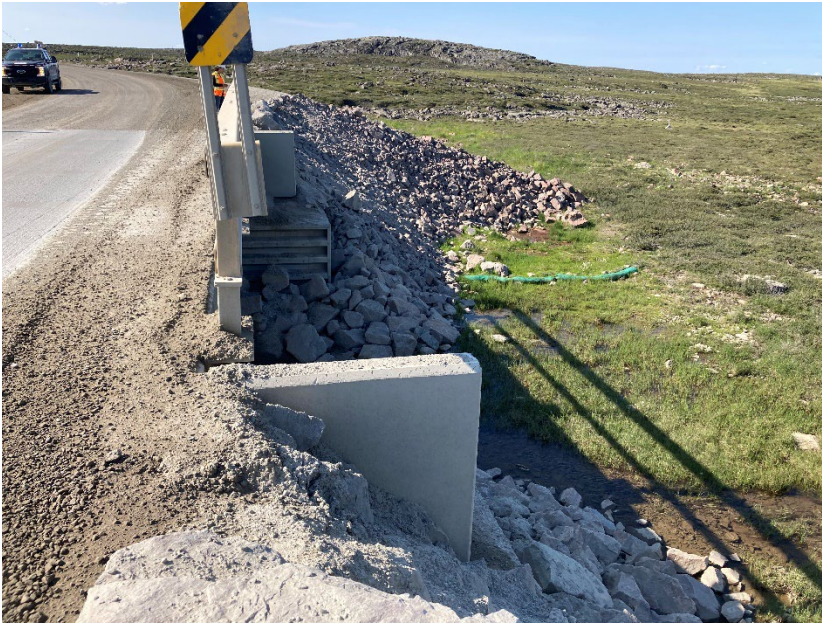
**Photograph E2-9 Bridges 4 – km 136+000**

**Description:** Looking at the south abutment. Surficial erosion of the granular material behind the concrete wall.

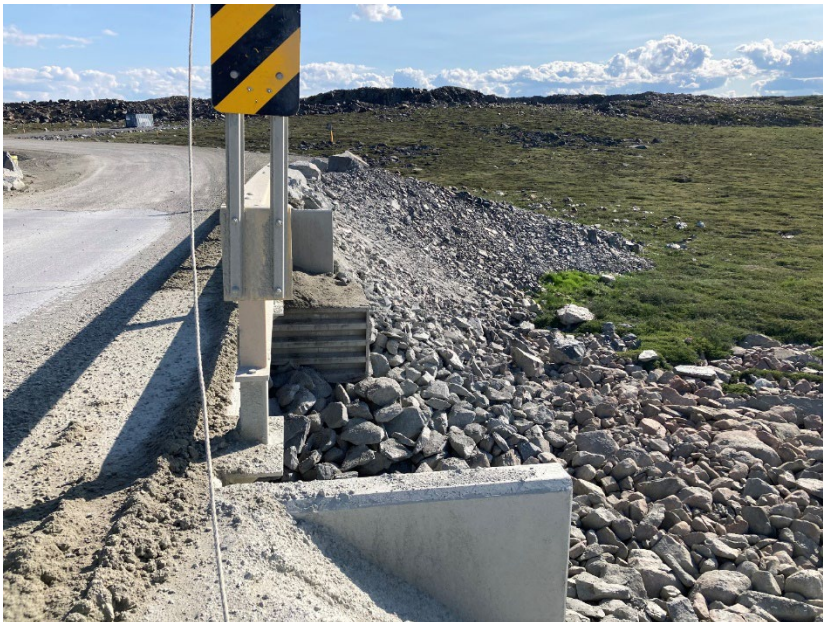
**Photograph E2-5 Bridges 2 – km 126+700**

**Description:** Looking at the north abutment. Surficial erosion of the granular material behind the concrete wall

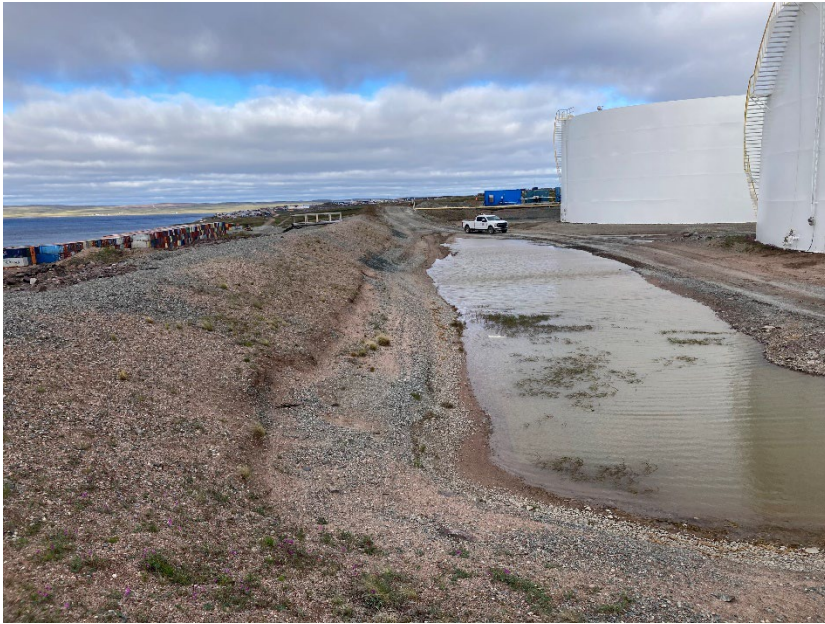
**341244 Photograph G1-03 Baker Lake Tank Farm**

**Description:** Looking northwest toward Tank 2. Presence of water ponding.

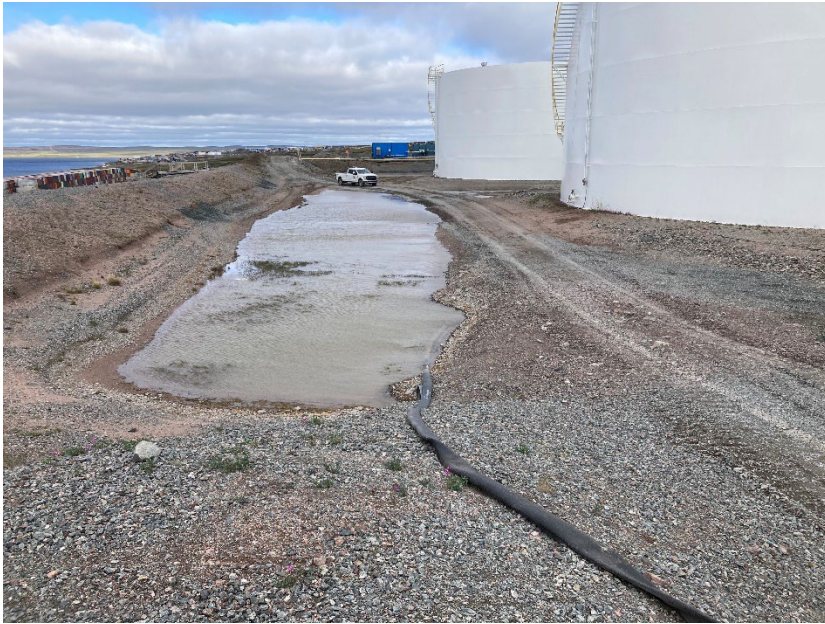
**Photograph G1-07 Baker Lake Tank Farm**

**Description:** From the southwestern corner of Tank 3 looking northeast. Presence of water ponding.

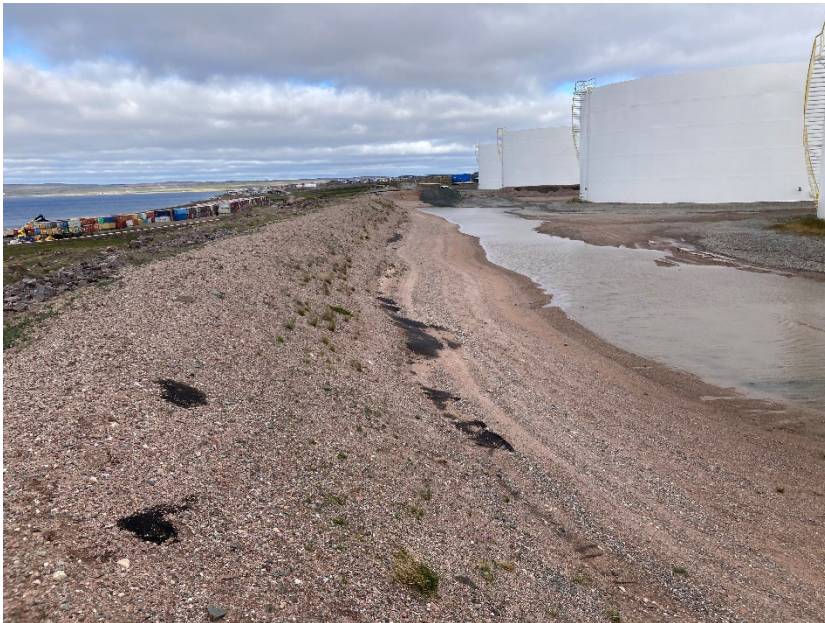
**Photograph G1-08 Baker Lake Tank Farm**

**Description:** From the south portion of the site looking northwest at the south side of Tank 3 and 4. View of exposed geosynthetics.
