# **Meadowbank and Whale Tail 2024 Annual Geotechnical Inspection**

# 2024 Annual Geotechnical Inspection

*Meadowbank Complex, NU*

Reference No. CA0038946.6657-1630-R-Rev0

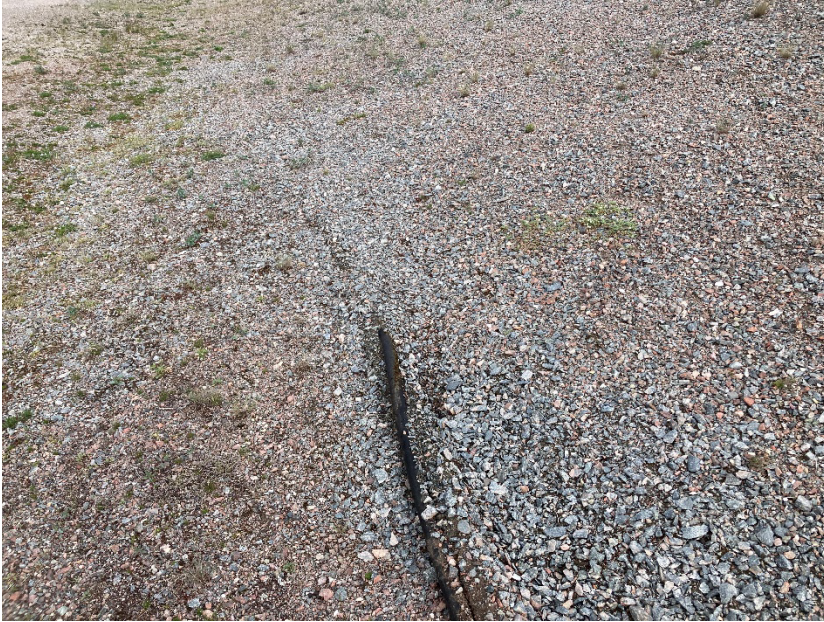
**Photograph G1-13 Baker Lake Tank Farm**

**Description:** Looking northwest at the northern and side of Tank 1. Exposed fold in liner.

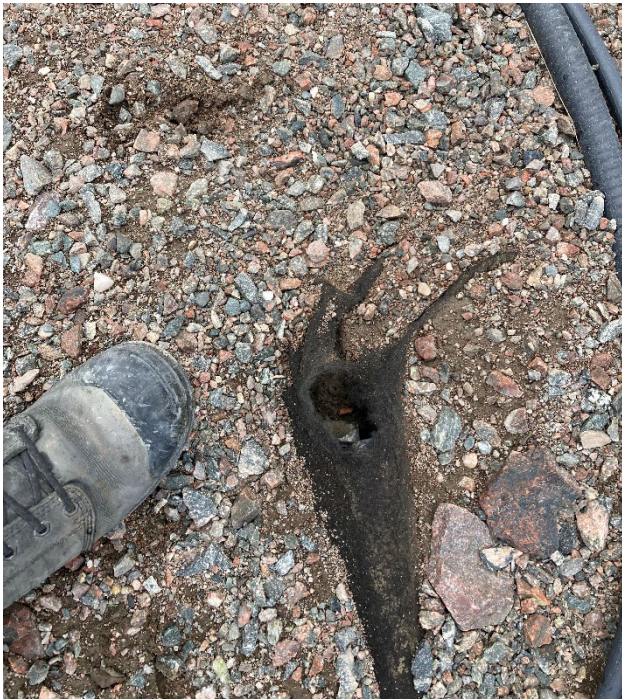
**Photograph G1-14 Baker Lake Tank Farm**

**Description:** From the west side of Tank 1, looking southwest. Depressions in liner, at the top of slope.

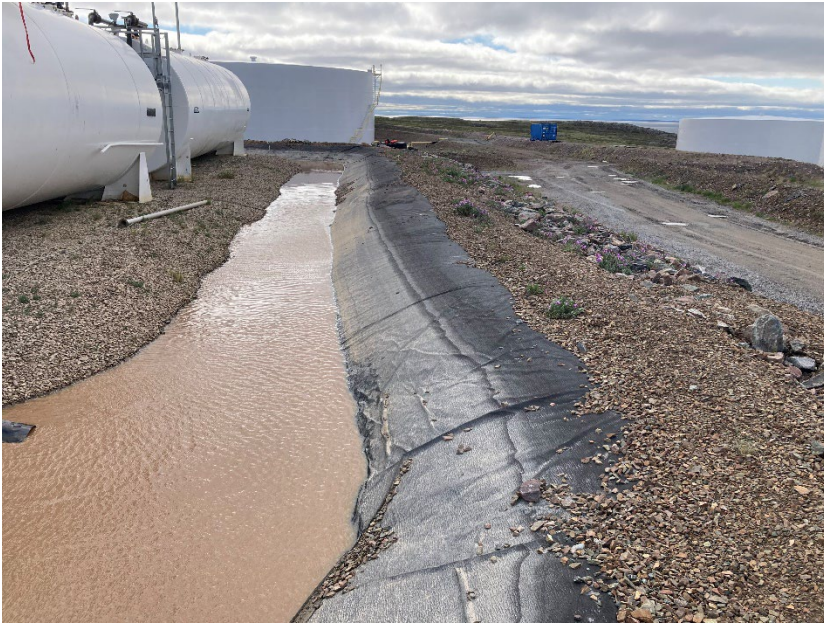
**Photograph G1-15 Baker Lake Tank Farm**

**Description:** From the southwestern corner of the Jet A fuel tanks looking east. Presence of exposed geomembrane and water ponding.

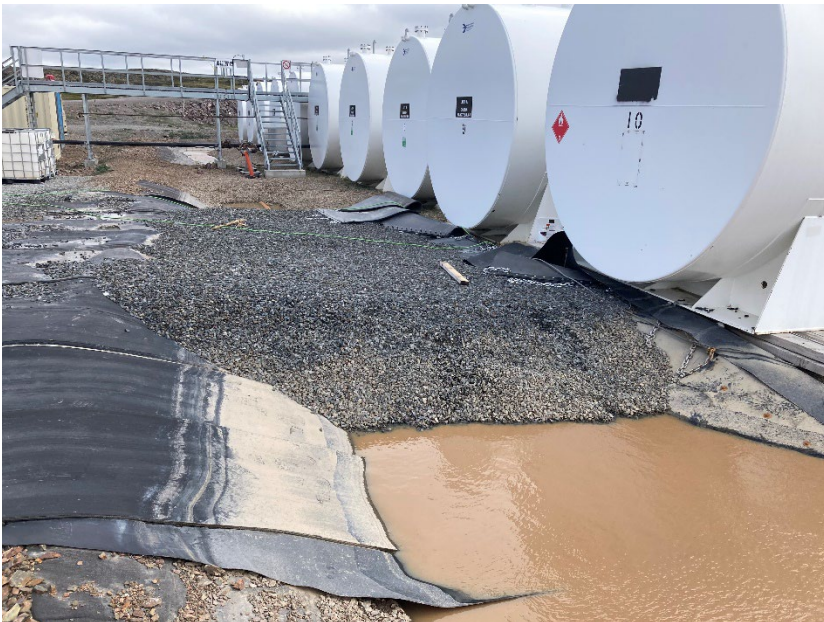
**Photograph G1-16 Baker Lake Tank Farm**

**Description:** From the southwestern corner of the Jet A fuel tanks looking northeast. Presence of exposed geomembrane and water ponding.

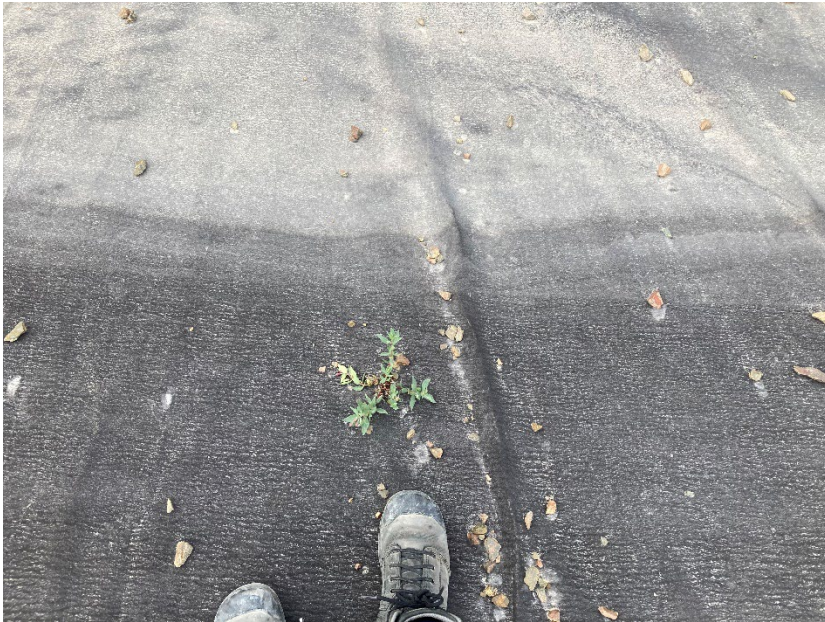
**Photograph G1-19 Baker Lake Tank Farm**

**Description:** From the northeastern corner of the Jet A fuel tanks looking southwest. There is a small hole in the liner.

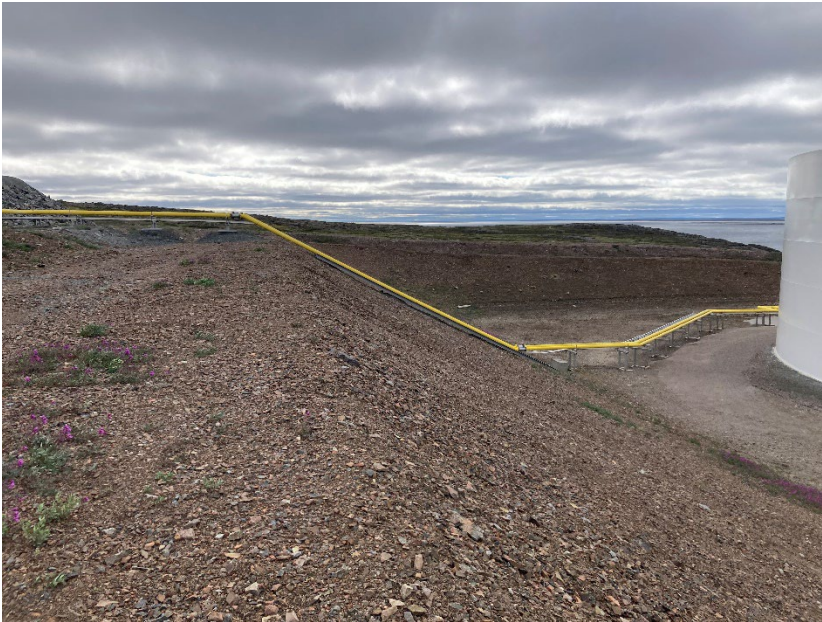
**Photograph G1-21 Baker Lake Tank Farm**

**Description:** Looking southeast at the northeastern side of Tank 6.

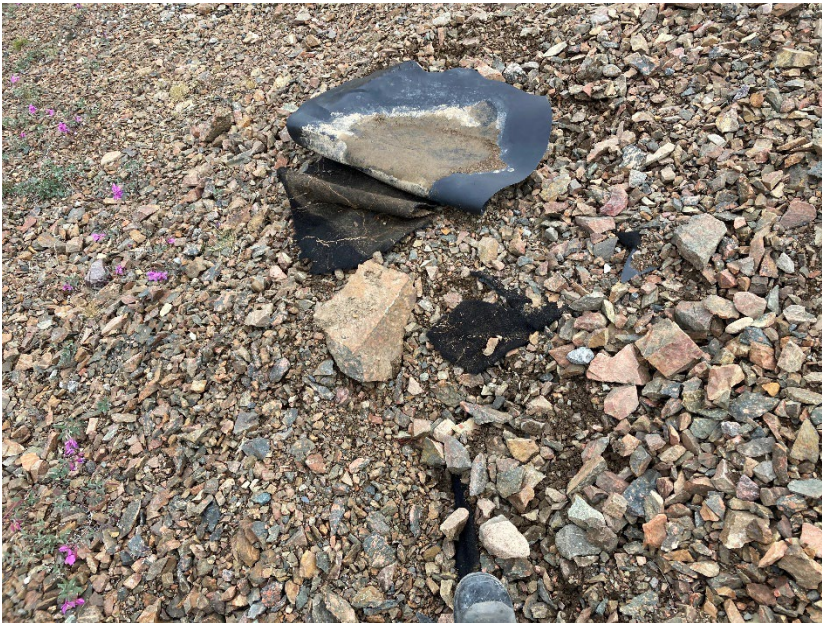
**Photograph G1-22 Baker Lake Tank Farm**

**Description:** From the eastern corner of Tank 6, looking northeast. Large rips in liner in the middle of the slope.

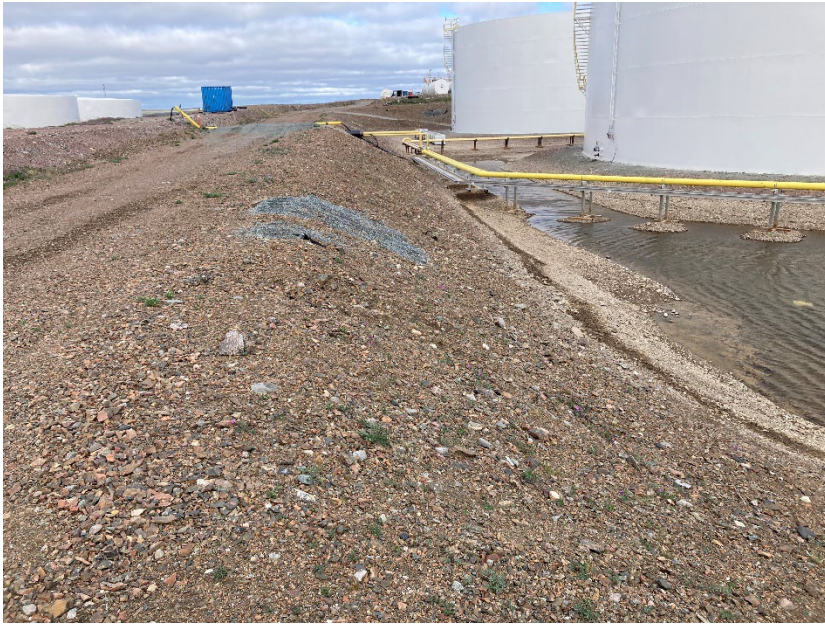
**Photograph G1-23 Baker Lake Tank Farm**

**Description:** From the southern corner of Tank 6, looking northeast at the southern side of Tanks 5 and 6. Presence of water ponding.

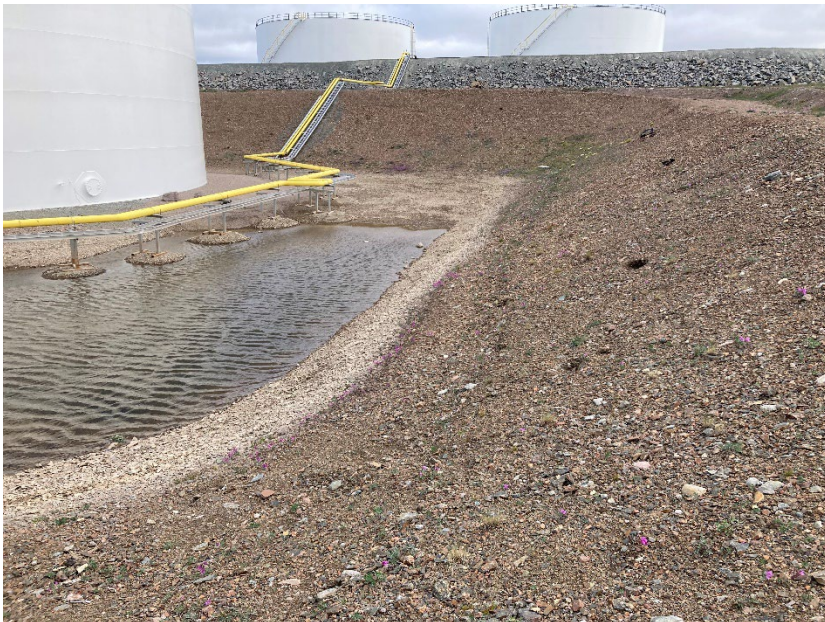
**Photograph G1-24 Baker Lake Tank Farm**

**Description:** From the eastern corner of Tank 6, looking northeast. Rips in the liner, in the middle of the slope. Presence of water ponding.

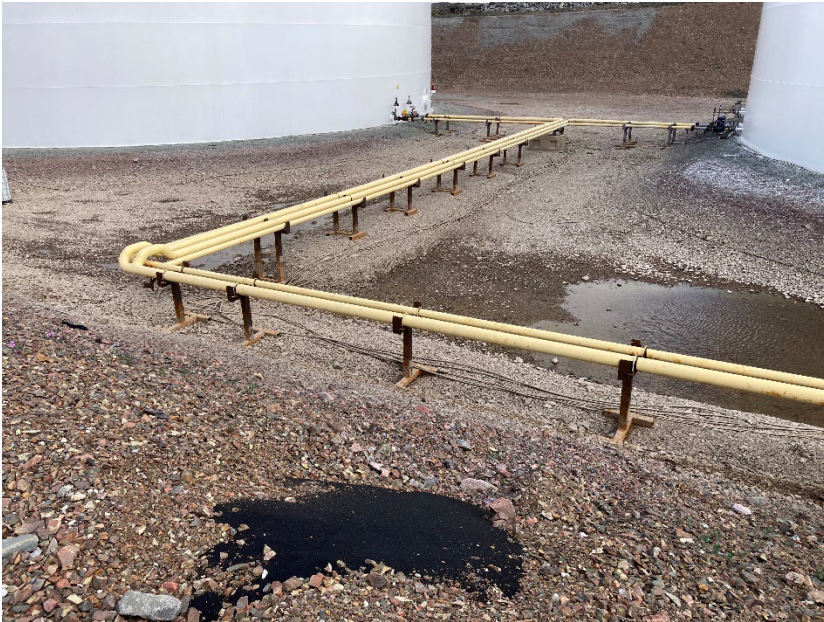
**Photograph G1-25 Baker Lake Tank Farm**

**Description:** Looking northeast between Tanks 5 and 6. Exposed liner at the top of slope.

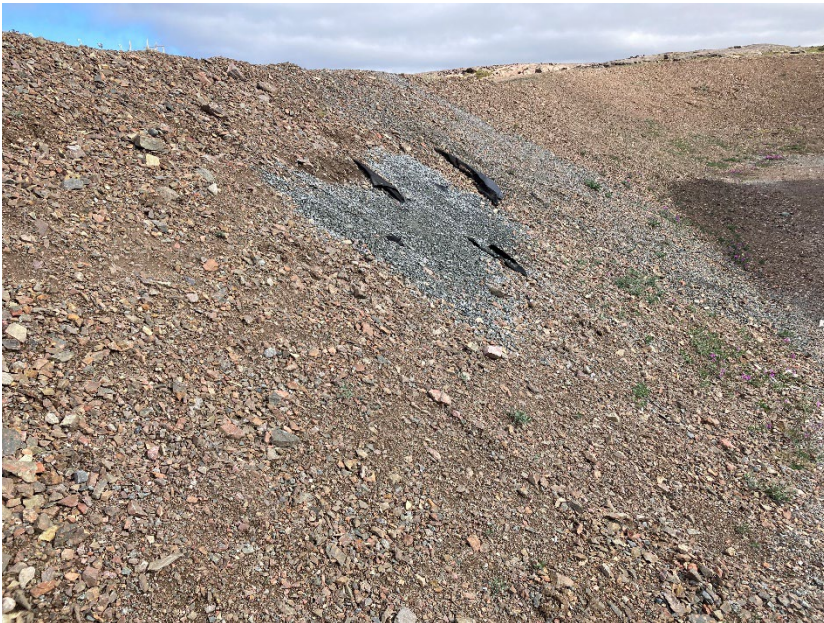
**Photograph G1-26 Baker Lake Tank Farm**

**Description:** Looking northeast between Jet A fuel Tank and Tank 5. Large rips in the liner in the middle of the slope.

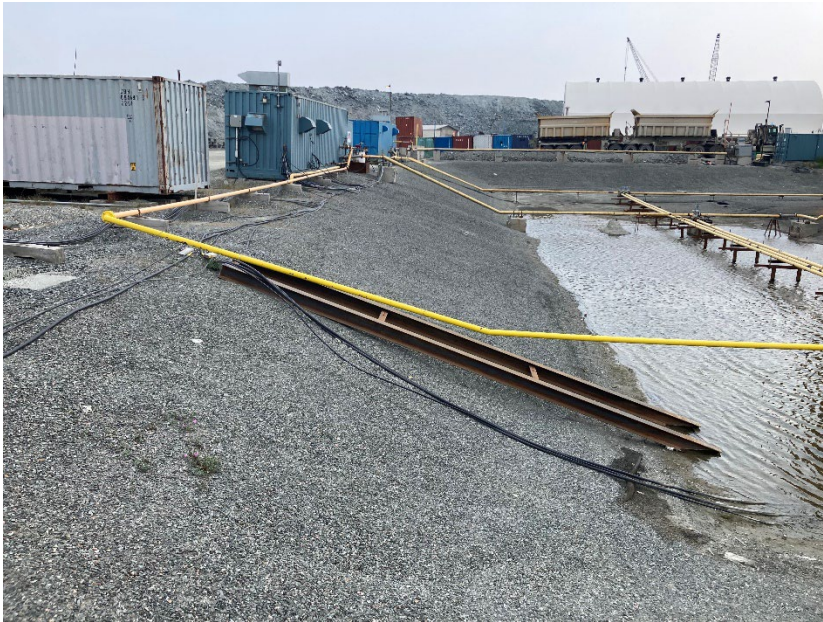
**Photograph G2-01 Meadowbank Tank Farm**

**Description:** Looking southeast from the northern side of the fuel storage tank. Presence of water ponding.

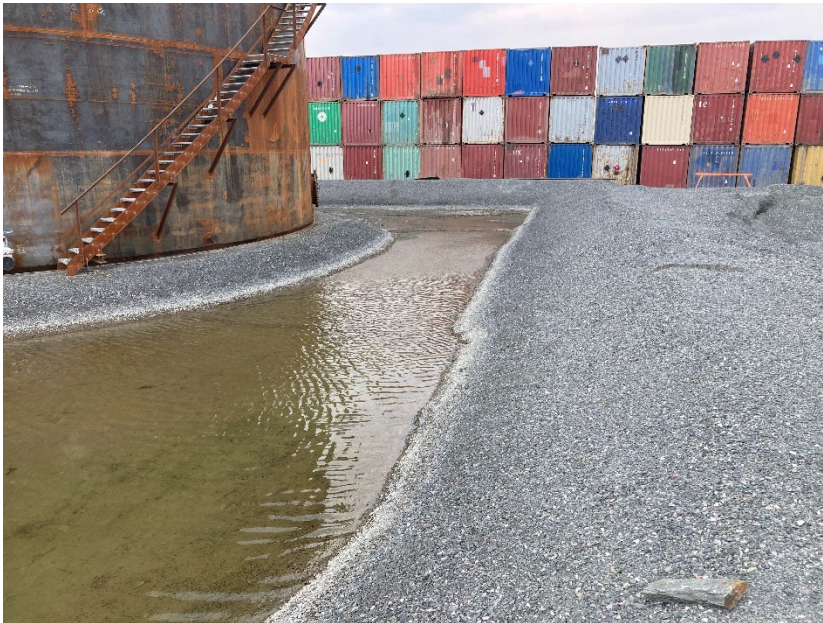
**Photograph G2-02 Meadowbank Tank Farm**

**Description:** Looking northwest from the northern side of the fuel storage tank. Presence of water accumulation (~130 mm).

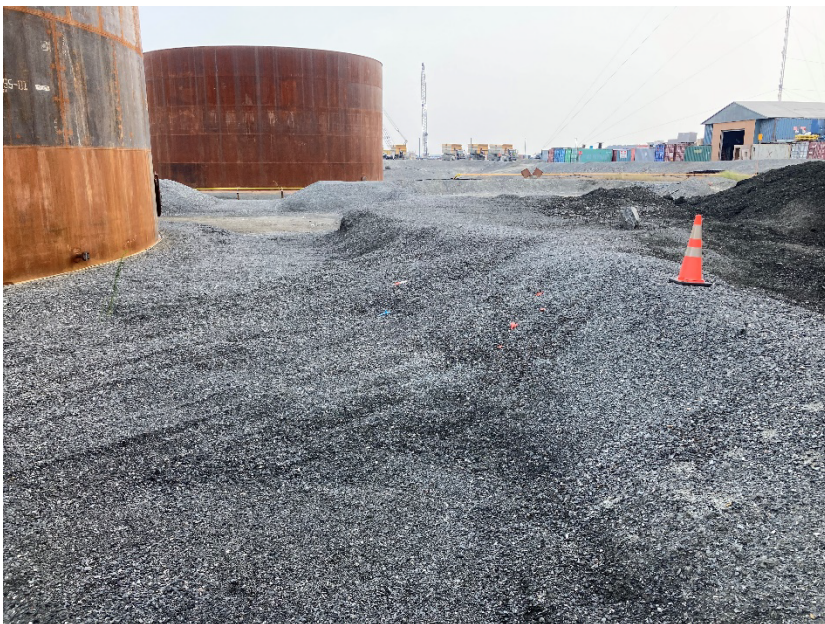
**Photograph G2-04 Meadowbank Tank Farm**

**Description:** Looking south from the western side of the new storage tank. Presence of minor tension cracks in the berm.

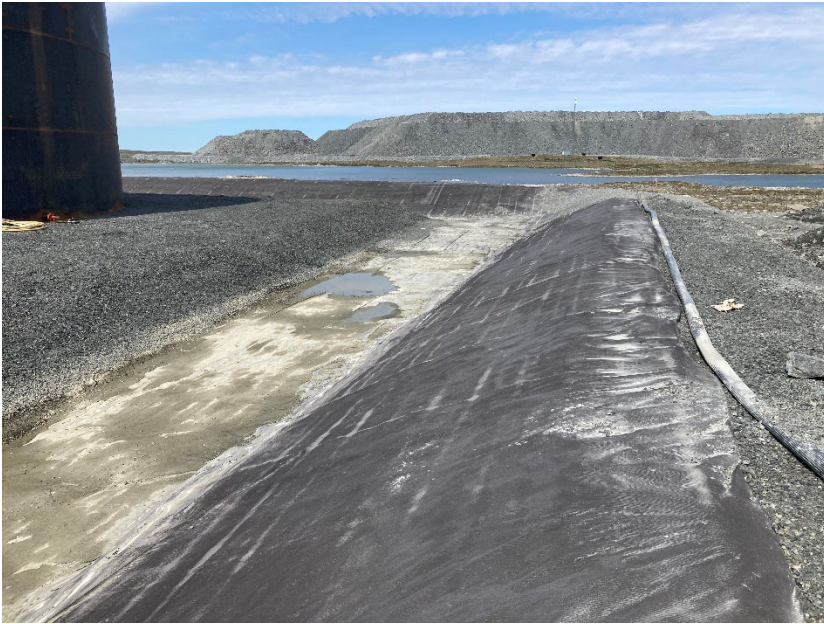
**Photograph G3-01 Whale Tail Project Site Tank Farm**

**Description:** From the southeast corner, looking north at the Tank Farm. Presence of water ponding.

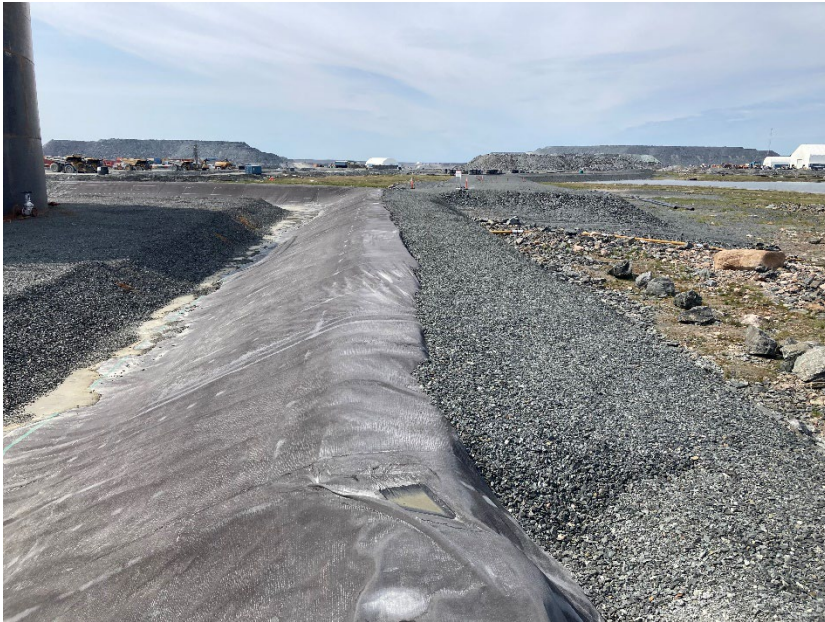
**Photograph G3-03 Whale Tail Project Site Tank Farm**

**Description:** From the northeast corner of the tank, looking west. An exposed anchor is observed.

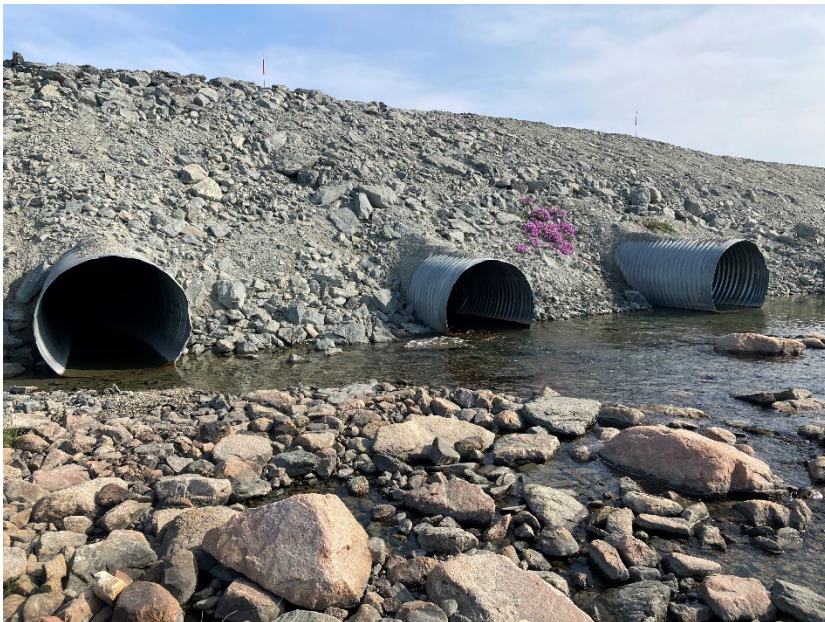
**Photograph H1-02 Vault Road Culverts**

**Description:** Looking at the outlet of the three culverts located on Vault Road at 640964E/7217466N. All of them are deformed in the middle.

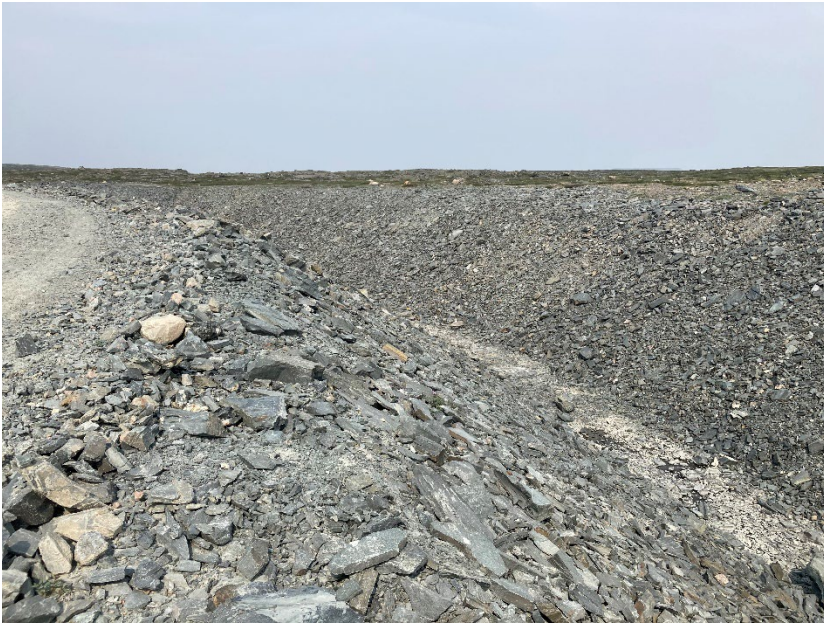
**Photograph H2-05 Diversion Ditch and its Sediment and Erosion Protection Structure**

**Description:** From the eastern diversion ditch looking northwest. Sloughing in riprap into upper slope (~2m diameter).

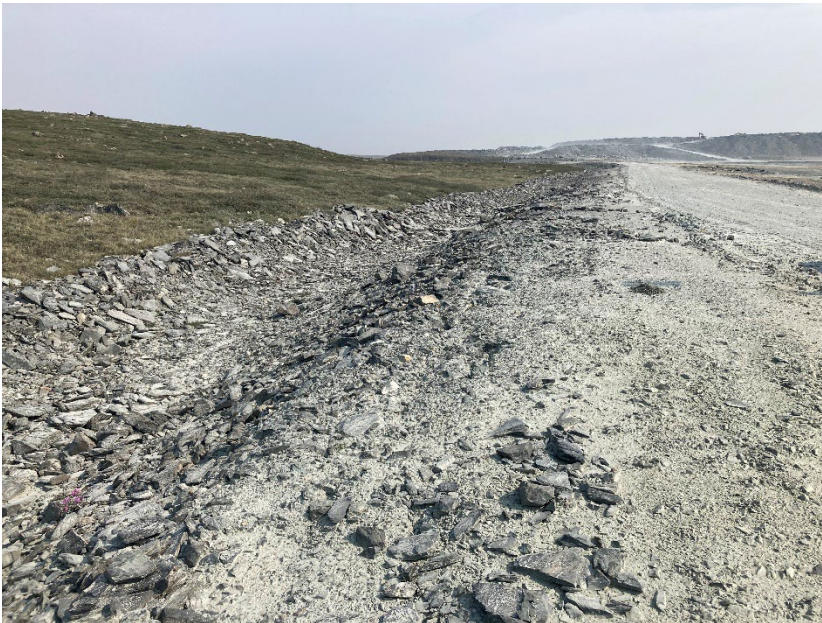
**Photograph H2-10** Diversion Ditch and its Sediment and Erosion Protection Structure

**Description:** From the northern diversion ditch looking east. Presence of tension cracks in progress in granular material, sloughing.

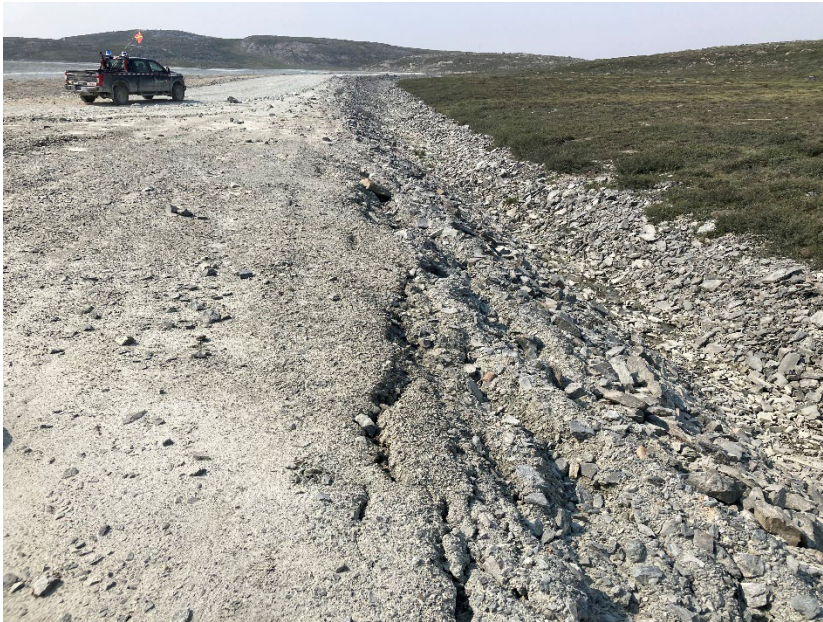
**Photograph H2-11 Diversion Ditch and its Sediment and Erosion Protection Structure**

**Description:** From the northern diversion ditch looking west. Presence of tension cracks in progress in granular material, sloughing.

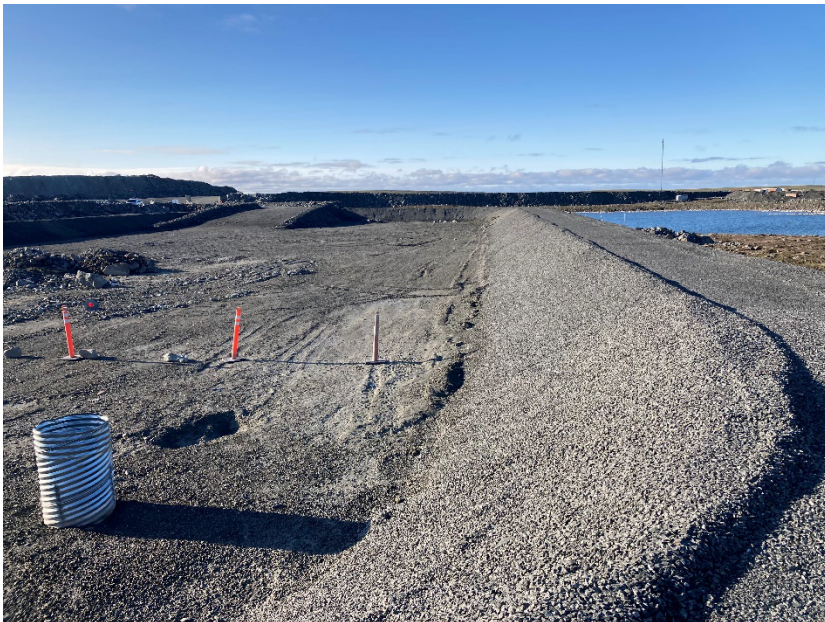
**Photograph H5-02 Meadowbank Contaminated Soil Storage and Bioremedial Landfarm Facility**

**Description:** From the eastern side of the Contaminated Soil Storage and Bioremedial Landfarm Facility, looking south. Some water ponding at pond side, but landfarm dry. Presence of rainwater.

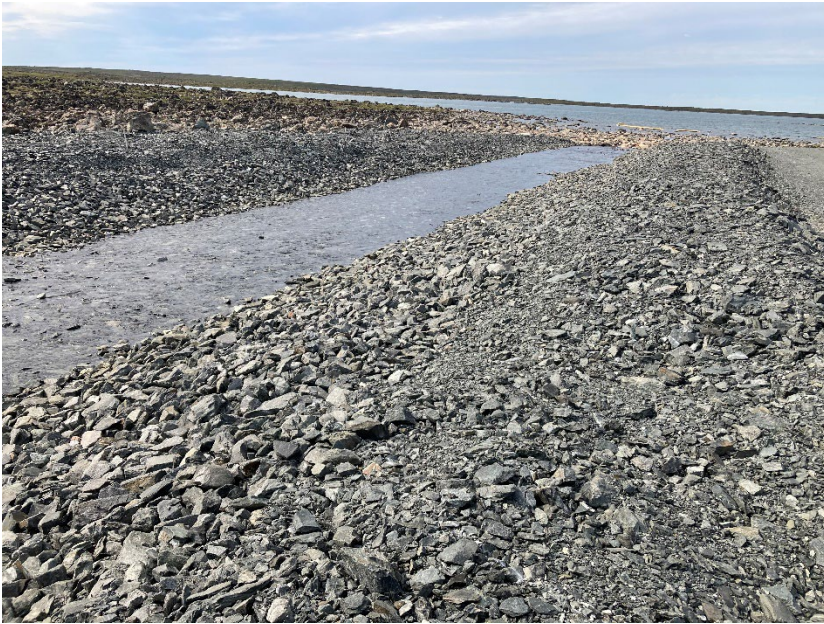
**Photograph H10-01 South Whale Tail Channel**

**Description:** From approx. Sta. 0+850, looking northwest. Sloughing and settlement of rockfill above riprap (~500 mm).

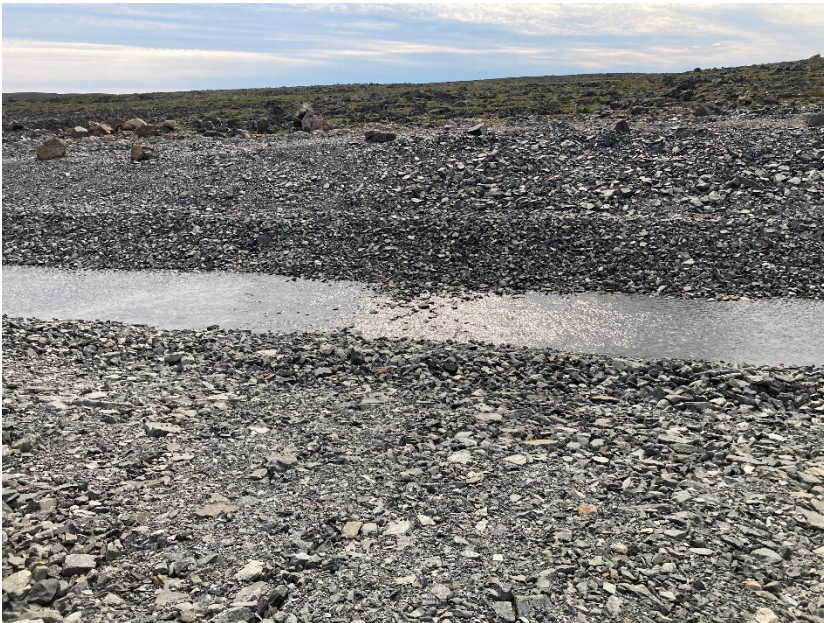
**Photograph H10-04 South Whale Tail Channel**

**Description:** From approx. Sta. 0+485, looking west. Limited sloughing of riprap, water still flowing well.

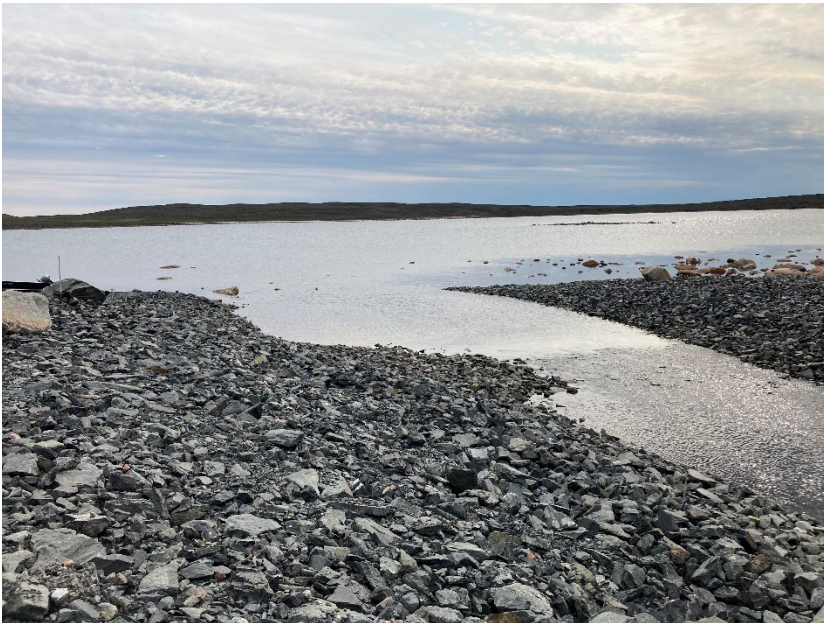
**Photograph H10-08 South Whale Tail Channel**

**Description:** From the Whale Tail South Lake inlet, looking southwest. Slight apparent sloughing in riprap.

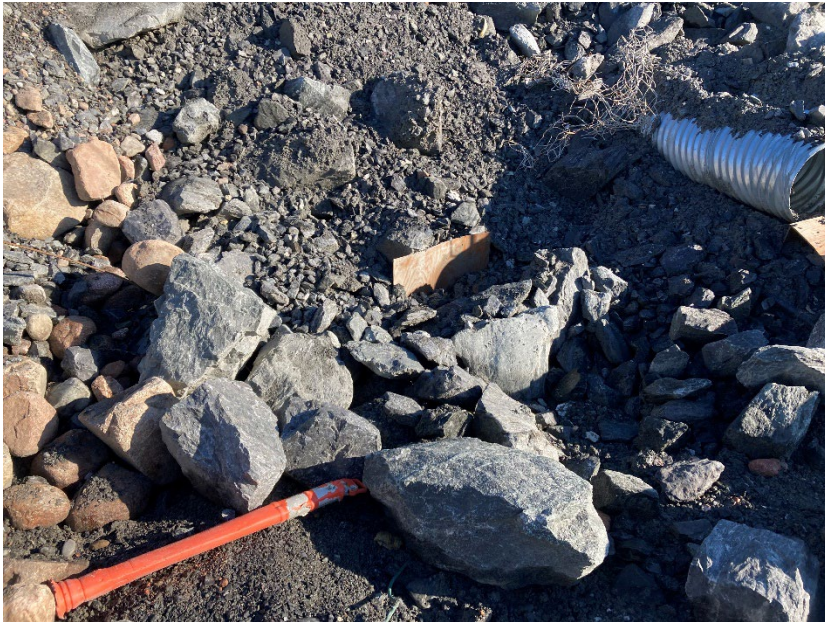
**Photograph H11-01 Saline Ditch**

**Description:** From approx. Sta. 0+670, looking east. Debris in ditch close to outlet.

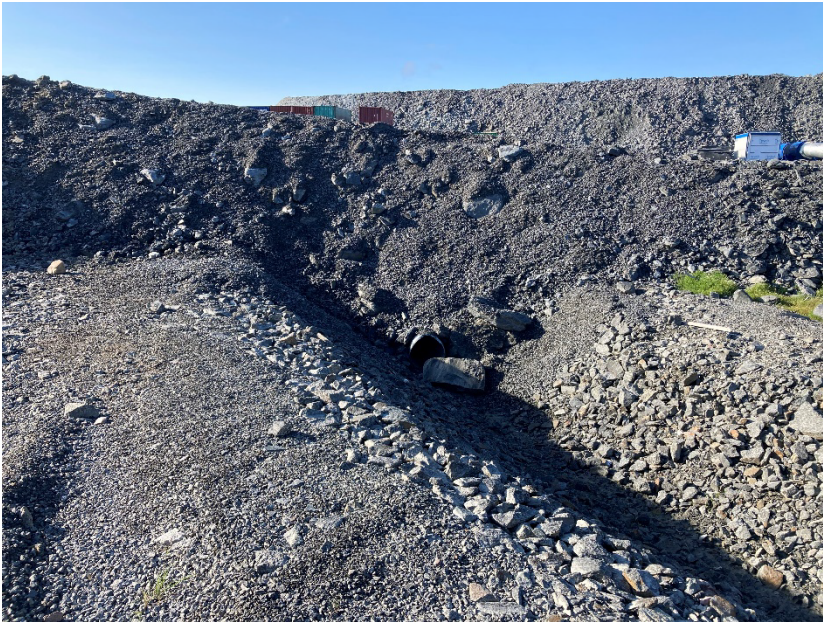
**Photograph H11-05 Saline Ditch**

**Description:** From approx. Sta. 0+530. Culvert obstructed by blocks and debris.

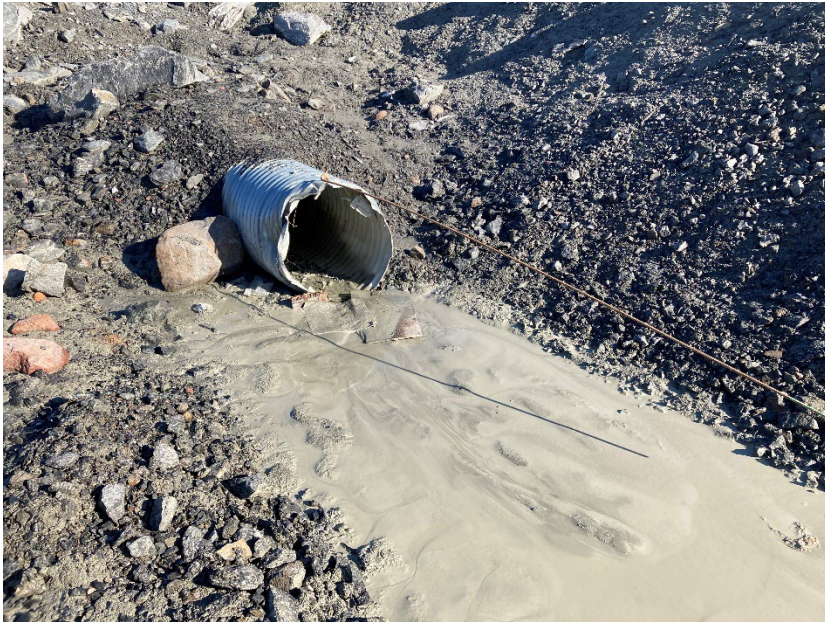
**Photograph H11-07 Saline Ditch**

**Description:** From the northern extremity of the Saline Ditch, looking west. The culvert is damaged, but functional.. Mud is accumulating in front of the inlet.

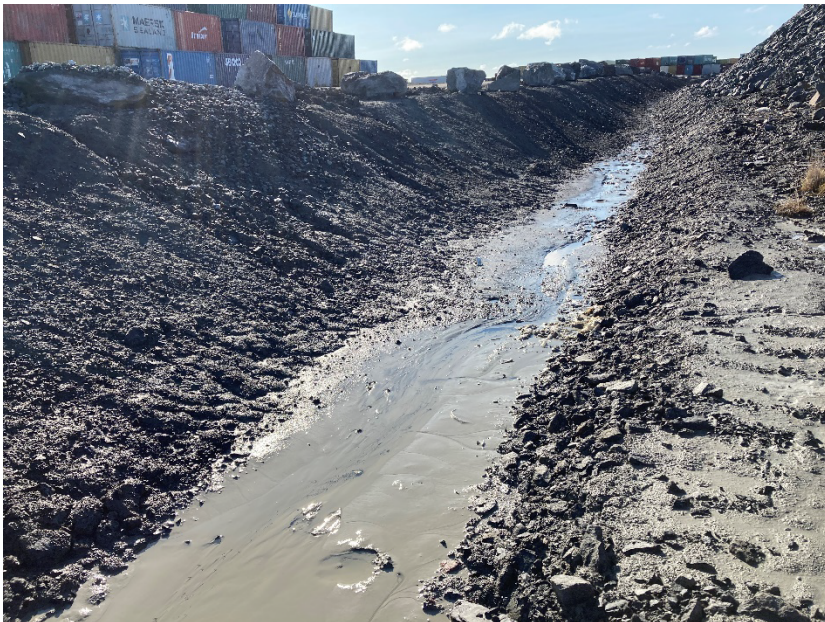
**Photograph H11-08 Saline Ditch**

**Description:** From the northern extremity of the Saline Ditch, looking east. Sediments are present in the ditch.

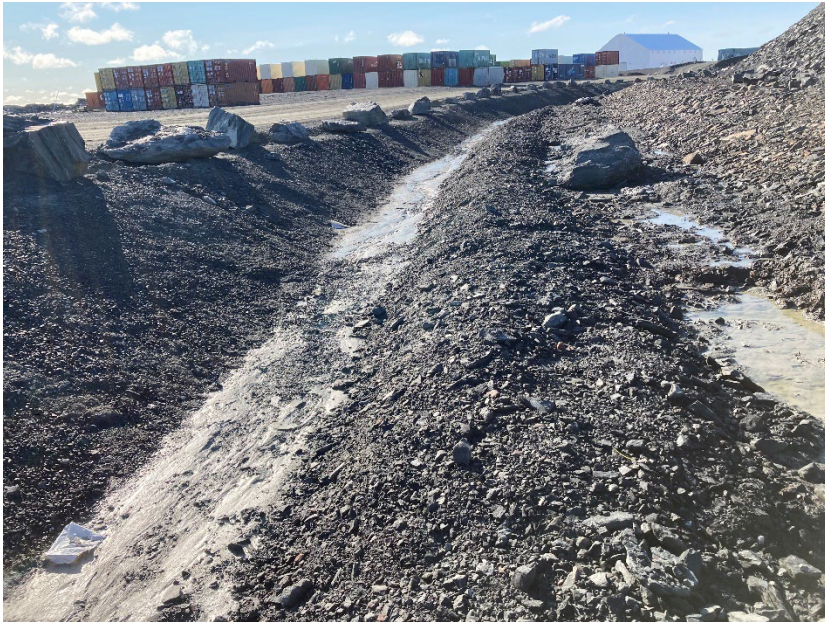
**Photograph H11-09 Saline Ditch**

**Description:** From approx. Sta. 0+180, looking southeast. Presence of mud and gravel in the ditch.

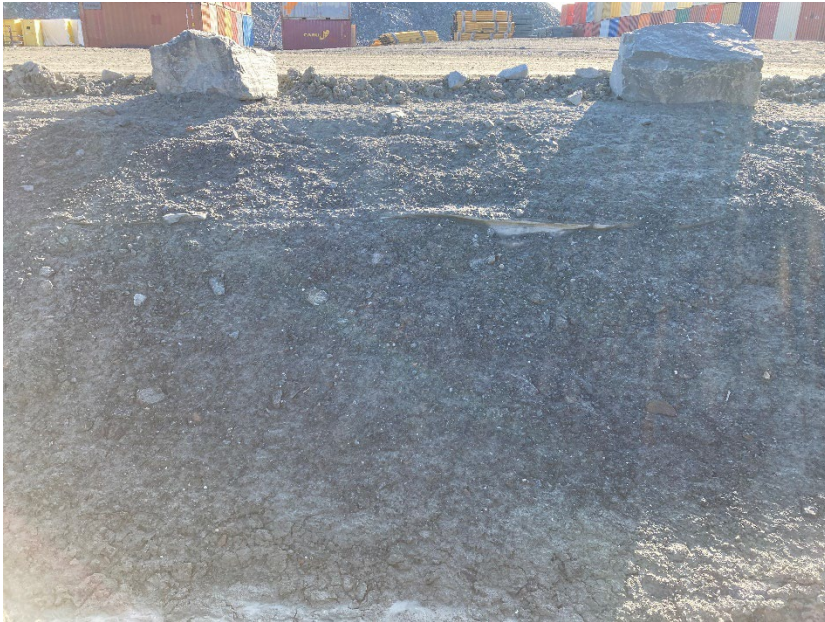
**Photograph H11-11 Saline Ditch**

**Description:** From approx. Sta. 0+250, looking east. Erosion of fine material, exposing liner underneath. Limited sloughing of fine material.

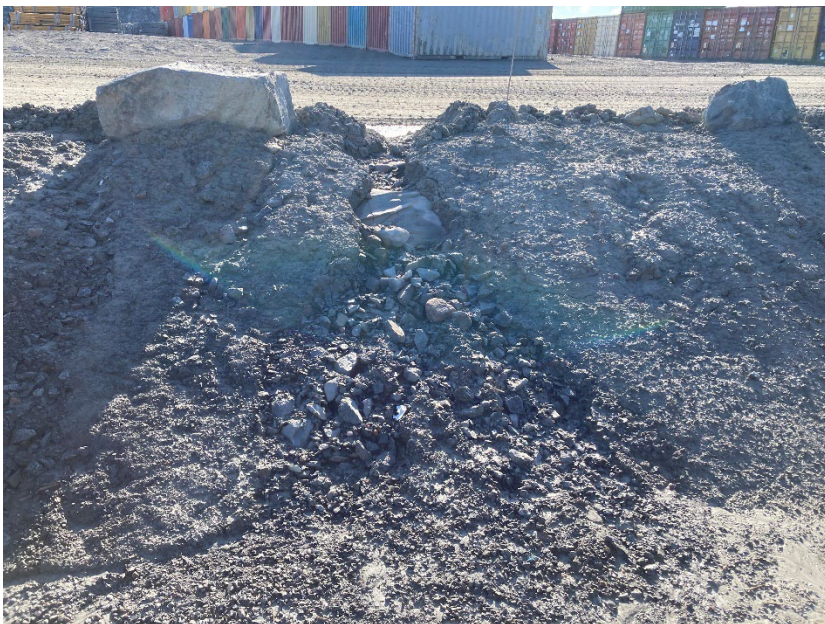
**Photograph H11-12 Saline Ditch**

**Description:** From approx. Sta. 0+250, looking west. Erosion of fine material, exposing liner underneath. Limited sloughing of fine material.

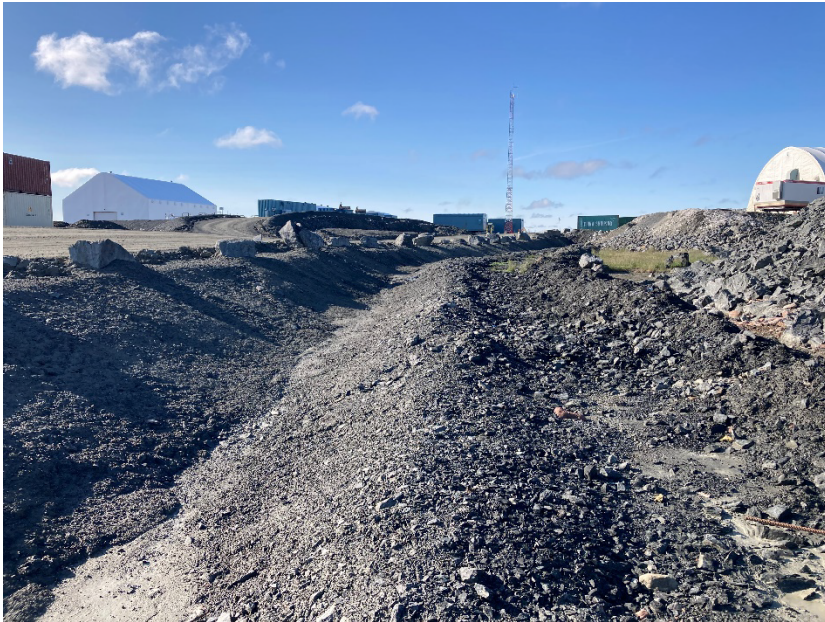
**Photograph H11-13 Saline Ditch**

**Description:** From approx. Sta. 0+300, looking south. Presence of gravel in the ditch.

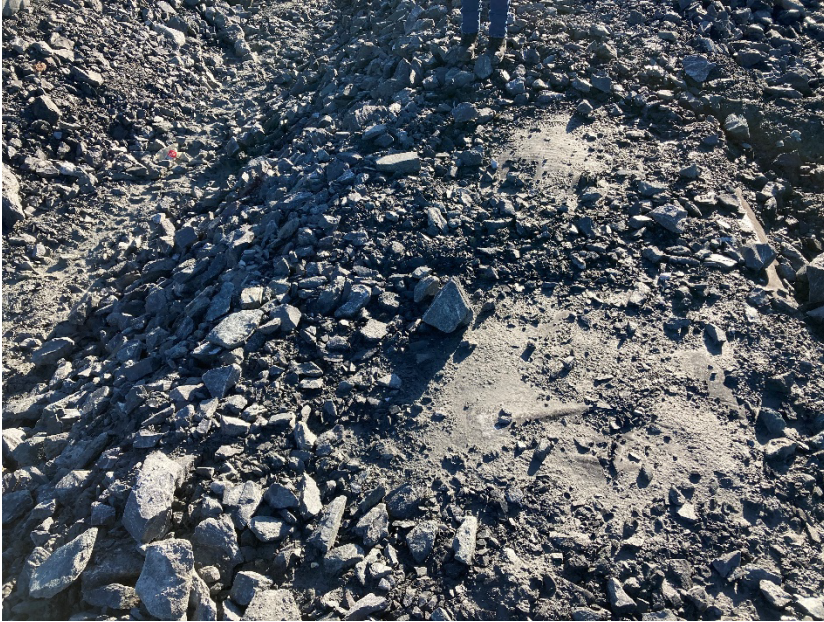
**Photograph H12-1 UG Ore Stockpile Saline Ditch**

**Description:** From the southeastern extremity of the UG Ore Stockpile Saline Ditch, looking northeast. Exposed liner in some points.

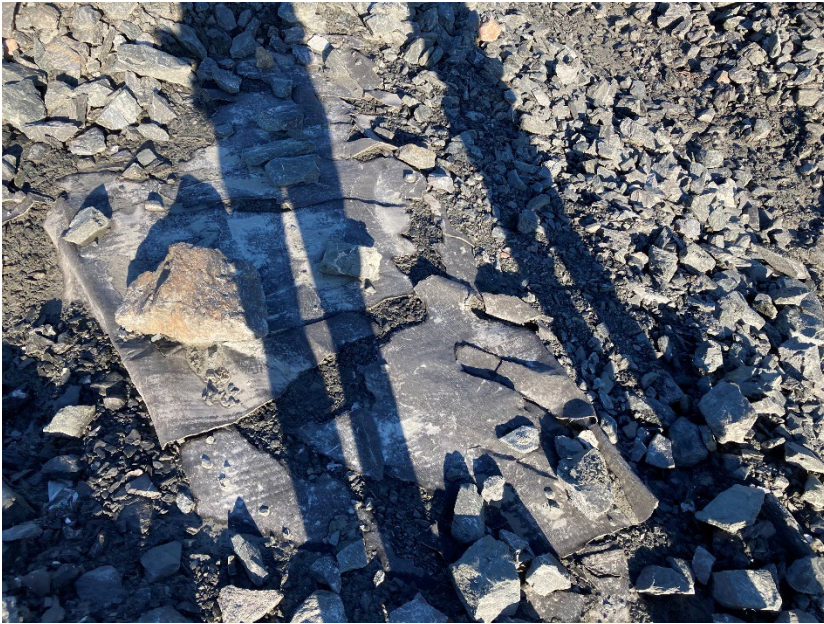
**Photograph H12-3 UG Ore Stockpile Saline Ditch**

**Description:** From the southeastern extremity of the UG Ore Stockpile Saline Ditch, looking northeast. Exposed and ripped liner.

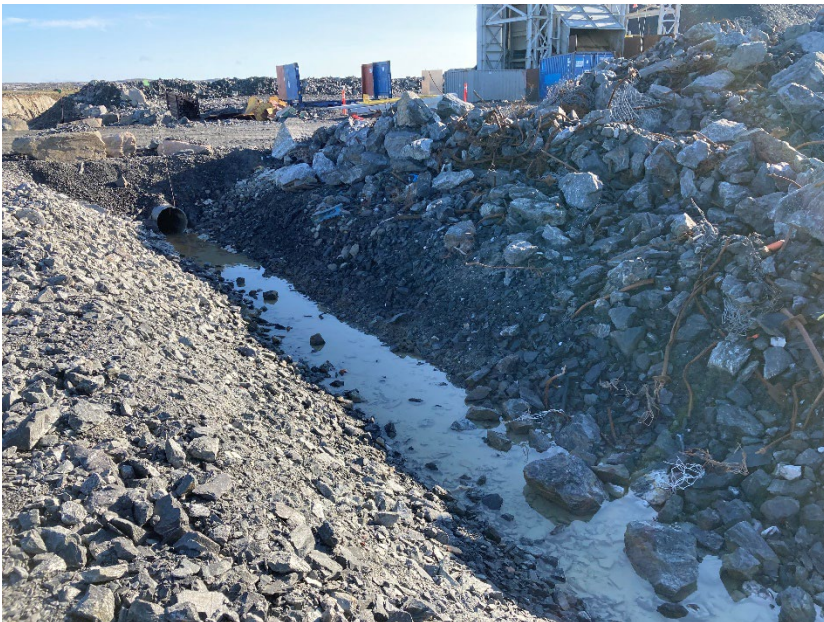
**Photograph H12-4 UG Ore Stockpile Saline Ditch**

**Description:** From approx. Sta. 0+050, looking southwest. Presence of debris in the ditch.

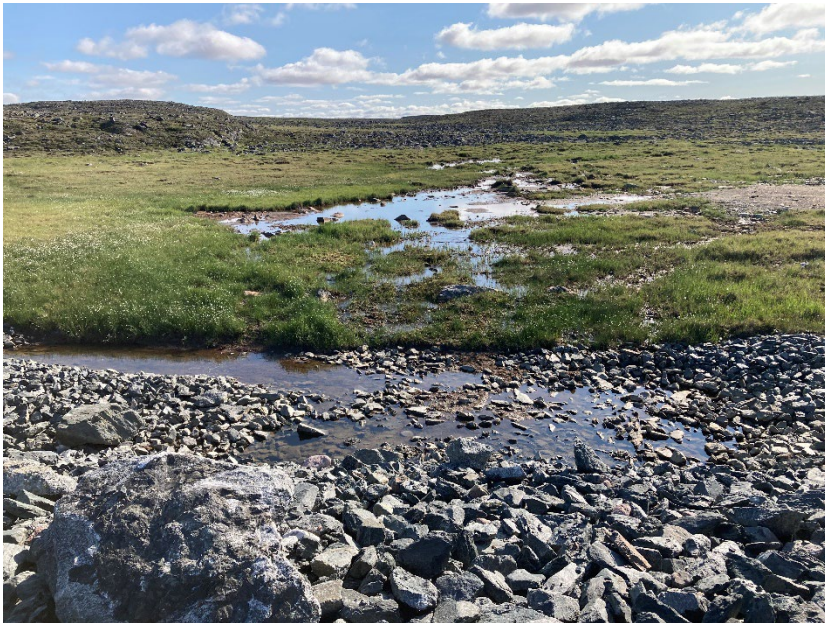
**Photograph H13-2 IVR Diversion Channel**

**Description:** From around Sta. 0+280, looking northeast. Water is entering the channel from the natural topography, increasing settlement.

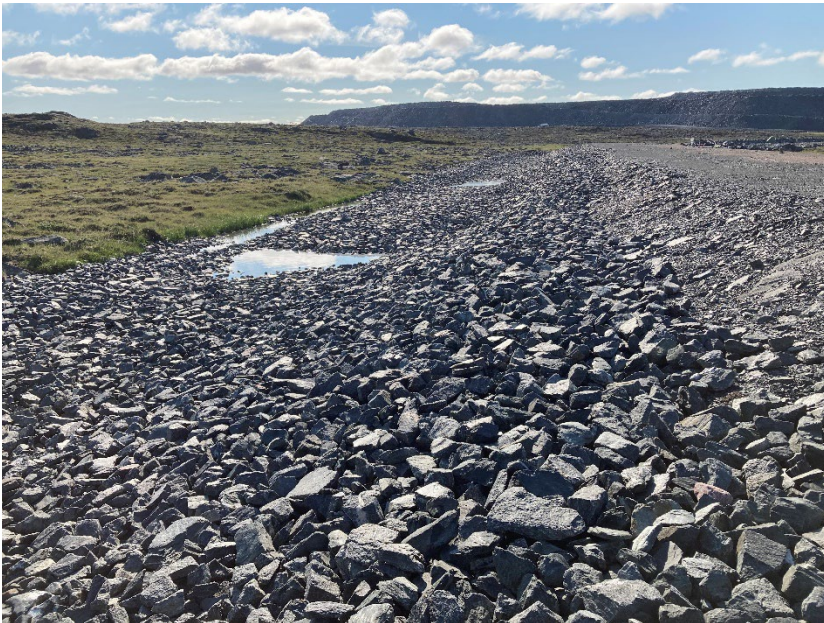
**Photograph H13-6 IVR Diversion Channel**

**Description:** From around Sta. 0+020, looking southeast. Presence of water ponding.

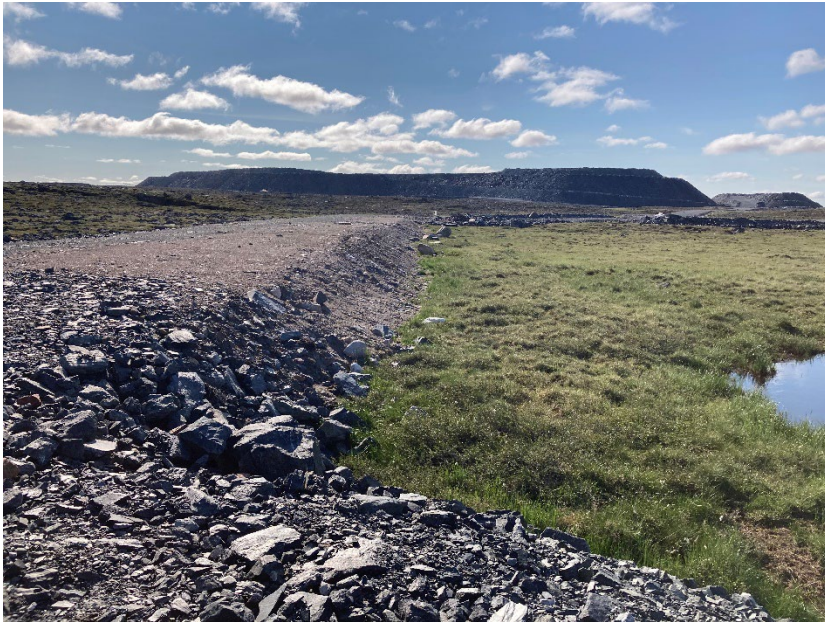
**Photograph H13-7 IVR Diversion Channel**

**Description:** From around the access road Sta. 0+020, looking southeast. Tension cracks and erosion in the sandy slope (upstream).

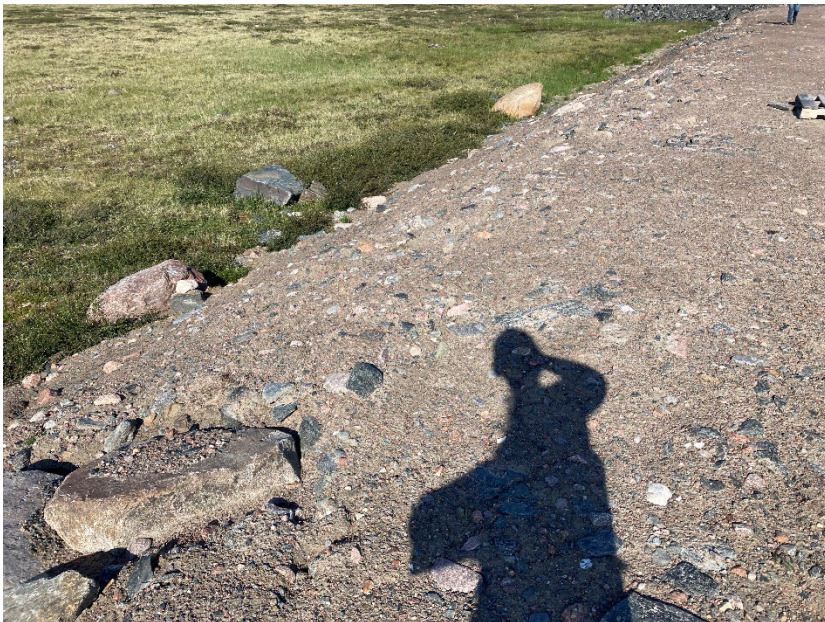
**Photograph H13-8 IVR Diversion Channel**

**Description:** From around the access road Sta. 0+080, looking northwest. Tension cracks and erosion in the sandy slope (upstream).
