Meadowbank 2025 Annual Open Pit Geomechanical Inspection Report

January 6, 2026

RE: Meadowbank Complex - Meadowbank Site - 2025 Annual Open Pit Geomechanical Inspection

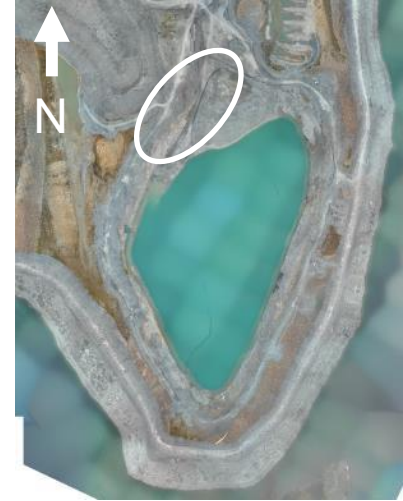
- The access to the pit has been reconfigured and personnel now travel for a short distance along a catch bench to reach a dock on the pit lake. As a result, personnel now travel closer to the uppermost 7 m bench face of the pit. Minor loose was observed on this face, which represents a rockfall hazard. The face should be scaled or a rockfall berm constructed.
- The ramp is clearly sign posted that access is restricted to authorized personnel only.

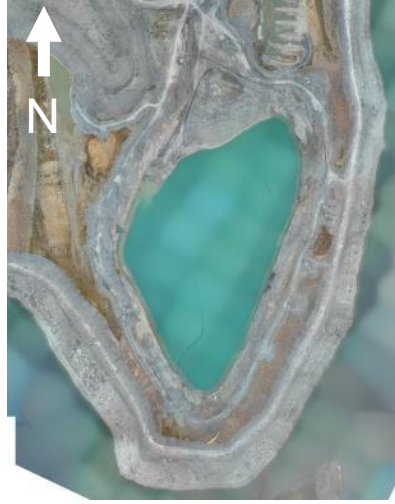
Looking South

- A portion of the upper bench is exposed above the current pit lake.
- The walls are performing well and no particular geomechanical concerns were noted.

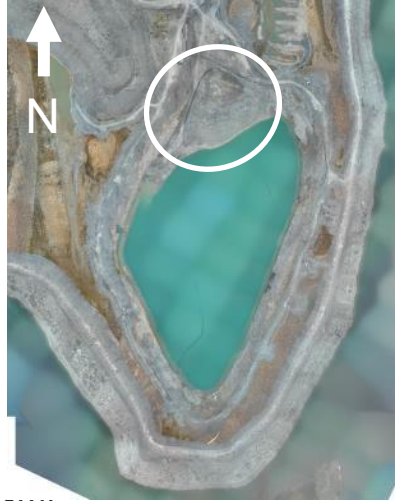
- The dump is inactive, and access is prevented by a rockfill berm and the presence of water pipes at the access point.
- The dump has been subsiding since 2015. The settlement is attributed to the deposition of water in the open pit, through a combination of thawing and increasing porewater pressure.
- The settlement has resulted in a series of scarps along the dump platform, that are now 3 to 4 metres in height (see photo below).
- The settlement is monitored as part of monthly inspections by the Geotechnical Group visually and using four survey pins installed in 2022. The observed deformation is discussed on the following slide.

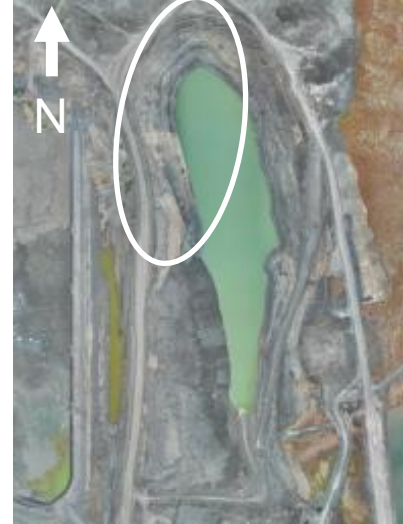
Pit A West Wall, looking northwest

- Approximately one bench is exposed above the pit lake.
- Tailings is being deposited from a spigot in the northwest corner of the open pit. The deposition does not appear to be adversely impacting bench performance.
- No significant change was observed in the pre-existing bench-scale failures remaining above the pit lake since the 2022 inspection, despite the pit lake now reaching the talus piles associated with the failures.
- Access to the East Ramp is restricted by berms at the top and bottom of the ramp (not shown in photo below).
- No particular geomechanical concerns were noted.

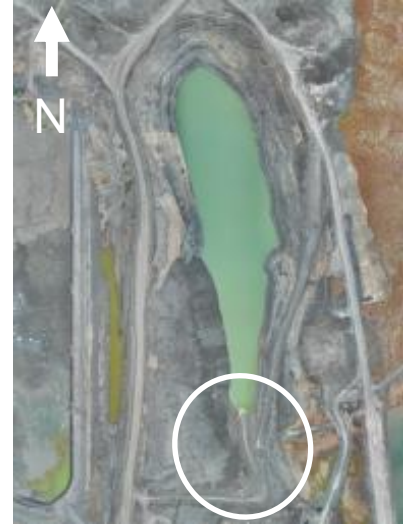
South Ramp, looking north from Crest of C Dump

- The South Ramp is used to access the pit lake.
- The ramp is clearly sign posted that access is restricted to authorized personnel only.
- The pump controls have been re-located up the ramp and around the corner from the pit lake, reducing the risk associated with a wave caused by a failure of the open pit slope or the dump.

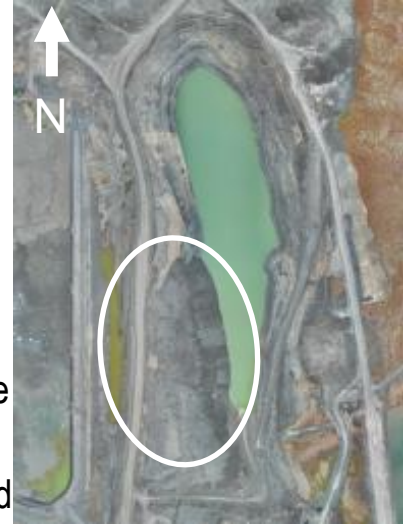
- The B Dump consists of an Upper and Lower Platform, both of which are inactive. Access to both platforms is prevented by berms.
- Failures of the dump slope are possible as the pit lake elevation rises but have not been observed to date. Such a failure could cause a large wave in the pit lake that poses a hazard to personnel conducting water sampling or managing the reclaim water lines.

- Tension cracks and subsidence continue to be observed on both platforms. The northern end of the Lower Platform has experienced the most subsidence. Sinkholes have also formed at the southern end of the Lower Platform. These are discussed on the following slides.

- An extensometer has been installed on the Lower Platform, and this is described further on a following slide.
- The possibility of the settlement progressing back to the Amaruq Road (West Road) was discussed in 2022 and concluded to be unlikely as the settlement and tension cracks appear to be limited to within the footprint of the pit. WSP has completed a detailed assessment of the stability of the road embankment as the water levels increase and the embankment was raised as a result. WSP has recommended that the embankment continue to be monitored as settlement is still possible.

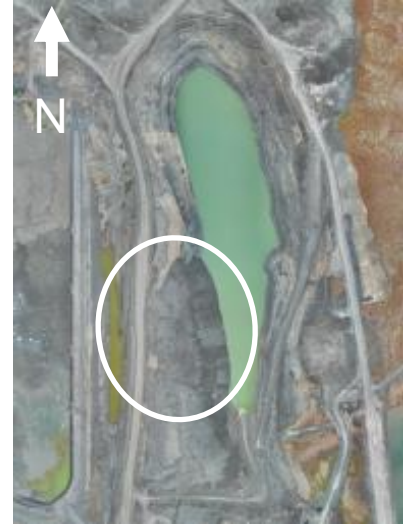
- Tension cracks are present along the western limit of the dump (outlined in white below). The cracks were surveyed a comparison completed in March 2025 suggests that they are located along the crests of the open pit benches. No obvious changes were observed in the tension cracks and associated settlement relative to the 2024 inspection.

- Extensometer EXT 24 was installed in 2022, and readings were taken approximately monthly until September 2024. No readings have been taken in 2025. The displacement rate has typically been less than 1 mm/day since mid-2023. This is TARP Blue status.

- No obvious changes were observed in the sinkholes and subsidence at the toe of the Upper Platform since the 2022 and 2023 inspections.
- As of 2025, the Lower Dump Platform is no longer being monitored. While the risk associated with a dump failure has decreased with the relocation of the pump controls on the Pit A Ramp, there is a need for basic monitoring. Recommend resuming the visual inspections and implementing InSAR or drone-based photogrammetry.

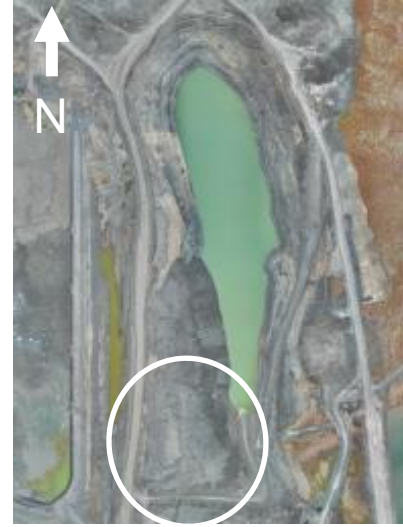
- The NW-SE tension cracks at the northern end of the Upper Platform have continued to increase in number and prominence since the 2024 inspections. Cracks are also now visible on the southeastern corner of the dump. Similar to the lower dump platform, the cracks are thought to be linked to the geometry of the underlying pit slope.

- The northern end of the Upper Platform has experienced settlement since at least 2022. Since 2024, a section of the platform 10-20 m back from the northern crest has subsided further than the platform at the northern crest. The reason for this is unclear. It could be evidence of a rotation of the dump towards the north, but no east-west tension cracks were observed and would be expected to occur under those circumstances.

- Visual inspection are being completed for the Upper Platform. InSAR or drone-based photogrammetry should be used to quantify and better understand the extents of the deformation.

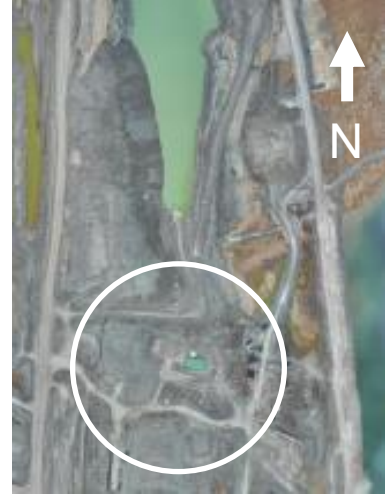
Looking north

- The C Dump, which backfilled Pit C, is located between Pits A and E and is inactive. Access to the dump platform is permitted but a berm has been constructed approximately 25 m back from the crest of the dump above Pit A. A single junction box remains within the berm.
- Settlement of the dump was expected and remains possible as the water elevations in Pit A and Pit E surpass the base of the dump (approximately 5085 mRL). The water elevations in both pits rose above the base of the dump in 2024 and water is now flowing from Pit A to Pit E below the dump. However, no evidence of settlement or instability has been observed to date.
- The ongoing use of the dump as a laydown is considered acceptable as no evidence of instability has been observed and experience at the other dumps suggests that the settlement is likely to be progressive in nature.

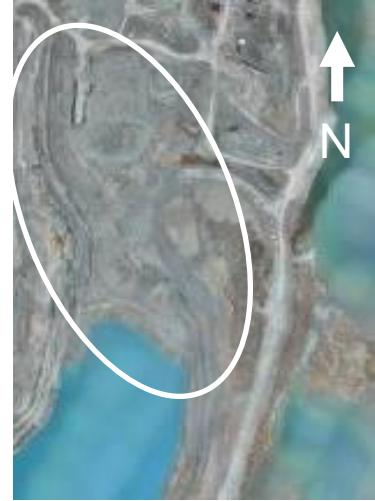
- The southwestern end of the dump started to settle in 2017 and is attributed to the deposition of water in the open pit. Tension cracks are visible in this area.

- The settlement and tension cracks have migrated progressively to the north as the elevation of the pit lake rises, and water migrates beneath the dump (see image).

- The dewatering pumps for Pit E are located at the toe of the dump. The pumps have been moved progressively up the ramp as the pit lake has risen. This has reduced the personnel to rockfall hazards along the ramp as well as any instability of the dump.

- Four wireline extensometers were installed at the crest of the dump and have been periodically relocated as the settlement has migrated north. At the time of the 2025 inspection, only one (EXT02, in the area outlined in black at right) was still being used and monitored, directly above the pumps.

- The extents of the settlement exceed what can be practically monitored with extensometers. Recommend using InSAR or drone photogrammetry to better understand the spatial distribution of the deformation. The extensometers could be limited to areas with increased exposure (e.g., above the pumps).

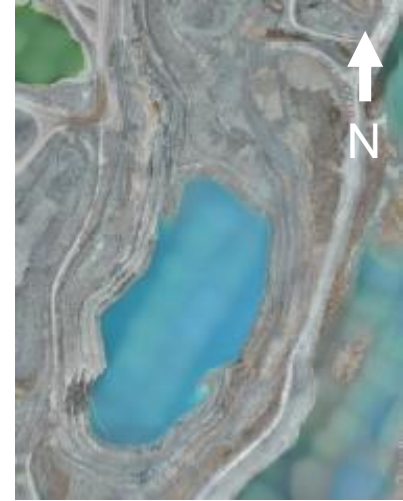
- The pit lake has continued to rise and approximately one bench is now exposed above the pit lake.
- The walls are generally performing well. No new instabilities were noted, and no significant change in the historical bench-scale instabilities along the south wall were observed.
- The deposition of tailings from the Southwest Wall has been discontinued. A new spigot point has been established along the West Wall. No particular geomechanical concerns were noted.

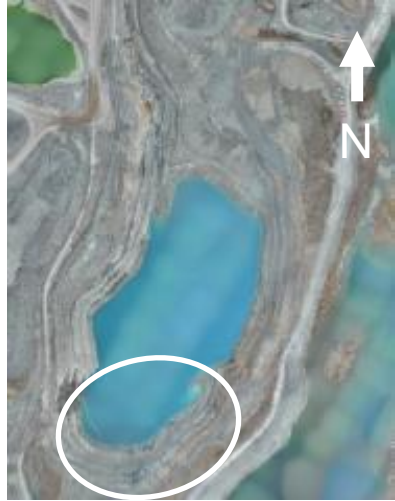
South Wall, looking southeast

- The berm preventing access to the ramp along the south wall has been re-established and the vibrating wire piezometer cable that was run along the ramp close to the pit wall has been removed. This is a positive development as rockfall continues to be observed on the ramp in this area.

- The pit lake water level has reached the toe of the historical bench-scale instabilities that occurred within the Ultramafics in the south wall. There is the potential for the instabilities to re-mobilize as the water level continues to rise. In particular, there is a possible wedge remaining in the westernmost of the two instabilities (outlined in white below).

The berm preventing access to the top of the South Ramp has been partially removed and it is no longer an effective barricade.	Re-establish the berm preventing access to the top of the South Ramp.	The berm preventing access to the top of the South Ramp of Pit E has been re-established.	None.	Complete
Portage Pit E and Tailings Management Facility				A vibrating wire piezometer has been installed at the base of the South Ramp. The cable for the piezometer runs along the ramp, within 5 m of the bench face. There are numerous active rockfall hazards along this ramp and a rockfall berm has not been established.	Re-locate the cable for the vibrating wire piezometer away from the wall. Alternatively, establish a rockfall berm along the inside of the ramp.	The vibrating wire piezometer and associated cable has been removed.	None.	Complete
						The rising pit lake water level may re-mobilize the historical bench-scale instabilities on the south wall of the open pit. There is currently no access above or below these instabilities. However, the mine is planning to re-open the access road at the crest of this slope and install a water line.	Estimate the potential failure limits of the historical instabilities prior to the re-opening of the road and locate the pipeline outside of these limits. Develop and implement a monitoring plan for this area prior to commencing any work.	P3

- There is currently no access above these instabilities as the road along the pit crest has been bermed off. However, it is understood that AEM wishes to route a water pipeline along the road as part of closure activities. The potential failure limits of the historical instabilities should be estimated and the pipeline located outside of these limits. A monitoring plan should be developed and implemented for this area prior to any work commencing.

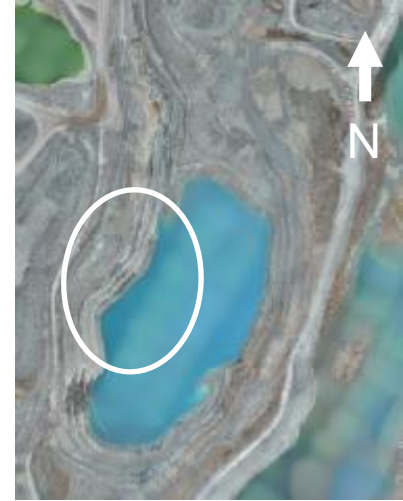
- A new tailings spigot has been established halfway along the west wall. Tailings are discharged from a line at the crest of this wall.
- The Bay Fault Zone dips into this wall in the area of the spigot point. The infiltration of water from the tailings into the fault could adversely impact slope performance. No evidence of instability was observed during the inspection.
- Recommend continuing the monthly visual inspections to monitor the area for bench degradation, tension cracks, seeps, etc.

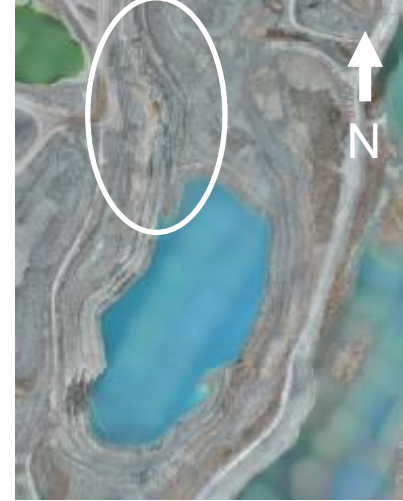
Lower Ramp, Looking South

- The Northwest Ramp is used to access the pit lake and water management infrastructure is present along the ramp.
- Multiple rockfall hazards have been previously identified along this wall. With the continued rise of the pit lake, almost all of these hazards have been flooded and no longer pose a risk to personnel. If the water level is lowered, some of these hazards may be re-exposed. The condition of the open pit walls will need to be re-assessed and the adequacy of the current control measures (e.g., rockfall berm) reviewed before access is allowed to these areas.

- The rockfall berm at the toe of the pit slope has been effective at managing rockfall. In 2023-2024, the berm was locally repositioned closer to the slope to create room for the pumps. The reconstructed berm is relatively short and may not be an effective rockfall barrier. It was recommended that the height of the berm in this area be increased to match the remainder of the berm. This work was not completed before this portion of the ramp was flooded. It should be completed before this portion of the ramp is re-accessed.

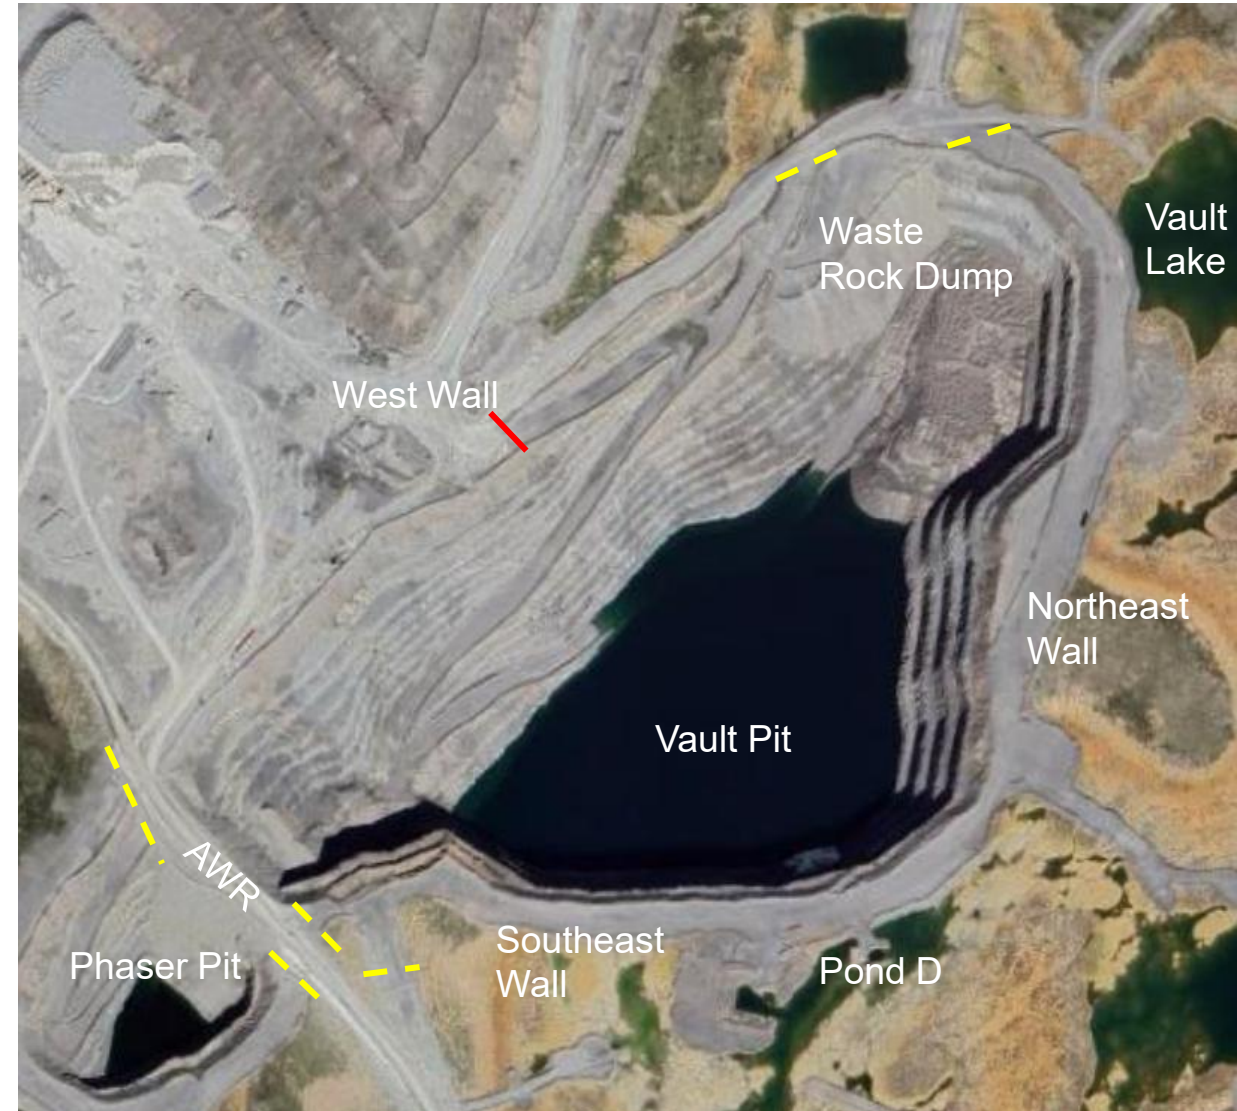
- Access to the open pit is limited to monthly water quality sampling when the pit lake is not frozen.
- At the time of the inspection, access to the open pit was restricted by candles. Access to the ring road is restricted by berms at the north and south ends of the road. The candles (red) and berms (yellow) are shown at right.

- The open pit is partially flooded. The elevation of the pit lake was 5068 mRL in June 2025, slightly higher than what is shown at right.
- The Amaruq All Weather Road (AWR) crosses between the Vault and Phaser Pits on a rockfill embankment.

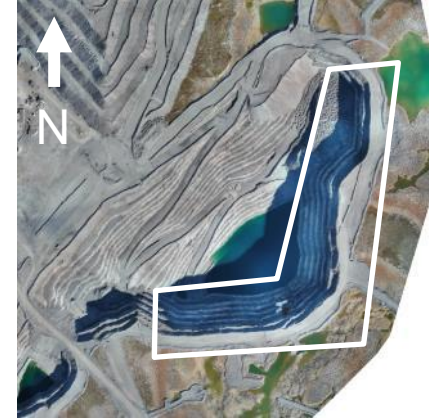
Northeast and Southeast Walls, looking east

- The walls are performing well. No particular geomechanical concerns were noted.
- The ice wall continues to form each winter on and below the talik zone in this wall. Limited seepage through the rock was observed at the time of the inspection.
- Treated water from the Goose Pit is planned to be discharged into the Vault Pit. The discharge pipe will be laid along the ramp and then submerged in the pit lake. The rockfall hazard to personnel working in the pit will need to be assessed prior to the start of work. A drone could be used to assist with this.

Treated water from the Goose Pit is planned to be discharged into the Vault Pit. The discharge pipe will be laid along the ramp and then submerged in the pit lake using a barge. Personnel may be exposed to rockfall hazards along the ramp and in the pit lake.	Evaluate the rockfall hazard to personnel installing the water pipe along the ramp and in the pit lake. Implement mitigation measures prior to the start of work. It is likely that rockfall berms will need to be constructed at least locally along the ramp. The evaluation of the rockfall hazard above the future barge location is likely best completed using a drone.	P3

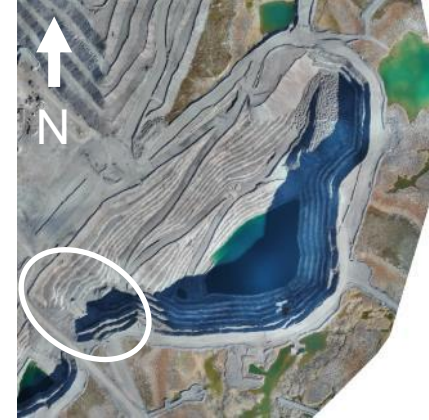
Southwest Wall, looking southwest

- The Amaruq AWR crosses a saddle between the Vault and Phaser Pits on a rockfill embankment.
- During the winter of 2023, tension cracks were observed on the surface of the road, perpendicular to the axis of the road. The cracks have not been observed since and may have been due to frost heave within the upper road surface.

- No evidence of instability in the AWR embankment was observed during the inspection (e.g., no tension cracks on the road surface or bulging of the embankment toe).

- The stability of the Amaruq AWR embankment could be impacted if the water level in the Phaser Pit on the other side of the embankment increases and water ponds behind the embankment. This has not occurred. Possible minor seepage at the toe of the embankment was observed at the time of the inspection. The presence of seepage should continue to be evaluated as part of the monthly inspections. Recommend noting the importance of this in the GCMP.

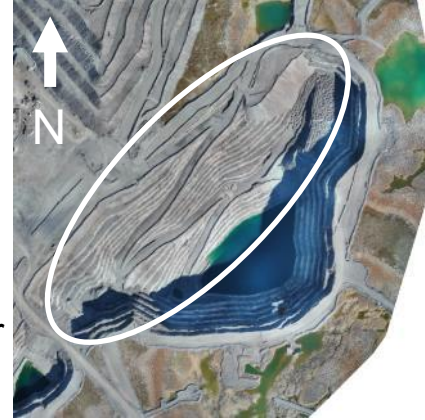
West Wall, Looking Northwest

- The West Wall is located along the footwall of the deposit. The wall was established with 7 m high single benches without pre-shear and commonly failed or were scaled back to the foliation. The ramp is located along this wall.
- At the time of the inspection, access to the ramp was restricted by a barricade.

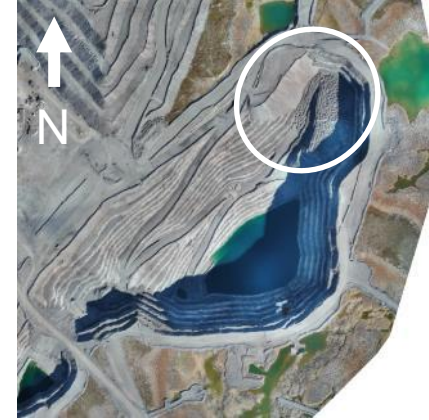
- A waste rock dump was constructed at the north end of the Vault Pit. The dump is inactive and consists of two platforms with elevations at approximately 5133 mRL and 5082 mRL.
- Settlement and tension cracks were observed at the crest of the upper platform at the north end of dump during the 2019 inspection. There appears to have been little change since that time. The affected area is relatively small and is not above the ramp.
- No other evidence of instability was observed during the inspection.
- Access to the dump is prevented with a berm.

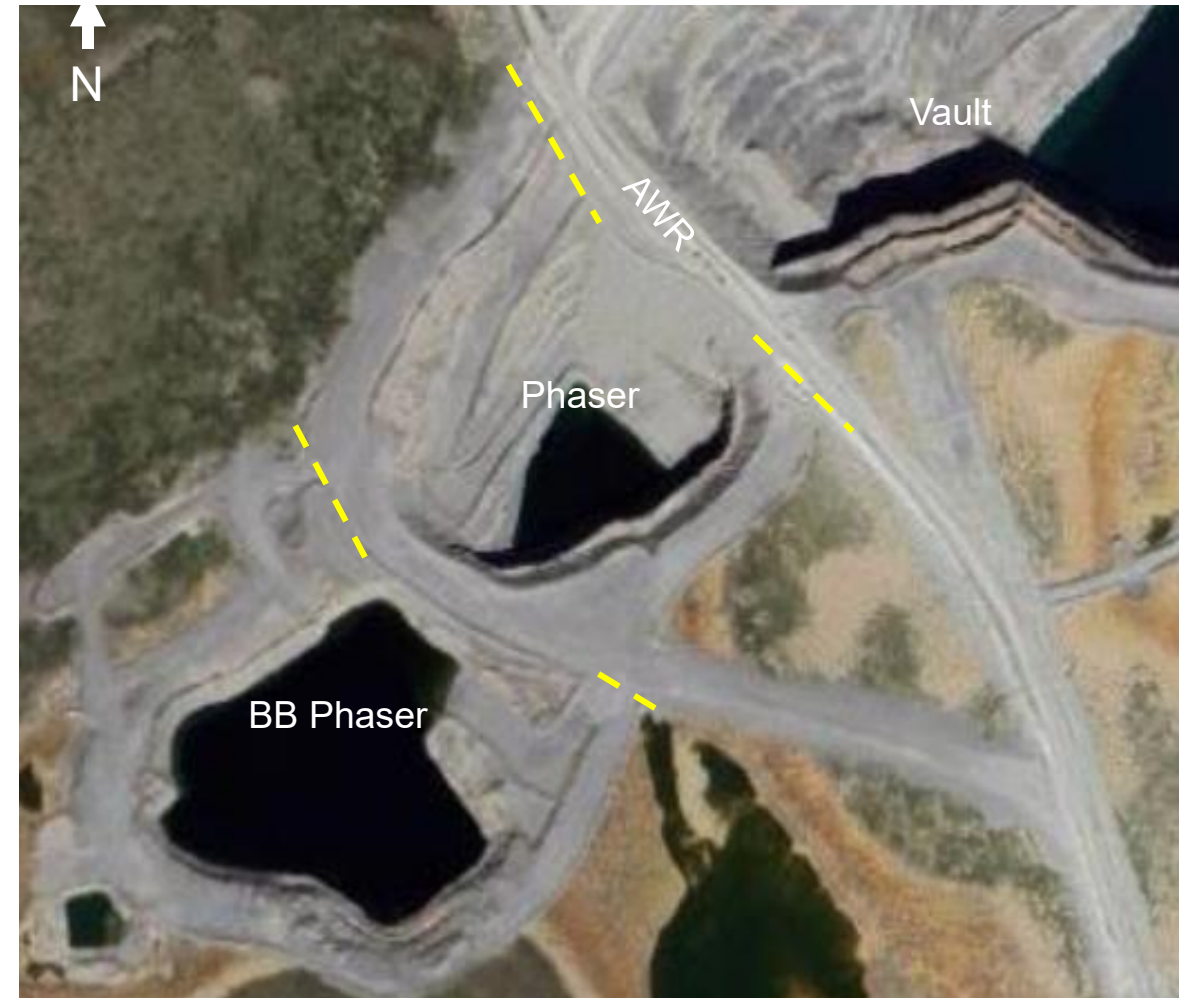
- Access to both of the open pits is limited to monthly water quality sampling when the pit lakes are not frozen.
- At the time of the inspection, the accesses to the open pits were barricaded by berms (shown as dashed lines at right).

- Note that the Amaruq All Weather Road (AWR) crosses between the Vault and Phaser Pits on a rockfill embankment.
- AEM continues to complete documented monthly geomechanical inspections of the open pits and the AWR crossing.
