WHALE TAIL ATTENUATION POND RAMP

Construction Summary Report

September 9, 2020

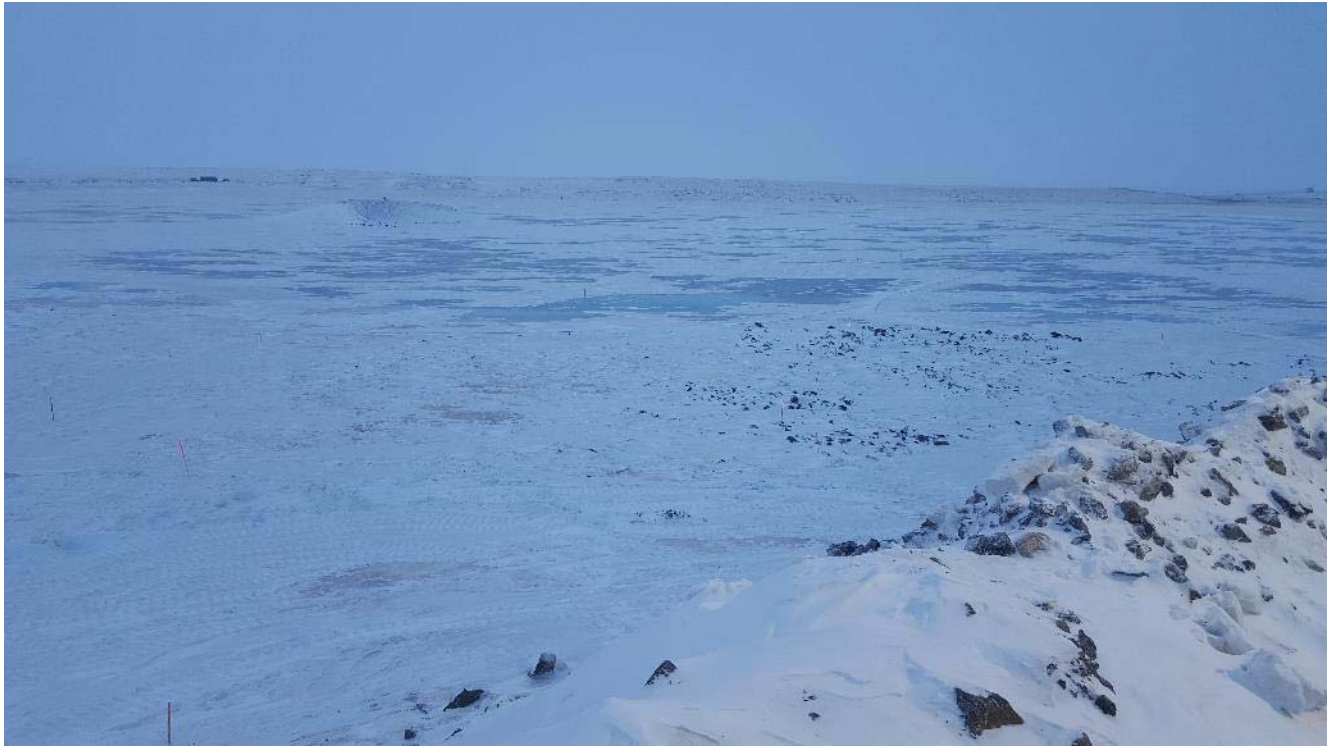
Picture 1 – View of Whale Tail North prior to the construction of the Whale Tail Attenuation Pond Ramp (January 5, 2019)

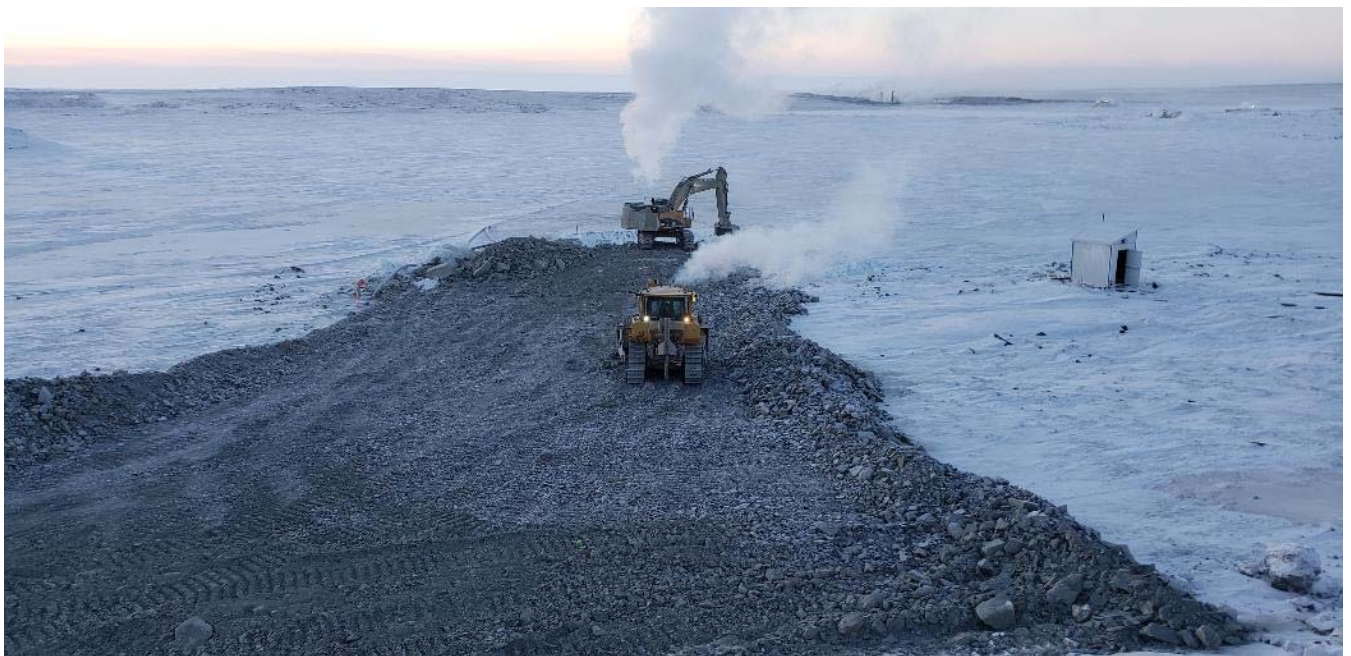
Picture 2 – Removal of ice and snow and placement of rockfill material over land for the Dewatering Ramp construction (January 11, 2019)

For the portion of the ramp built over land, all snow, ice, large boulders, and any deleterious material were removed from the foundation before rockfill placement. Material was brought by 100T haul trucks and was placed with a D8 dozer. Compaction was achieved by trafficking on the ramp with haul trucks.

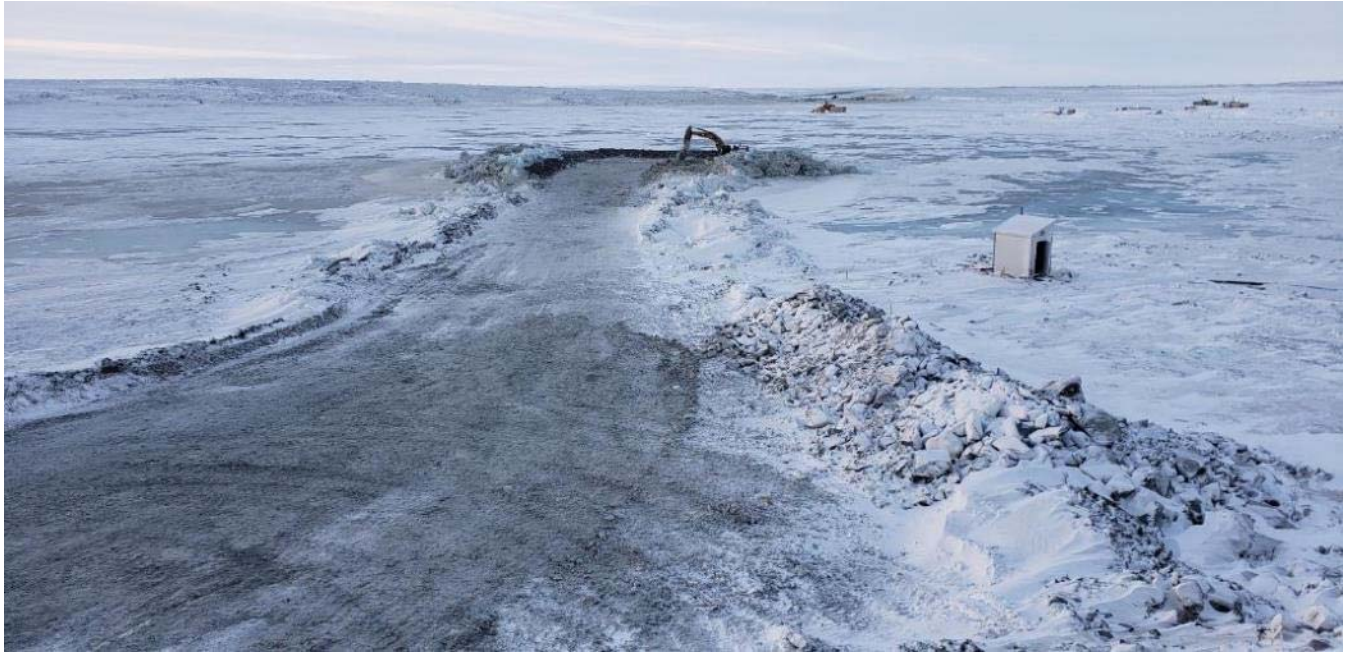
Picture 5 – Construction of the Dewatering Ramp pump pad. Placement of rockfill material in water with an excavator (January 20, 2019)

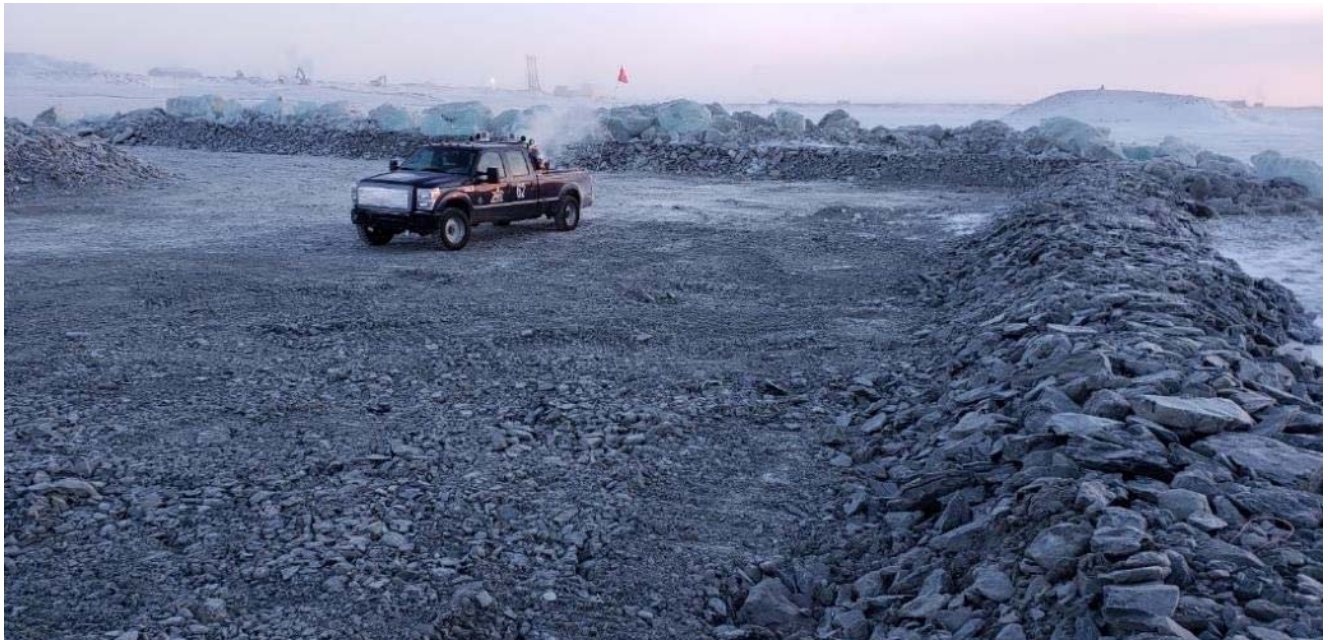
Picture 6 – Construction of the Dewatering Ramp pump pad (January 21, 2019)

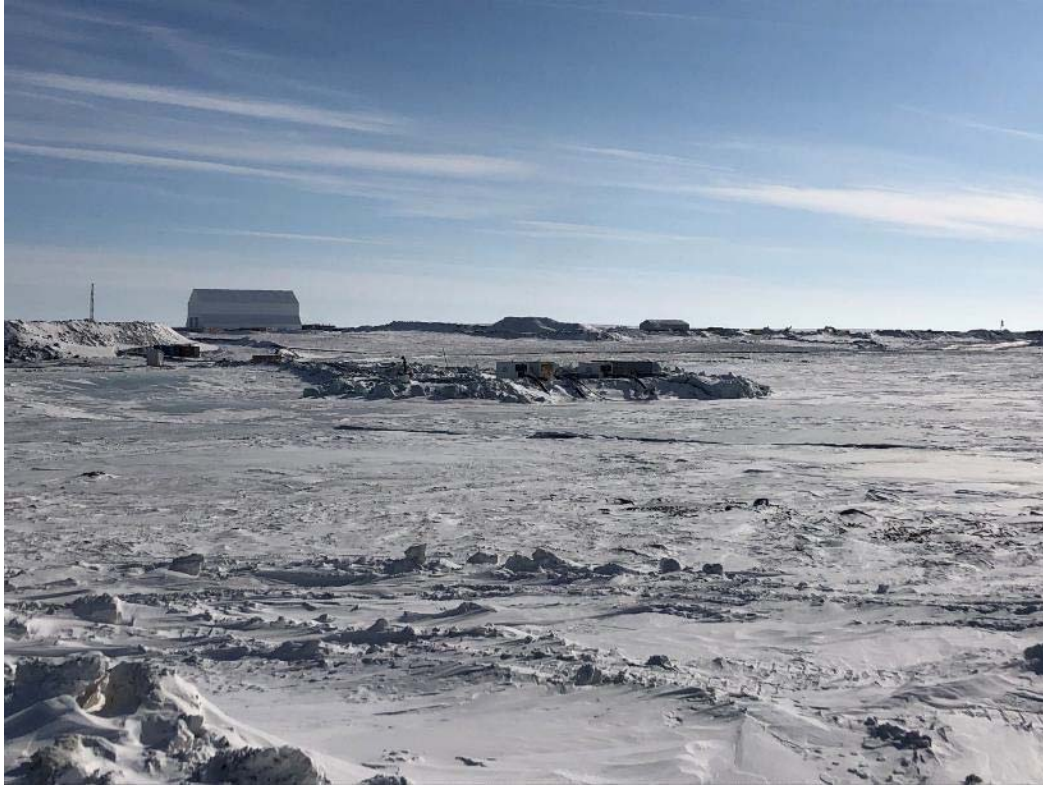
Picture 9 – Dewatering Ramp with pumping system installed (March 25, 2019)

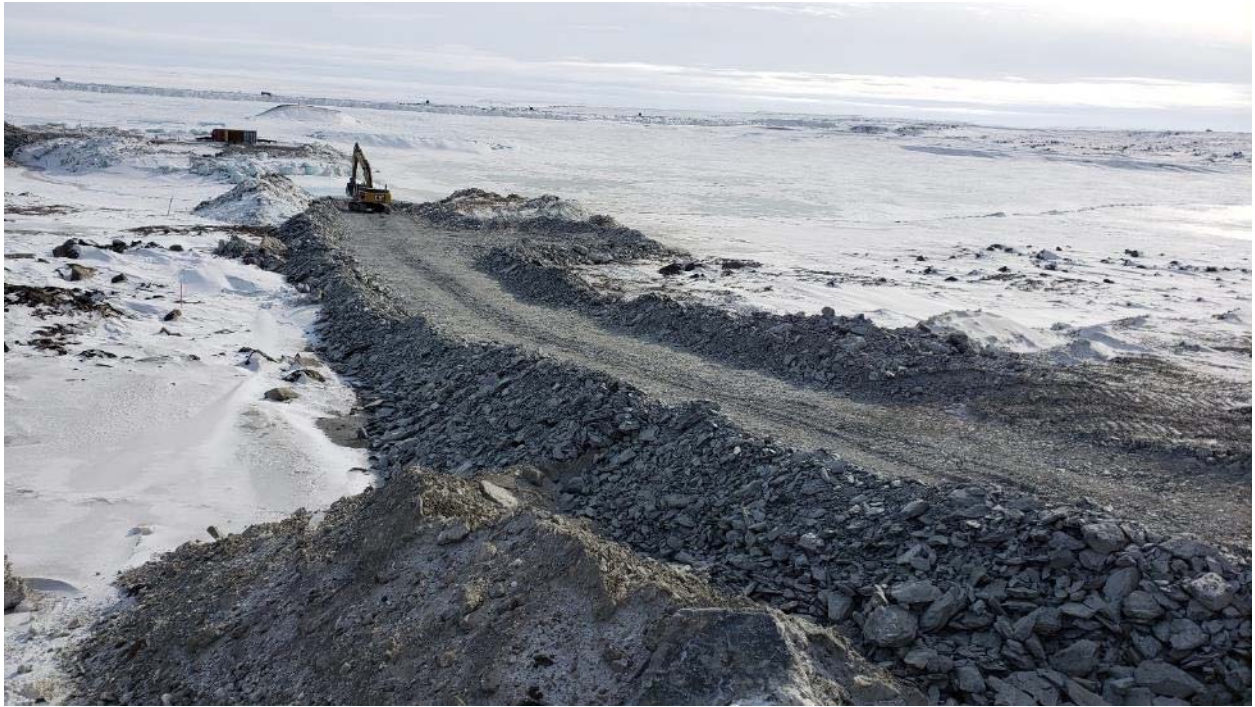
Picture 13 – Construction of new access to lower the dewatering ramp pump pad (Phase 2) (April 14, 2019)

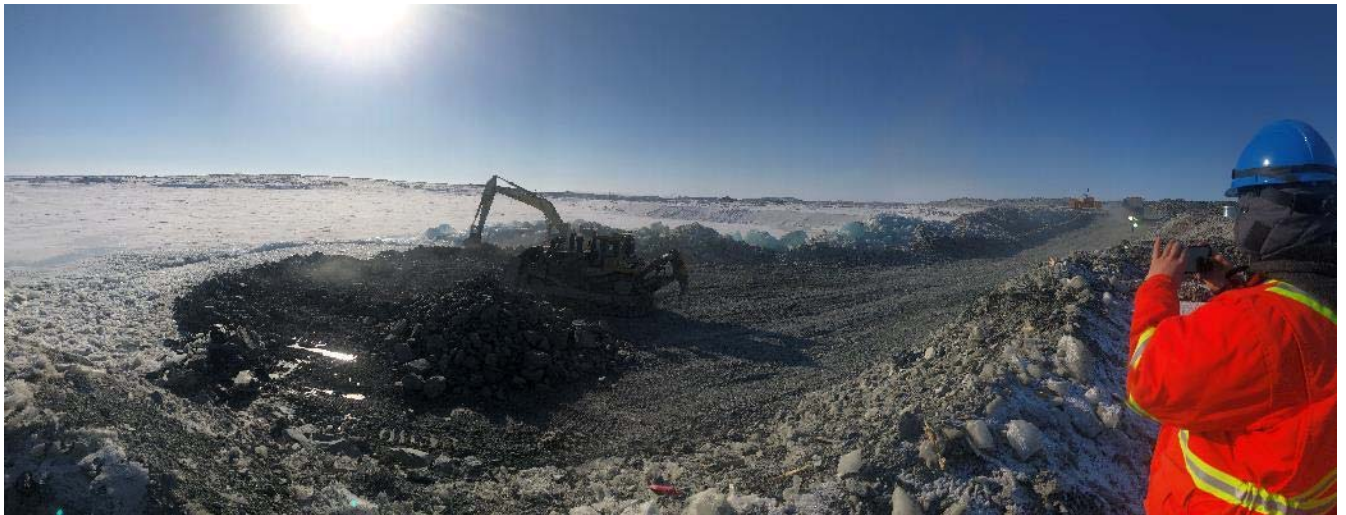
Picture 14 – Construction of the Phase 2 of the Ramp. Placement of rockfill material to construct the access road perpendicular to the Phase 1 Ramp. Picture taken from Phase 1 dewatering pad (April 16, 2019)

The Phase 2 access ramp was built using the same methodology as the Phase 1 Ramp. Due to the instability in the Phase 1 Ramp from ice and snow present in the foundation, the construction of this extension was performed under increased supervision to ensure a suitable foundation for the structure.

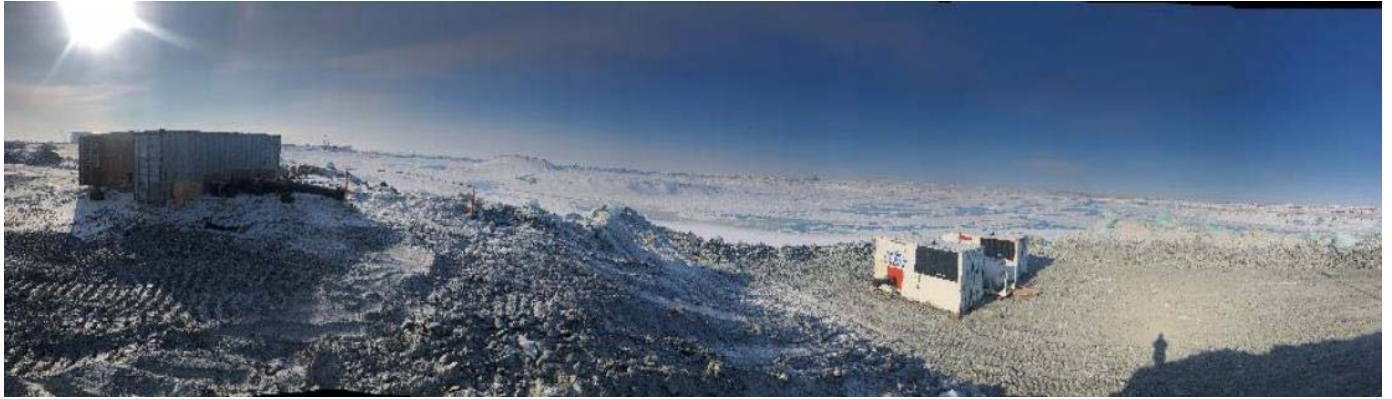
Picture 15 – Construction of the Phase 2 of the Ramp. Placement of rockfill material to construct the access road perpendicular to the Phase 1 Ramp. Picture taken from Phase 1 dewatering pad (April 20, 2019)

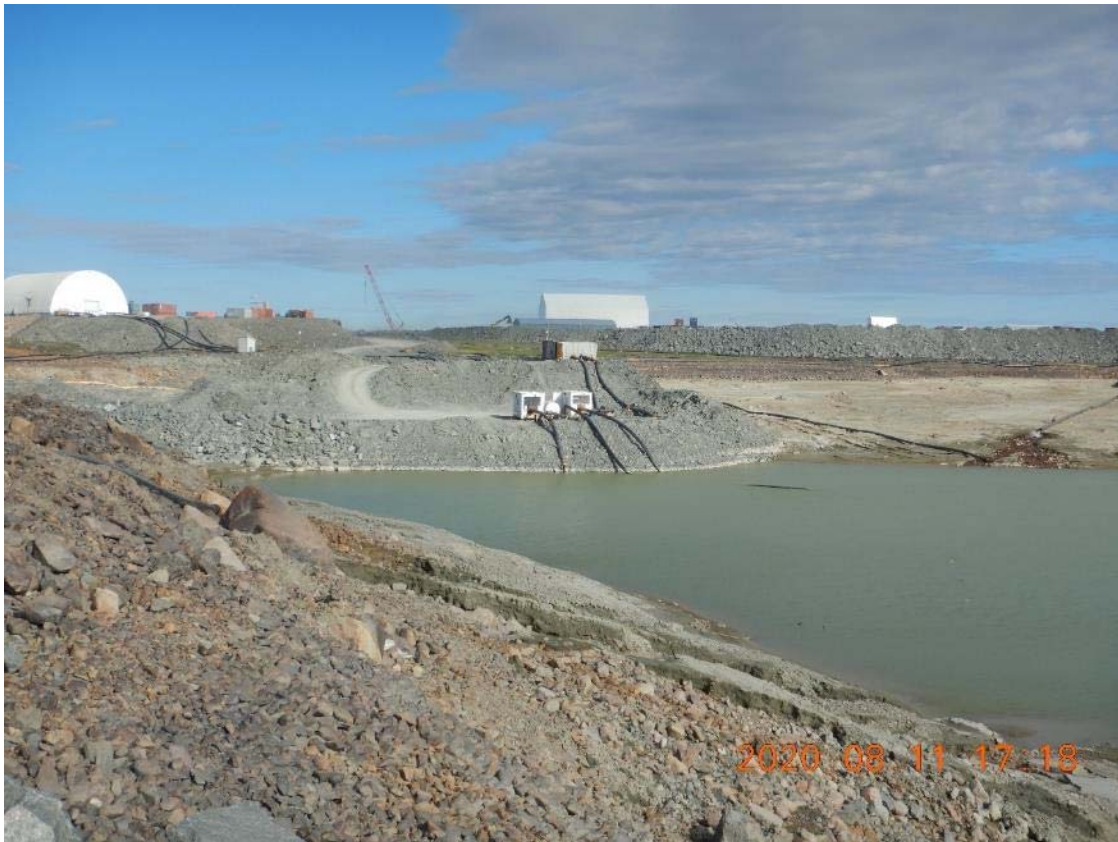
Picture 22 – View of the Whale Tail Attenuation Pond Ramp after commissioning (August 11 2020)

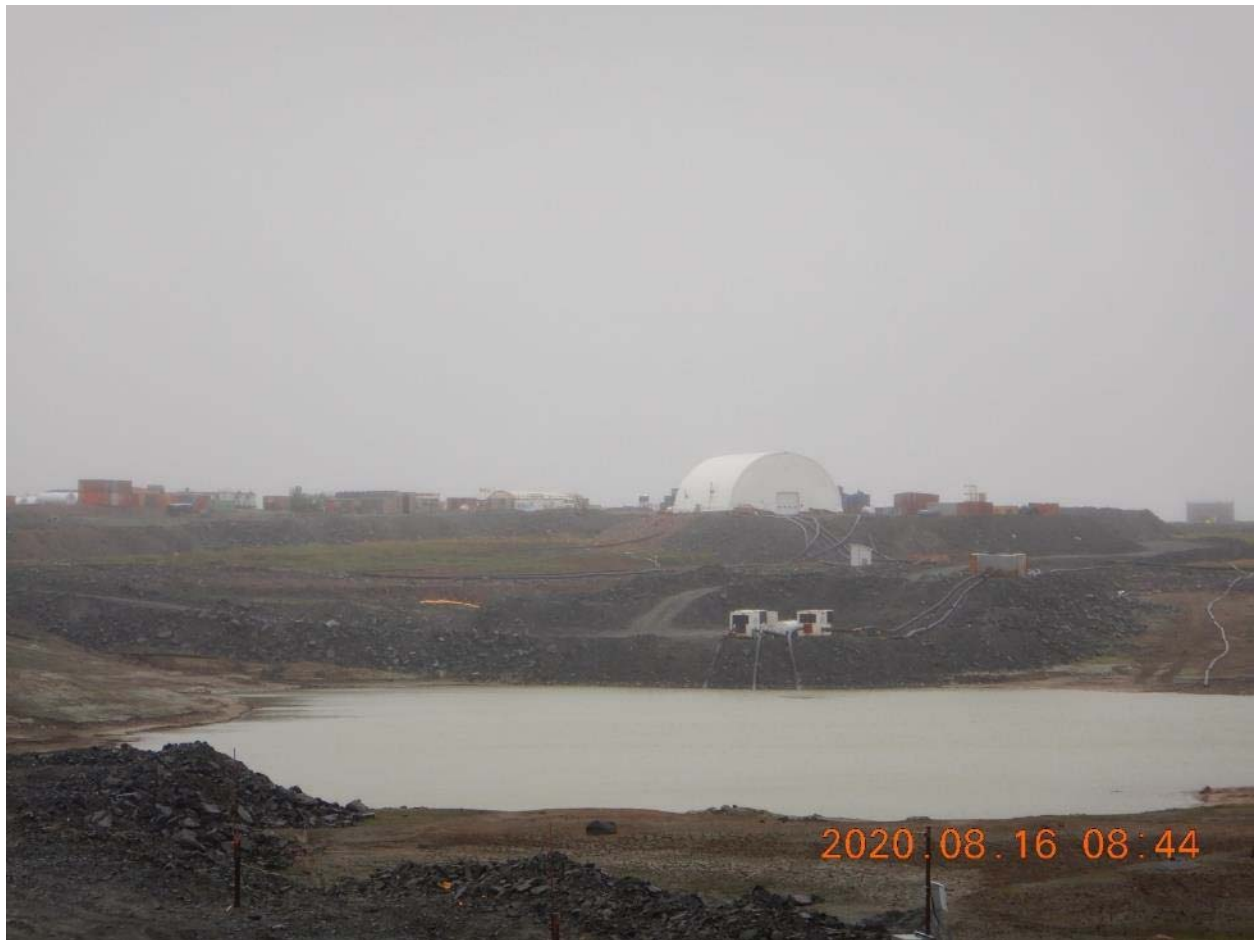
Picture 23 – View of the Whale Tail Attenuation Pond Ramp after commissioning (August 16 2020)
