# CONSTRUCTION SUMMARY REPORT

## Whale Tail Dewatering Phase 2

Agnico Eagle Mines Ltd

6127-648-132-REP-002\_R2

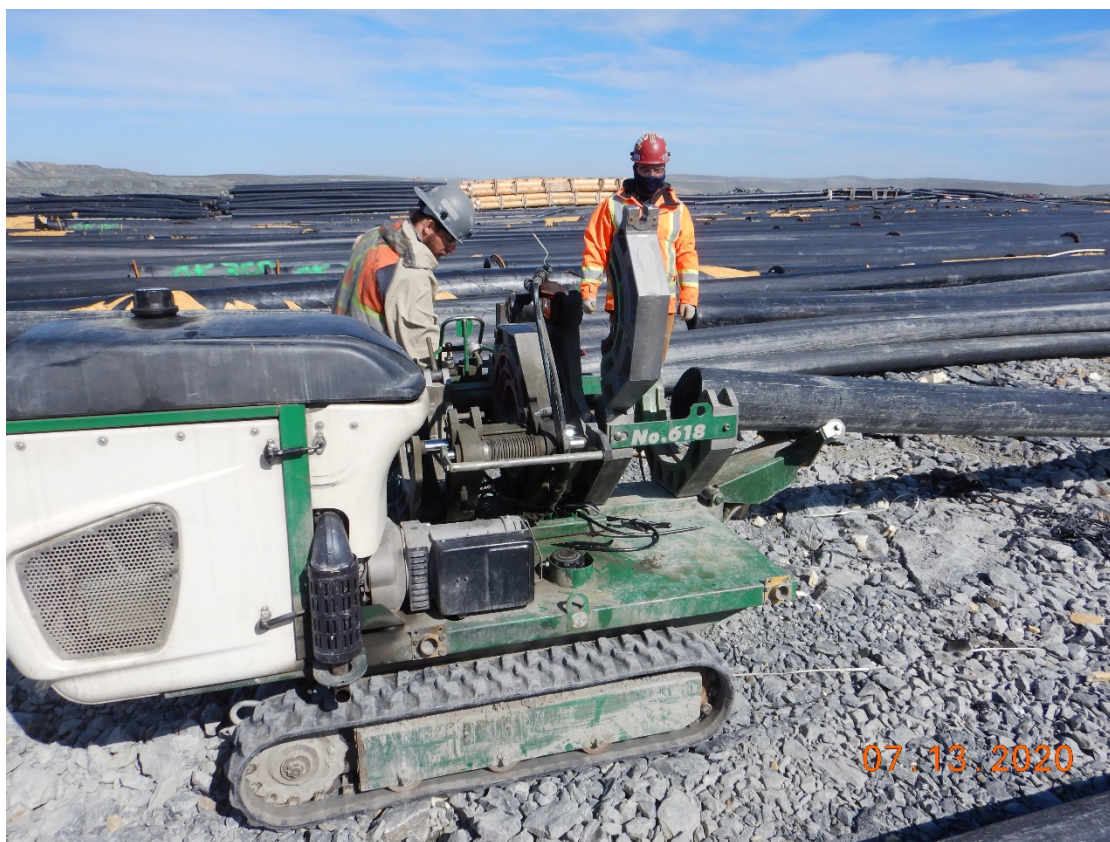
*Photo 1. Ongoing fusion on old 8" DR11 Pipe, Fusion Pad*

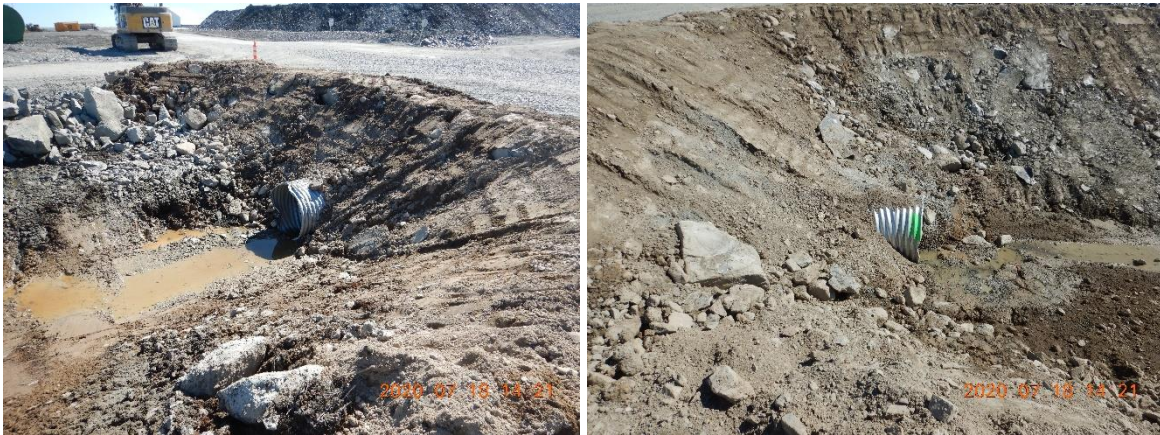
*Photo 1. Culvert crossing ring road by AP5*

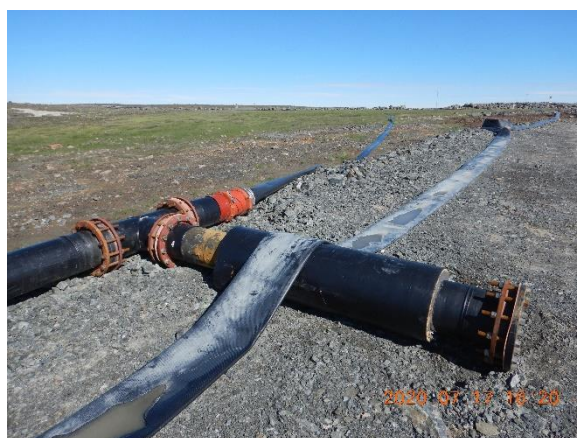
*Photo 5. 12" MineFlex Line 0214 (NE Dike – East Leg)*

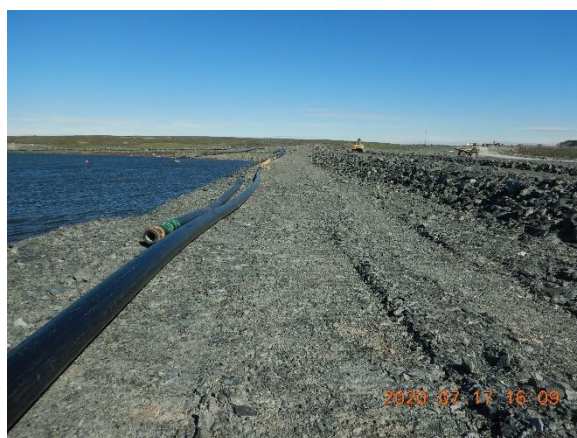
*Photo 6. 14" HDPE line 0214 (NE Dike – West Leg)*

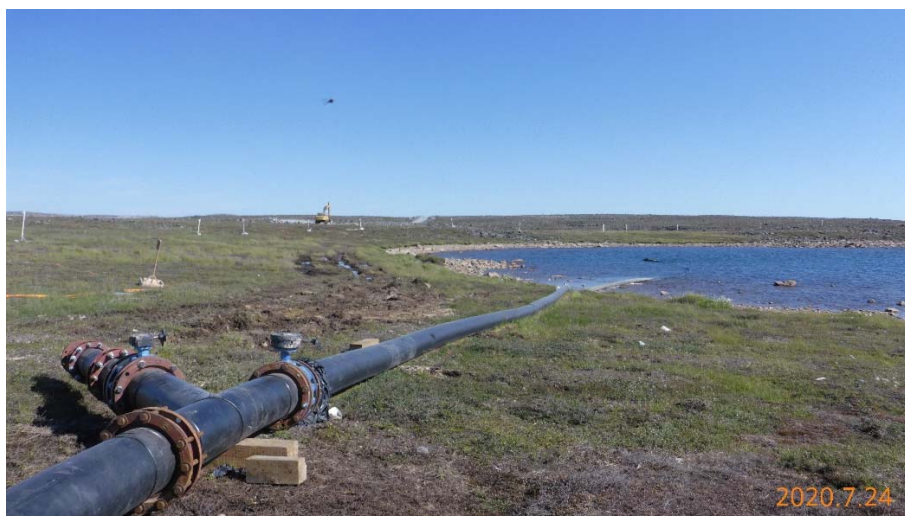
| Elements | Location | Scope and comments |
|---|---|---|
| Piping | Line #0211 | Installation of a Y on the suction. Will be remove. (Photo 1) |

*Photo 1. Y on the suction of the Line #0211*

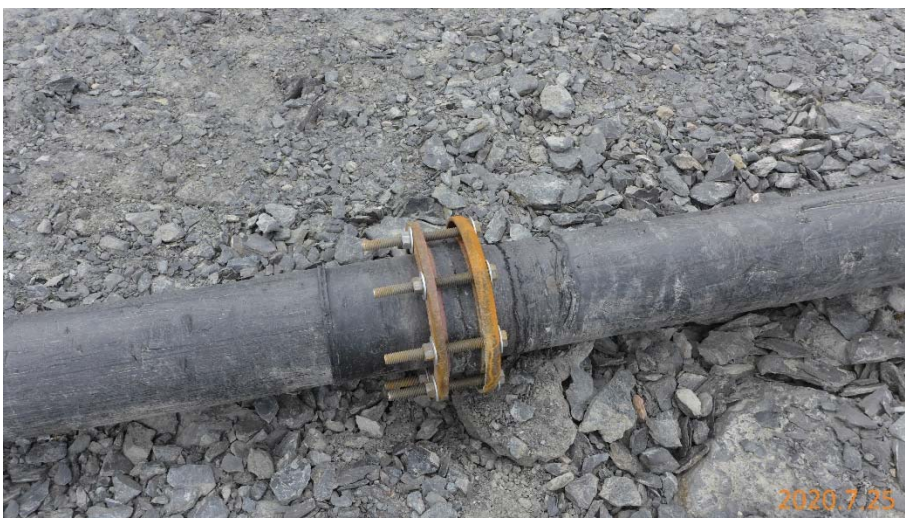
| Elements | Location | Scope and comments |
|---|---|---|
| Flange connection | Line #0217 | No gasket on flange assemblie (Photo 3) |

*Photo 3. Flange connection Line #0217*

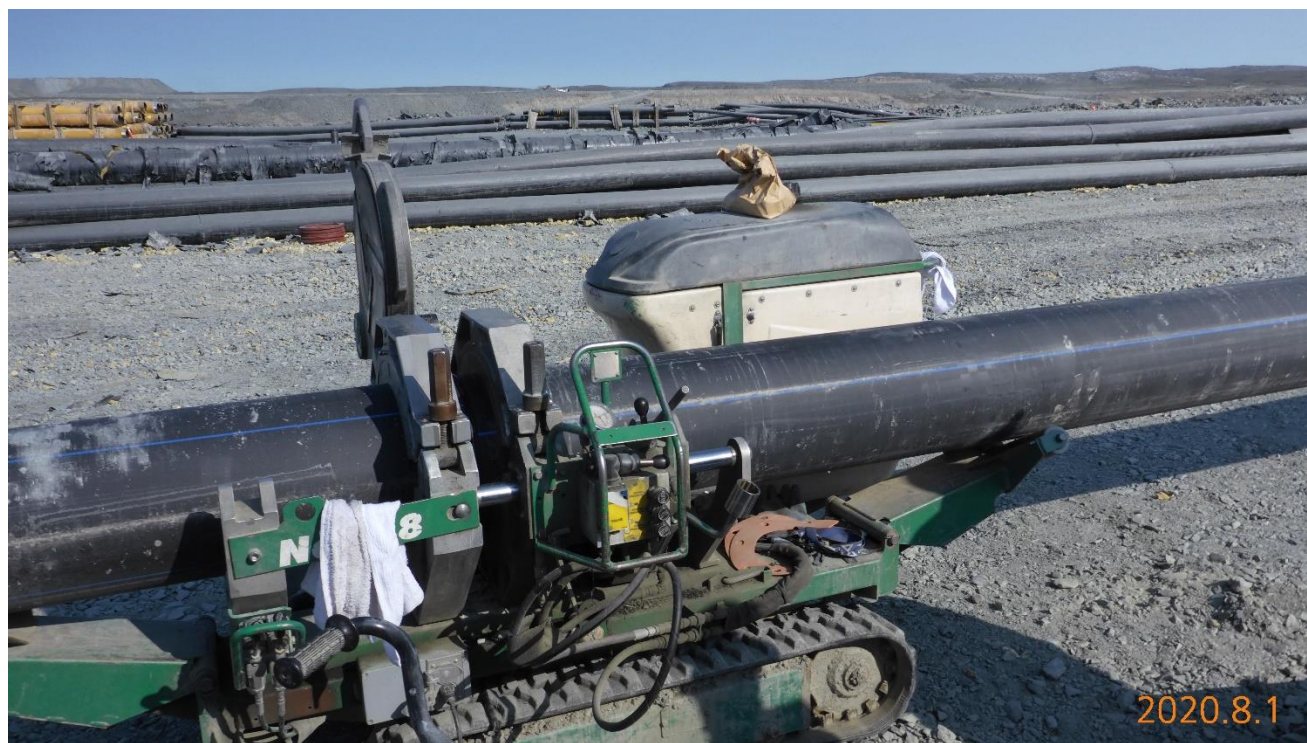
*Photo 1. Pipe fusion on 14" DR17 (Blue line)*

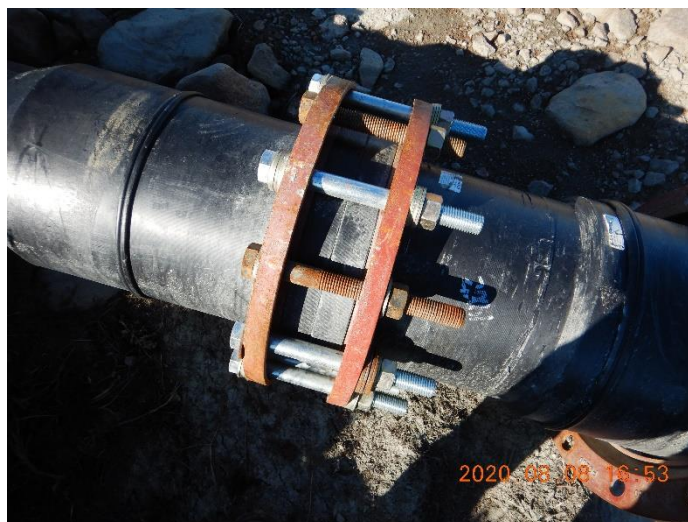
*Photo 3. Flange connection Line #0219*

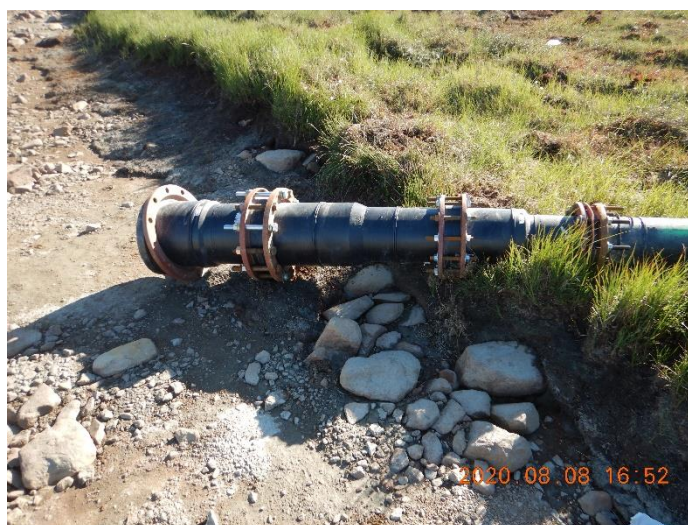
*Photo 4. Discharge end Line #0219*

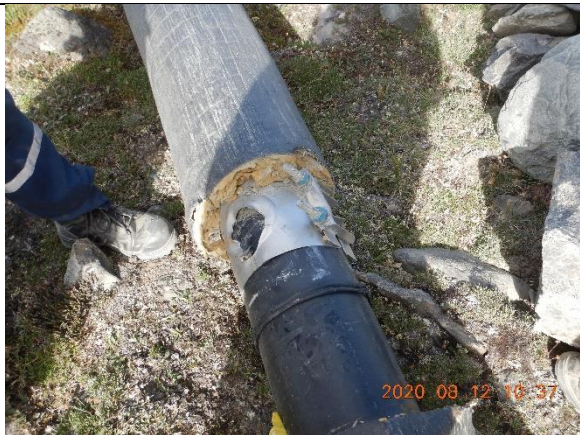
1.1 Holes underneath saddle for former paddlewheel

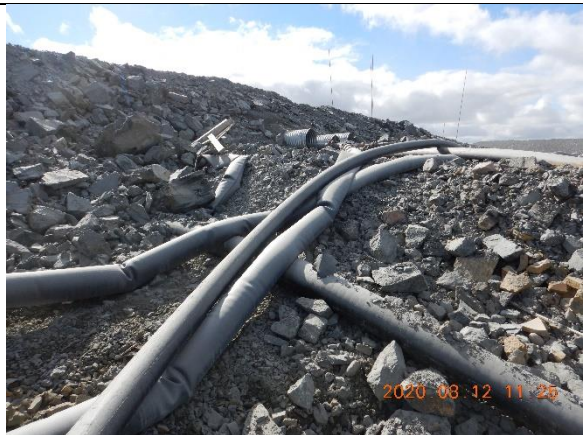
1.6 Mineflex upstream of ring road crossing – squeezed by 8" HDPE pipe

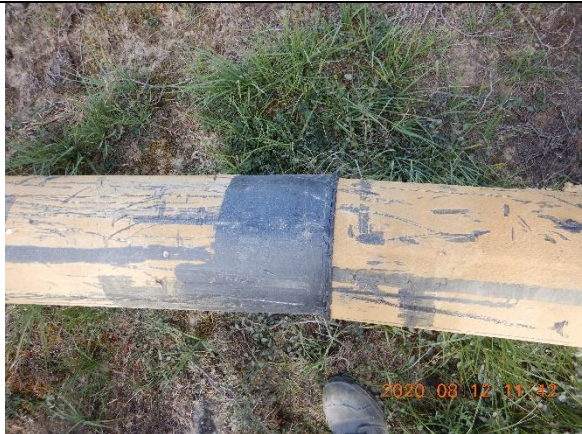
2.1 bad pipe alignment at fusion joint

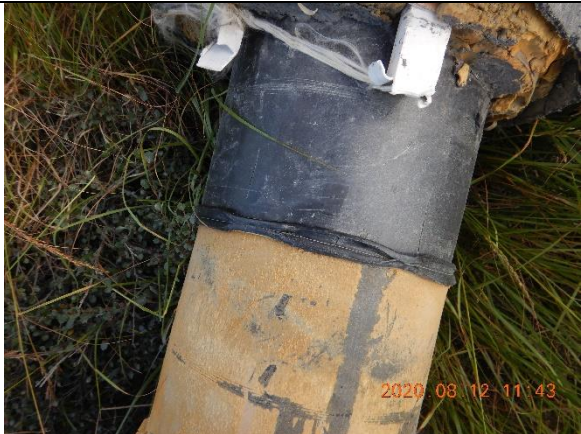
| Activities | Approximate location | Visual observation during field visit |
|---|---|---|
| Pipe walkdown | A53 to attenuation pond | <ul style="list-style-type: none"> <li>• Bad pipe alignment at fusion connection (line 210)</li> <li>• Pipe running on electrical cable (line 210)</li> <li>• Improper/insufficient bolting at valve connections (line 210 &amp; 211 tie-in)</li> </ul> |

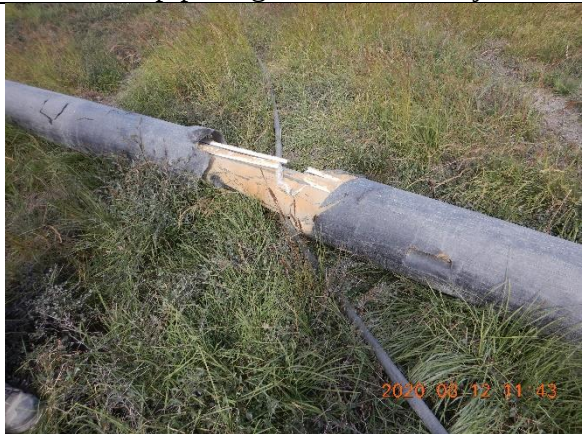
2.2 bad pipe alignment at fusion joint

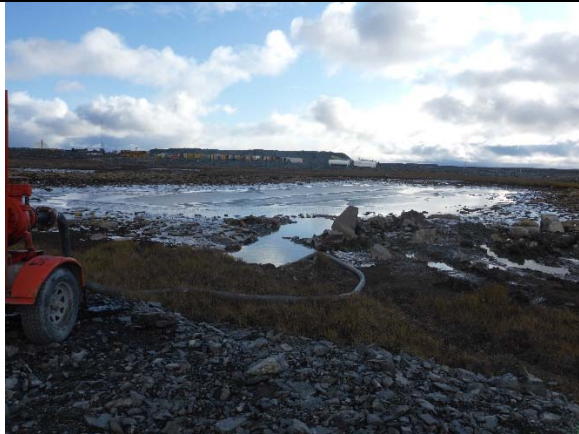
| Activities | Approximate location | Visual observation during field visit |
|---|---|---|
| Dewatering pipe inspection | Lake A-50 and A-51 | <ul style="list-style-type: none"> <li>• The dewatering of the lake A-50 and A-51 is ongoing.</li> <li>• Gaskets missing on multiple flanges.</li> <li>• The pipe used for the dewatering of lake A-50 is cracked and leaking.</li> <li>• The pipe used for the dewatering of lake A-51 is cracked and leaking.</li> <li>• Both pumps are activated and pumping the two lakes in lake A-53.</li> <li>• One flange is leaking on the pipe used for the dewatering of lake A-50</li> </ul> |

1.4 Flange leaking near lake A-50
