Construction Summary Report IVR Diversion Channel

Agnico Eagle Mines Ltd

6127-695-132-REP-012_R2

February 16, 2021

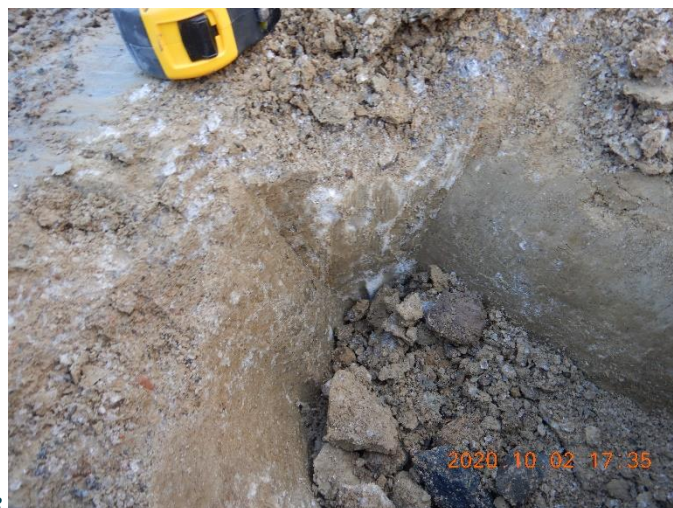
Photo 5. Ice lenses (A), ice pockets and ice rich material (B) observed between 0+230 and 0+240. All this material has been removed.
