**SNC-LAVALIN**

**SITE REPORT**  
(Detailed)

20180813-DS-SR

Visit date 13/08/2018	Time (Start/End) 6AM-6PM	Project No. 658309	Prepared by A. Arbuzov
Project WTD construction		Client Agnico Eagle	
Consultant SNC-Lavalin		Contractor KCG

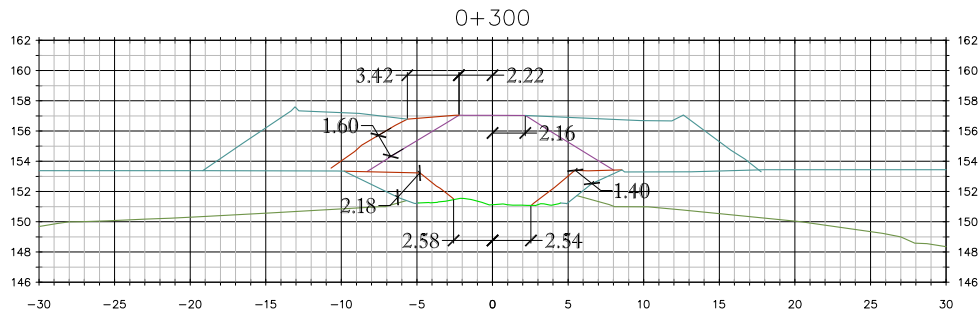
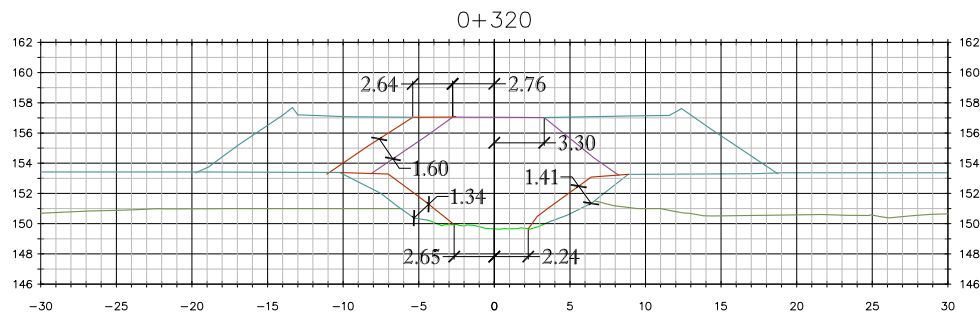
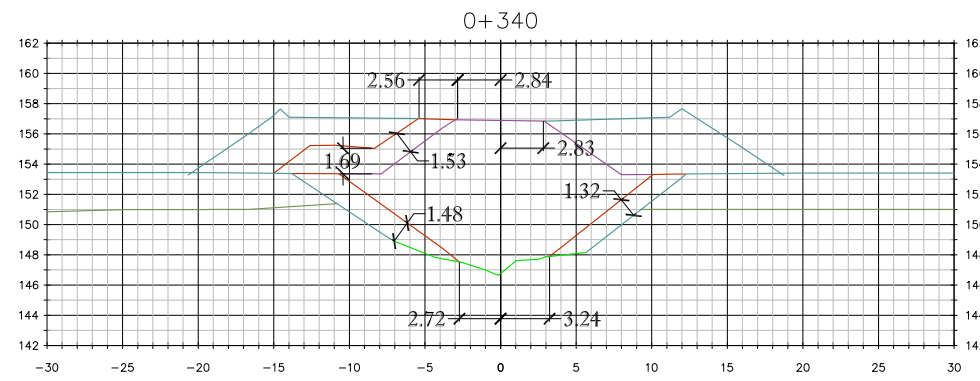
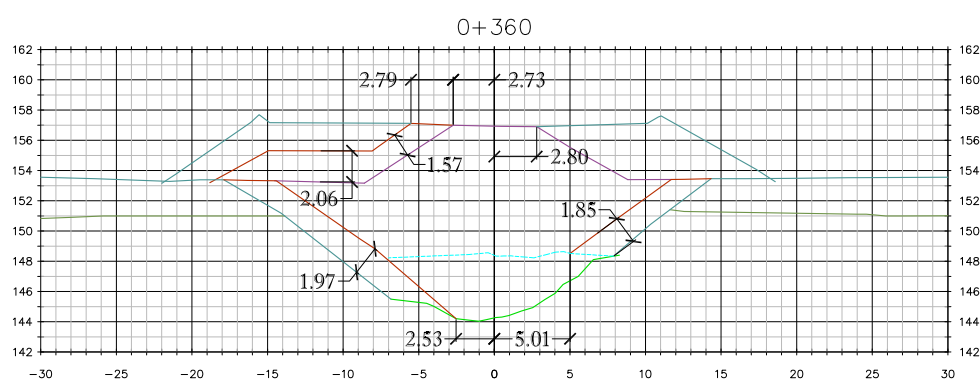
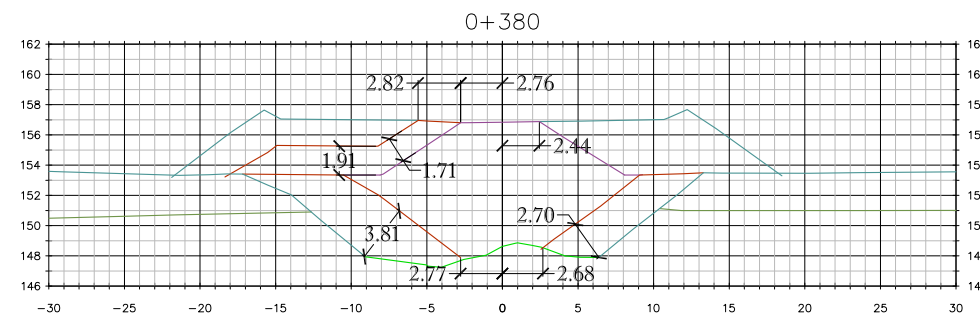
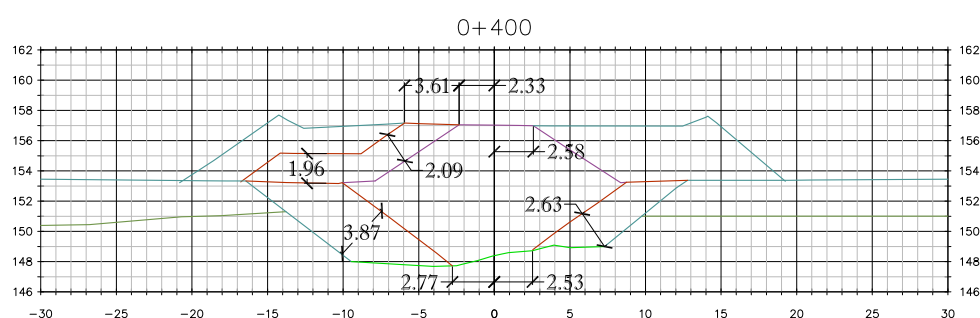
AS-BUILT 0+300 to 0+420  
WHALE TAIL DIKE CONSTRUCTION  
CONTRACT # 11-811

→ It was discussed with the client and contractor that between st. 0+330 to 0+410, the coarse filter downstream (between st. 153.5 to 157.0m) was missing some rock fill due to the deep zone of bedrock encountered (see sketch). A minimum length of 2.0m was stated by the designer in order to protect the coarse filter between these stations.

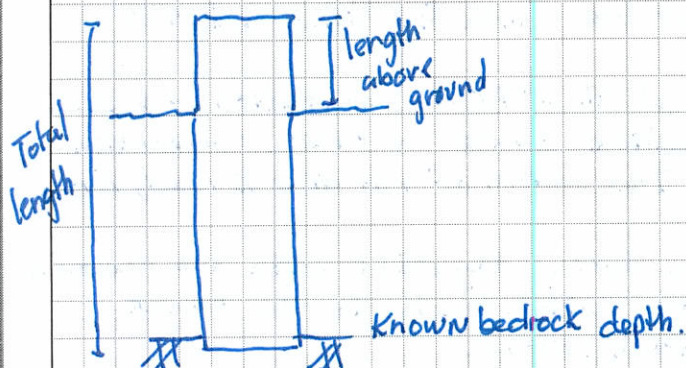
<u>Secant Pile</u>	<u>station</u>	<u>Implemented depth.</u>
0049	0+127.15	5.511m
0053	0+130.35	5.626m
0057	0+133.55	5.983m
0061	0+136.75	5.746m
0065	0+139.95	5.897m
