SITE REPORT (Detailed)

20180909-DS-SR

WTD Construction Agnico Eagle

Project Client

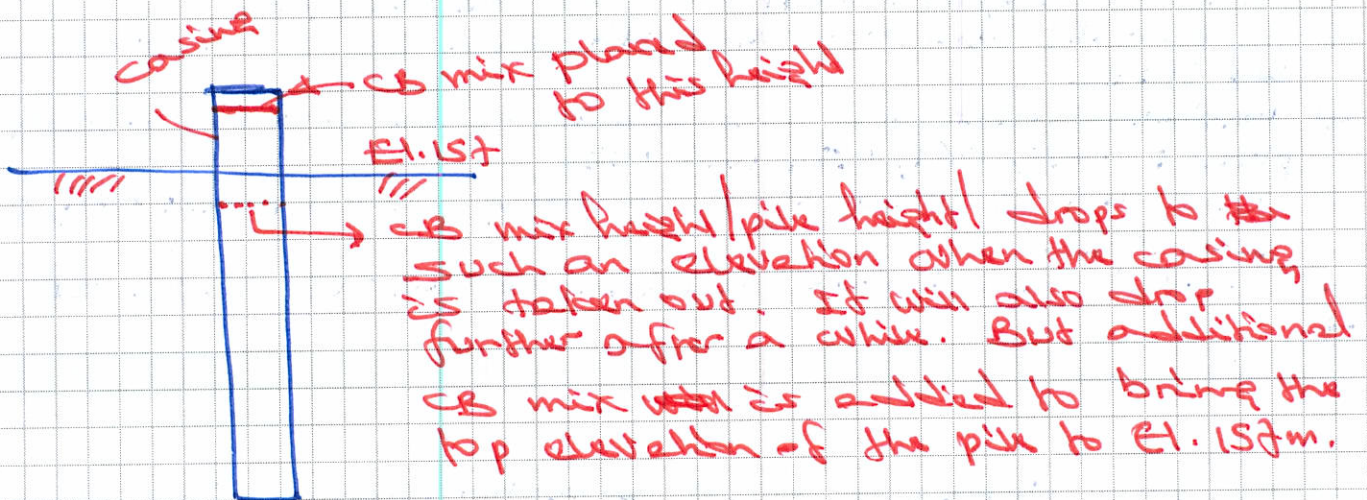
No Subject Given to
→ The pile dropped in height after placement (as shown in Figure 1) but was later on filled to full design elevation. But the monitoring should continue as there could be further drop in height/elevation of top of pile fill. This situation is illustrated in the sketch at the back of the in the next page

Figure 1 - Drop in Pile Height After Placement in Primary Pile 065: The pile was filled to the full elevation later on
