WHALE TAIL PROJECT

Monitoring Program Summary Report

December 2019

Type A Water License 2AM-WTP1826

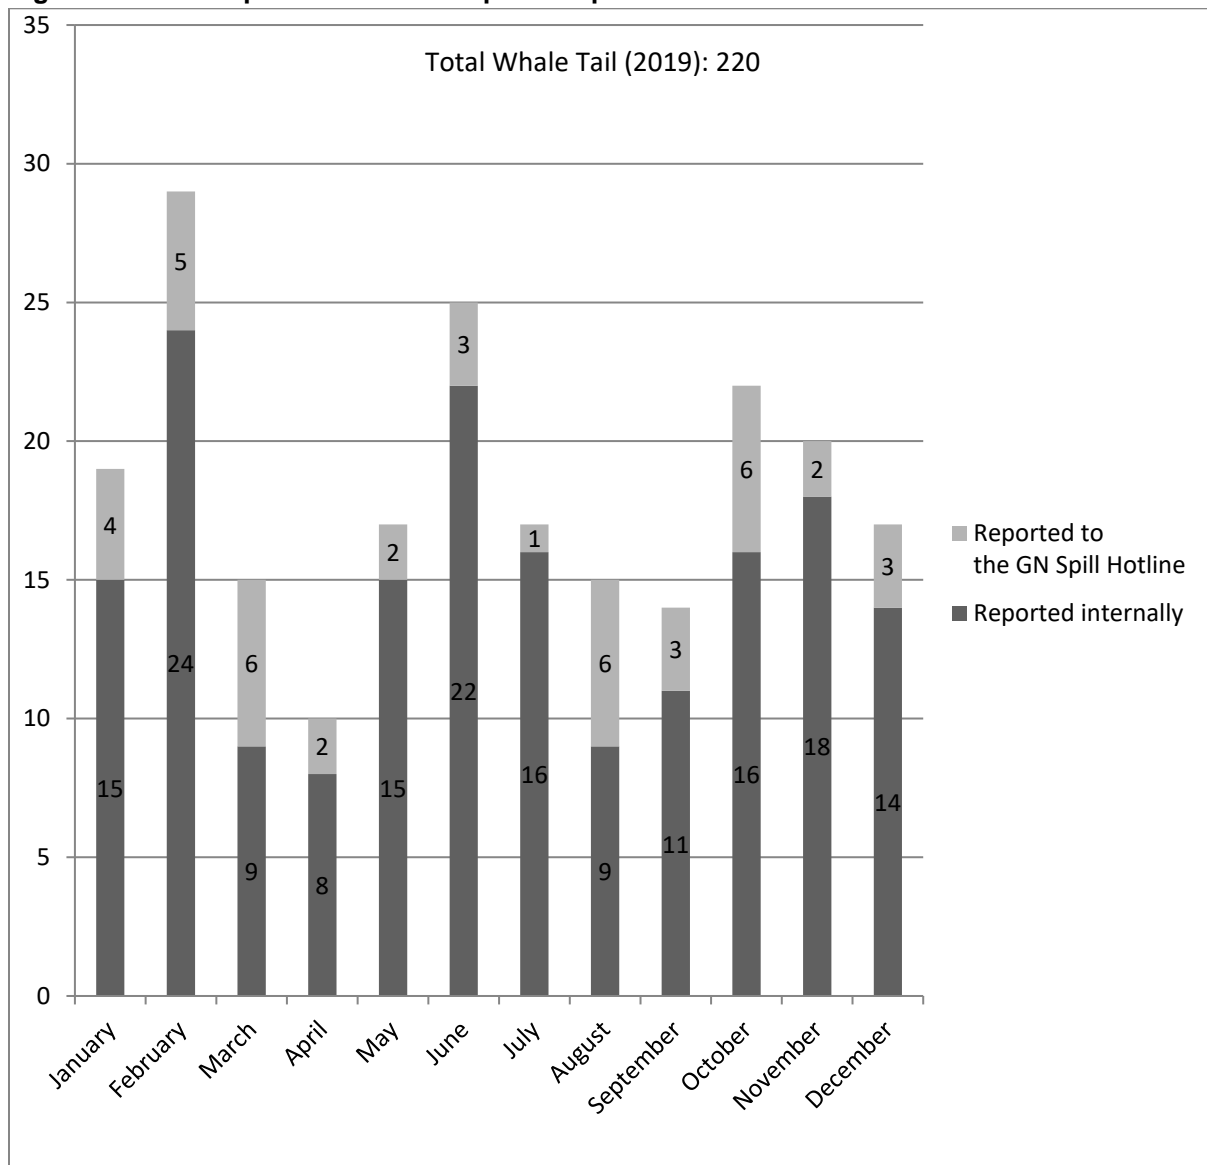
Figure 3.1 2019 Reported and Non-Reported Spills

Figure 3.1 shows reported and non-reported spills for 2019 broken down per month and Table 3.1 summarizes Agnico Eagle spill reports for December.

All spills reported internally (14) were managed appropriately on site according to Agnico's spill contingency plan. Three (3) spills were reported to regulators in December. Spills were contained and cleaned, contaminated material was disposed to the appropriate area, and the clean-up actions were monitored closely by the Environment Department. There was no off site impact to any watercourses.

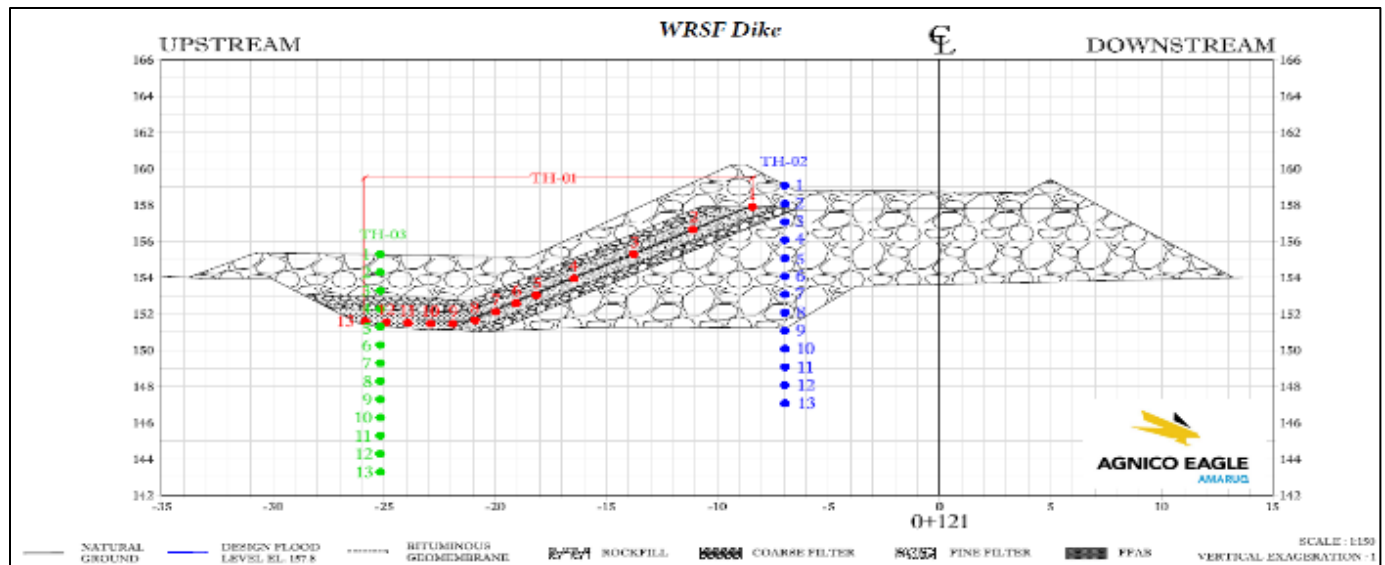
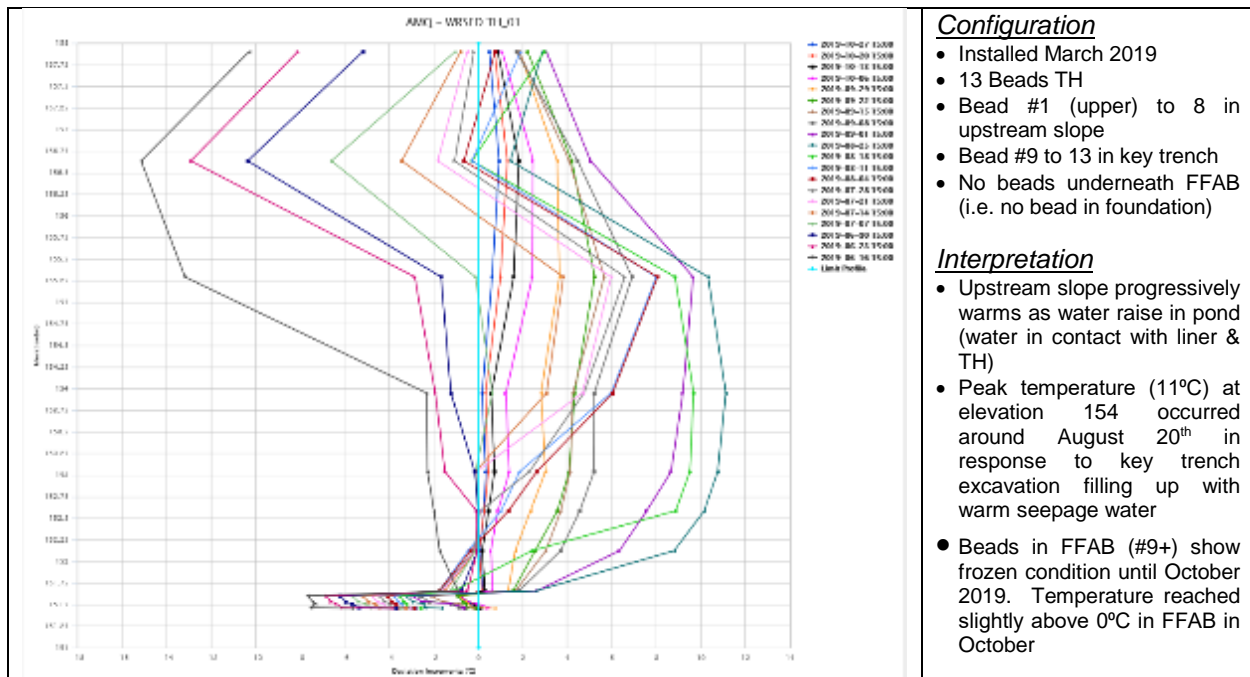
Figure 4: WRSF Thermistor locations

Installation of additional thermal monitoring instrumentation was completed in October 2019 in response to the seepage event. In addition to the existing 3 thermistors (TH-01, TH-02, TH-03), 4 new vertical instruments were installed (TH-04, TH-05, TH-06, TH-07). Locations are detailed in Figures 4 and 5 below. Figures 6 to 12 show collected data for the thermistors along with a short explanation of each instrument configuration and an interpretation of each thermistor data set. All data are logged into an existing data collection system.
