Meadowbank and Whale Tail 2024 Annual Geotechnical Inspection

2024 Annual Geotechnical Inspection

Meadowbank Complex, NU

Reference No. CA0038946.6657-1630-R-Rev0

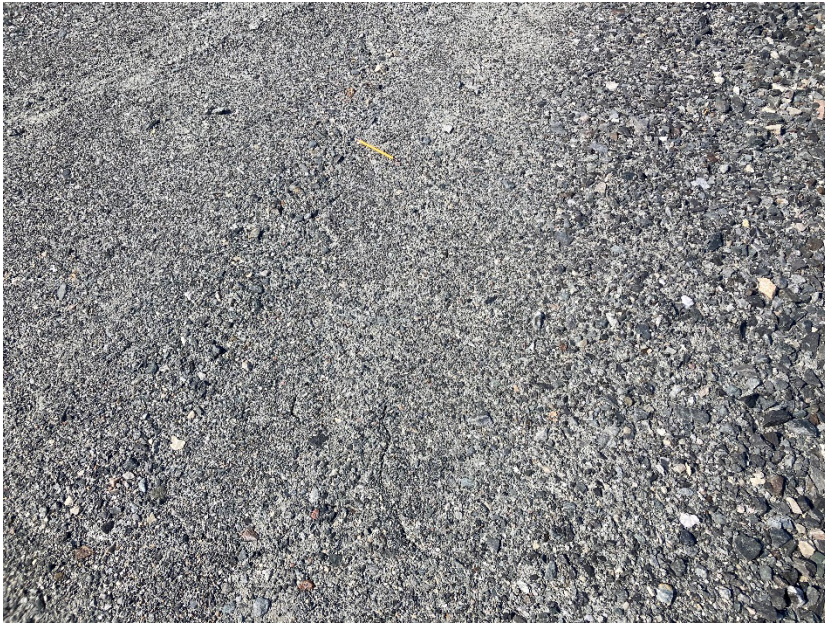
Photograph A1-07 East Dike

Description: From approximately Sta. 60+650, looking north at the upstream slope. Small cracks in crest surface, likely surface desiccation.

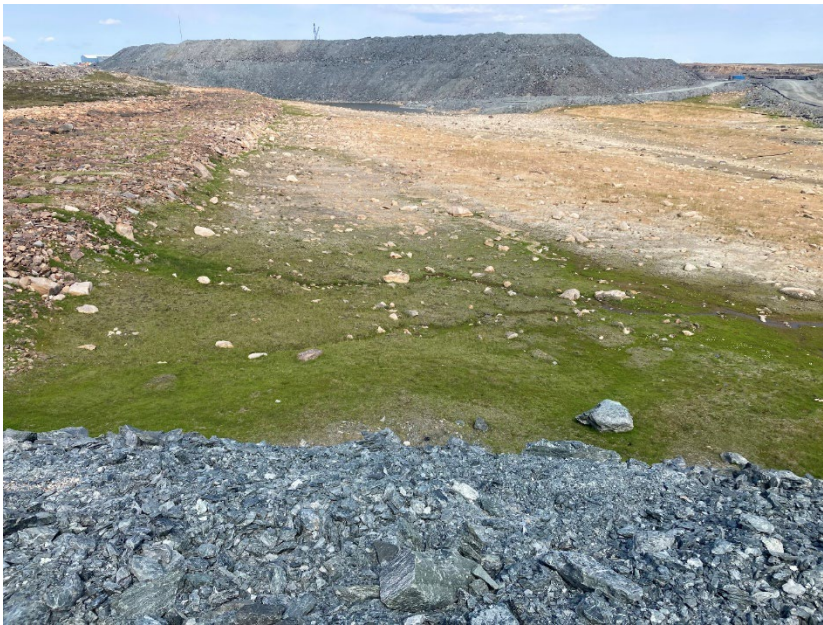
Photograph A3-04 Bay Goose Dike

Description: From approximately Sta. 32+030 looking southeast at the Channel 1, downstream toe.

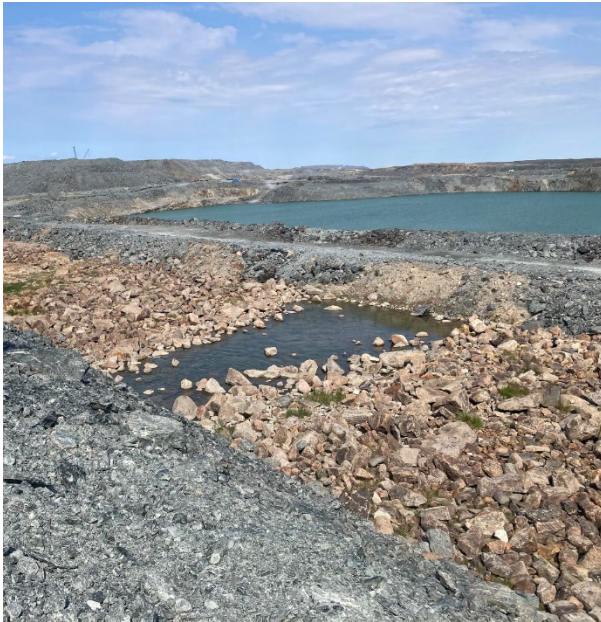
Photograph A3-09 Bay Goose Dike

INSPECTION ITEM	OBSERVATIONS DATA	PHOTO	COMMENTS & OTHER DATA
	North Channel		Monitored by stations 8 (30+420). Water flowing was observed during the inspection.
	Central Shallow		Presence of 2 seepage channels at 30+650 and 30+625. Flow was observed during inspection at 30+655. Monitored by station 7.
	Central Channel		Presence of a seepage channel at Sta. 31+165. Water ponding was observed at the time of the inspection. It was pumped once after freshet only.
	Channel 3		Light flow observed during inspection at Sta 31+500 m. Monitored by station 6.
	Channel 1		This seepage channel was not flowing at the time of the inspection.
	Water Ponds		Presence of water pond with no sign of seepage. Located at 31+750. between Channels 1 and 2.

Description: From the crest at approximately Sta. 31+740, looking north at downstream slope and toe, note the water pond at Sta. 31+750.

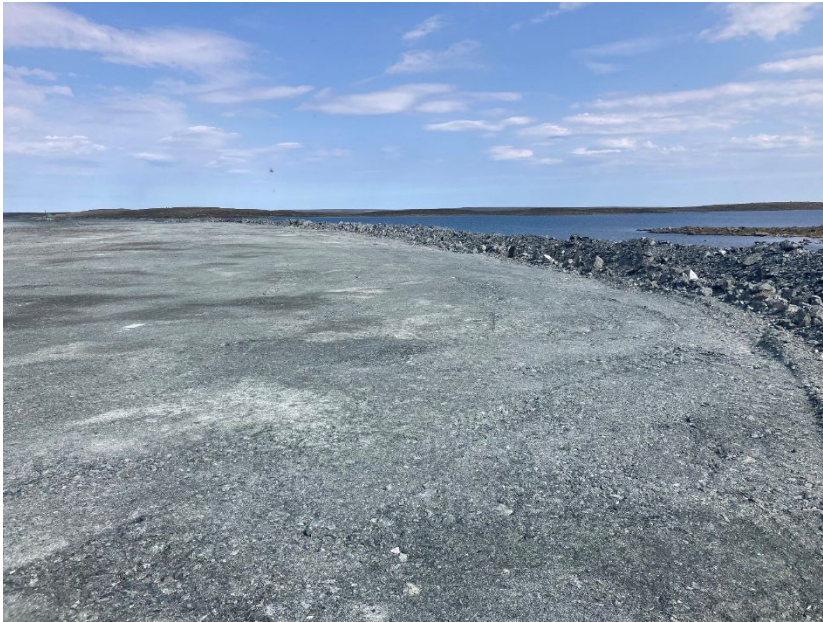
Photograph A3-19 Bay Goose Dike

INSPECTION ITEM	OBSERVATIONS DATA	PHOTO	COMMENTS & OTHER DATA
1.5 Unexpected settlement	Yes		Tension cracks observed in 2013 and 2014 on the upstream side within the thermal cap (between approximately Sta. 32+100 and 31+750) were no longer visible during the 2024 inspection after the crest of the dike was resurfaced in 2023. Around Sta. 31+430, old cracks and depression (3 m long, 5 mm wide) are still detectable but less visible after the resurfacing.

Description: From approximately Sta. 31+430 looking northeast at the crest. Old cracks and depression (3 m long, 5 mm wide). The cracks are less pronounced after crest resurfacing.

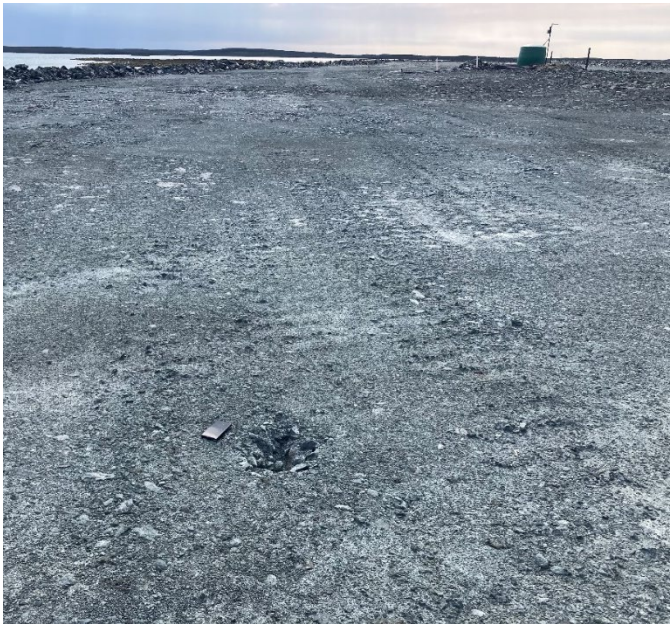
Photograph A3-26 Bay Goose Dike

1.6 Lateral movement	Not apparent		
1.7 Other unusual conditions	Yes		Two depressions in crest (~150 mm) near to Sta. 31+150.
2. UPSTREAM SLOPE		178, 179, 184, 185, 188, 189, 190, 194, 195, 196, 197, 198, 203, 204, 205, 206, 208, 209, 212, 213

Description: From approximately Sta. 31+130, looking southwest at the crest. Two depressions are observed in crest (~150 mm).

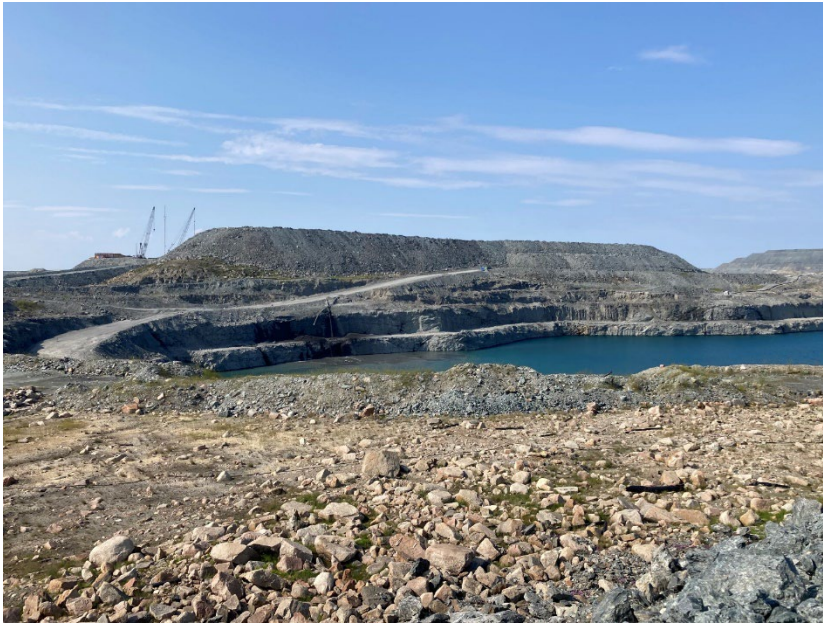
Photograph A3-33 Bay Goose Dike

Description: From approximately Sta. 30+340, looking northwest at the north seepage channel.

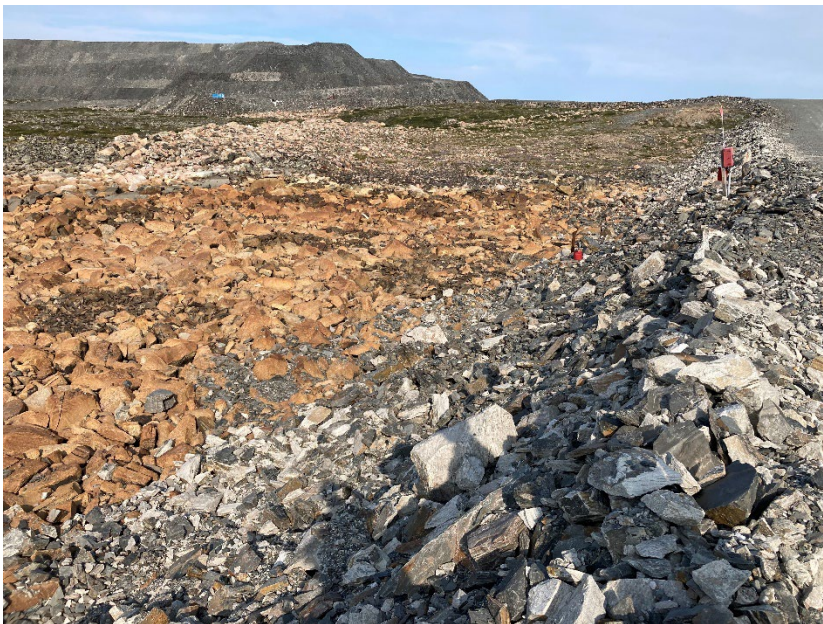
Photo Number: 147

Description: From the west abutment, looking southeast at the crest.
Presence of a surficial depressions in the crest (diameter around 250 mm).

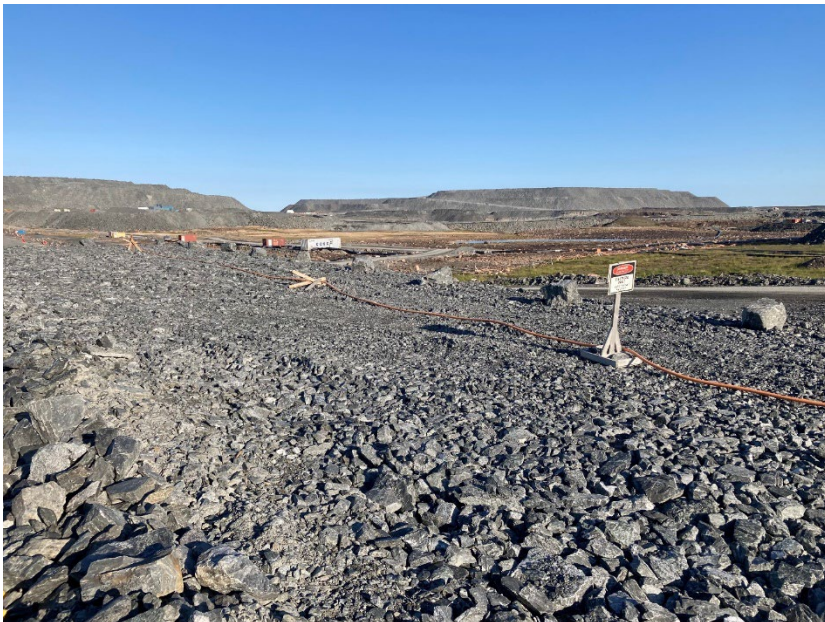
Photo Number: 111

Description: From approx. Sta. 0+775 downstream, looking west at the downstream rockfill buttress.

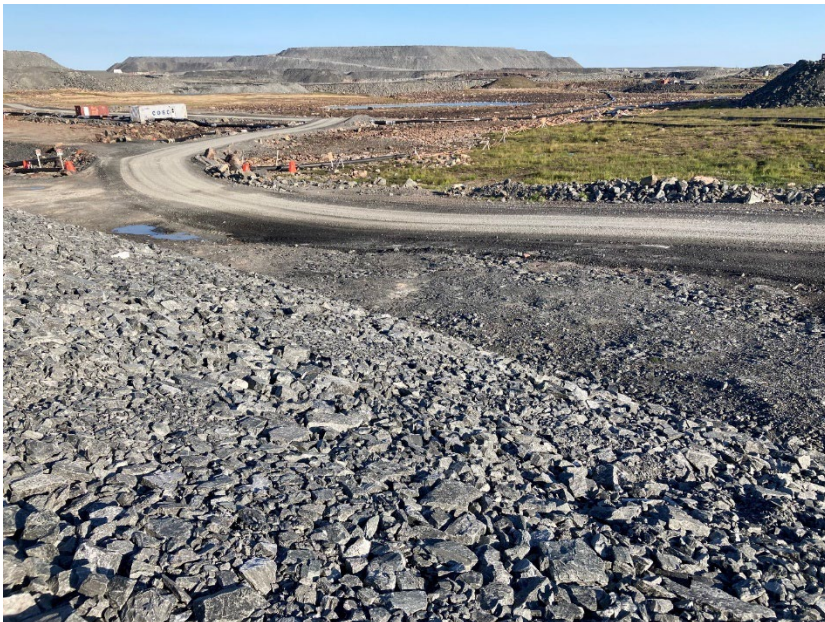
Photo Number: 113

INSPECTION ITEM	OBSERVATIONS DATA	PHOTO	COMMENTS & OTHER DATA
1.4 Surface cracking	Yes	109, 112	Associated to foundation thawing. Cracks parallel to center line (20 mm wide) depressions (500-700 mm) with some perpendicular to center line. Seem inactive and less visible than 2023. Circular cracks in crest at Sta. 0+725 and 0+775 (1-3 m long, 5-10 mm wide)

Description: From approx. Sta. 0+725 downstream, looking northwest at the downstream side of the crest where tension cracks are visible.

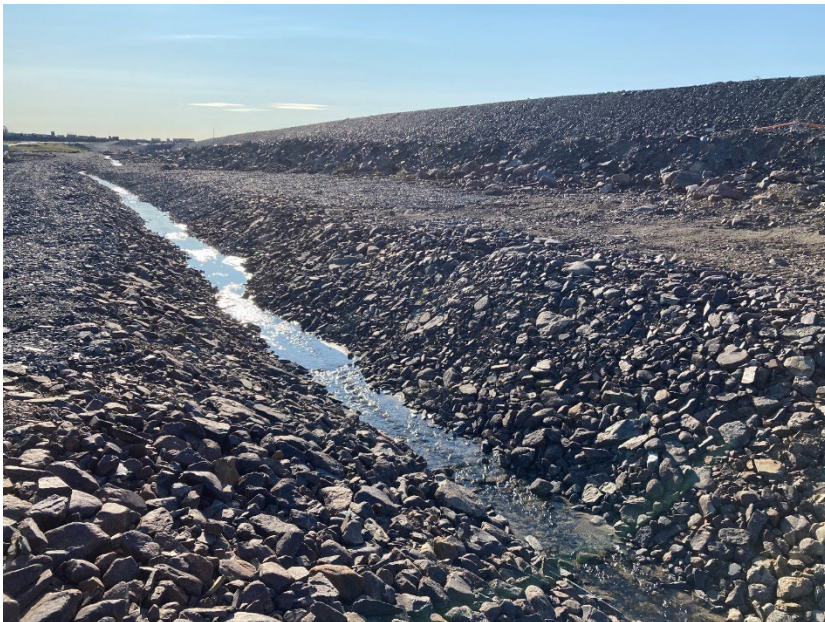
Photo Number: 121

Description: From approx. Sta. 0+250 downstream (P4 pumping station), looking southwest. A large amount of water is ponding.

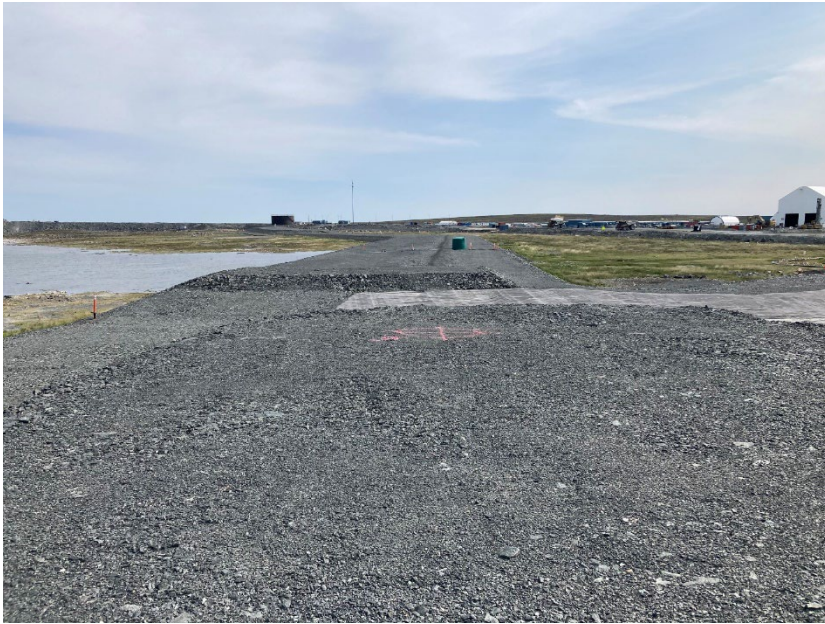
Photo Number: 59

1.5 Unexpected settlement	Yes	59	Likely related to rockfill, esker and shallow foundation thawing after winter construction. Settlement of about 300 to 500 mm (2023). A large area of the dike between Sta. 0+100 and 0+340 show settlement (up to about 300 mm), roughly in the footprint of the former water channel.

Description: From approx. Sta. 0+030 (west abutment), looking southeast at the crest. Presence of settlement in the rockfill surface.

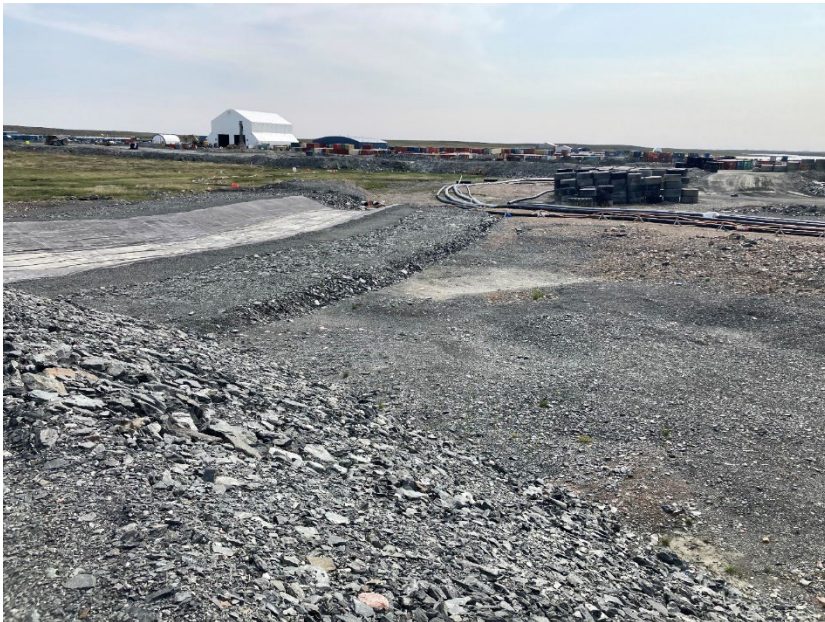
Photo Number: 60

INSPECTION ITEM	OBSERVATIONS DATA	PHOTO	COMMENTS & OTHER DATA
7.6 Presence of debris or blockage	Yes, piping in the lower spillway		
7.7 Closure mechanism operational	None		
7.8 Slope protection	None		
7.9 Instability of side slopes	None		
7.10 Other unusual conditions	Yes		Section of spillway on upstream side appears shallow.
8. INSTRUMENTATION			
8.1 Piezometers	No		
8.2 Settlement cells	No		
8.3 Thermistors	Yes		See Section 4.3.2 of the report.
8.4 Settlement monuments	No		
8.5 Seismograph	No		
8.6 Inclinator	No		
8.7 Weirs and flow monitors	No		
8.8 Data logger(s)	Yes		
8.9 Other	No		
9. DOCUMENTATION			
9.1 Operation, Maintenance and Surveillance (OMS) Plan			
9.1.1 OMS Plan exists	Yes		
9.1.2 OMS Plan reflects current dam conditions	Yes		
9.1.3 Date of last revision	January 2024

Description: From approx. Sta. 0+050, looking south at the spillway. Presence of piping at the outlet of the spillway.

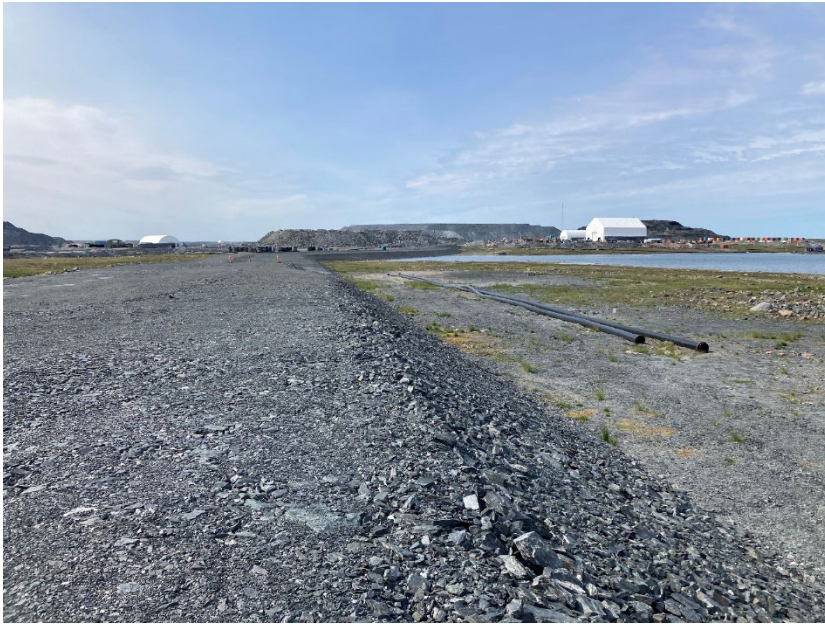
Photo Number: 68

Description: From approx. Sta. 0+420 (east abutment), looking west at the crest (thermal cap) and upstream slope. Presence of tension cracks (50 to 100 mm wide, seems inactive) approximately 2 m from the crest.

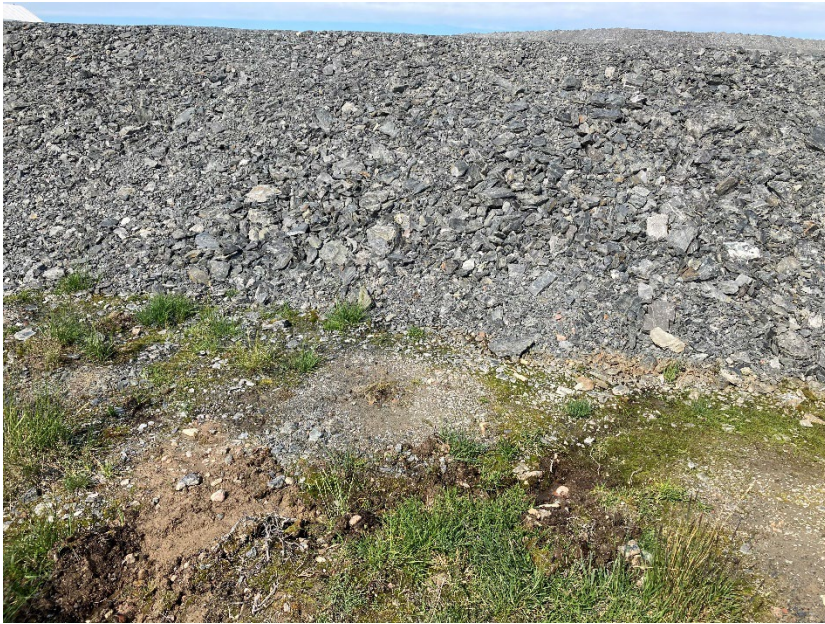
Photo Number: 72

Description: From approx. Sta. 0+350, looking east at the crest and downstream slope. Presence of tension cracks (5-6 m long, inactive).

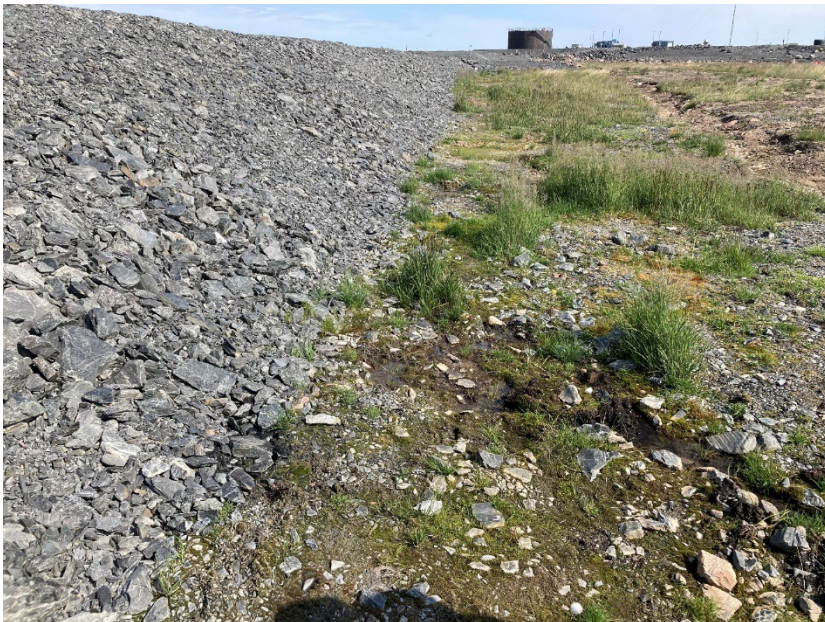
Photo Number: 73

Description: From approx. Sta. 0+320, looking north at the crest and upstream slope. Traces of flow. Presence of two zones of seepage at toe likely related to runoff exiting the rockfill.

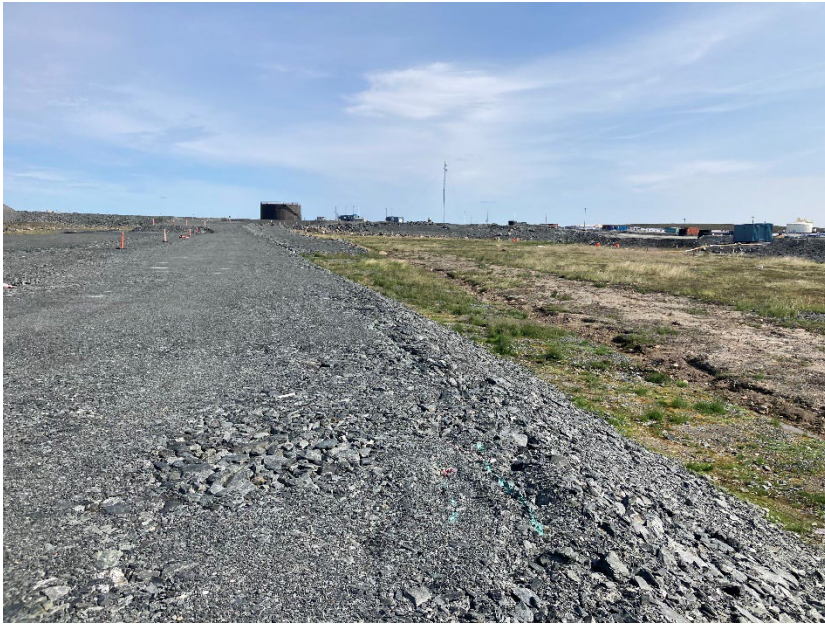
Photo Number: 74

Description: From approx. Sta. 0+300, looking east at the crest and downstream slope. Traces of flow. Presence of two zones of seepage at toe likely related to runoff exiting the rockfill.

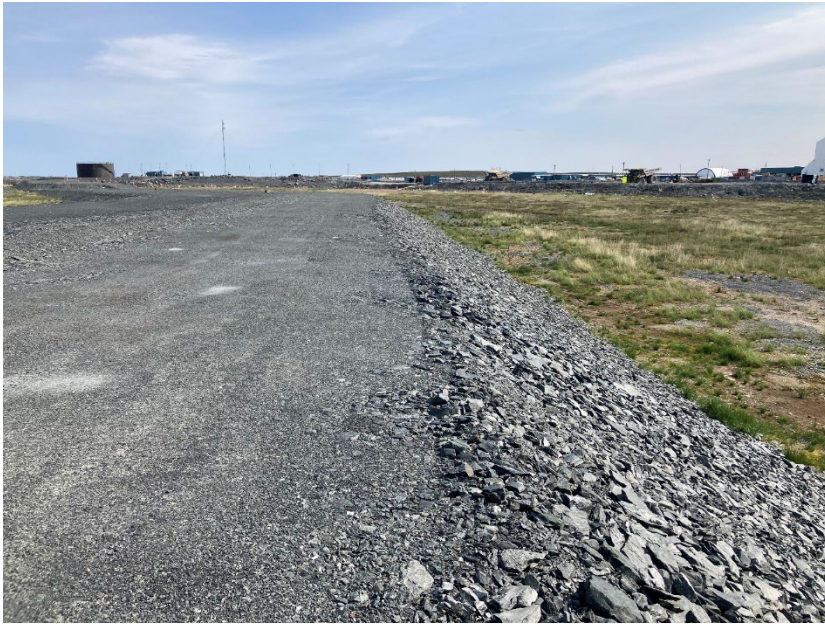
Photo Number: 75b

Description: From approx. Sta. 0+300, looking northwest at the crest and downstream slope. Presence of tension cracks (up to 30mm wide) approximately 1m from the crest edge.

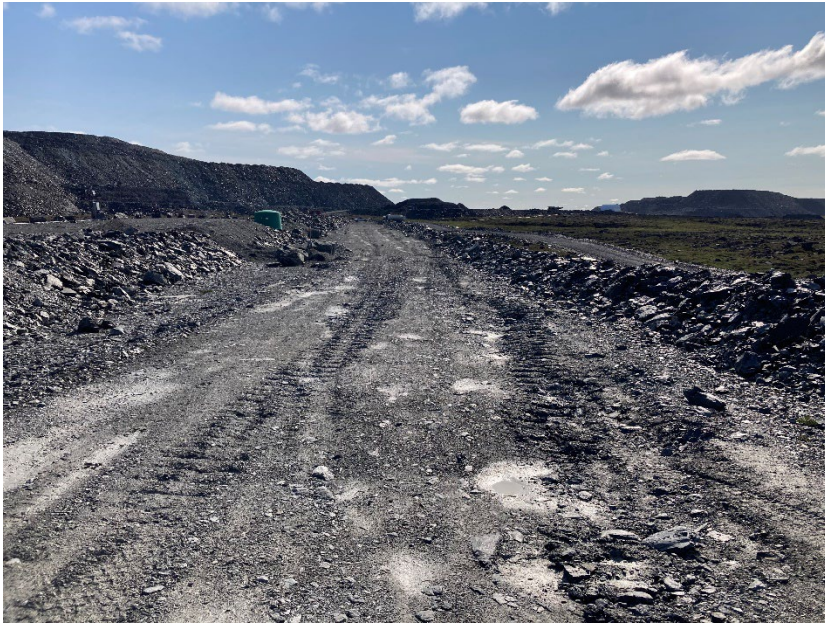
Photo Number: 41

INSPECTION ITEM	OBSERVATIONS DATA	PHOTO	COMMENTS & OTHER DATA
1.7 Other unusual conditions	Yes	41	Depression (300 mm deep) at upstream thermal berm crest.

Description: From approx. Sta. 0+080 (west abutment), looking east at the upstream thermal berm crest. Presence of depressions (approx. 300mm), likely from a drill rig or equipment.

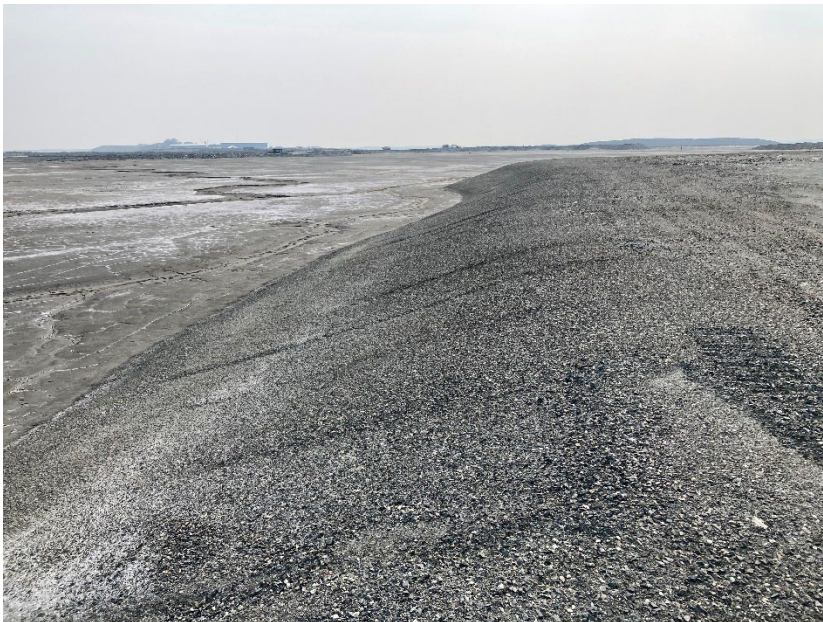
Photo Number: 312

Description: From the North Cell Internal Structure, looking north toward the diversion ditch. Small tension cracks in ditch slope.

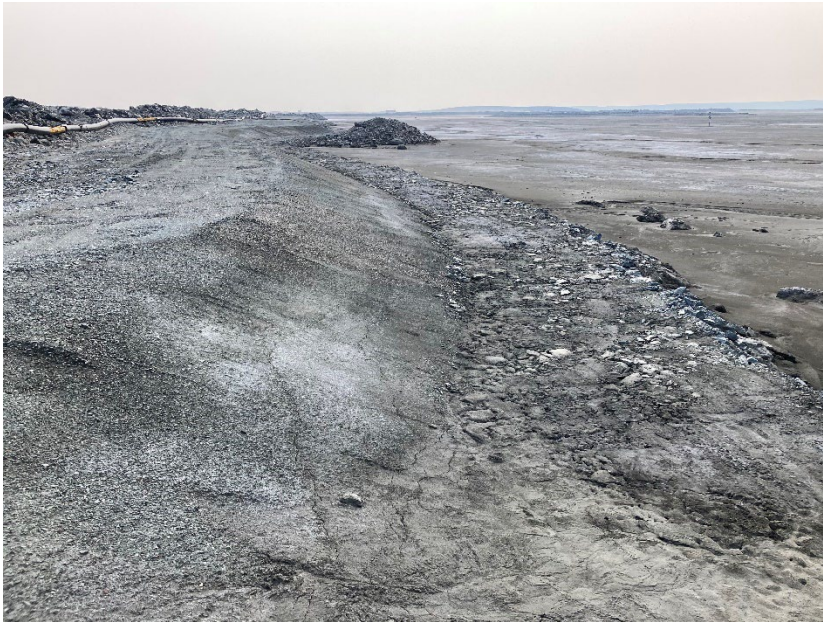
Photo Number: 321

Description: From the North Cell Internal Structure, looking south at the upstream slope. Presence of tension crack on upstream slope (approx. 10-20 mm wide), water channeling at the toe.

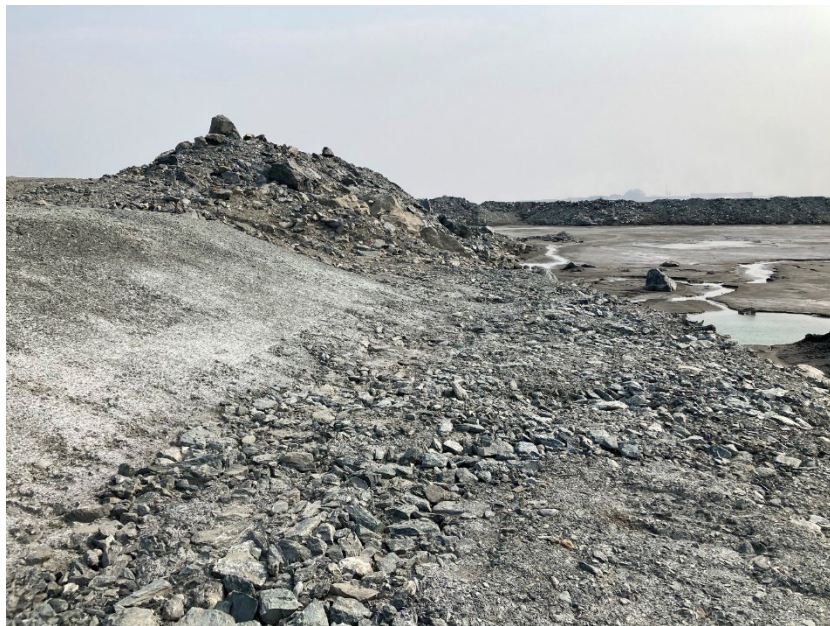
Photo Number: 323

Description: From the North Cell Internal Structure, looking northeast at the upstream slope and water channelling at the toe.

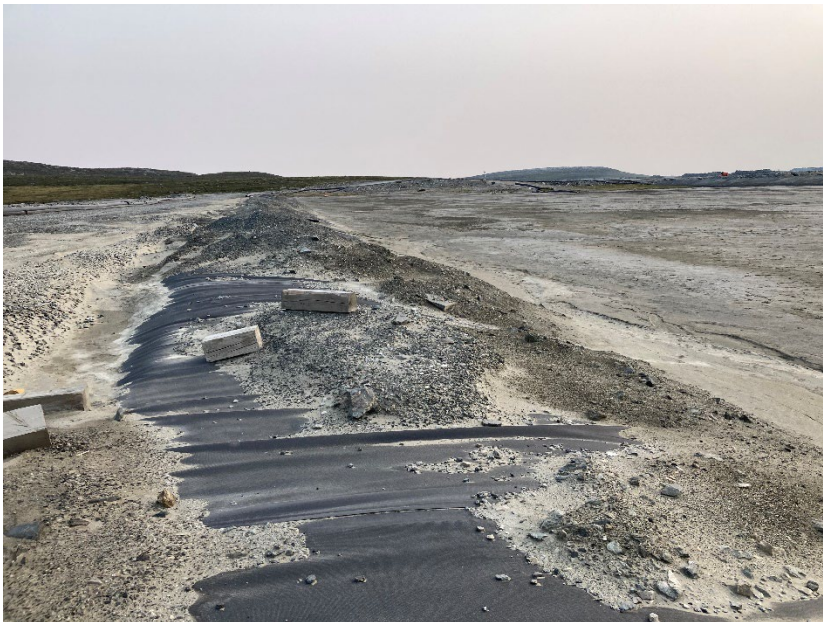
Photograph B2-04 Saddle Dam 1

Description: From approximately Sta. 0+195 upstream, looking north at the upstream slope. Adequate tailings beach against SD1.

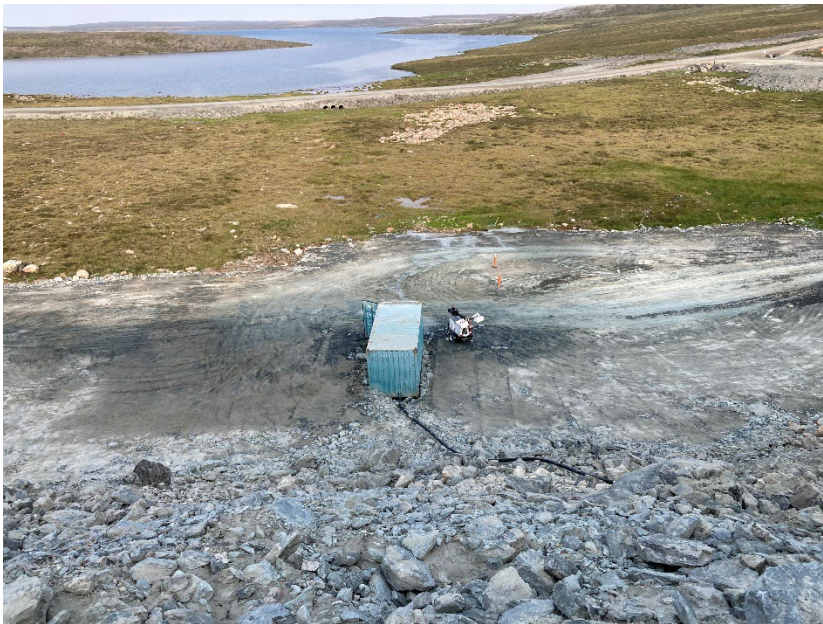
Photograph B2-09 Saddle Dam 1

Description: From Sta. 0+150 looking west at the downstream face. Notice the sea-can container where a sump is installed. Presence of water flowing out of sump on rockfill platform.

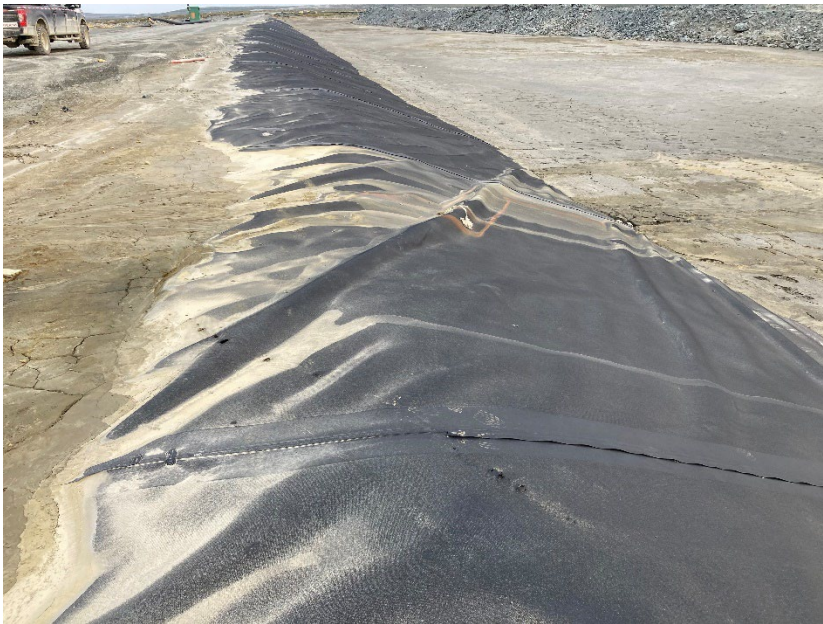
Photograph B3-01 Saddle Dam 2

INSPECTION ITEM	OBSERVATIONS DATA	PHOTO	COMMENTS & OTHER DATA
2.3 Signs of movement (deformation)	None observed		
2.4 Cracks	None observed		
2.5 Face liner condition (if applicable)	Good	245, 247	Drag marks and small holes in liner (top of slope and crest) at approx. Sta. 20+370 and 20+520

Description: From Saddle Dam 2 (approximately Sta. 20+520) upstream, looking northwest at the upstream slope of Saddle Dam 2. Presence of drag marks and holes on the liner.

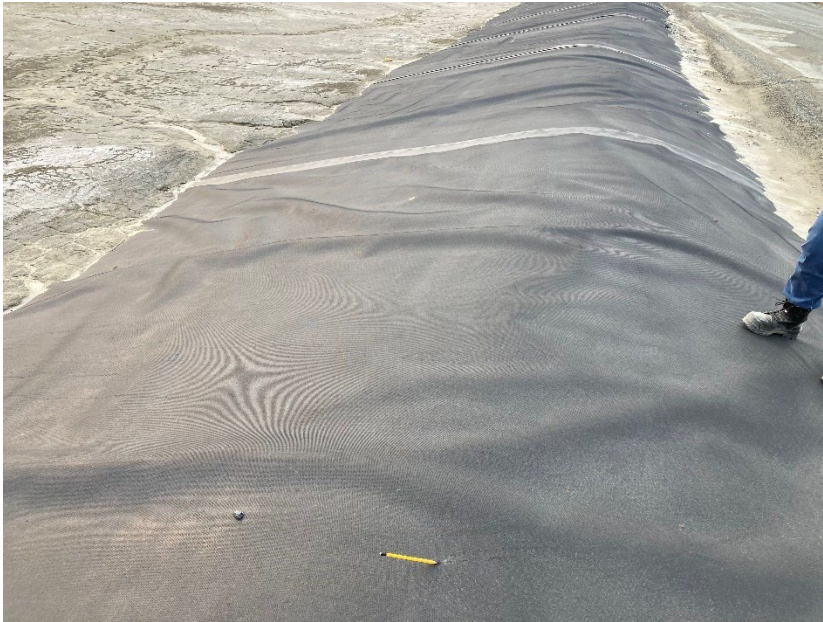
Photograph B3-03 Saddle Dam 2

Description: From approximately Sta. 20+370 looking southeast at the crest and the downstream slope. Small holes on the top of slope and crest are observed.

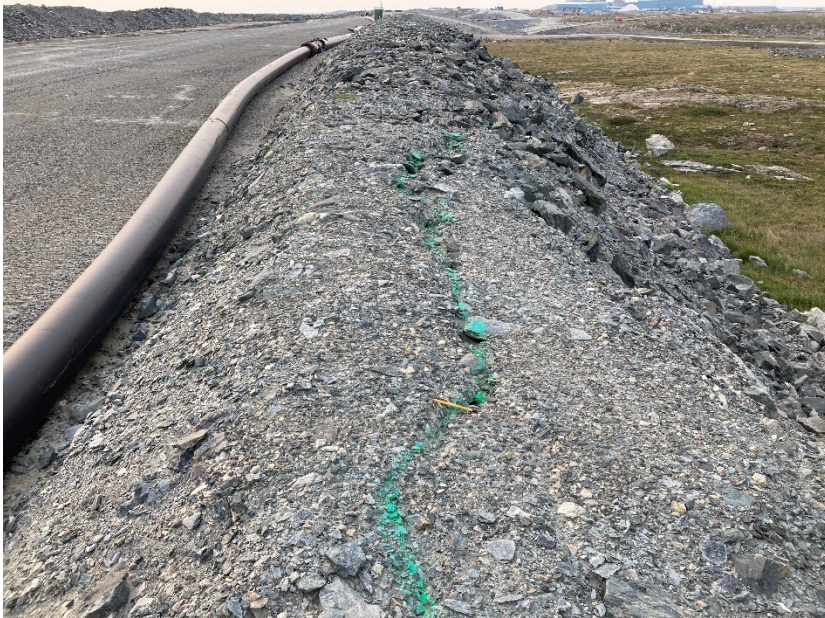
Photograph B3-09 Saddle Dam 2

3.3 Signs of movement (deformation)	None observed		
3.4 Cracks	Yes	253, 254	Cracks in berm at approx. 20+110 and 20+500, likely uncompacted rockfill
3.5 Seepage or wet areas	None observed on slope

Description: From Saddle Dam 2 (approximately Sta. 20+110) looking southeast at the crest and downstream slope. Cracks in berm are observed.

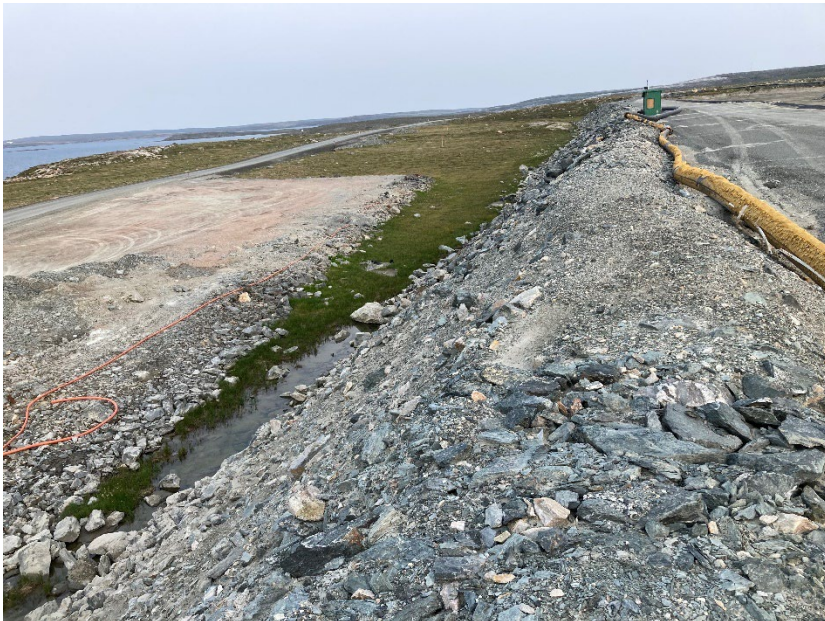
Photograph B3-10 Saddle Dam 2

INSPECTION ITEM	OBSERVATIONS DATA	PHOTO	COMMENTS & OTHER DATA
4.5 Outlet operating problem (if applicable)	Not applicable		
4.6 Other unusual conditions	Yes	254	Limited water pond within the rockfill embankment at Sta. 20+500 approximately.

Description: From Saddle Dam 2 (approximately Sta. 20+500) downstream, looking northwest at the downstream toe and slope of Saddle Dam 2. Presence of water ponding at the toe and small cracks on the berm.

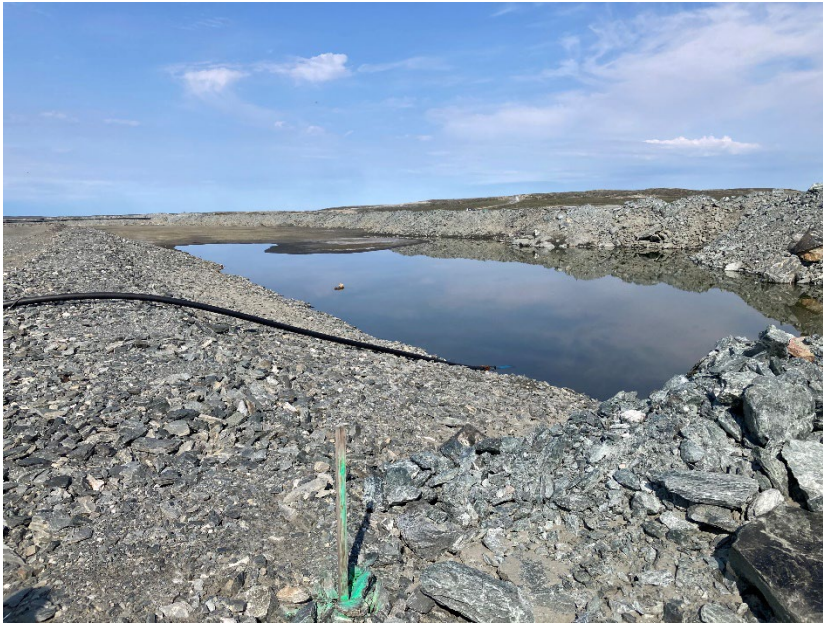
Photograph B4-08 Stormwater Dike

2.5 Face liner condition (if applicable)	Good conditions.		
2.6 Other unusual conditions	Yes	164, 165, 166	Large rocks on liner and several open liner welds from approx. 10+100 to 10+600). Water ponding at approx. 10+550

Description: From approximately Sta. 10+550 looking northwest. The liner was covered with granular material for protection from capping. Presence of water pond.

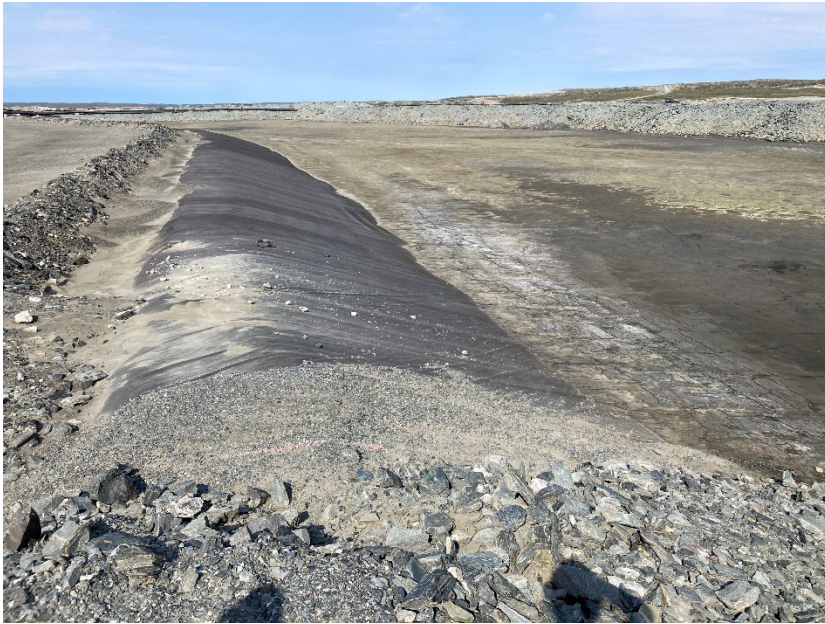
Photograph B4-09 Stormwater Dike

Description: From approximately Sta. 10+575 looking northwest at upstream slope. Presence of large rocks on liner.

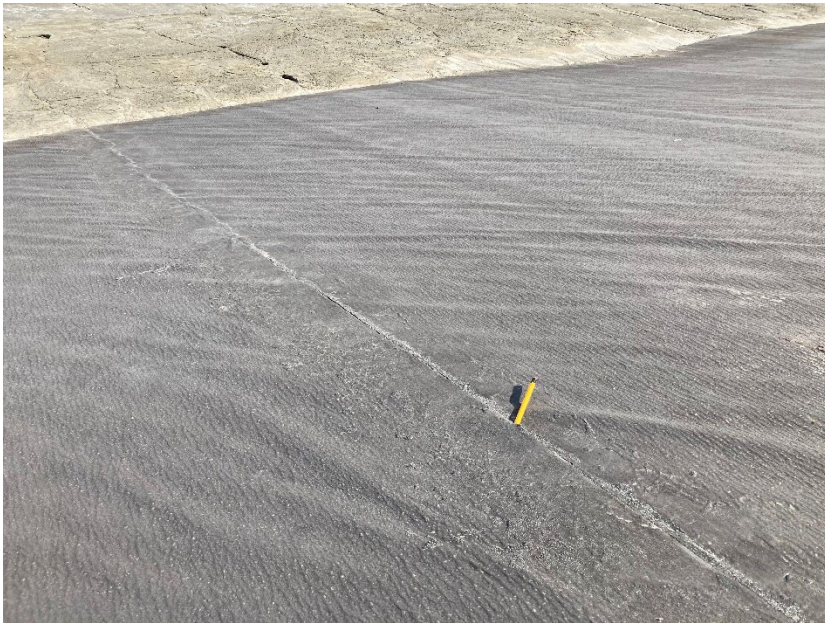
Photograph B4-10 Stormwater Dike

Description: From approximately Sta. 10+575 looking northwest. Presence of open liner welds.

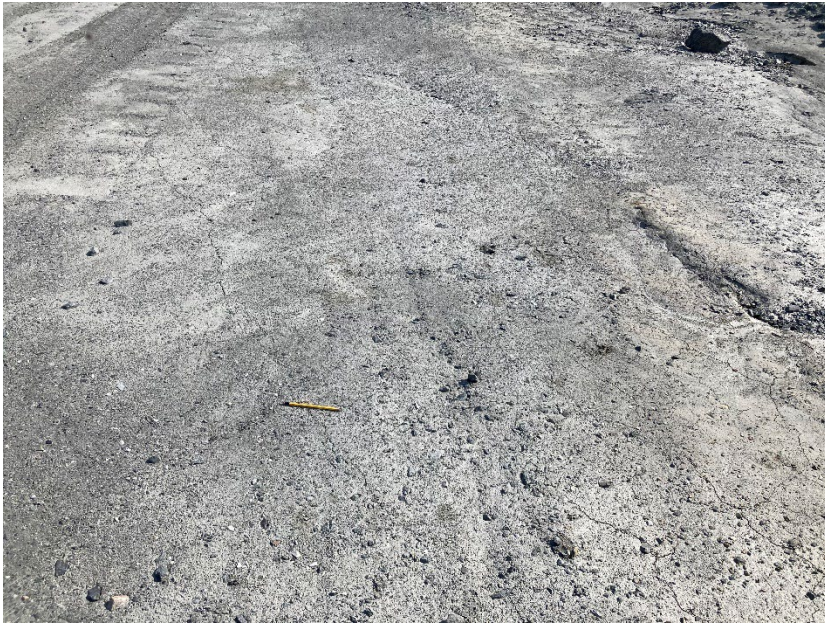
Photograph B4-14 Stormwater Dike

INSPECTION ITEM	OBSERVATIONS DATA	PHOTO	COMMENTS & OTHER DATA
1.5 Unexpected settlement	No		Old tension cracks (mostly around 10+300) are inactive and are disappearing. They have since been filled with bentonite. Presence of small new cracks (~ 5mm wide, 4-5 m long) in 2024.

4. DOWNSTREAM TOE AREA	Not visible	170	Downstream toe and berm is submerged by the South Cell pond. The berm was constructed at the downstream toe to stabilize the movement and cracks observed in 2016. Small new cracks (~ 5mm wide, 4-5 m long) at downstream slope at approx. 11+000 Sta.

Description: From the east abutment (10+900 approximately), looking northeast at the downstream slope. Old cracks still visible (seems inactive and healing). Presence of small new cracks (~ 5mm wide, 4-5 m long).

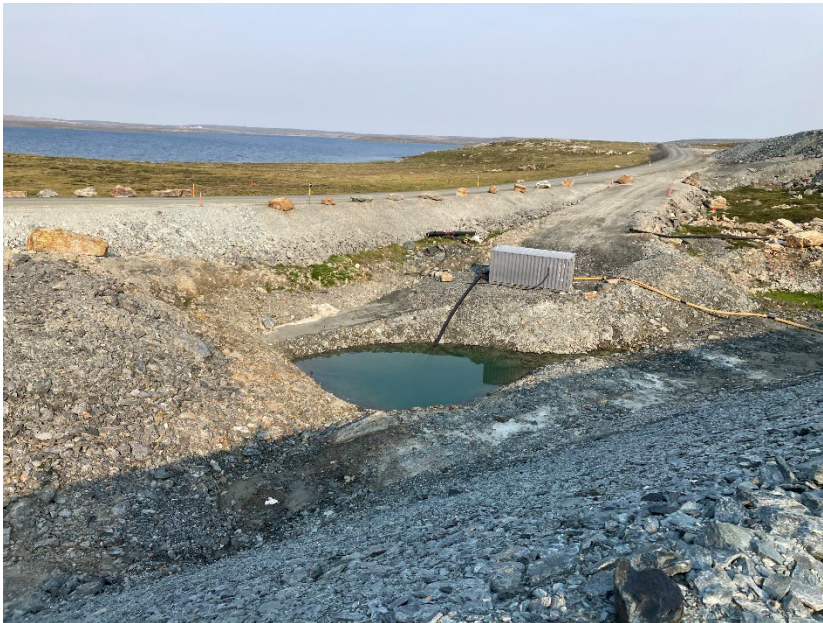
Photograph B5-04 Saddle Dam 3

INSPECTION ITEM	OBSERVATIONS DATA	PHOTO	COMMENTS & OTHER DATA
4.5 Outlet operating problem (if applicable)	Not applicable		
4.6 Other Conditions	Yes	269	A sump was constructed on the downstream side to collect the ponding water, so its level does not exceed the elevation of the granular layer of the upstream toe liner tie-in. Water pond at approx. 20+625 in downstream area.

Description: From Sta. 20+610, looking west at the downstream slope and sump. Presence of water pond.

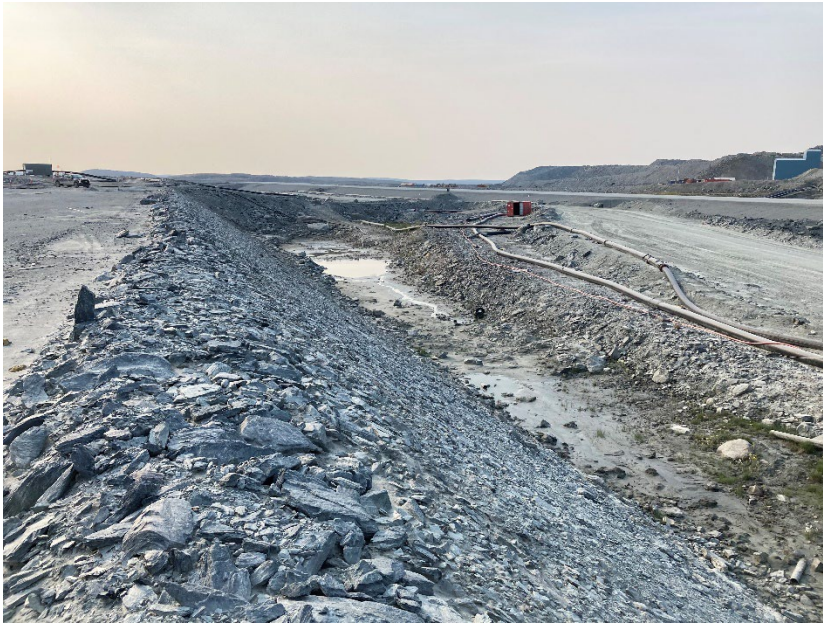
Photograph B6-01 Saddle Dam 4

4.6 Other Conditions	Yes	271, 272	Runoff water accumulate at the downstream side of the structure. It is pumped out so that the water level does not exceed the elevation of the granular layer of the upstream toe liner tie-in.

Description: Looking southeast at the downstream slope and toe. There is some water ponding at the toe.

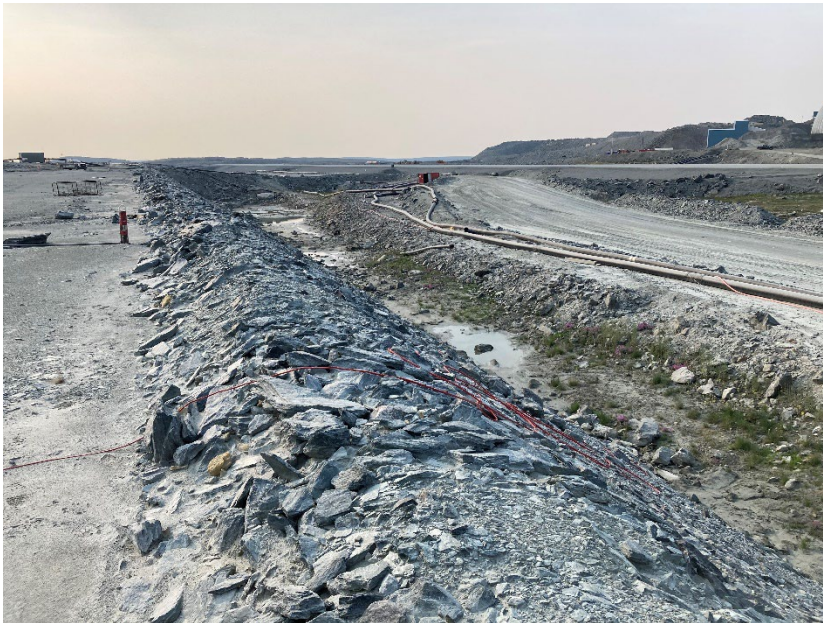
Photograph B6-02 Saddle Dam 4

Description: From the crest looking southeast at the crest and the downstream slope and toe. There is some water ponding at the toe.

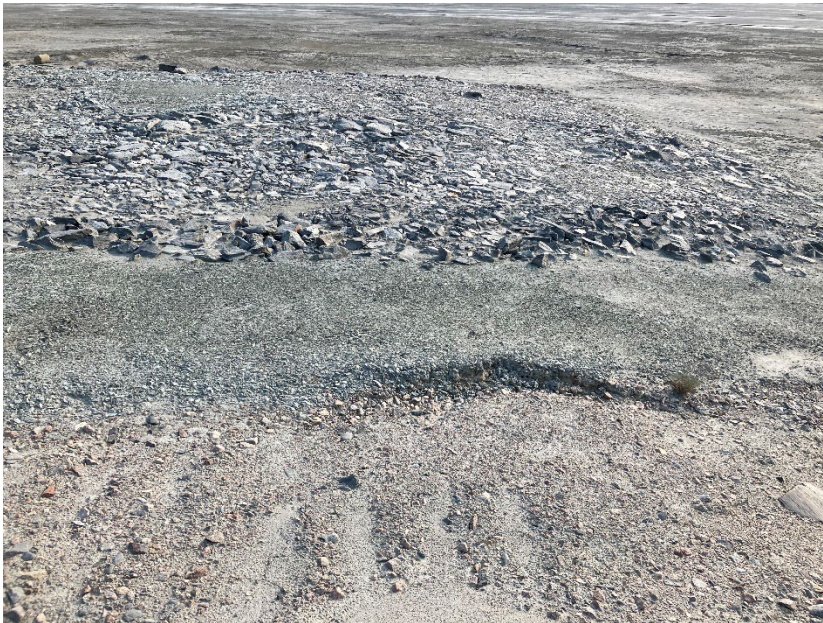
Photograph B6-04 Saddle Dam 4

Photo Number: 274

Description: Looking northeast at the upstream slope. Some erosion of the liner protection till layer.

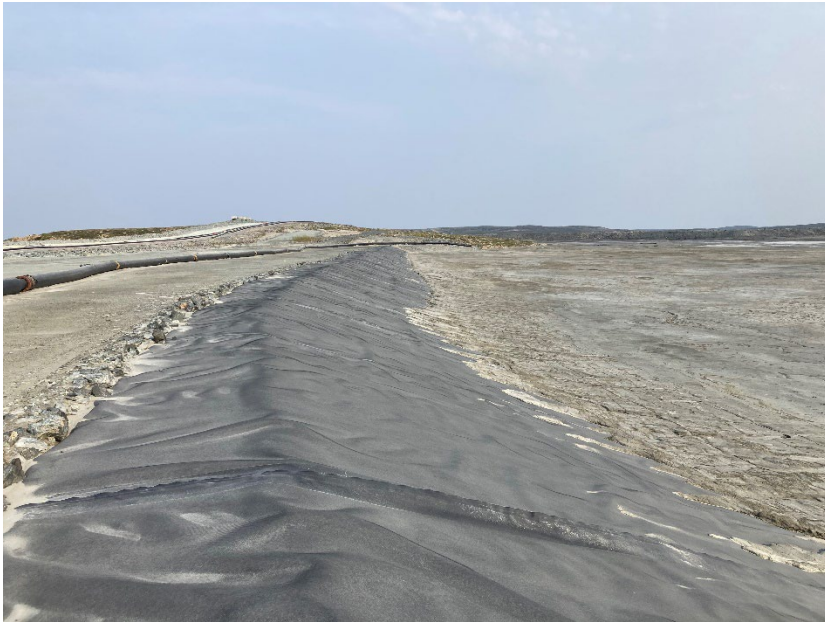
Photograph B6-05 Saddle Dam 4

Photo Number: 276

Description: Looking northwest at the upstream slope and the South Cell.

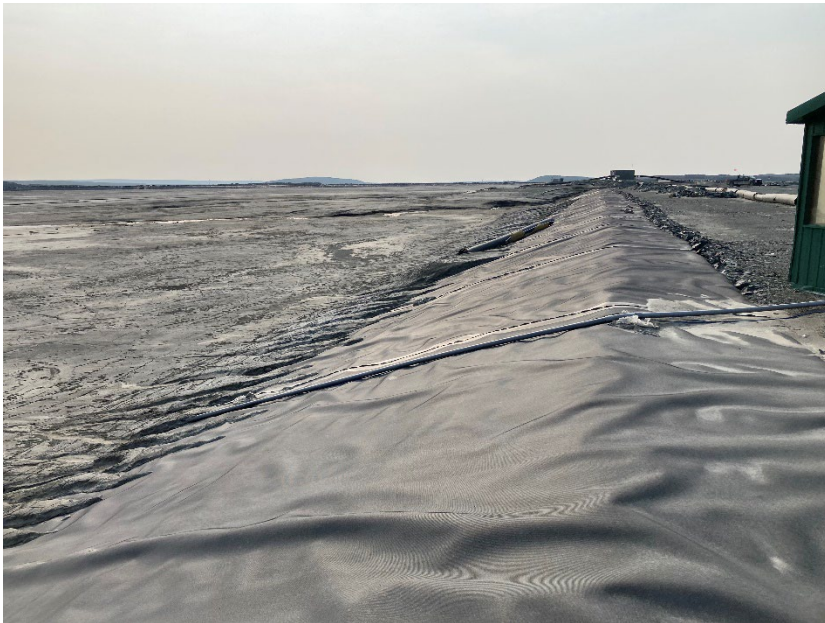
Photograph B6-06 Saddle Dam 4

Photo Number: 277

Description: Looking southeast at the crest and the upstream slope.

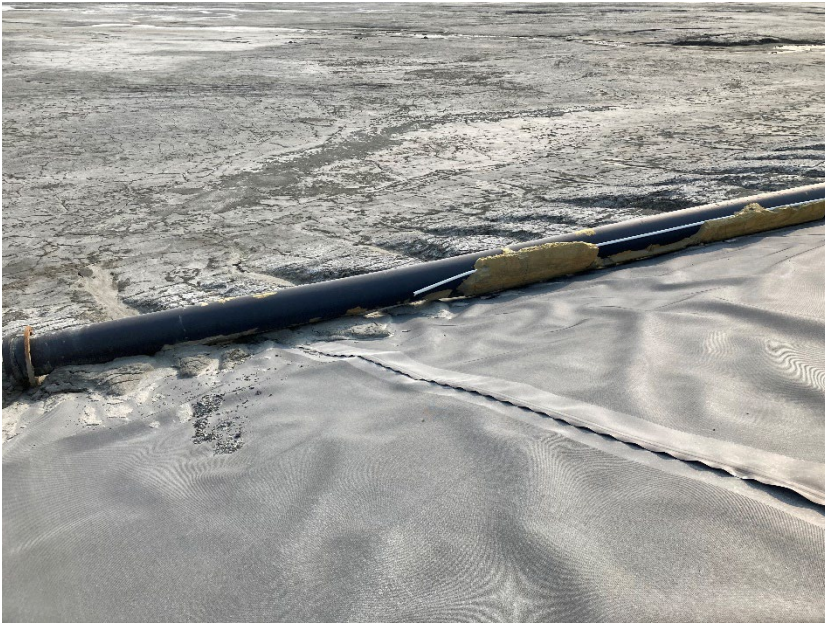
Photograph B6-07 Saddle Dam 4

Photo Number: 278

Description: Looking southeast at the upstream slope. Presence of a pipe on the liner.
