Meadowbank and Whale Tail 2024 Annual Geotechnical Inspection

2024 Annual Geotechnical Inspection

Meadowbank Complex, NU

Reference No. CA0038946.6657-1630-R-Rev0

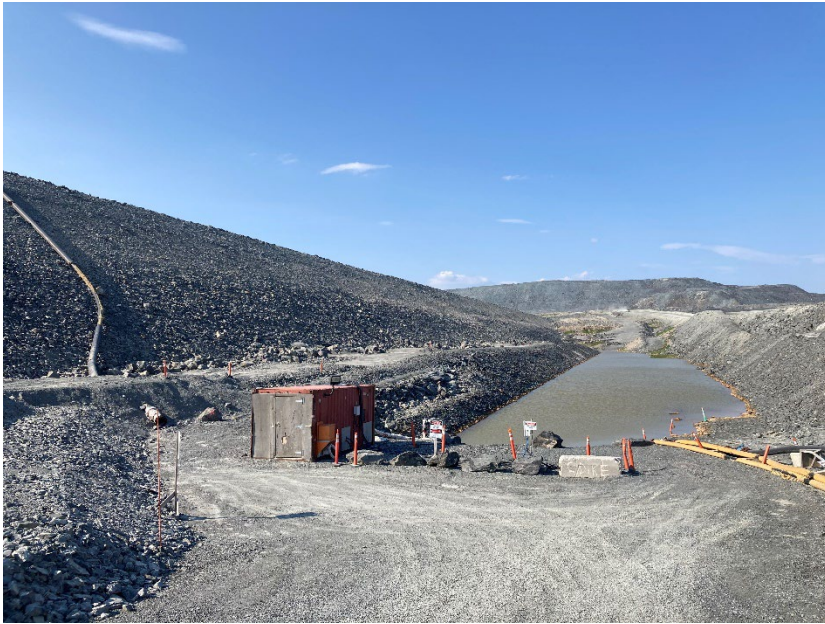
Photograph B7-01 Central Dike and Saddle Dam 5

INSPECTION ITEM	OBSERVATIONS DATA	PHOTO	COMMENTS & OTHER DATA
3.7 Other Unusual Conditions	None		
4. DOWNSTREAM TOE AREA		232, 234	
4.1 Seepage from Dam	Yes	232, 234	<p>Presence of a water pond formed by seepage on the downstream side between the downstream toe and West Road (0+300 to 0+830 approximately). The pond is pumped back to the South Cell and maintained at El. 115 m. The pumping rate was 150 m³/h at the time of the inspection.</p> <p>Presence of water pond approx. 0+100 Sta (runoff).</p>

Photo Number: 232

Description: From approximately Sta. 0+900 downstream, looking north at the downstream water pond.

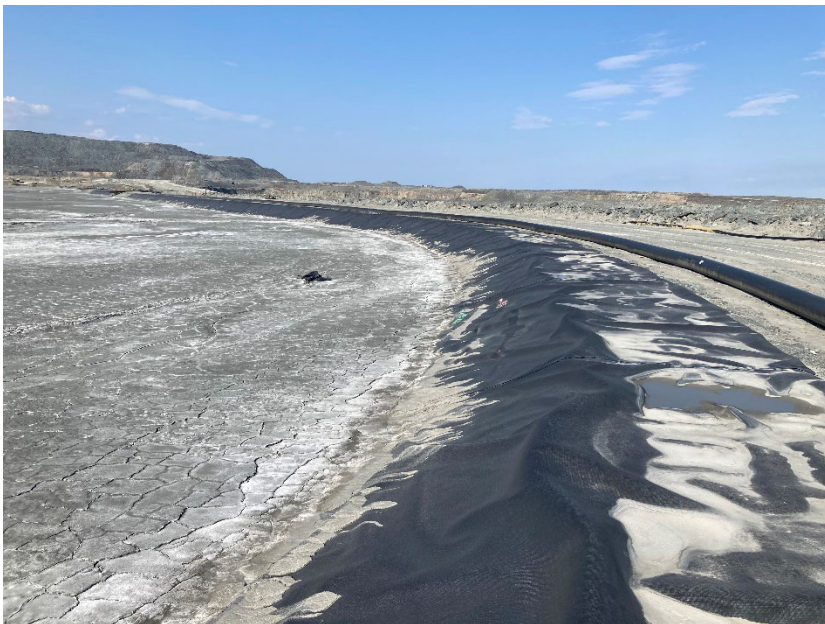
Photograph B7-02 Central Dike and Saddle Dam 5

Photo Number: 233

Description: From approximately Sta. 0+950, looking south at the upstream slope.

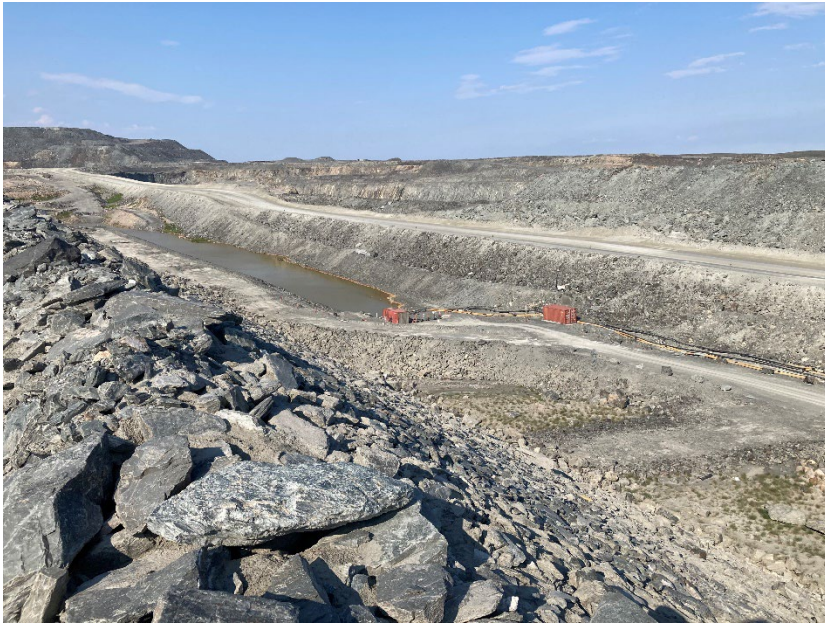
Photograph B7-03 Central Dike and Saddle Dam 5

Photo Number: 234

Description: From approximately Sta. 0+875, looking northeast at the downstream slope, toe and water pond.

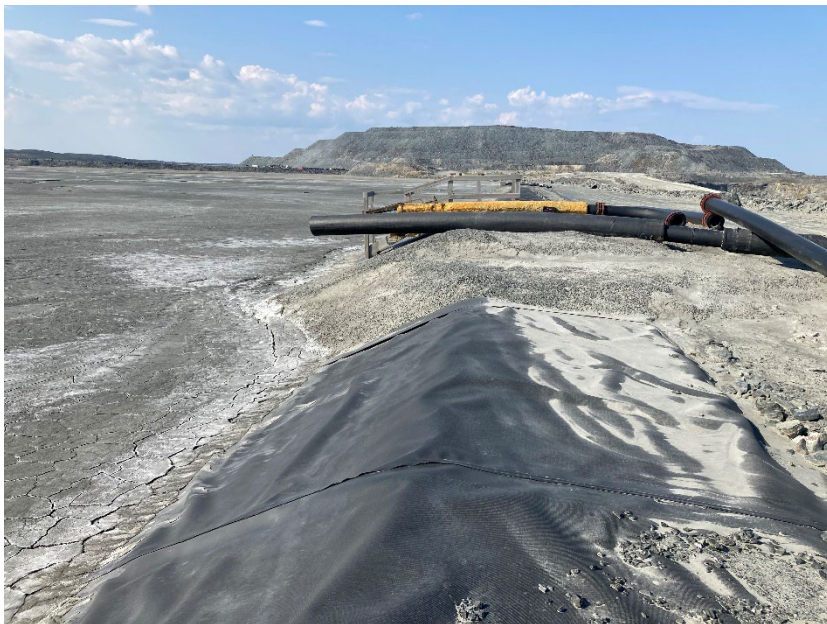
Photograph B7-04 Central Dike and Saddle Dam 5

Photo Number: 235

Description: From approximately Sta. 0+800, looking north at the crest and the upstream slope. Gravel overspilling from deposition on liner.

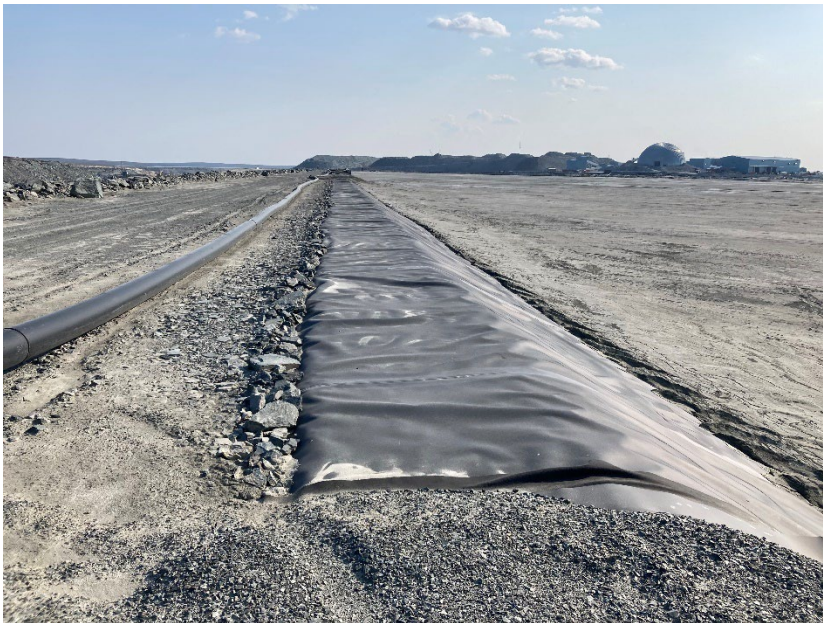
Photograph B7-10 Central Dike and Saddle Dam 5

Photo Number: 241

Description: From approximately Sta. 0+400 (deposition point) looking southwest at the crest and upstream slope. Adequate tailings beach against the south section of the structure.

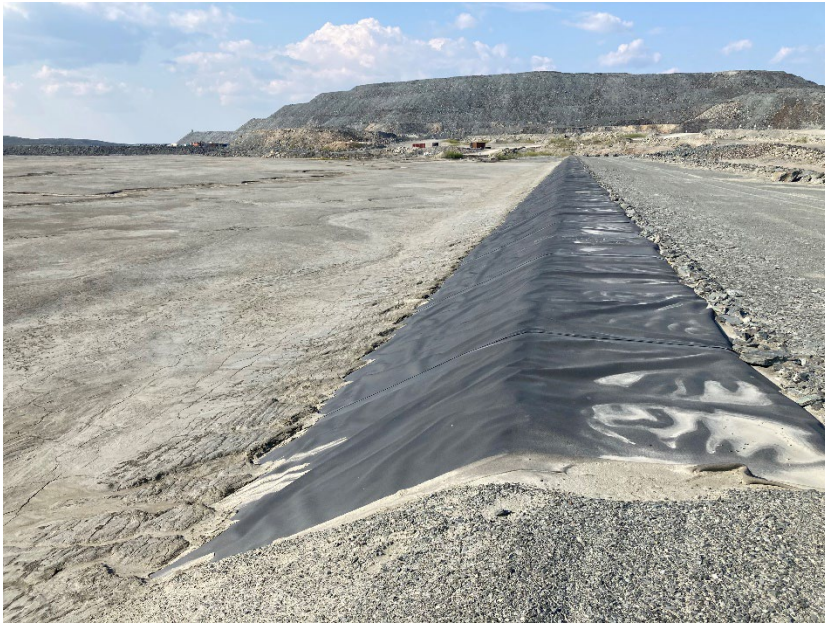
Photograph B7-11 Central Dike and Saddle Dam 5

Photo Number: 242

Description: From approximately Sta. 0+400 (deposition point) looking northwest at the upstream slope and South Cell. Adequate tailings beach against the south section of the structure.

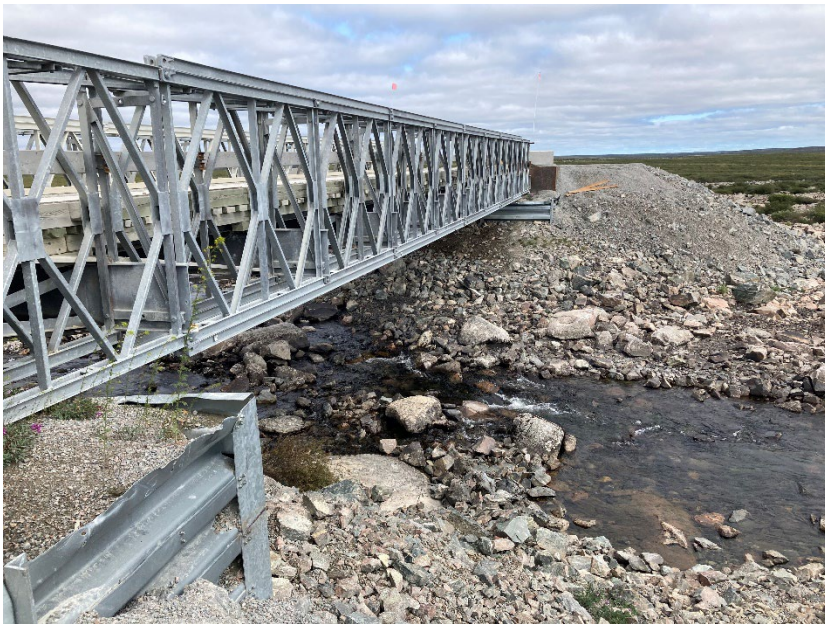
Photograph D3-1 Bridges 1 – R02 km 8+750

Photo Number: 382

Description: Looking at the north abutment. The corrugated steel bin shows deformation under the weight of the bridge.

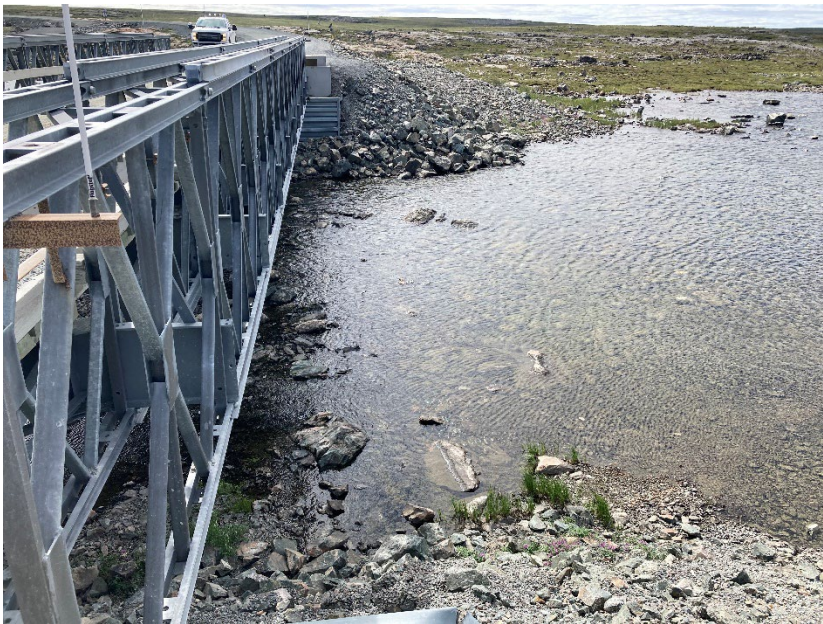
Photograph D3-6 Bridges 3 – R06 km 23+100

Photo Number: 388

Description: Looking at the south abutment. Some tension cracks in granular material on abutments.

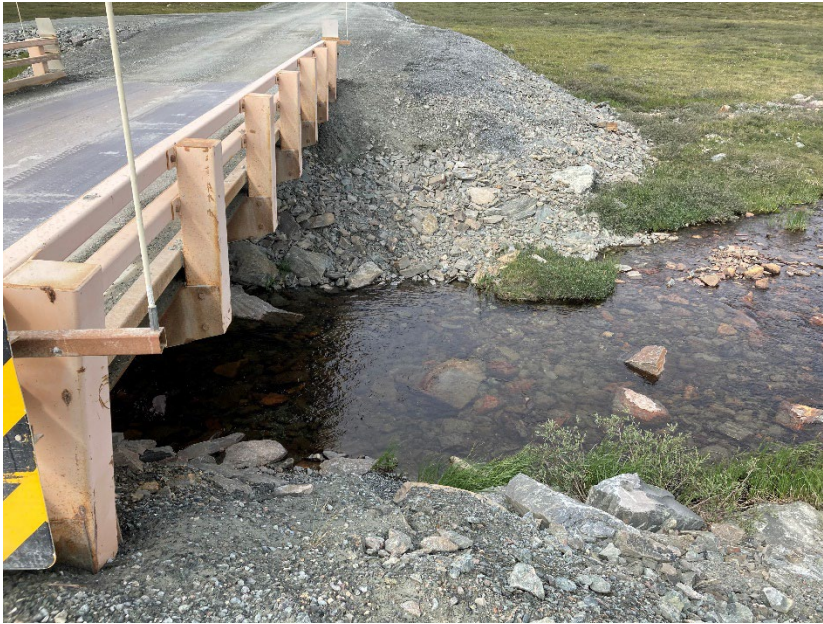
Photograph D3-7 Bridges 4 – R09 km 48+500

Photo Number: 390

Description: Looking at the north abutment. In good general condition. Some water flowing under the northeast abutment, but no sign of erosion.

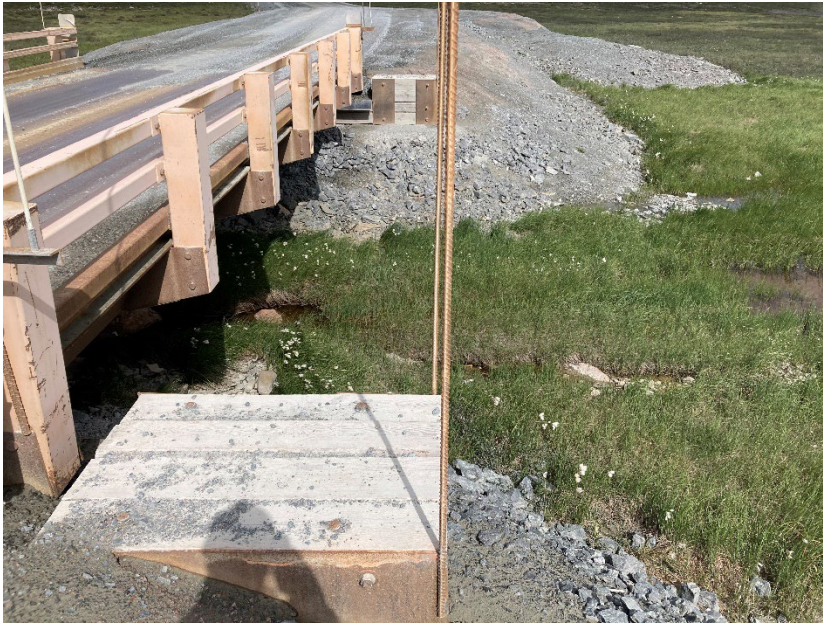
Photograph D3-9 Bridges 5 – R13 km 62+060

Photo Number: 392

Description: Looking at the north abutment. In general good condition. Tension cracks on southeast, southwest and northeast abutments.

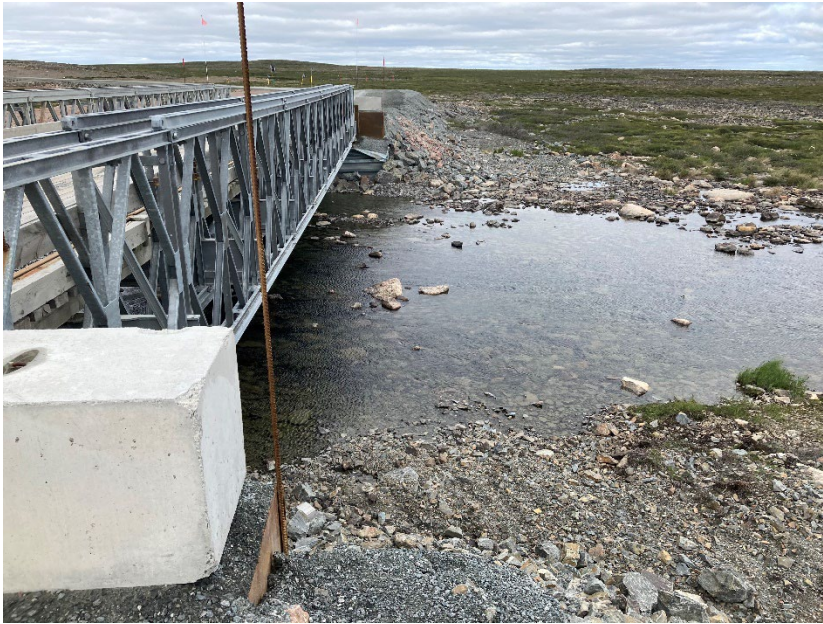
Photograph D3-11 Bridges 6 – R15 km 69+200

Photo Number: 396

Description: New bridge, in good condition. North metal bin damaged due to snow removal, but not an issue.

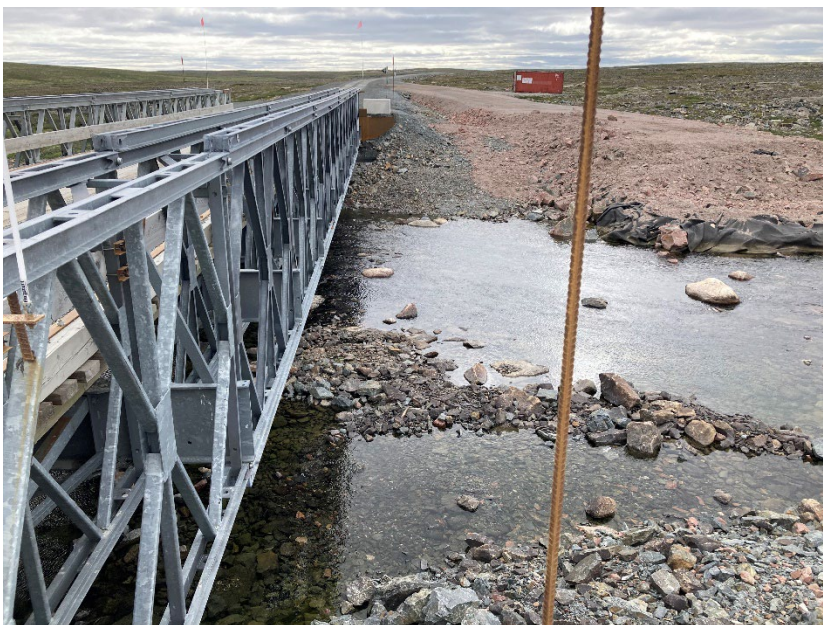
Photograph D3-12 Bridges 6 – R15 km 69+200

Photo Number: 397

Description: New bridge, in good condition. North metal bin damaged due to snow removal, but not an issue.

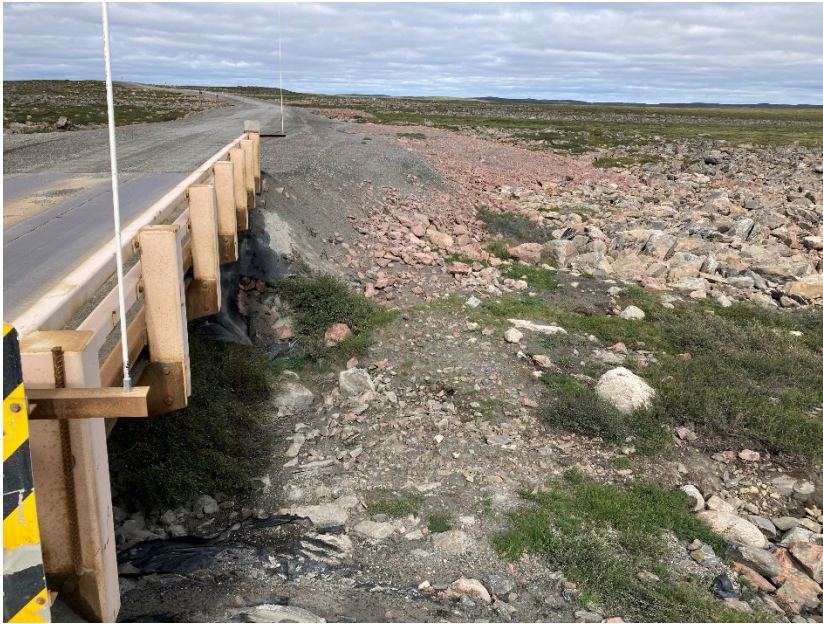
Photograph D3-15 Bridges 8 – R18 km 79+500

Description: Looking at the north abutment. In good condition.

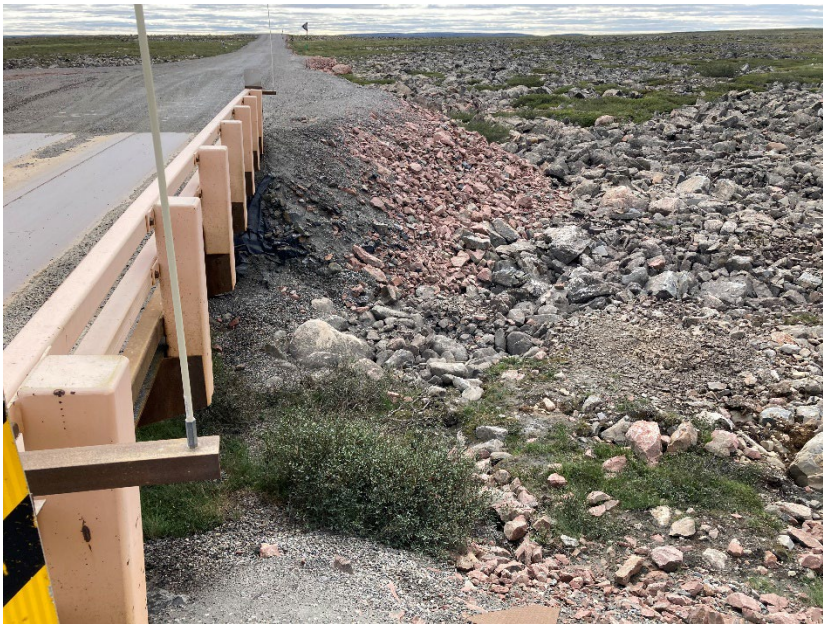
Photograph D3-16 Bridges 8 – R18 km 79+500

Description: Looking at the south abutment. In good condition.

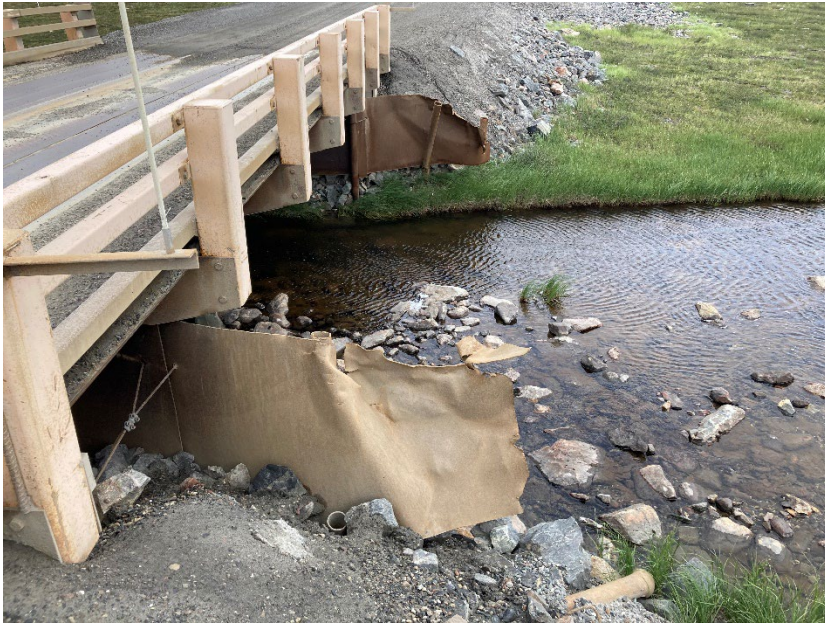
Photograph D3-17 Bridges 9 – R19 km 83+150

Description: Looking at the north abutment. Minor damage to steel plate due to snow removal activity. Minor tension cracks in the top surface on the north and southwest abutments. To monitor.

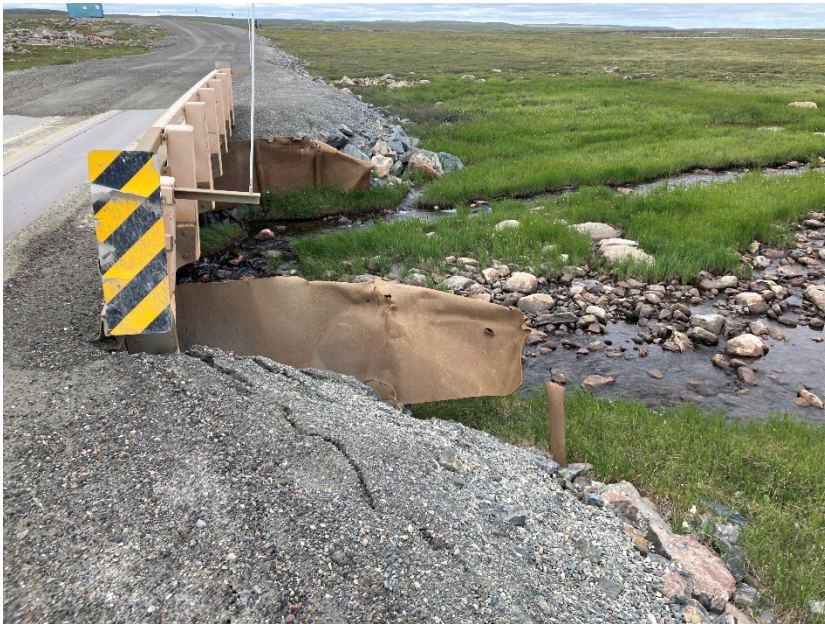
Photograph D3-18 Bridges 9 – R19 km 83+150

Description: Looking at the south abutment. Minor damage to steel plate due to snow removal activity. Minor tension cracks in the top surface on the north and southwest abutments. To monitor.

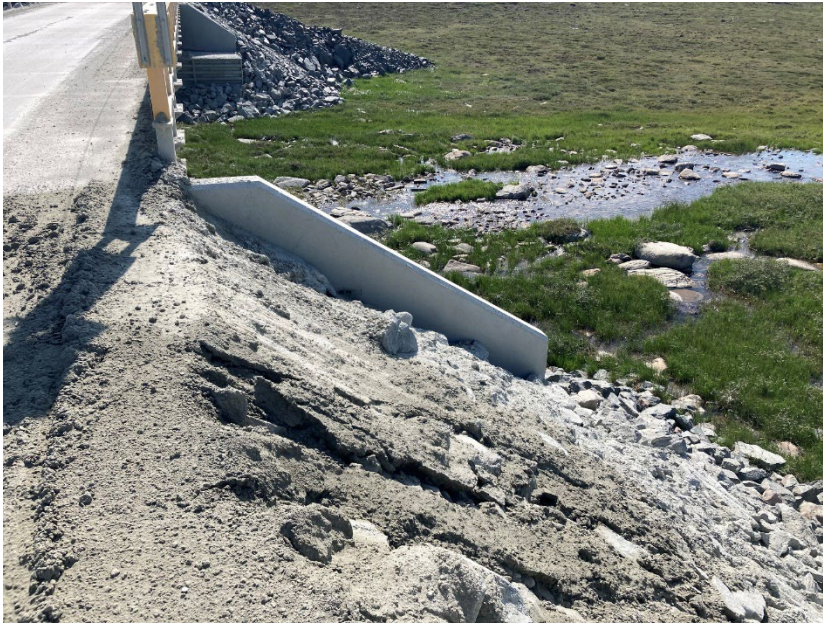
Photograph E2-20 Bridges 9 – km 160+800

Description: Looking at the south abutment. Surficial erosion of the granular material behind the concrete wall.

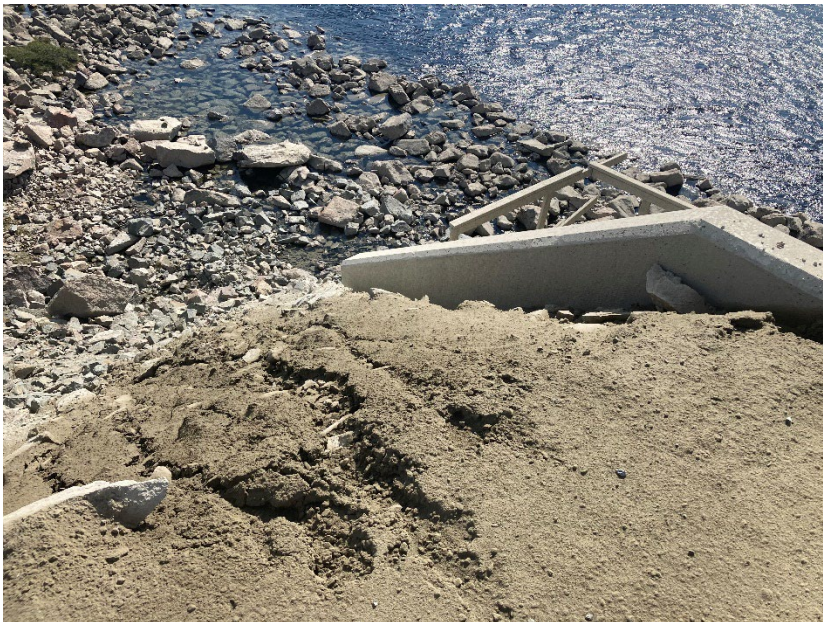
Photograph E2-16 Bridges 7 – km 148+300

Description: Looking at the southwest abutment. Surficial erosion of the granular material behind the concrete wall.

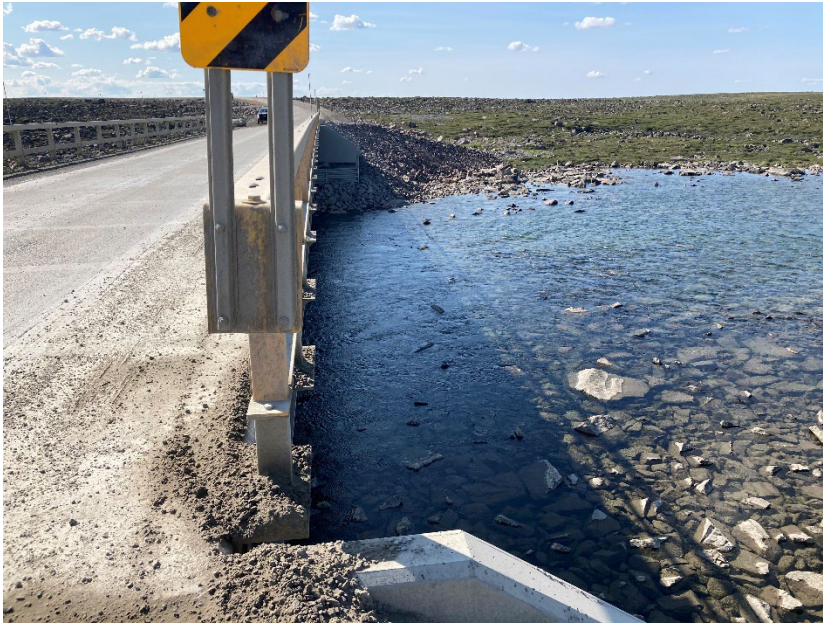
Photograph E2-10 Bridges 5 – km 139+900

Description: Looking at the north abutment. Surficial erosion of the granular material behind the concrete wall.

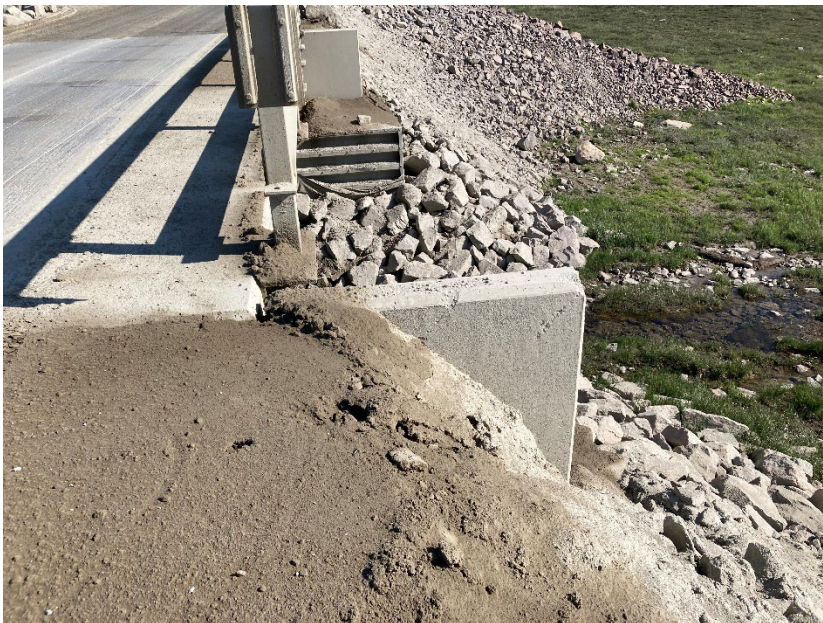
Photograph E2-8 Bridges 4 – km 136+000

Description: Looking at the south abutment. Surficial erosion of the granular material behind the concrete wall.

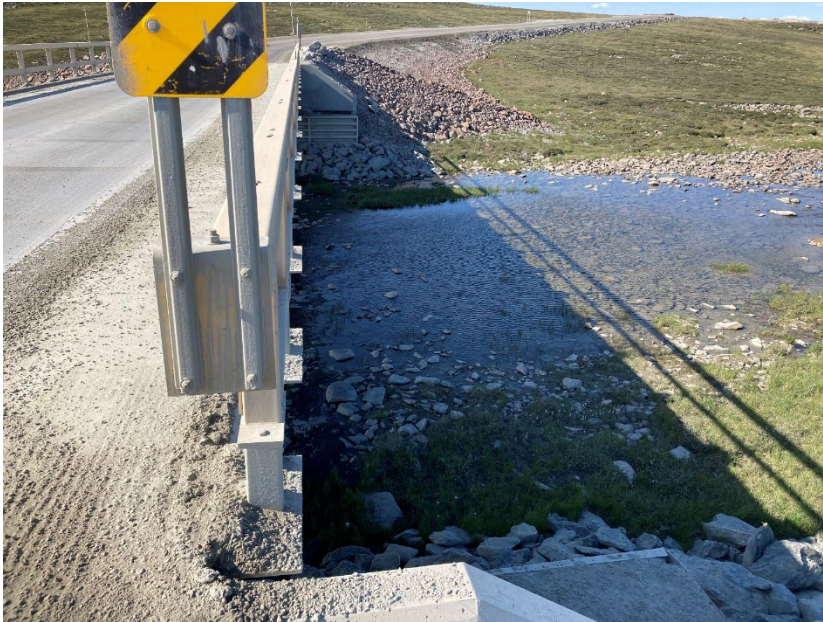
Photograph E2-6 Bridges 3 – km 132+000

Description: Looking at the north abutment. Surficial erosion of the granular material behind the concrete wall

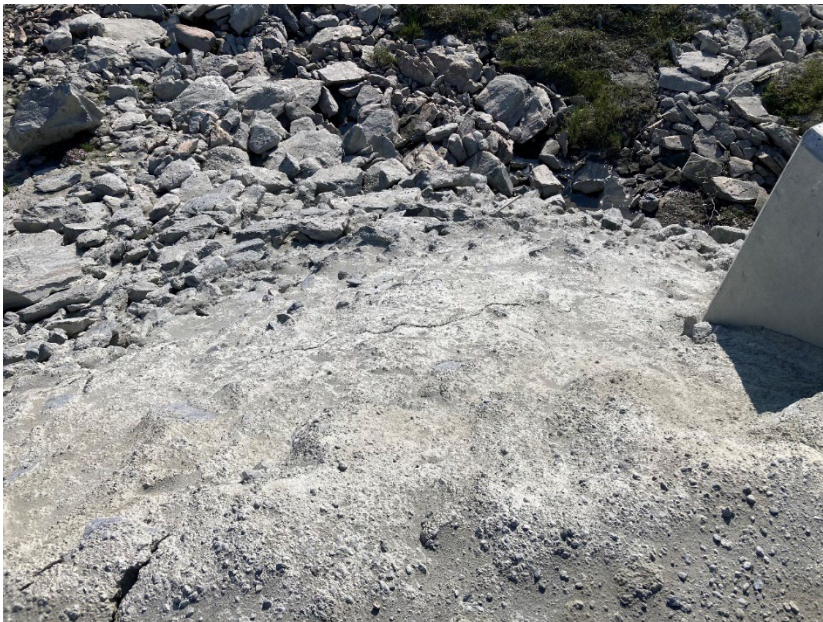
Photograph E2-3 Bridges 1 – km 119+400

Description: Looking at the southwest abutment. Minor tension cracks are observed.

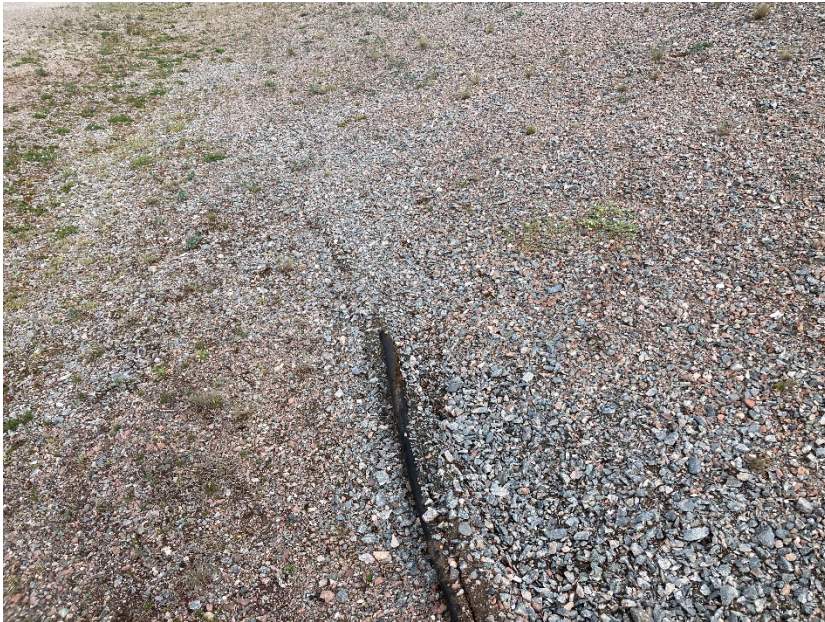
Photograph G1-13 Baker Lake Tank Farm

Description: Looking northwest at the northern and side of Tank 1. Exposed fold in liner.

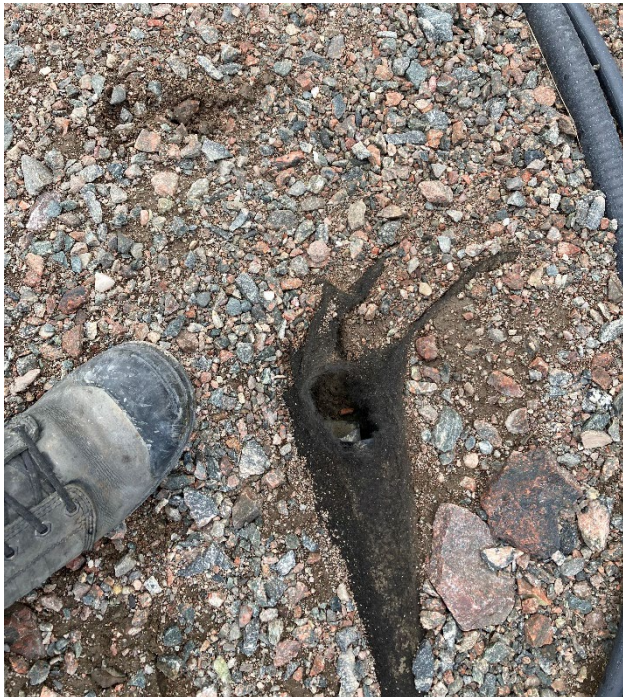
Photograph G1-14 Baker Lake Tank Farm

Description: From the west side of Tank 1, looking southwest. Depressions in liner, at the top of slope.

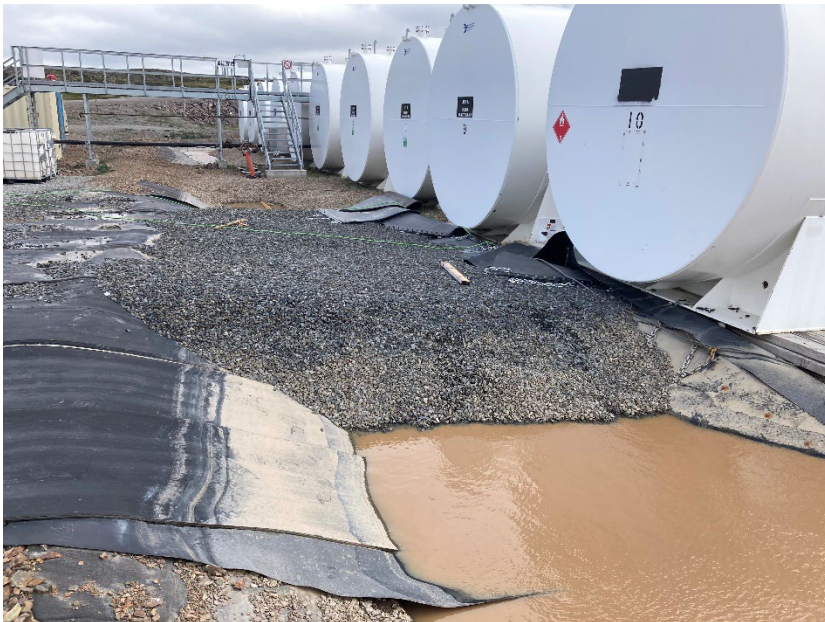
Photograph G1-16 Baker Lake Tank Farm

Description: From the southwestern corner of the Jet A fuel tanks looking northeast. Presence of exposed geomembrane and water ponding.

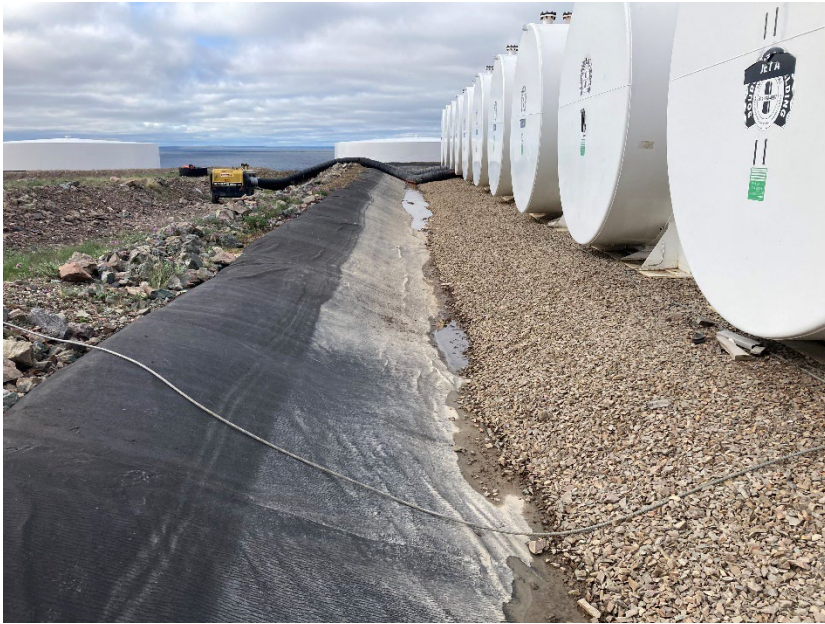
Photograph G1-17 Baker Lake Tank Farm

Description: From the northeastern corner of the Jet A fuel tanks looking south.

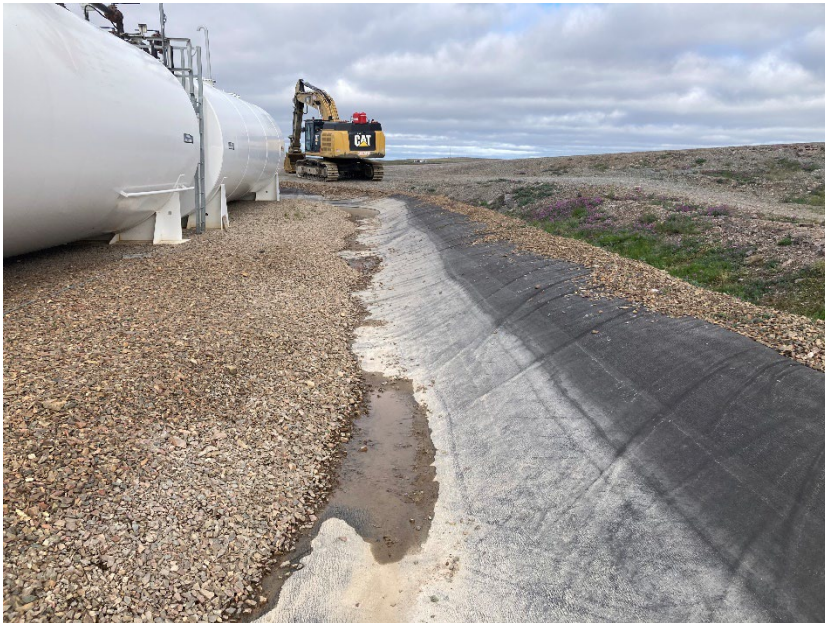
Photograph G1-18 Baker Lake Tank Farm

Description: From the northeastern corner of the Jet A fuel tanks looking west.

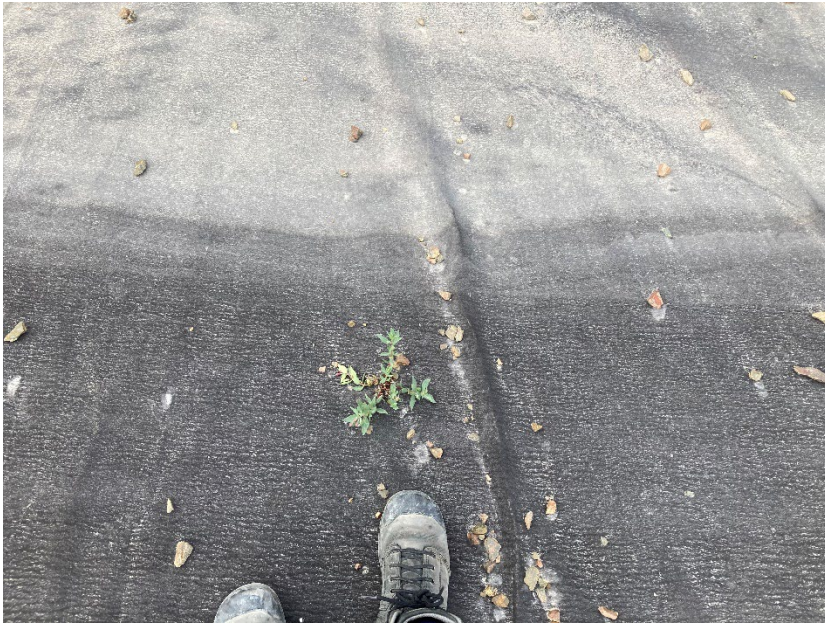
Photograph G1-19 Baker Lake Tank Farm

Description: From the northeastern corner of the Jet A fuel tanks looking southwest. There is a small hole in the liner.

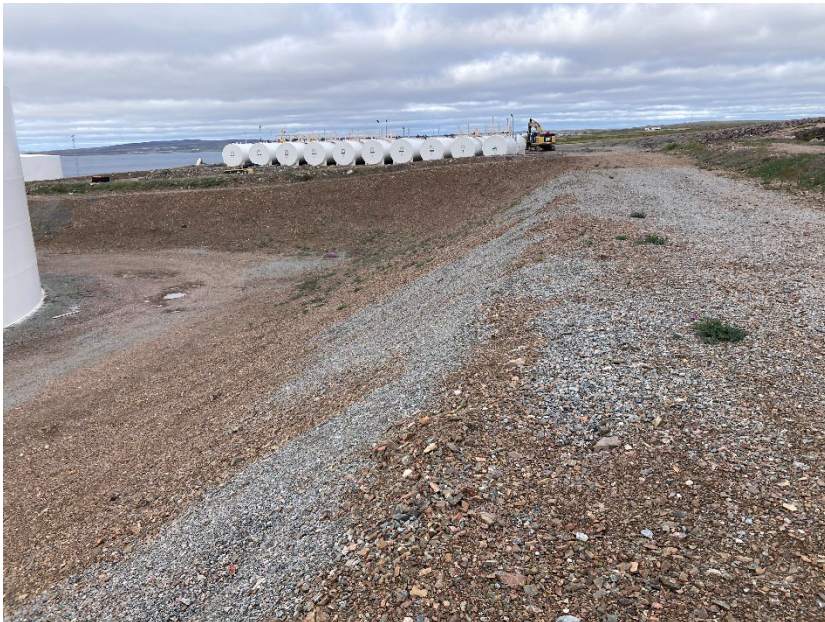
Photograph G1-20 Baker Lake Tank Farm

Description: Looking west at the crest on the northeastern side of Tank 5.

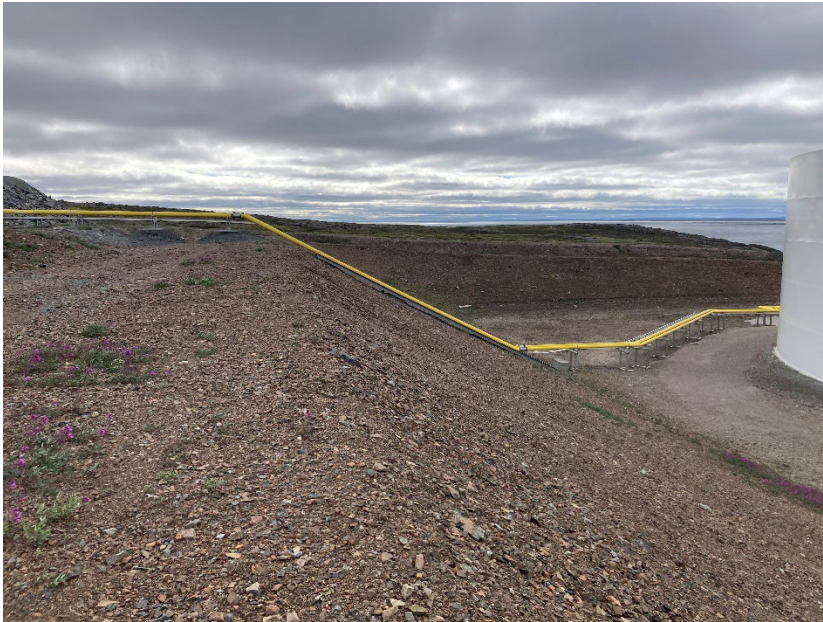
Photograph G1-21 Baker Lake Tank Farm

Description: Looking southeast at the northeastern side of Tank 6.

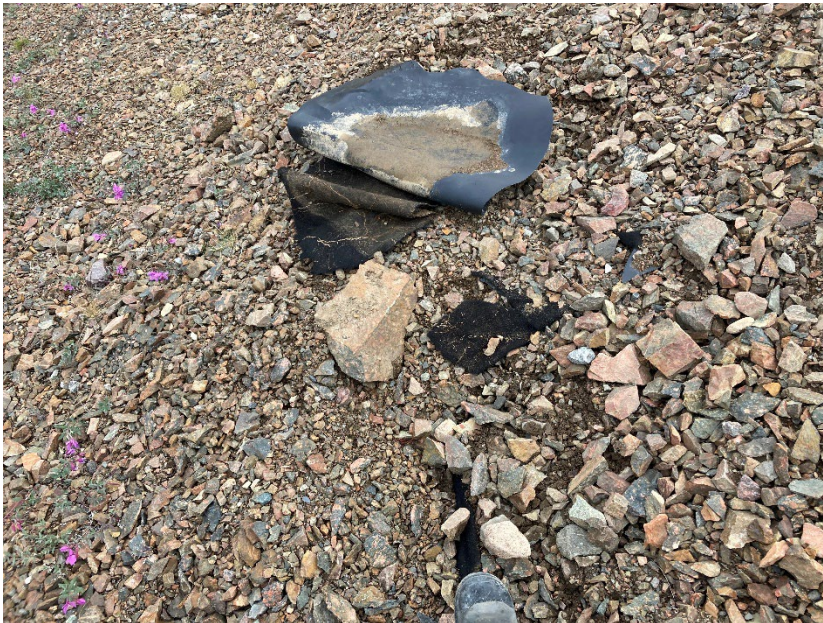
Photograph G1-22 Baker Lake Tank Farm

Description: From the eastern corner of Tank 6, looking northeast. Large rips in liner in the middle of the slope.

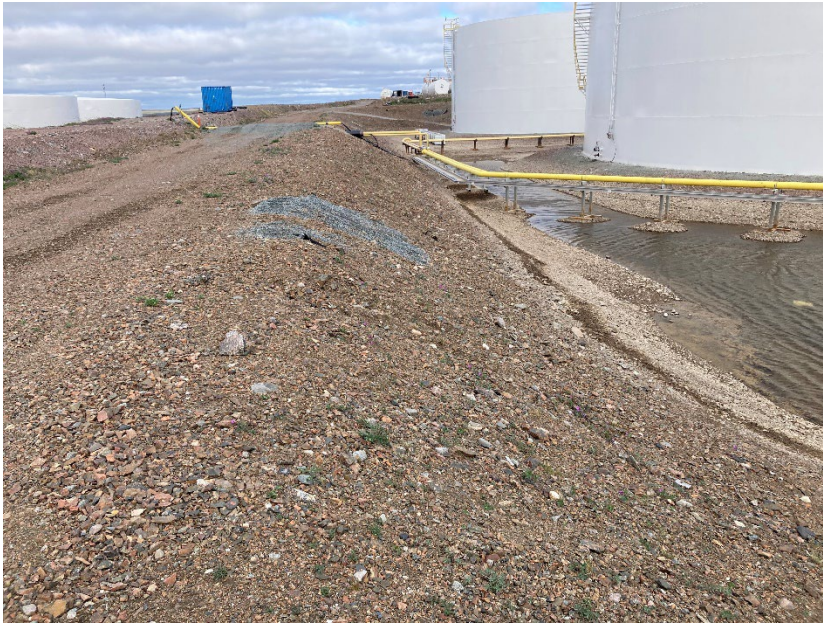
Photograph G1-23 Baker Lake Tank Farm

Description: From the southern corner of Tank 6, looking northeast at the southern side of Tanks 5 and 6. Presence of water ponding.

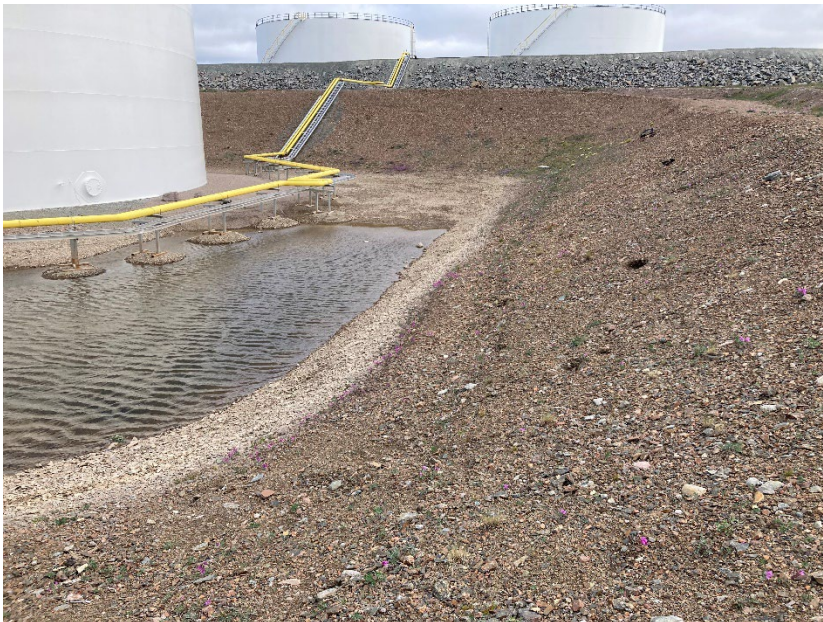
Photograph G1-24 Baker Lake Tank Farm

Description: From the eastern corner of Tank 6, looking northeast. Rips in the liner, in the middle of the slope. Presence of water ponding.

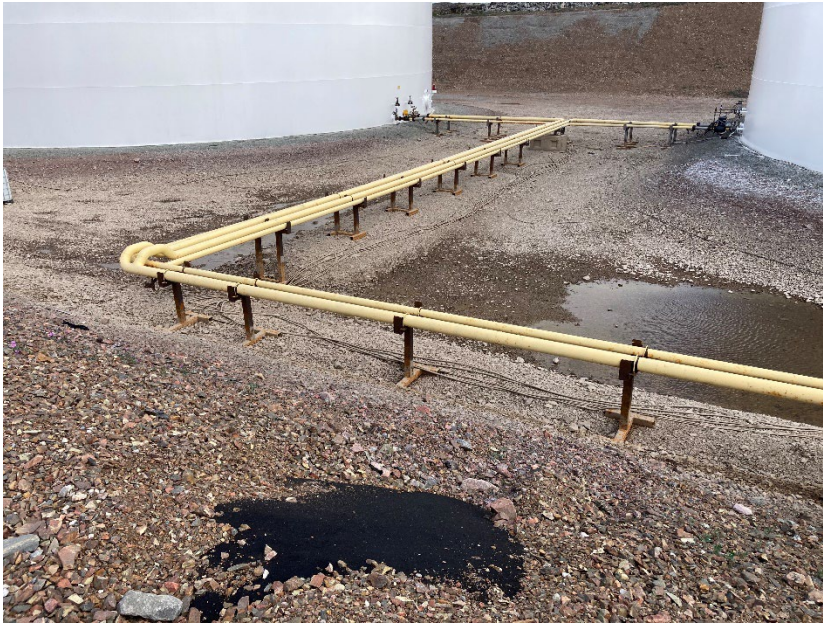
Photograph G1-25 Baker Lake Tank Farm

Description: Looking northeast between Tanks 5 and 6. Exposed liner at the top of slope.

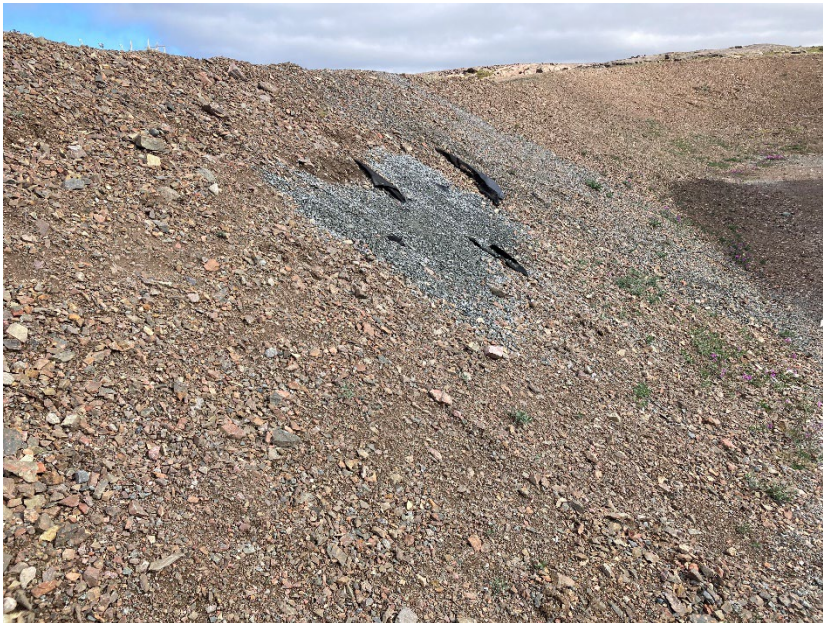
Photograph G1-26 Baker Lake Tank Farm

Description: Looking northeast between Jet A fuel Tank and Tank 5. Large rips in the liner in the middle of the slope.

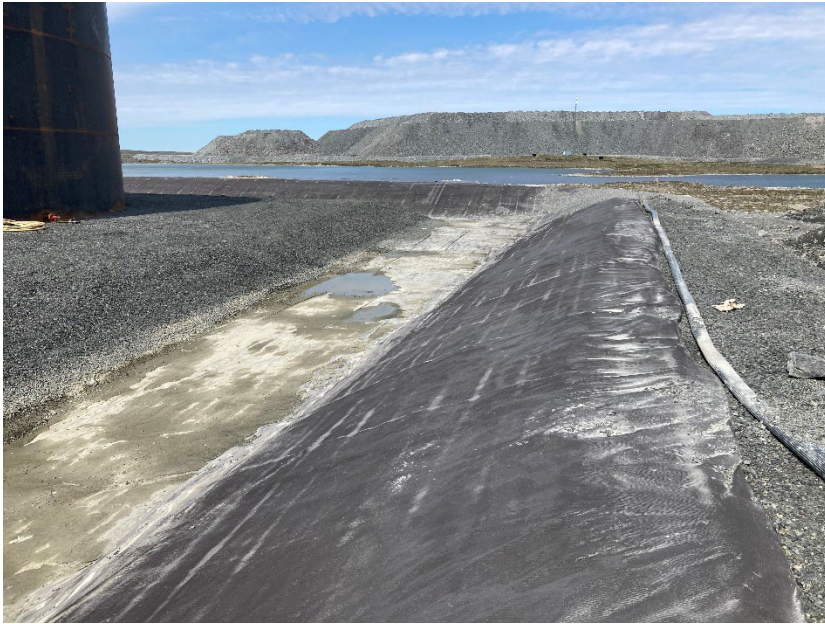
Photograph G3-01 Whale Tail Project Site Tank Farm

Description: From the southeast corner, looking north at the Tank Farm. Presence of water ponding.

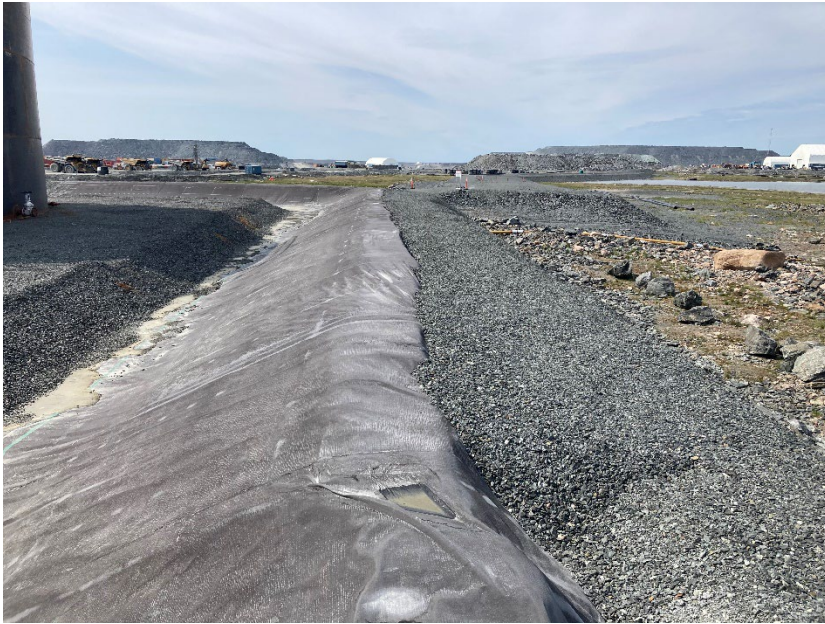
Photograph G3-03 Whale Tail Project Site Tank Farm

Description: From the northeast corner of the tank, looking west. An exposed anchor is observed.

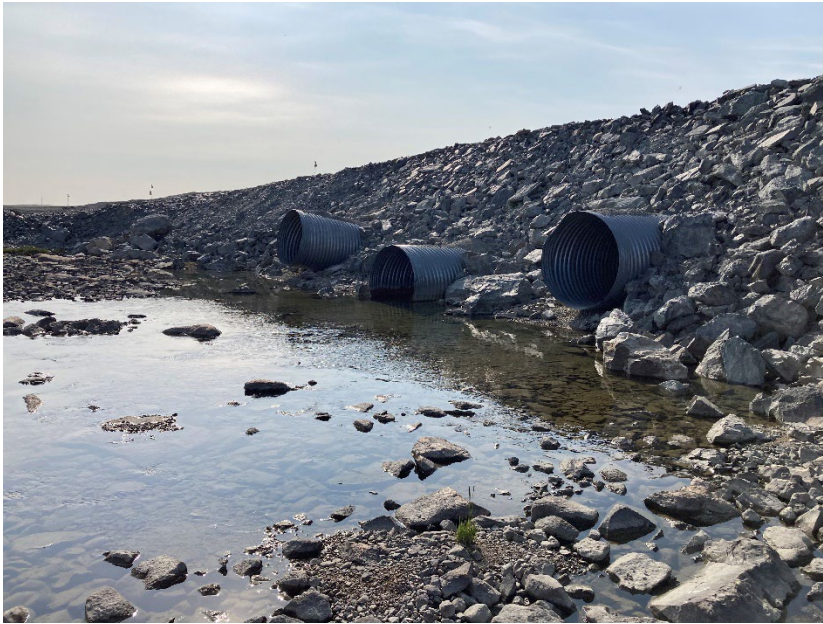
Photograph H1-01 Vault Road Culverts

Description: From the inlet side of the three culverts located on Vault Road at 640964E/7217466N. The culverts are slightly deformed on top in the middle.

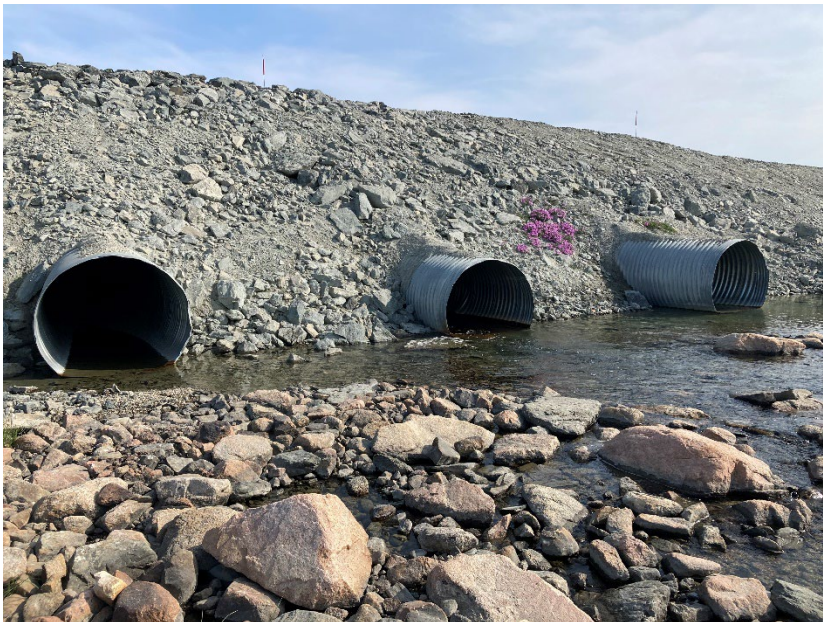
Photograph H1-02 Vault Road Culverts

Description: Looking at the outlet of the three culverts located on Vault Road at 640964E/7217466N. All of them are deformed in the middle.

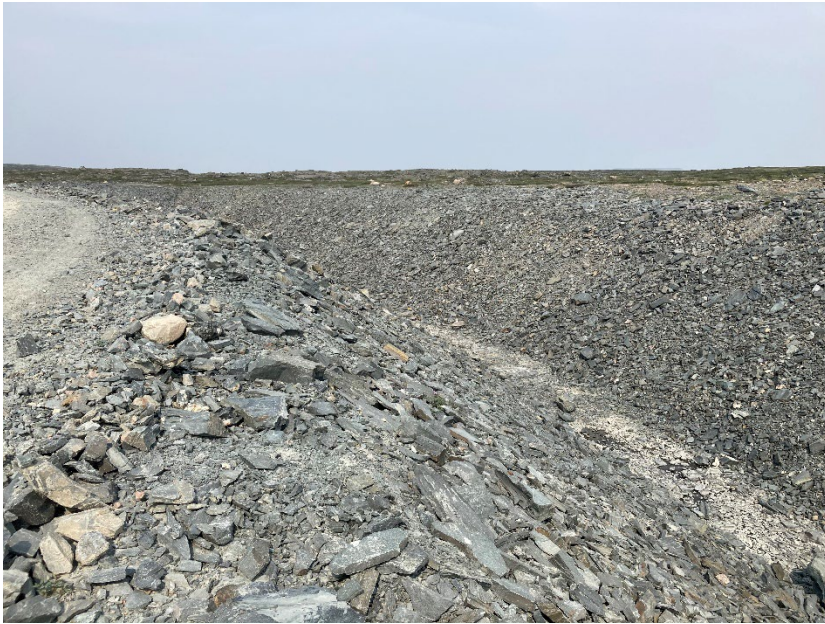
Photograph H2-05 Diversion Ditch and its Sediment and Erosion Protection Structure

Description: From the eastern diversion ditch looking northwest. Sloughing in riprap into upper slope (~2m diameter).

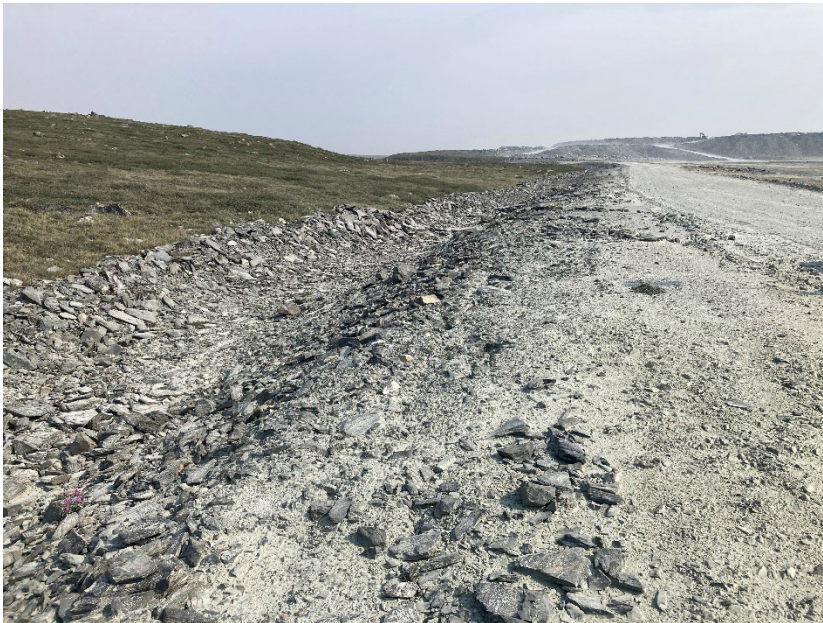
Photograph H2-10 Diversion Ditch and its Sediment and Erosion Protection Structure

Description: From the northern diversion ditch looking east. Presence of tension cracks in progress in granular material, sloughing.
