Meadowbank and Whale Tail 2024 Annual Geotechnical Inspection

2024 Annual Geotechnical Inspection

Meadowbank Complex, NU

Reference No. CA0038946.6657-1630-R-Rev0

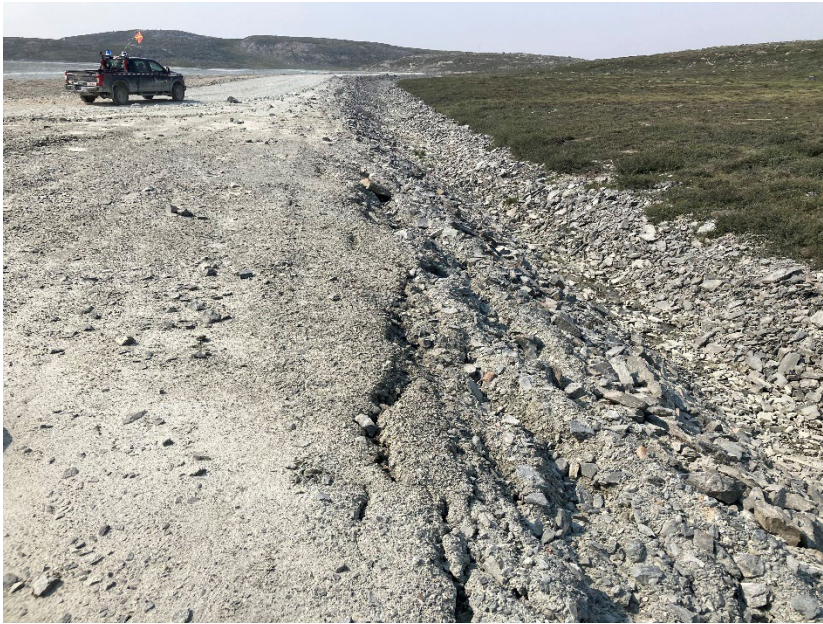
Photograph H2-11 Diversion Ditch and its Sediment and Erosion Protection Structure

Description: From the northern diversion ditch looking west. Presence of tension cracks in progress in granular material, sloughing.

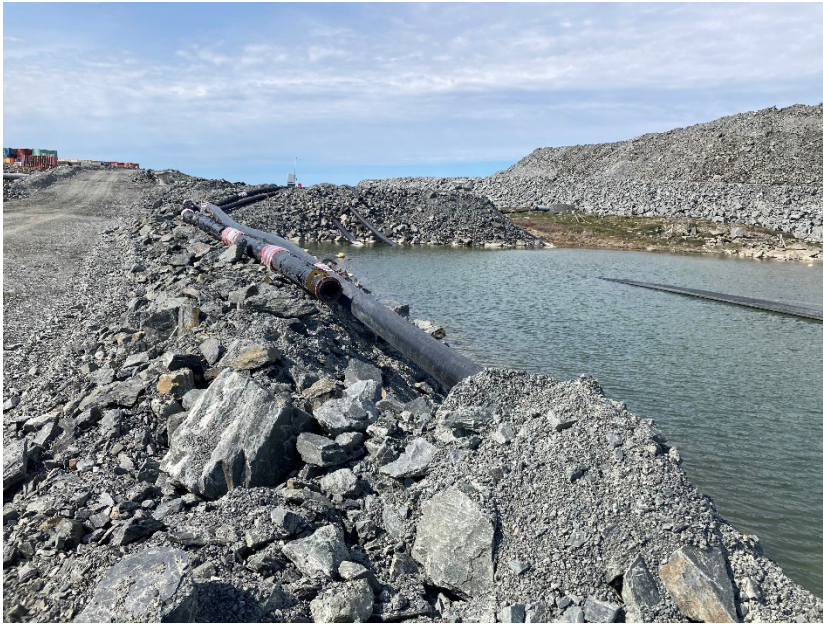
Photograph H8-01 IVR Attenuation Pond Jetty

Description: From the pump pad, looking south at the Attenuation Pond and jetty.

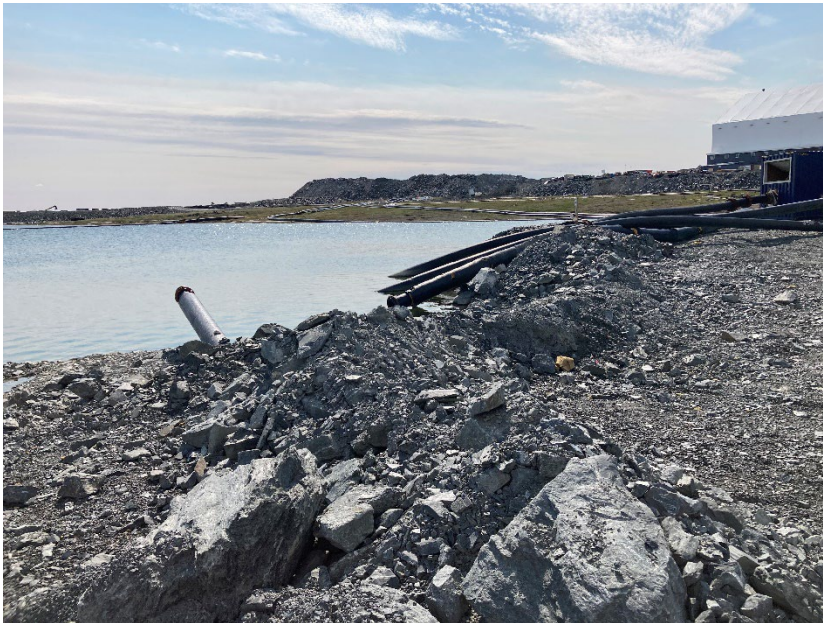
Photograph H8-02 IVR Attenuation Pond Jetty

Description: From the pump pad, looking east at the Attenuation Pond.

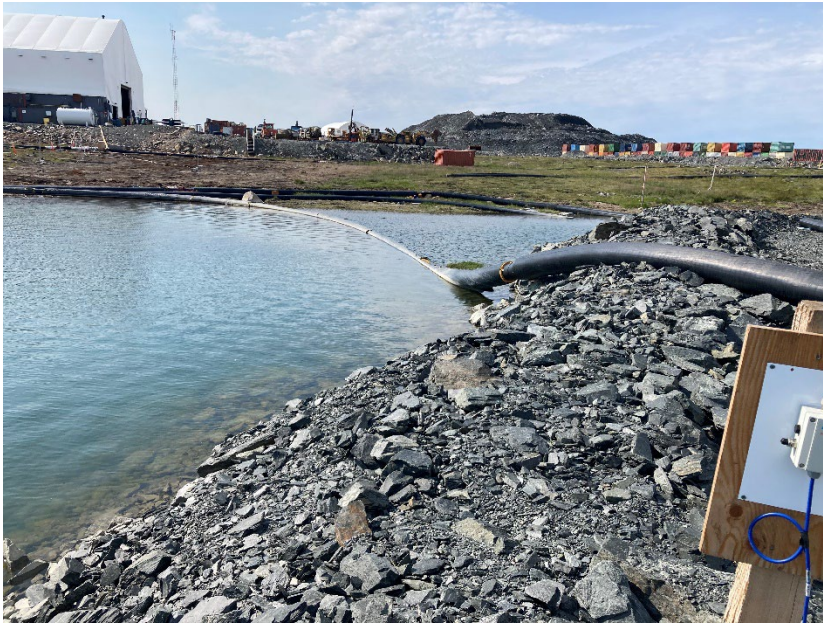
Photograph H8-03 IVR Attenuation Pond Jetty

Description: From the pump pad, looking south at the northern slope of the pump pad.

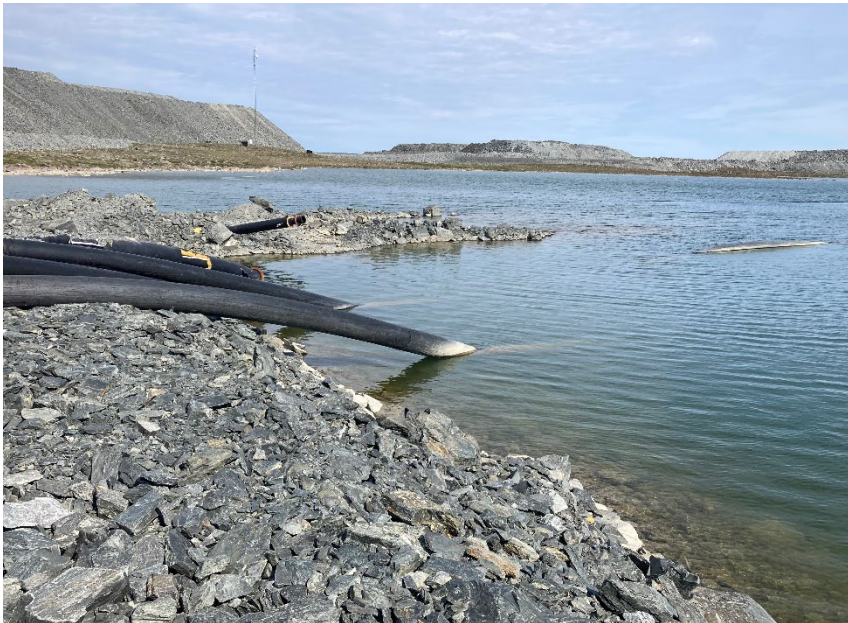
Photograph H8-04 IVR Attenuation Pond Jetty

Description: From the pump pad, looking northwest at the northern slope of the pump pad.

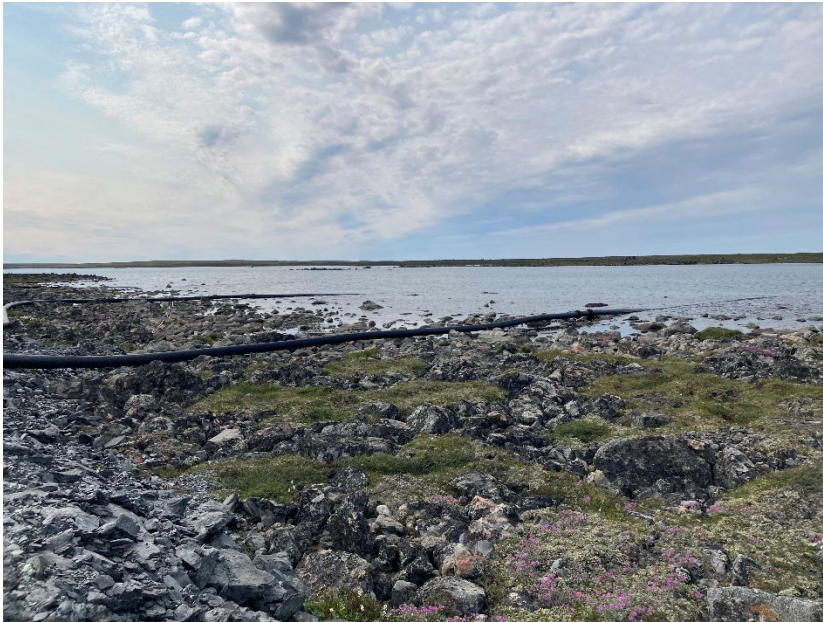
Photograph H9-01 Whale Tail South Diffuser

Description: From the east abutment of Whale Tail Dike, looking south. The diffuser is present and working normally.

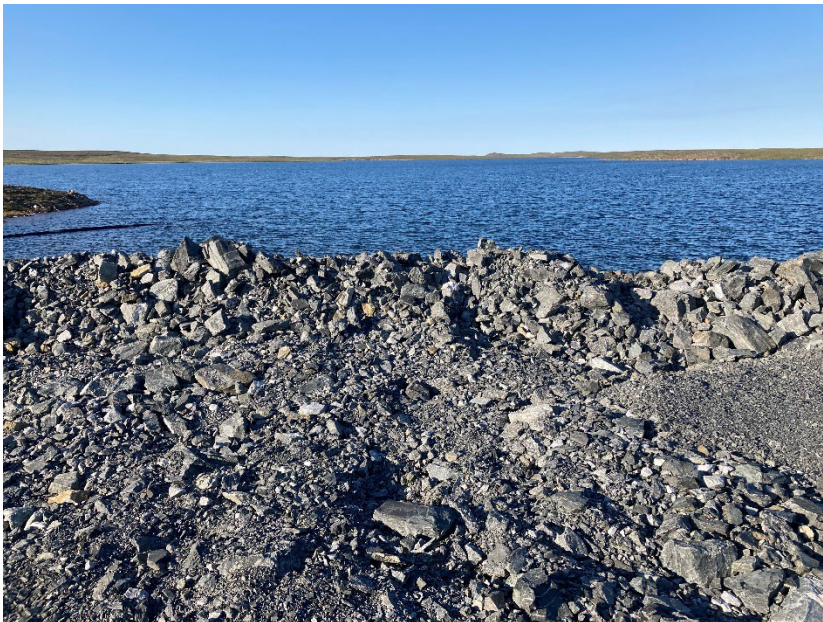
Photograph H9-02 Mammoth Lake Diffuser

Description: From the access road, looking west. Three diffusers are present and working normally.

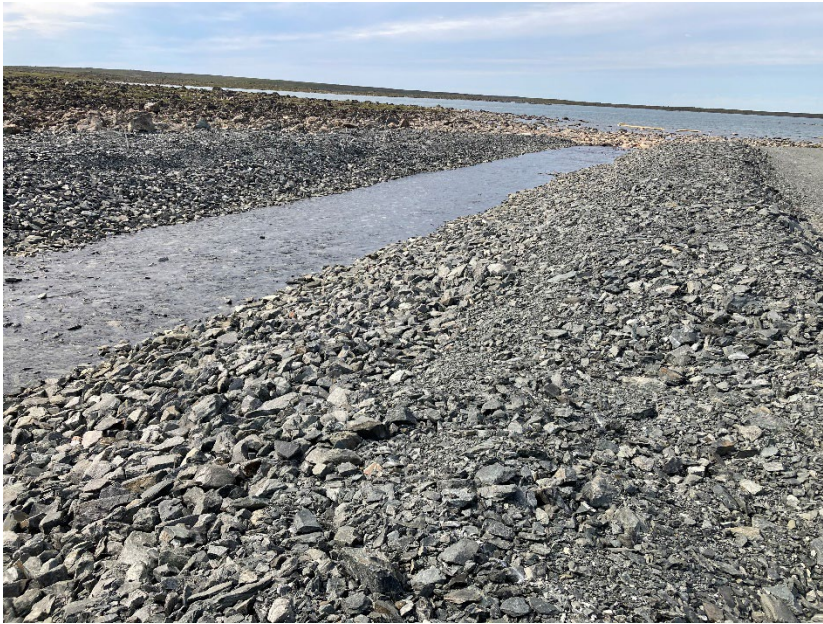
Photograph H10-01 South Whale Tail Channel

Description: From approx. Sta. 0+850, looking northwest. Sloughing and settlement of rockfill above riprap (~500 mm).

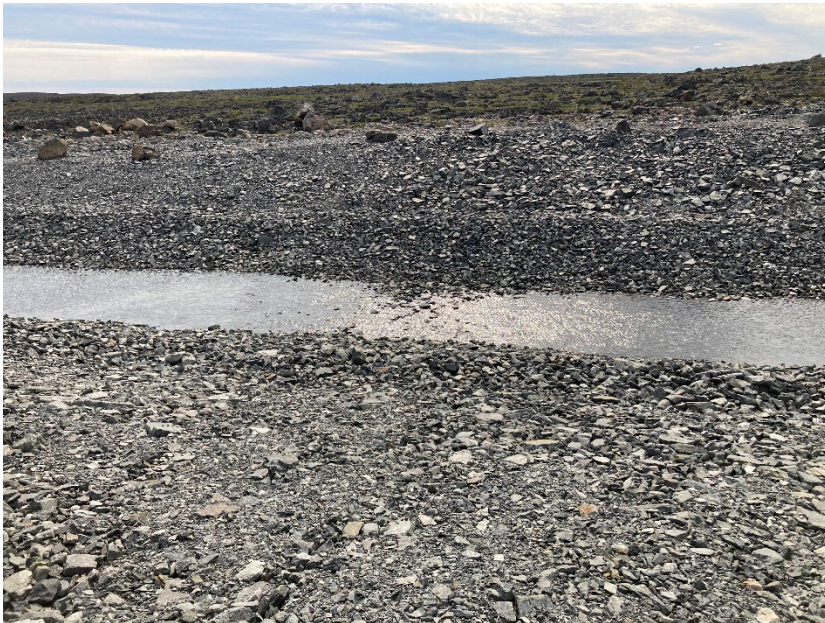
Photograph H10-04 South Whale Tail Channel

Description: From approx. Sta. 0+485, looking west. Limited sloughing of riprap, water still flowing well.

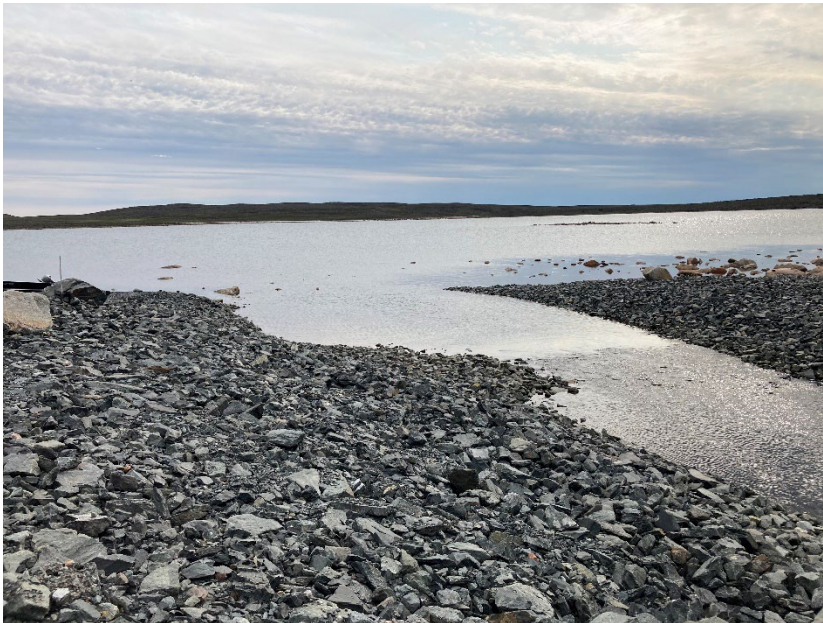
Photograph H10-08 South Whale Tail Channel

Description: From the Whale Tail South Lake inlet, looking southwest. Slight apparent sloughing in riprap.

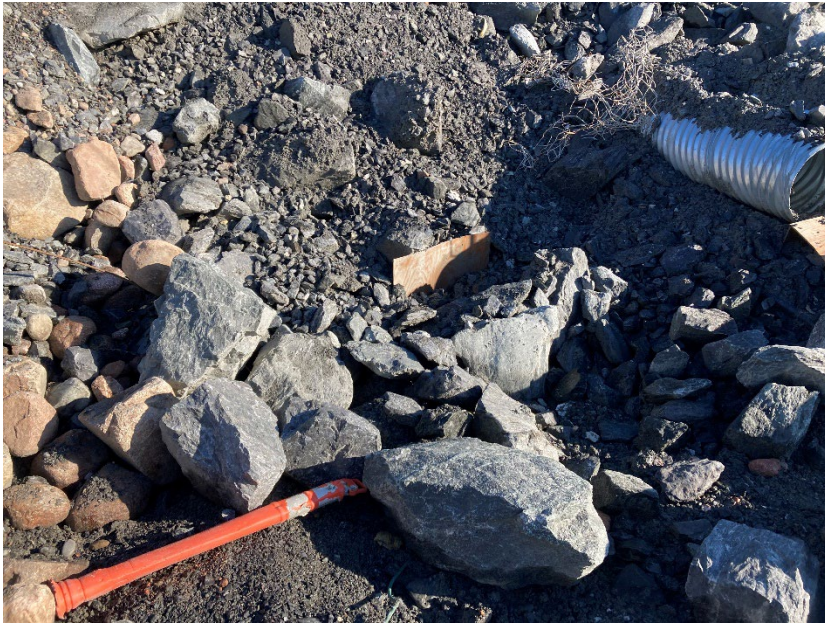
Photograph H11-01 Saline Ditch

Description: From approx. Sta. 0+670, looking east. Debris in ditch close to outlet.

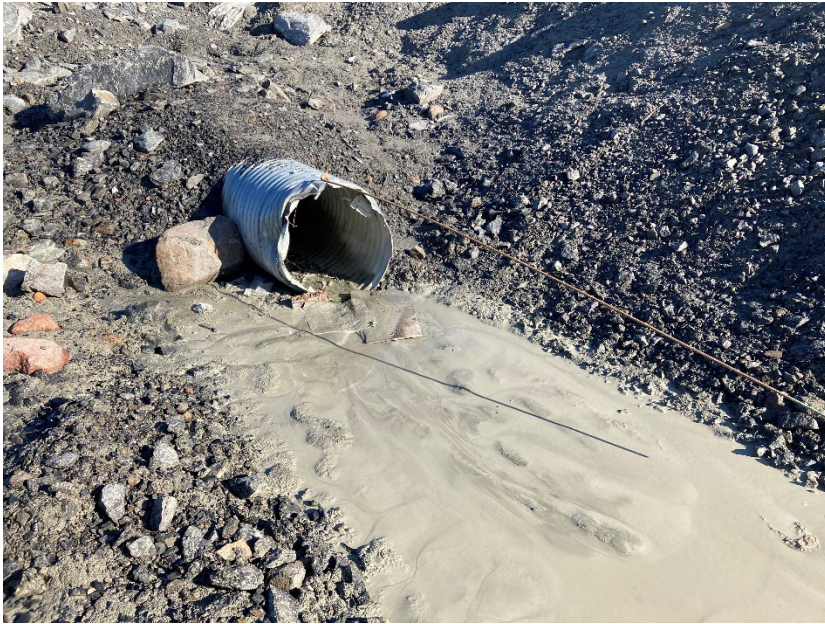
Photograph H11-07 Saline Ditch

Description: From the northern extremity of the Saline Ditch, looking west. The culvert is damaged, but functional.. Mud is accumulating in front of the inlet.

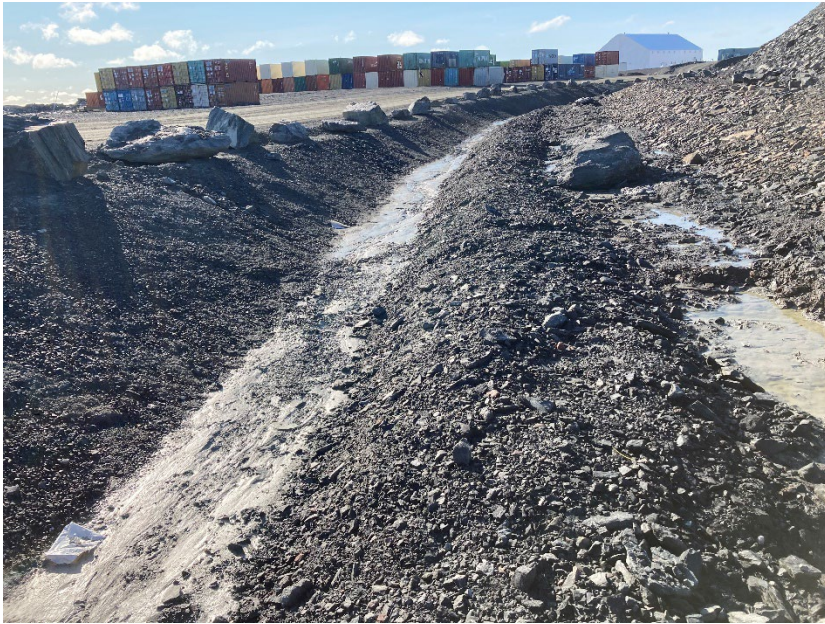
Photograph H11-09 Saline Ditch

Description: From approx. Sta. 0+180, looking southeast. Presence of mud and gravel in the ditch.

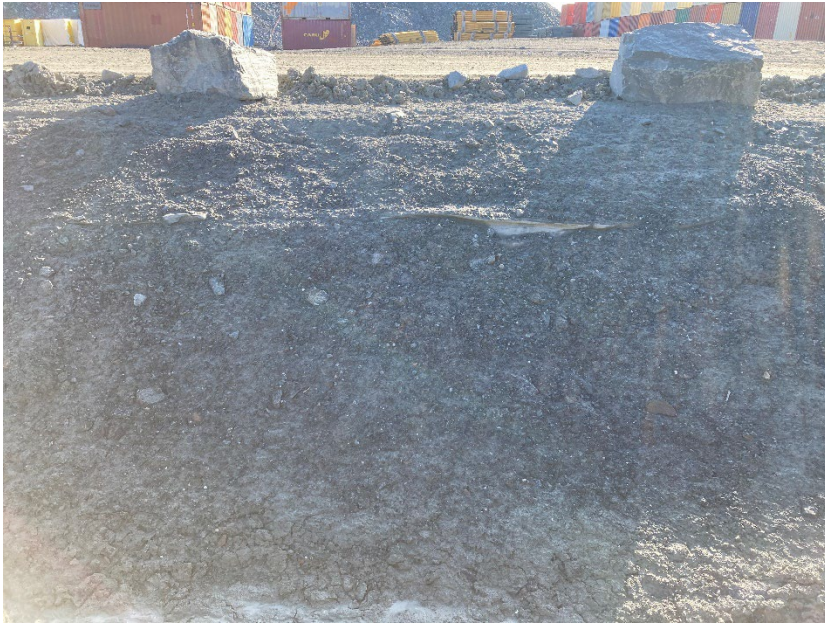
Photograph H11-11 Saline Ditch

Description: From approx. Sta. 0+250, looking east. Erosion of fine material, exposing liner underneath. Limited sloughing of fine material.

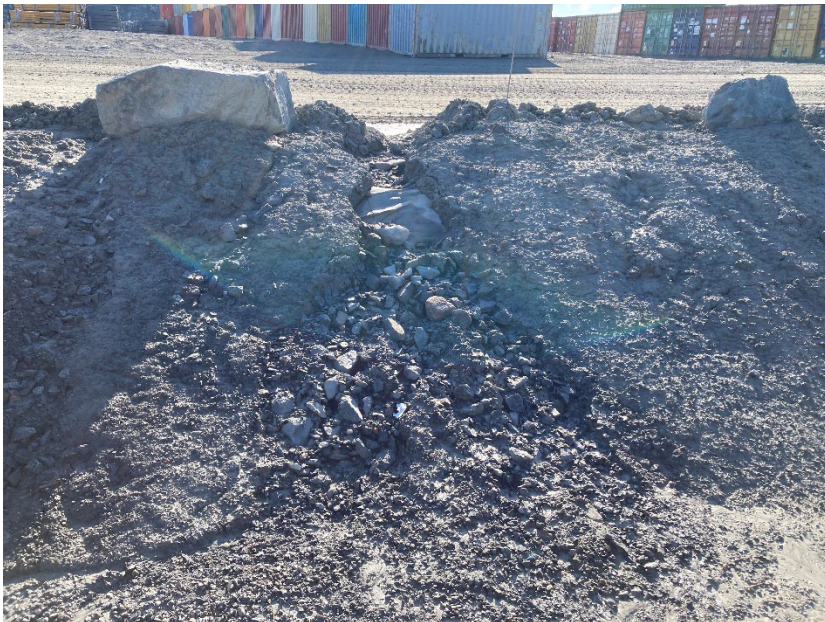
Photograph H11-12 Saline Ditch

Description: From approx. Sta. 0+250, looking west. Erosion of fine material, exposing liner underneath. Limited sloughing of fine material.

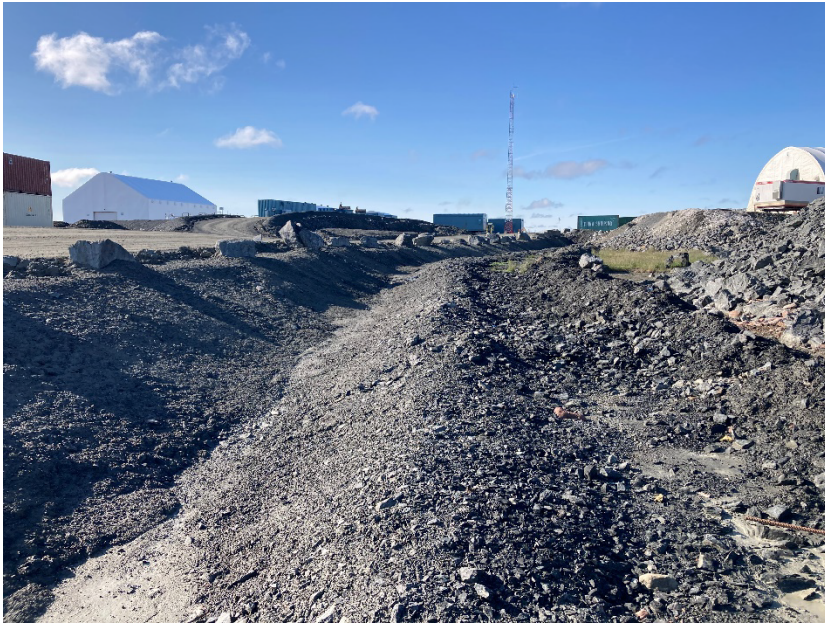
Photograph H11-13 Saline Ditch

Description: From approx. Sta. 0+300, looking south. Presence of gravel in the ditch.

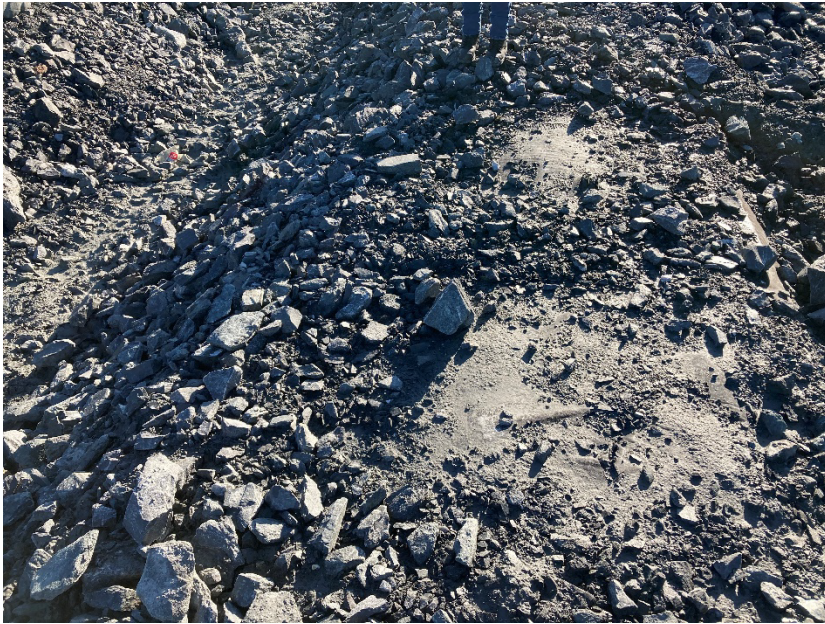
Photograph H12-1 UG Ore Stockpile Saline Ditch

Description: From the southeastern extremity of the UG Ore Stockpile Saline Ditch, looking northeast. Exposed liner in some points.

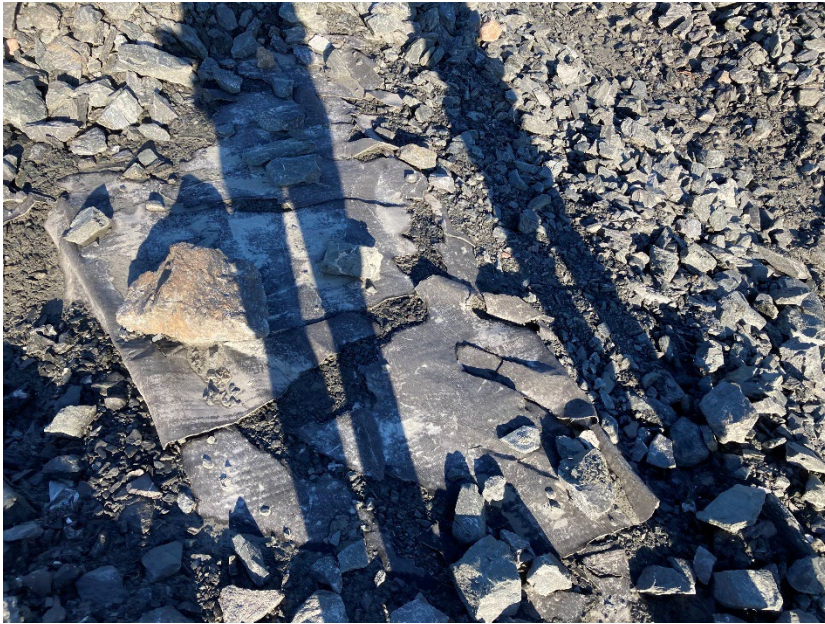
Photograph H12-3 UG Ore Stockpile Saline Ditch

Description: From the southeastern extremity of the UG Ore Stockpile Saline Ditch, looking northeast. Exposed and ripped liner.

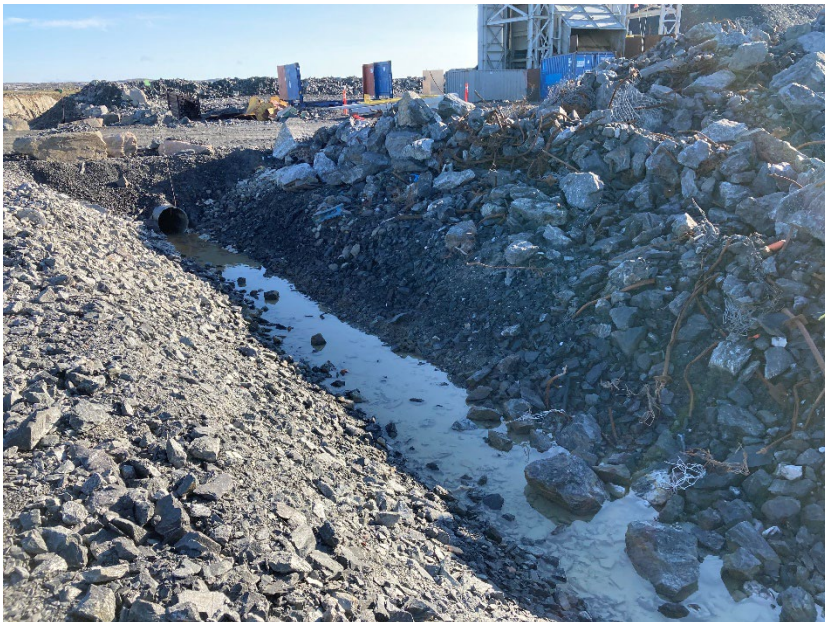
Photograph H12-4 UG Ore Stockpile Saline Ditch

Description: From approx. Sta. 0+050, looking southwest. Presence of debris in the ditch.

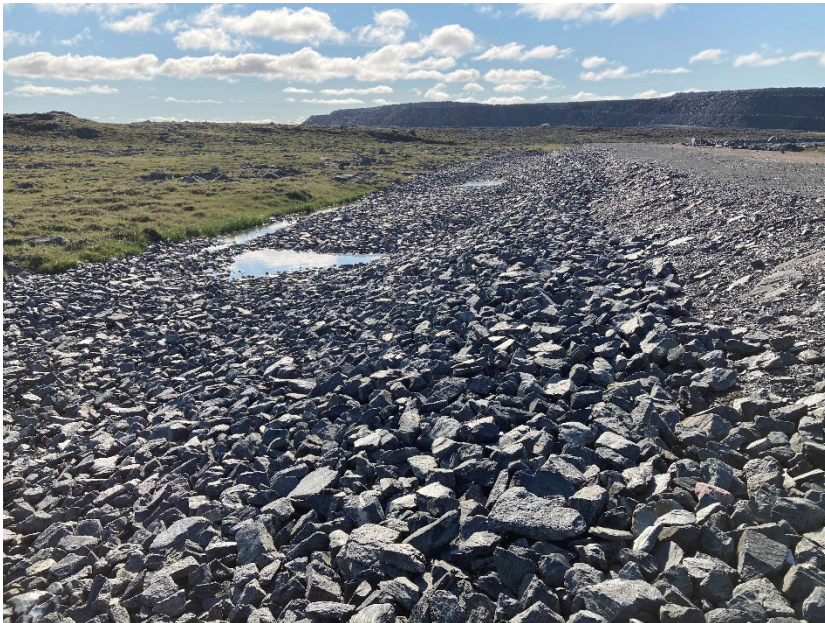
Photo Number: 30

Description: From around Sta. 0+020, looking southeast. Presence of water pounding.

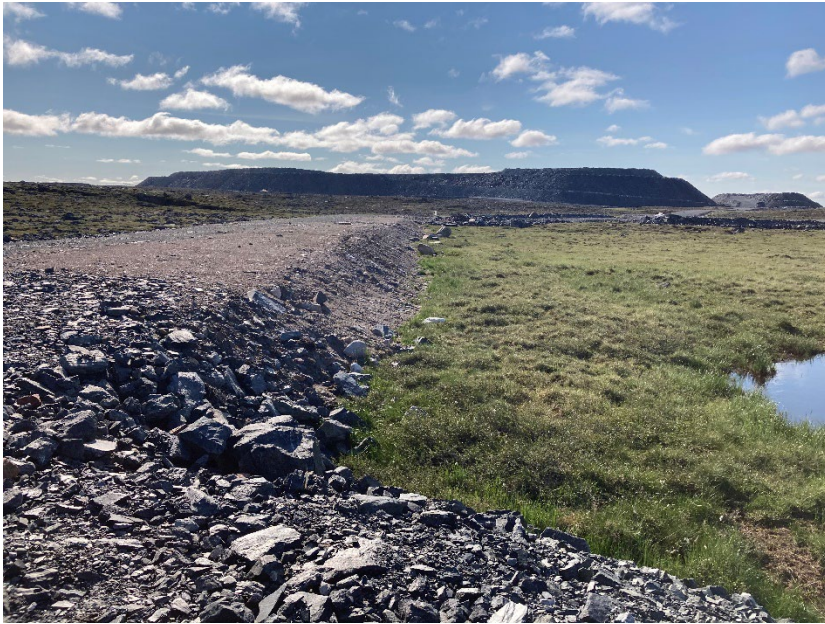
Photo Number: 32

Description: From around the access road Sta. 0+020, looking southeast. Tension cracks and erosion in the sandy slope (upstream).
