CONSTRUCTION SUMMARY (AS-BUILT) REPORT FOR FUEL FARM ENLARGEMENT

HOPE BAY -BOSTON CAMP, NUNAVUT

Doc. N°: 6207-416-132-REP-002

APPENDIX D – TANKS INSEPCION REPORT

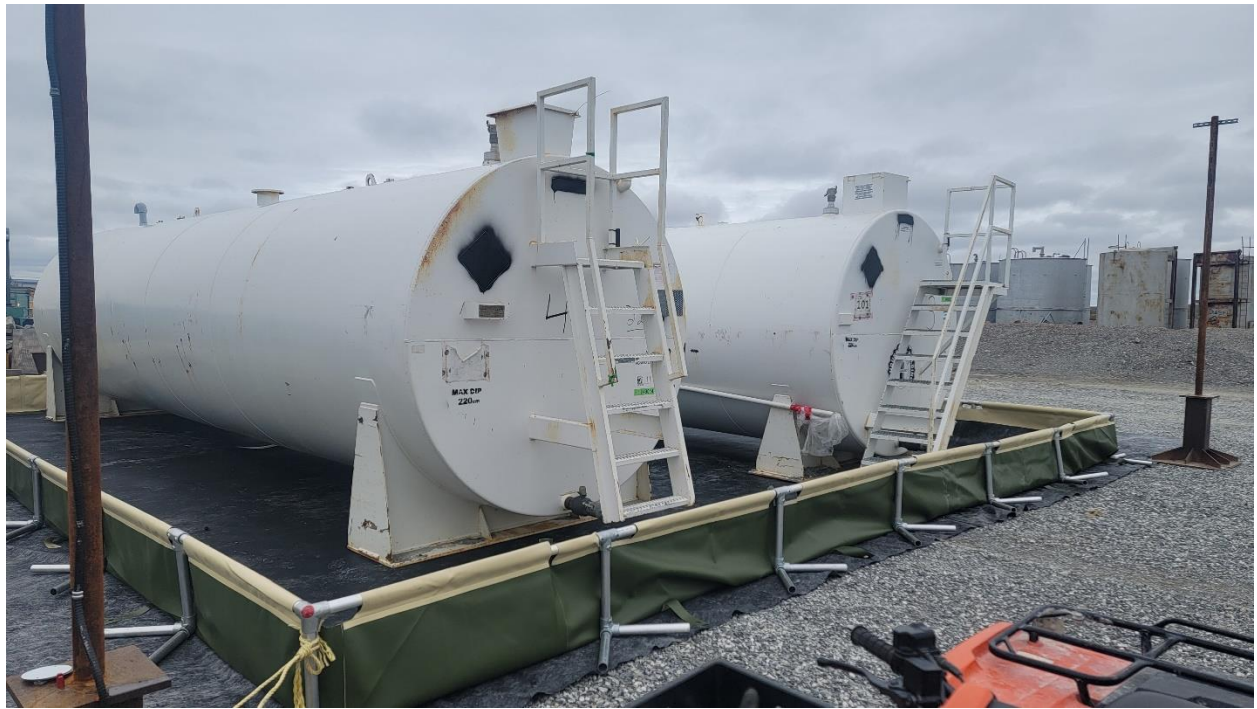
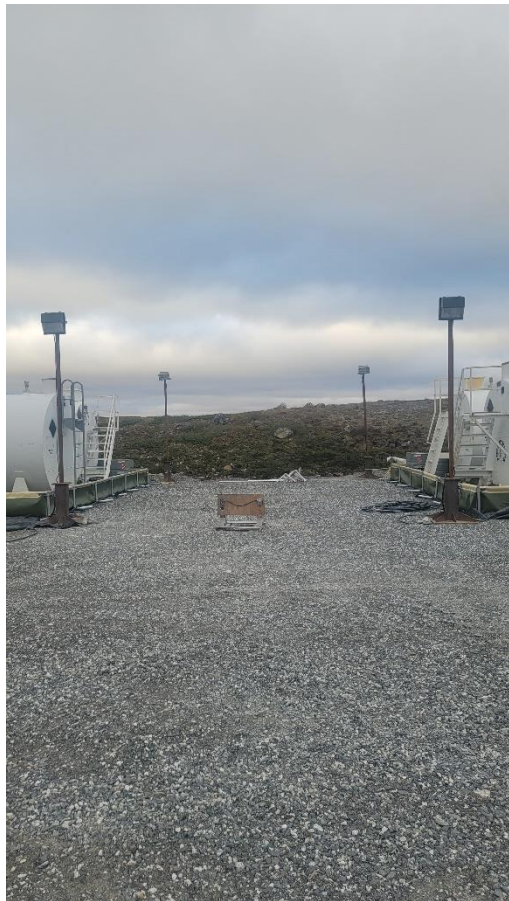
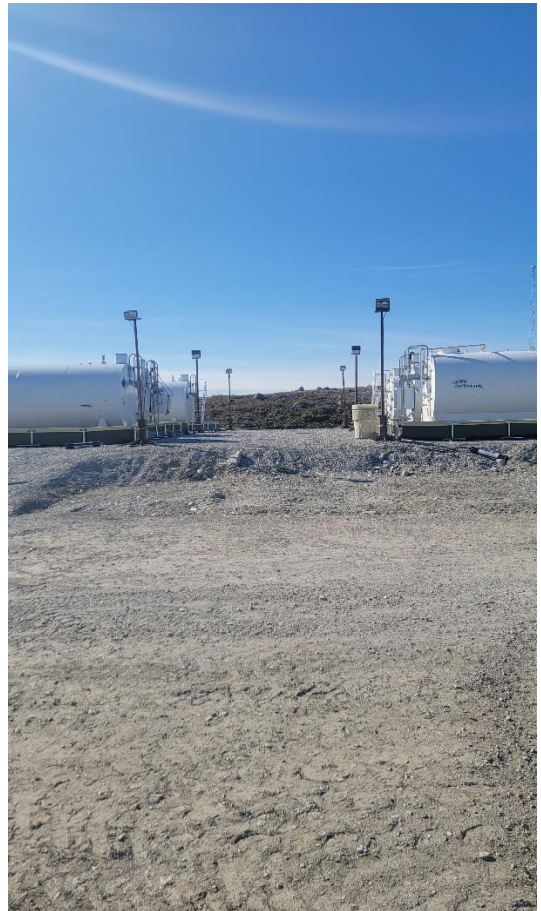
- The measurement in yellow are the only changes made to original plans
- Also tank 6 and tank 8 are 36 ' 9" long not 33' 4" like stated in plan
- The front of the tanks distance from the berm varied depending on style of ladder or stairs that were on the tanks

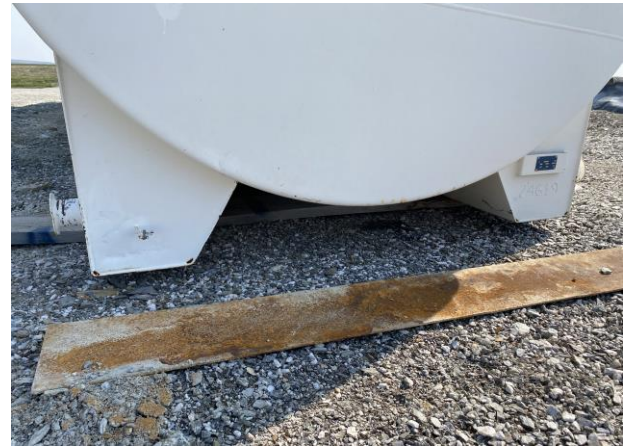
Tank foundation

As New	Acceptable In-Service Condition	Continue to Monitor	Requires Repair	NA	Comments
					Elevated by skid foundation

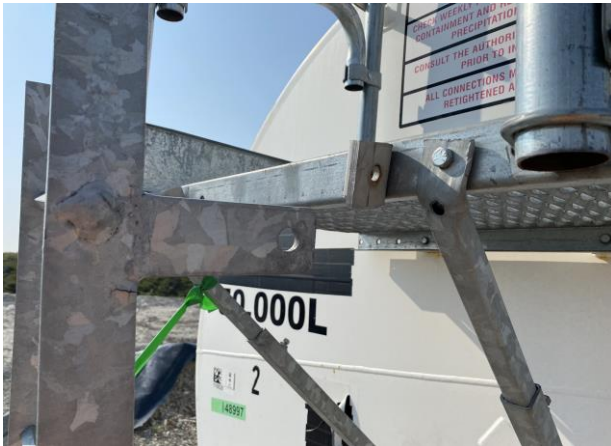
- A visual external inspection was performed on horizontal double wall fuel tank and found to be in acceptable condition
- Tank is out of service with plans of being filled by winter for start up of Boston Camp
- Tank is not grounded
- External coating is chipped/ flaking away with no signs of external atmospheric corrosion occurring on shell or head
- Ladder and platform are not properly connected/bolted to tank

Not properly connected

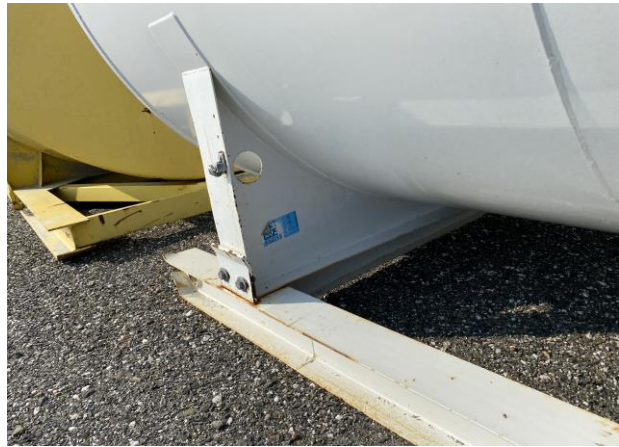
Tank foundation

As New	Acceptable In-Service Condition	Continue to Monitor	Requires Repair	NA	Comments
					Skid is bent in multiple places

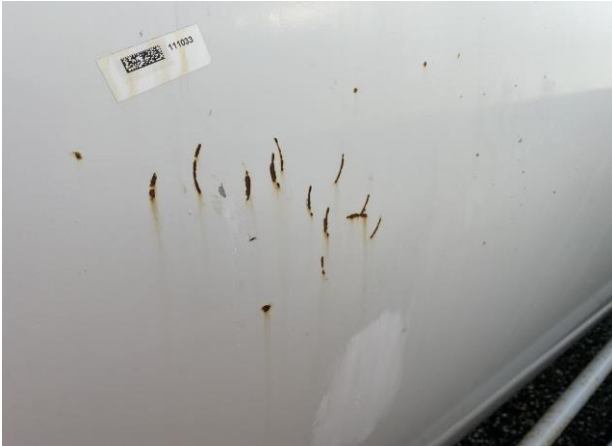
Coating is chipping

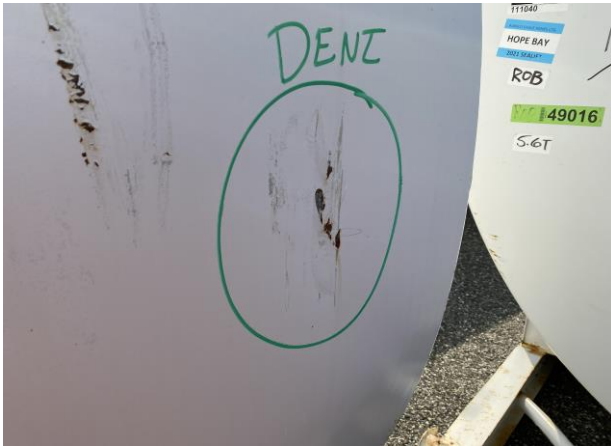
Dent in shell

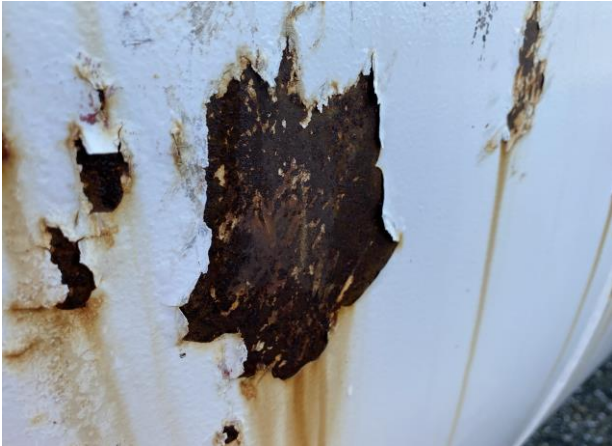
Coating is chipping

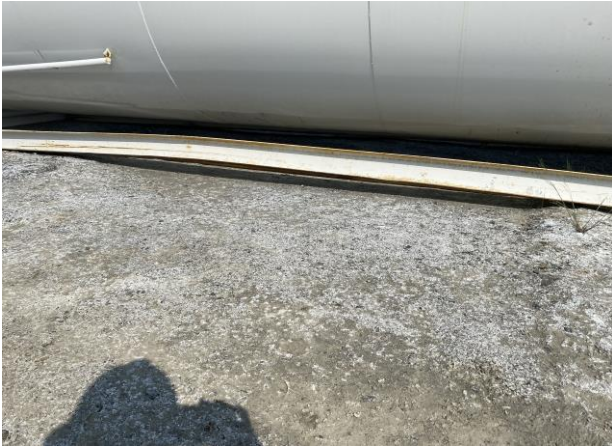
Skid is bent
