WATER LICENCE INSPECTION FORM

PHOTO LOG

**Re: Meliadine – 2BB-MEL1424
Meliadine Portal Area – Water Quality Monitoring in Lake A54
Adverse Trends Noted – Mitigation Measures being implemented**

TYPICAL SECTIONS OF P1 WATER MANAGEMENT
INFRASTRUCTURE FOR FRESHET 2016

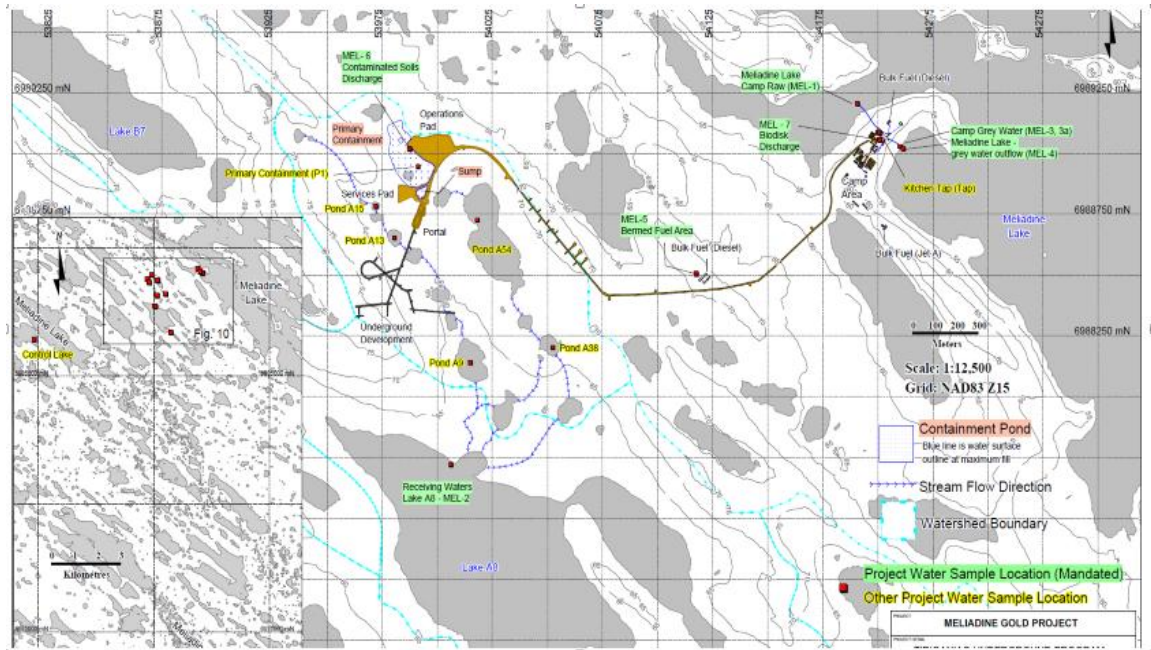
Figure 3: Meliadine Decline Water Management - Water Quality Monitoring Stations

Under the WMP, water quality monitoring stations have been established by Agnico and regularly sampled in the open water season, specifically P1 (Mel6), Pond A54, Pond A38, Pond A9 and in Lake A8 (Mel 2) (see Figure 3) (Mel6 and Mel2 are mandated under the Water License). Typically four sampling events have occurred each year. The results from this water quality monitoring activity has been previously reported to the NWB and KIA through the Water License monthly and annual reports since 2009 (2009 thru 2011 by Comaplex, 2012 thru today by Agnico).

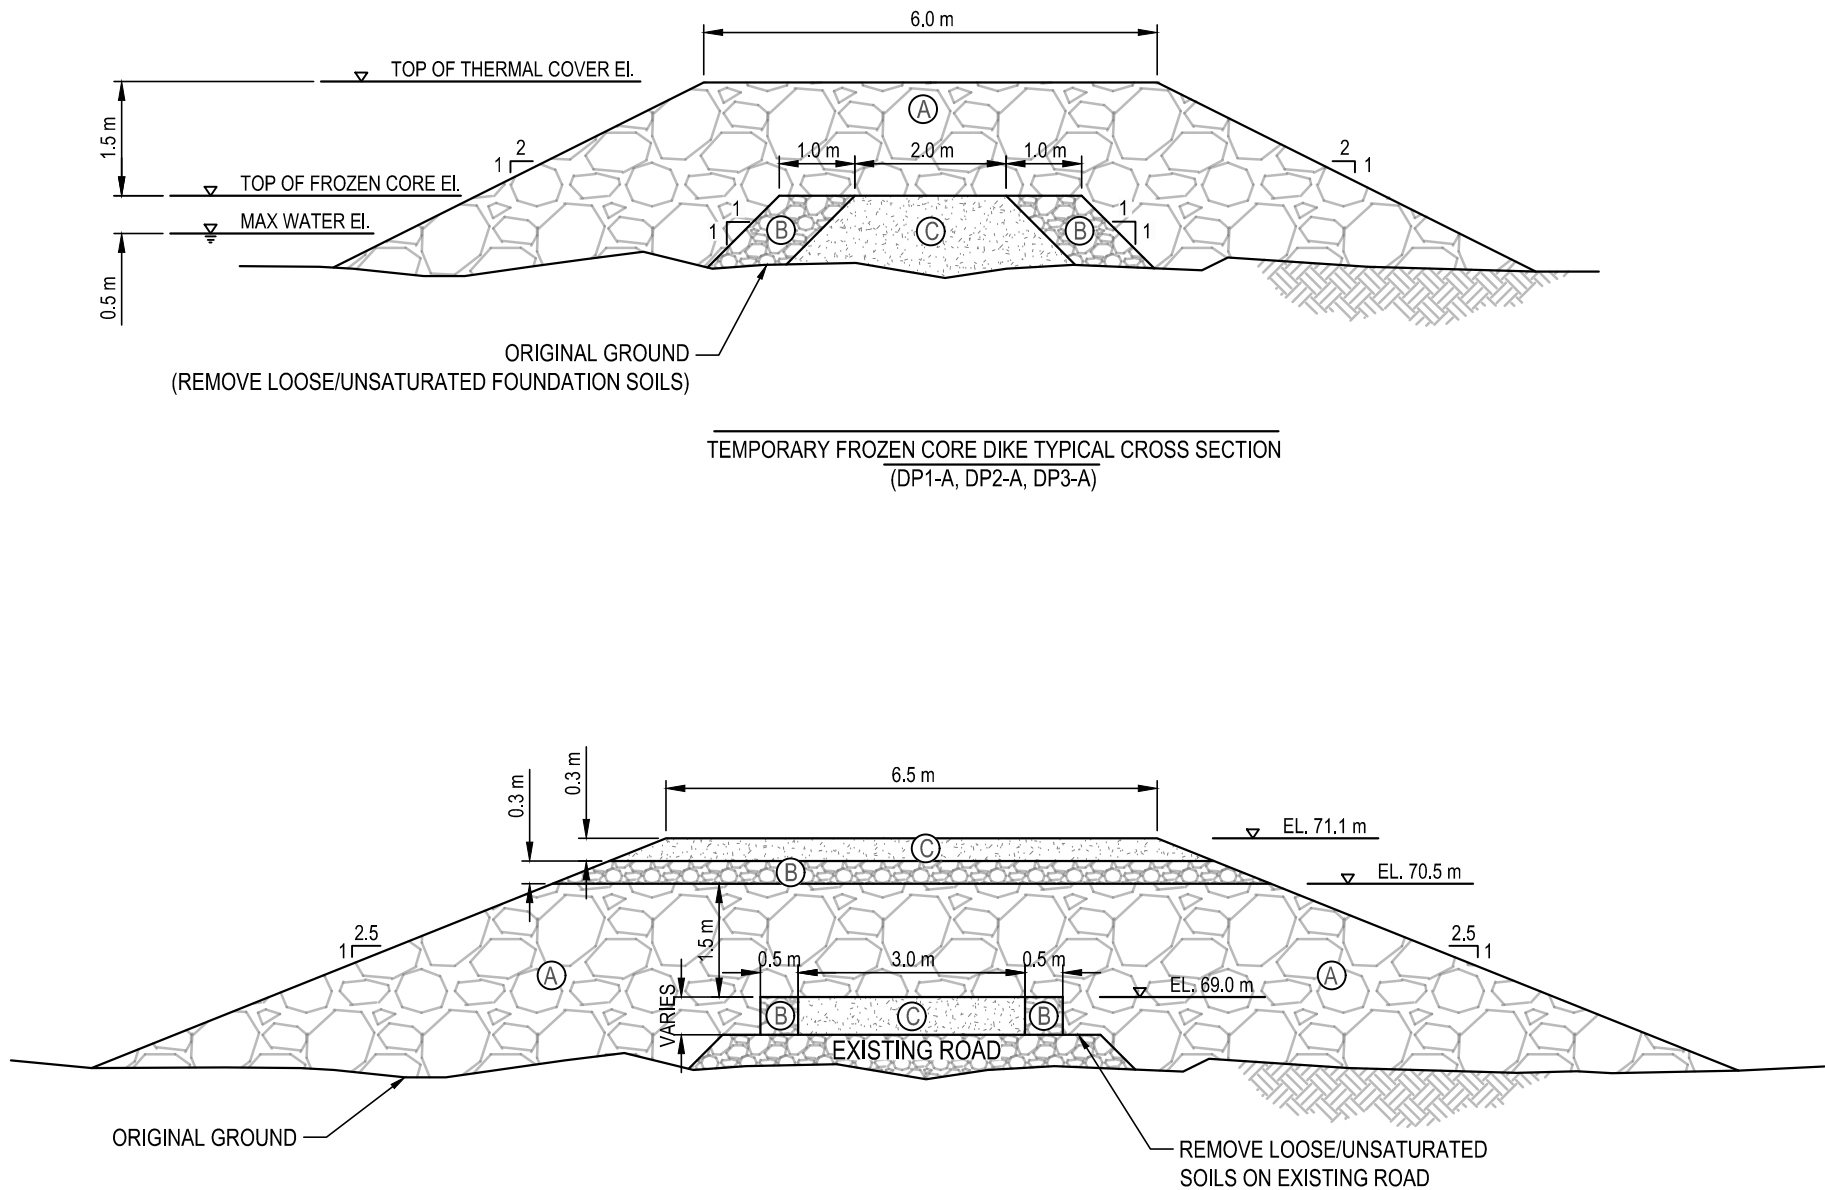
10. An additional dyke, DP1-B has been added to the design, which is located the north side of A58 Lake.
11. AEM is preparing an emergency plan to mitigate other risks caused by the construction activity.

TEMPORARY FROZEN CORE DIKES			
FROZEN CORE DIKE	MAX WATER EL. (m)	TOP OF FROZEN CORE EL. (m)	TOP OF THERMAL COVER EL. (m)
DP1-A	68.5	69.0	70.5
DP1-B	68.5	69.0	70.5
DP2-A	67.5	68.0	69.5
DP3-A	67.0	67.5	69.0
