WATER LICENCE INSPECTION FORM

☐ Original  
☒ Follow-Up Report

On May 8<sup>th</sup>, 2017 Indigenous and Northern Affairs Canada’s Water Resource Officer, Christine Wilson conducted a follow up to the April 10<sup>th</sup> inspection of Agnico Eagle Mines Limited’s (‘AEM’) Meliadine Advanced Exploration project, water licence 2BB-MEL1424. The inspection was completed with the assistance of AEM’s, Environmental Technician, Philip Roy.

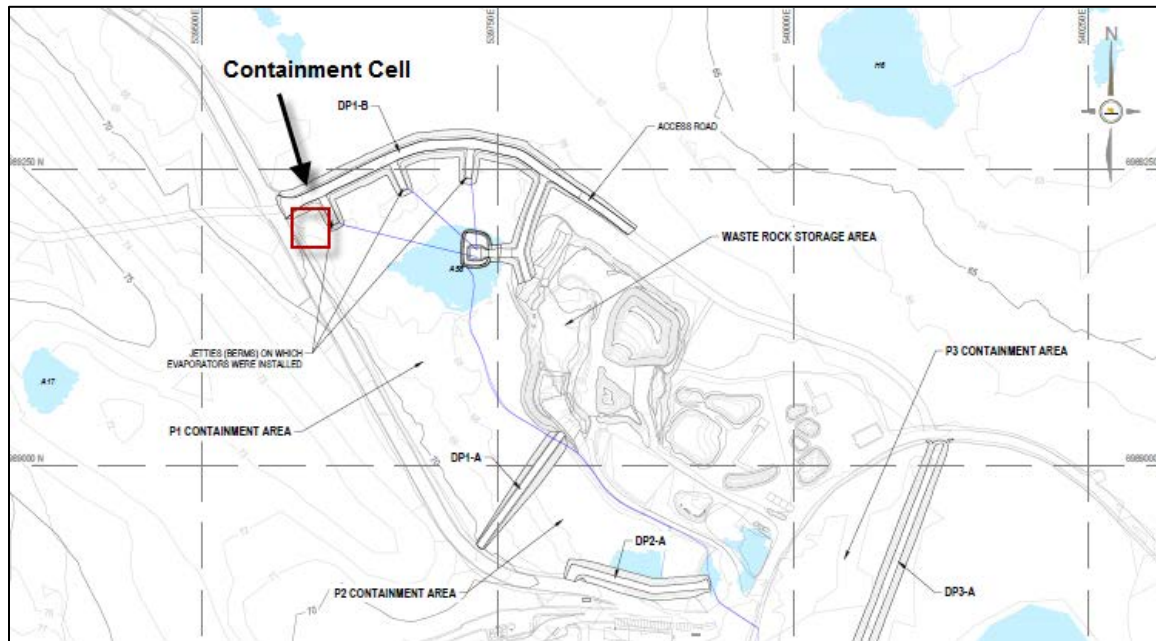
**Figure 1 – Containment Cell General Location**

The Containment Cell will be located in the P1 area, on the upstream side of the DP1-B structure, as presented on Figure 1. The cell will be located on the west corner of the DP1-B, between the rock finger build for the placement of the evaporator, and between the access road. In order to build the Containment Cell, the following work elements will be completed, as detailed on the attached drawing (draft version).
