Meliadine Exploration Project

**Fuel Tank in Meliadine Lake,
Closing Report**

September 17th, 2020

**Agnico Eagle Mines Limited,
Exploration Division**

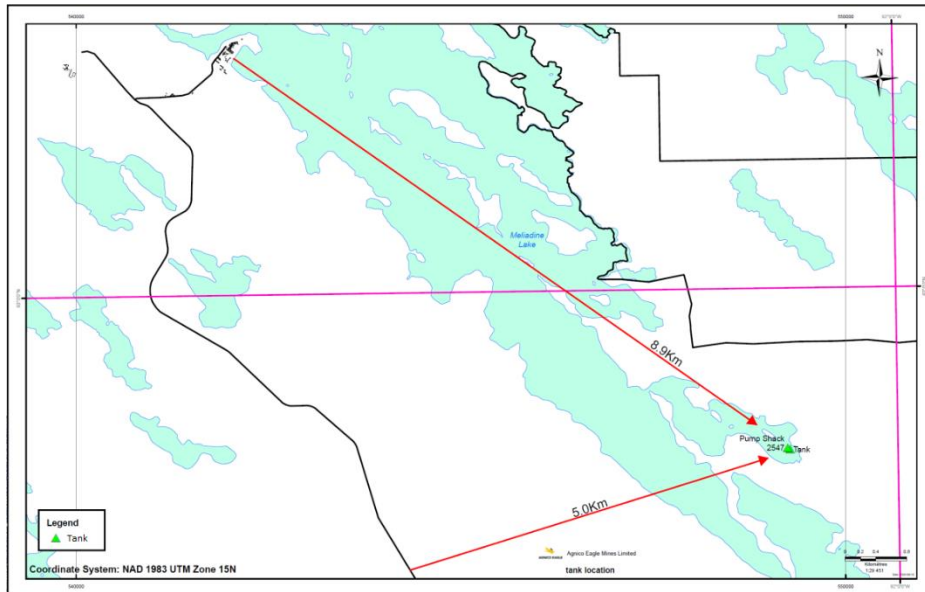
Figure 2. Location of the fuel tank

On August 18th, Agnico Eagle Mines Limited (Agnico Eagle) was informed by Crown-Indigenous Relations and Northern Affairs Canada (CIRNAC), Water Resources Officer, that a steel sled and fuel tank had been observed in Meliadine Lake (see Figure 1) at coordinates N62 58' 53.0" W092 01' 41.2" at approximately 8.9 km southeast of the Meliadine exploration camp (see Figure 2).

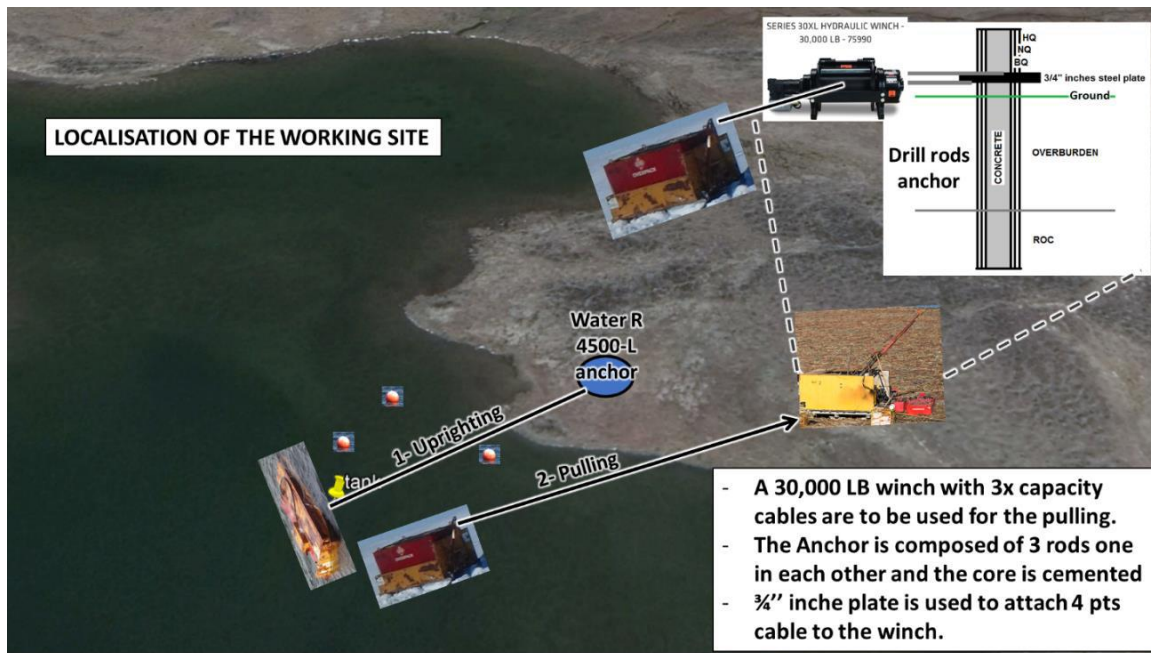
Figure 4. Plan view of the planned operation

In preparation for the operation, a 4,500-liter water container was heliported and filled with water on the shore to be used as an anchor during the pivoting operation (see Figure 5). Straps were attached to the container and a chain block was installed. The cable was attached from the container to the side of the submerged tank and a slight tension was applied. Divers observed that only by this slight tension the tank was starting to rise. The skid that would act as a pivot point seemed to be anchored securely enough to the ground so that any other means to avoid its sliding during the lifting operation would be unnecessary.
