November 19, 2008

Baffinland Iron Mines Corporation  
Suite 1016, 120 Adelaide Street West  
Toronto, ON M5T 1T1

**RE: ANNUAL GEOTECHNICAL INSPECTION 2008  
BAFFINLAND IRON MINES CORPORATION  
OUR REFERENCE NO. 07-039**

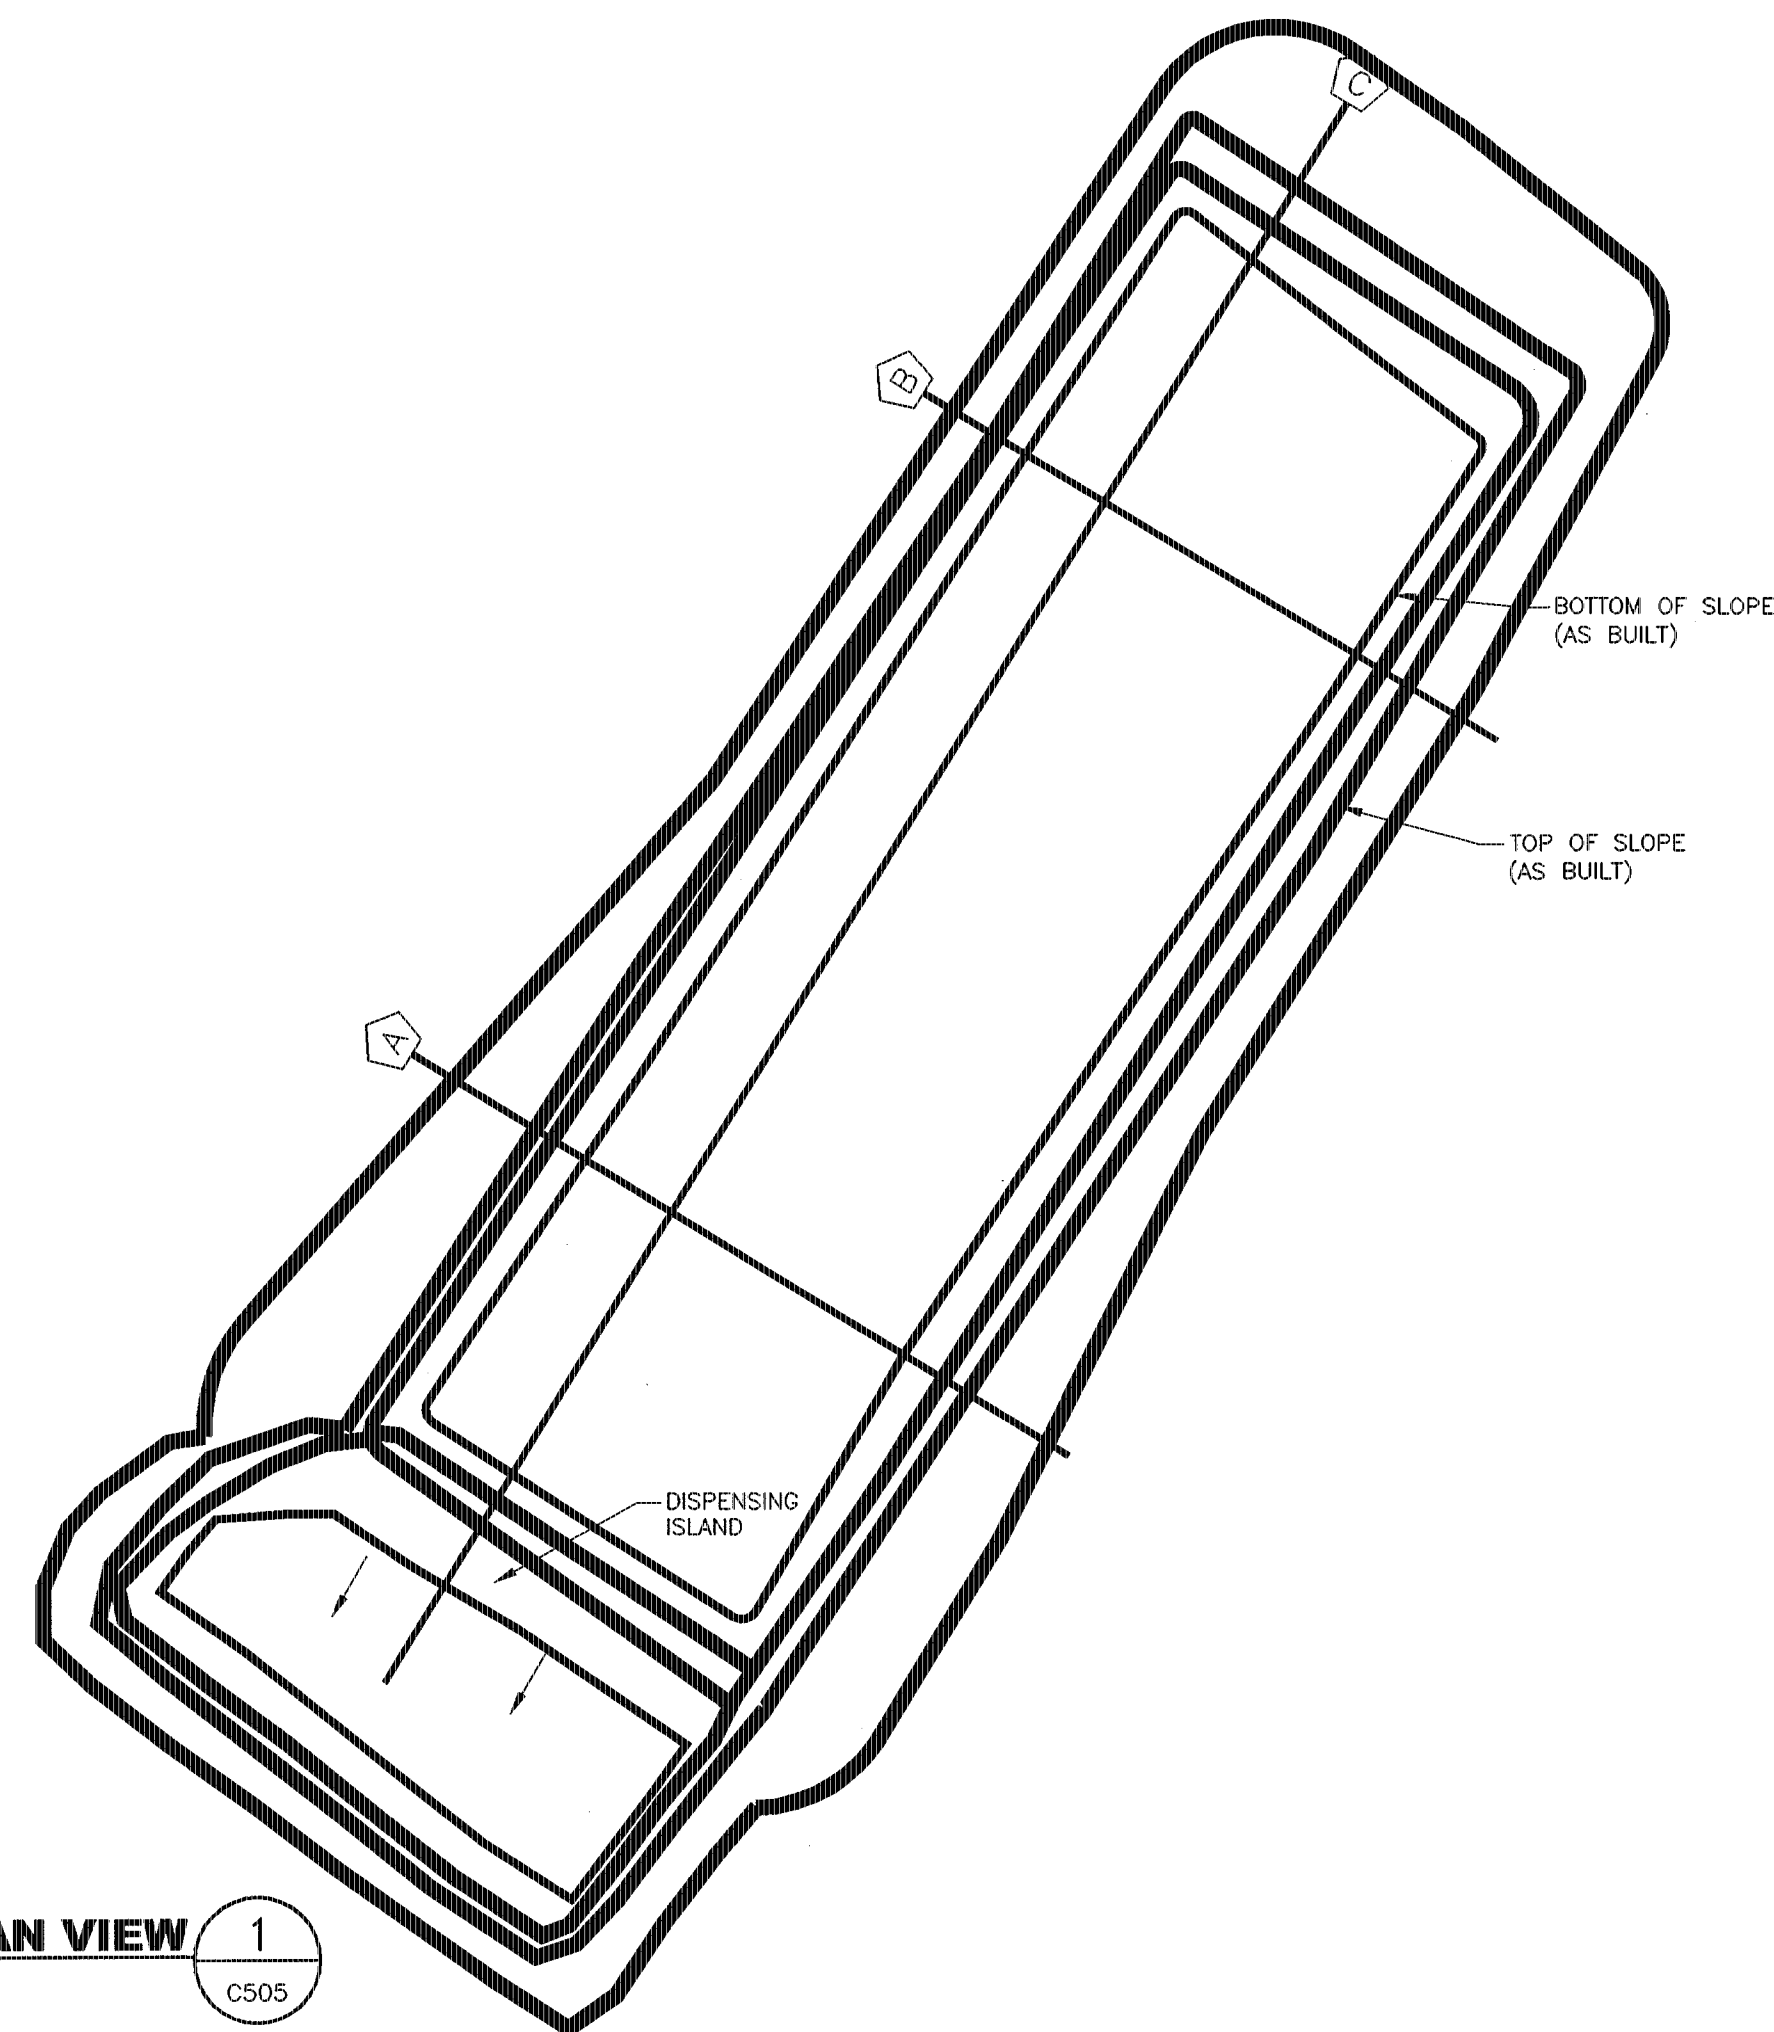
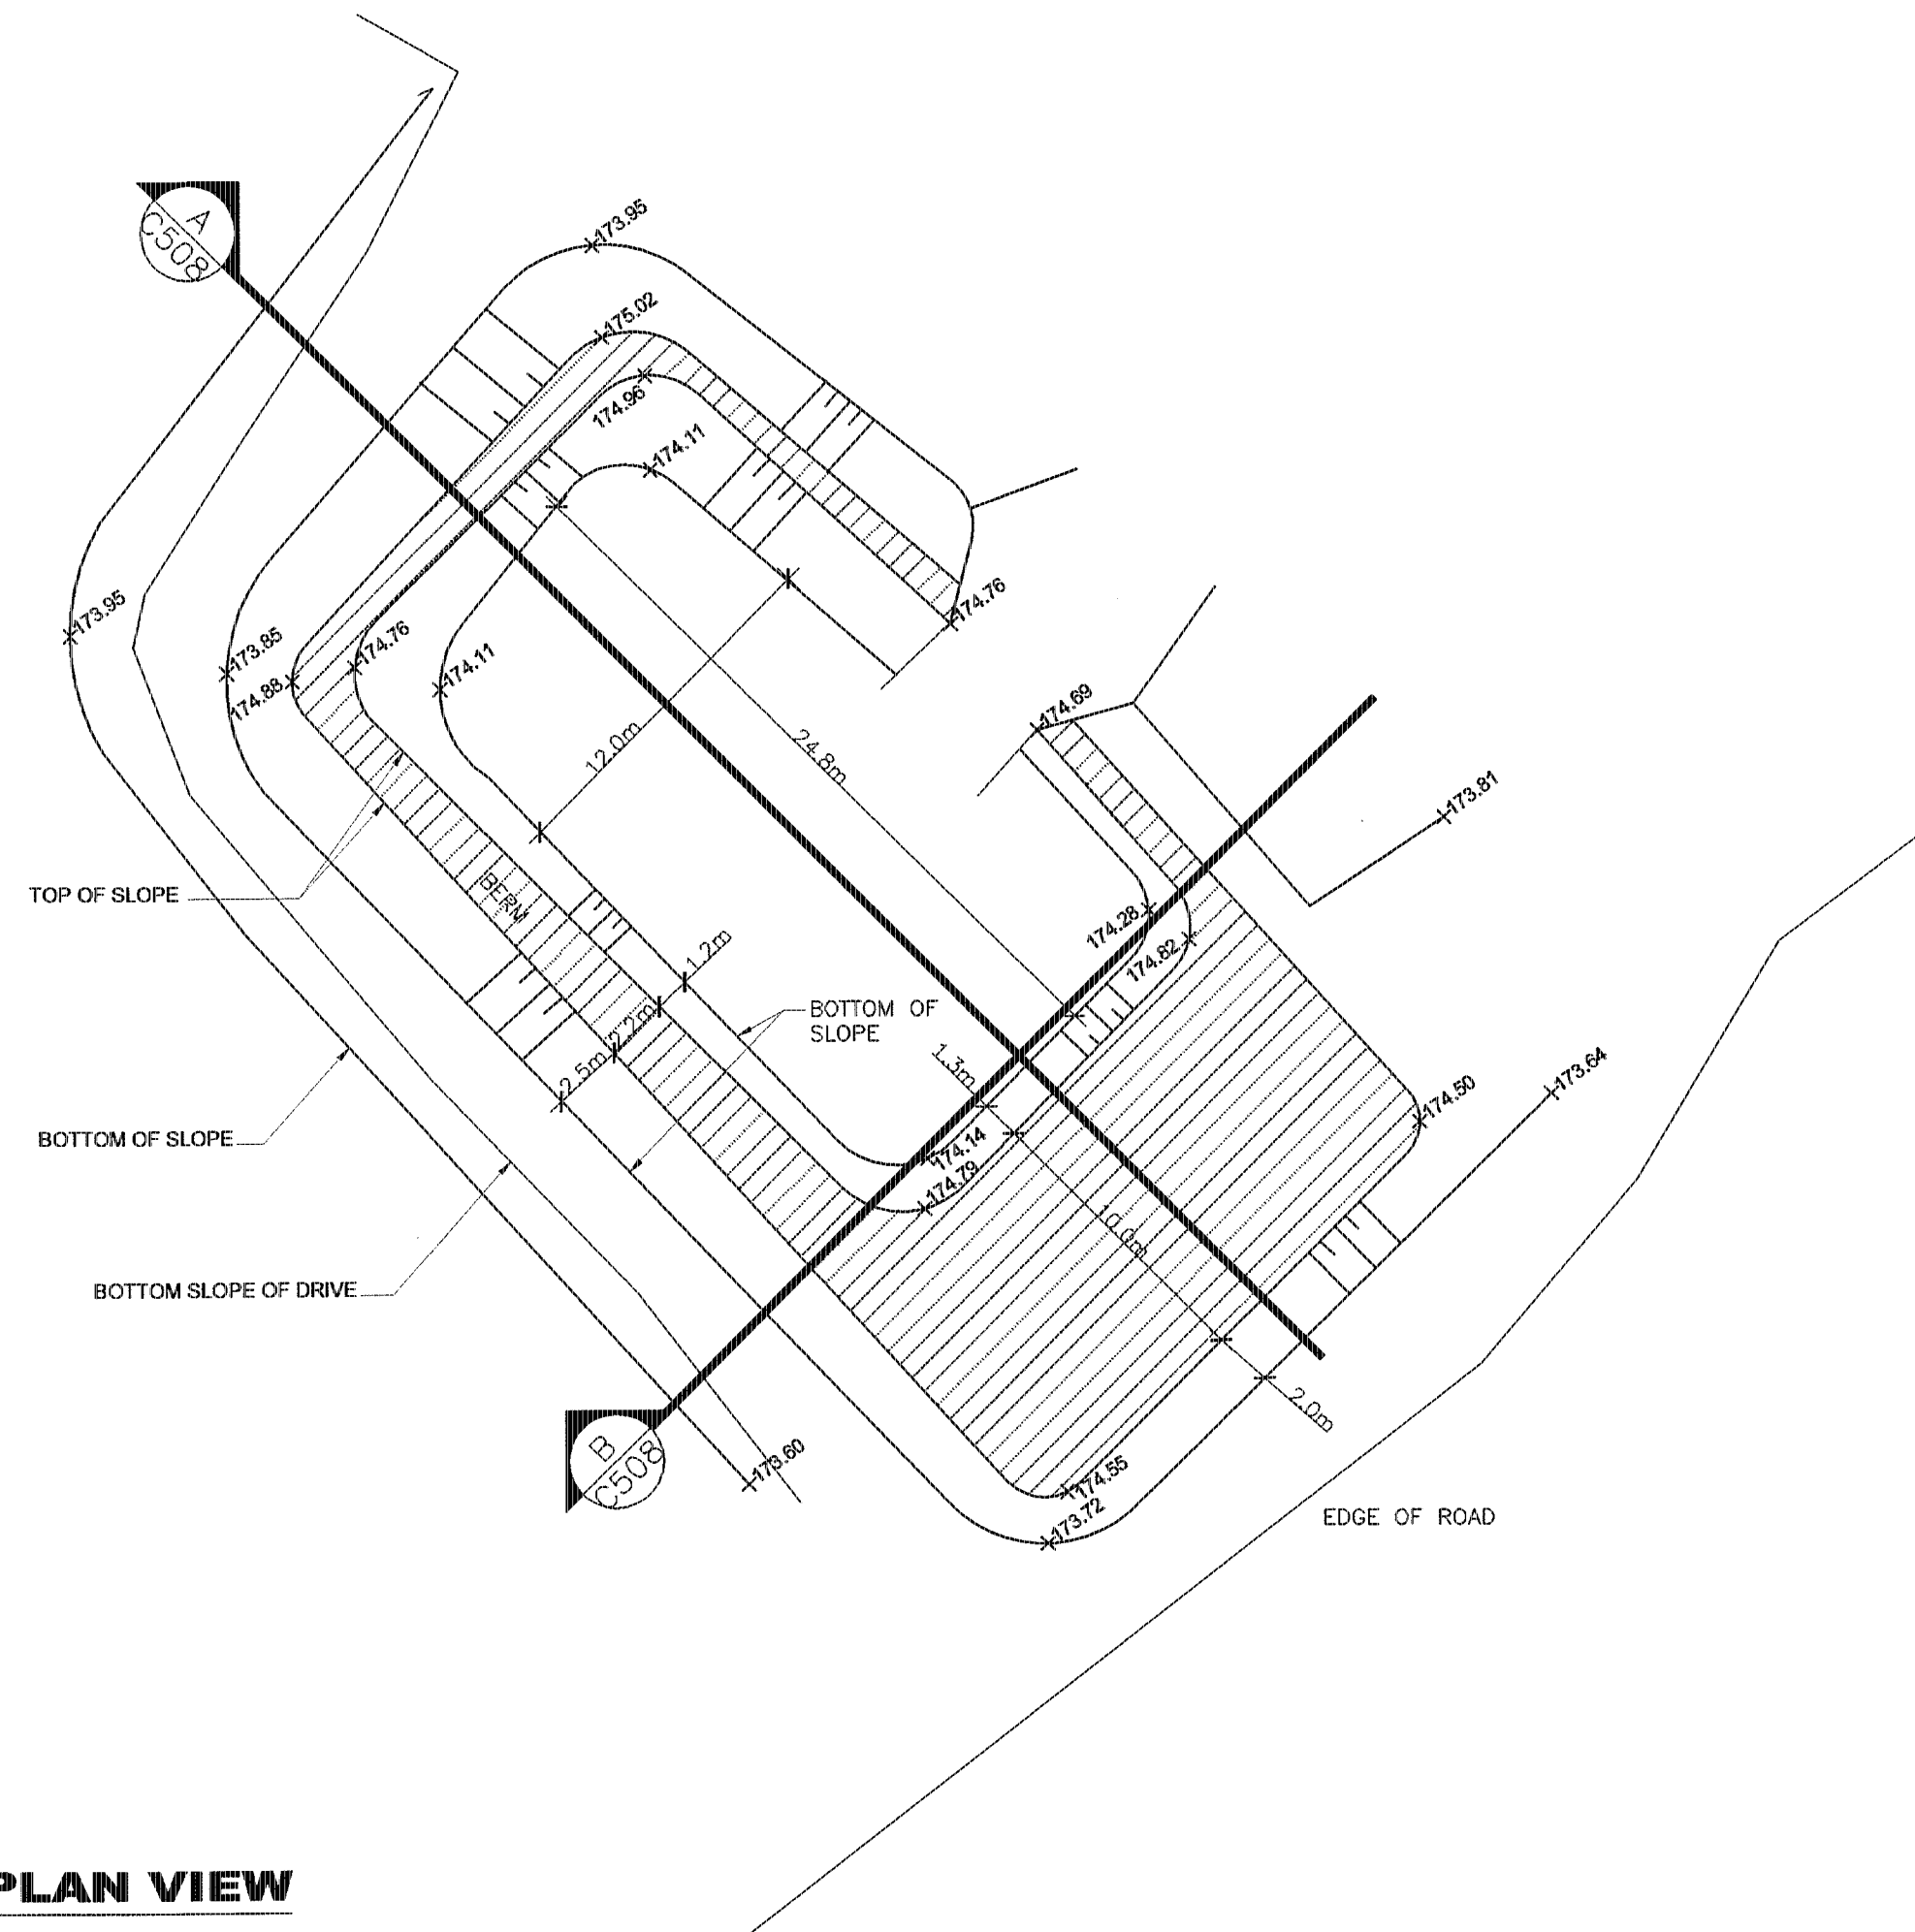
Project  
**MARY RIVER PROJECT**  
**BAFFIN LAND IRON**  
**MINES CORPORATION**  
BAFFIN ISLAND NUNAVUT  
Drawing  
**MARY RIVER FUEL FARM**  
**REQUIRED GRADING**  
**PLAN AND SECTIONS**

A review of the exterior and top of the dykes showed no indication of settlement or cracking which would be indicative of overstress on the structure.

A review of the exposed liner on the upper edge of the dyke showed a number of tears in the upper edge of the liner caused by vehicular traffic on the top of the dyke and generally within a distance of 30 m of the ramp access to the top of the dyke.

The structure is considered to be stable in its present condition.

- It is recommended that the exterior slopes on the dykes be built out to a 4:1 slope if the effluent level exceeds the levels measured on September 4, 2008 (175.90).
- In consideration of the potential for the thawing of permafrost regime under the PWSP, it is recommended that monitoring points be established on the dyke structure and an elevation monitoring program be implemented to measure any potential settlement. It is recommended that a monthly monitoring be implemented from May through October 2009.
- The liner rips should be repaired as soon as practicable.

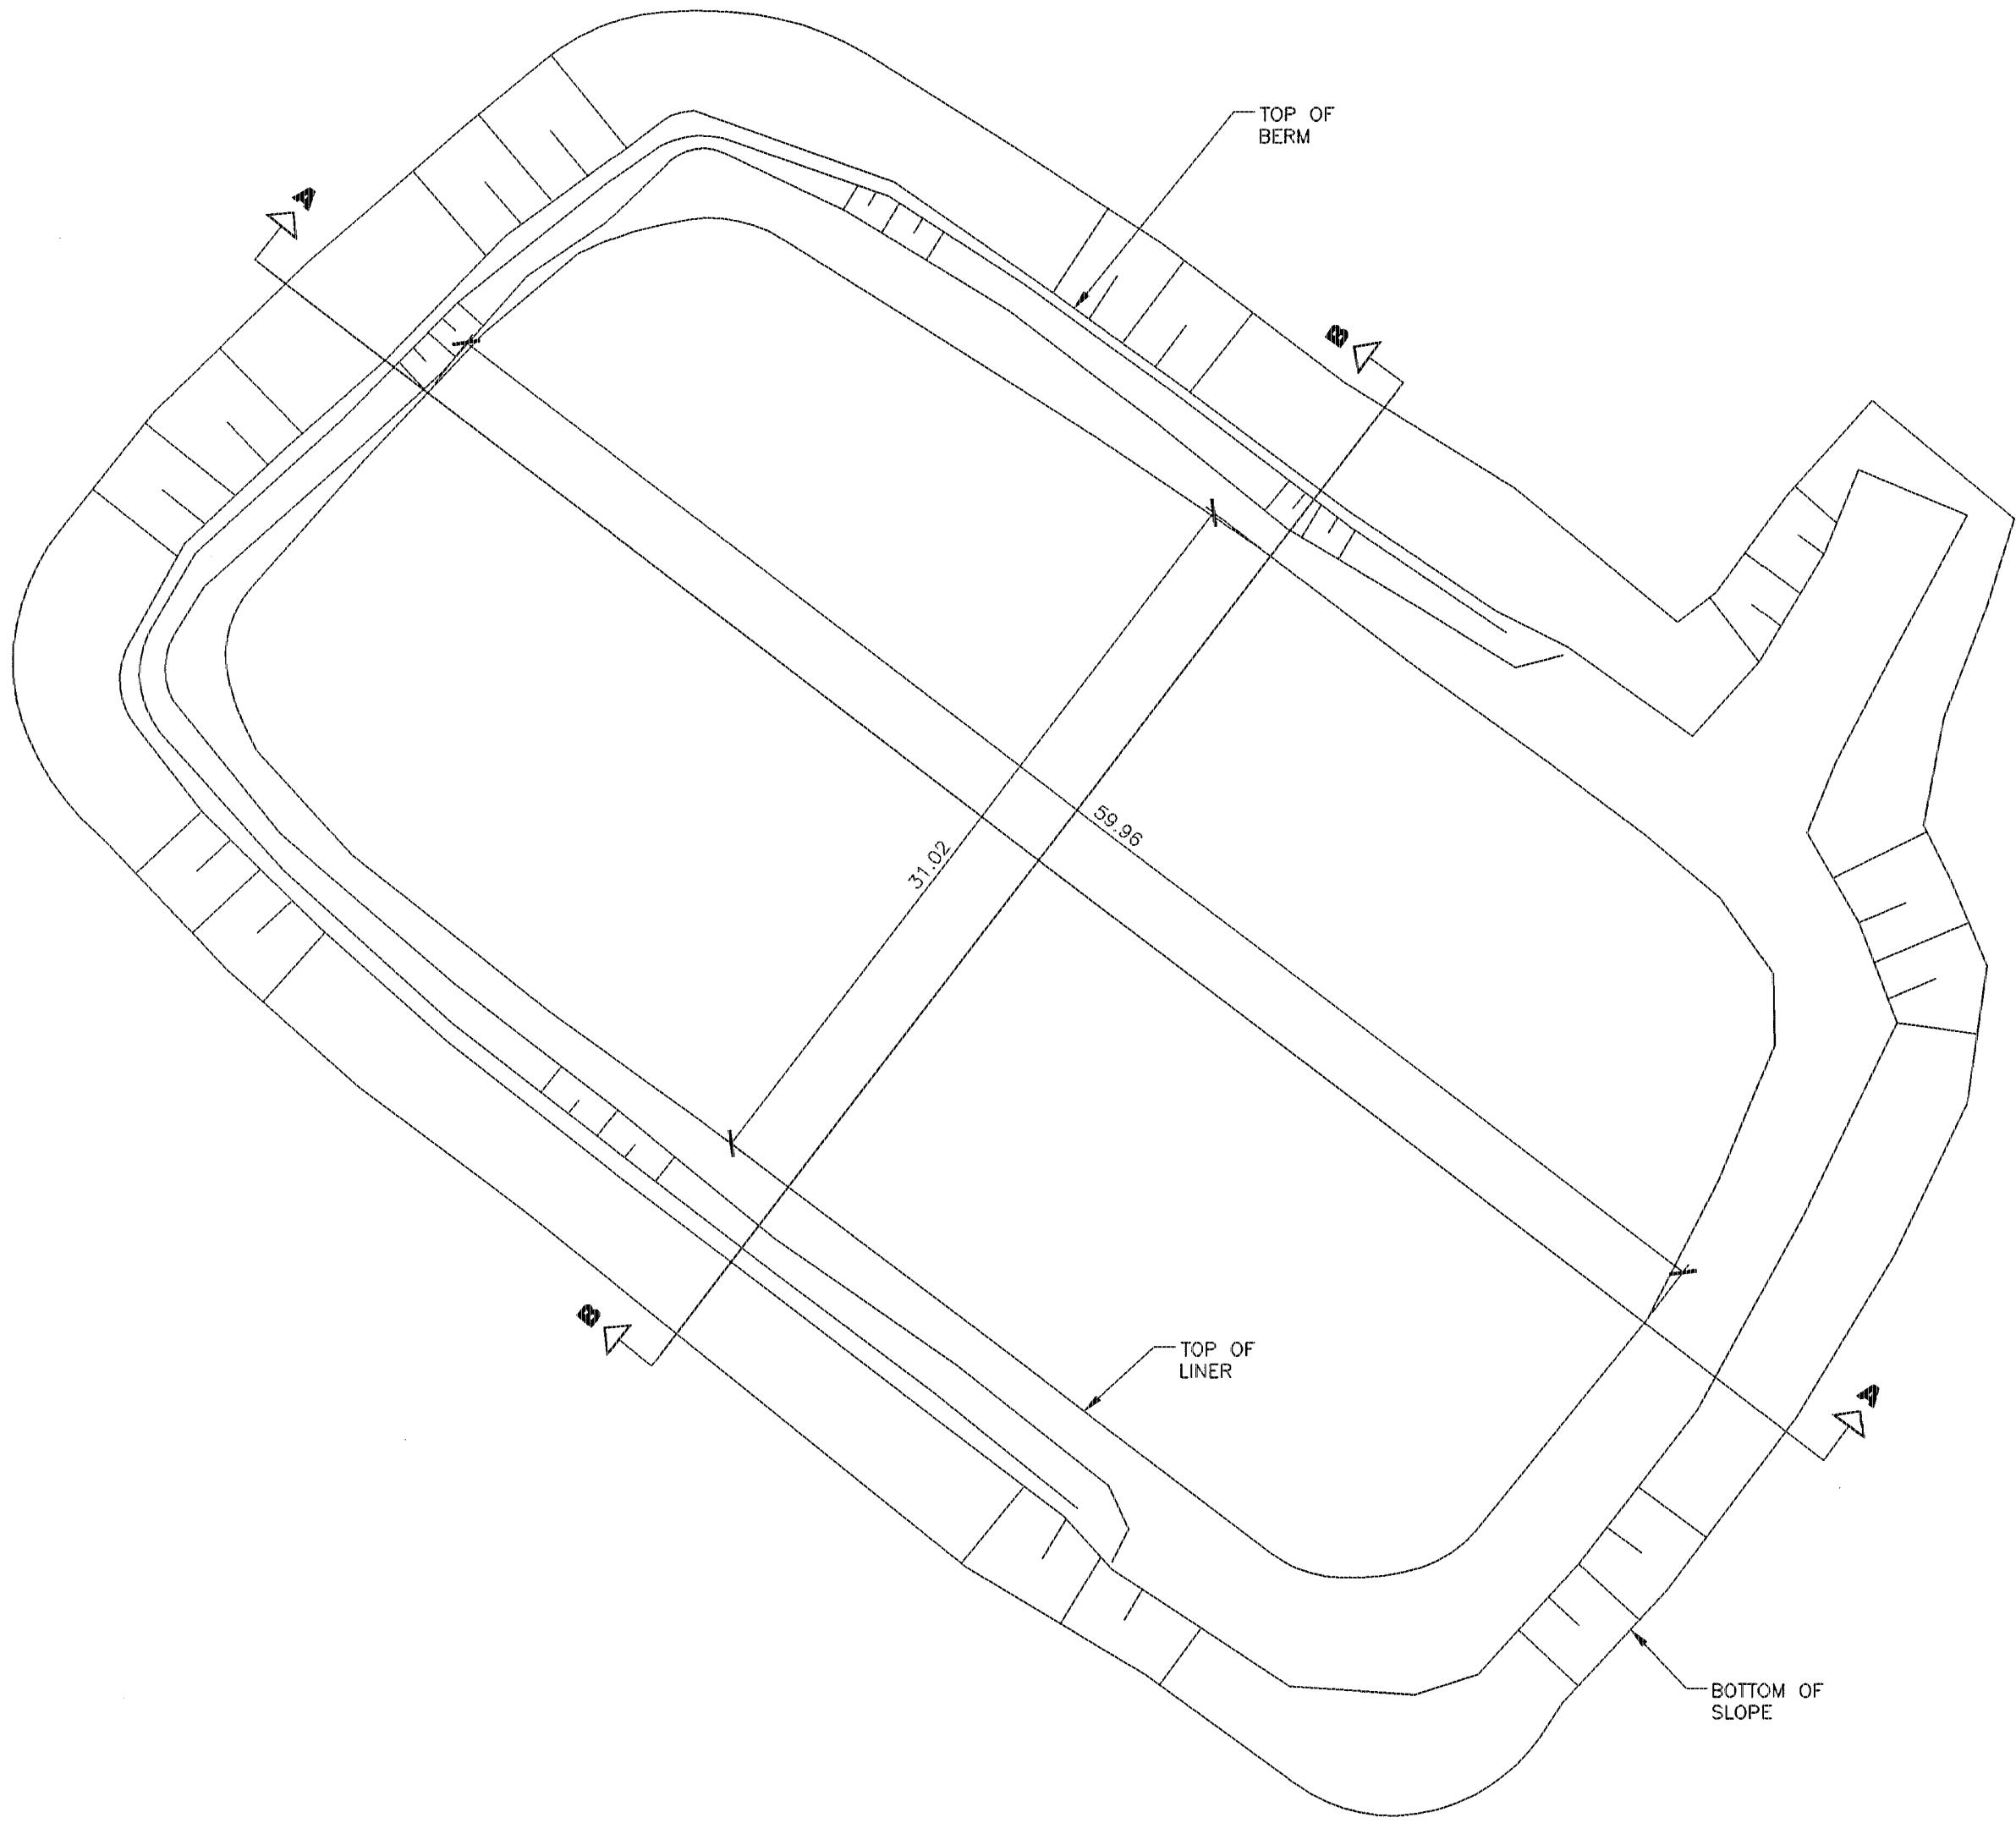
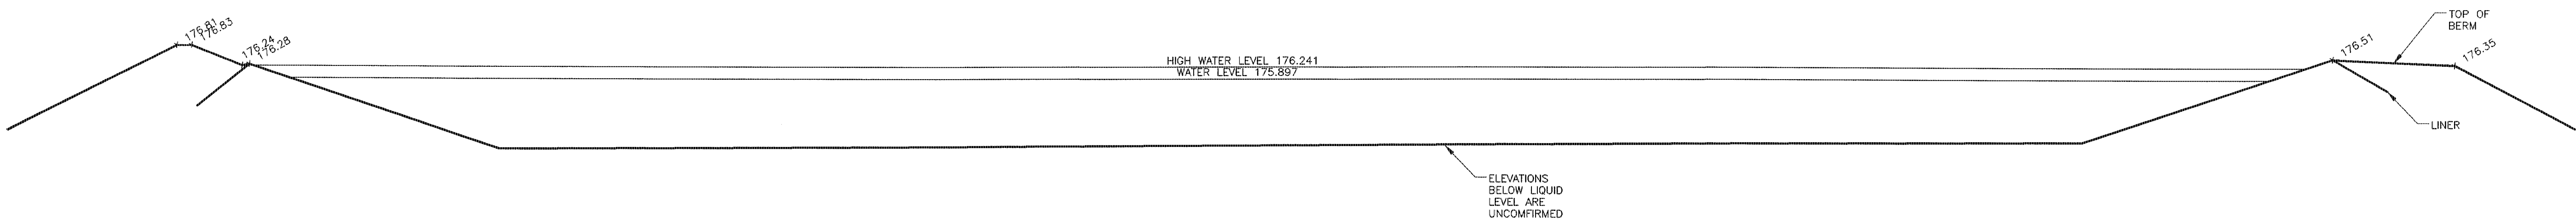
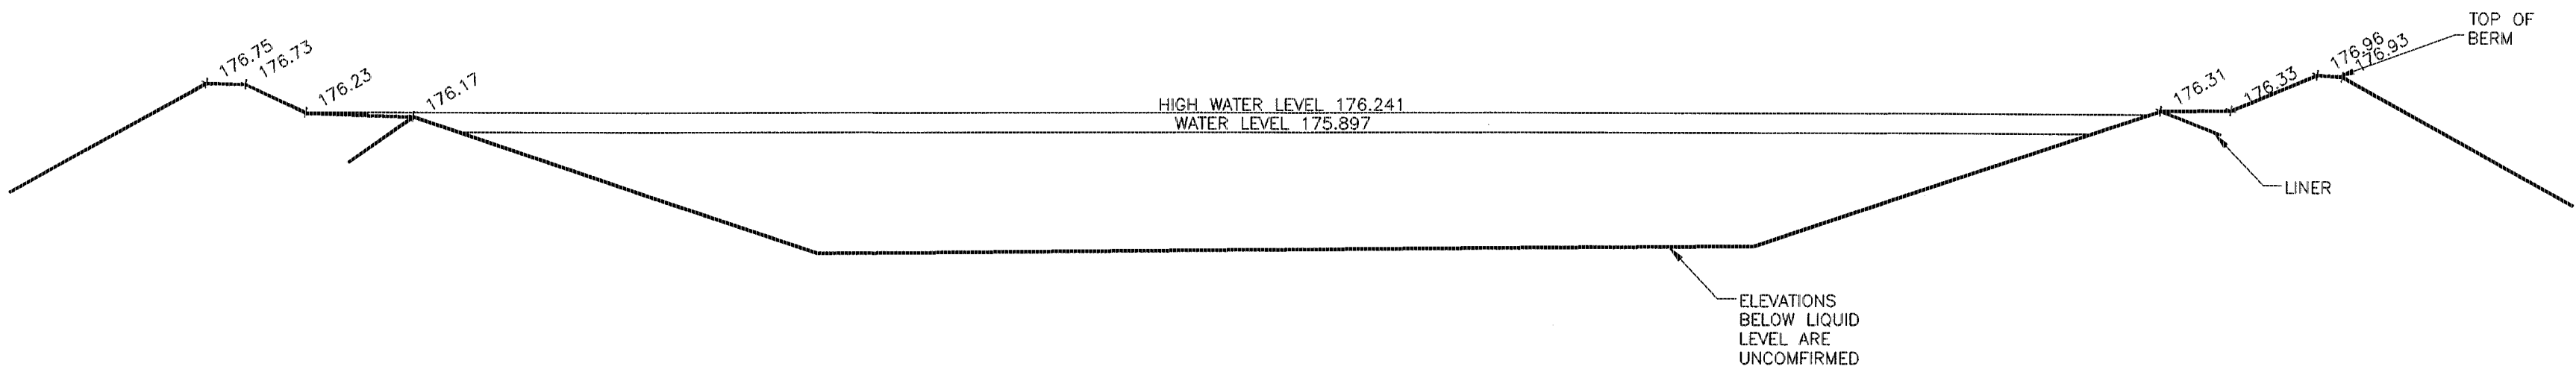
Drawing  
**AS CONSTRUCTED**  
**PWSP 1**  
**PLAN AND SECTIONS**

Our review of the area around the pond at the base of the slopes showed no signs of water (sewage) and hence we conclude that the liner has been effective in containing the sewage and there are no tears or ruptures in the membrane.

A review of the exterior and top of the dykes showed no indication of settlement, seepage, or cracking which are signs of overstress on the structure. The structure is considered to be stable at its present condition.

- Based on the current 4:1 backslope the level of sewage in the cell shall not exceed a height of 1.8 m.
- In consideration of the potential for the thawing of permafrost regime under the PWSP, it is recommended that monitoring points be established on the dyke structure and an elevation monitoring program be implemented to measure any potential settlement. It is recommended that monthly monitoring be implemented from May to October 2009.
