## **REMEDIAL ACTION REPORT**

Detailing work completed to address  
*2013 Land Use Inspection Report and 2014 Water Licence Inspection Report*

### **COMMITTEE BAY PROJECT Kitikmeot Region, Nunavut Territory, Canada**

30 September 2014

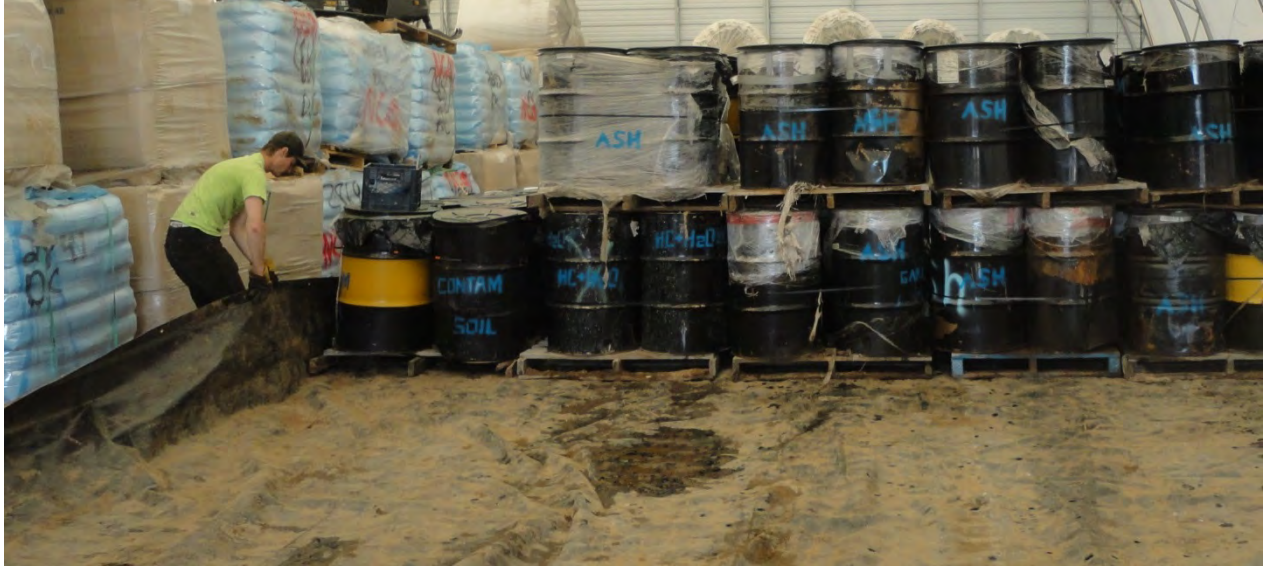
Figure 2 – Securing berm walls.
