APPENDIX 7

Inspection Report

2014 Water Licence Inspection Report and correspondence

WATER LICENCE INSPECTION FORM

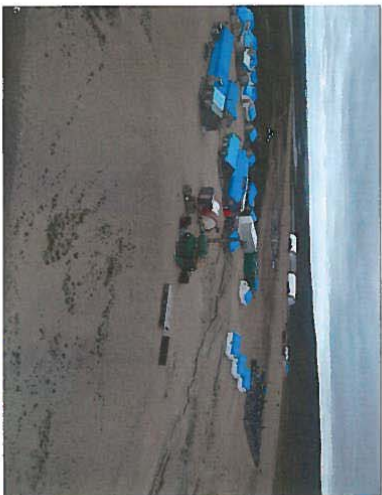
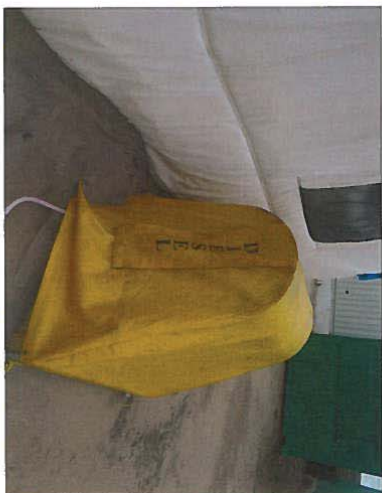
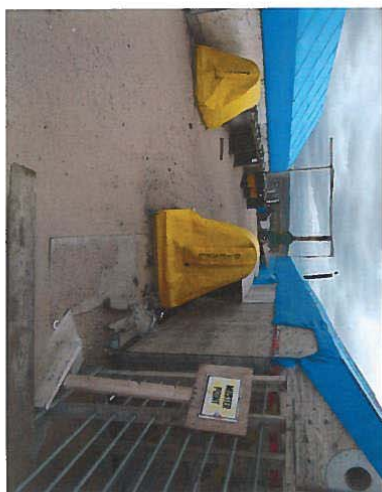
HAYES CAMP

As per photo sheet #1 of the Hayes Camp, there was some garbage found around the Incinerator that needs to be cleaned up and disposed of, the valve on the large red tank is unsecure and needs to be covered or locked, and the secondary containment on 1 of the 2 fuel caches needs attending to as water has accumulated on top causing other areas to be exposed. The covered secondary containment for individual drums behind each structure is very nice thank you.

The above deficiencies need to be fixed and “before” and “after” photos shall be provided to me to show compliance. These sites will be Inspected again in 2014 to ensure compliance.

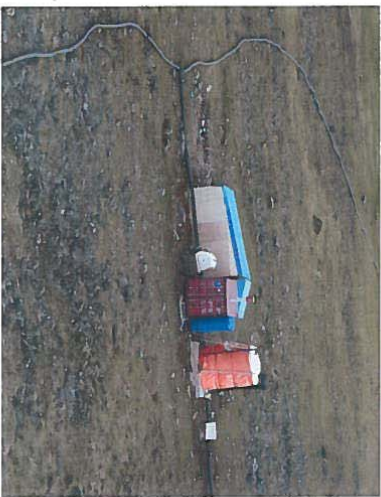
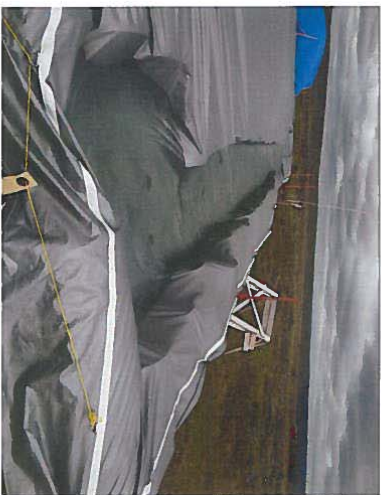
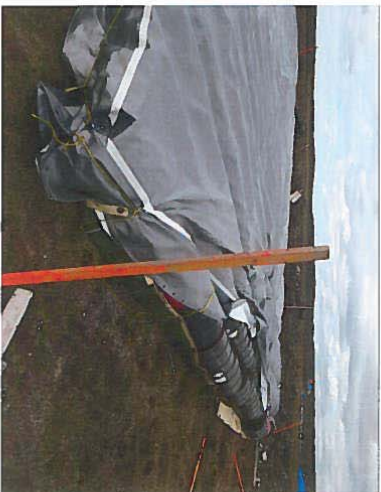
PALE LAYDOWN & FUEL CACHE

As per photo sheet #2 of the Drill Laydown area and Fuel Cache, 1 Tent Frame is weather damaged and needs repairing and 1 Fuel Cache has a large pool of standing water that needs to be drained off and the other Fuel Cache has had part of the cover blown off and a section of the containment wall has collapsed from the support strings coming off.

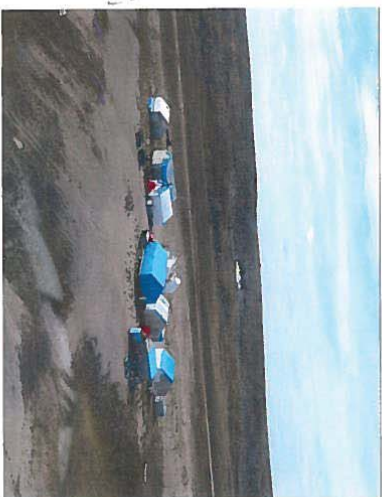
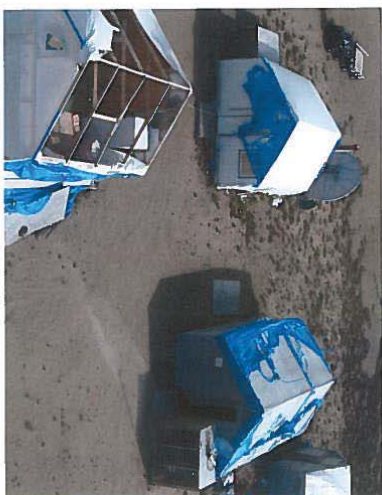
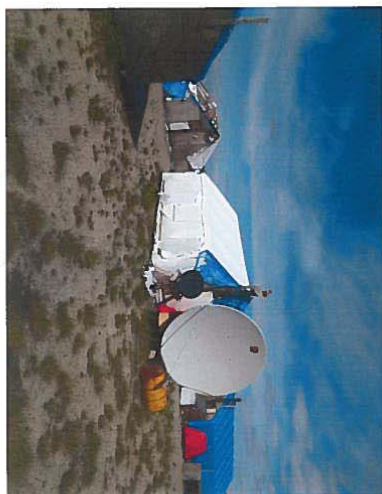
BOULDER CAMP

As per photo sheet #2, at least 6 structures in the camp have sustained extensive weather damage. These must all be repaired and all structures must be secure. You shall provide me with “before” and “after” photos of your repairs to ensure compliance.

AT LEAST 6 STRUCTURES HAVE EXTENSIVE WEATHER
DAMAGE, THESE ALL NEED TO BE REPAIRED
