Attachment 10 – Inspections and Responses

WATER LICENCE INSPECTION FORM

CROWN LAND USE INSPECTION FORM

Reference: High Lake Camp Inspection

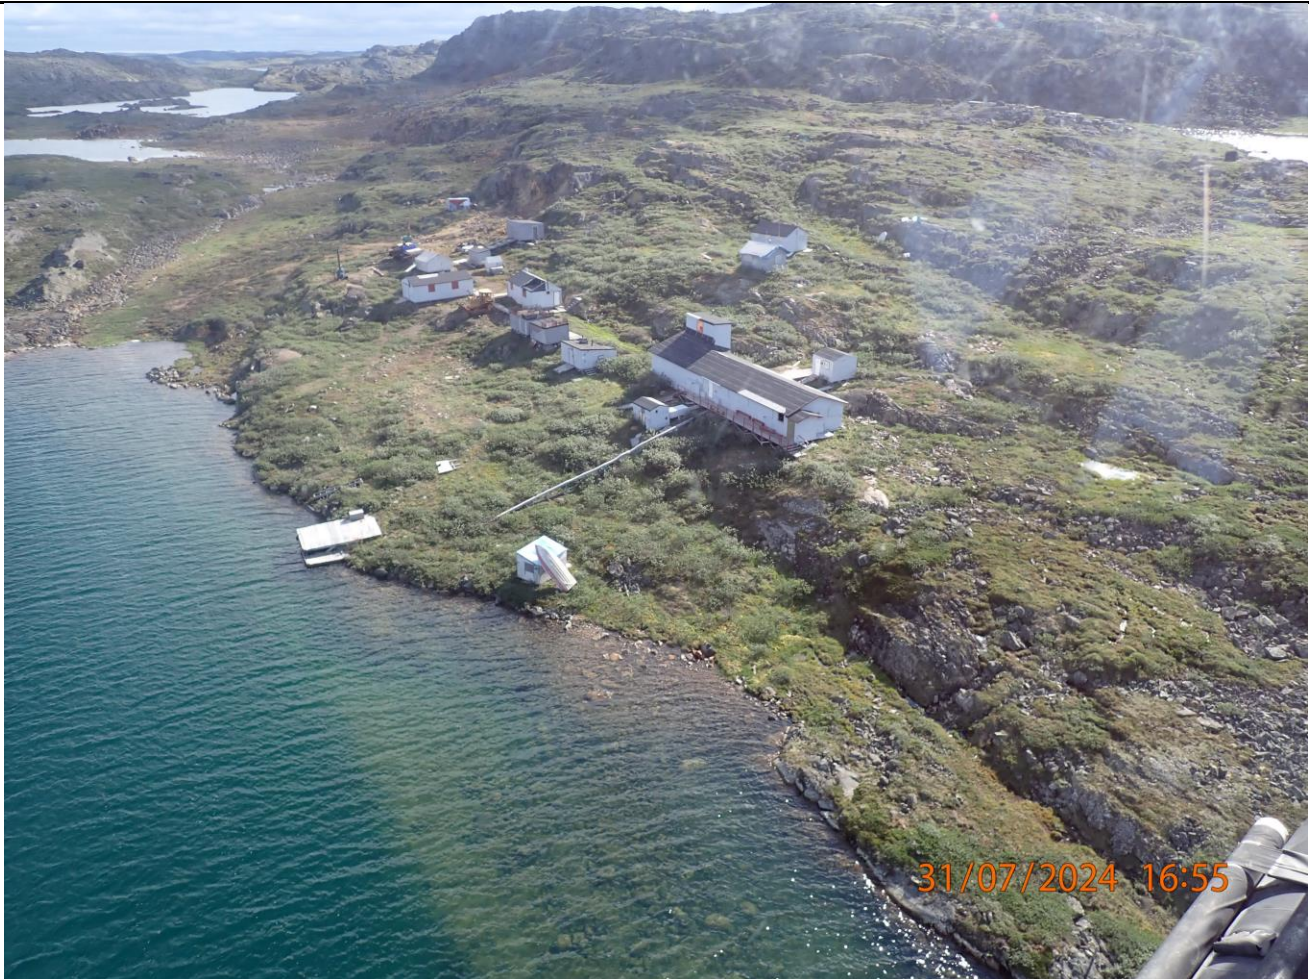
Photo 1

1. Inspectors arrive at 5:00pm, Aerial photos of the Site were taken (Photo#1and #2)
2. A pile of scrap metal was observed beside a drill shack (Photo #3)

High Lake camp Aerial Looking south.

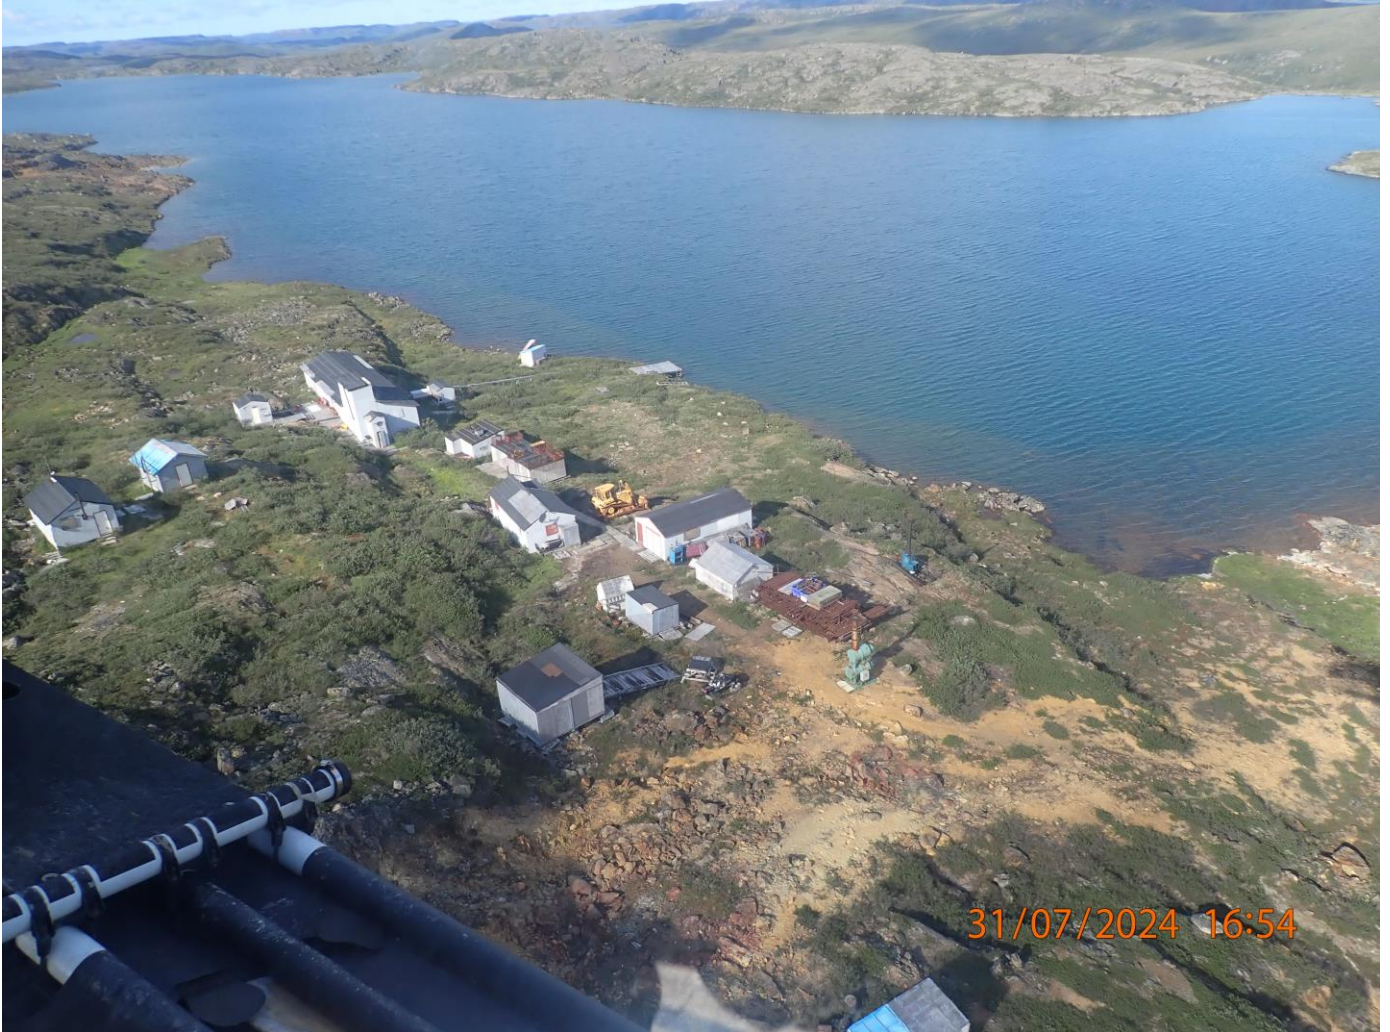
Photo 2

High Lake Looking North

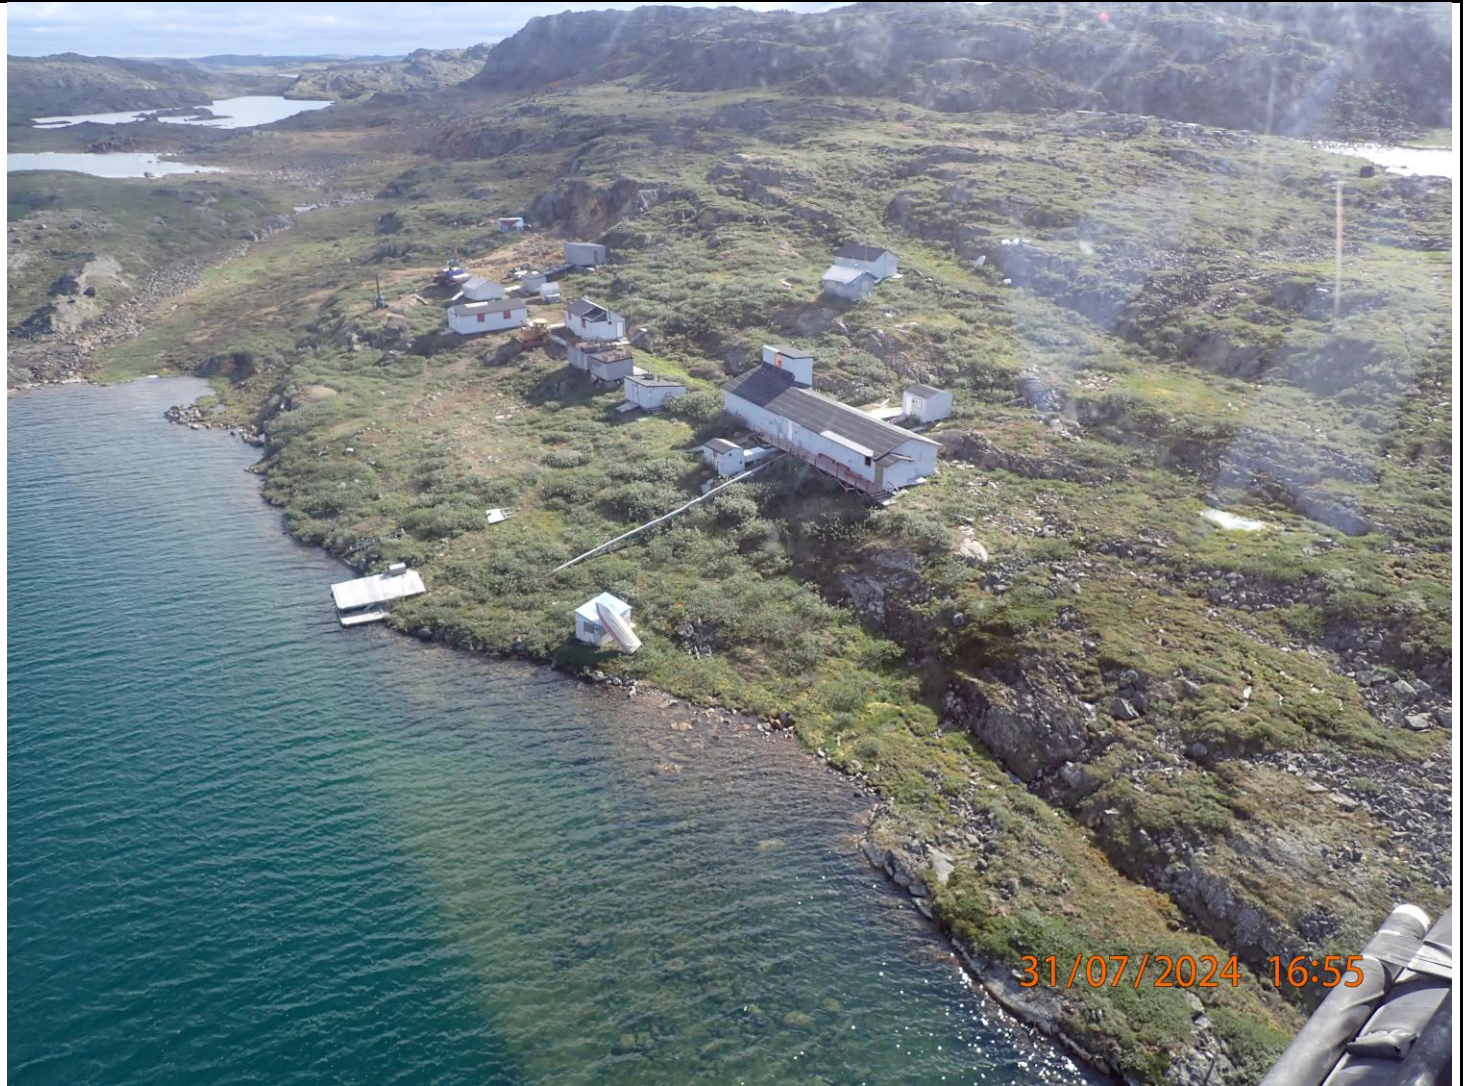
Photo 1

- Inspectors arrive at 5:00pm, Aerial photos of the Site were taken (Photo#1and #2)
- A pile of scrap metal was observed beside a drill shack (Photo #3)

High Lake camp Aerial Looking south.

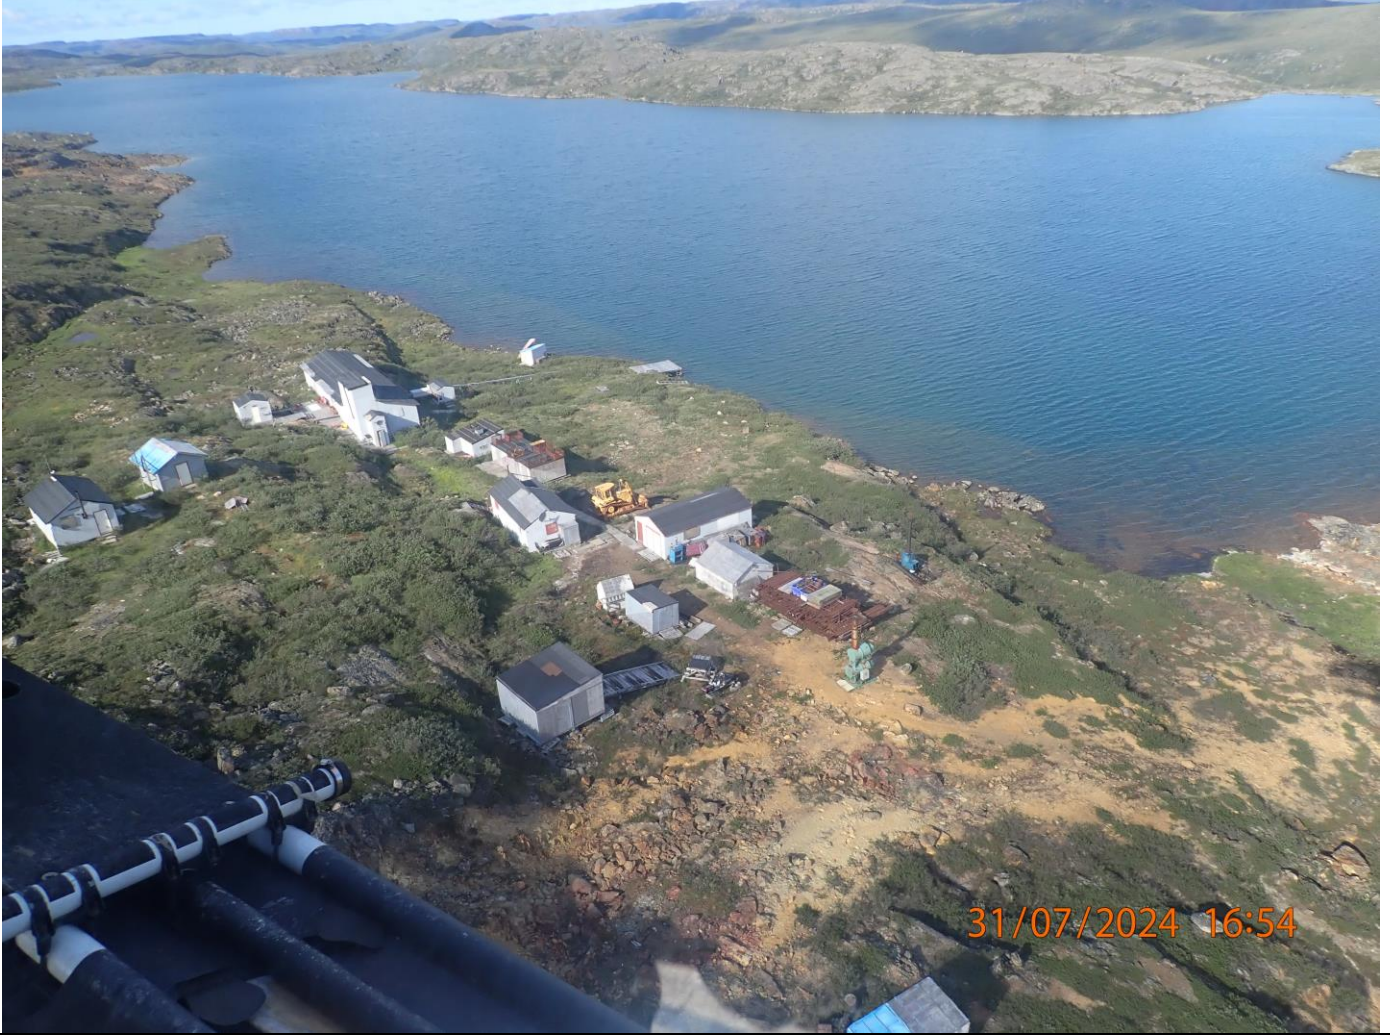
Photo 2

High Lake Looking North
