**PROPOSED LONG TERM REMEDIAL STRATEGY –  
FUEL SPILL, WINDY LAKE CAMP, NUNAVUT, SPILL  
NUMBER 04-388**

EBA File No: 1740065-003

**REVIEW OF THE RESPONSE BY MIRAMAR HOPE BAY  
LIMITED TO THE JUNE 16, 2004 OIL SPILL AT WINDY  
LAKE CAMP**

**FSC Project Number: 2005-0820  
Date: October 25, 2005**

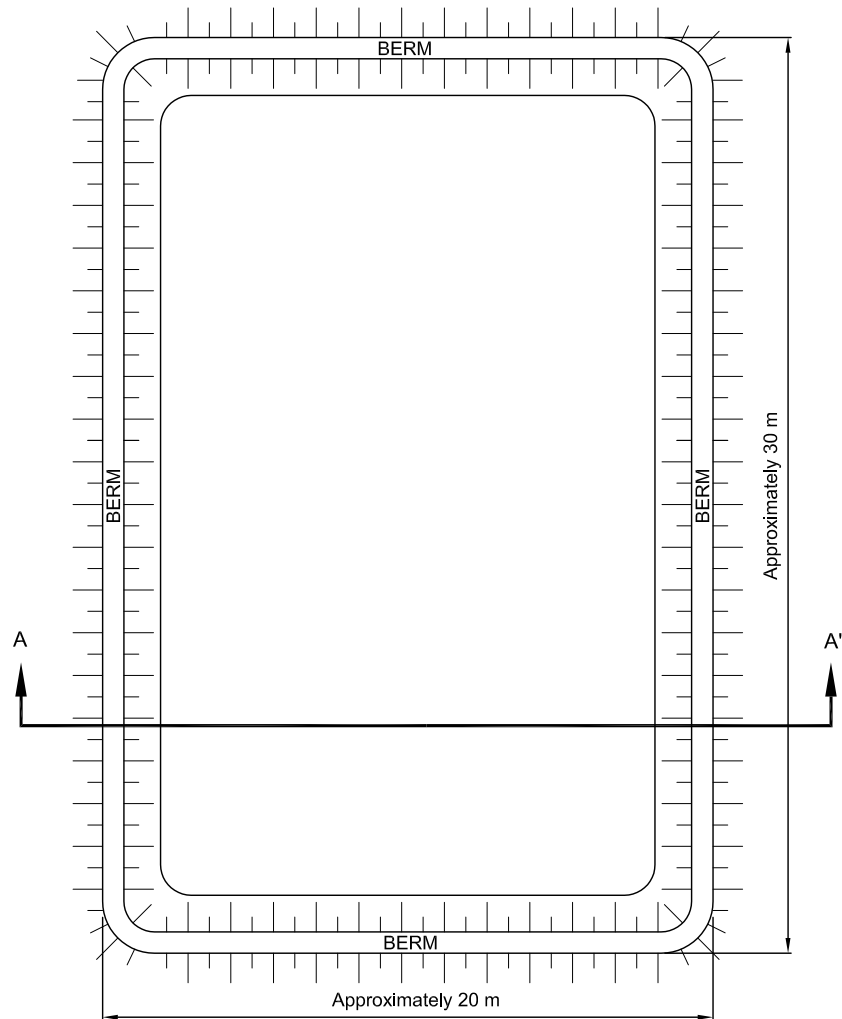
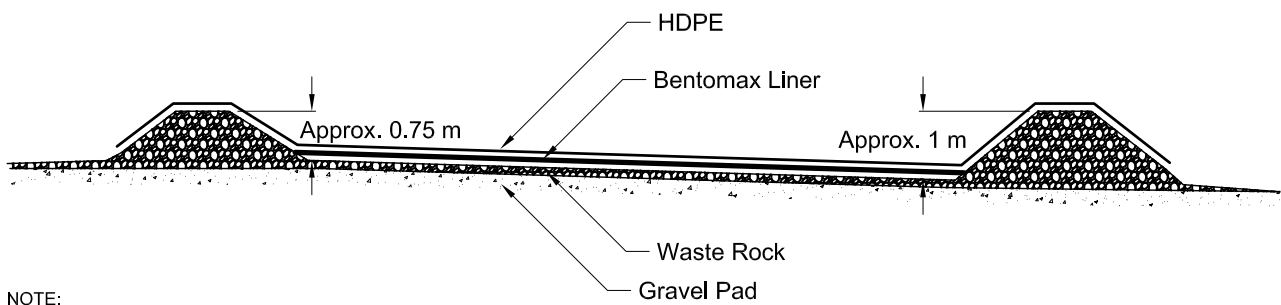
Figure 2  
General Schematic  
Land Treatment Area

the liner. A general schematic of the proposed landfarm or land treatment area is presented as Figure 2.

A combination of *ex-situ* soil bio-treatment and mechanical water treatment methods are recommended to address the residual impacts associated with the land portion of the impacted spill site. It is proposed that a land treatment area (LTA) be constructed in the area situated topographically down-gradient from the fuel storage tanks (Figure 1). This area was impacted by the hydrocarbon release and is the primary area where soil hydrocarbon impacts are observed. The LTA would be constructed using a 60 mil HDPE liner underlain by native soil consisting of clay. The liner will be of a thickness to prevent accidental damage and to prevent the ongoing migration of hydrocarbon-impacted waters to the environment. The liner will be installed on clean soil following the removal of all hydrocarbon-impacted material. A conceptual as-built diagram is provided as Figure 2. A final version will be provided upon completion of construction. The dimensions of the proposed LTA will be approximately 50 metres by 30 metres wide with a minimum dyke height of 0.75 metres. As fill material is in short supply at the site, it is proposed that the liner be propped up with wooden cribbing around the perimeter of

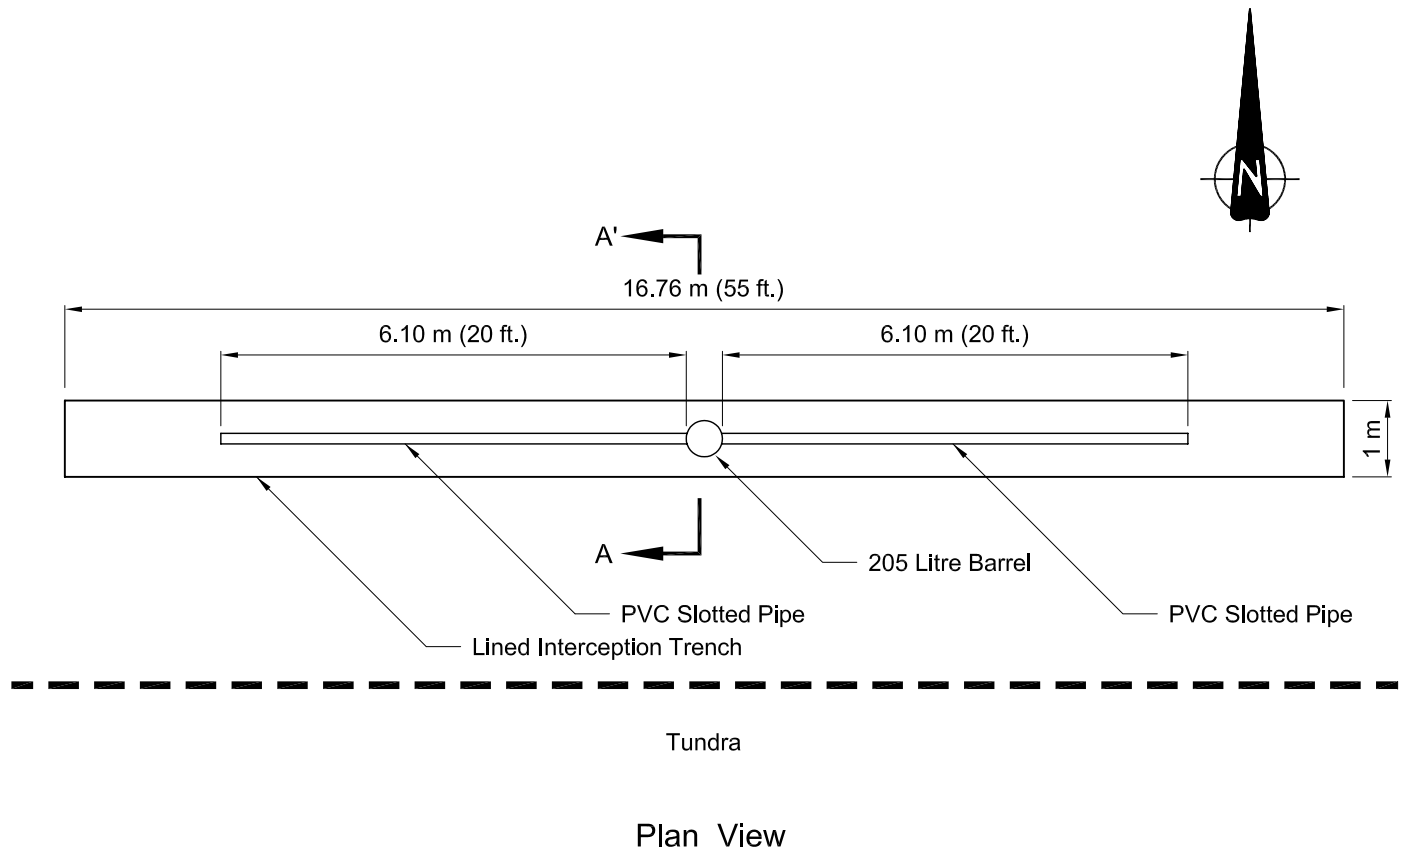
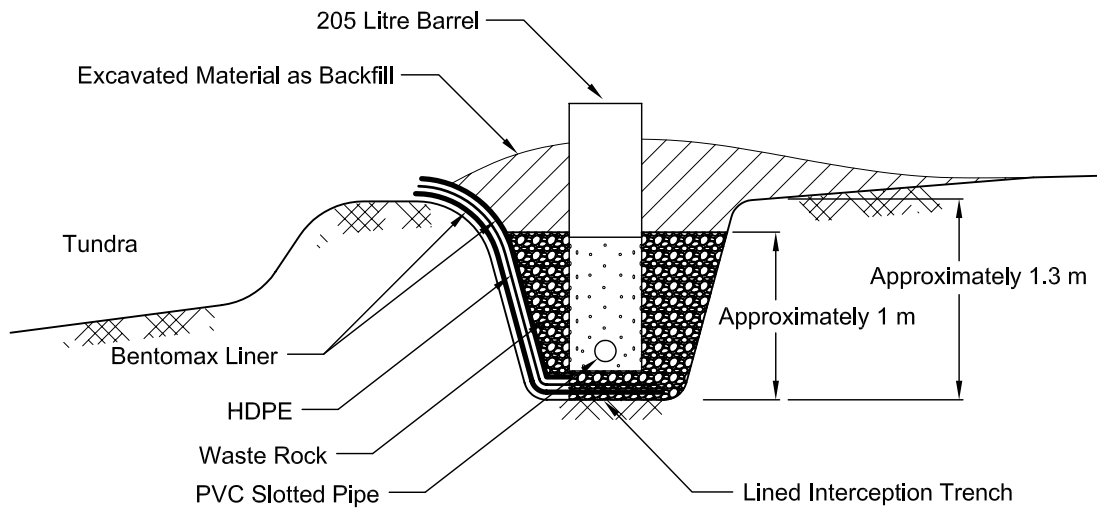
Figure 3  
General Schematic  
Containment Trench

As the ongoing migration of hydrocarbon-impacted surface waters is a significant environmental concern, it is proposed that an interception trench be constructed on the western portion of the LTA situated between the LTA and the lakeshore. The trench will be excavated to a depth of approximately 1.0 metres below surface grade, lined on the west wall and base with hydrocarbon resistant high density polyethylene (HDPE) liner and backfilled with clean fill (obtained from the site). A catch basin will be installed at the northwest end of the trench. The basin, a 205 litre drum with holes drilled along the sides, allows for the placement of a pump to remove the captured water. A general schematic is presented as Figure 3.

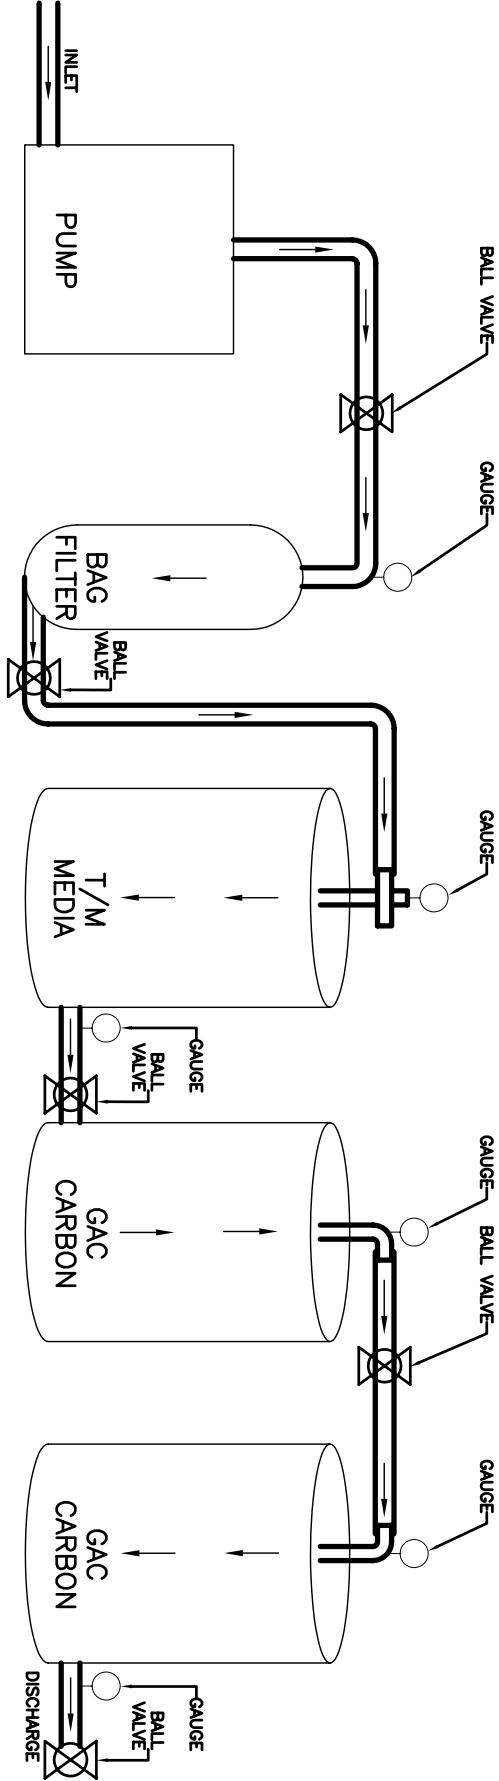
Figure 4

To effectively address the presence of hydrocarbon-impacted waters captured within the proposed LTA and the interception trench, it is proposed that a FII Oil Absorption System provided by Terry Ruddy Sales of Edmonton, Alberta be utilized. The water would be first emptied into 1,400-litre capacity plastic basins present on site on site for de-emulsification purposes and coarse sediment removal. The free-phase product and sludge would then be skimmed from the water surface and large sediment particles will be removed from the water processing system by means of screening and filtration through a burlap net. The water would then be directed through the treatment unit. The treated water would be directed into the RBC lift station and pumped up to the existing sewage discharge location situated east of the camp. A schematic of the treatment system is provided as Figure 4.

General Schematic  
Granular Activated Carbon (GAC) Unit

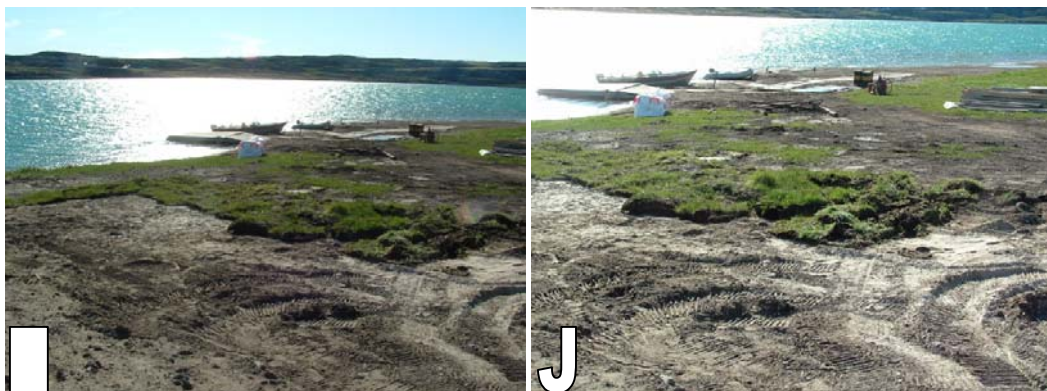
Photos taken in 2005 (I & J) showing mats of borrowed natives grasses placed on bare strip between LTA and Windy Lake front. The objectives were to slow down runoffs thus allowing eroded sediments to settle and promote natural grass growth.
