Windy Lake Camp Treated RBC Effluent Incident Report
Spill Number #08-061

HOPE BAY MINING LIMITED

March 2008

In-house Document # HBMLENV 01 2008
March 2008

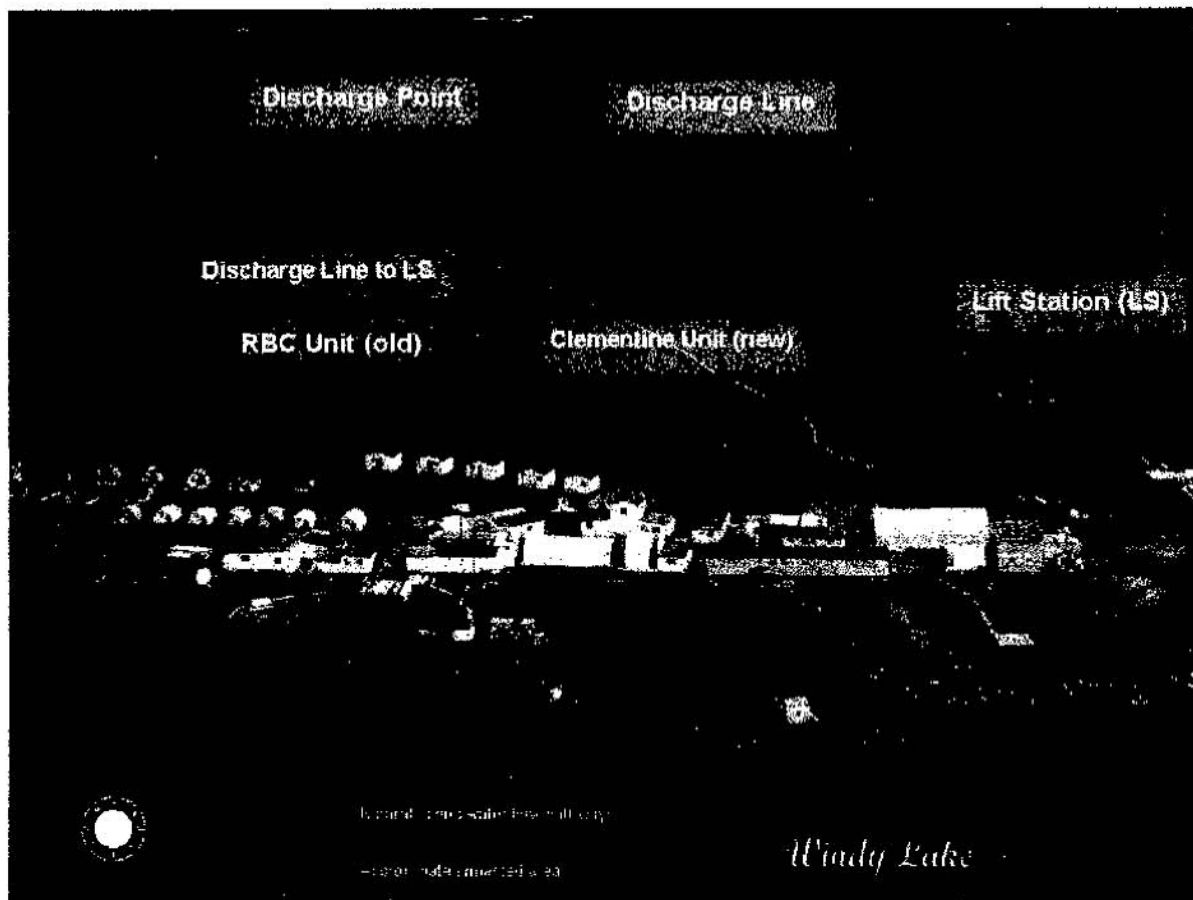
Figure 1: Aerial photograph showing Windy Lake camp sewer treatment and discharge system

The Sewer System is made out of a Rotating Biological Contractor (RBC) Unit, a Clementine Unit, a Lift Station and 500 meters of HDPE discharge lines. Figure 1 shows the location of each of the component of the system.

The lift station is actually an insulated fibreglass tank installed on the tundra at the foot of the hill east of the camp (Appendix 1). Inside the tank is a submersible pump, which is a sealed unit. The pump that failed had been in operation for about five years. A second pump was at hand onsite as part of the contingency planning. A float is attached to the pump to initiate start-up and shut down. At a given water level, the pump kicks in and pumps treated effluent through an insulated 2-inch HDPE line.
