Attachment 12 – Inspections and Responses

CROWN LAND USE INSPECTION FORM

WATER LICENCE INSPECTION FORM

Reference: Ham Lake Camp Inspection

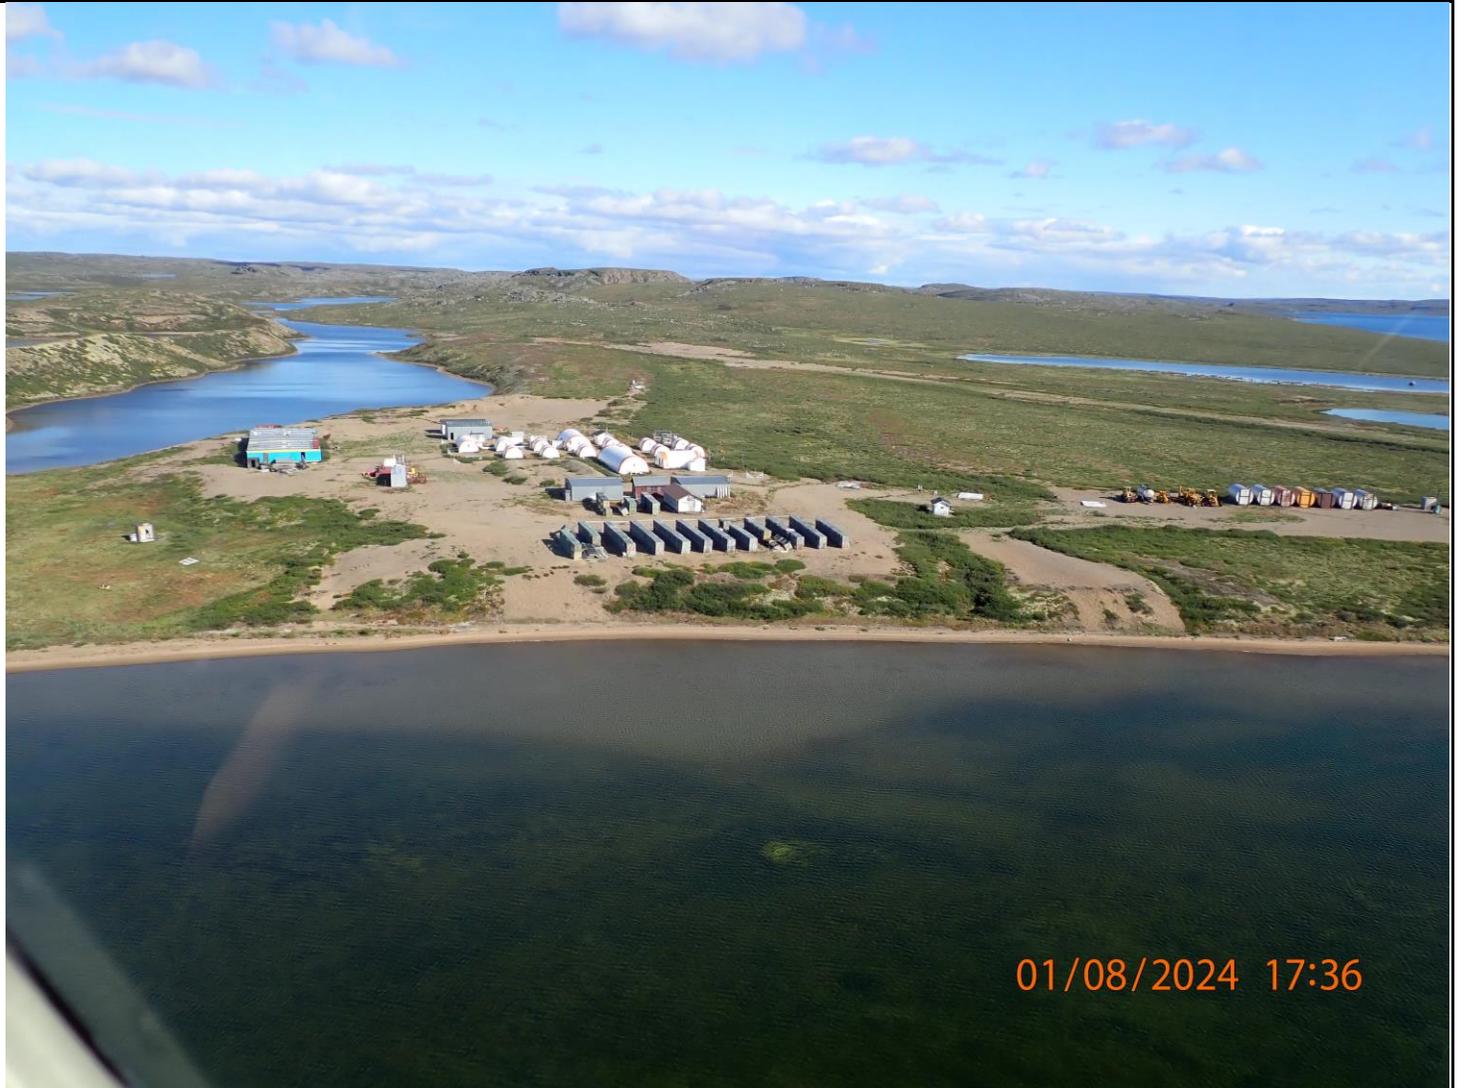
Photo Log # 1
Photo 1

1. Inspectors arrive on site at 5:40pm on August 1, 2024. Aerial photos were taken (Photo #1, #2, #3)
2. During the inspection the Inspectors noted several buildings with their doors open. 1 weather haven had its door open, the core shack had an open door, the building that houses the bobcat/skidoos and the garage beside it that houses the loader had their doors open. (Photo #4 shows the shop with a door open, this building stores skidoos and the bobcat inside, Photo #1 shows the garage door open) (Photo # 12 and #13 show the open door of the core shack and the inside of the core shack.)

Aerial view of Izok camp on Ham lake. The airstrip, accommodations, equipment and fuel tanks are shown.

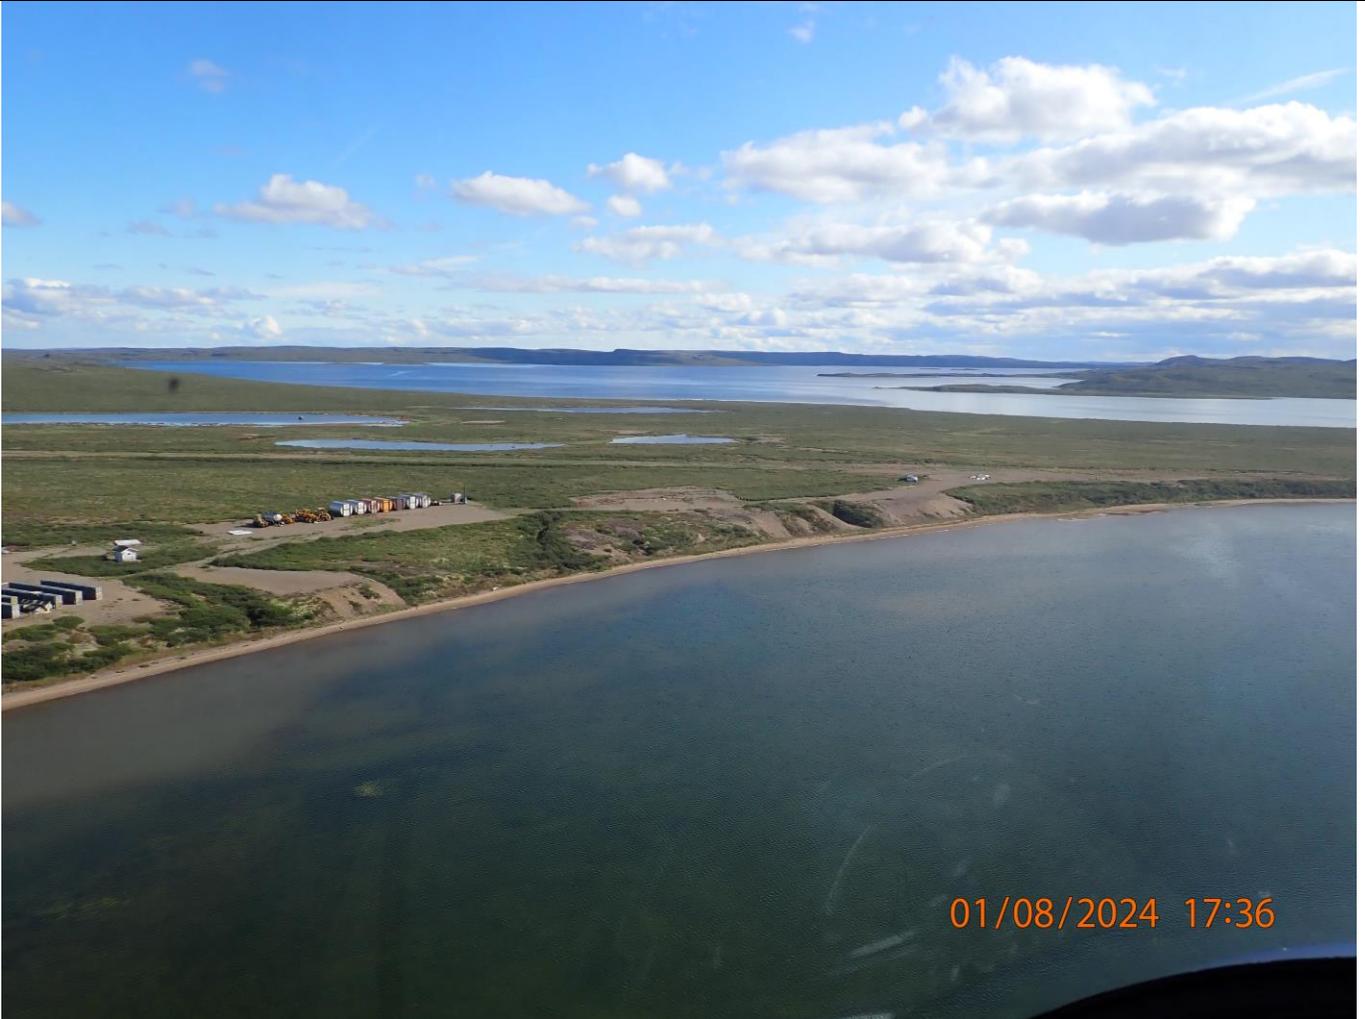
Photo 2

Aerial View of Izok camp on ham lake showing the rest of the airstrip, equipment, and fuel tanks stored on site.

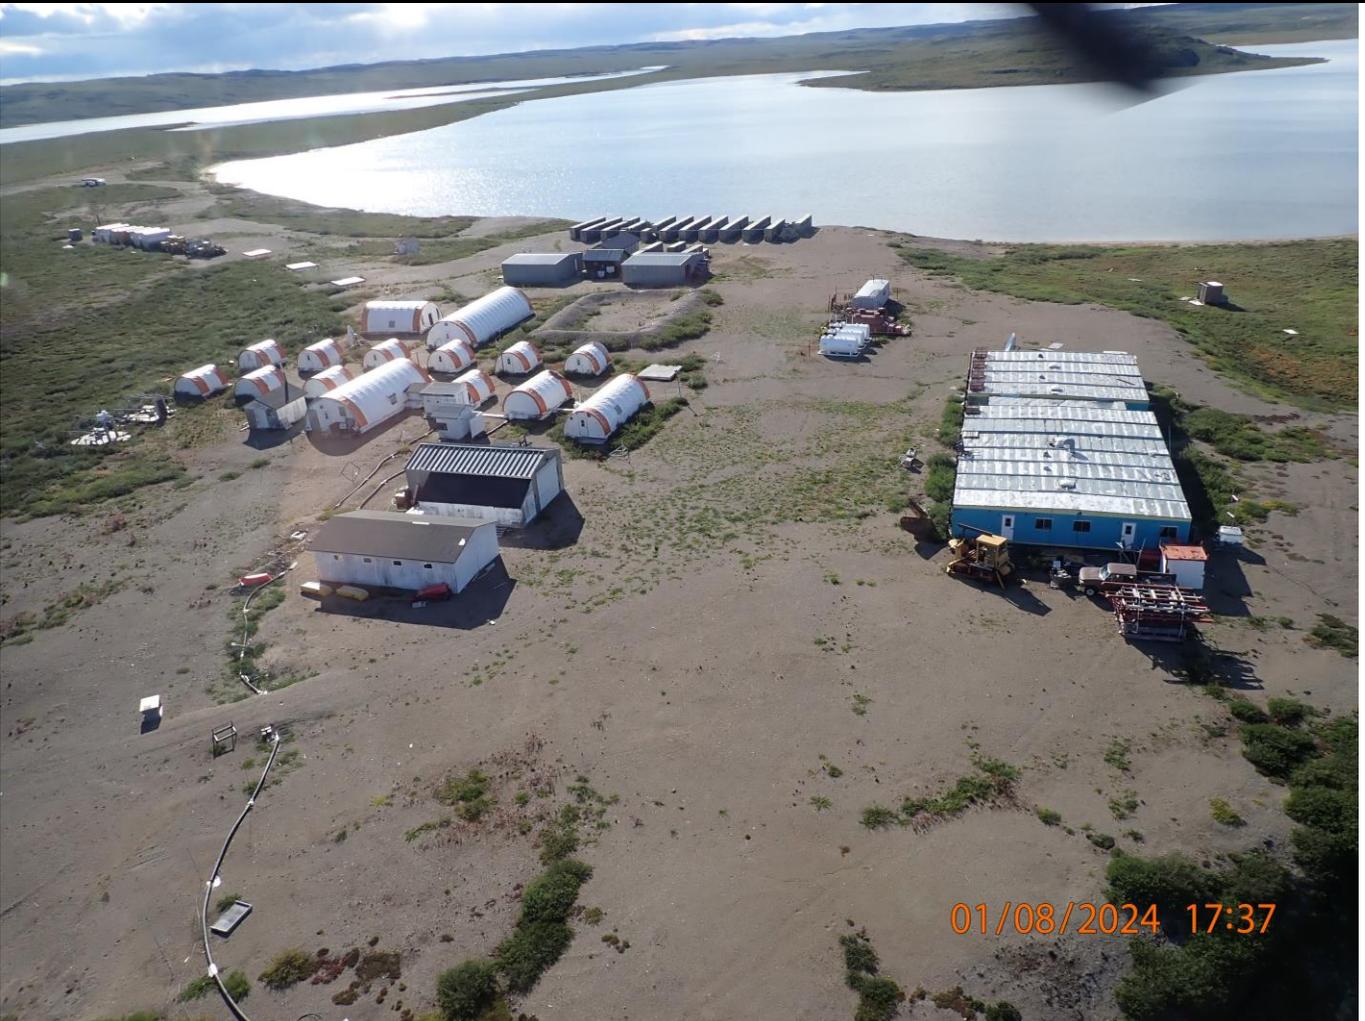
Photo 3

Aerial of Izok camp. Looking west.

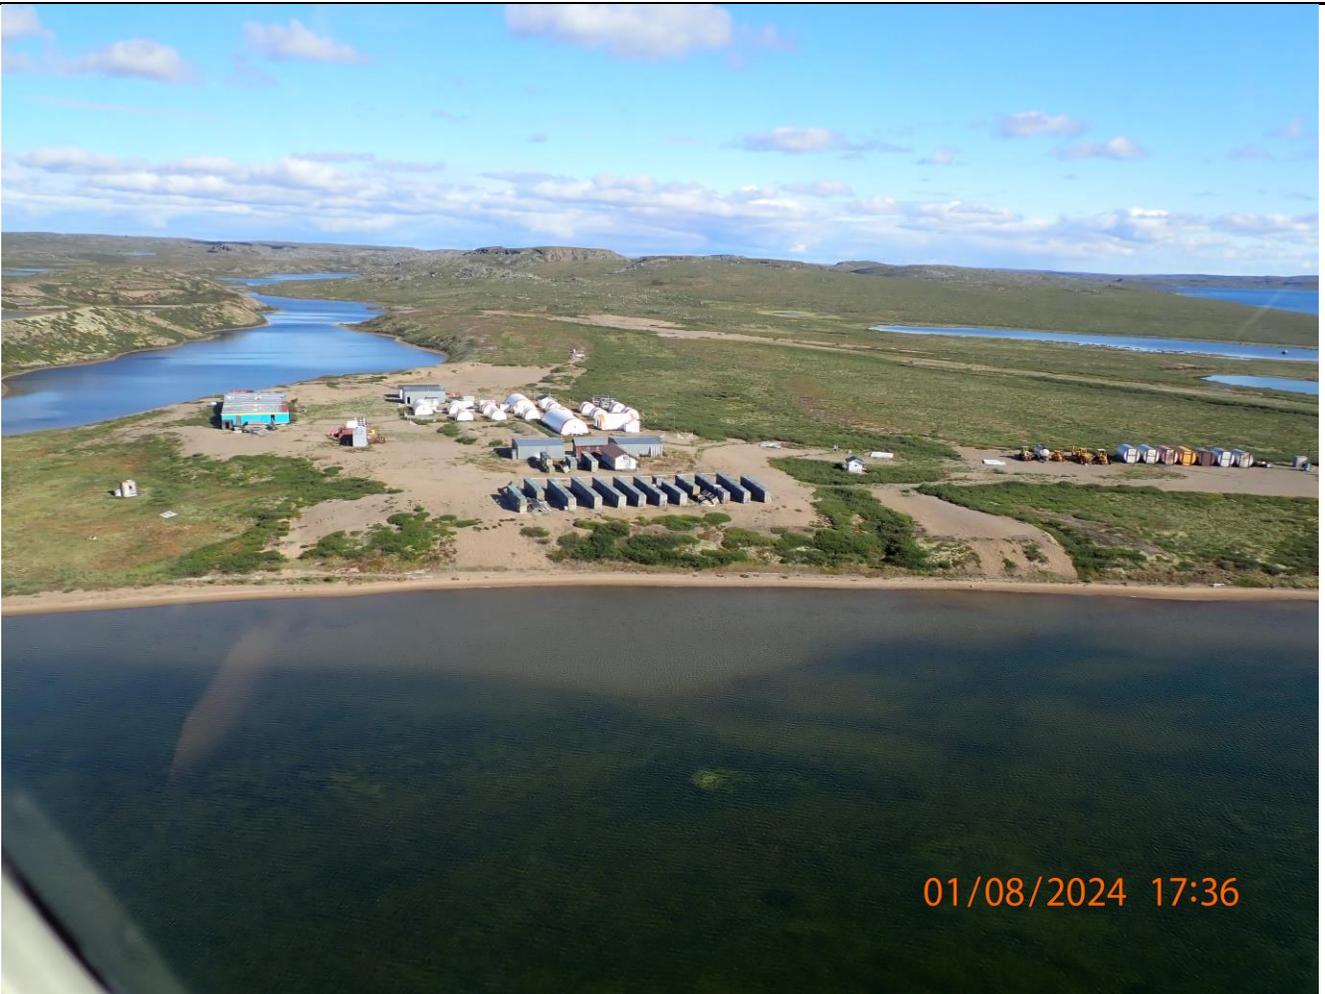
Photo 1

1. Inspectors arrive on site at 5:40pm on August 1, 2024. Camp Location 65*41'06.30"N 112*52'53.93"W. Aerial photos where taken (Photo #1, #2, #3)
2. During the inspection the Inspectors noted several buildings with their doors open. 1 weather haven had its door open, the core shack had an open door, the building that houses the bobcat/skidoos and the garage beside it that houses the loader had their doors open. (Photo #4 shows the shop with a door open, this building stores skidoos and the bobcat inside, Photo #1 shows the garage door open) (Photo # 12 and #13 show the open door of the core shack and the inside of the core shack.)

Aerial view of Izok camp on Ham lake. The airstrip, accommodations, equipment and fuel tanks are shown.

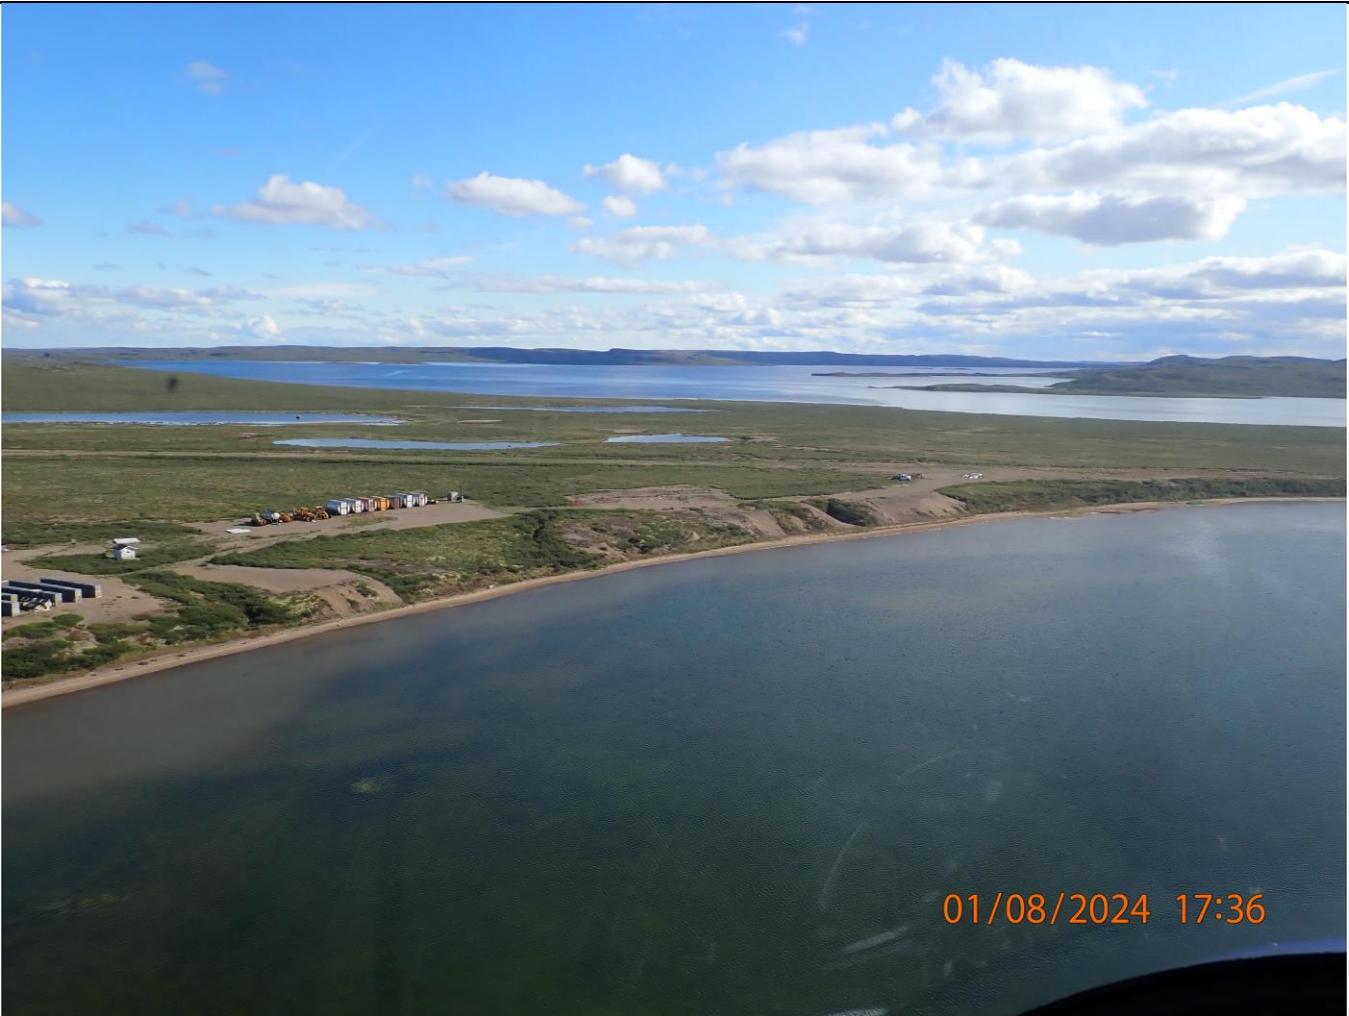
Photo 2

Aerial View of Izok camp on ham lake showing the rest of the airstrip, equipment, and fuel tanks stored on site.

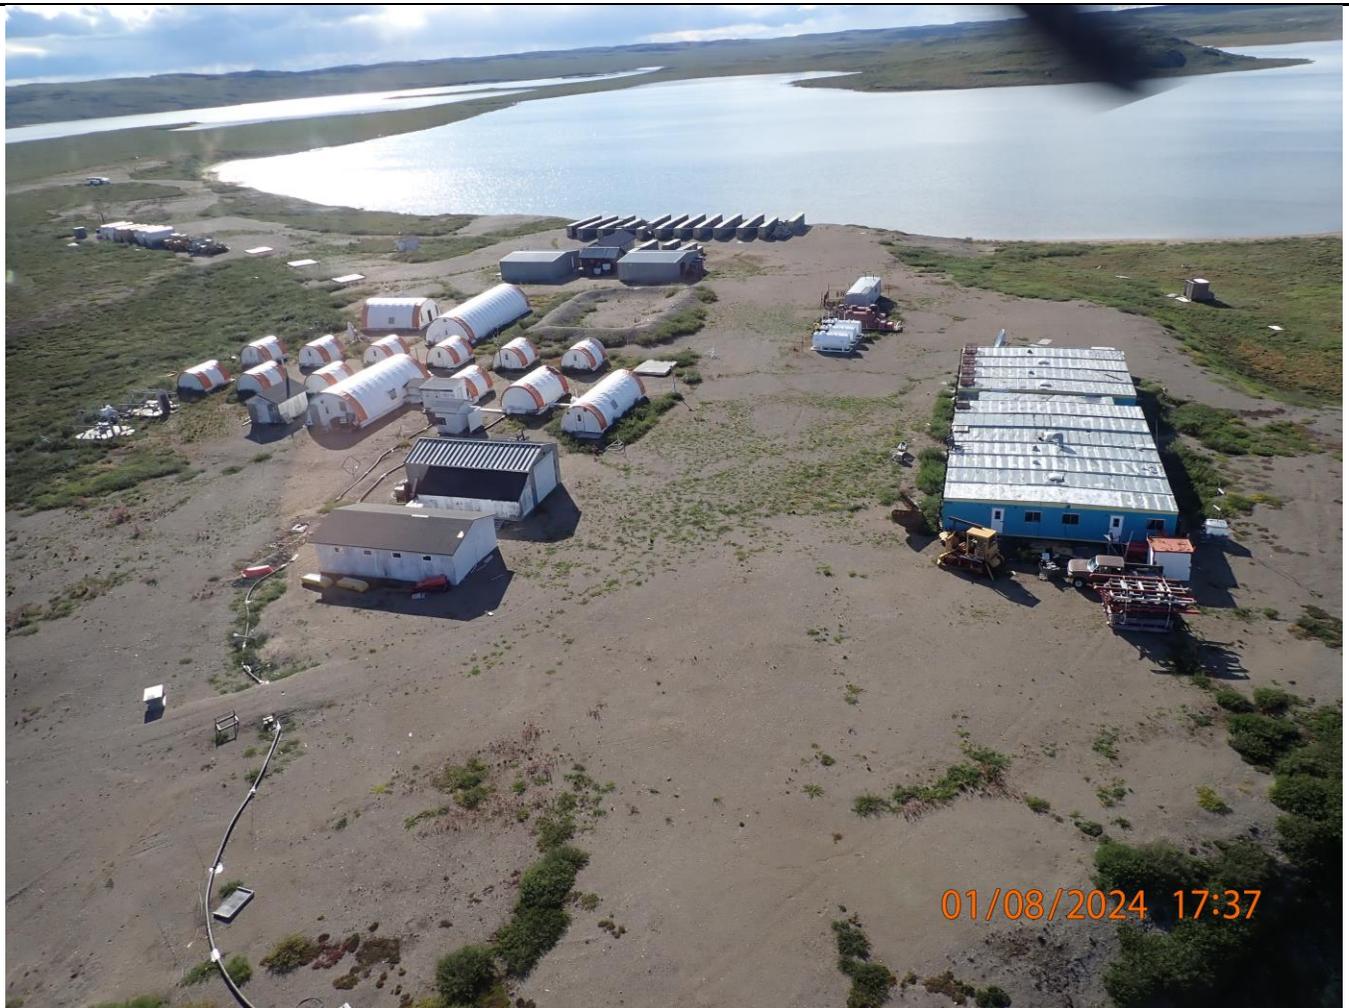
Photo 3

Aerial of Izok camp. Looking west.

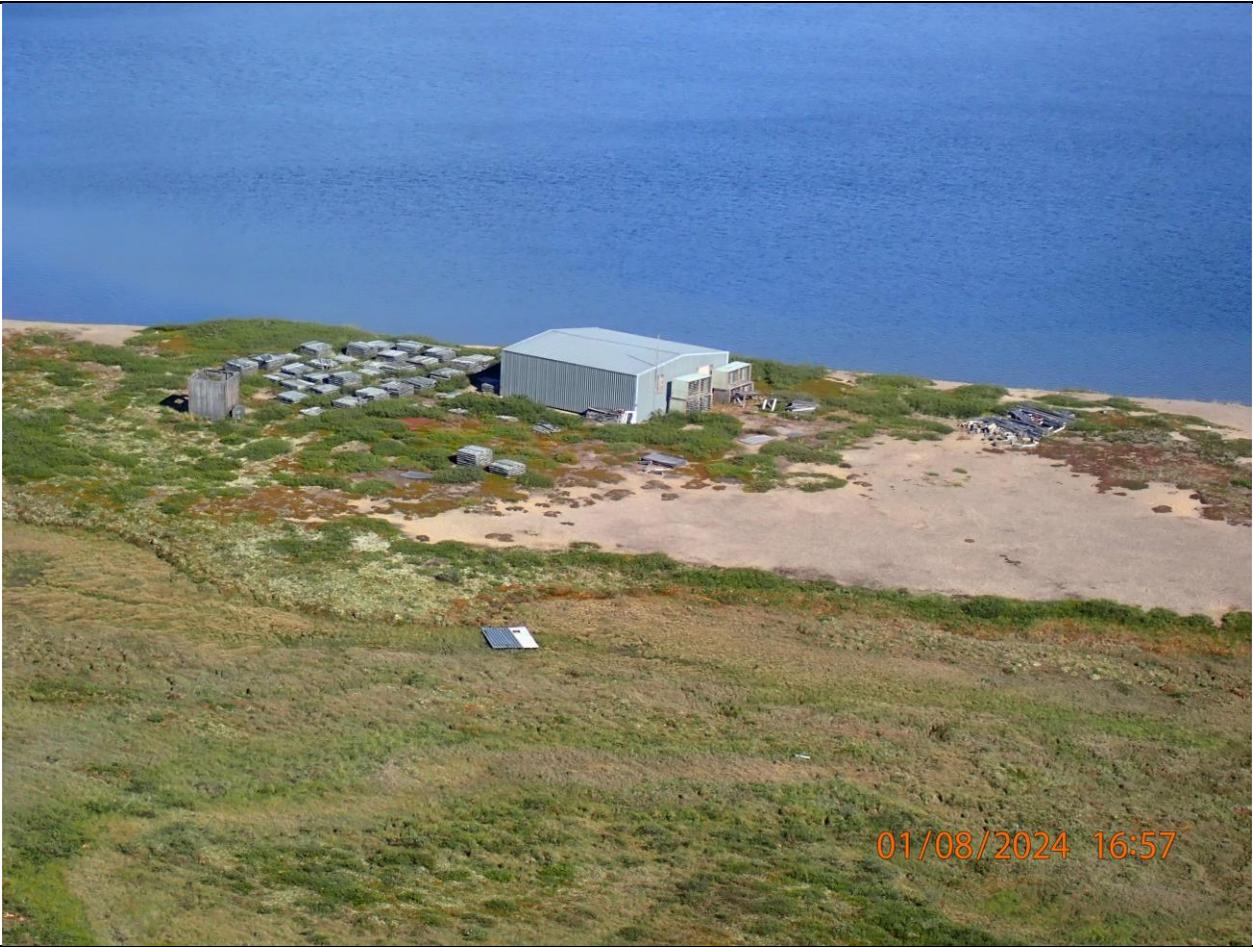
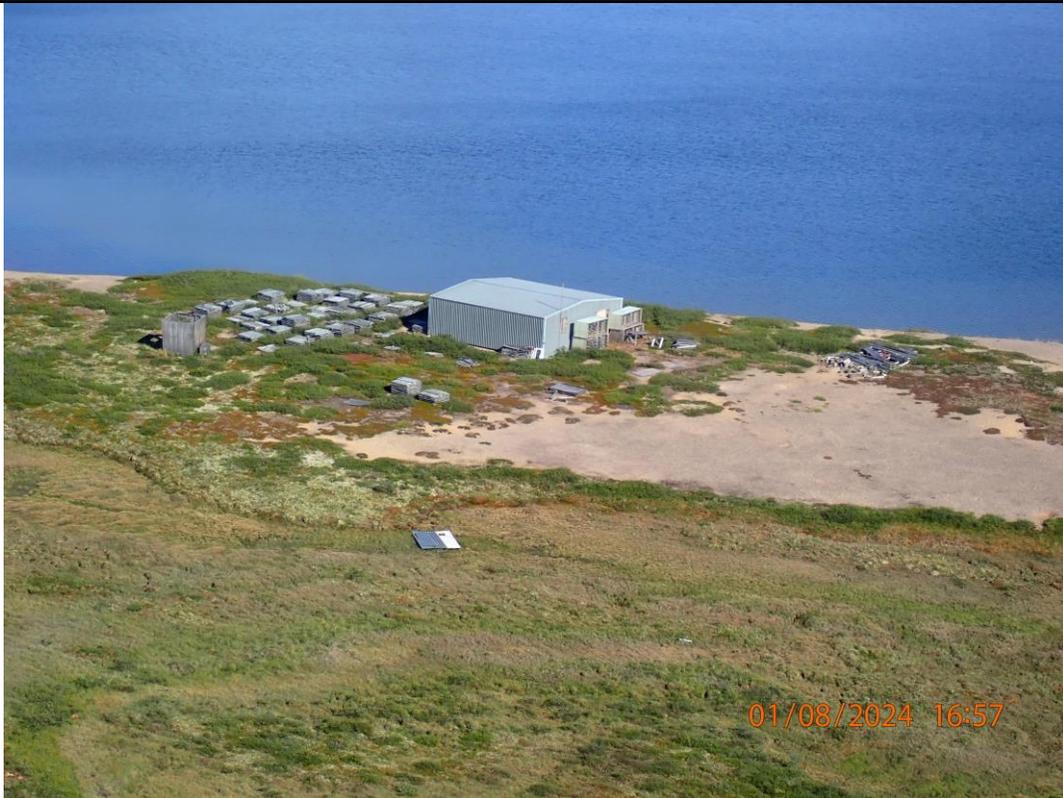
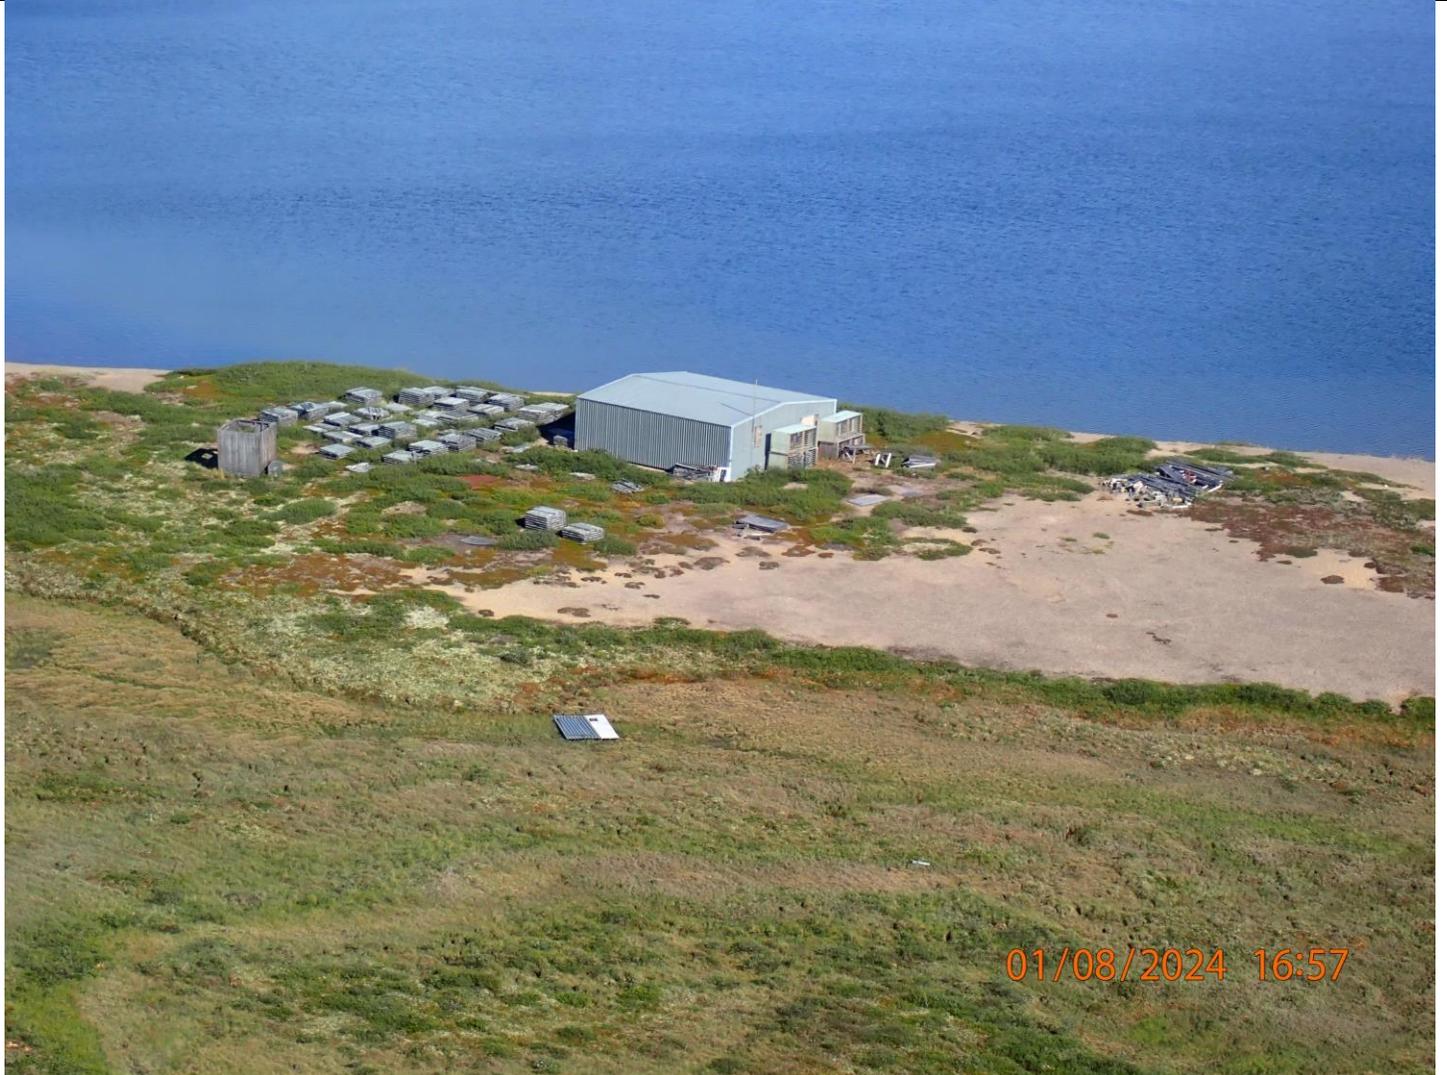
Photo 1

1. Inspectors arrived on site at 5:00PM on August 1st, 2024.
2. Aerial Photos were taken (Photo # 1 and #2)
3. Drill rods were present on site in a stacked manner. (Photo #3)

Description: Aerial View of Hood Camp. Core shack is the large building, core boxes, drill rods and an abandoned shack observed.

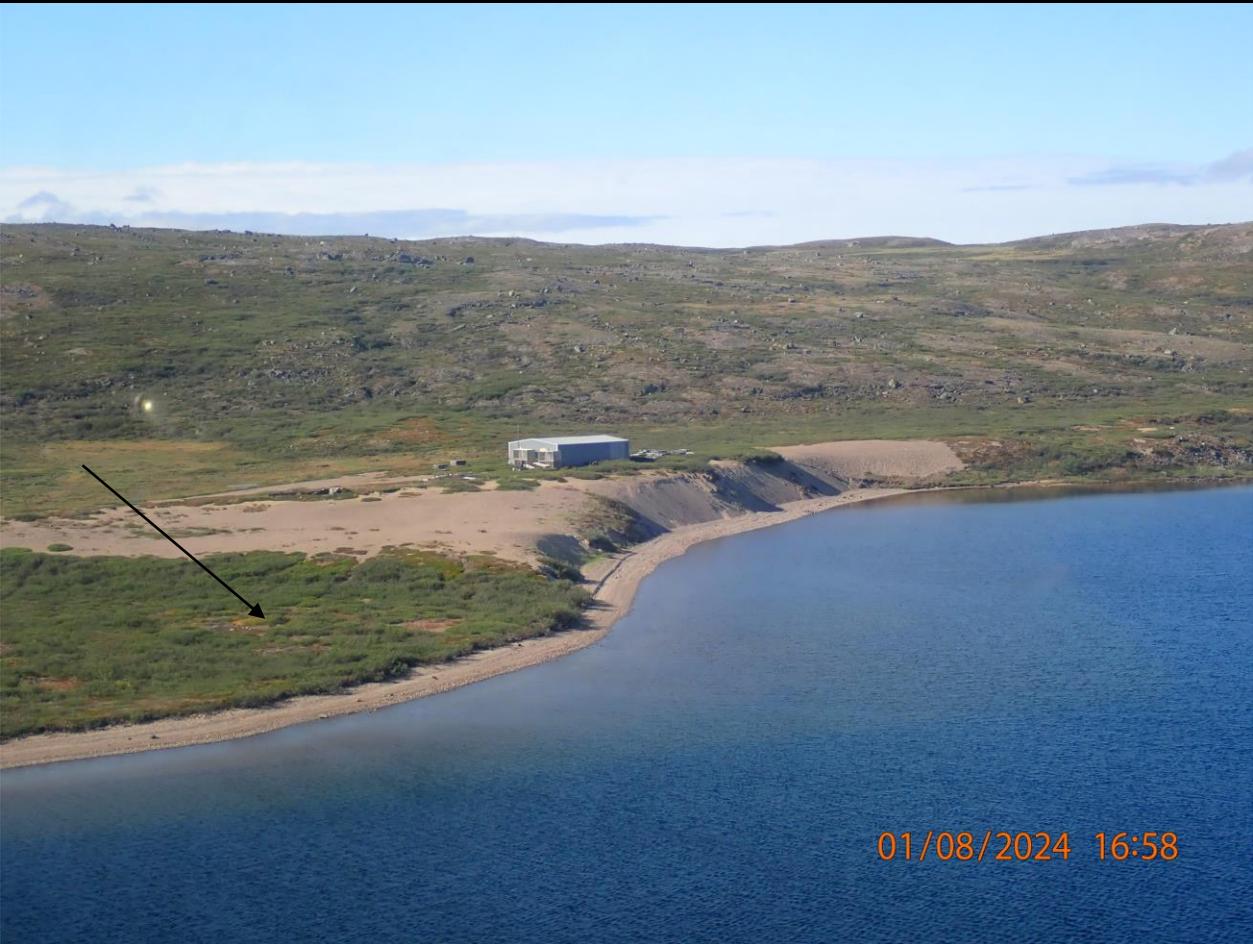
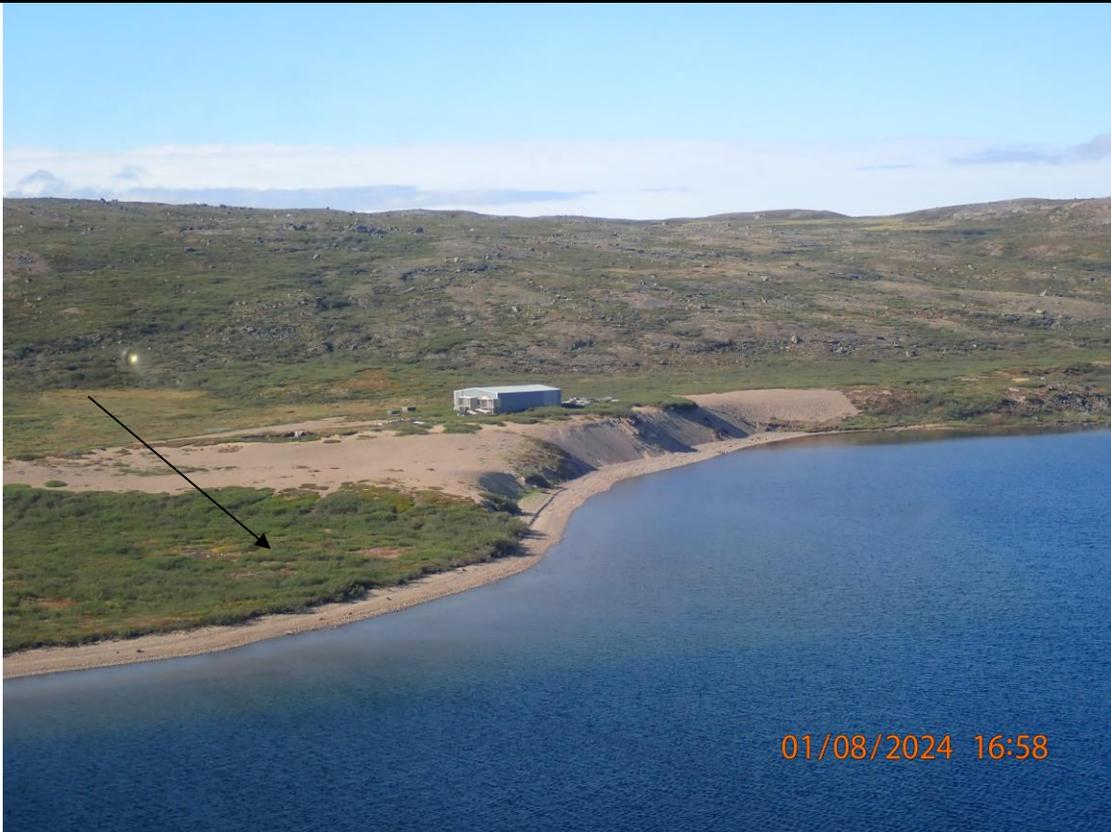
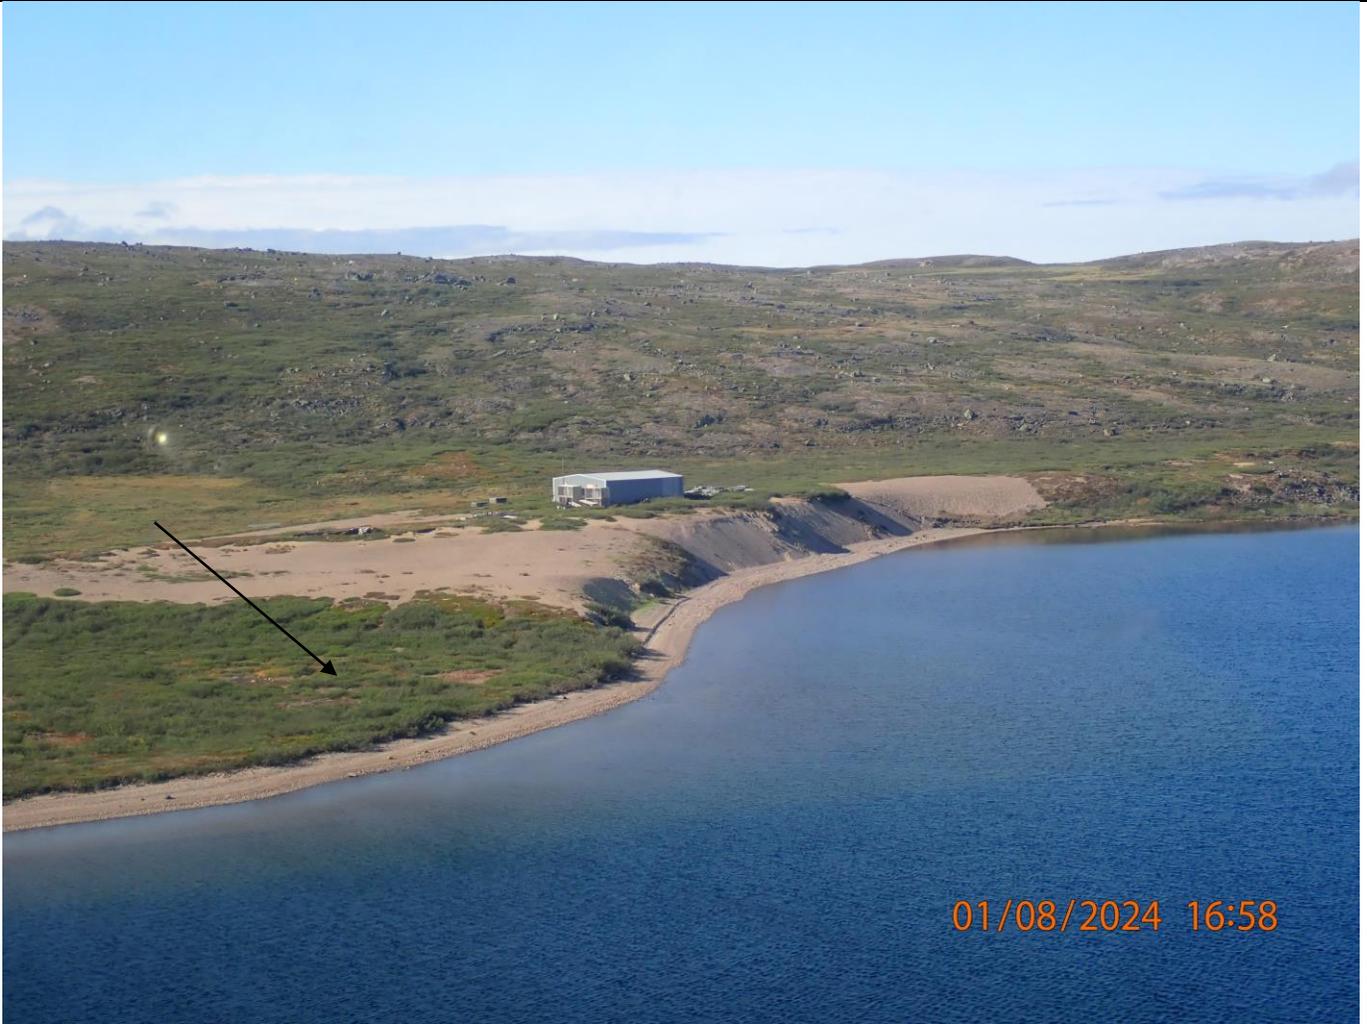
Photo 2

Description: Aerial View #2, showing the removal of 3 cabins that used to be where the arrow on the image is pointing.

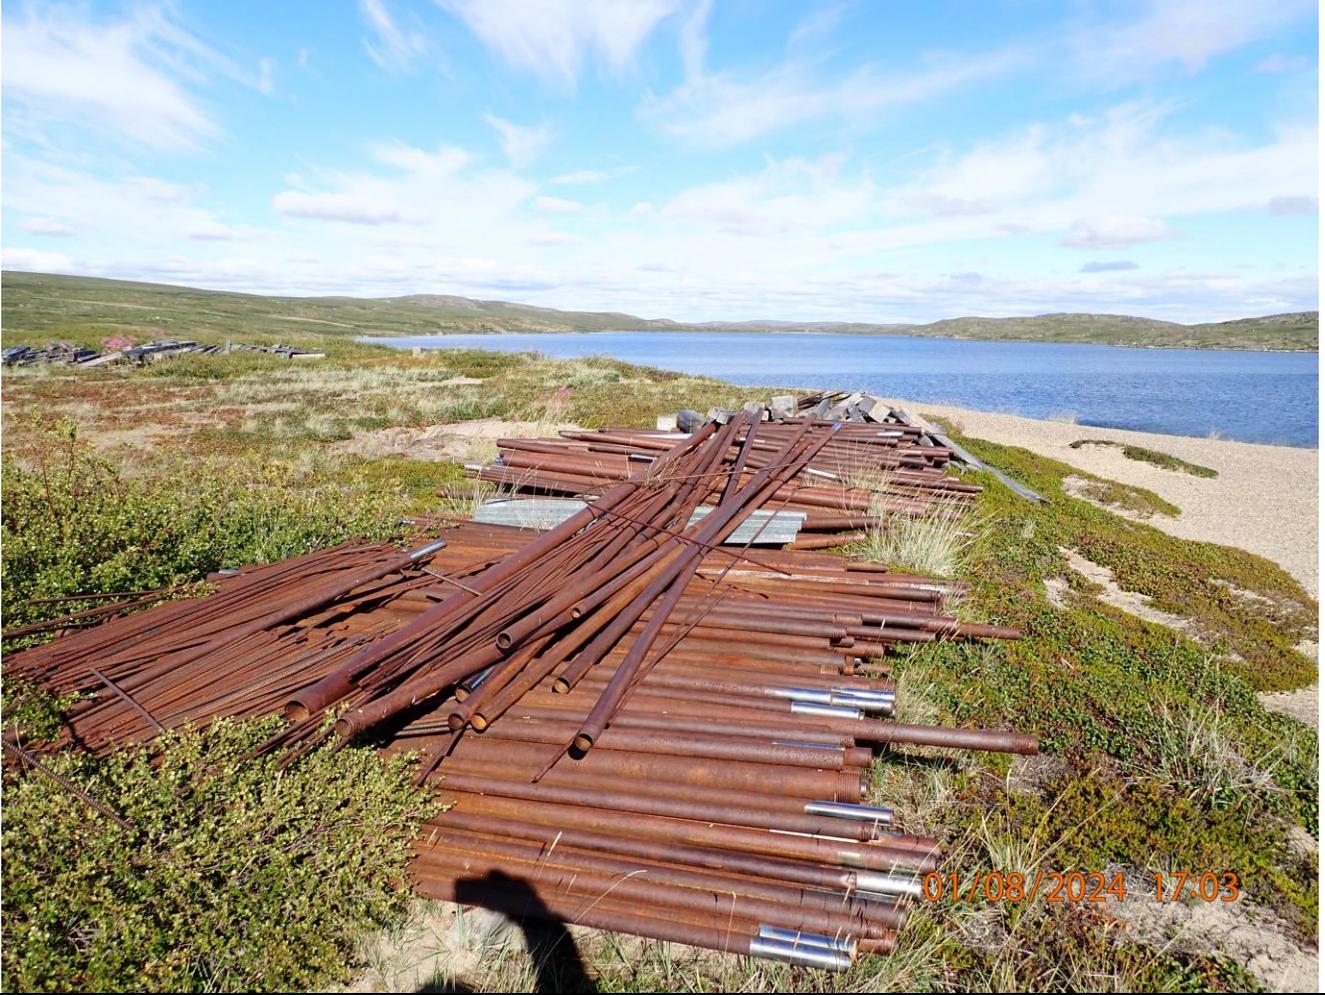
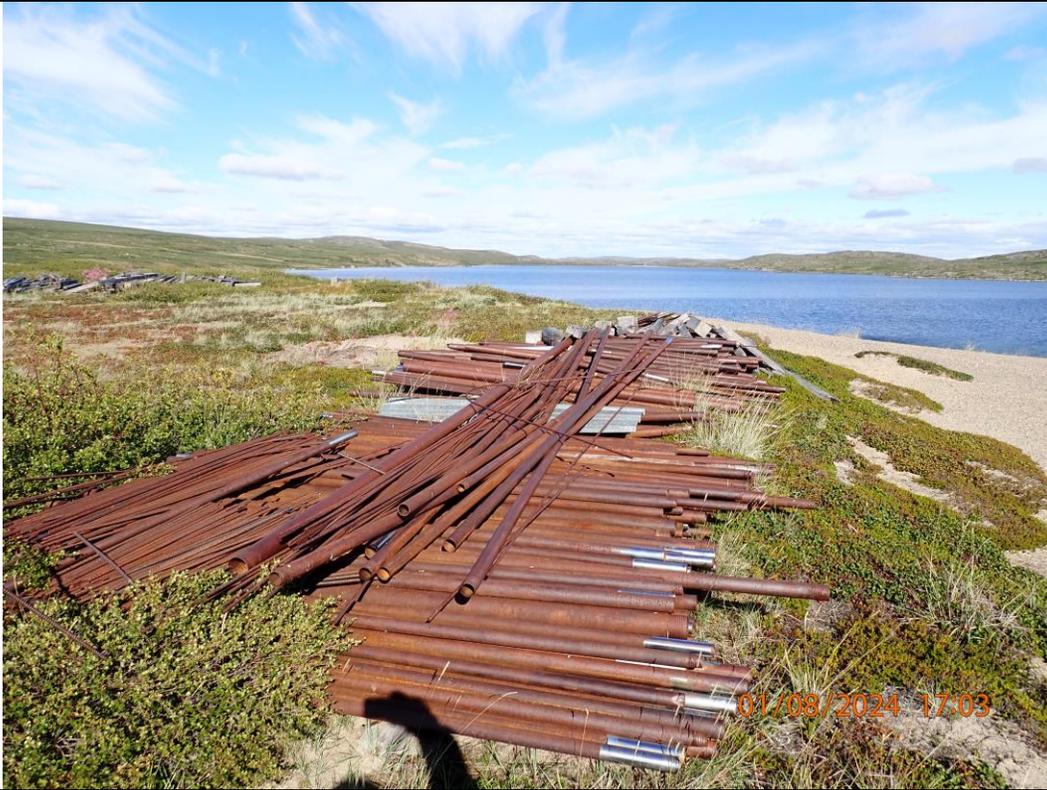
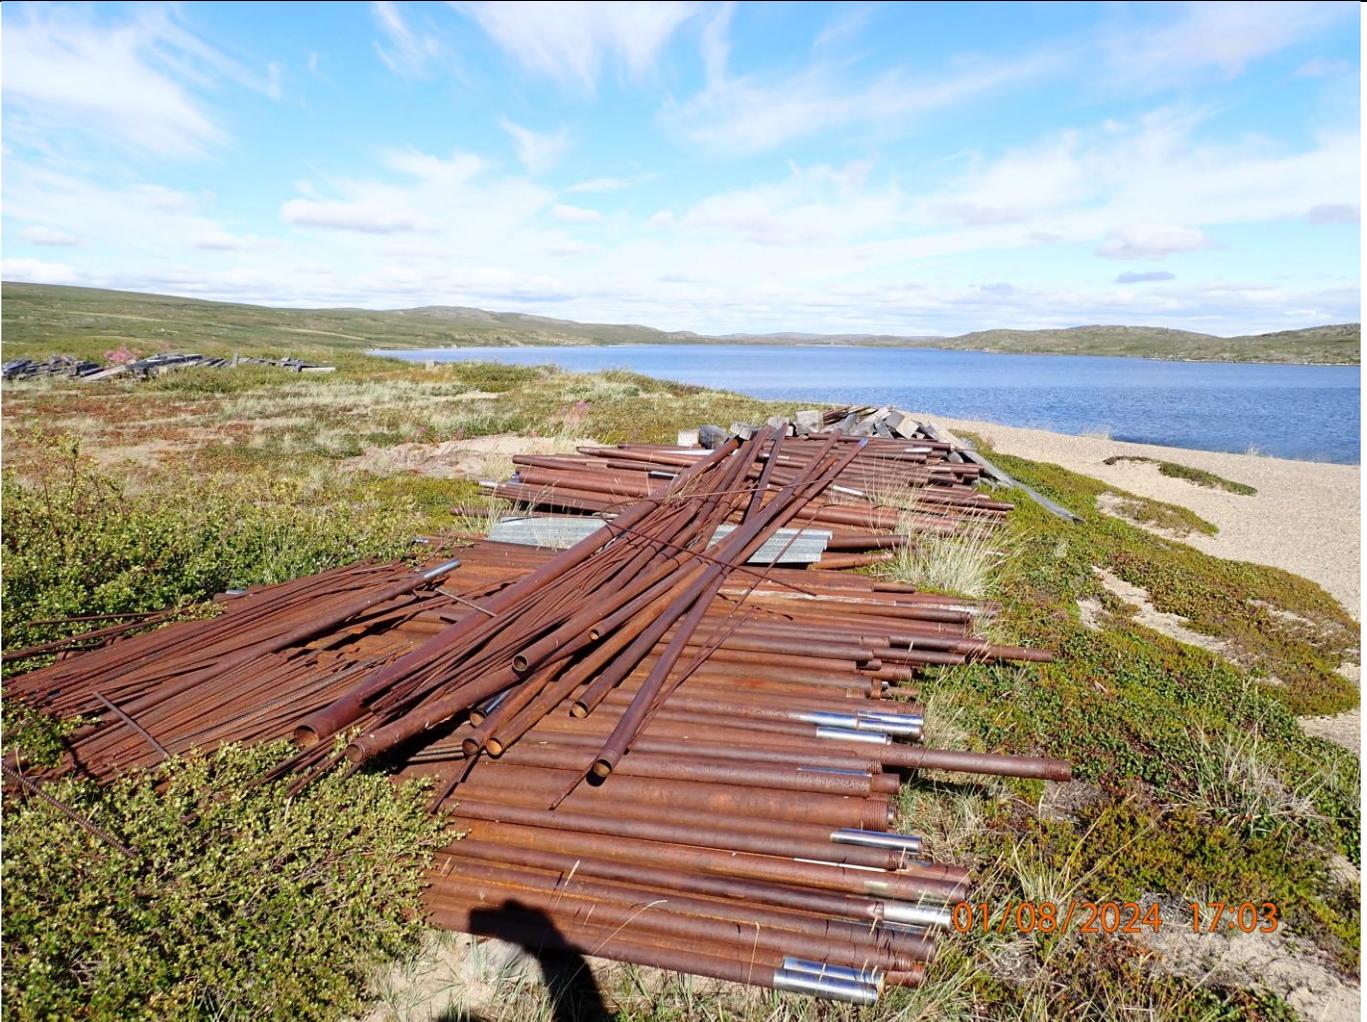
Photo 3

Description: Stack of drill rod present on site.

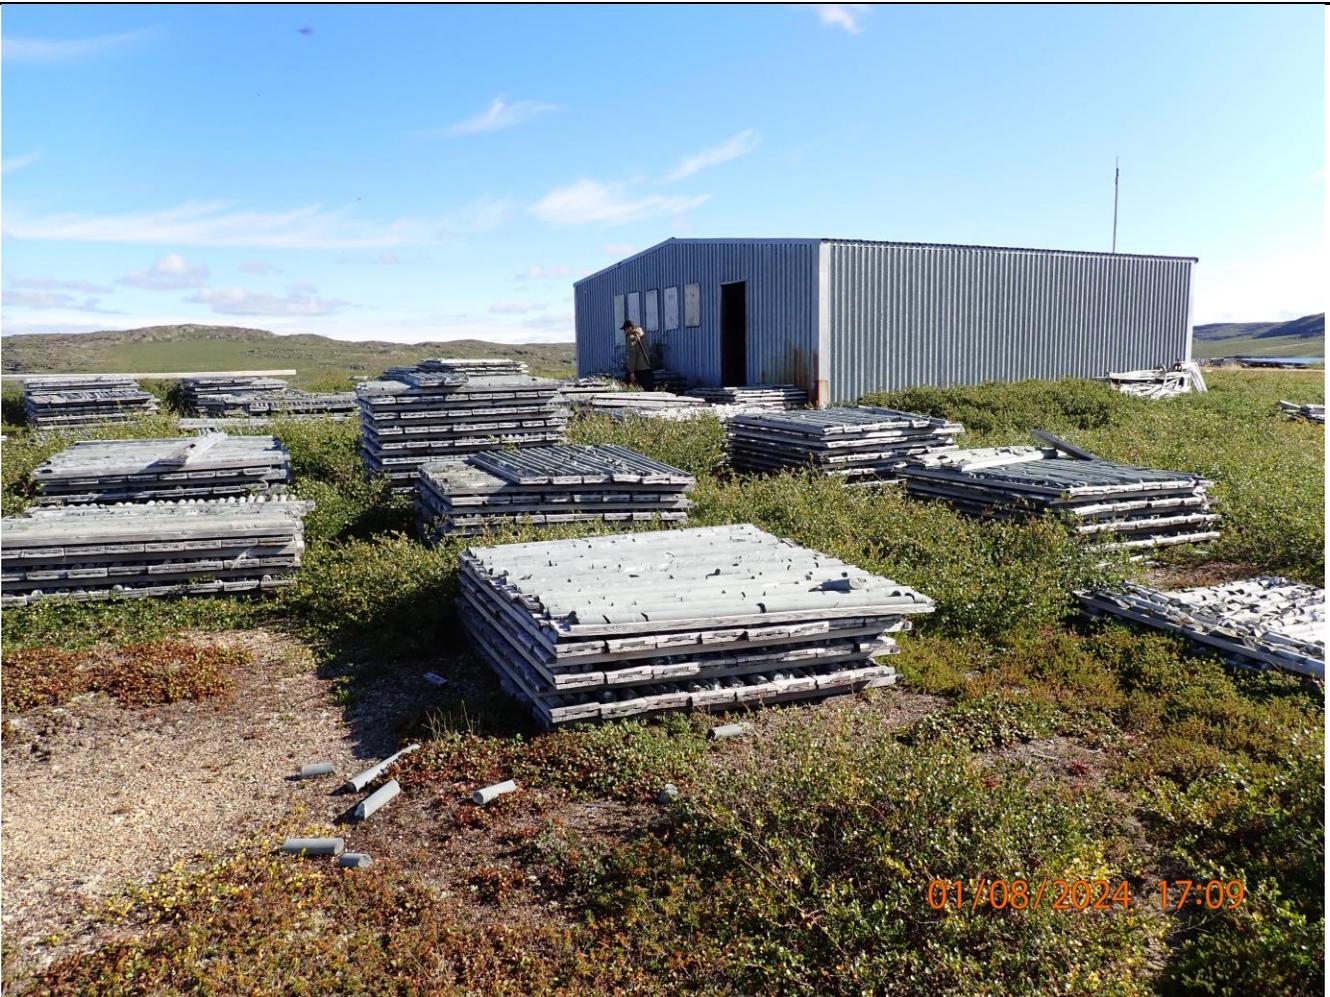
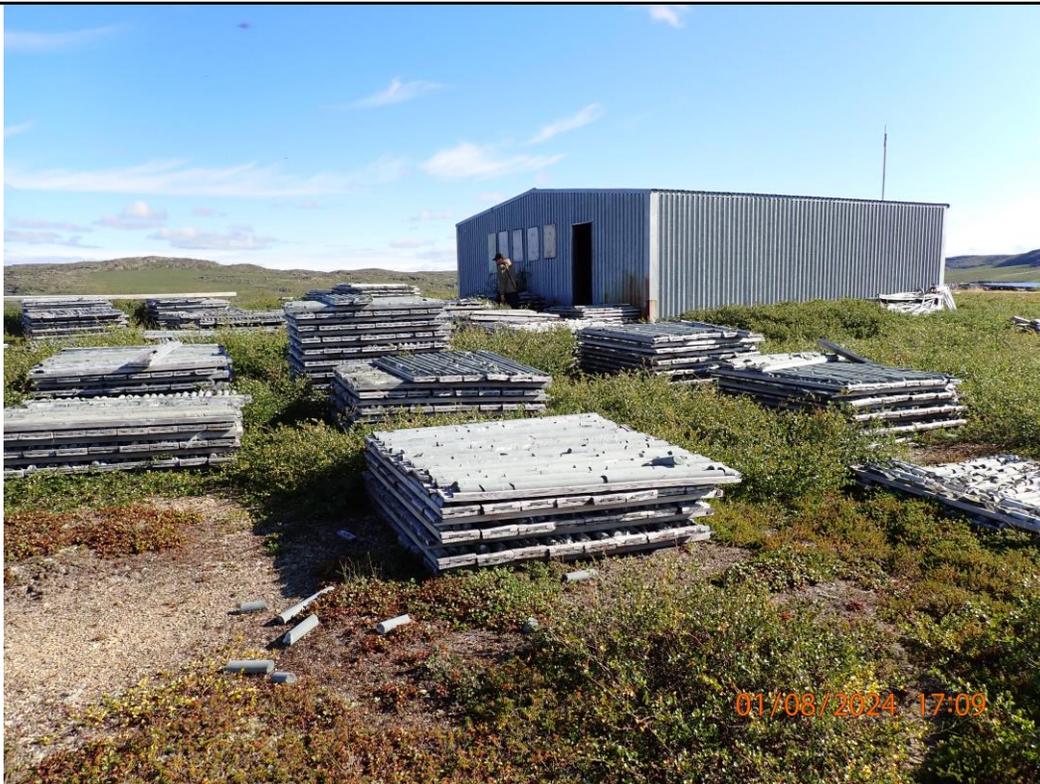
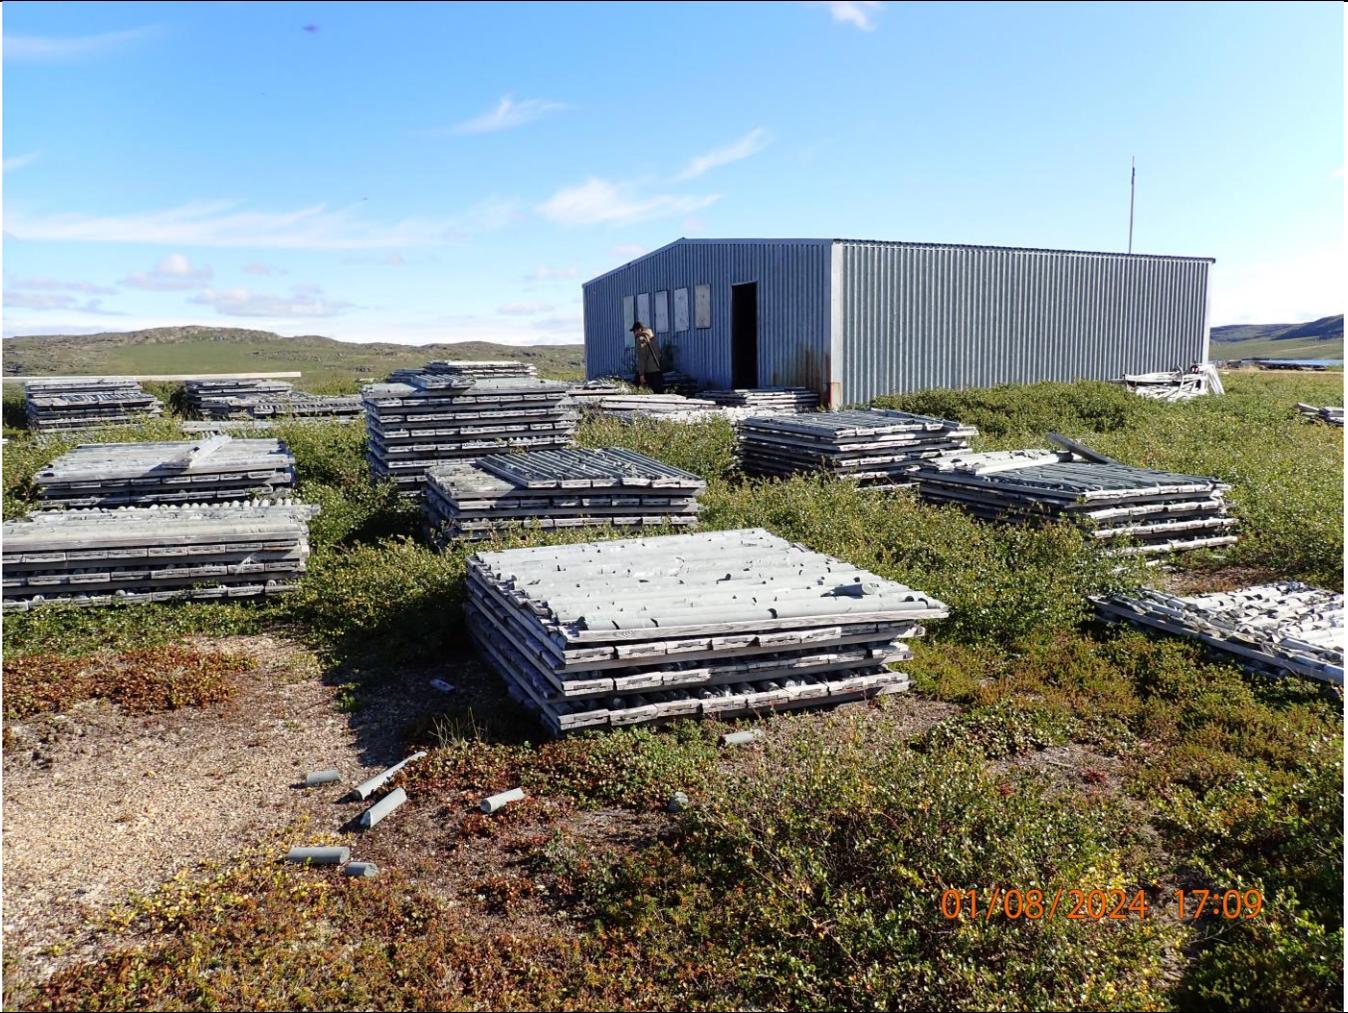
Photo 8

8. Core boxes were observed on the north side of the core shack. No issues noted. (Photo #8)
9. The door of the core shack was damaged and open. Signs of a bear breaking in were observed as the door was broken, scratched and chewed up (Photo #9)

Description: Core boxes outside, core shack (Silver) shown with an open door
