Attachment 12 – Inspections and Responses

CROWN LAND USE INSPECTION FORM

WATER LICENCE INSPECTION FORM

Reference: Ham Lake Camp Inspection

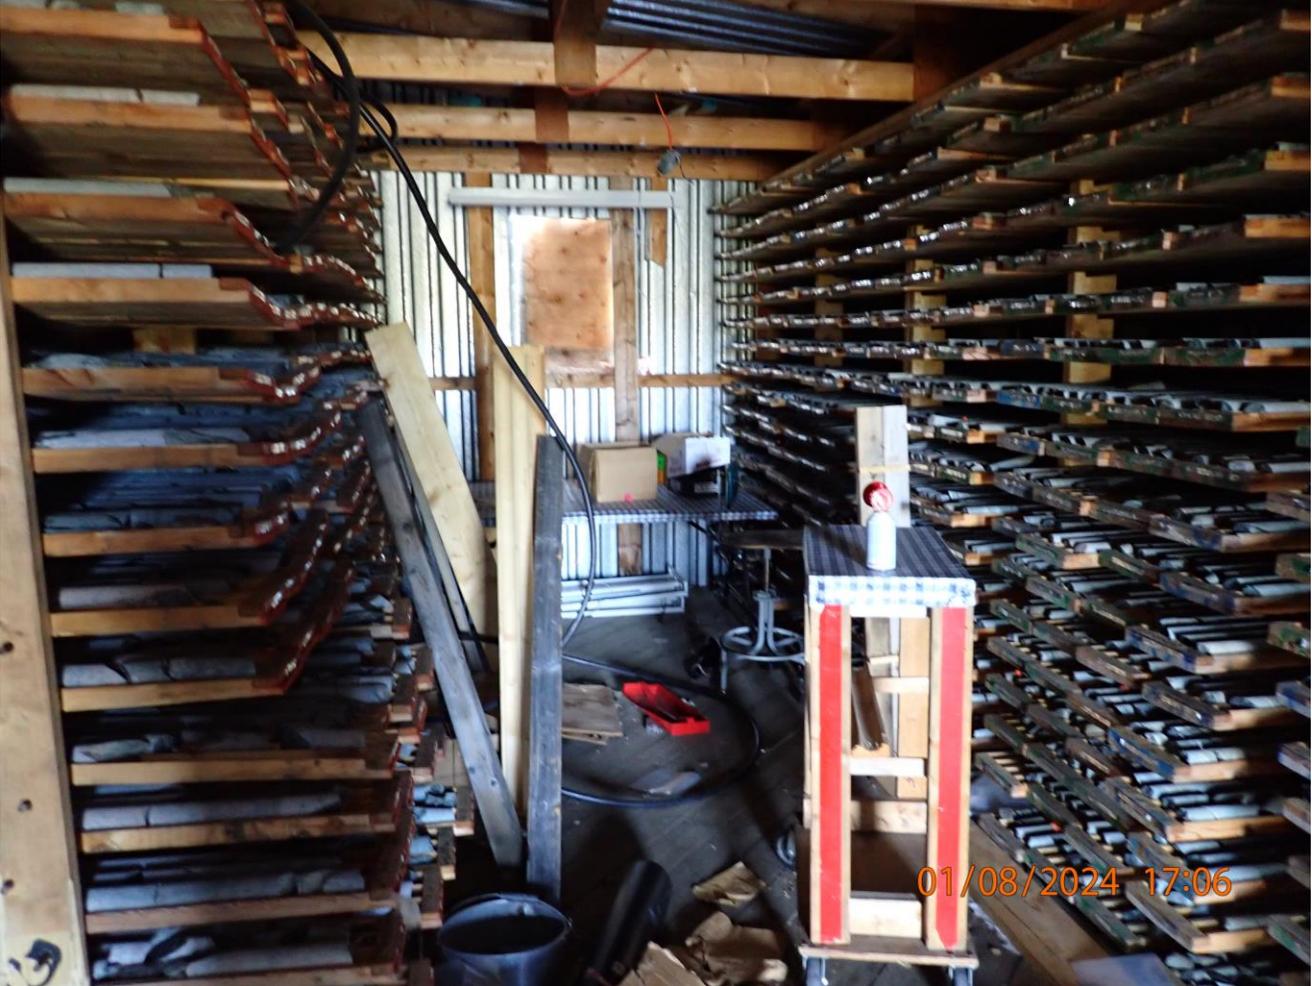
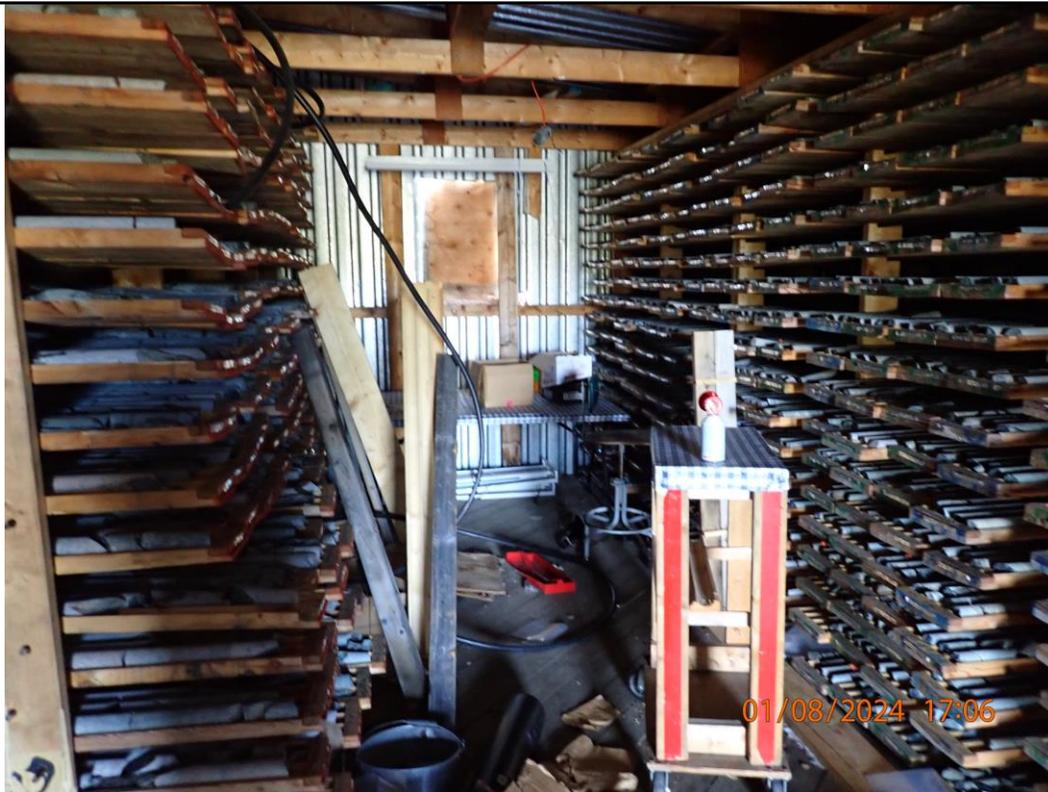
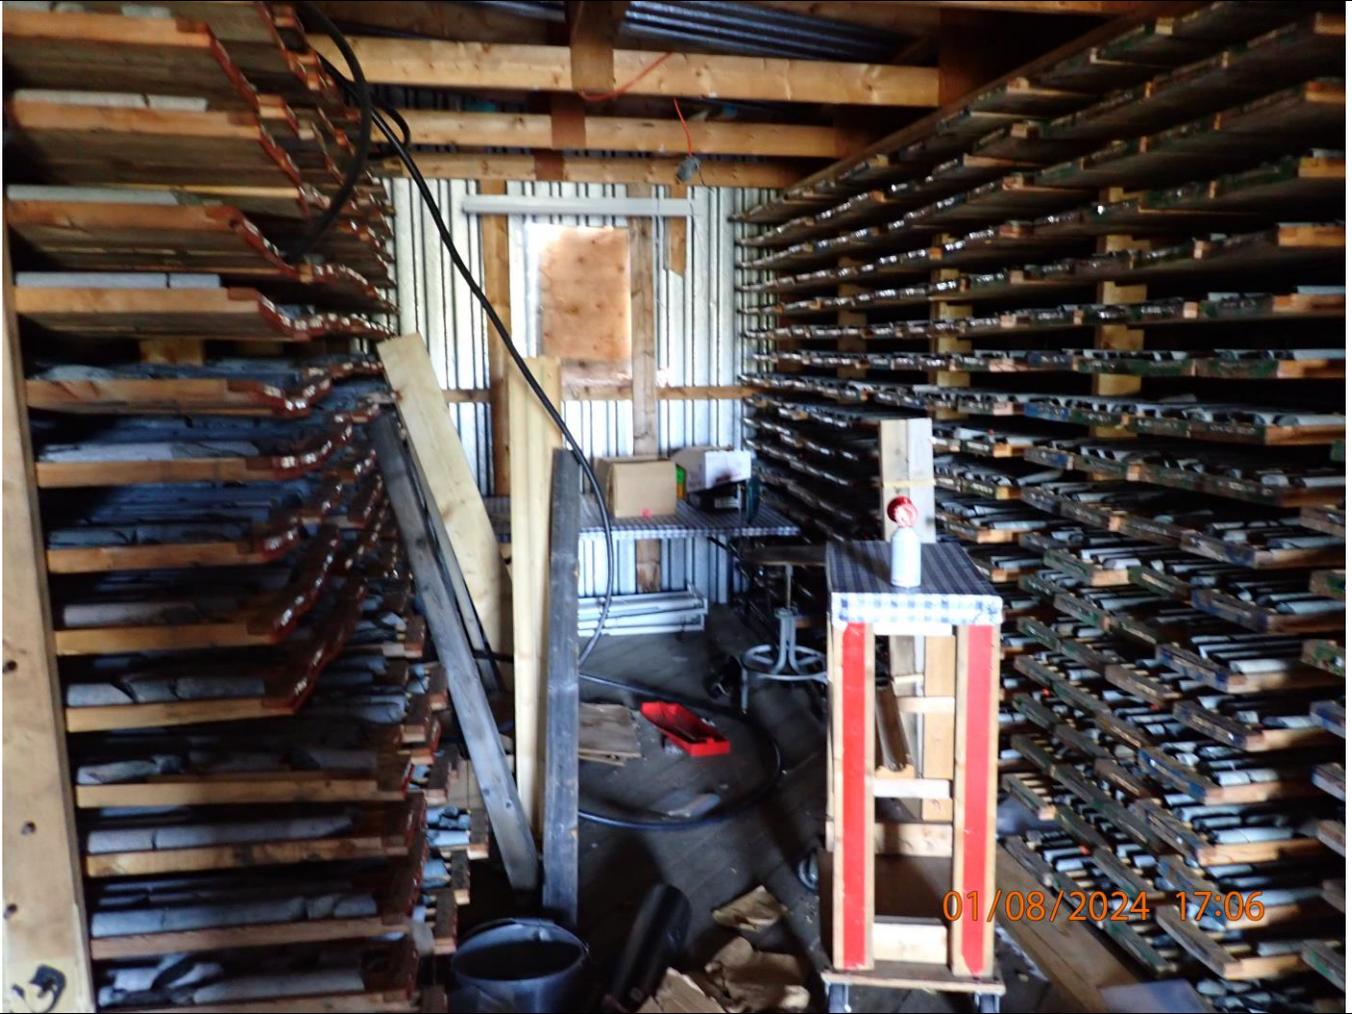
Photo 10

Description: Active tank farm, 6 tanks

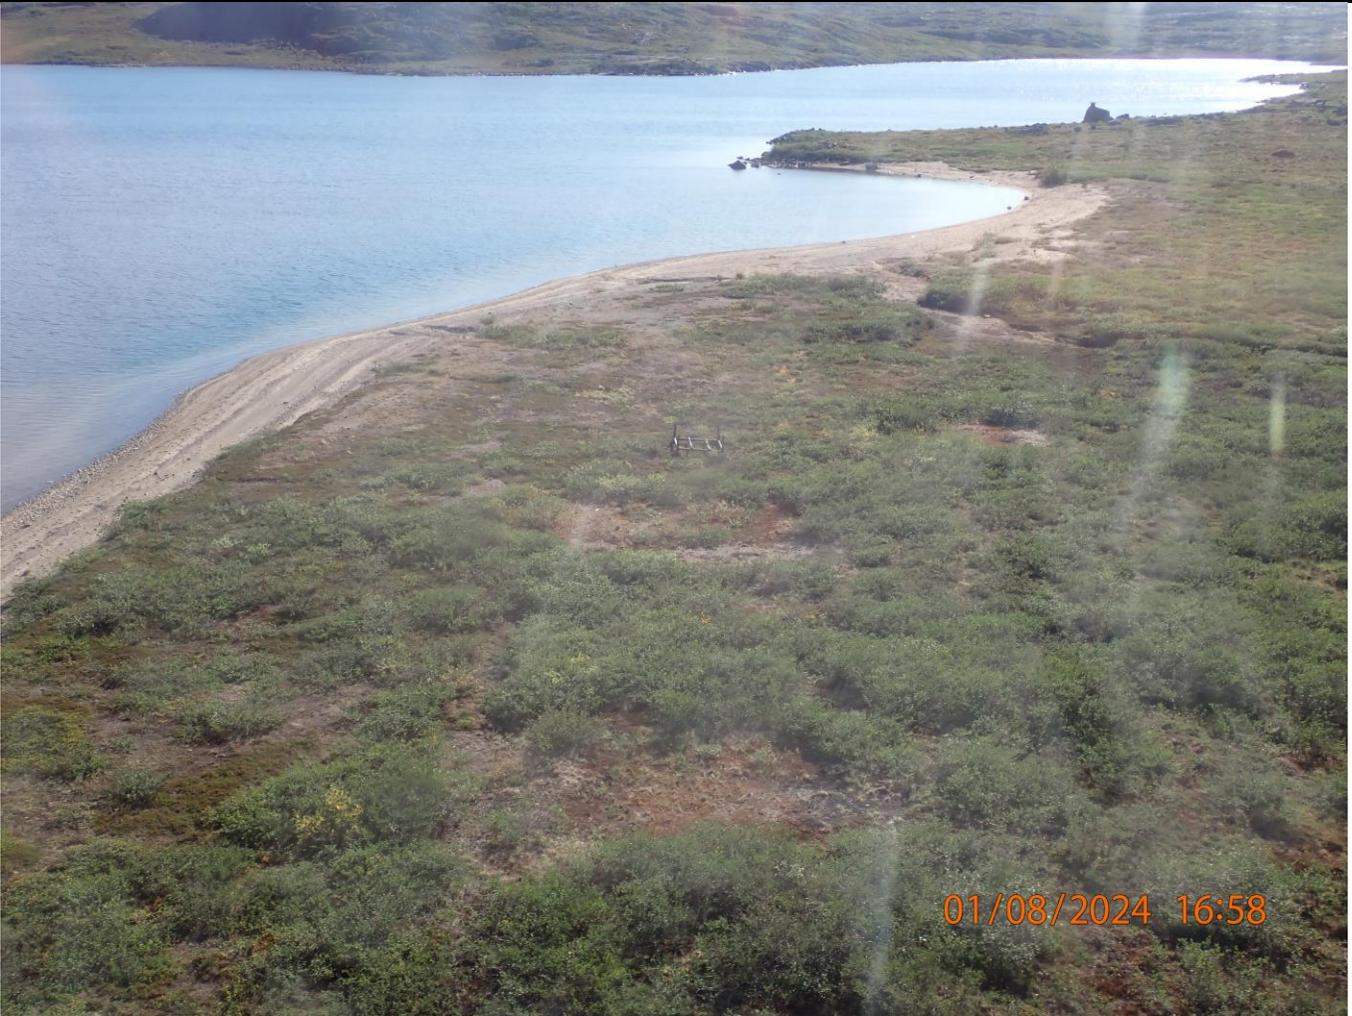
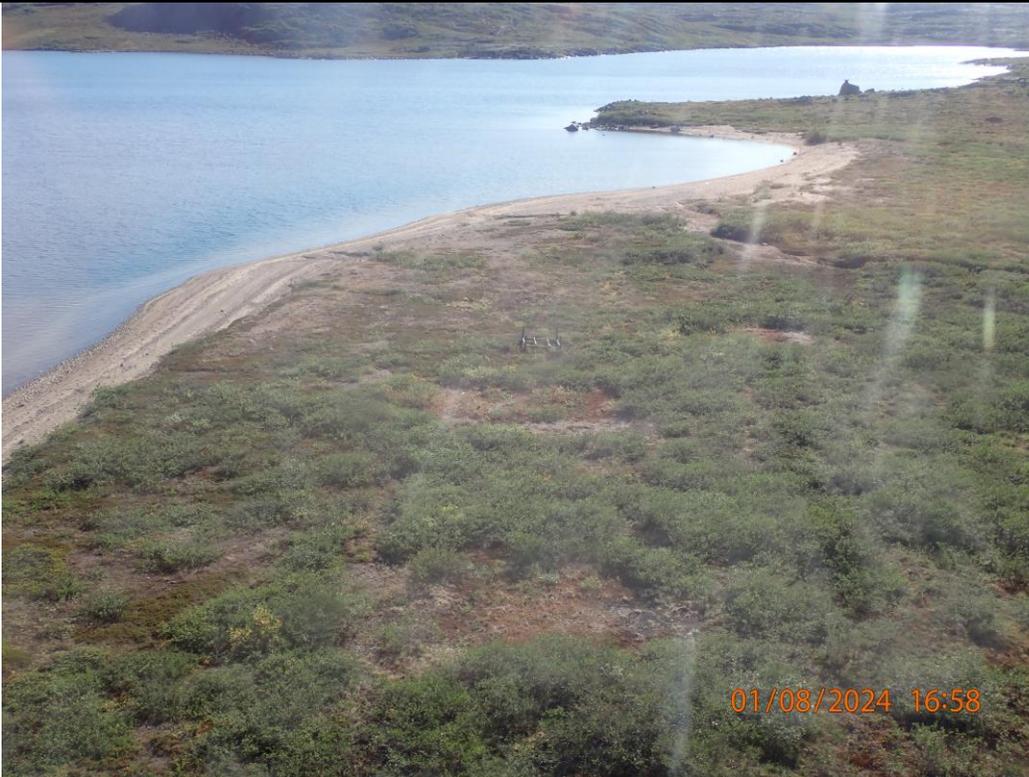
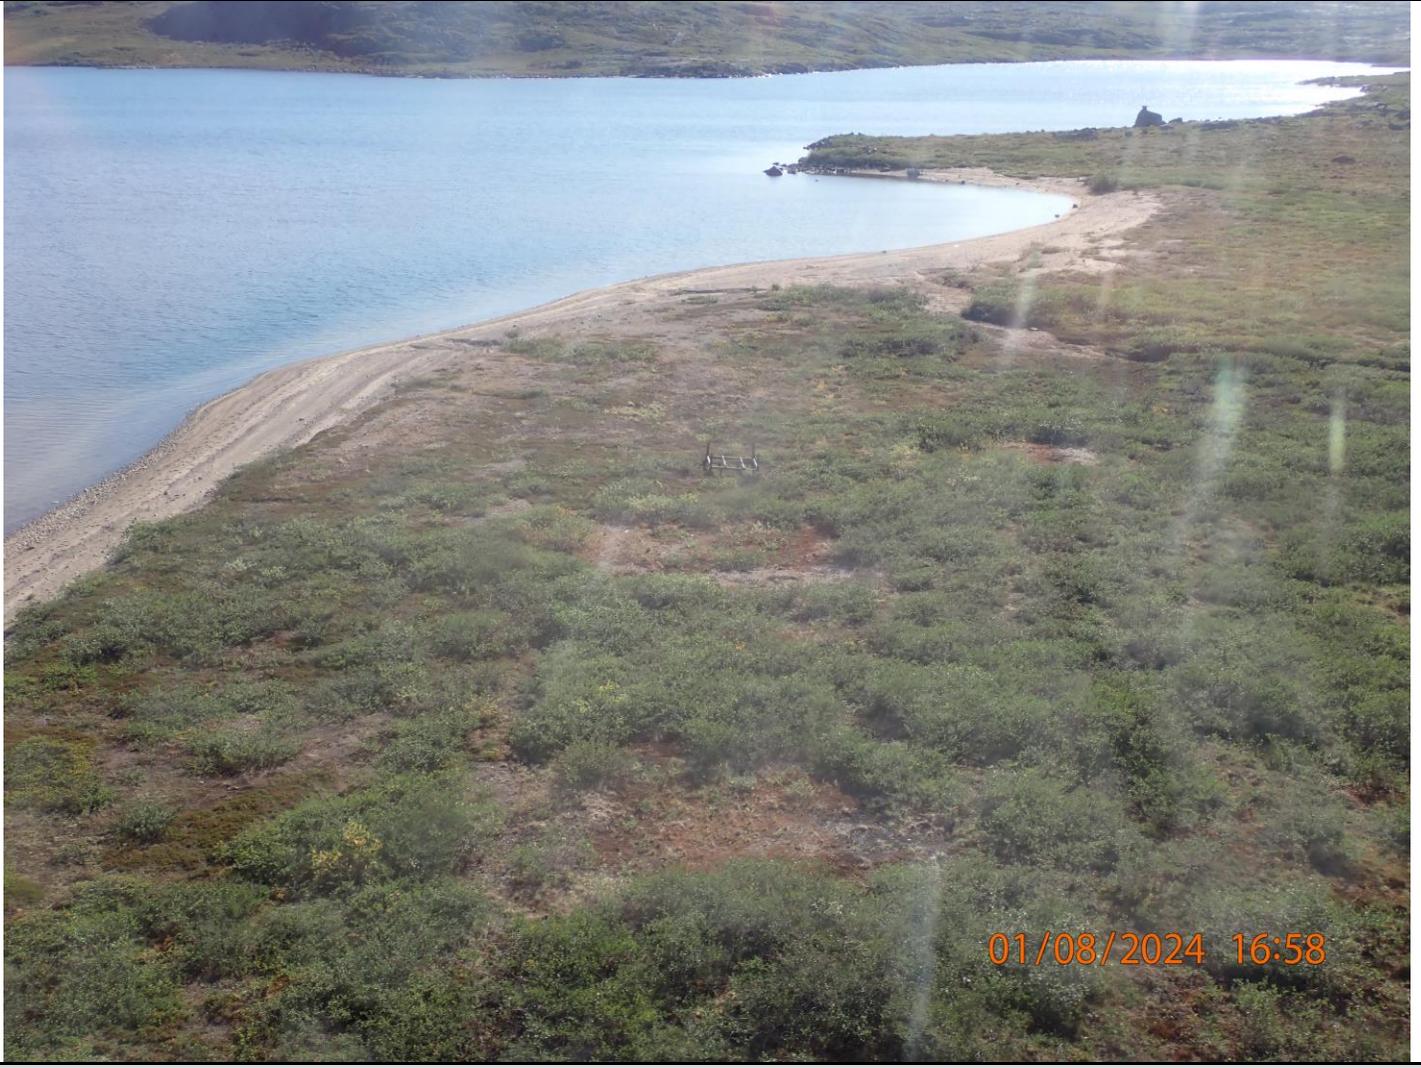
Photo 11

10. Signs of a bear staying in the core shack were observed. Debris and mess were observed all around the floor (Photo #10 and #11)
11. A steel frame was observed close to the shore of the lake (Photo #12)

Description: A large steel frame on the tundra close to where old cabins were situated.

Removal of equipment, site restoration.

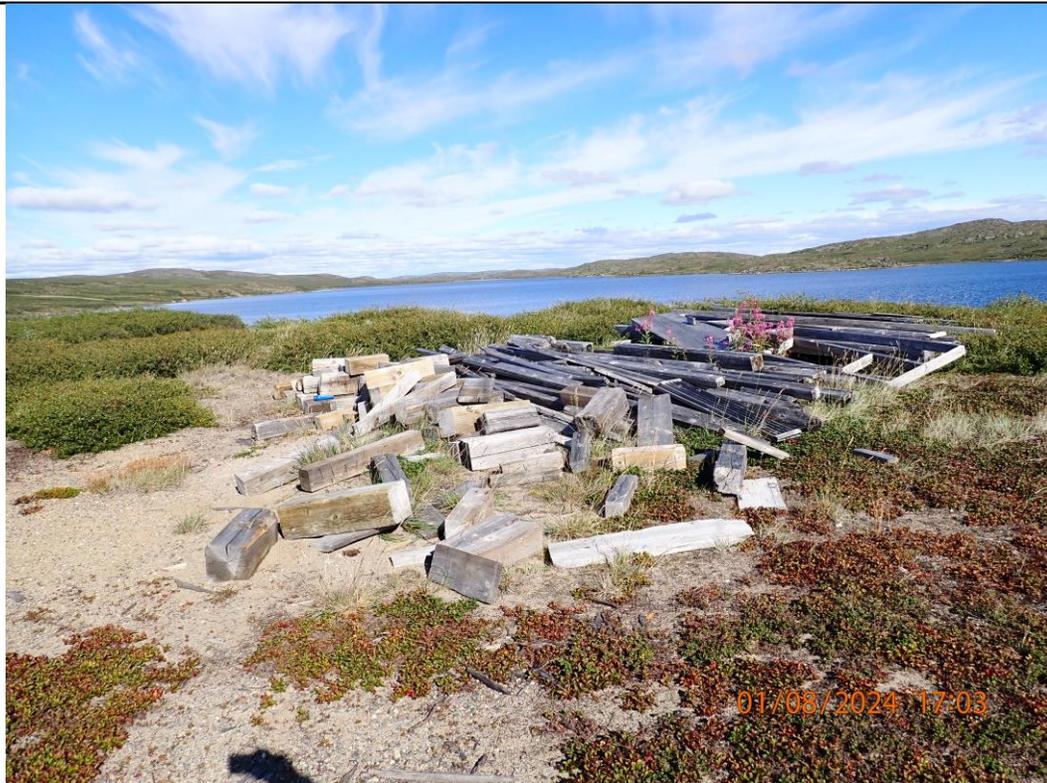
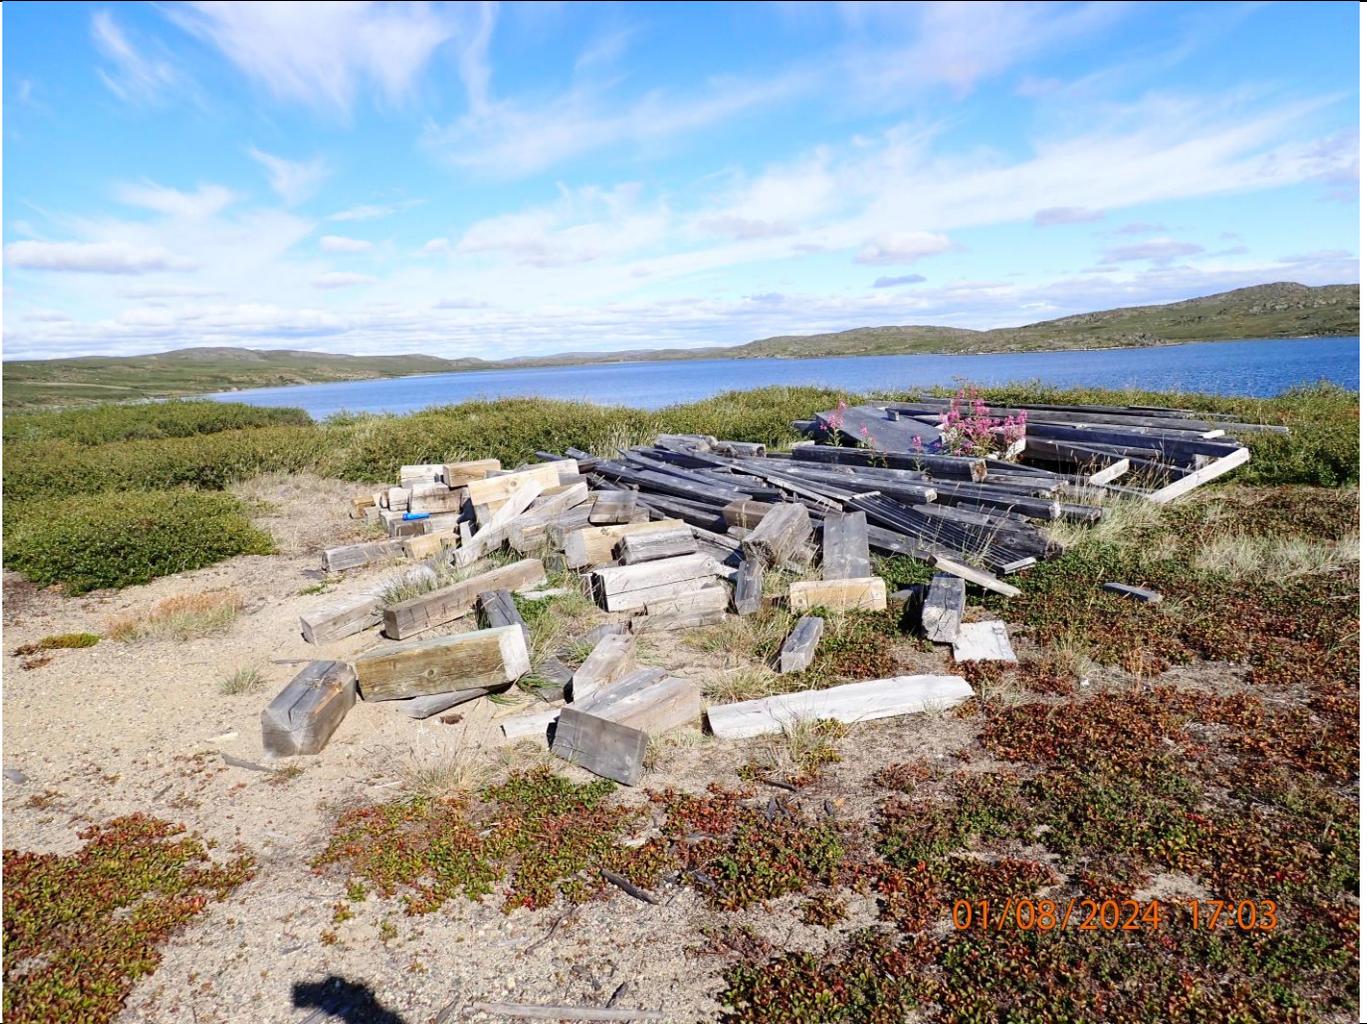
Photo 4

4. A pile of lumber was observed on site (Photo # 4)
5. Roofing material was stacked on top of a wooden wall in the tundra (Photo #5)
6. Ply wood debris observed on the ground behind the core shack. (Photo #6)

Description: Stack of Lumber present on site.

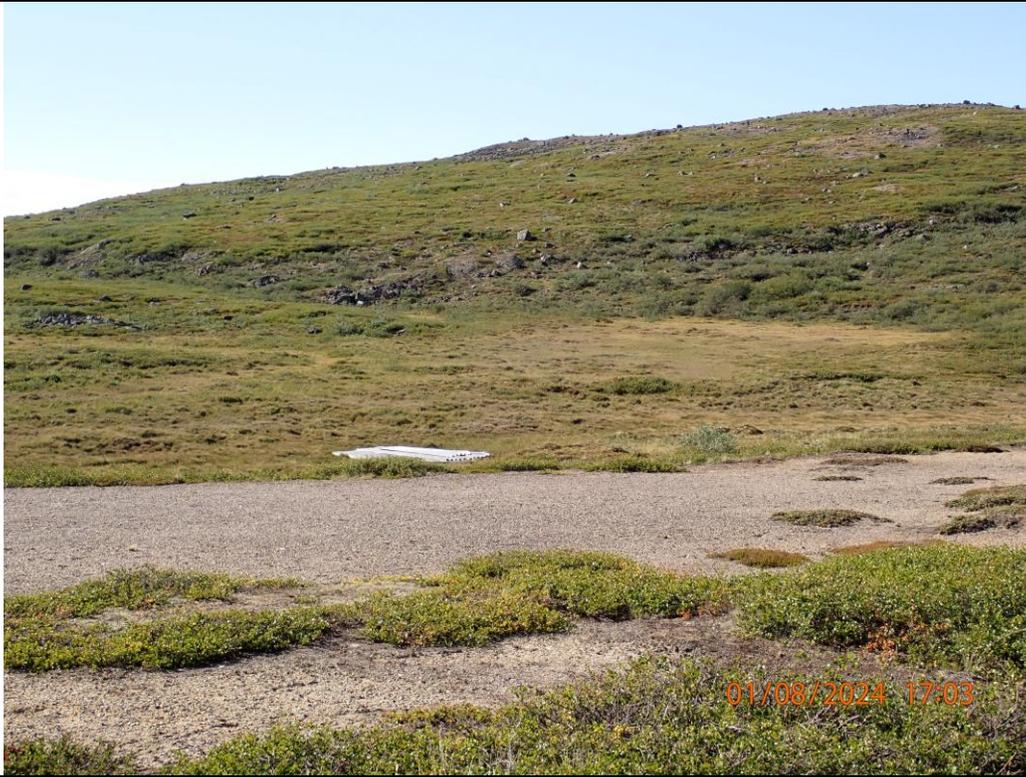
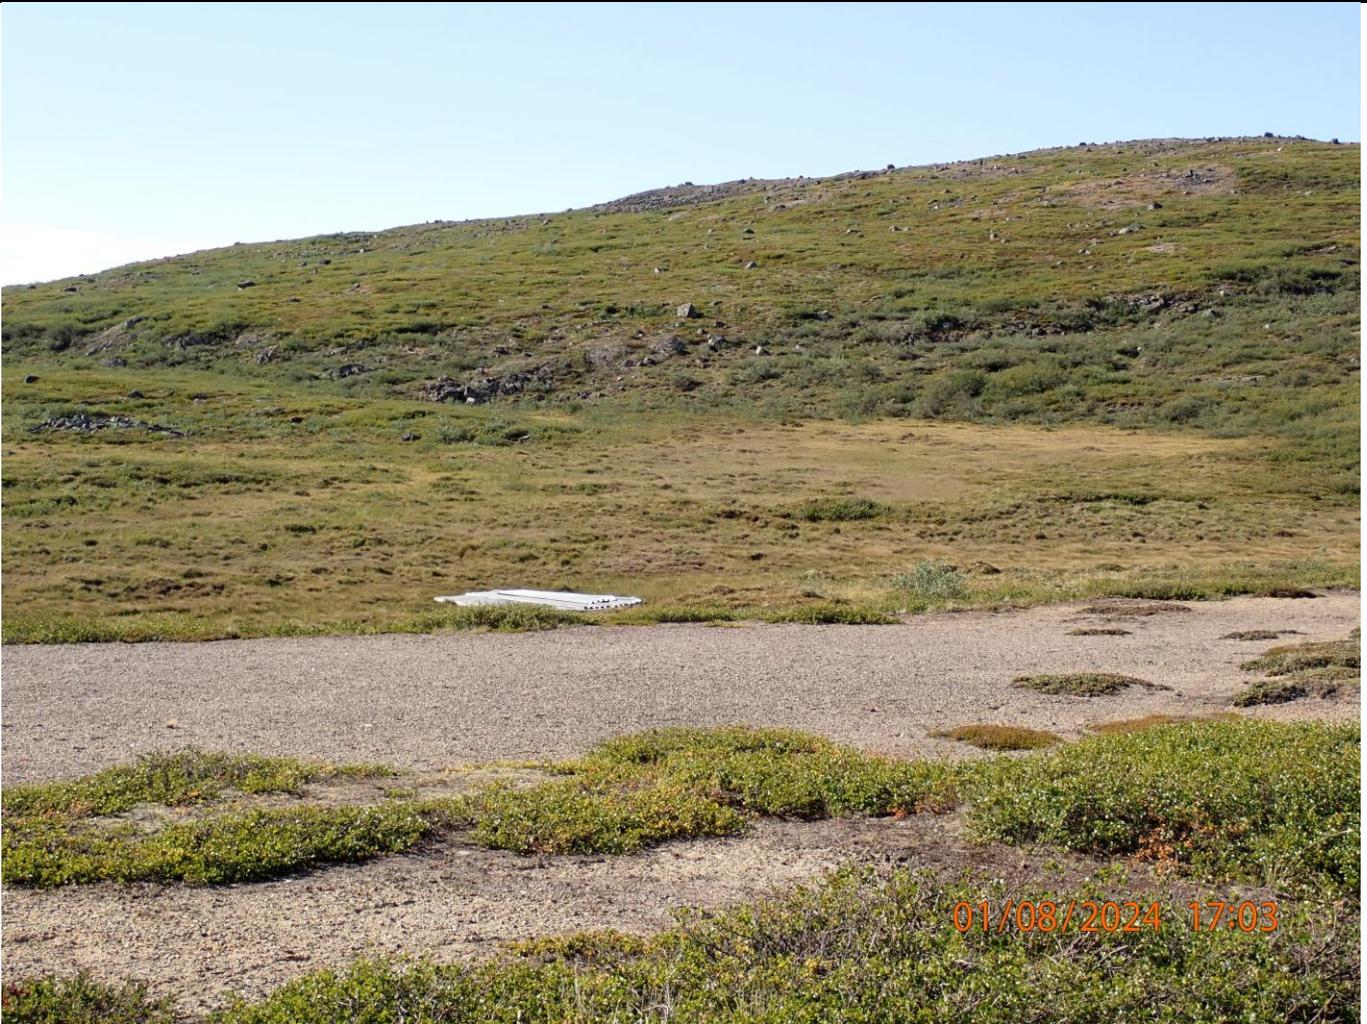
Photo 5

Description: Metal sheet roofing placed on top of a wooden wall in the tundra.

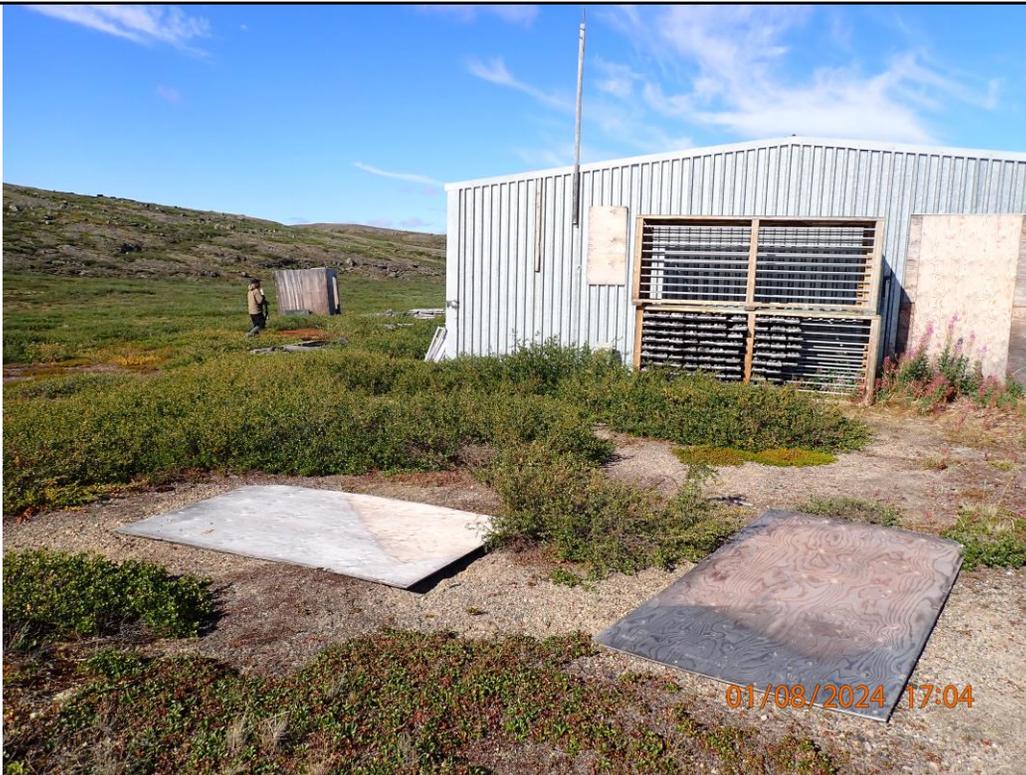
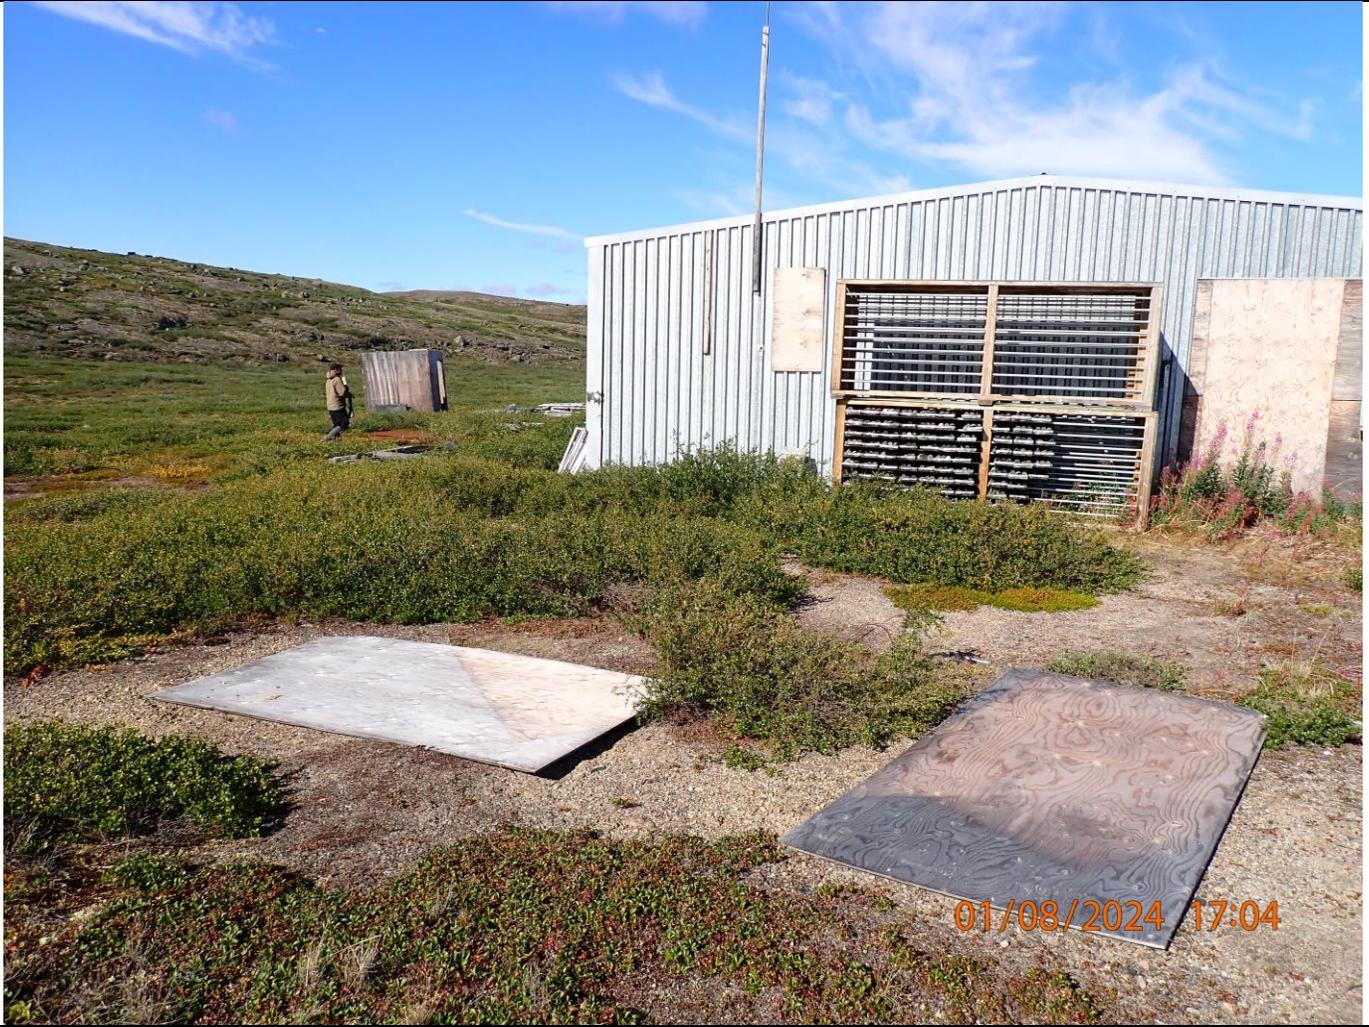
Photo 6

Description: ply wood debris behind the core shack (silver)

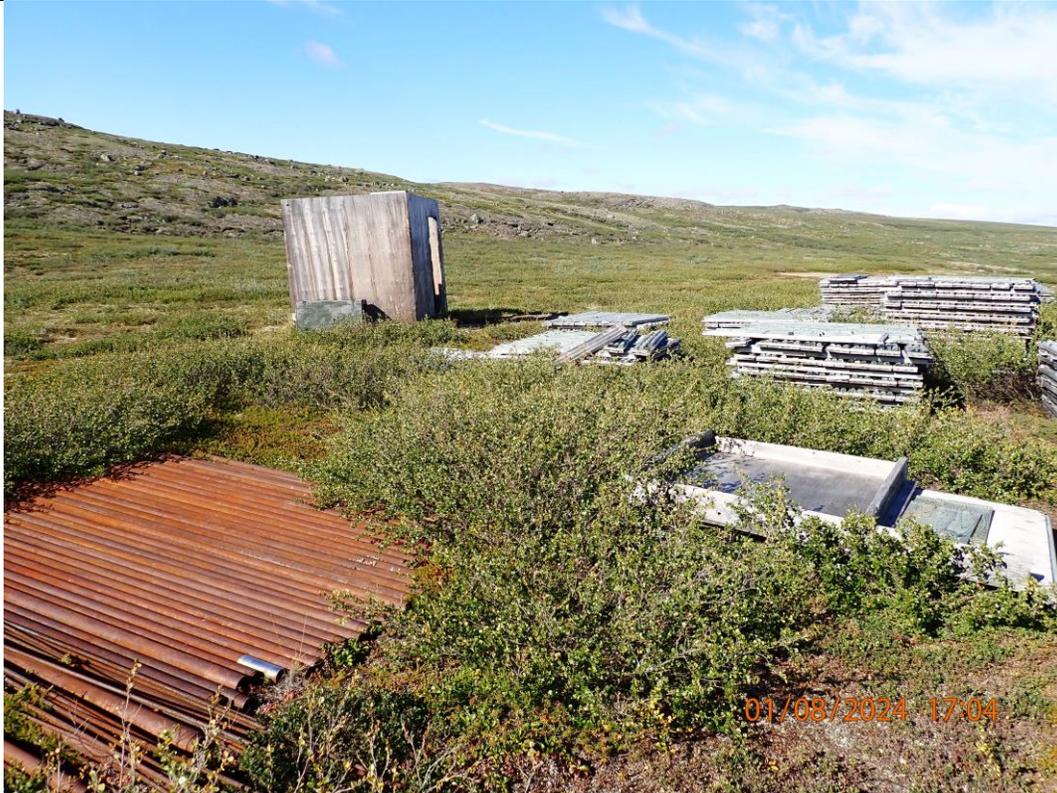
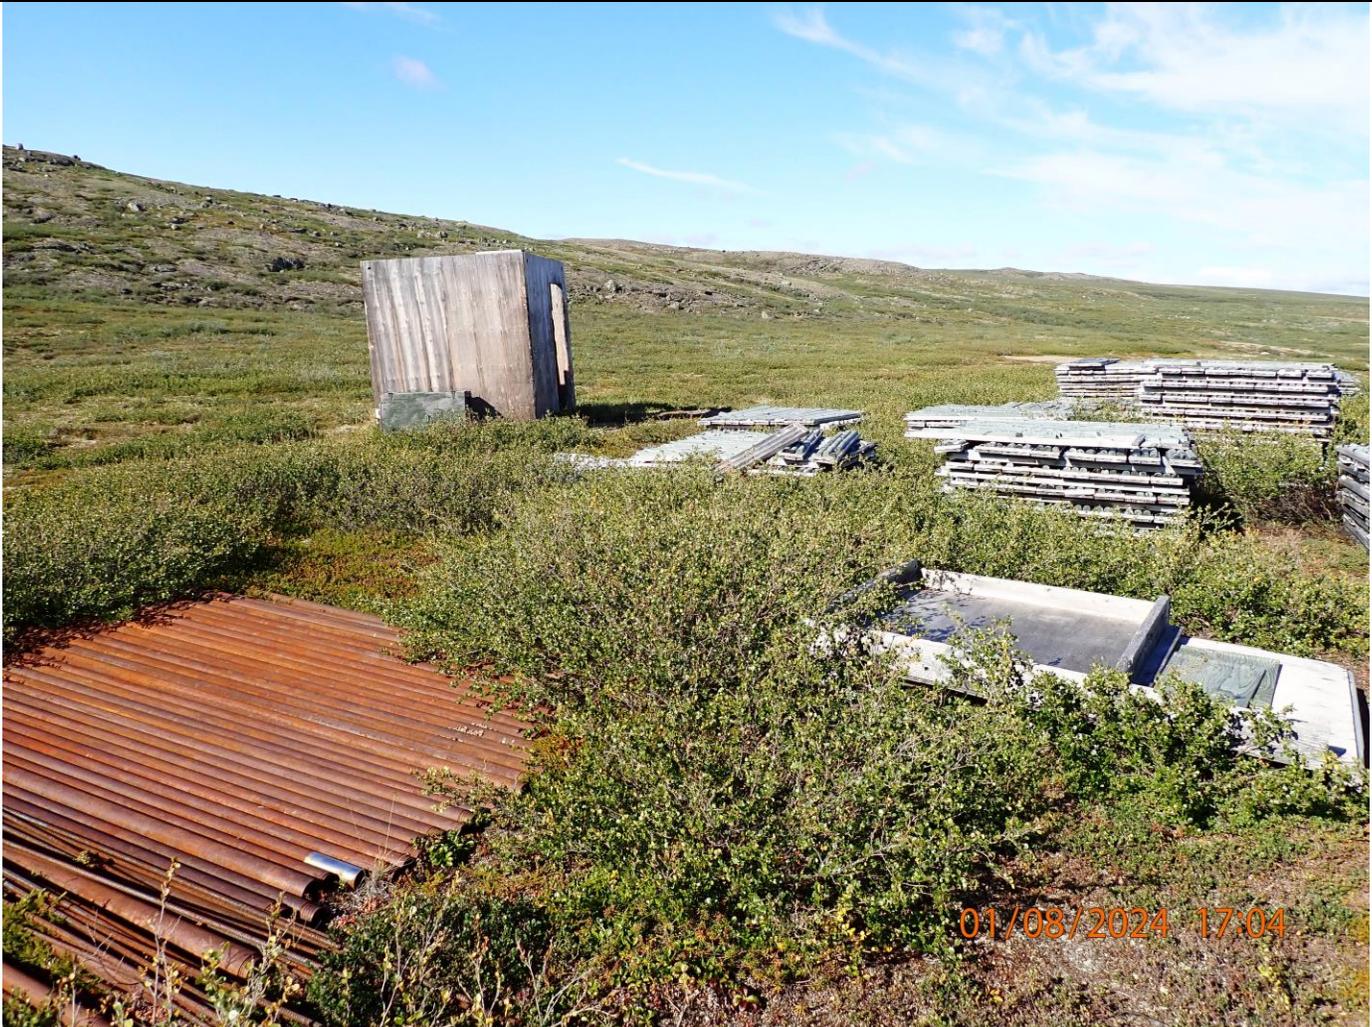
Photo 7

7. A small abandoned shack was observed on site with no roof and no door. There was nothing in the shack that would attract wildlife. Reclamation of this building is required. (Photo #7)

Description: Stacked drill rods, abandoned shack and some core boxes.
