Re: Kiggavik – Follow-up Report to June 23, 2009 spill of potentially contaminated drill muds

**AREVA Resources Canada Inc.
Kiggavik Project, Nunavut**

Final Incident Report for June 23, 2009 Spill

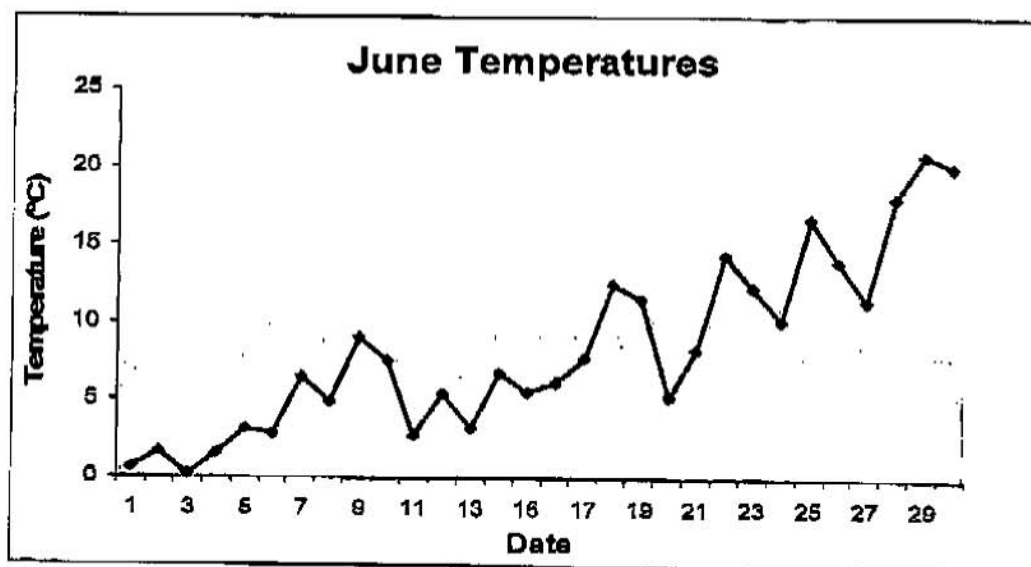
Graph 1 – Daily High Temperatures in June

increase in snow melt (Graph 1). The red coloured water from the drill casing mixed with melt water was able to make its way to the closest temporary stream. Sandbag berms were put in place prior to installation of casing in close vicinity of drill. Casing was installed during the night and further sandbagging within the area was not installed once the direction of water flow was established. Dayshift crew did not do any further sandbagging and continued to drill during the day. Daily inspections were conducted by Radiation and Environment supervisor at approximately 1500 hours on June 22nd, and discovered the run off of drill casing water flowing toward the stream. At this time, a sandbag berm was put in place to prevent further flow of drill casing water. (Figures 5 and 6).
